## **Phase One Environmental Assessment**

*Proposed Development at Riverside Drive and Hunt Club Road, Ottawa Ontario*

**Golder Associates Ltd.**

December 2022

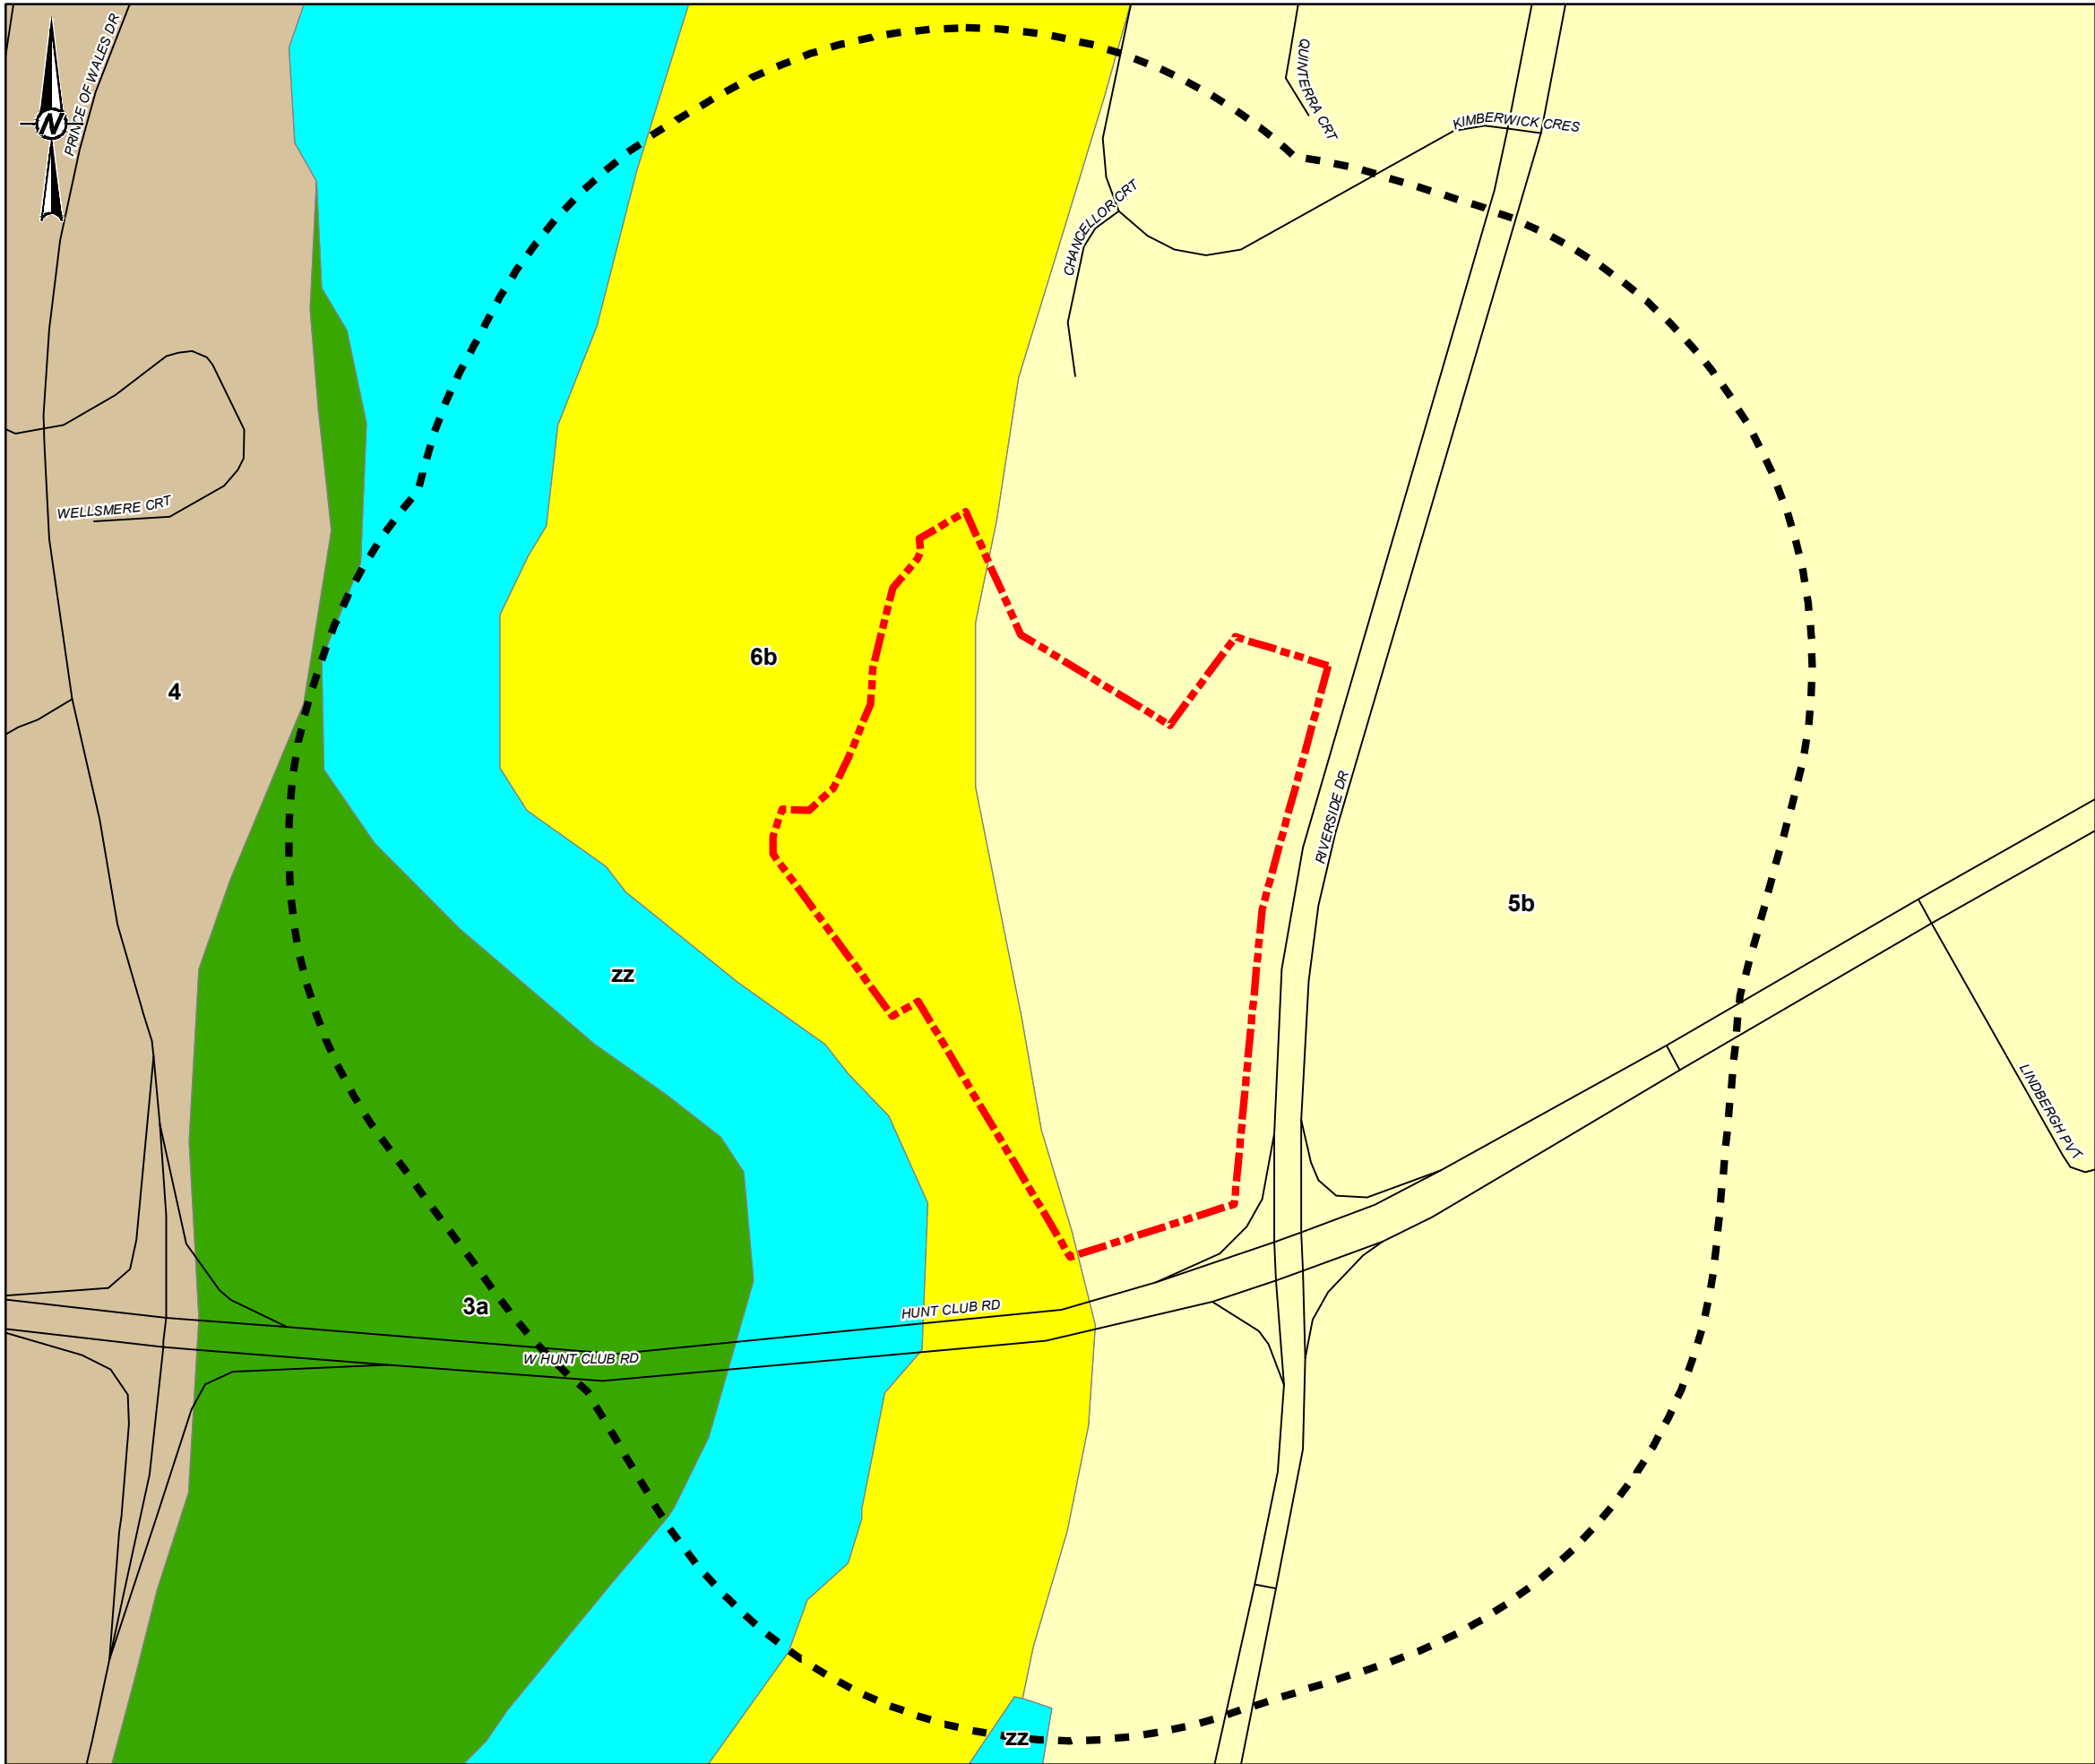
- ROADWAY
- PHASE ONE SITE
- PHASE ONE STUDY AREA
- 6b: ALLUVIAL DEPOSITS: MEDIUM GRAINED STRATIFIED SAND WITH SOME SILT
- 5b: NEARSHORE SEDIMENTS: FINE TO MEDIUM GRAINED SAND
- 4. DELTAIC AND ESTUARY DEPOSITS: MEDIUM TO FINE GRAINED SAND
- 3a. OFFSHORE MARINE DEPOSITS: CLAY, SILT UNDERLYING EROSIONAL TERRACES
- zz. WATERBODY

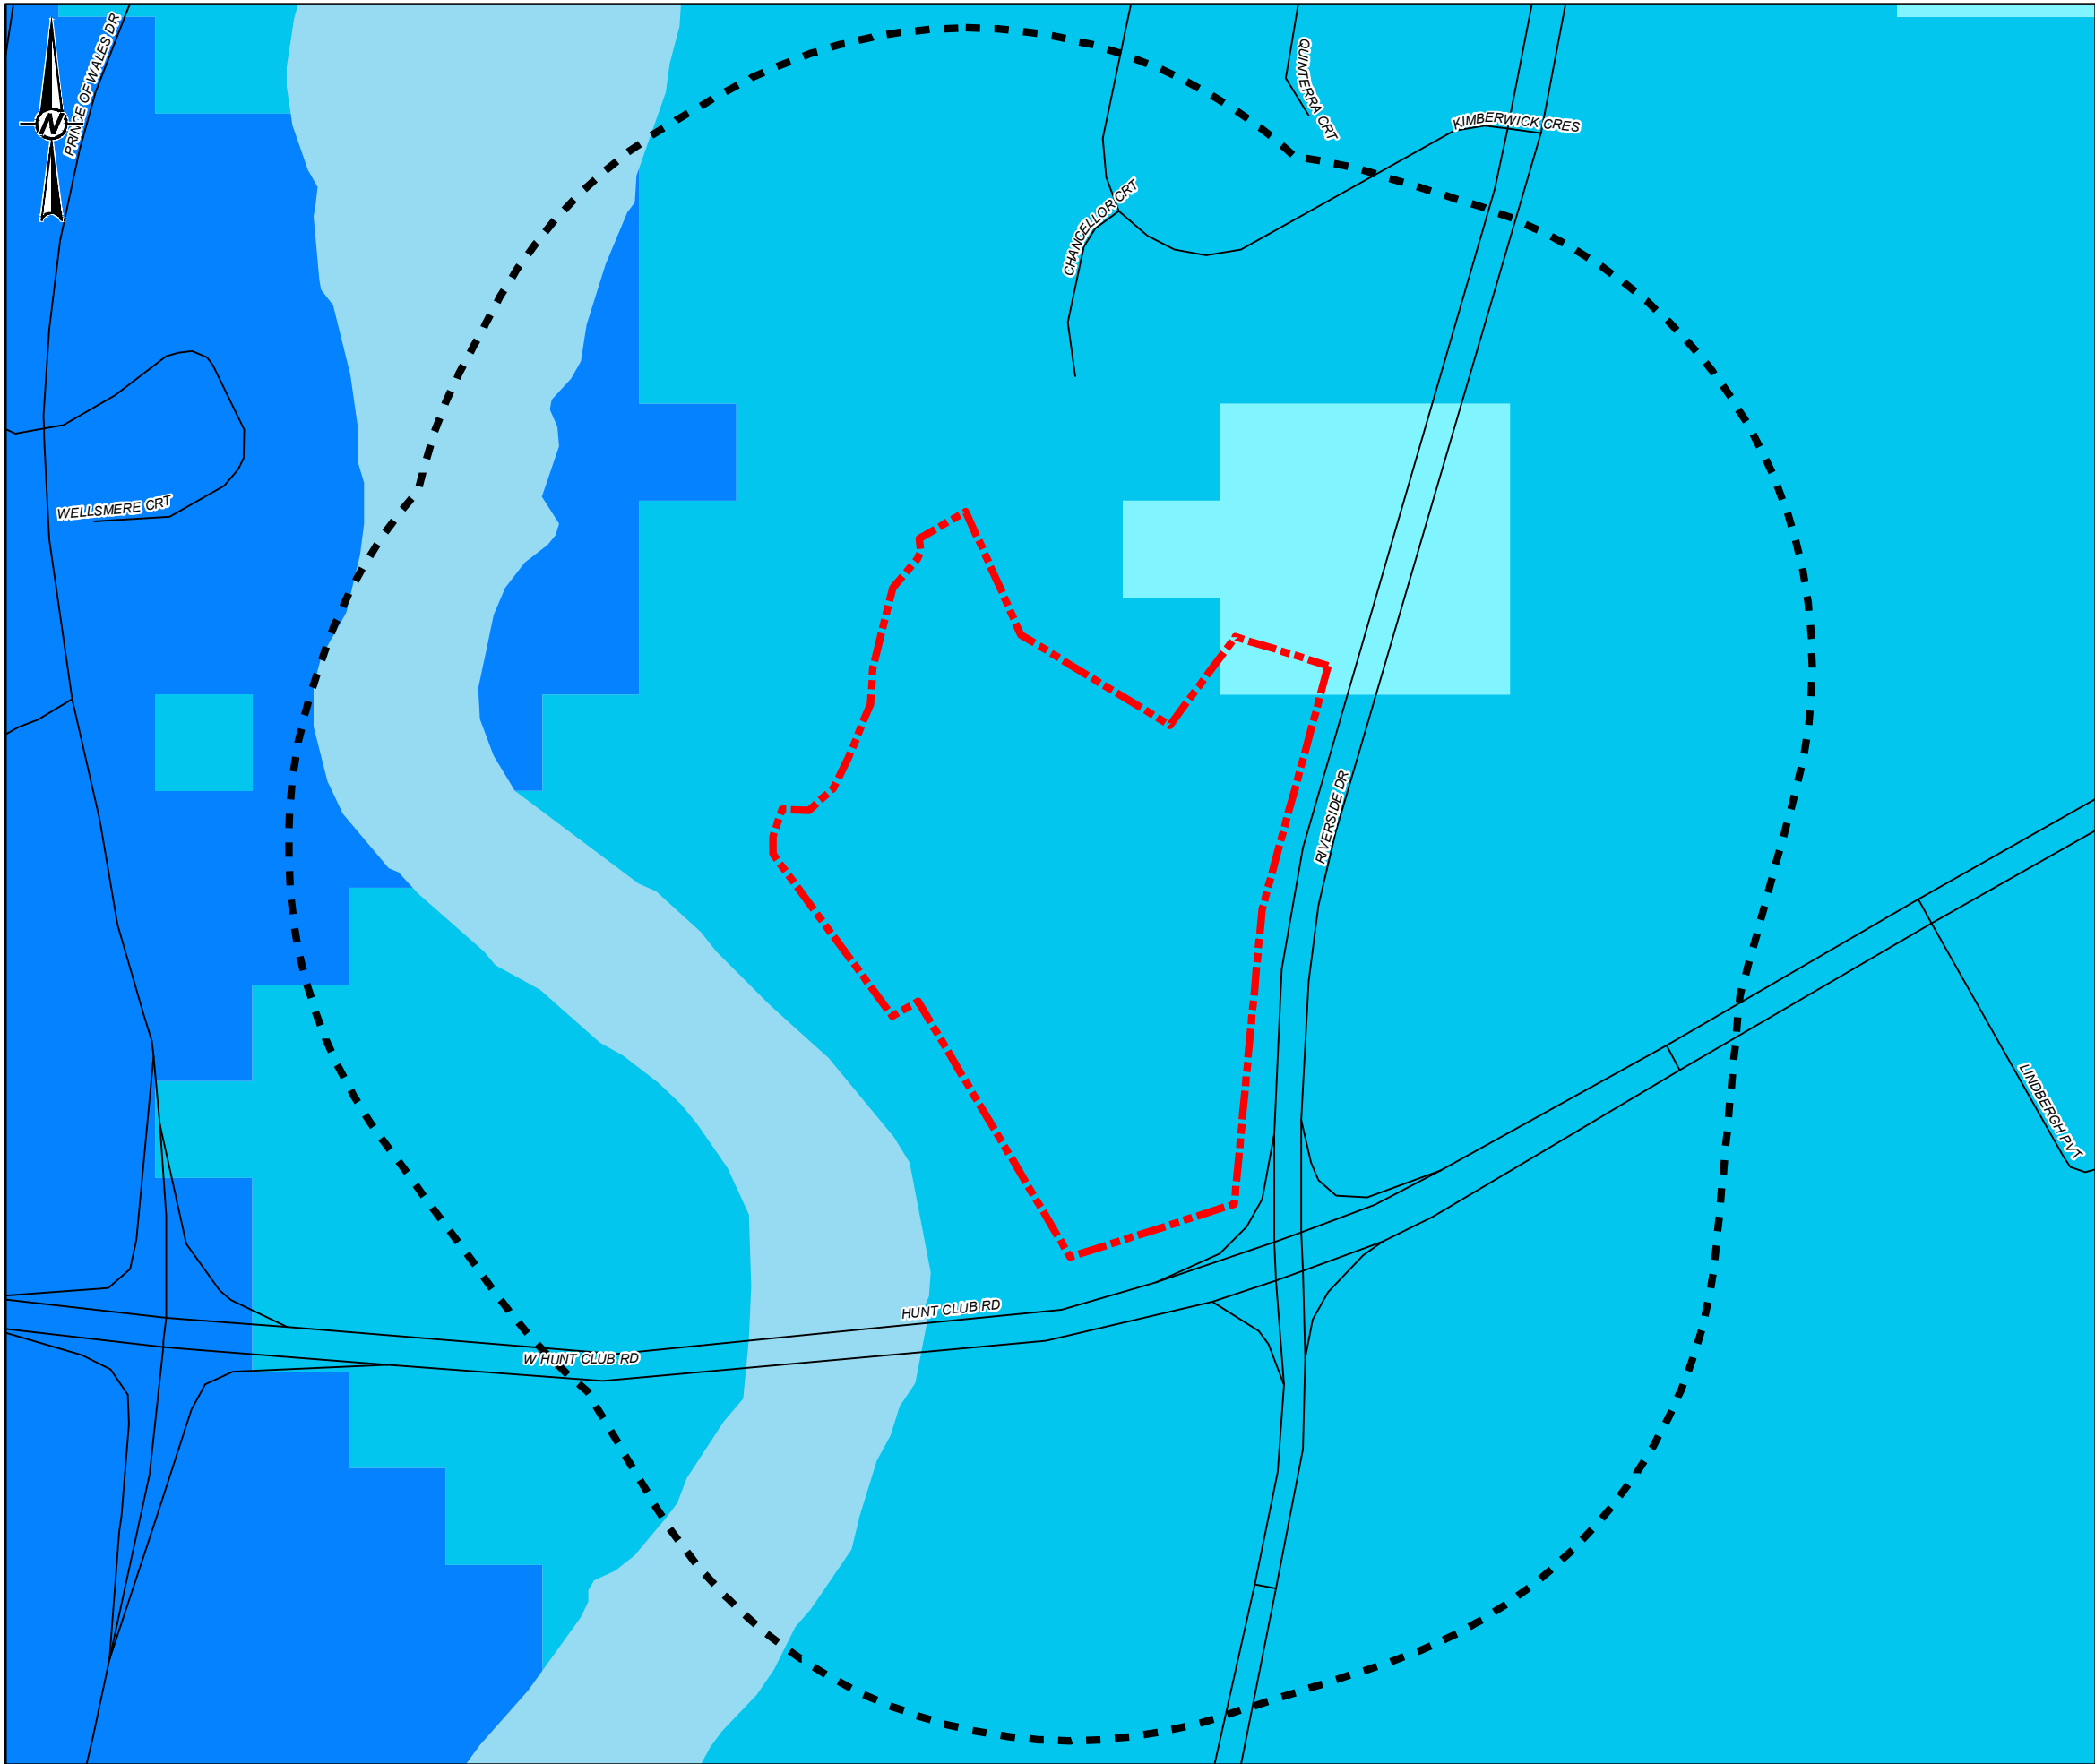
**LEGEND**  
ROADWAY  
WATERBODY  
PHASE ONE SITE  
PHASE ONE STUDY AREA  
**TREND IN DEPTH TO BEDROCK (METRES)**  
10 to 15  
15 to 25  
25 to 50

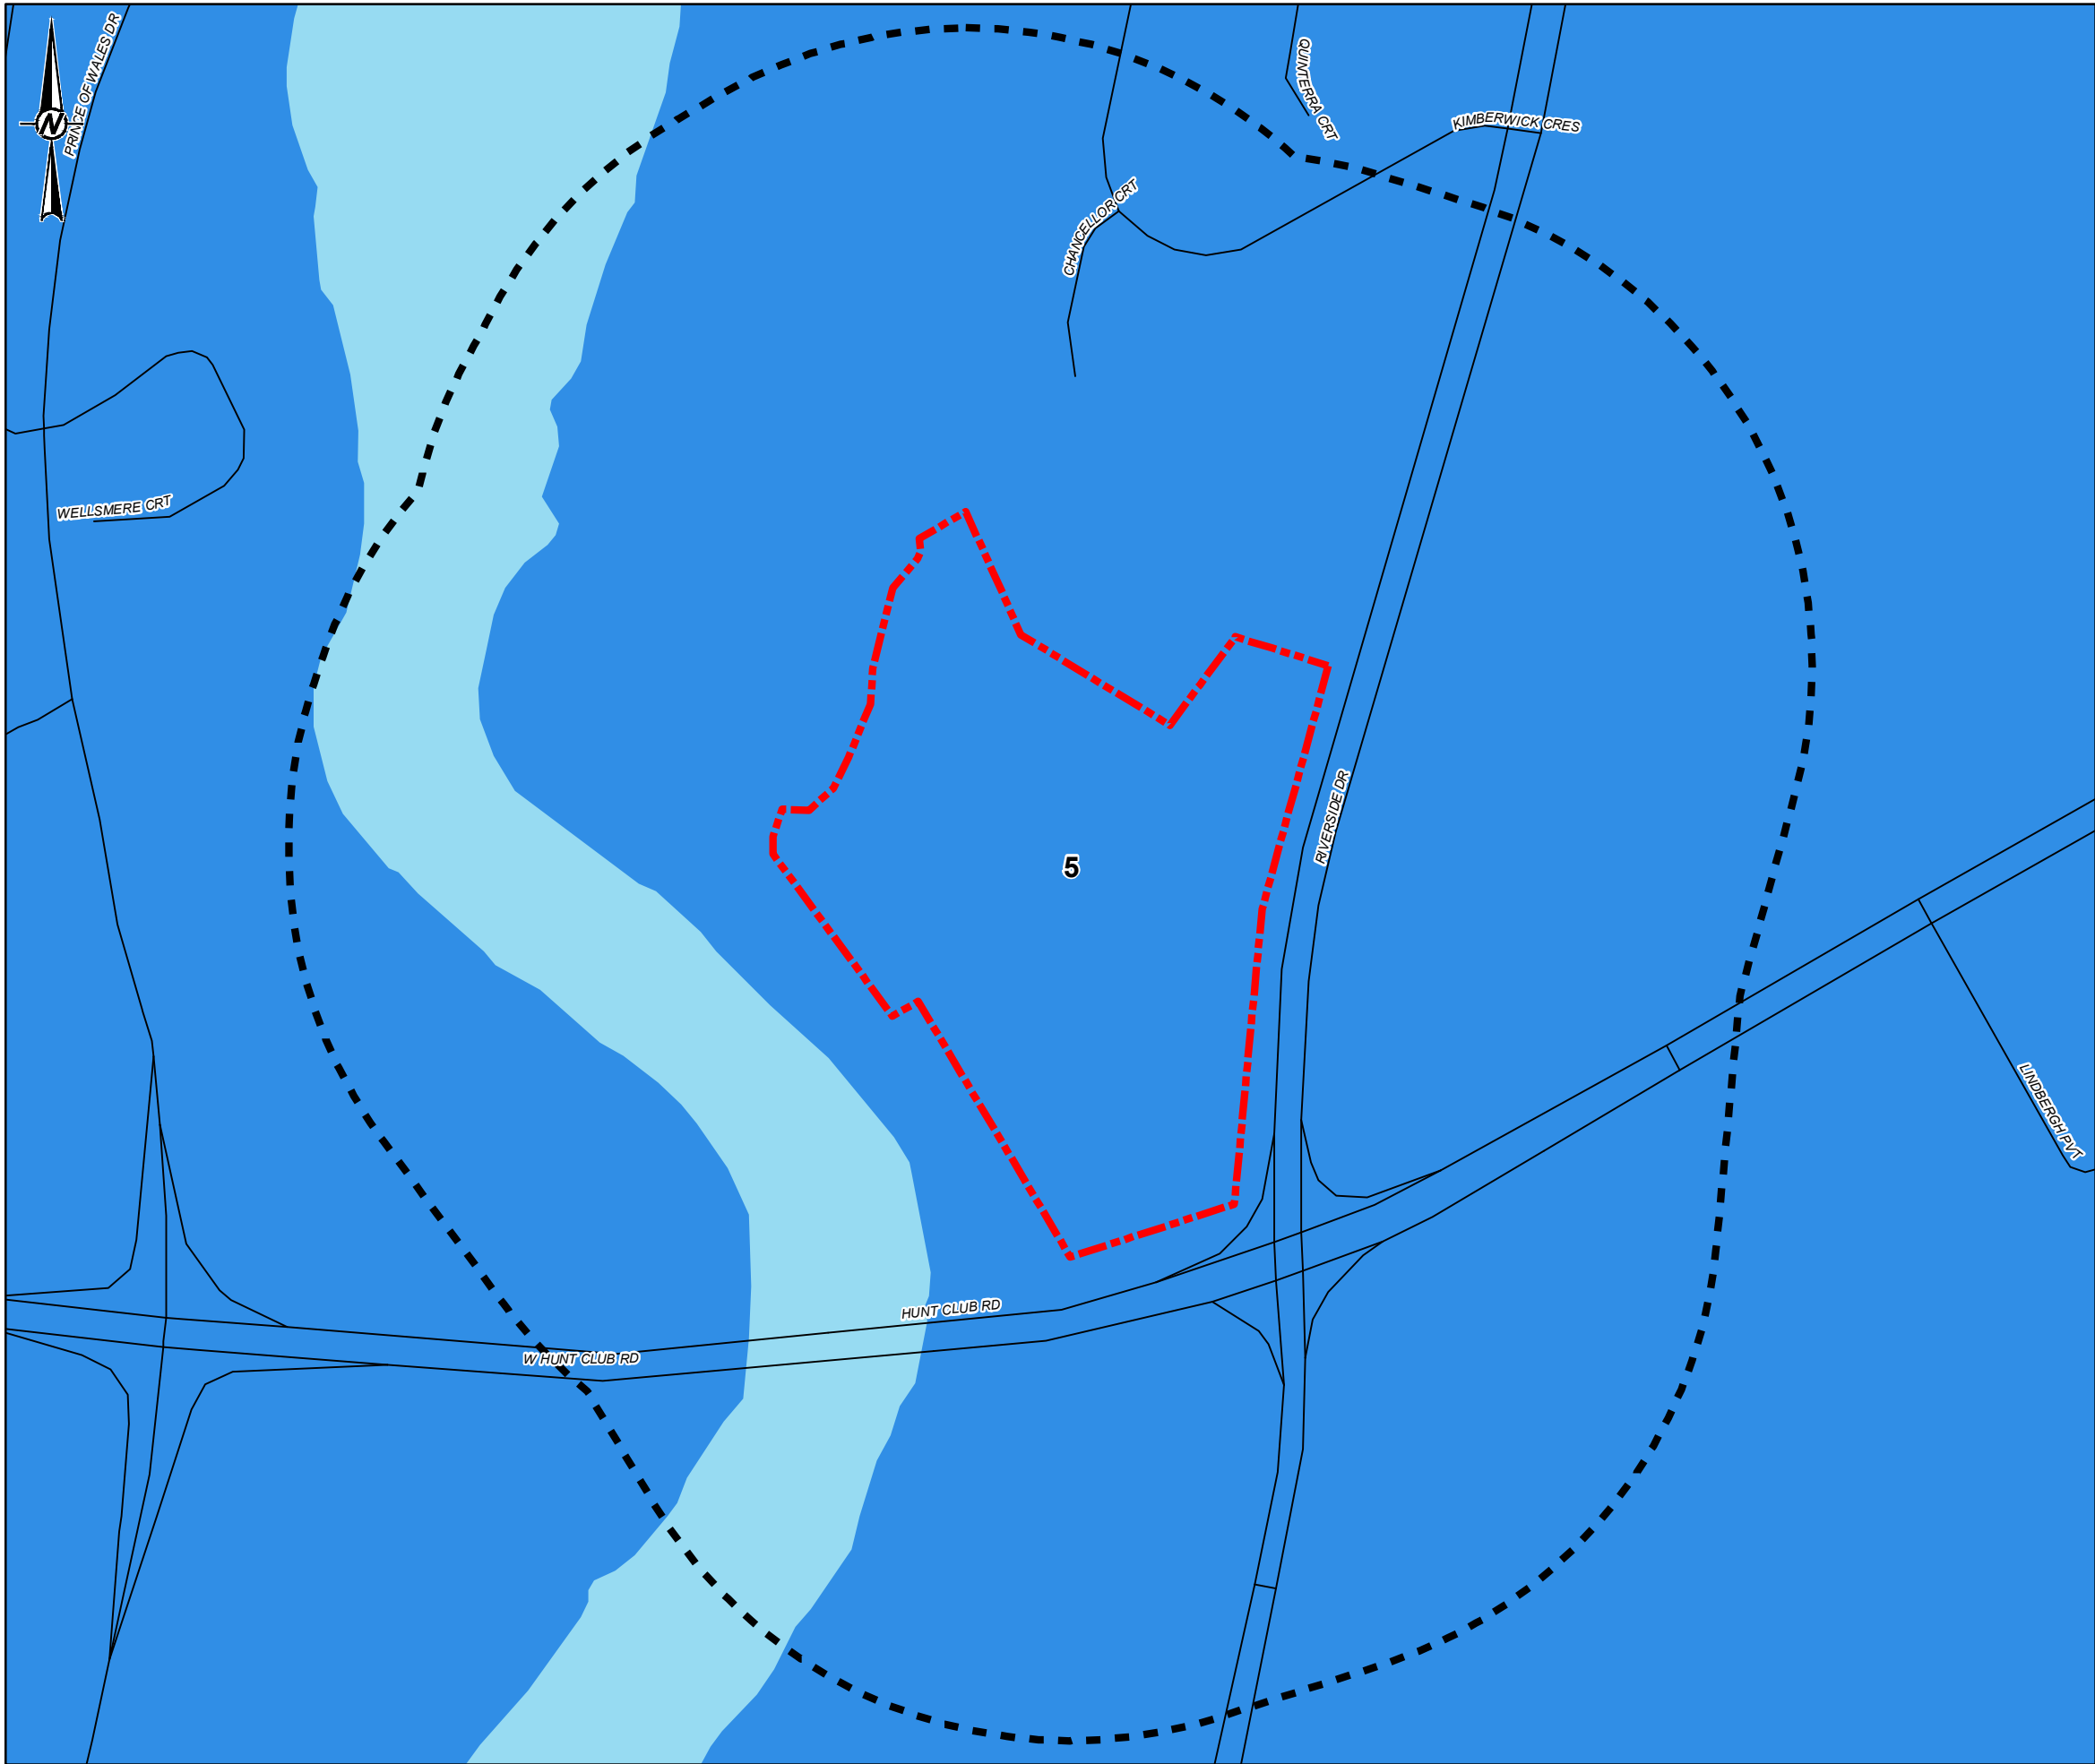
- ROADWAY
- WATERBODY
- PHASE ONE SITE
- PHASE ONE STUDY AREA
- 5: OXFORD FORMATION - DOLOSTONE, MINOR SHALE AND SANDSTONE

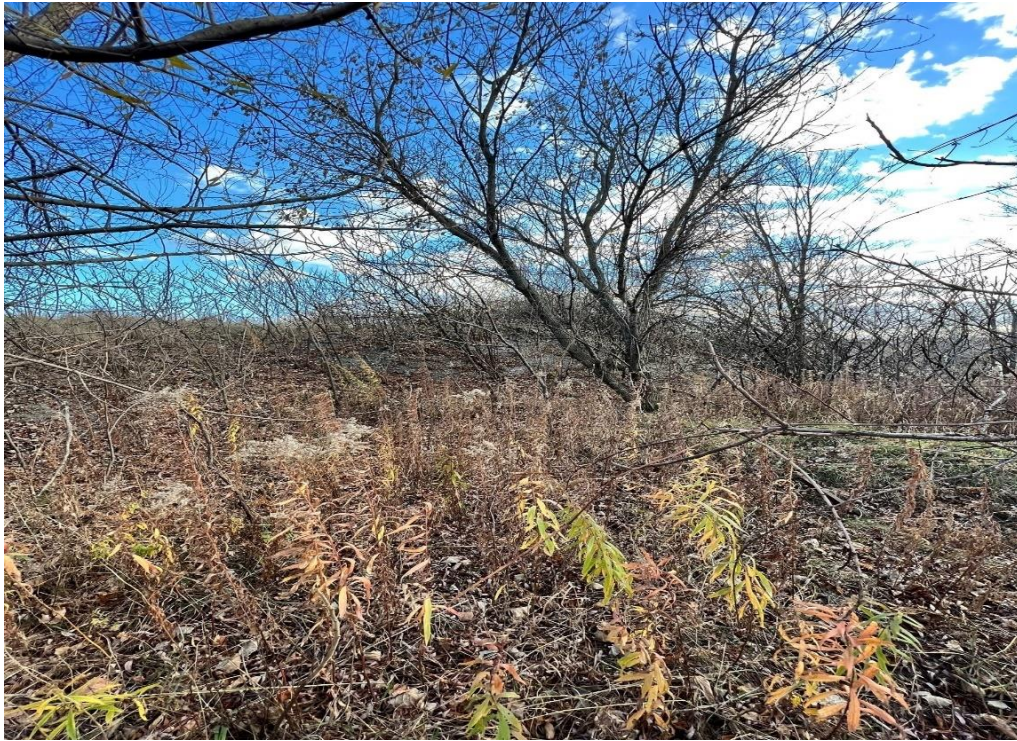
*Photo 1: Looking west at the Site from the central portion of the eastern Site boundary. A higher elevation hill is present, with lifeless foliage.*

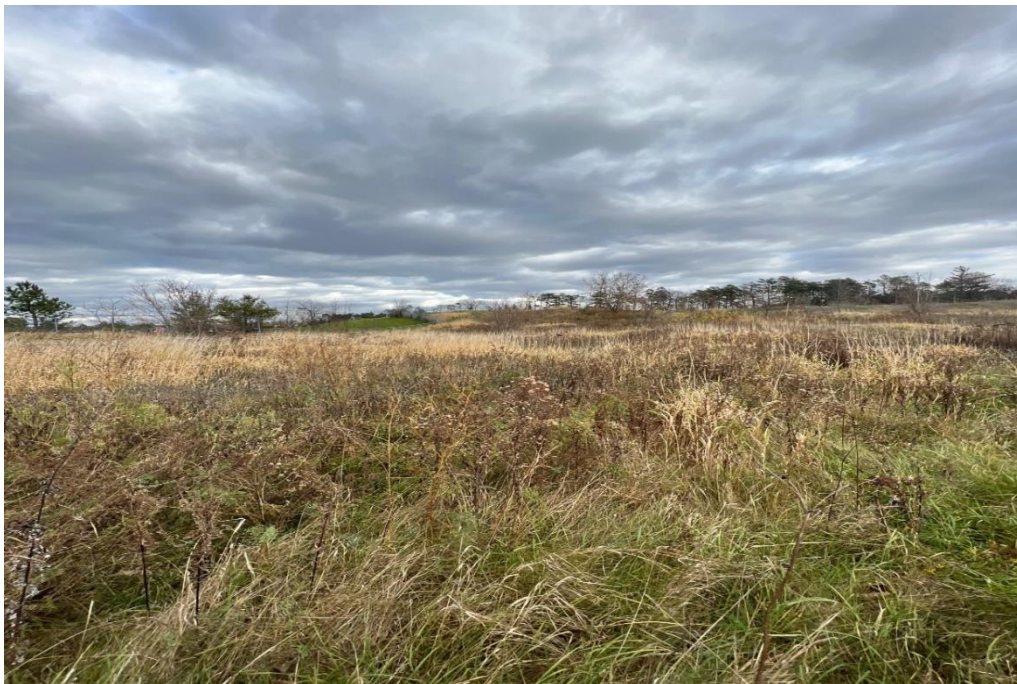
*Photo 2: Looking north at the northern portion of the Site. The northeast corner of the Site with a high elevation is visible.*

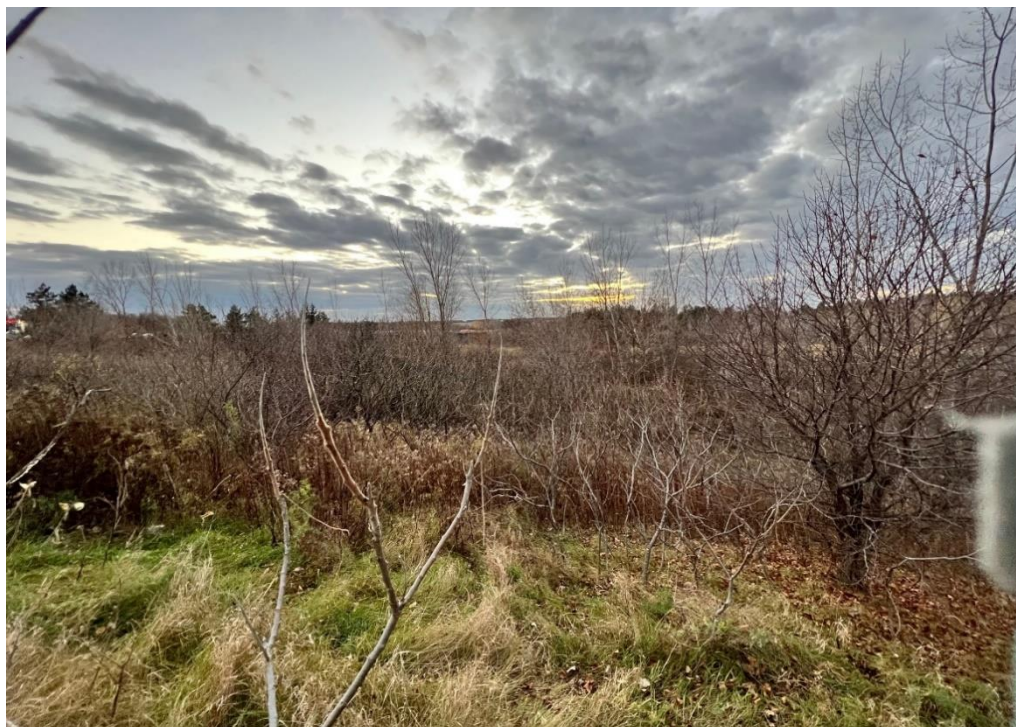
Photo 3: View of the eastern portion of the Site looking northwest.

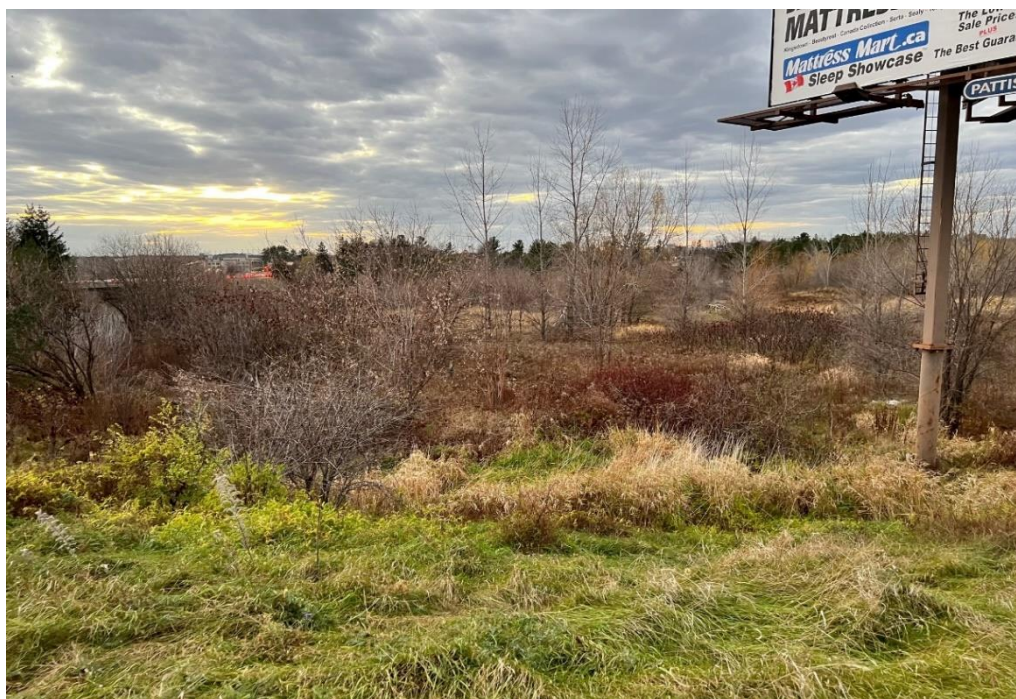
Photo 4: Looking West at the Site from the Eastern portion of the Site.

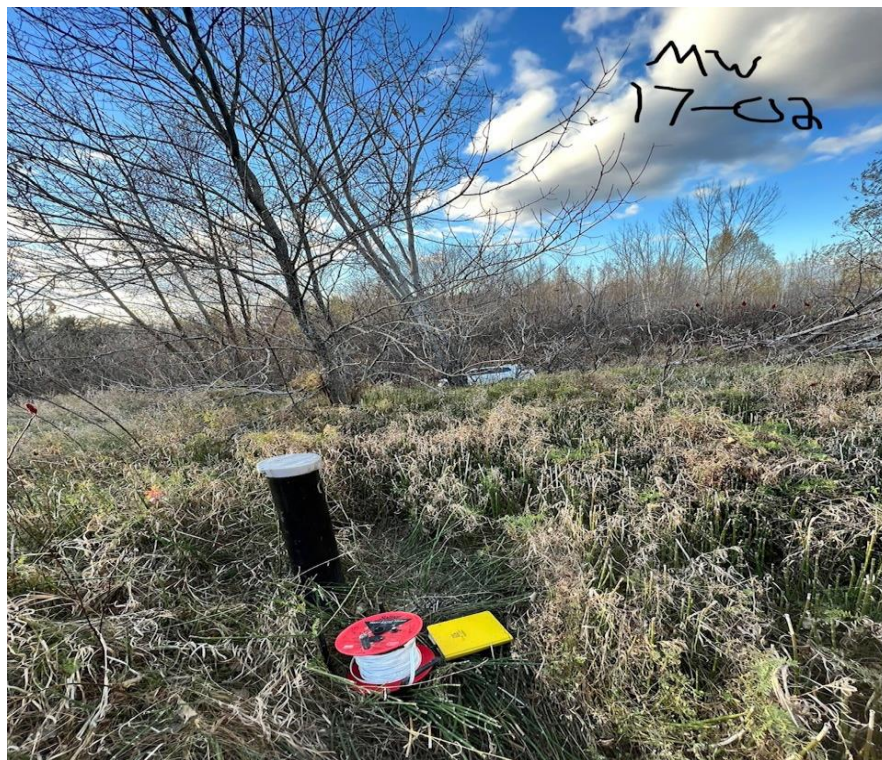
Photo 5: Monitoring well located on the southern portion of the Site near the western Site boundary.

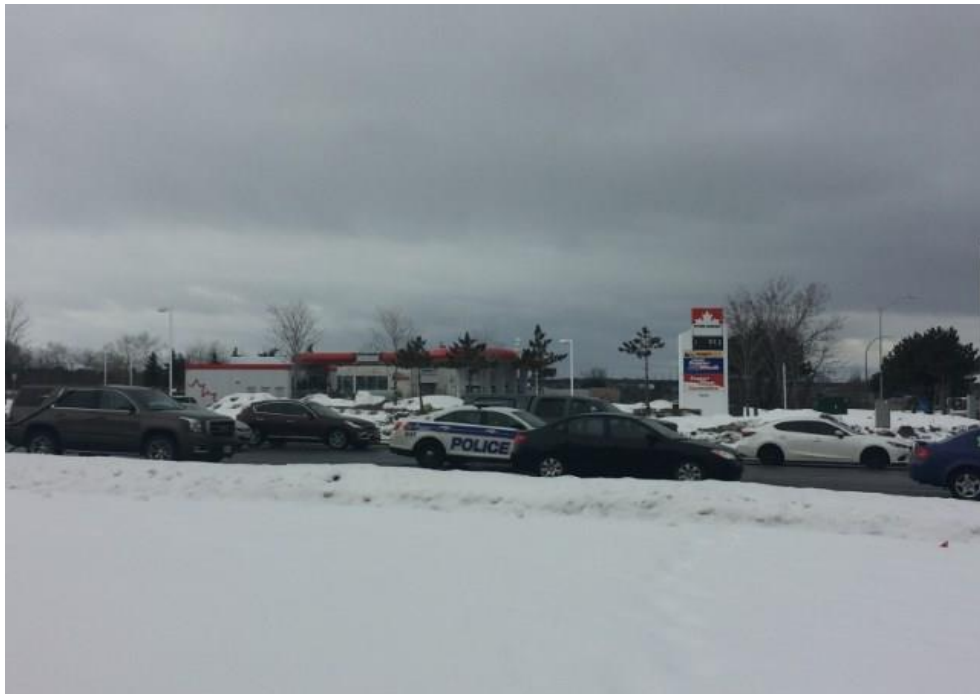
*Photo 8: Looking west at the retail fuel outlet located on the surrounding lands south of the Site at the southeast corner of Hunt Club Road and Riverside Drive.*

It was noted during the site visit that a retail fuel outlet was located on the surrounding lands south of the Site at 4000 Riverside Drive; approximately 70 m south of the Site. The presence of this retail fuel outlet is considered to be an off-Site PCA. As previously discussed, construction debris is present in the fill material located on the Site and fill material of unknown original and quality has been placed on the Site since the most recent Phase Two ESA investigation in 2001. As such, the current presence of this fill material on the Site is an on-Site PCA.
