BGO Bank & Walkley
 Ottawa, ON

Title
 TREE CONSERVATION REPORT

Date January, 2025 Sheet
 Scale 1:500
 Drawn JE
 Checked PG
 Job No. 24-190
TCR 01

Title
TREE CONSERVATION REPORT

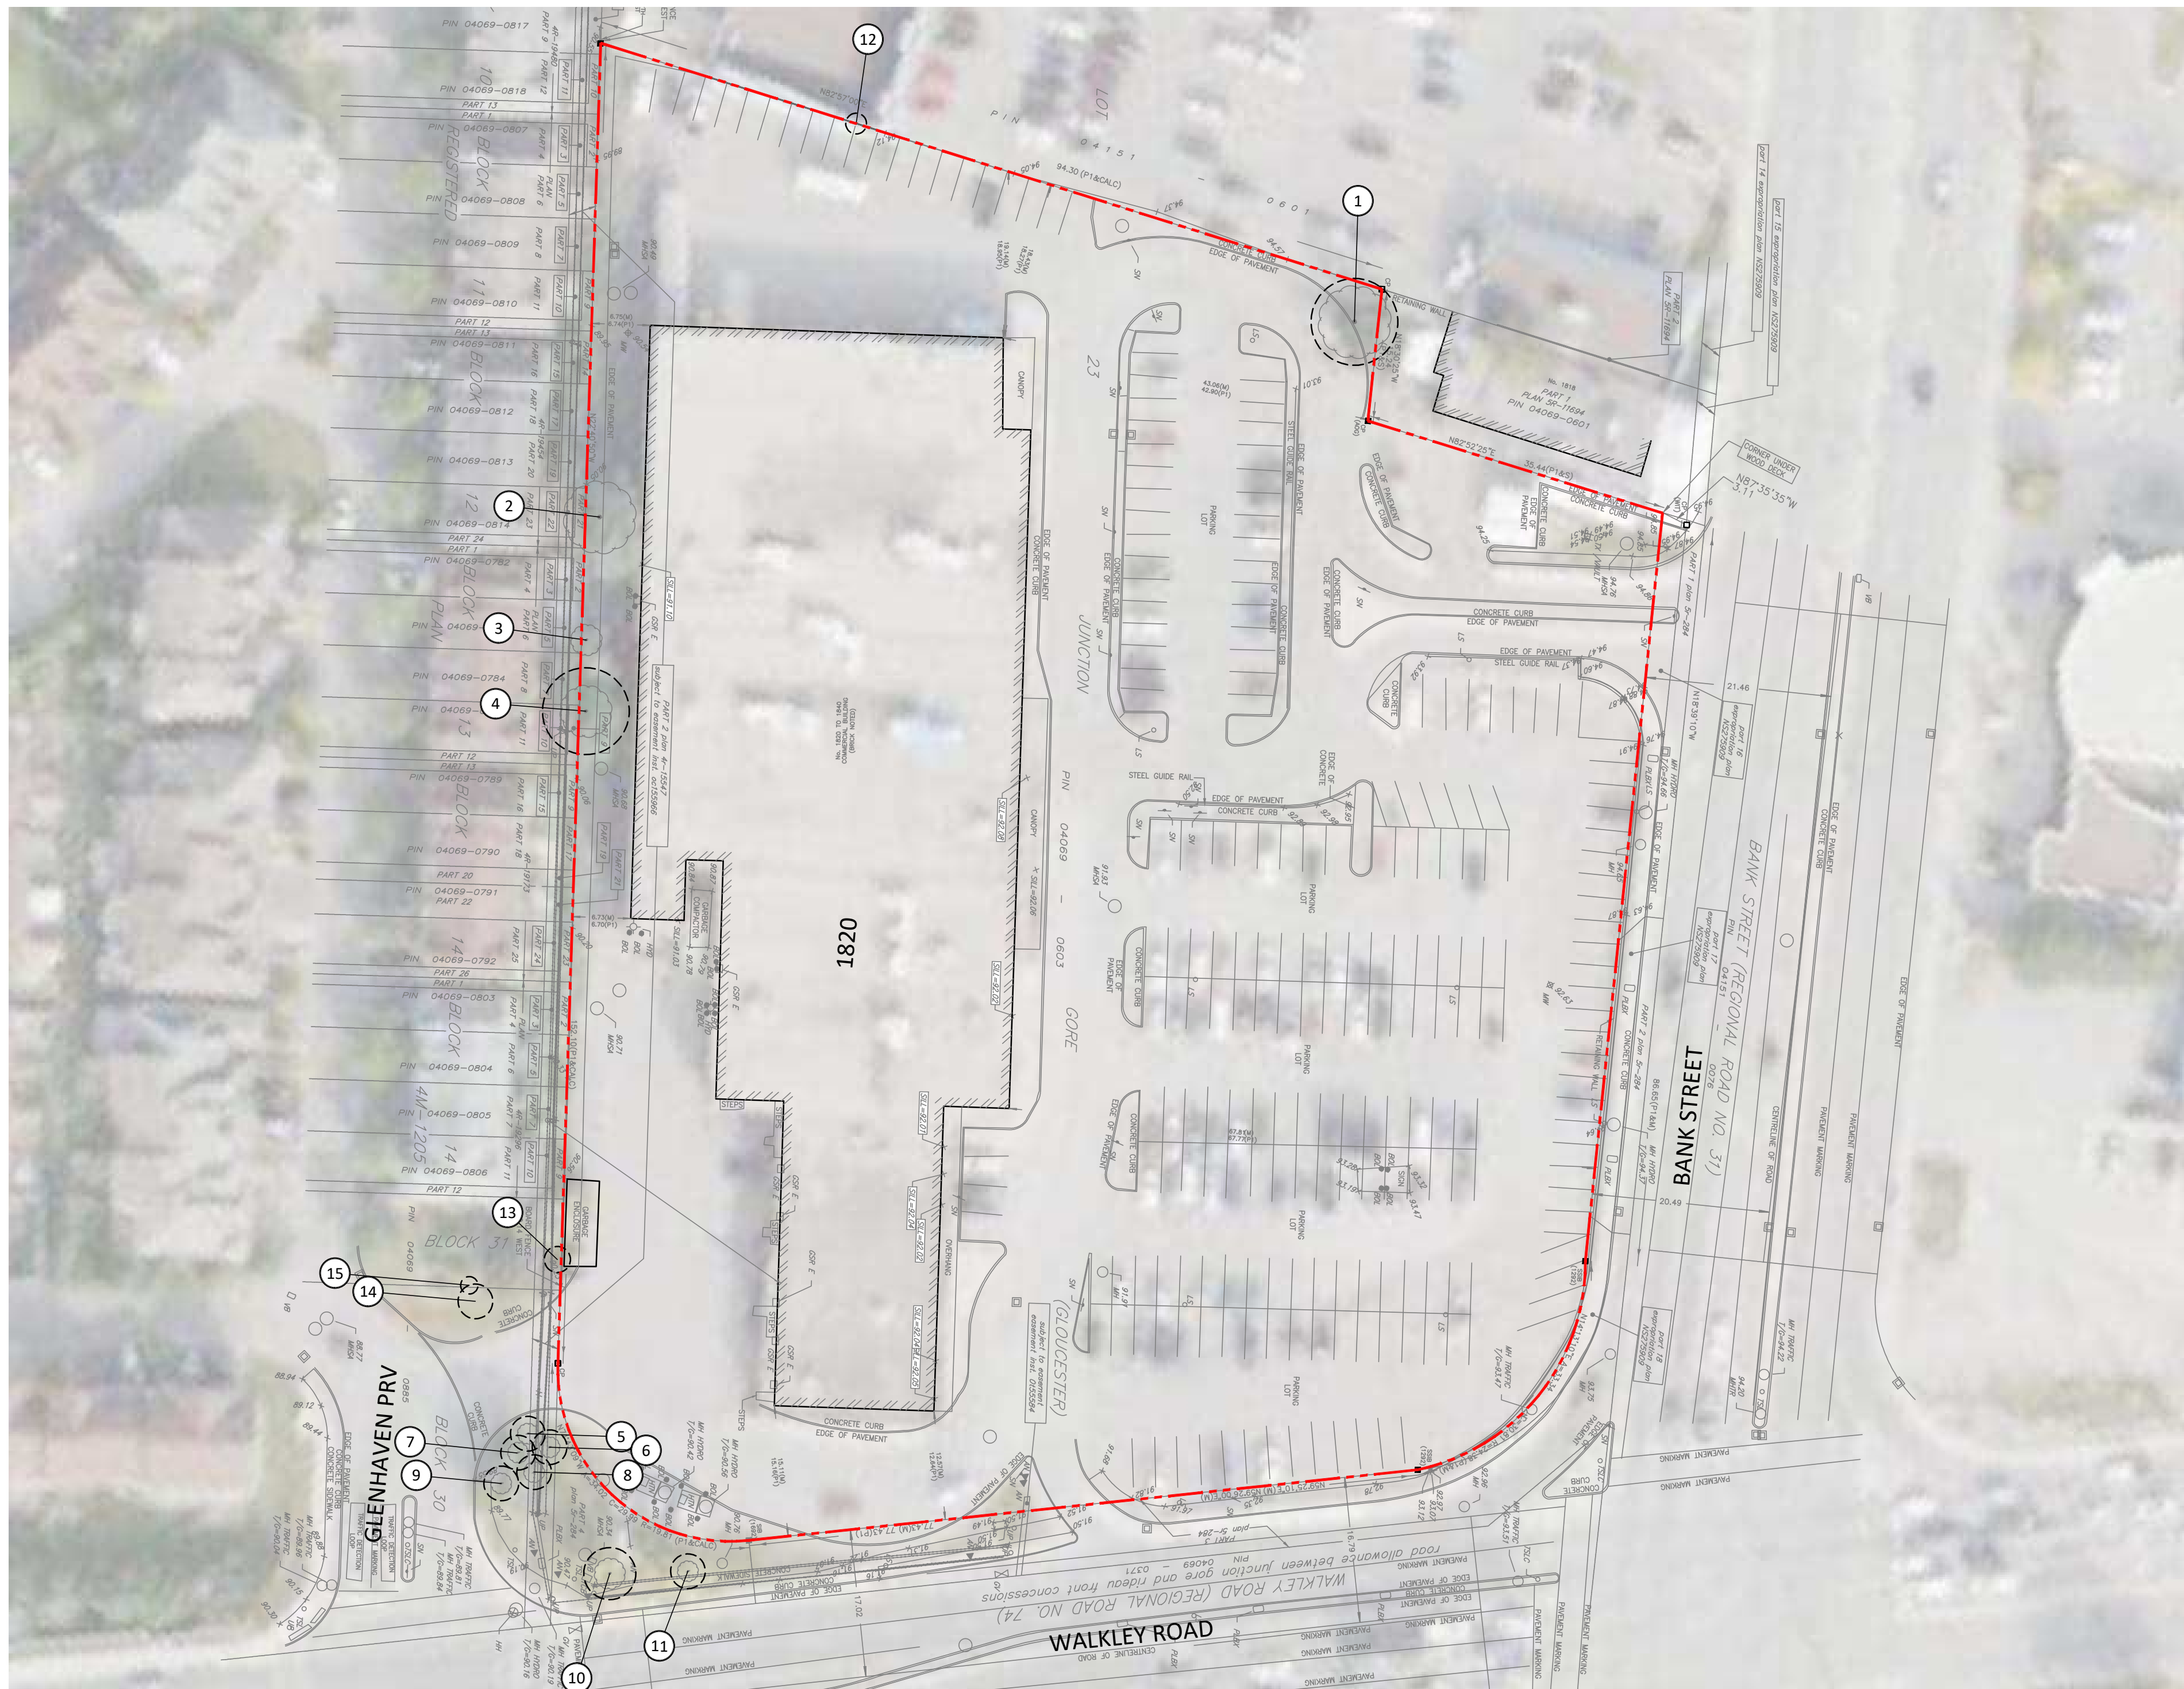
1 EXISTING CONDITIONS Scale: 1:500

Tree #	Botanical Name	Common Name	DBH (cm)	Ownership	Condition	NOTES	To Be Preserved	Reason for Removal
1	Acer platanoides	Norway Maple	50	Private	Moderate	Asymmetrical canopy, Dieback ~15% @ canopy, Broken limbs, Single stem, Bark rot @ limbs, Girdled roots	NO	Tree location in conflict with proposed site construction
2					Missing	Tree Removed	N/A	
3					Missing	Tree Removed	N/A	
4	Ulmus spp.	Elm	50	Private	Moderate	Asymmetrical canopy, Dieback ~10% @ limbs, Pruned @ O.H., Poor branch union, Multi-stem w/ 3	NO	Heavily pruned tree and conflict with site construction activities
5	Acer platanoides	Norway Maple	20	Private	Moderate	Asymmetrical canopy, Dieback ~30% @ Canopy, Pruned limbs, Single stem, Bark rot @ cavities	YES	
6	Acer platanoides	Norway Maple	20	Private	Moderate	Asymmetrical canopy, Broken limbs, Single stem, Pruned branches, Heart rot @ limbs, Girdled trunk from staking	YES	
7	Acer platanoides	Norway Maple	20	Private	Moderate	Asymmetrical canopy, Dieback ~10% @ canopy, Single stem, Included bark, Girdled roots	YES

8	Acer platanoides	Norway Maple	20	Private	Good	Asymmetrical canopy, Pruned branches @ O.H., Single stem	YES	
9	Acer platanoides	Norway Maple	20	Private	Good	Asymmetrical canopy, Dieback ~10% @ canopy, Single stem, Girdled roots	YES	
10	Acer platanoides	Norway Maple	30	City	Moderate	Symmetrical canopy, Dieback ~15% @ canopy, Single stem, Girdled roots	NO	Tree location in conflict with proposed ROW construction
11	Acer platanoides	Norway Maple	20	City	Good	Symmetrical canopy, Single stem	NO	Tree location in conflict with proposed ROW construction
12	Ulmus spp.	Elm	12	Boundary	Moderate	Asymmetrical canopy, Broken limbs, Single stem, (2) Leaders @ 2m above grade, Included bark, Grown into C.L. fence	NO	Tree location in conflict with proposed site construction
13	Celtis occidentalis	Hackberry	15	Private	Moderate	Symmetrical canopy, Single stem, Grown btwn 2 privacy fences	NO	Tree location in conflict with proposed site construction

14	Acer platanoides 'Crimson King'	Norway Maple	20	Private	Moderate	Symmetrical canopy, Single stem, (3) Leaders @ 2m above grade, Large crack on trunk	NO	Tree location in conflict with proposed site construction
15	Picea pungens var. 'Glauca'	Colorado Blue Spruce	10	Private	Poor	Asymmetrical canopy, Dieback ~80% @ canopy, Single stem	NO	Tree location in conflict with proposed site construction

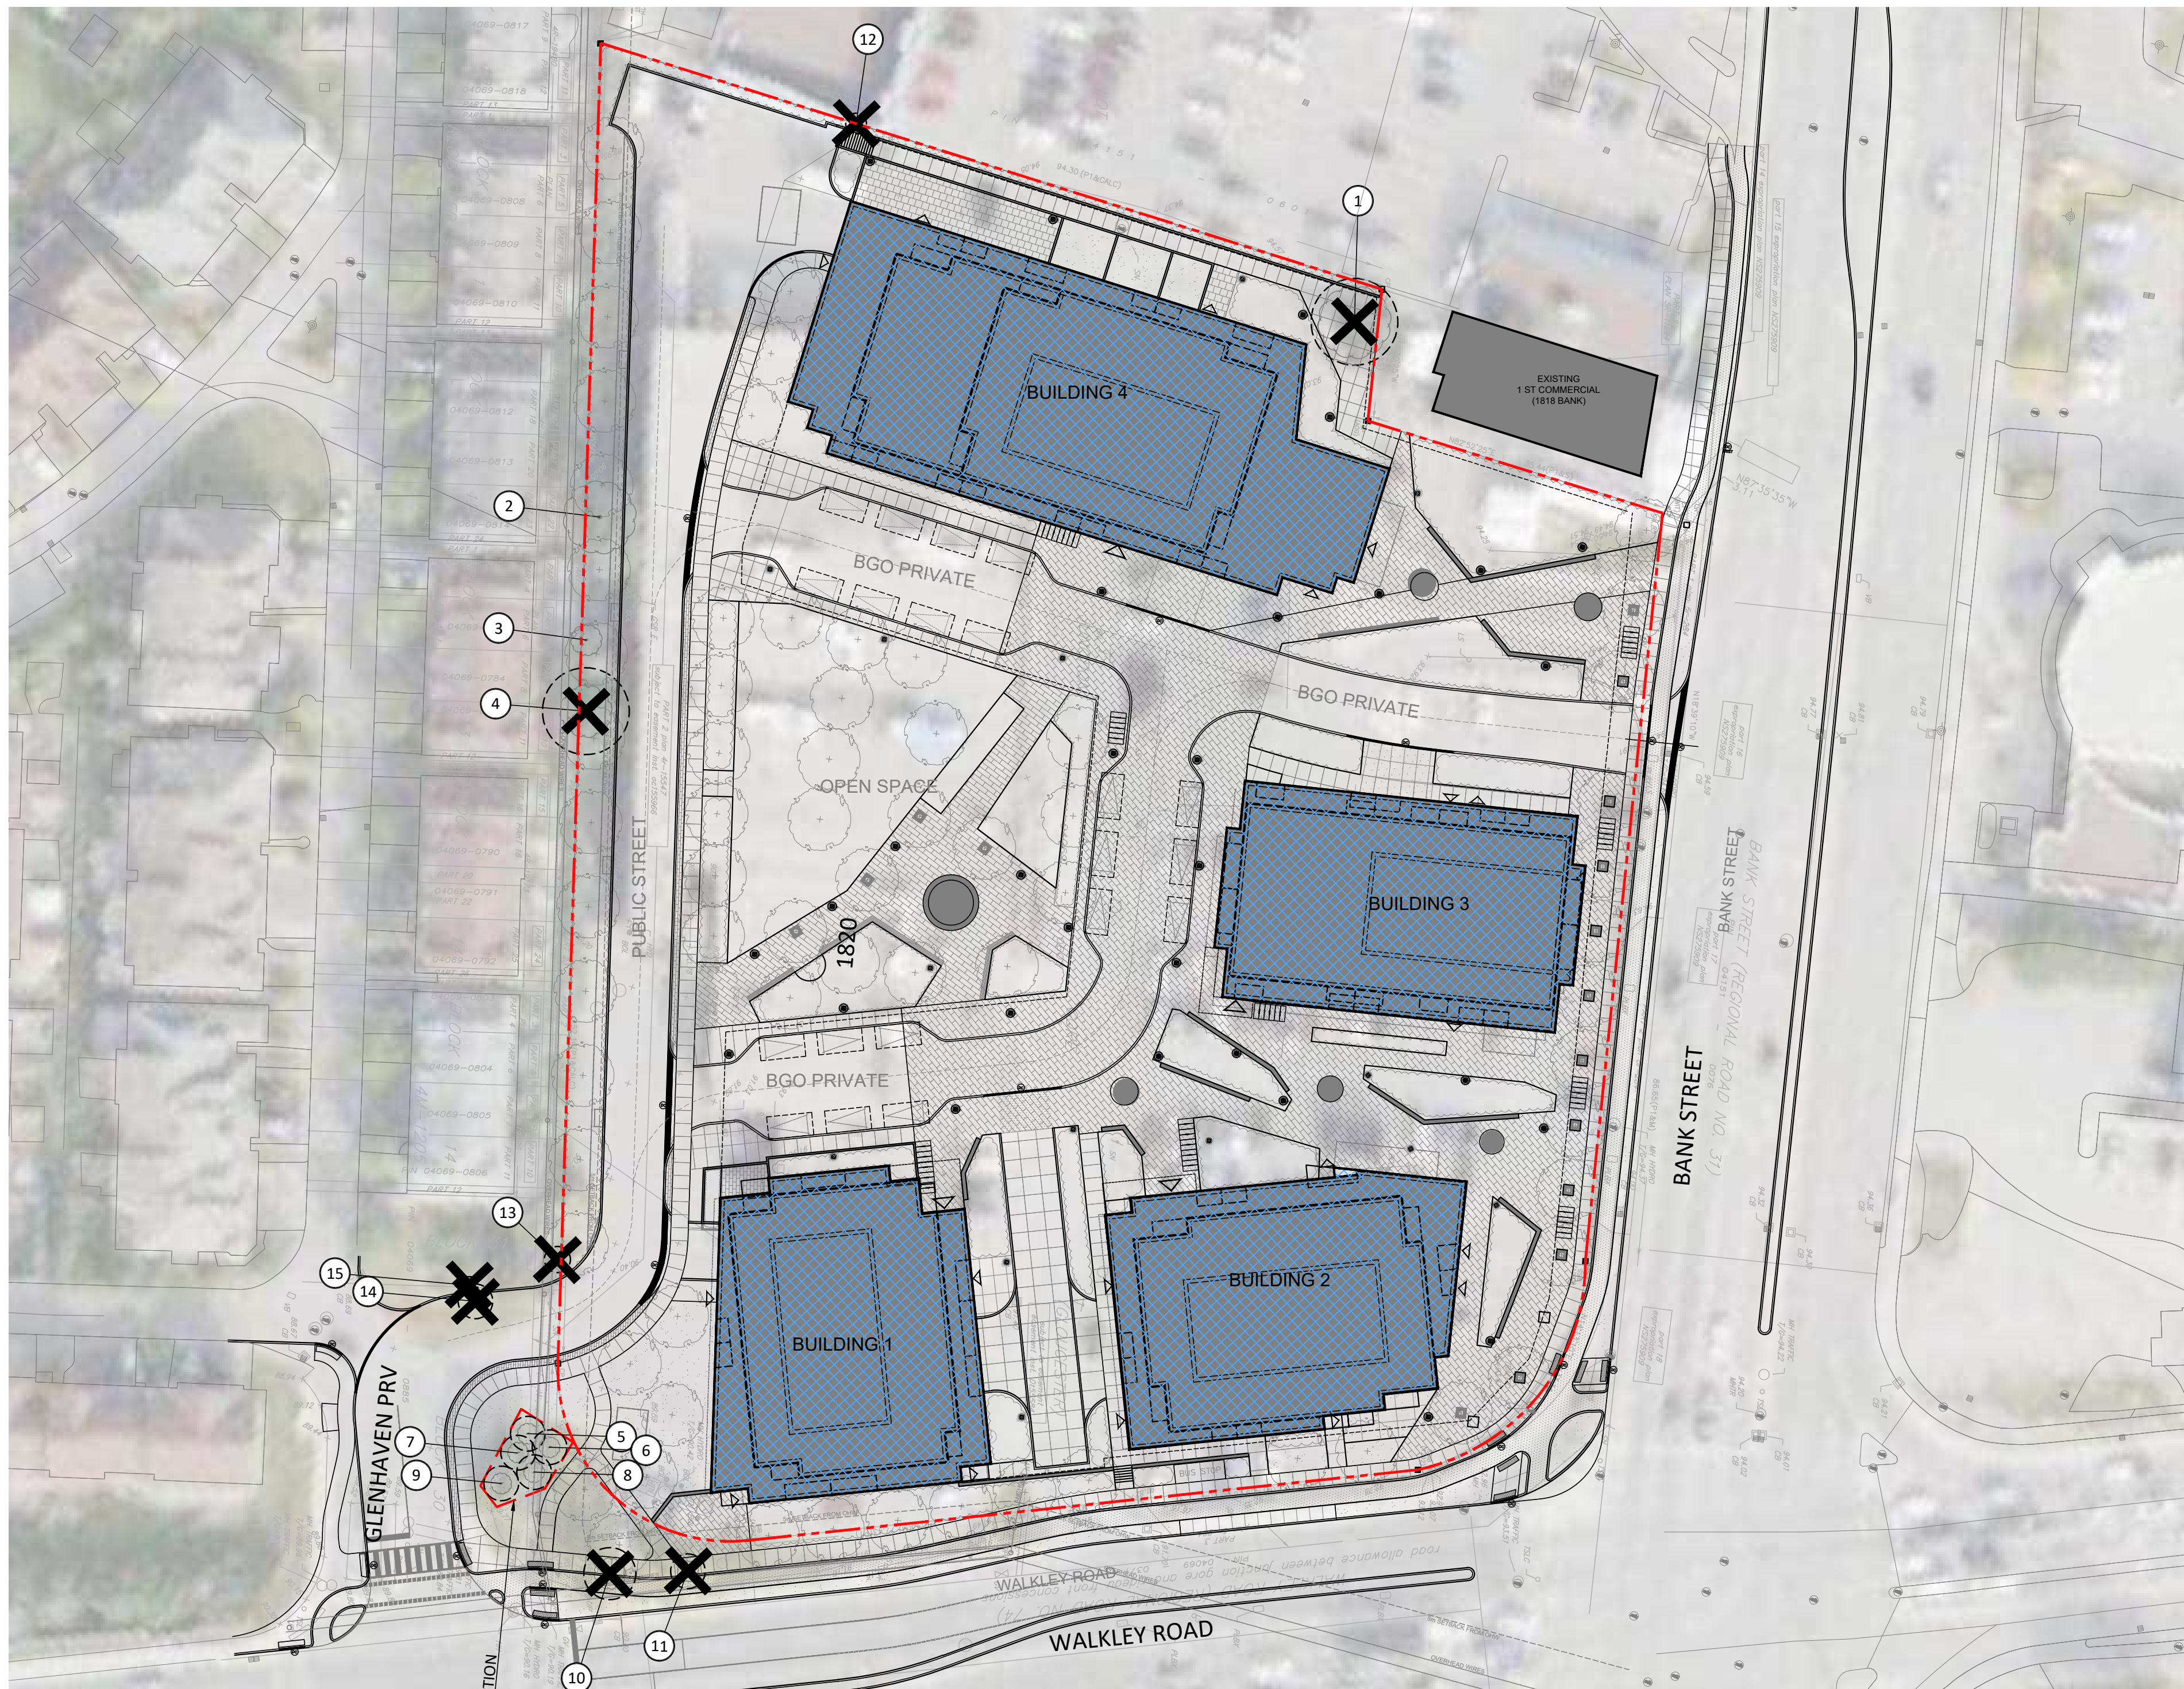
2 PROPOSED DEVELOPMENT

Tree #	Botanical Name	Common Name	DBH (cm)	Ownership	Condition	NOTES	To Be Preserved	Reason for Removal
1	Acer platanoides	Norway Maple	50	Private	Moderate	Asymmetrical canopy, Dieback ~15% @ canopy, Broken limbs, Single stem, Bark rot @ limbs, Girdled roots	NO	Tree location in conflict with proposed site construction
2					Missing	Tree Removed	N/A	
3					Missing	Tree Removed	N/A	
4	Ulmus spp.	Elm	50	Private	Moderate	Asymmetrical canopy, Dieback ~10% @ limbs, Pruned @ O.H., Poor branch union, Multi-stem w/ 3	NO	Heavily pruned tree and conflict with site construction activities
5	Acer platanoides	Norway Maple	20	Private	Moderate	Asymmetrical canopy, Dieback ~30% @ Canopy, Pruned limbs, Single stem, Bark rot @ cavities	YES	
6	Acer platanoides	Norway Maple	20	Private	Moderate	Asymmetrical canopy, Broken limbs, Single stem, Pruned branches, Heart rot @ limbs, Girdled trunk from staking	YES	
7	Acer platanoides	Norway Maple	20	Private	Moderate	Asymmetrical canopy, Dieback ~10% @ canopy, Single stem, Included bark, Girdled roots	YES

8	Acer platanoides	Norway Maple	20	Private	Good	Asymmetrical canopy, Pruned branches @ O.H., Single stem	YES	
9	Acer platanoides	Norway Maple	20	Private	Good	Asymmetrical canopy, Dieback ~10% @ canopy, Single stem, Girdled roots	YES	
10	Acer platanoides	Norway Maple	30	City	Moderate	Symmetrical canopy, Dieback ~15% @ canopy, Single stem, Girdled roots	NO	Tree location in conflict with proposed ROW construction
11	Acer platanoides	Norway Maple	20	City	Good	Symmetrical canopy, Single stem	NO	Tree location in conflict with proposed ROW construction
12	Ulmus spp.	Elm	12	Boundary	Moderate	Asymmetrical canopy, Broken limbs, Single stem, (2) Leaders @ 2m above grade, Included bark, Grown into C.L. fence	NO	Tree location in conflict with proposed site construction
13	Celtis occidentalis	Hackberry	15	Private	Moderate	Symmetrical canopy, Single stem, Grown btwn 2 privacy fences	NO	Tree location in conflict with proposed site construction

14	Acer platanoides 'Crimson King'	Norway Maple	20	Private	Moderate	Symmetrical canopy, Single stem, (3) Leaders @ 2m above grade, Large crack on trunk	NO	Tree location in conflict with proposed site construction
15	Picea pungens var. 'Glauca'	Colorado Blue Spruce	10	Private	Poor	Asymmetrical canopy, Dieback ~80% @ canopy, Single stem	NO	Tree location in conflict with proposed site construction

- TREES IDENTIFIED FOR RETENTION ARE IN MODERATE TO GOOD CONDITION AND CAN BE REASONABLY PROTECTED FROM CONSTRUCTION ACTIVITIES, GIVEN ADEQUATE TREE PROTECTION MEASURES AS DESCRIBED ARE TAKEN.

- THE AREAS WITHIN THE TREE PROTECTION ZONE MUST REMAIN UNDISTURBED AT ALL TIMES. NO WORK OR MATERIAL STORAGE IS PERMITTED WITHIN THE TREE PROTECTION ZONE.

- INSTALLATION OF TREE PROTECTION FENCE SHALL BE LOCATED AT THE CRITICAL ROOT ZONE.
CRITICAL ROOT ZONE : 10cm x DIAMETER AT BREAST HEIGHT (DBH)
EXAMPLE: DBH = 30cm; CRZ = 300cm / 3.0m
