**RE: TREE CONSERVATION REPORT FOR 593, 601-603 LAURIER AVE WEST, OTTAWA**

This revised Tree Conservation Report (TCR) was prepared by IFS Associates Inc. (IFS) on behalf of Heritage Investments Ltd. in support of their proposed redevelopment of 593, 601-603 Laurier Avenue West in Ottawa. The need for this report is related to trees protected under the City of Ottawa's Tree Protection By-law (By-law No. 2020-340). Presently the subject property is occupied by two multi-storey buildings and one multi-storey heritage dwelling. The proposed redevelopment will include the demolition of the two existing buildings and construction of a 28-storey apartment building with three levels of below grade parking. The heritage dwelling will be retained.

DRAWING:  
Tree Conservation Plan

PROJECT:  
593, 601-603 LAURIER  
AVENUE WEST  
CITY OF OTTAWA

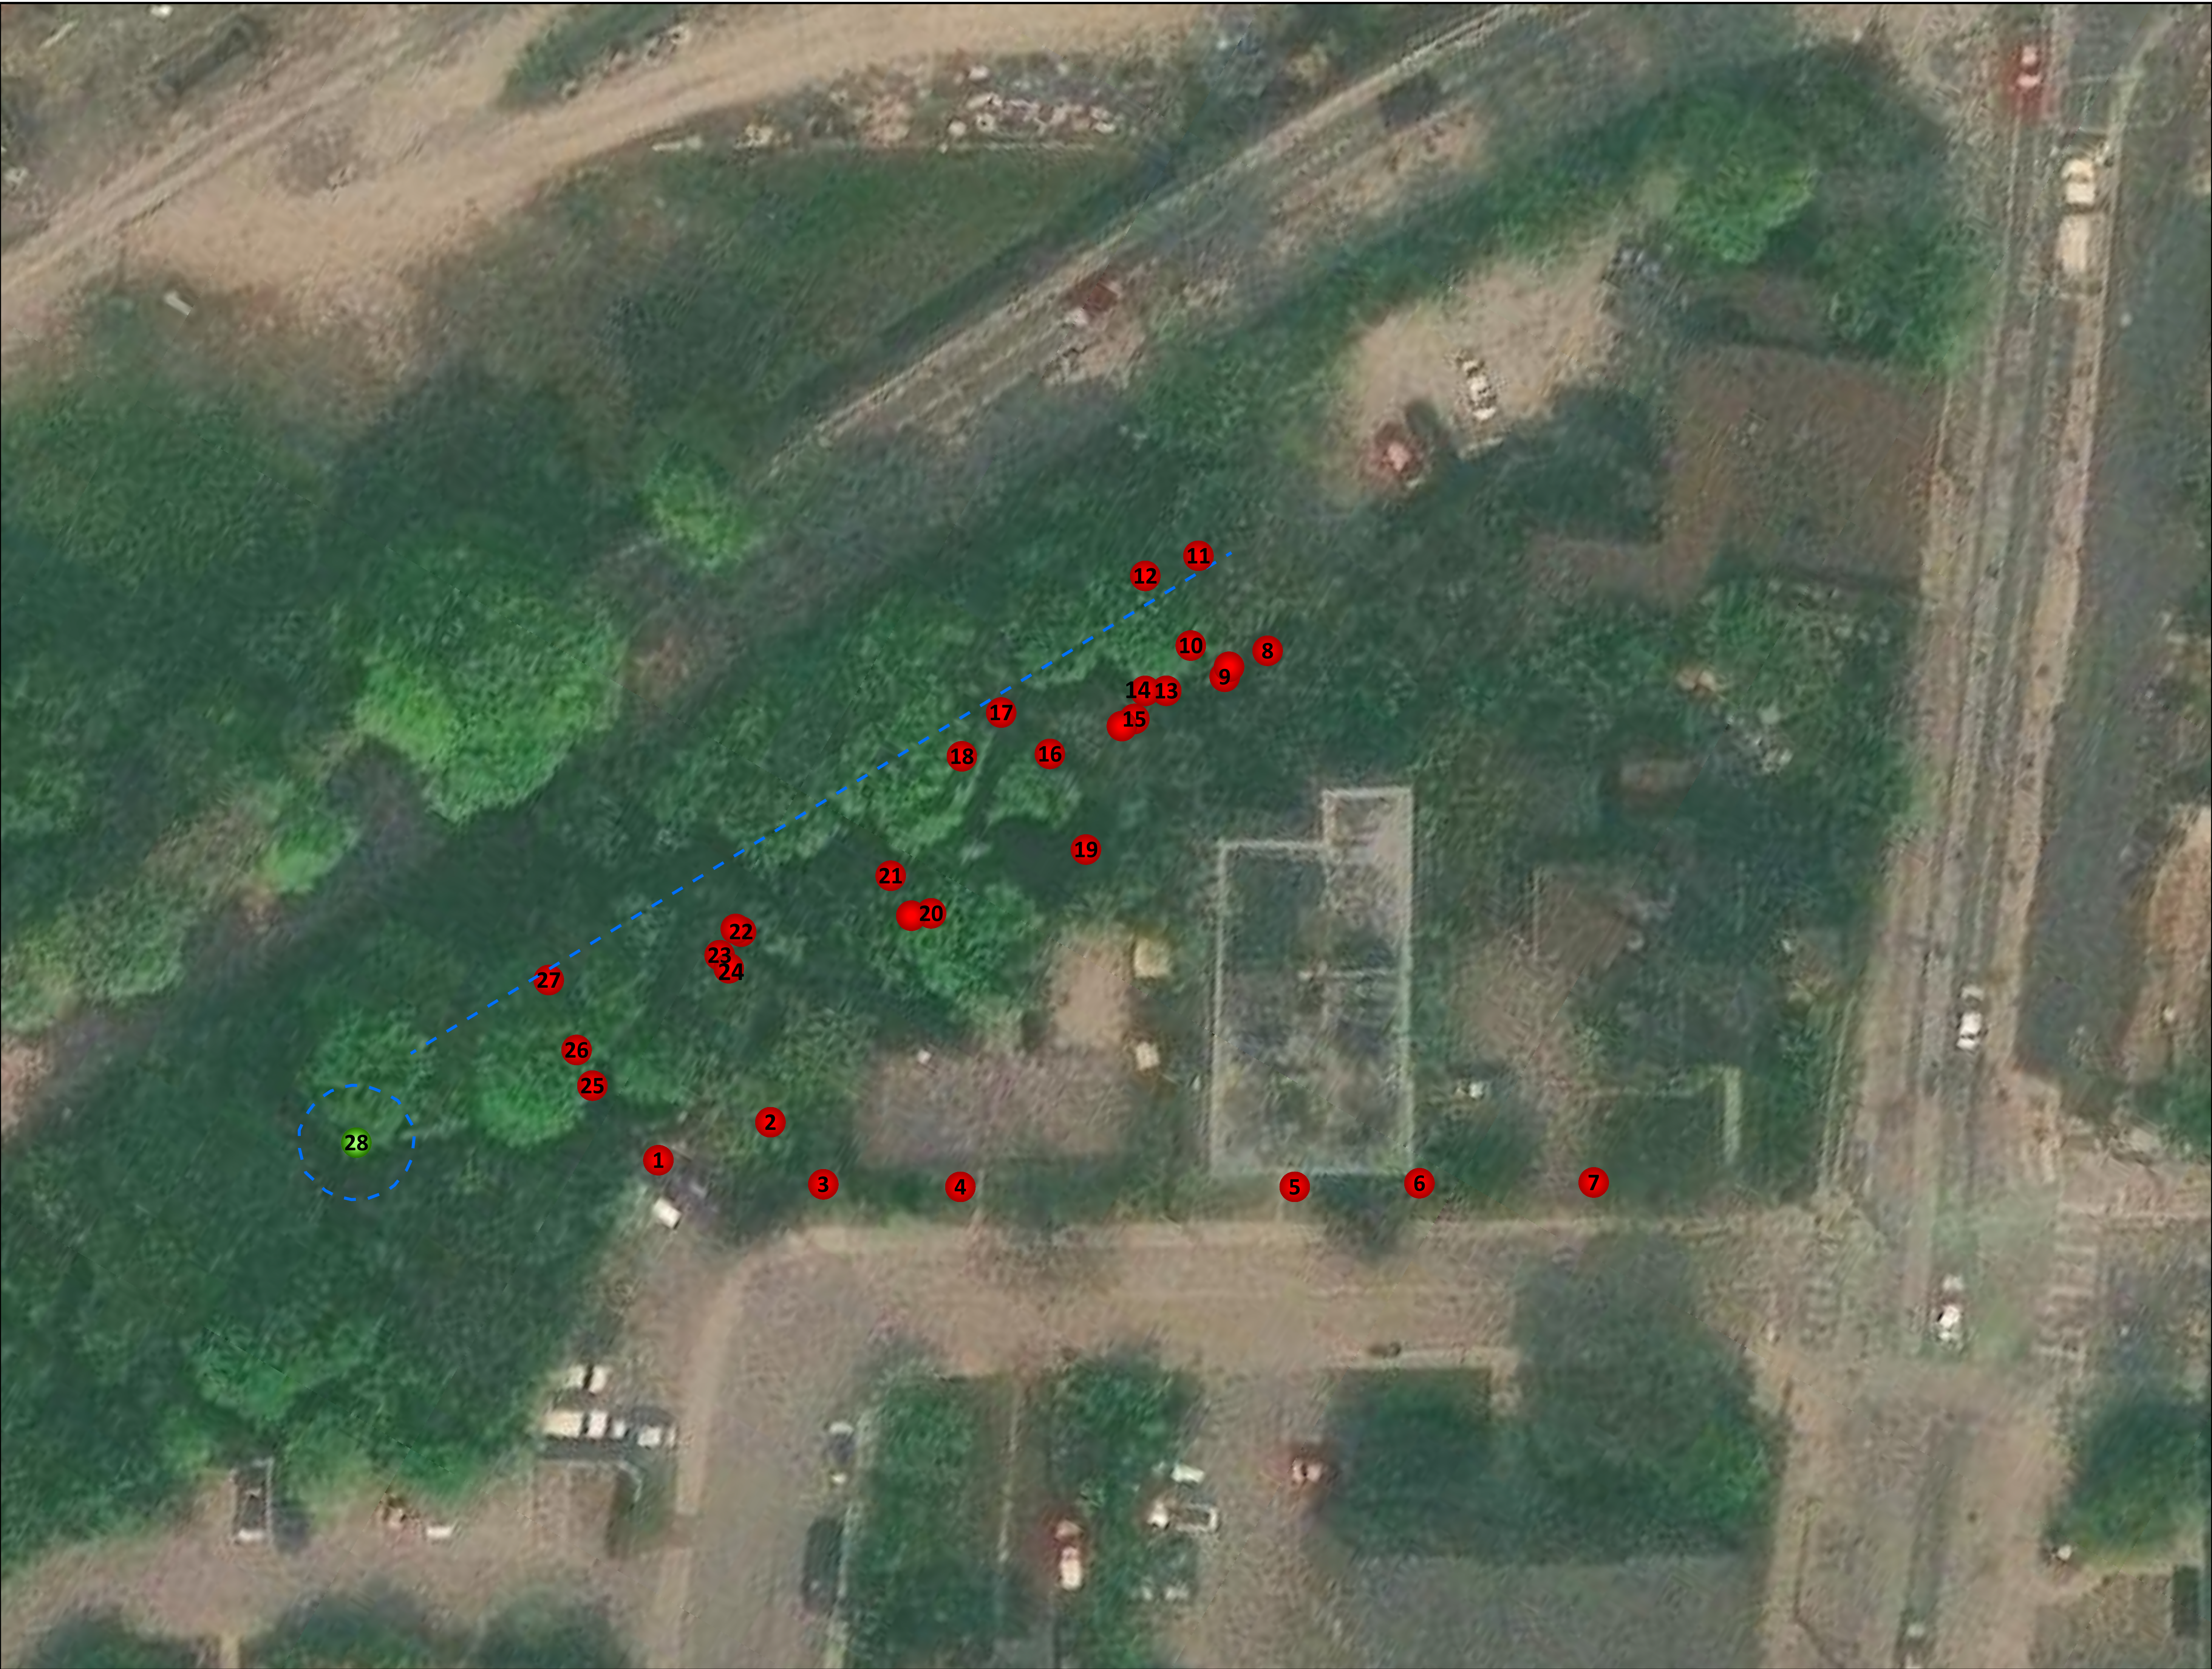
Table 1 below details the species, size (diameter), ownership, condition and status of the individual trees on and adjacent to the subject property. Each of these trees is referenced by the numbers plotted on the tree conservation plans included on page 6 and 7 of this report.

- TREE TO REMAIN
- CRITICAL ROOT ZONE
- TREE TO BE REMOVED
- PROTECTIVE FENCING

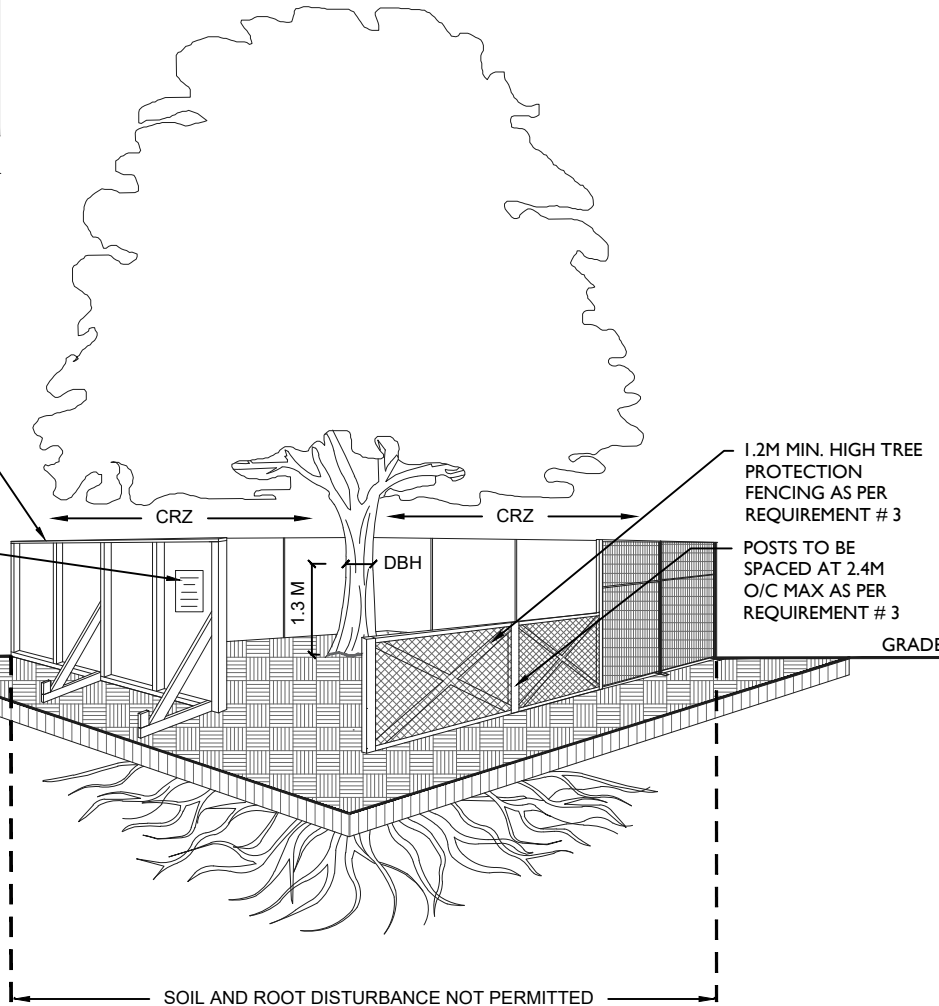
## TREE PROTECTION SPECIFICATION

PLAN VIEW

TREE PROTECTION FENCING

TREE TRUNK

CRZ = DBH X 10CM.  
CRZ IS TO BE MEASURED FROM THE OUTSIDE EDGE OF THE TREE BASE

TREE PROTECTION SIGNAGE AS PER CITY STANDARD

GRADE

SOIL AND ROOT DISTURBANCE NOT PERMITTED

1. PRIOR TO ANY WORK ACTIVITY WITHIN THE CRITICAL ROOT ZONE (CRZ = 10 X DIAMETER) OF A TREE, TREE PROTECTION FENCING MUST BE INSTALLED SURROUNDING THE CRITICAL ROOT ZONE, AND REMAIN IN PLACE UNTIL THE WORK IS COMPLETE.

- DO NOT EXTEND HARD SURFACE OR SIGNIFICANTLY CHANGE LANDSCAPING
3. TREE PROTECTION FENCING MUST BE AT LEAST 1.2M IN HEIGHT, AND CONSTRUCTED OF RIGID OR FRAMED MATERIALS (E.G. MODULOC - STEEL, PLYWOOD HOARDING, OR SNOW FENCE ON A 2"X4" WOOD FRAME) WITH POSTS 2.4M APART, SUCH THAT THE FENCE LOCATION CANNOT BE ALTERED. ALL SUPPORTS AND BRACING MUST BE PLACED OUTSIDE OF THE CRZ, AND INSTALLATION MUST MINIMISE DAMAGE TO EXISTING ROOTS. (SEE DETAIL)

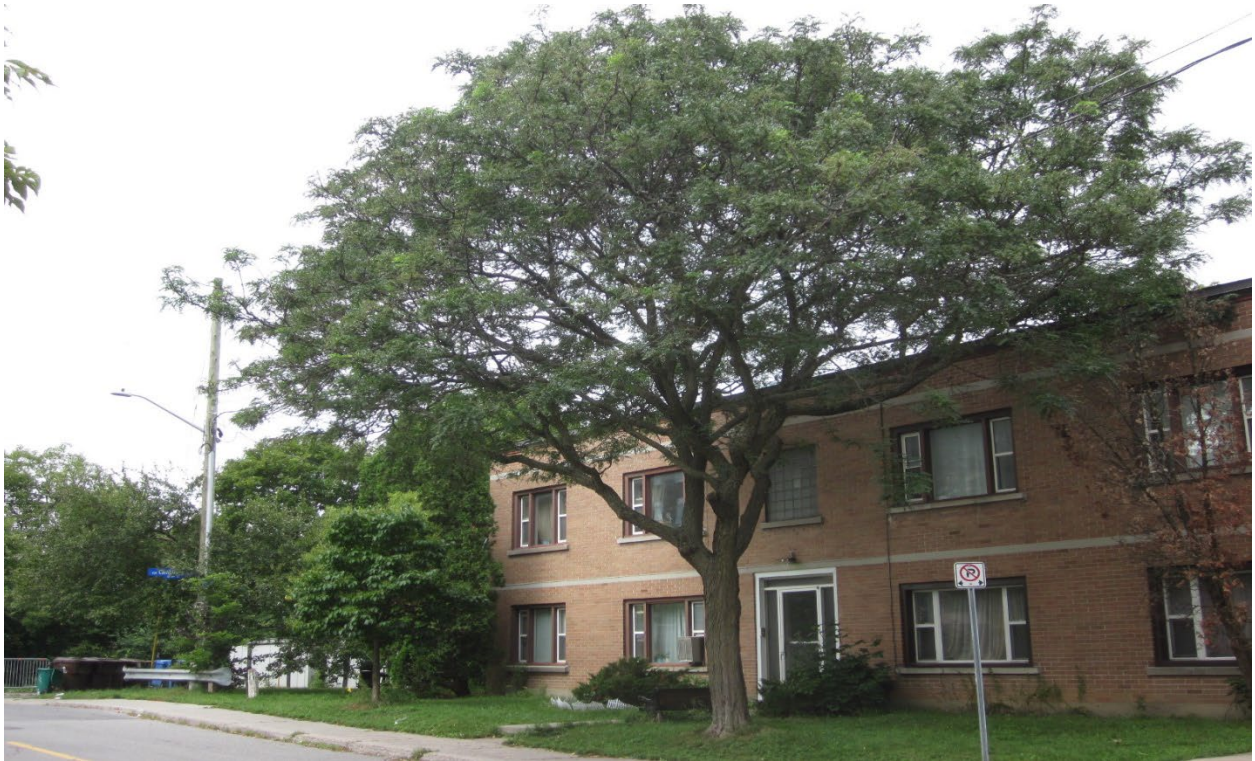
| Tree No. | Tree species | DBH <sup>1</sup> (cm) | Ownership | Age class, tree condition notes & <b>preservation status</b> (to be removed or preserved and protected) |
|---|---|---|---|---|
| 3 | Japanese tree lilac ( <i>Syringa reticulata</i> ) | 11 | City | Maturing; good; <b>to be removed</b> (conflicts with high voltage underground line) |

Picture 1. Tree #3 - city owned locust tree adjacent 593, 601-603 Laurier Avenue West

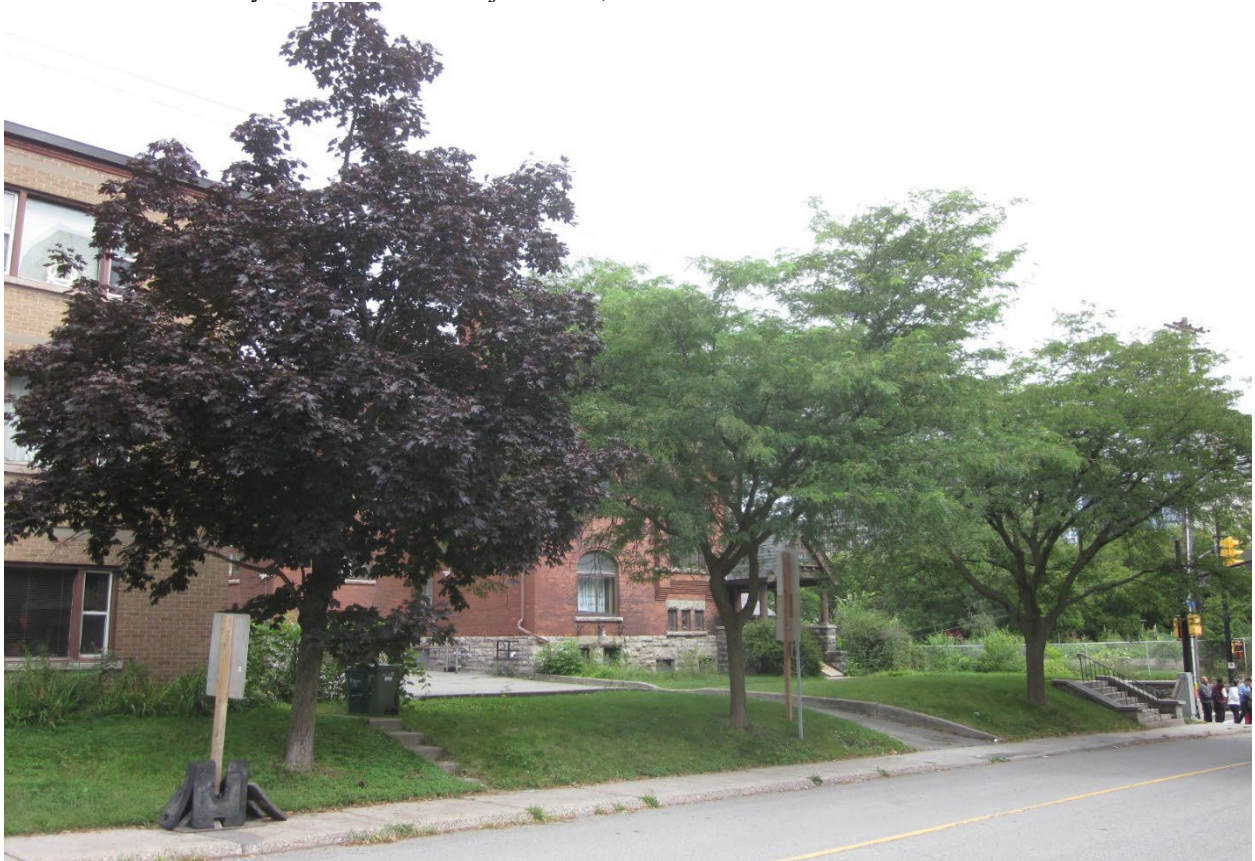
| Tree No. | Tree species | DBH <sup>1</sup> (cm) | Ownership | Age class, tree condition notes & <b>preservation status</b> (to be removed or preserved and protected) |
|---|---|---|---|---|
| 4 | Honey-locust<br>( <i>Gleditsia triacanthos</i> ) | 42 | City | Mature; good – mildly pruned from overhead Hydro lines; <b>to be removed</b> (conflicts with high voltage underground line) |
| 5 | Norway maple<br>( <i>Acer platanoides</i> ) | 49 | City | Mature; fair - moderately pruned from overhead Hydro lines; <b>to be removed</b> (conflicts with high voltage underground line) |
| 6 | Honey-locust<br>( <i>Gleditsia triacanthos</i> ) | 27 | City | Mature; fair - moderately pruned from overhead Hydro lines; <b>to be removed</b> (conflicts with high voltage underground line and ramp to below grade parking) |

Picture 2. Trees #4, 5 and 6 – city owned maple and locust trees adjacent 593, 601-603 Laurier Avenue West

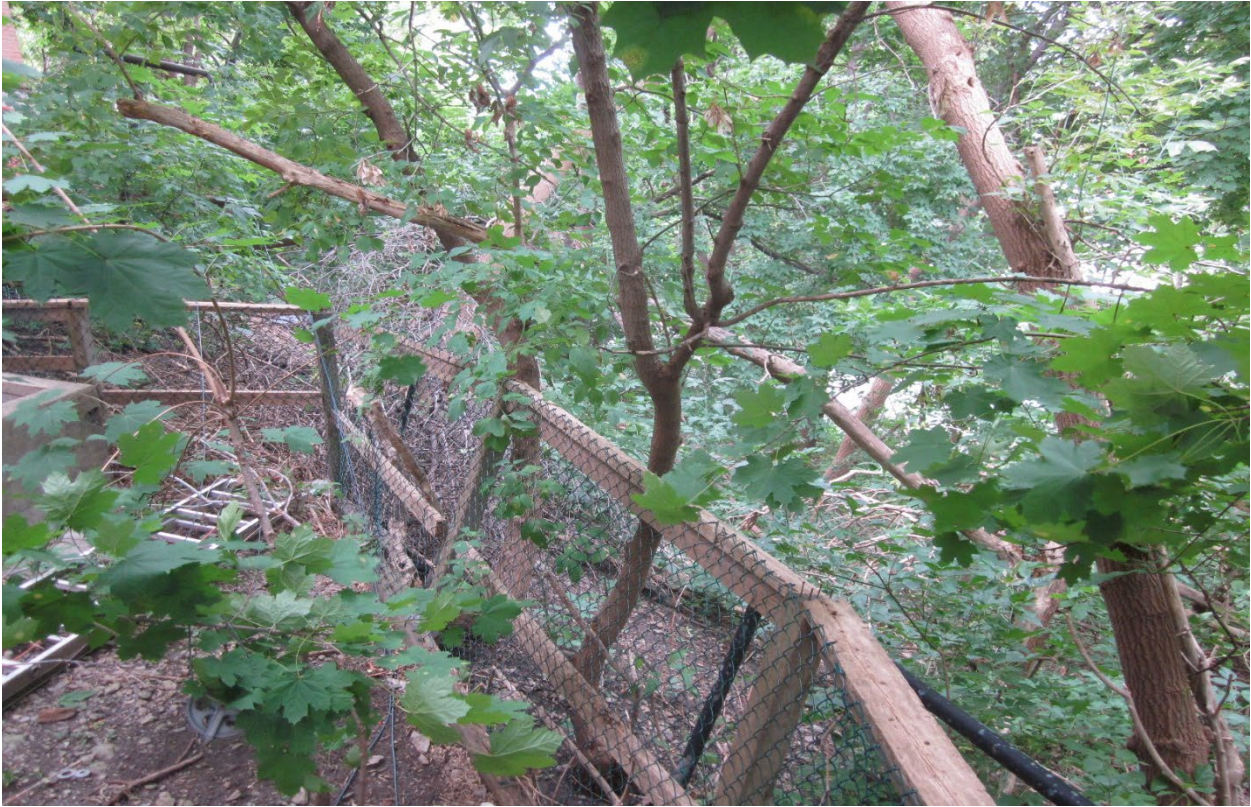
Picture 3. Representative picture of trees within escarpment forest at 593, 601-603 Laurier Avenue West

The forest within the escarpment has been deemed a natural heritage feature in the City of Ottawa's Official Plan. As a result, its preservation is critical. To that end, the following measures are recommended:

- 1) Due to the depth of excavation necessary for the three levels of below grade parking, shoring at the limits of subject property will be necessary. At the rear of the property this will serve the important dual purpose of avoiding any over excavation into the escarpment forest.

- 2) Blasting will be necessary to remove bedrock. If not done carefully this work will impact the escarpment trees as their root-soil interfaces will likely be disturbed within their critical rooting zones. It is these intimate interfaces which allow for the absorption of moisture and nutrients from the soil. To mitigate damage from blasting the following specifications should be adhered to:

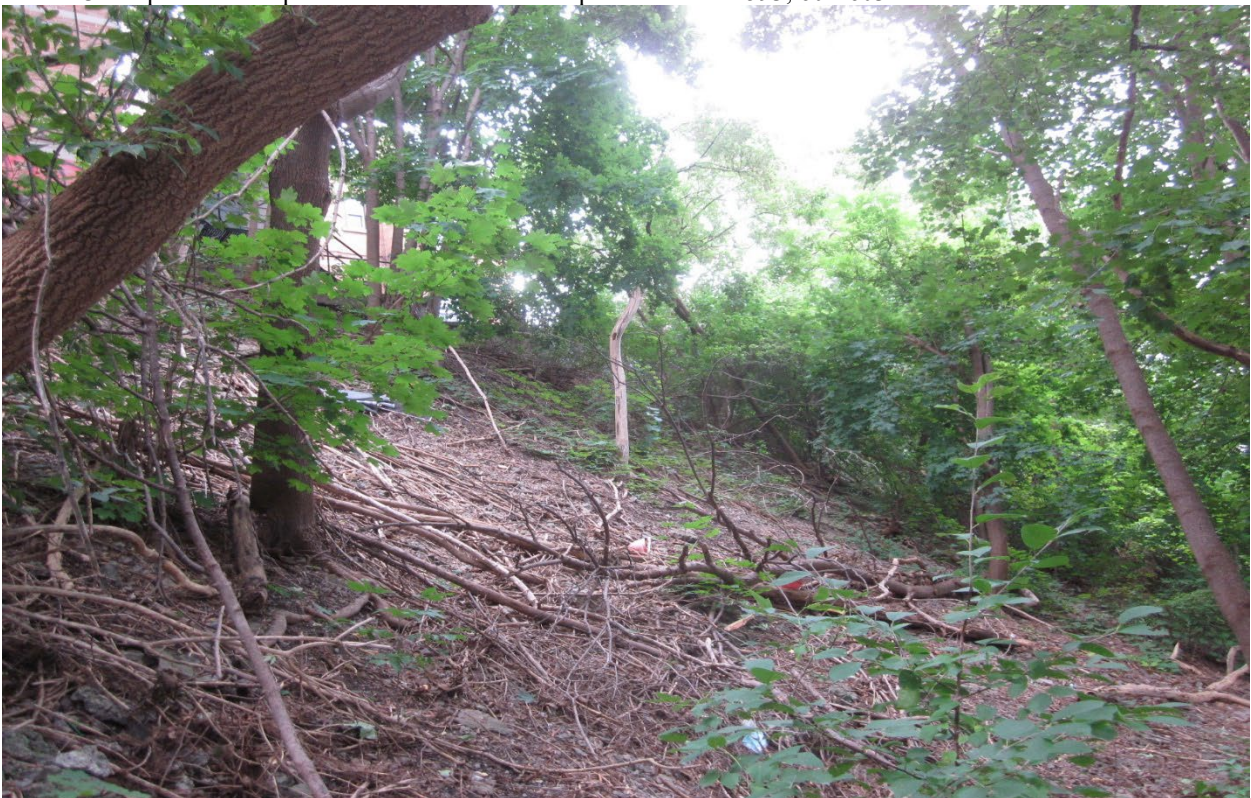
Picture 4. Representative picture of trees within escarpment forest at 593, 601-603 Laurier Avenue West
