May 1, 2025  
File: PE6587-LET.01

Subject: **Phase I-Environmental Site Assessment Update**  
**6259, 6267, 6271 and 6273 Renaud Road**  
**Ottawa, Ontario**

Further to your request, Paterson Group (Paterson) carried out a Phase I Environmental Site Assessment (ESA) Update for the aforementioned properties. This report updates four previous Phase I ESAs prepared for the Phase I Property in 2022, 2023 and 2024. This report is intended to meet the requirements of a Phase I ESA Update, as per the MECP Standard O.Reg. 153/04, as amended, under the Environmental Protection Act. This report is to be read in conjunction with the previous reports.

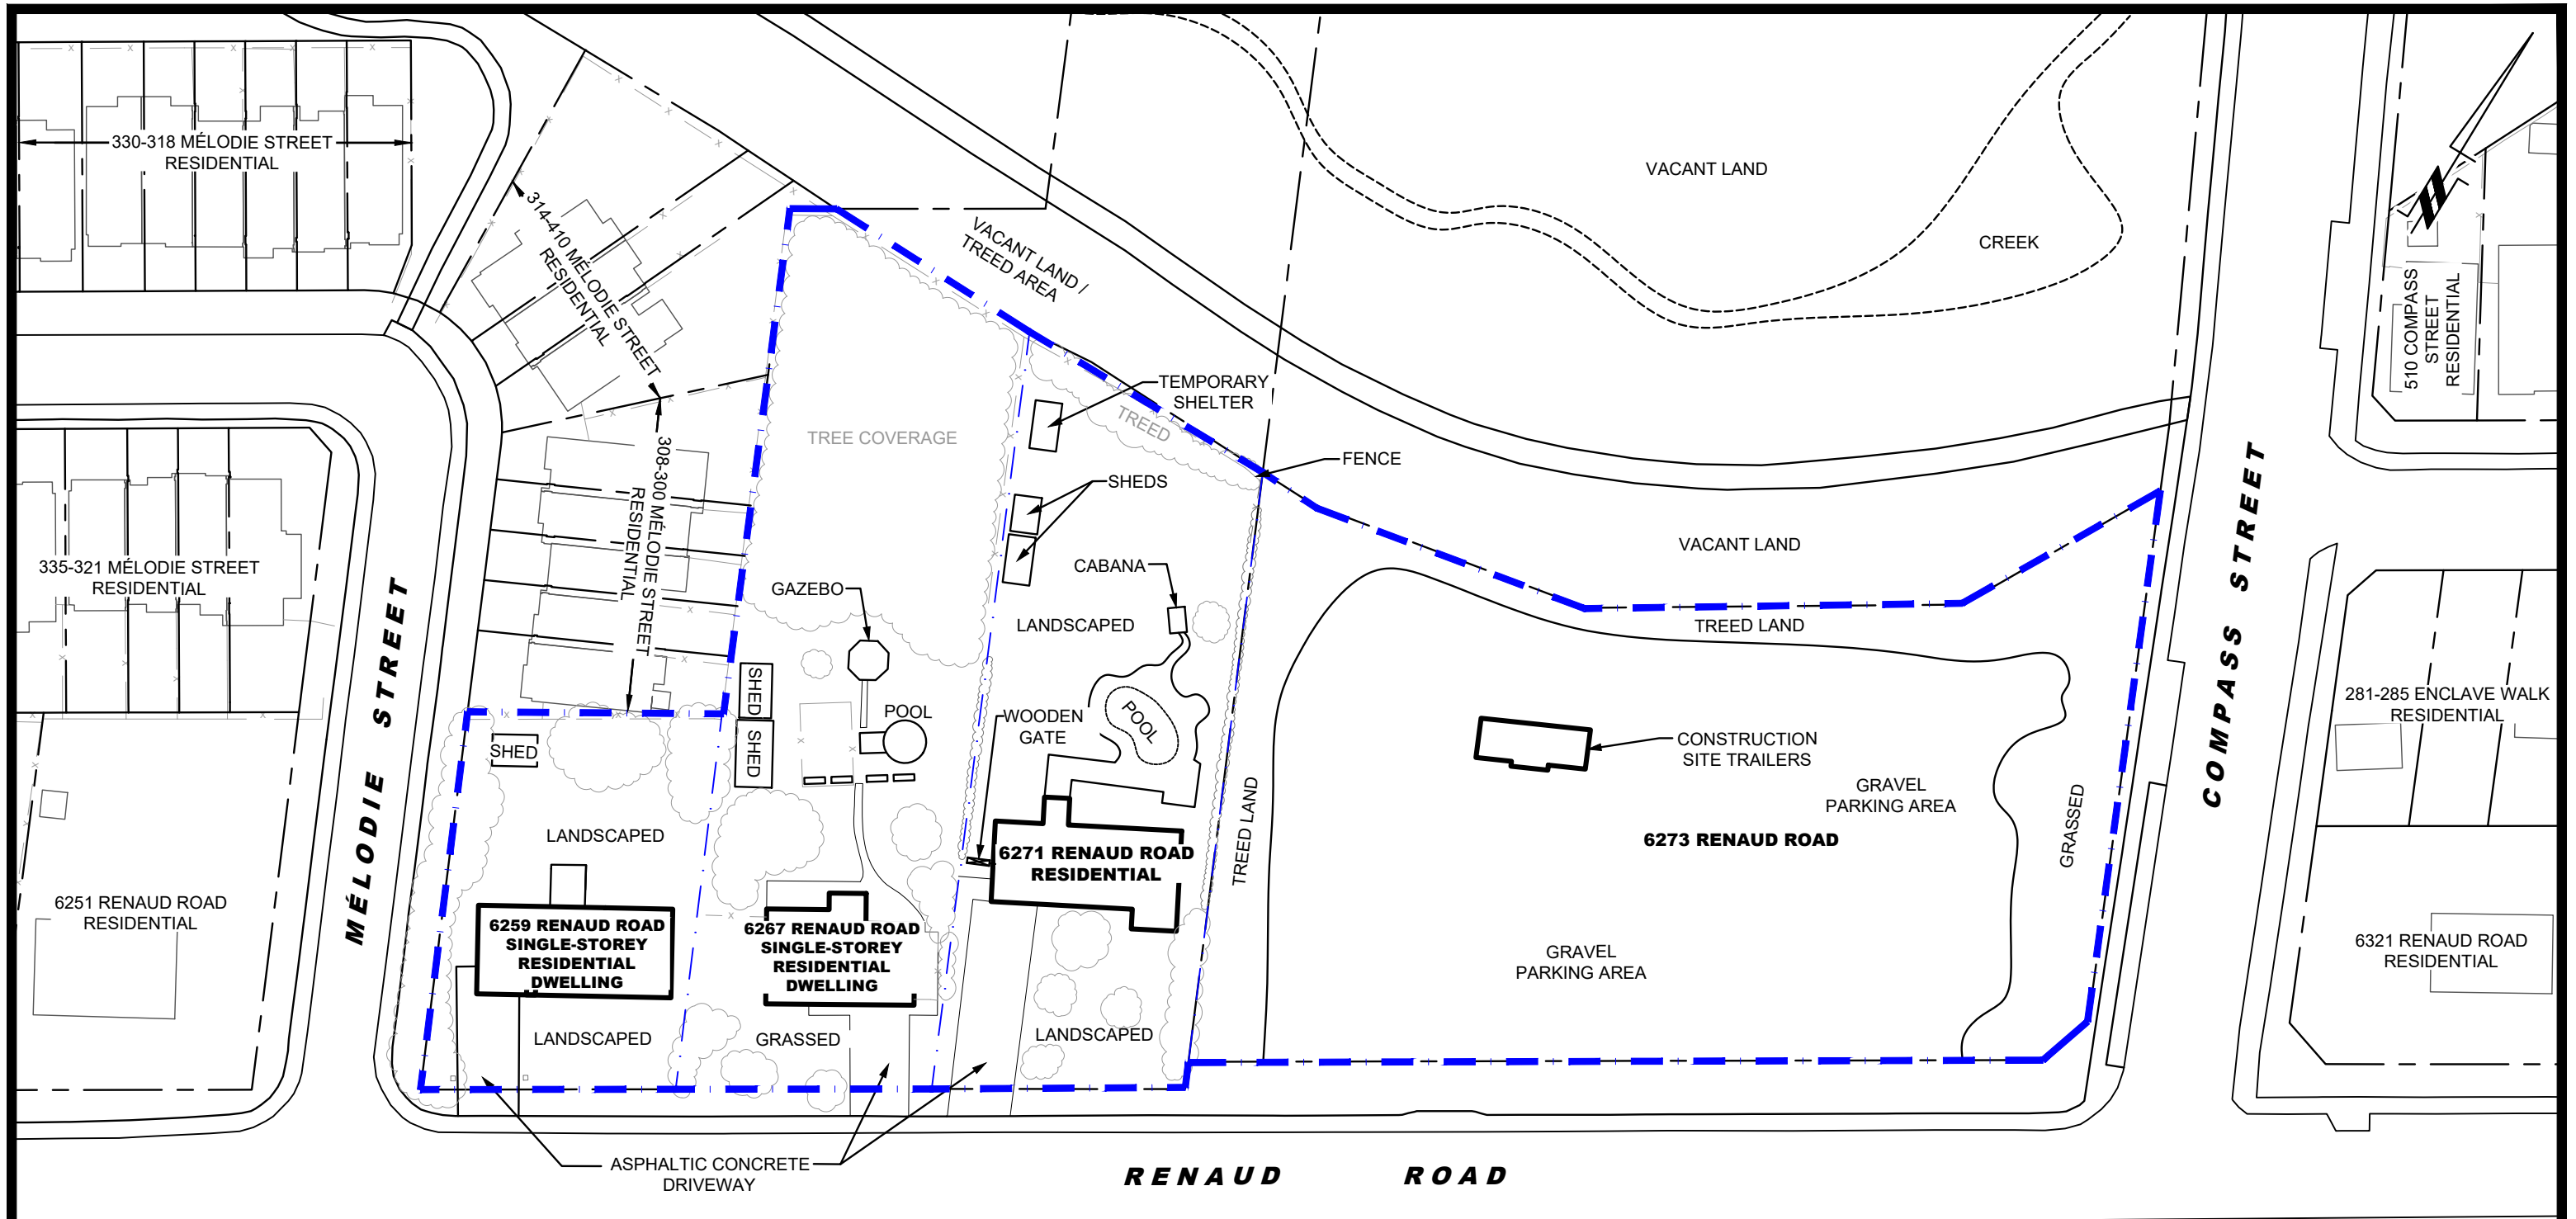
Scale:	1:750	Date:	04/2025
Drawn by:	GK	Report No.:	PE6587-LET.01
Checked by:	MR	Dwg. No.:	<b>PE6587-2</b>
Approved by:	MSD	Revision No.:

The Phase I Property is occupied by three residential dwellings on the central and western portions of the site, while the eastern portion of the site is vacant. The Phase I Property is located at the northwest corner of the Compass Street and Renaud Road intersection, in the City of Ottawa, Ontario. The Phase I property is an irregular lot in an IA1– Minor Institutional Zone and in a DR - Development Reserve Zone. The property is surrounded by residential, parkland and institutional properties. The Phase I Property is situated in a municipally serviced area. The configuration of the Phase I Property is shown on Drawing PE6587-2 - Site Plan, which is appended to this report.

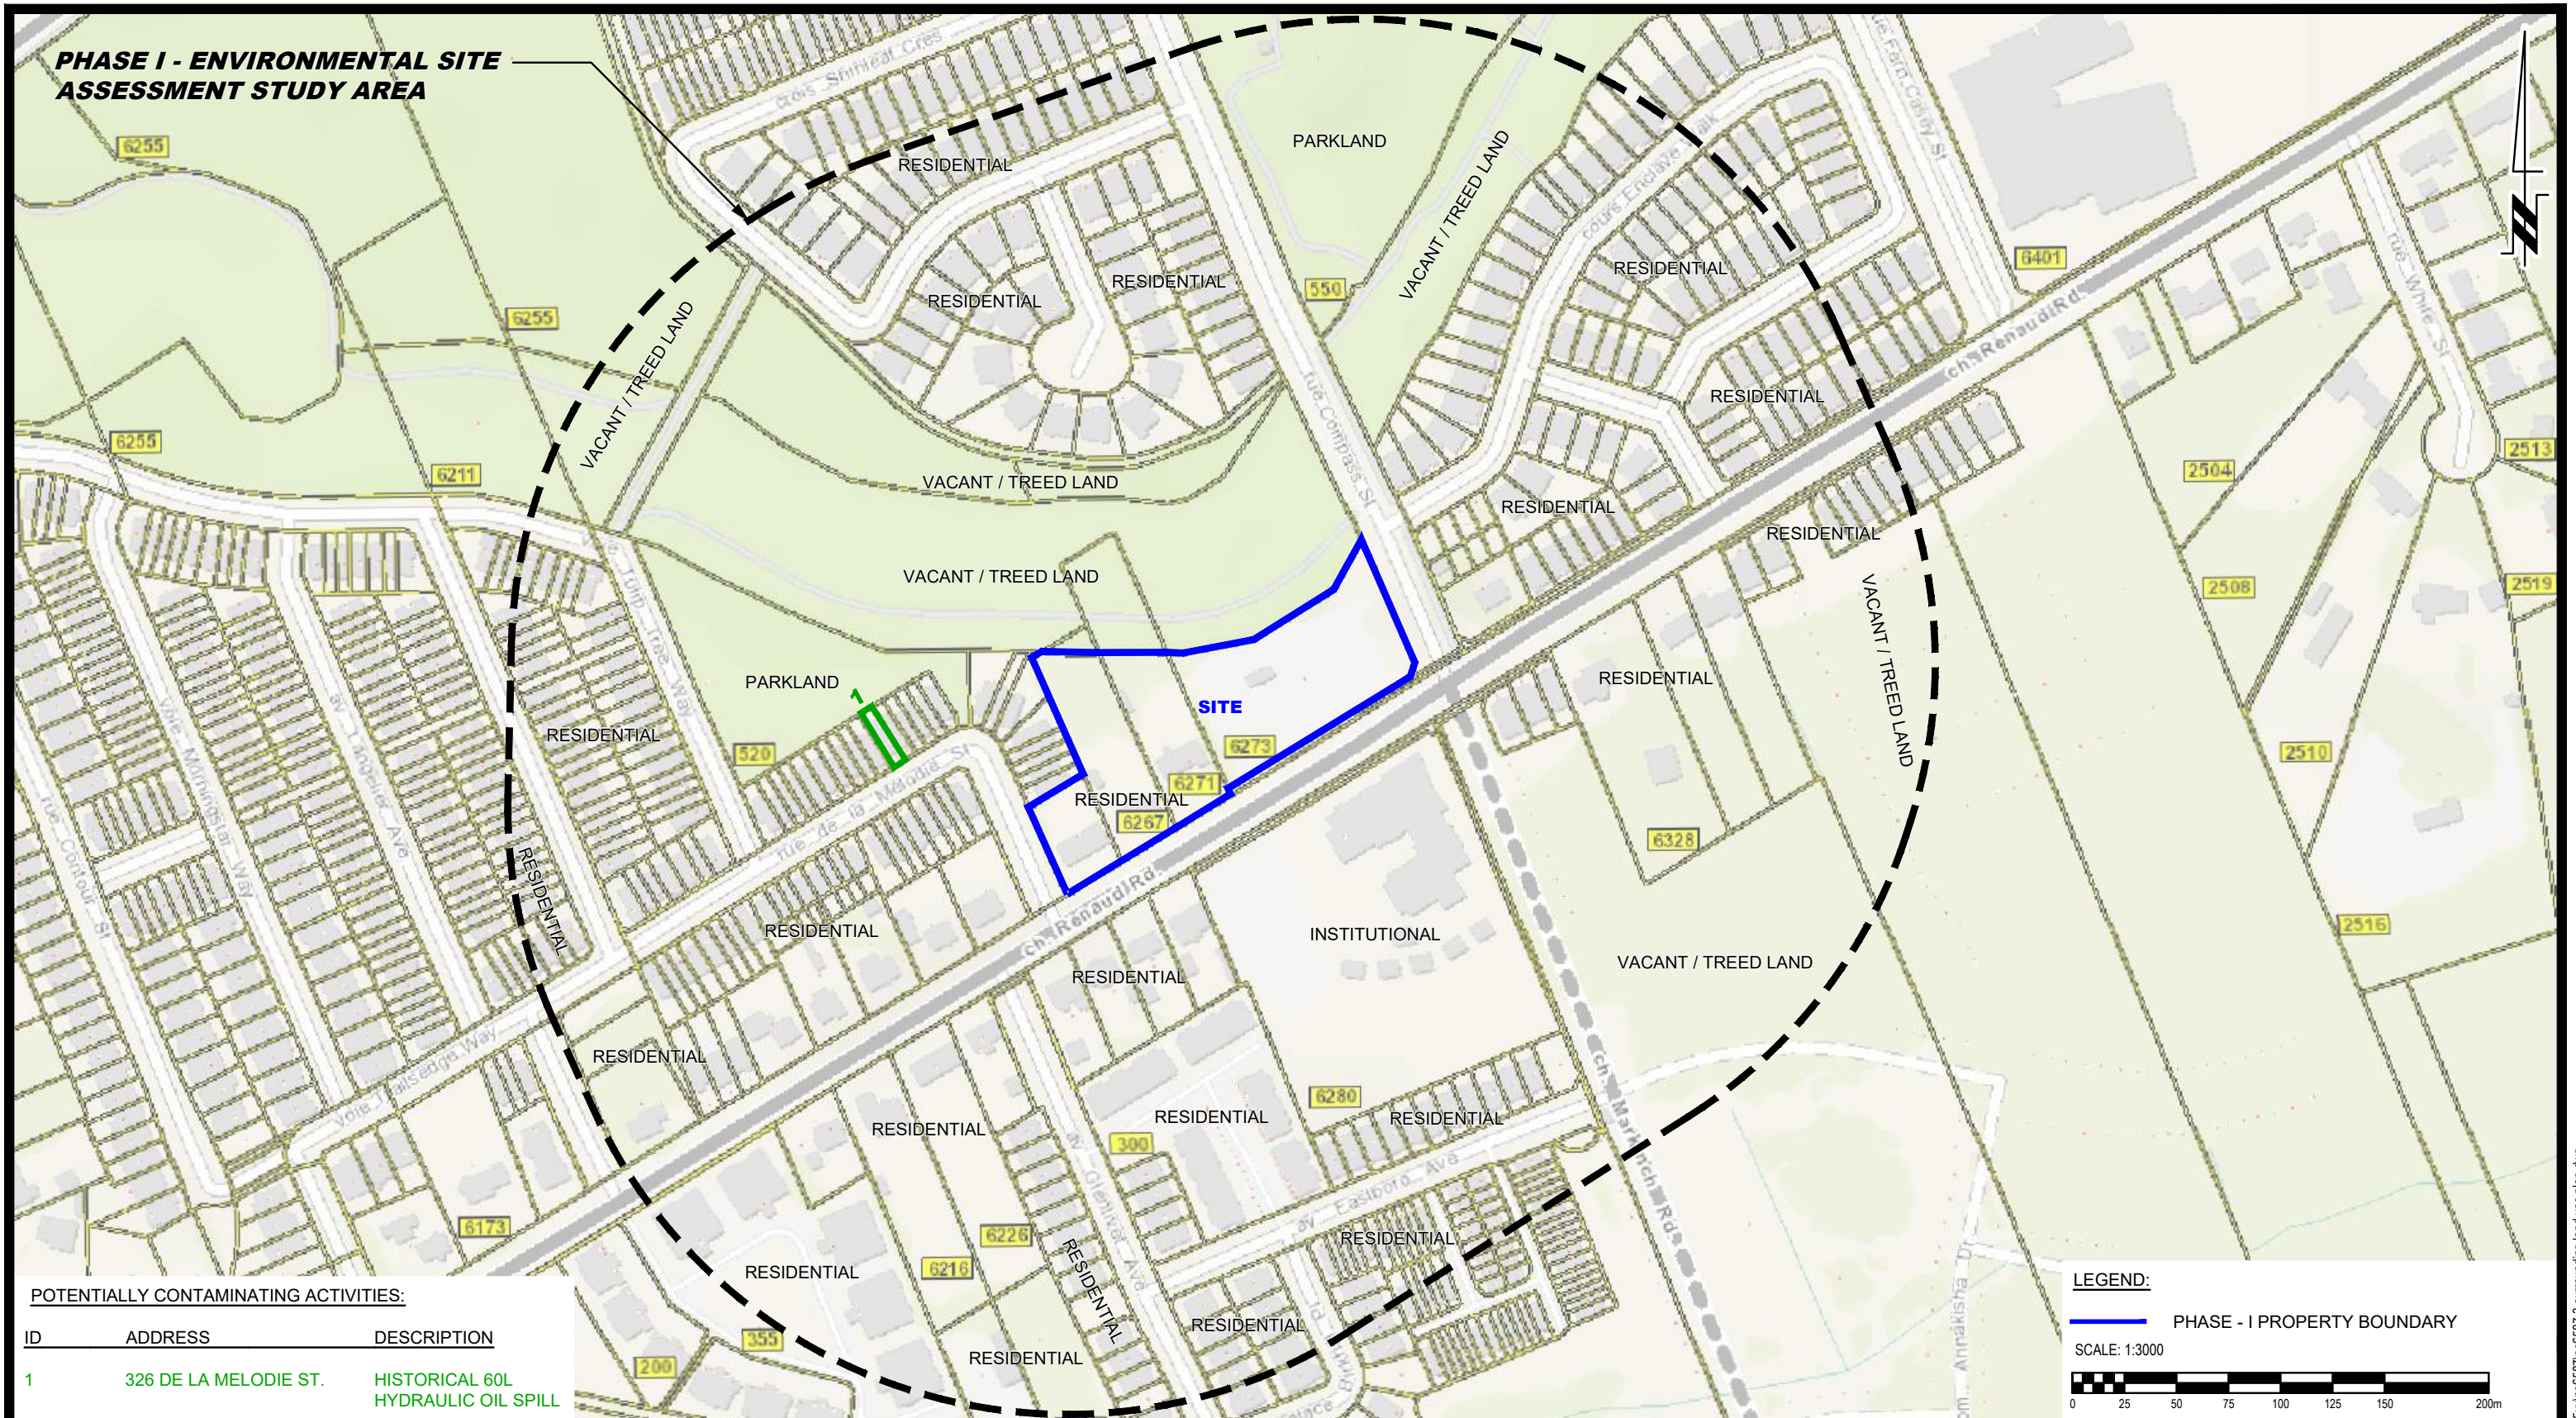
**PHASE I - ENVIRONMENTAL SITE ASSESSMENT STUDY AREA**

ID	ADDRESS	DESCRIPTION
1	326 DE LA MELODIE ST.	HISTORICAL 60L HYDRAULIC OIL SPILL
