**RE: TREE CONSERVATION REPORT FOR 475 TERRY FOX DRIVE, OTTAWA**

This Tree Conservation Report (TCR) was prepared by IFS Associates Inc. (IFS) on behalf of Ruhland & Associates Ltd. in support of the development of 475 Terry Fox Drive in Ottawa. The need for this report is related to trees protected under the City of Ottawa's Tree Protection By-law (By-law No. 2020-340). The By-law reflects Section 4.8.2. of the City of Ottawa's Official Plan which calls for the retention of the City's urban forestry canopy and, in particular, large healthy trees.

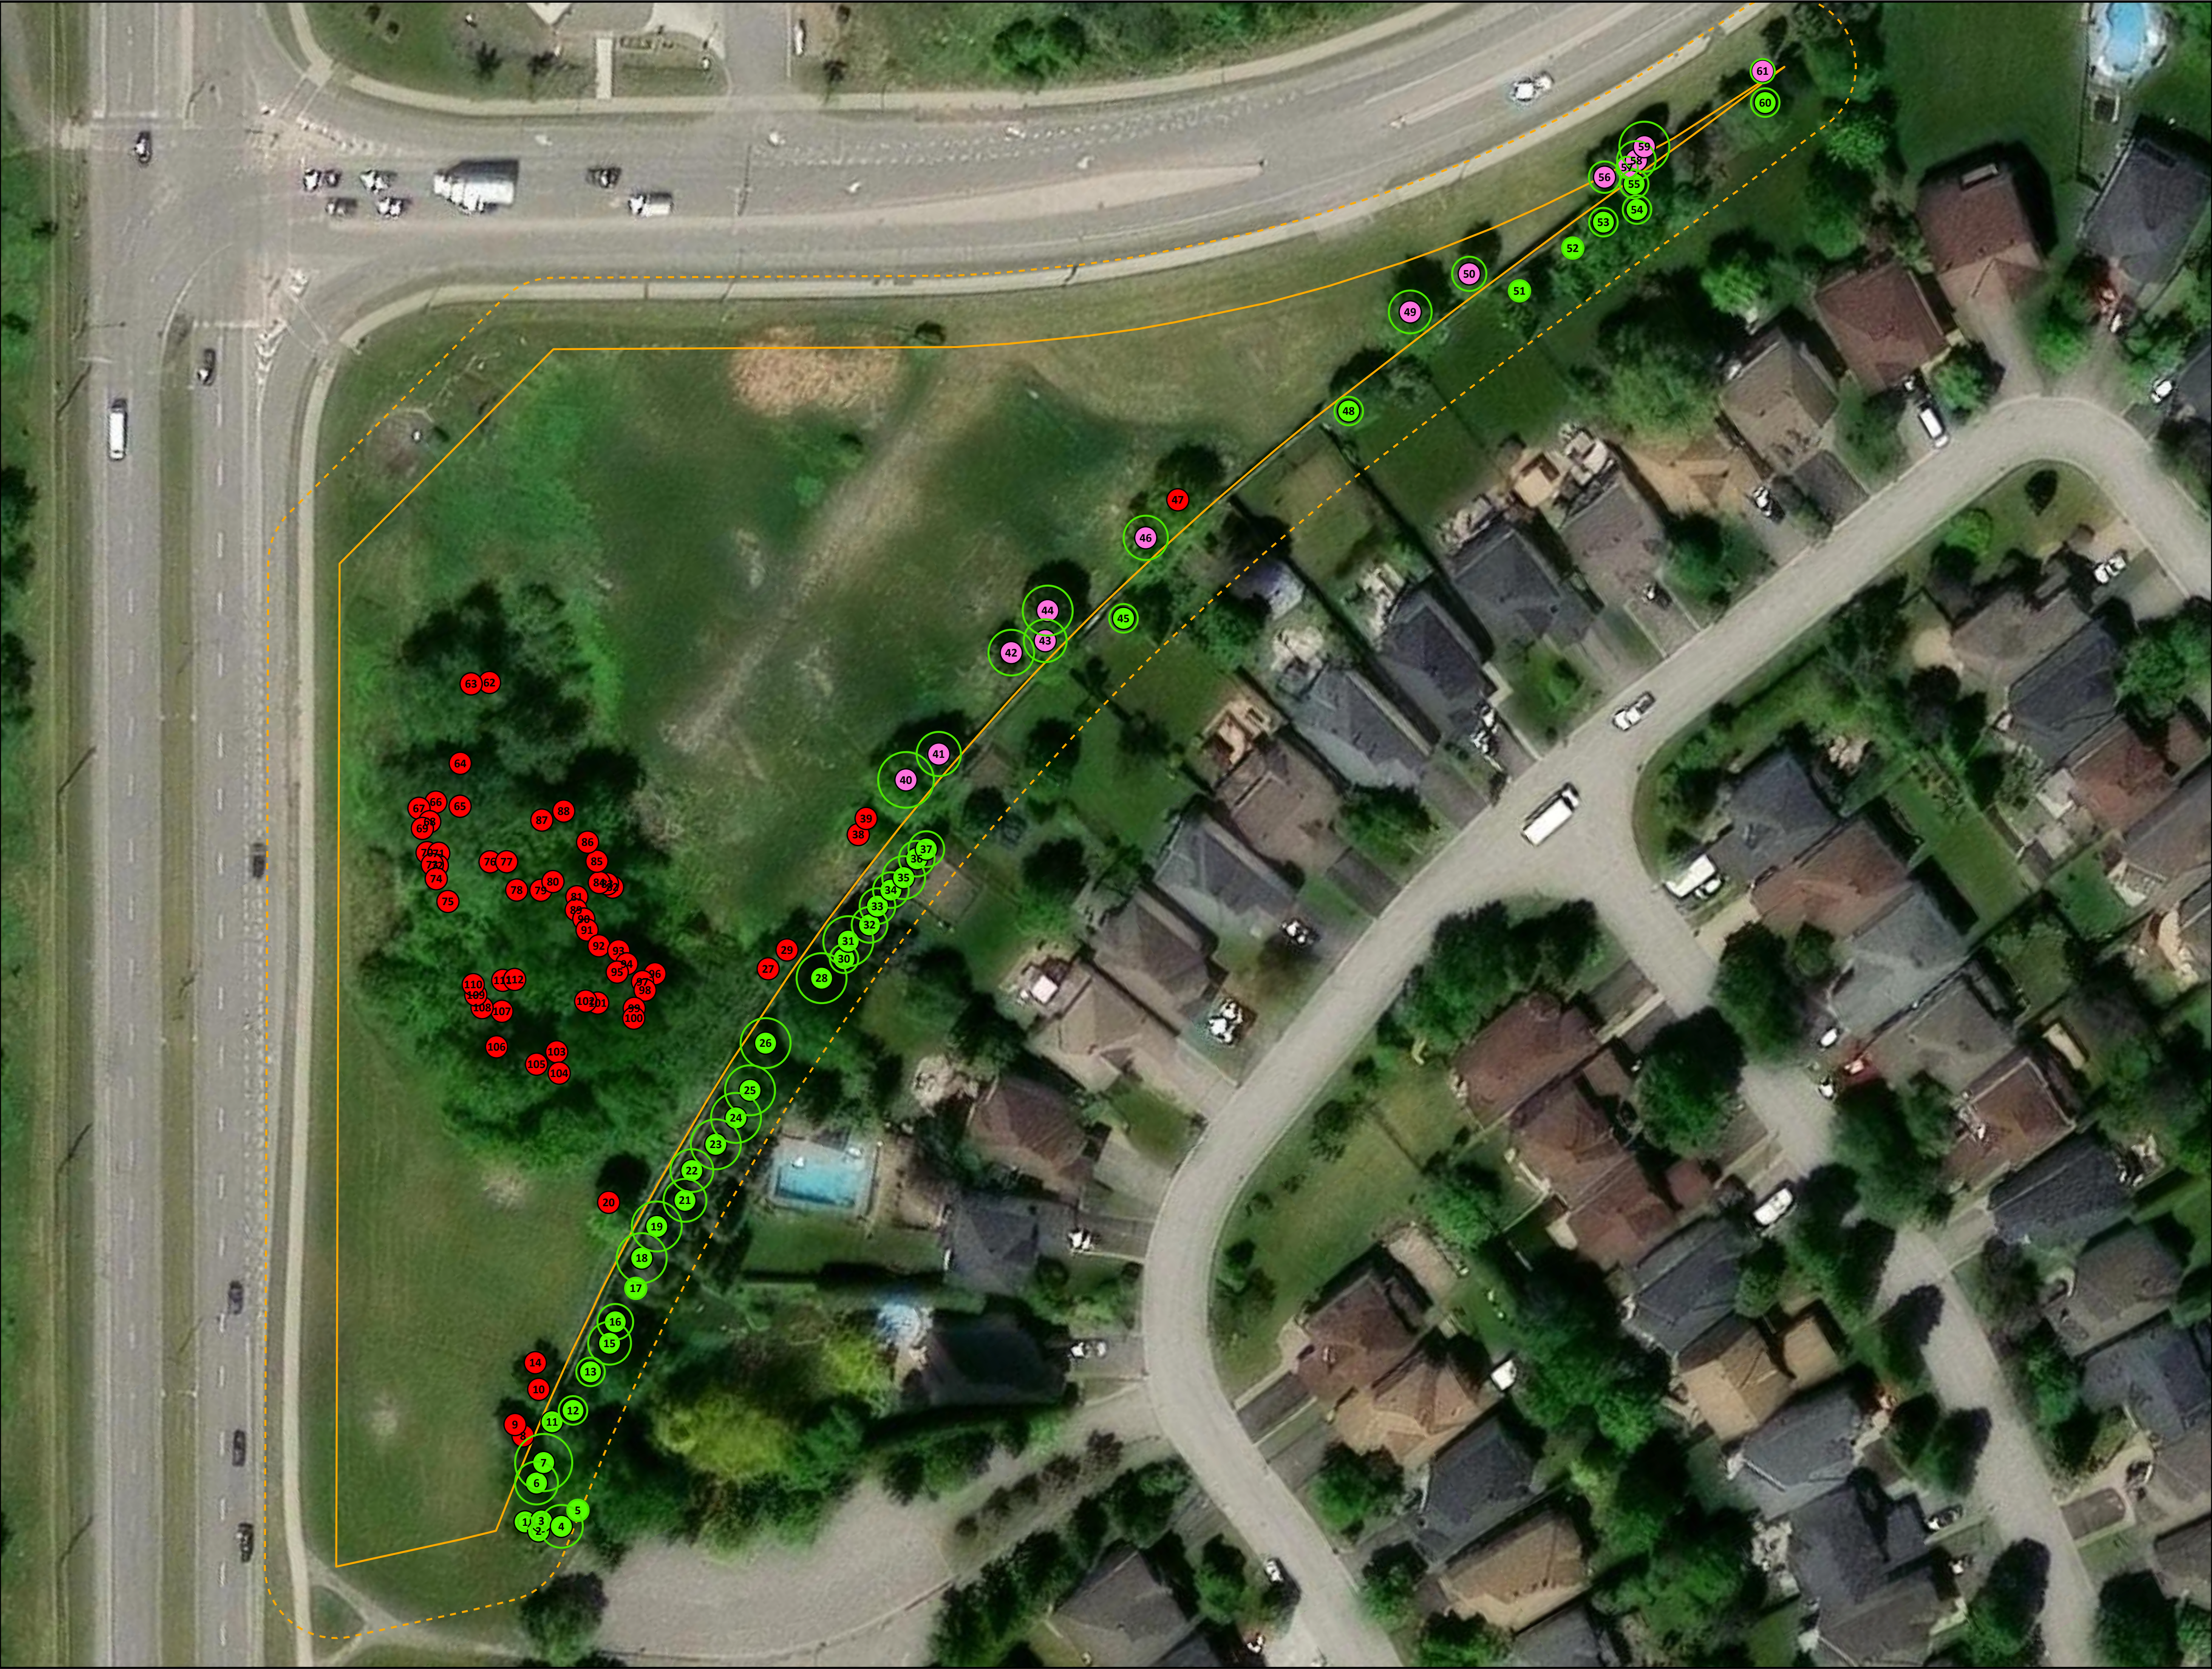
**Page 14: Figure 3 SPECIES AT RISK SEARCH AREA**  
(prepared by IFS Associates)

The area surveyed for butternut and black ash consisted of a 50m buffer around the subject property, while the tree survey was restricted to the 10m from the work area.

- 1) The Provincial Endangered Species Act (ESA, 2007) mandates that tree species on the Species at Risk in Ontario (SARO) list be identified. Butternut (*Juglans cinerea*) and black ash (*Fraxinus nigra*) are present in Eastern Ontario and are listed as threatened on the SARO. Because of this they are protected from harm. One butternut was found on site (see Table 1 on page 5 and Figure 3 on page 14). No black ash trees were found on or near the subject properties.  
A Butternut Health Experts (BHE) Report was completed and submitted to the Ministry of Environment, Conservation and Parks (MECP) in June 2025. The butternut was found to be a Category 1 tree (i.e. 'unretainable').

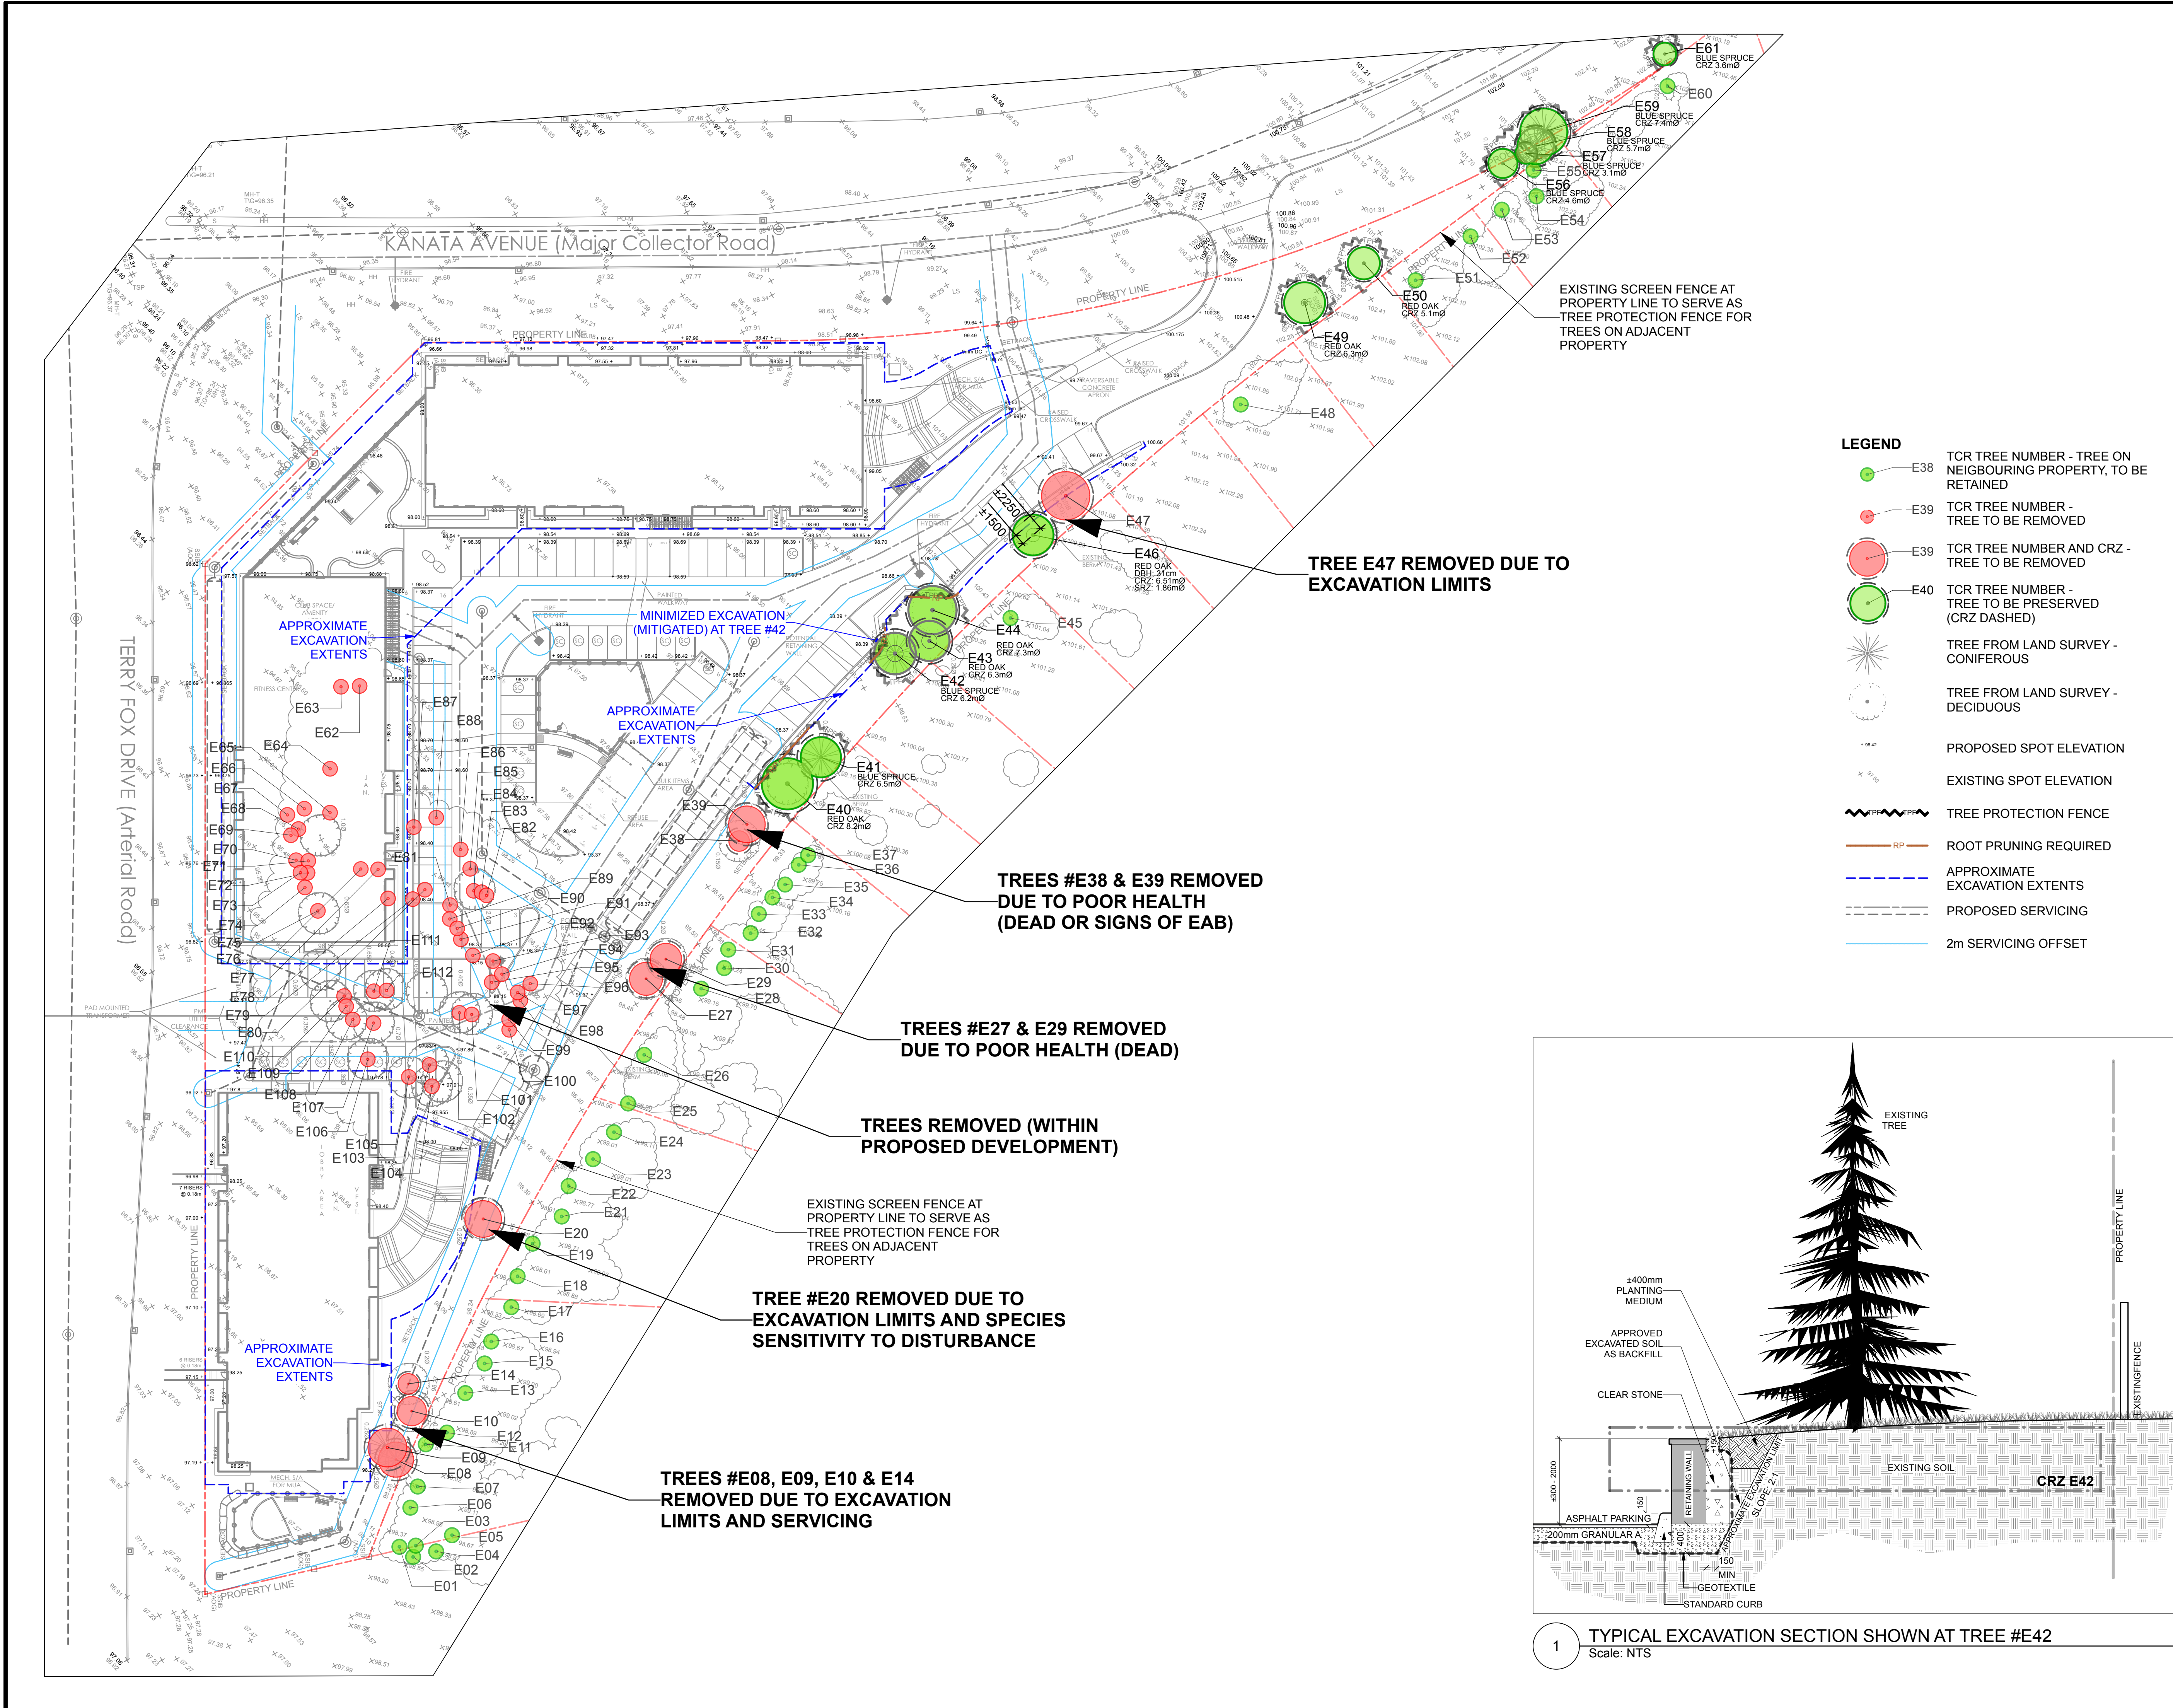
**Map #2**  
Rev #2

- LEGEND**
- E38 TCR TREE NUMBER - TREE ON NEIGHBOURING PROPERTY, TO BE RETAINED
  - E39 TCR TREE NUMBER - TREE TO BE REMOVED
  - E39 TCR TREE NUMBER AND CRZ - TREE TO BE REMOVED
  - E40 TCR TREE NUMBER - TREE TO BE PRESERVED (CRZ DASHED)
  - Tree symbol with star: TREE FROM LAND SURVEY - CONIFEROUS
  - Tree symbol with dot: TREE FROM LAND SURVEY - DECIDUOUS
  - Star symbol: PROPOSED SPOT ELEVATION
  - Dot symbol: EXISTING SPOT ELEVATION
  - Wavy line symbol: TREE PROTECTION FENCE
  - Orange line symbol: ROOT PRUNING REQUIRED
  - Blue dashed line symbol: APPROXIMATE EXCAVATION EXTENTS
  - Blue dashed line symbol: PROPOSED SERVICING
  - Blue line symbol: 2m SERVICING OFFSET

Tables 1 and 2 on pages 5 through 10 of this report detail the species, size (DBH), health condition, critical root zone, preservation status and ownership of the individual trees found on the subject property ('proponent') and adjacent properties ('neighbour'). Each of these trees is referenced by the numbers plotted on the tree conservation plans within Figures 1 and 2 on pages 12 and 13 of this report.
