# **Phase I – Environmental Site Assessment**

4816 Bank Street  
Ottawa, Ontario

Prepared for DCR Phoenix Development Corporation Ltd.

**Report: PE6552-1**  
**July 25, 2024**

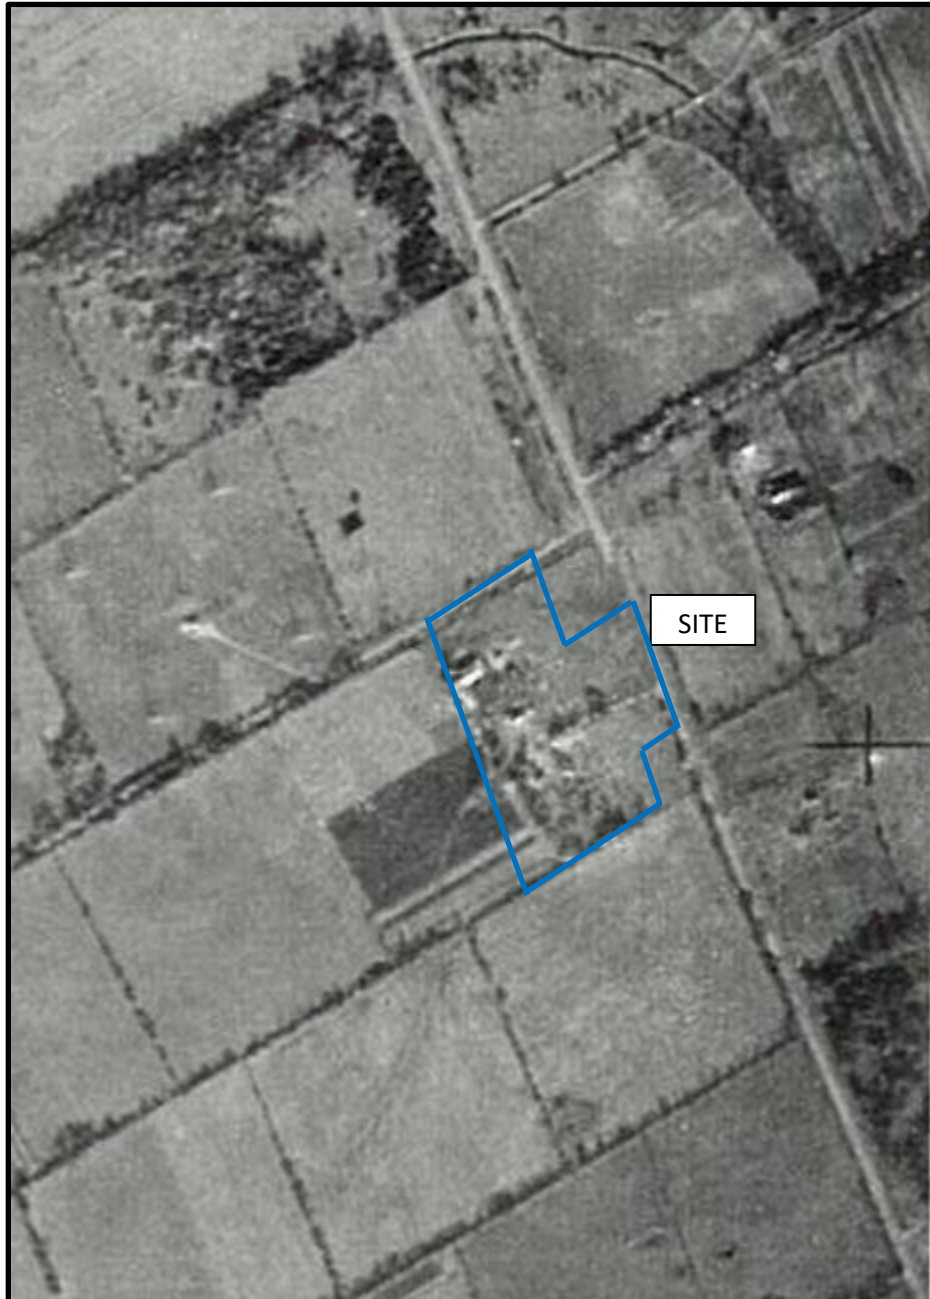
AERIAL PHOTOGRAPH  
1945

| 1945 | (Poor Quality, National Air Photo Library) A farmstead consisting of multiple structures is observed on the Phase I Property. The surrounding properties are largely vacant or used for agricultural purposes. Structures can be seen to the northwest and northeast of the Phase I Property. A portion of Bank Street is observed east of the Phase I Property. |

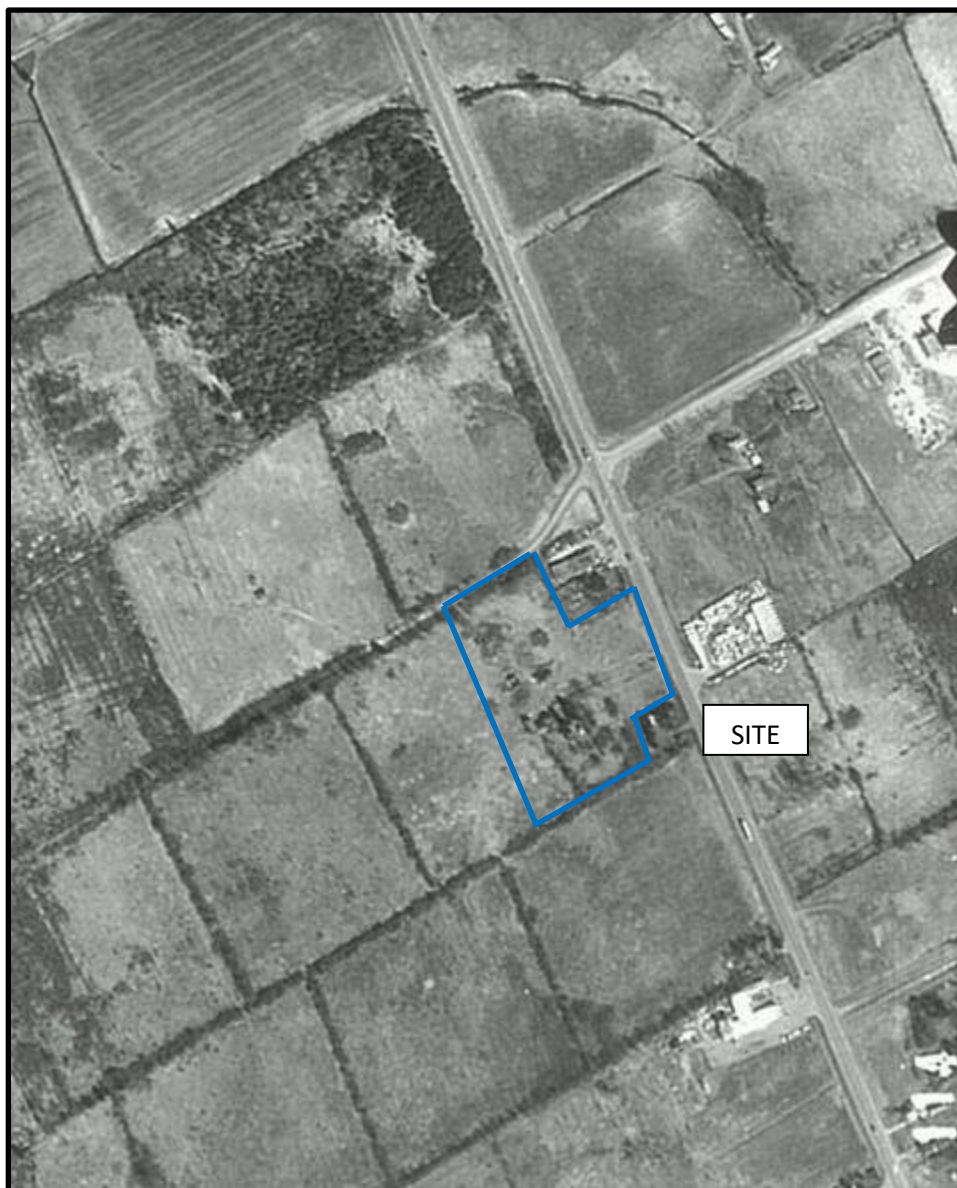
AERIAL PHOTOGRAPH  
1985

- 1985 (National Air Photo Library) The northern most building on the Phase I Property has been removed since the previous photo. The structures at 4815 Bank Street have been replaced with permanent structures. No other significant changes are apparent with respect to the surrounding lands.

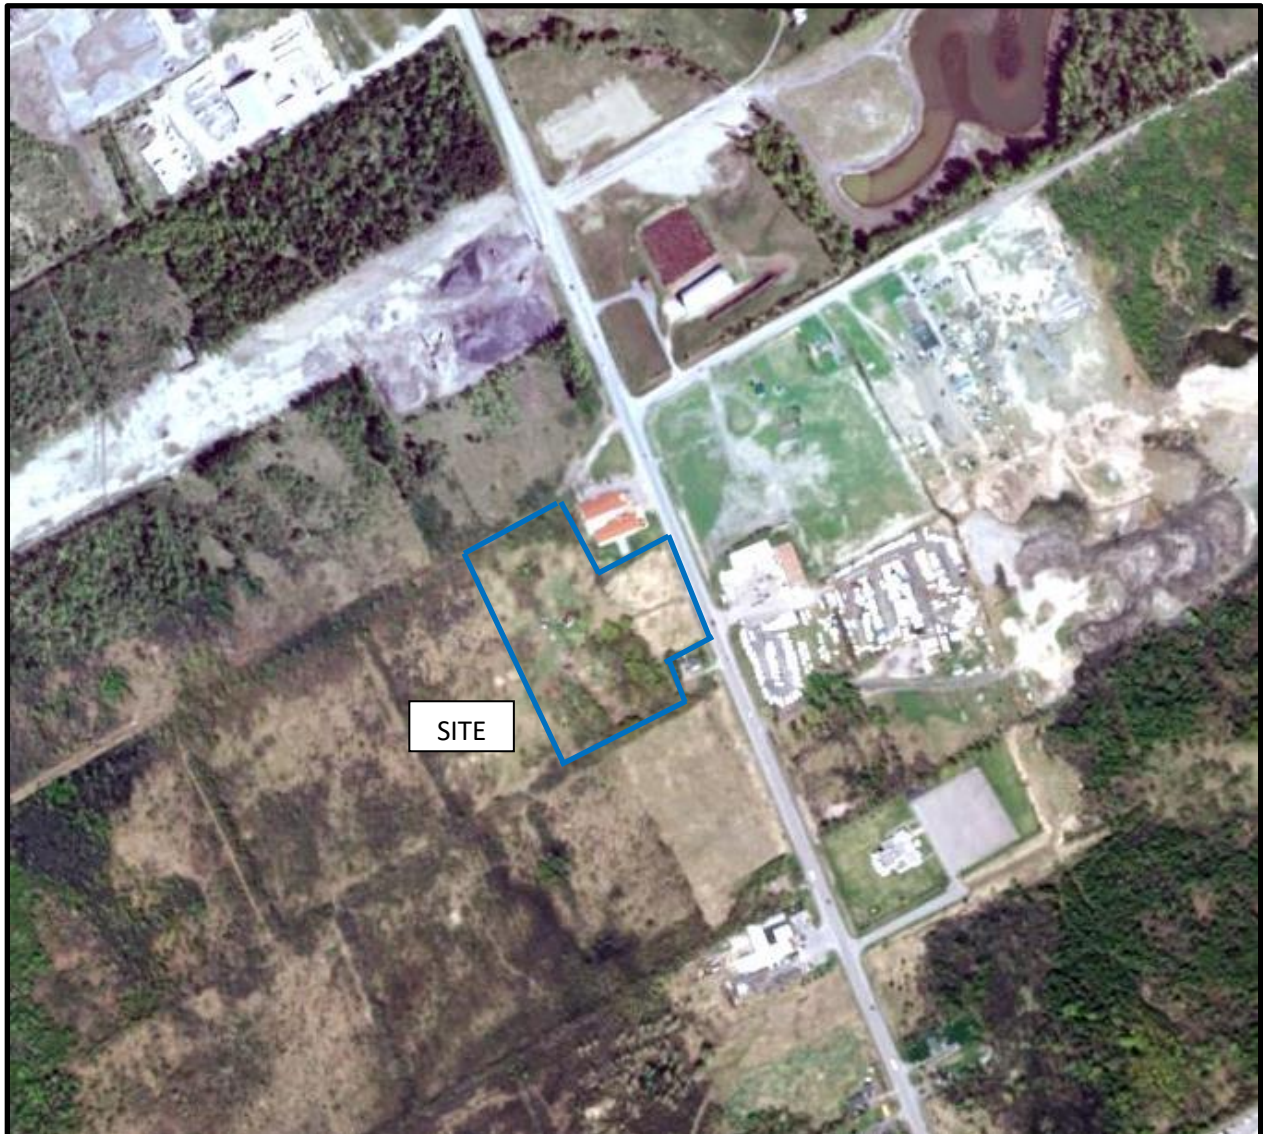
AERIAL PHOTOGRAPH  
2008

- 2008 (geoOttawa) A structure on the south side of the Phase I Property was removed and fenced gardens have been erected north and south of its former footprint since the previous photograph. The buildings directly north of the Phase I Property located at 4806 Bank Street have been demolished and replaced with two new commercial buildings. Tree clearing and earthworks are observed further North
