Phase One Environmental Site Assessment

Orleans Town Centre – 530 Brisebois Crescent, part of 265 Centrum Boulevard (Forum Lands), Ottawa, Ontario

OTT-22022218-A0

2025-12-02

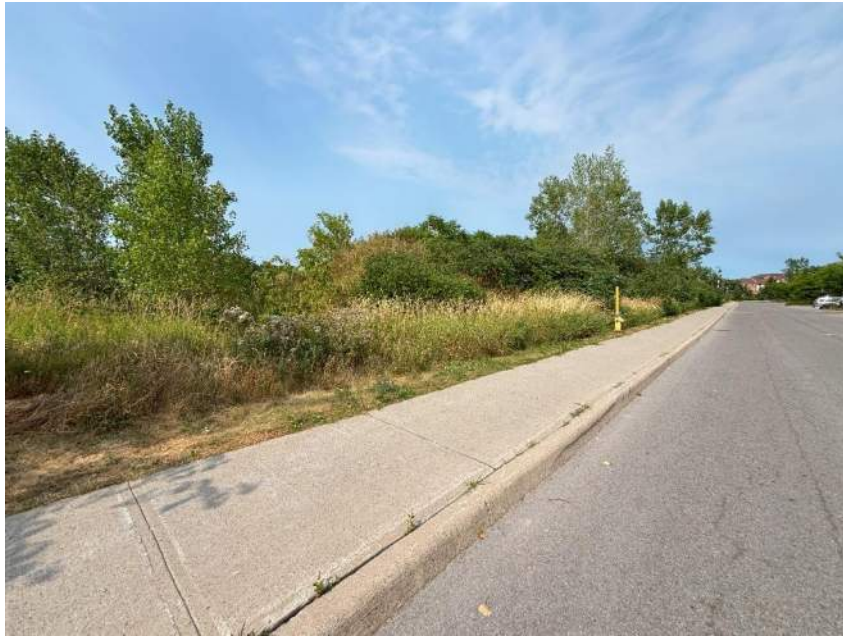
Photograph No. 1

View of the northern portion of the Phase One property along Brisebois Crescent, facing north.

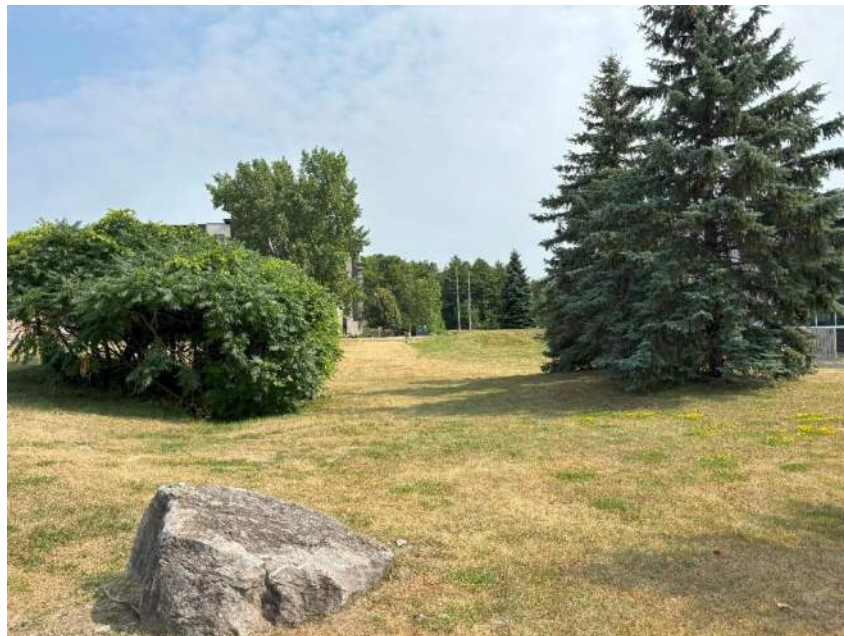
Photograph No. 2

View of the southern portion of the Phase One property along Brisebois Crescent and Centrum Boulevard, facing southeast.

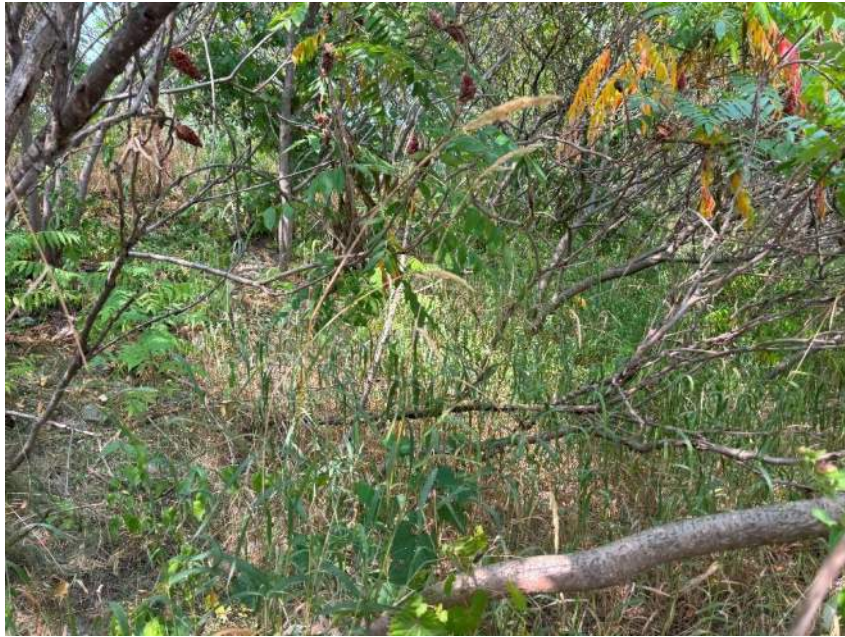
Photograph No. 3

A large hill in the northern portion of the Phase One property was observed, with a much higher elevation than the surrounding properties (PCA #30 Importation of Fill Material of Unknown Quality). No debris was observed on the Phase One property.

View of the suspected fill material in the northern portion of the Phase One property (PCA #30 Importation of Fill Material of Unknown Quality).

The Qualified Person who oversaw this work, Leah Wells, P.Eng., QP_{ESA}, recommends that a Phase Two ESA be completed to address the condition of the soil within the APEC identified on the Phase One property.

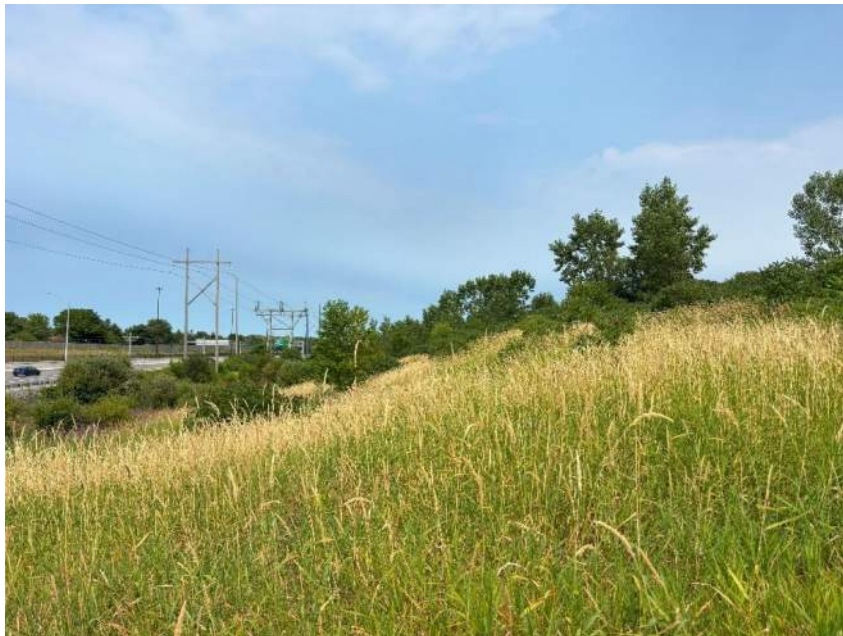
Photograph No. 4

View of the slope of the mound, suspected to be comprised of fill material (PCA #30 Importation of Fill Material of Unknown Quality).

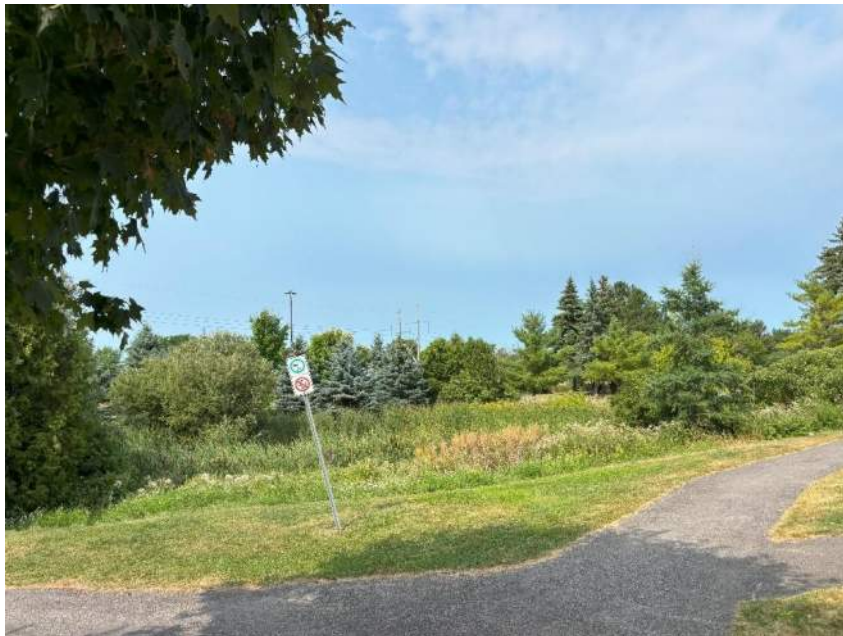
Photograph No. 6

View of the stormwater pond east of the Phase One property.

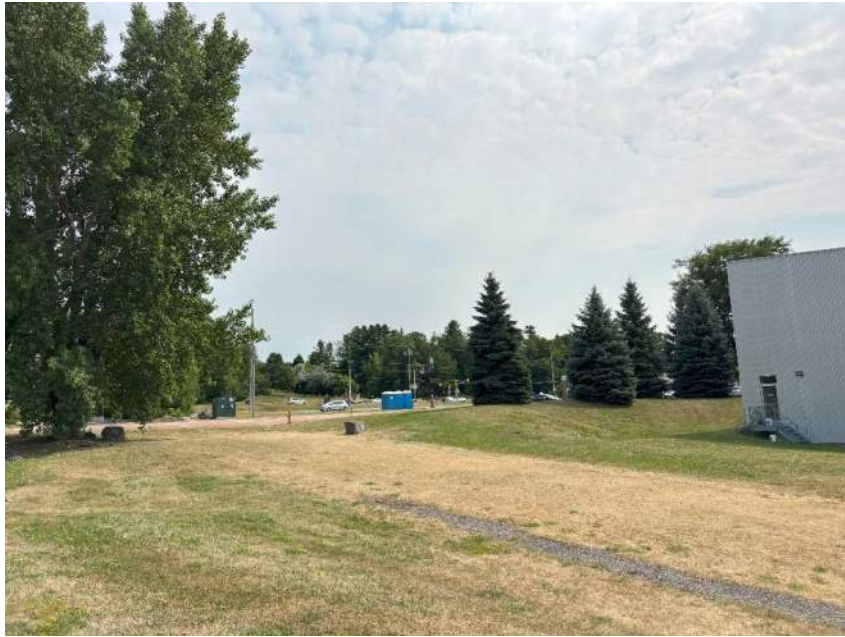
Photograph No. 7

View of the southern portion of the Phase One property, facing south.
