## **Phase II – Environmental Site Assessment**

260 MacLaren Street  
Ottawa, Ontario

Prepared for: Claridge Homes

Report: PE7414-2  
July 27, 2026

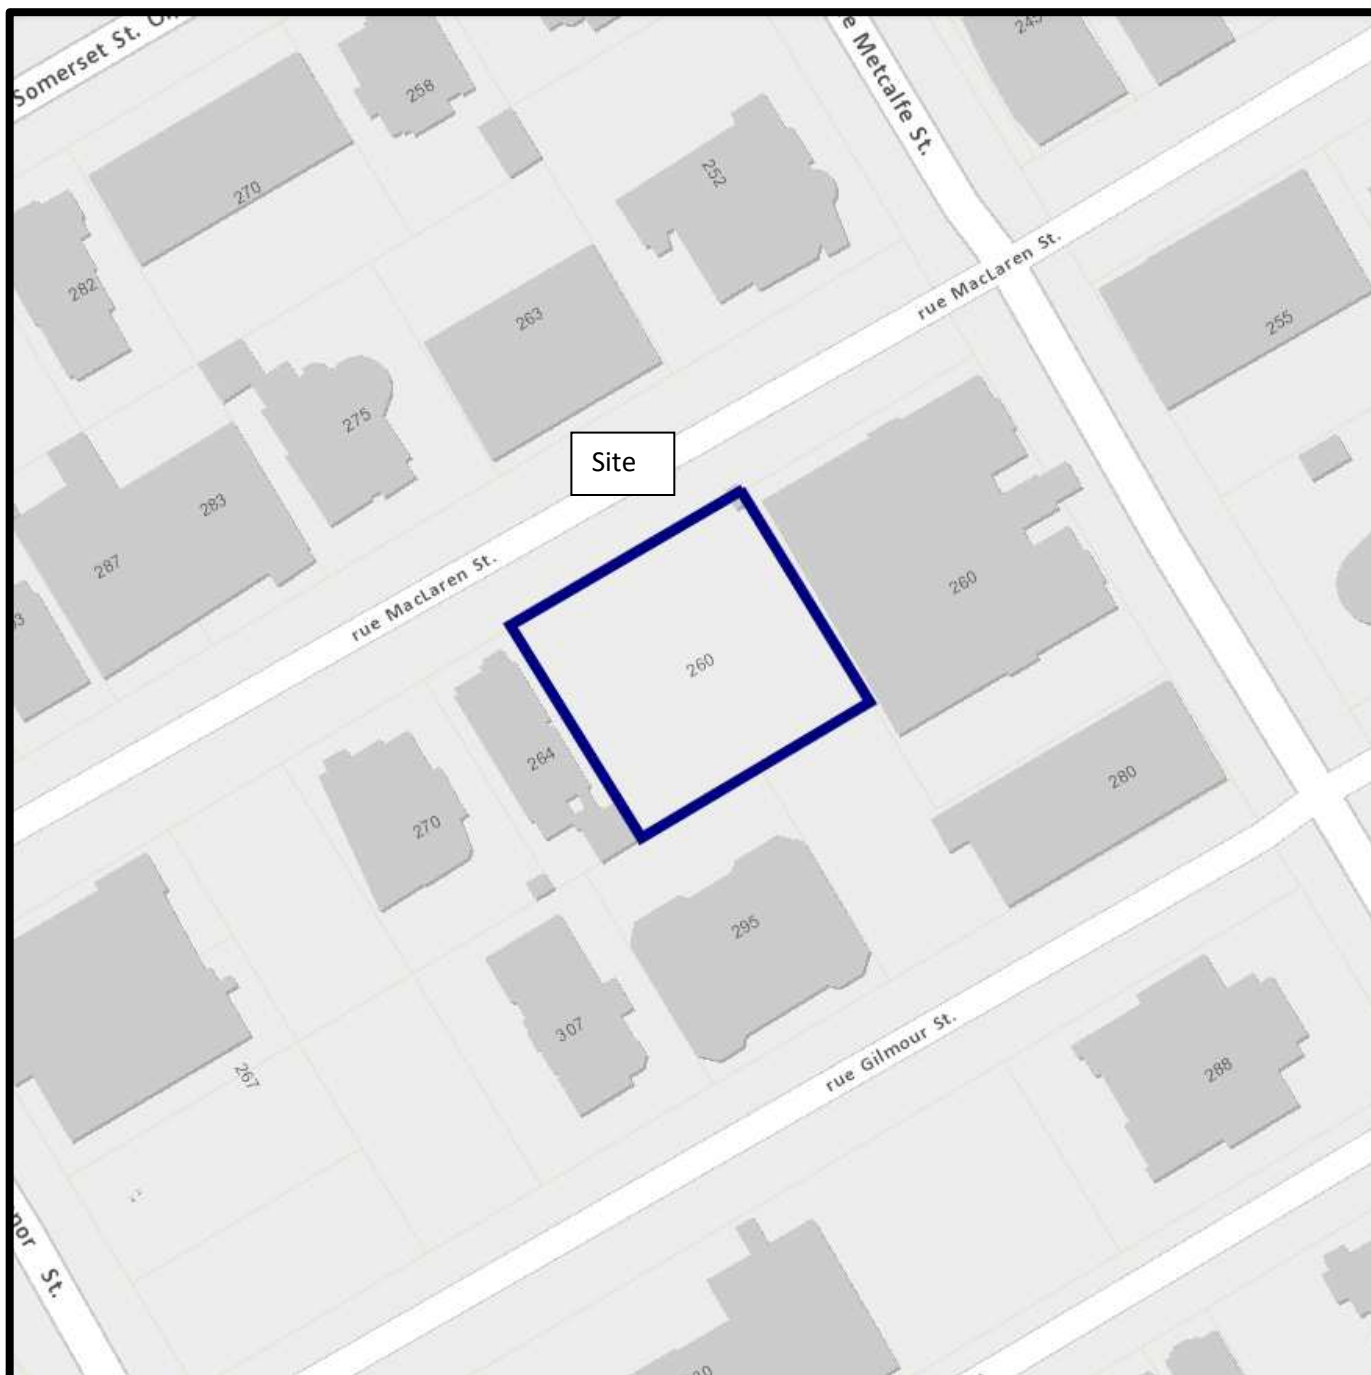
FIGURE 1  
KEY PLAN

Location: The Phase II Property is located on the south side of MacLaren Street, approximately 40 m west of the MacLaren Street and Metcalfe Street intersection, in the City of Ottawa, Ontario. Refer to Figure 1 - Key Plan in the Figures section following the text.

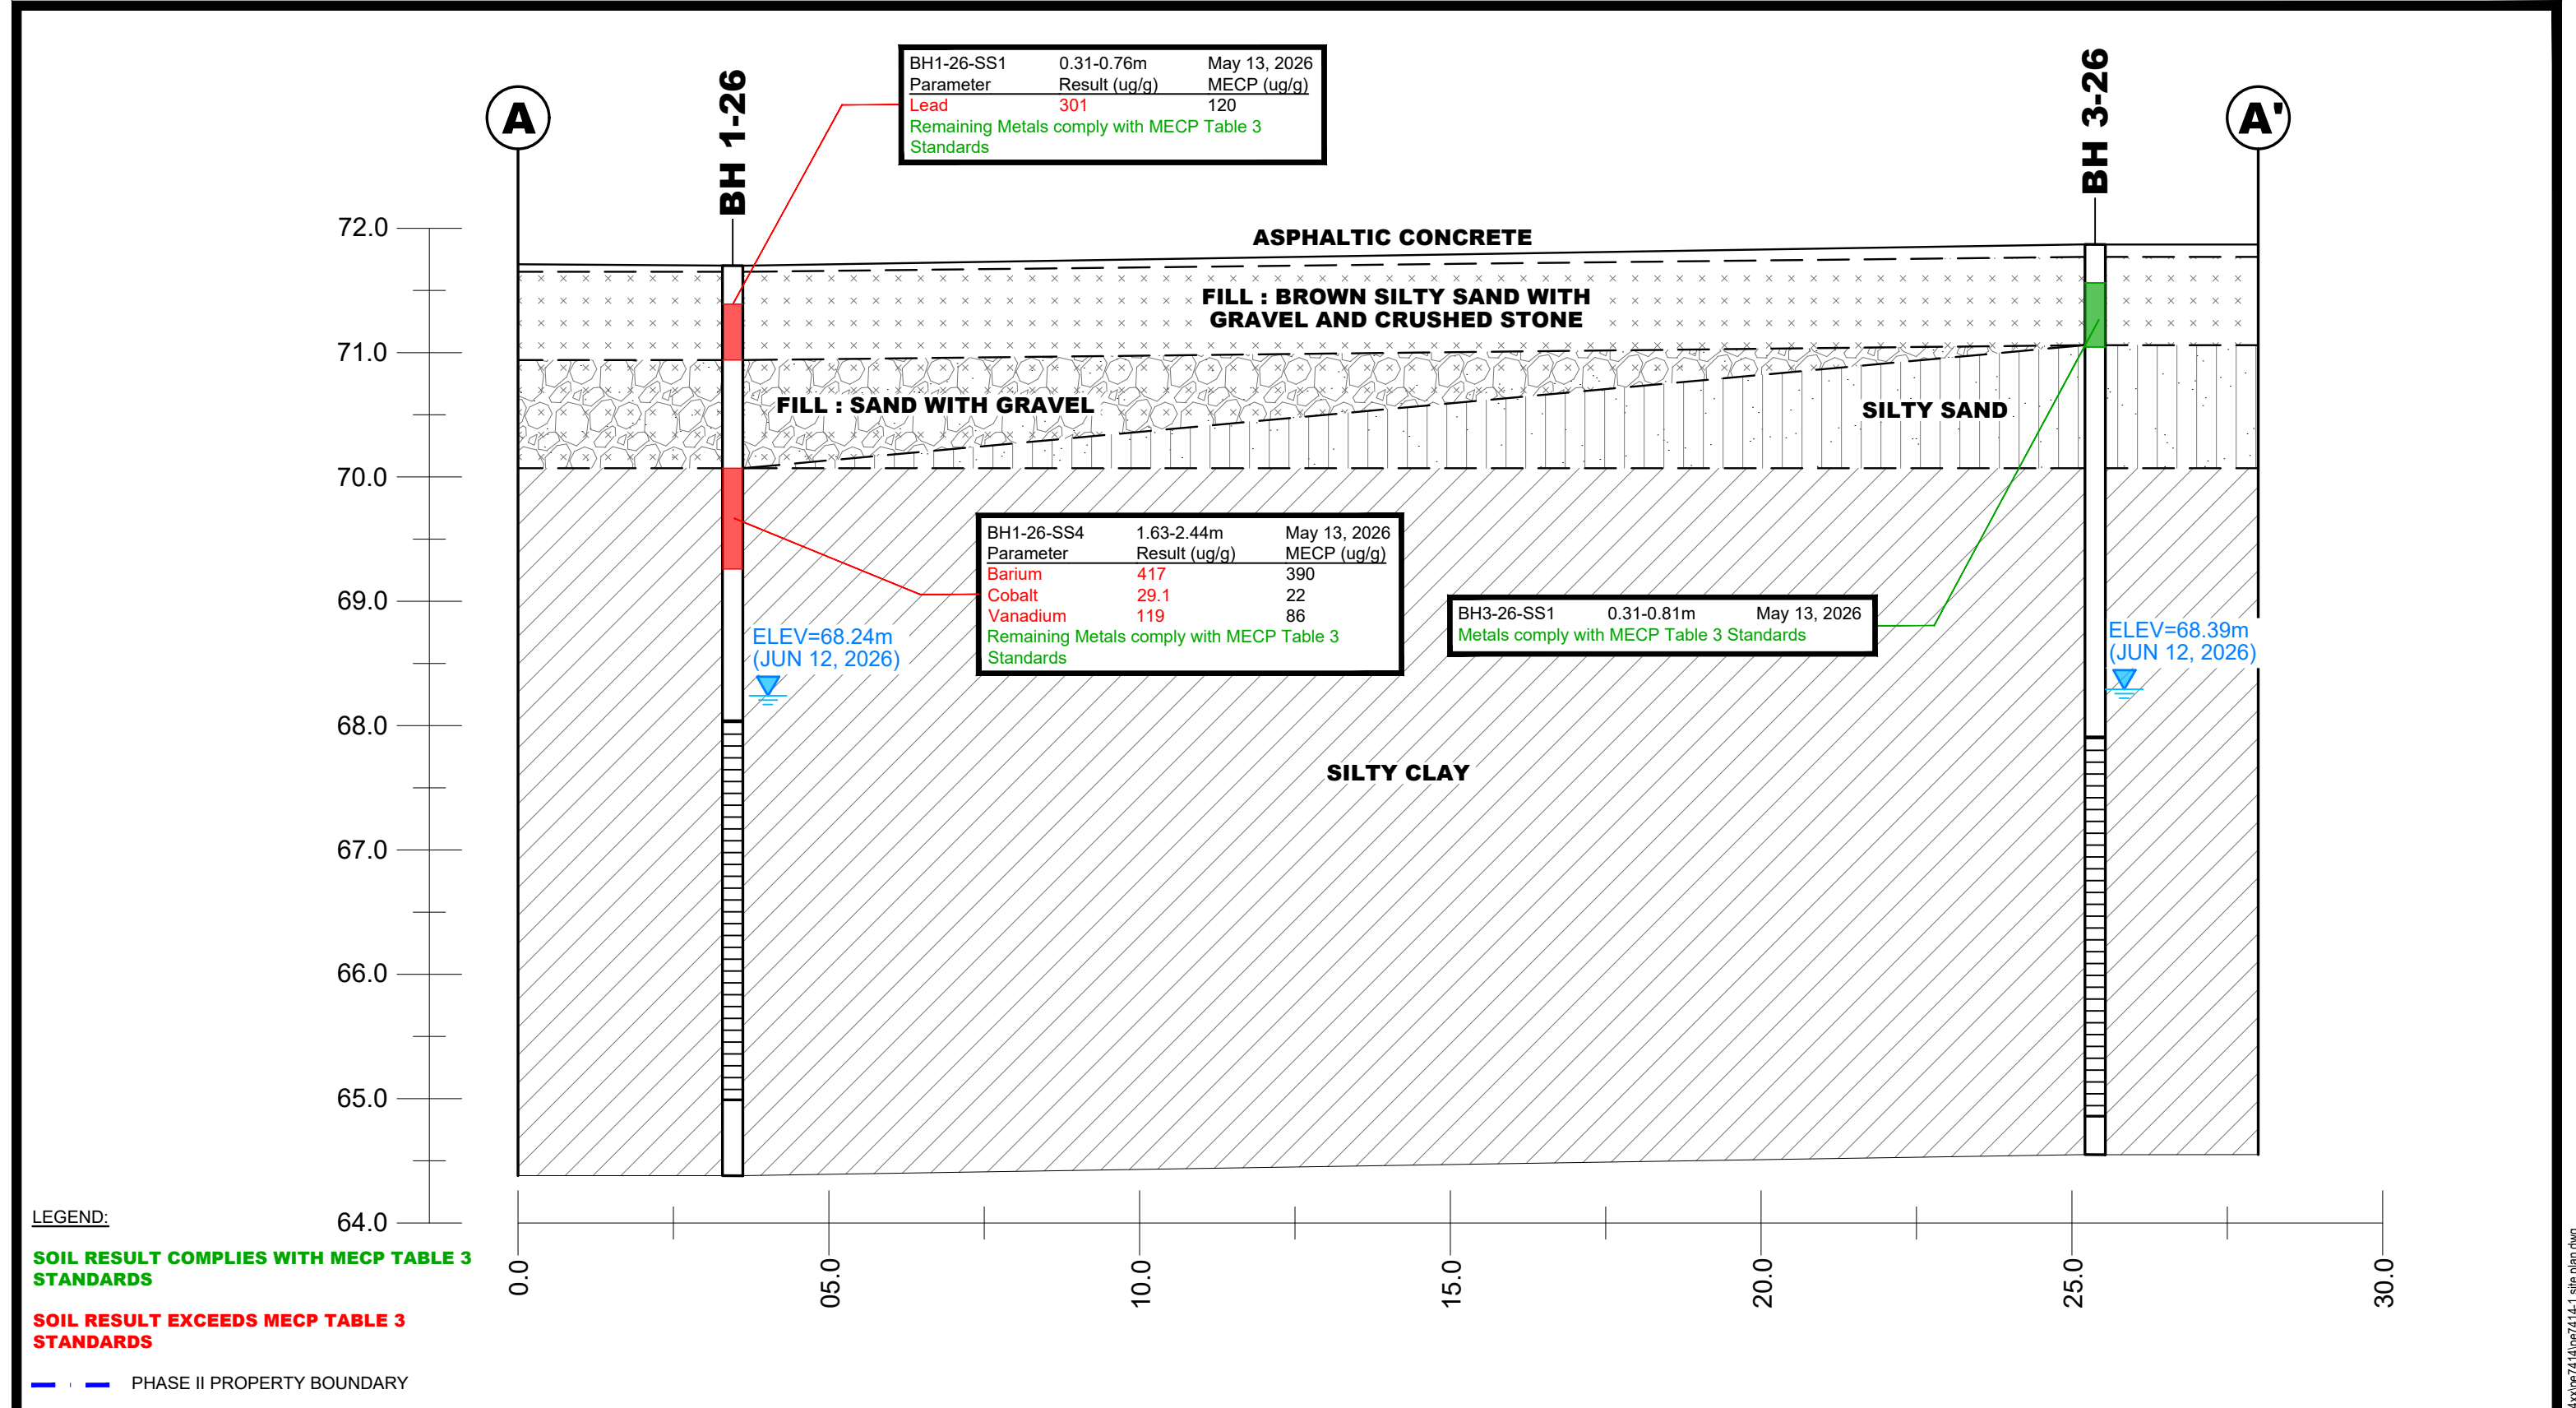
| Checked by: | NS | Dwg. No.: | PE7414-6 |

The concentrations of some metals (barium, cobalt, and vanadium) in Sample BH1-26-SS4 were also found to exceed the selected Standards. Given that this sample was collected from the underlying native silty clay layer, these concentrations are considered to be representative of naturally occurring elevated levels commonly encountered in clay soils within Eastern Ontario. As such, the concentrations of these parameters are not considered to represent a contaminant issue.

The concentrations of barium, cobalt, and vanadium in Sample BH1-26-SS4 were also found to exceed the selected Standards. Given that this sample was collected from the native silty clay layer, these concentrations are considered to be representative of naturally occurring elevated levels commonly encountered in clay soils within Eastern Ontario. As such, the concentrations of these parameters are not considered to represent a contaminant issue.

As the Phase II Property is to be redeveloped in the future, it is our recommendation that the contaminated soil be remediated in conjunction with site excavation activities. At such a time, the contaminated soil will be excavated from the site and transported to a licensed waste disposal facility.

It is recommended that Paterson personnel be present on-site at the time of remedial activities to assist with the segregation of contaminated soil from clean soils, as well as to fulfill the confirmatory soil sampling requirements in accordance with Table 2 of O. Reg. 153/04.

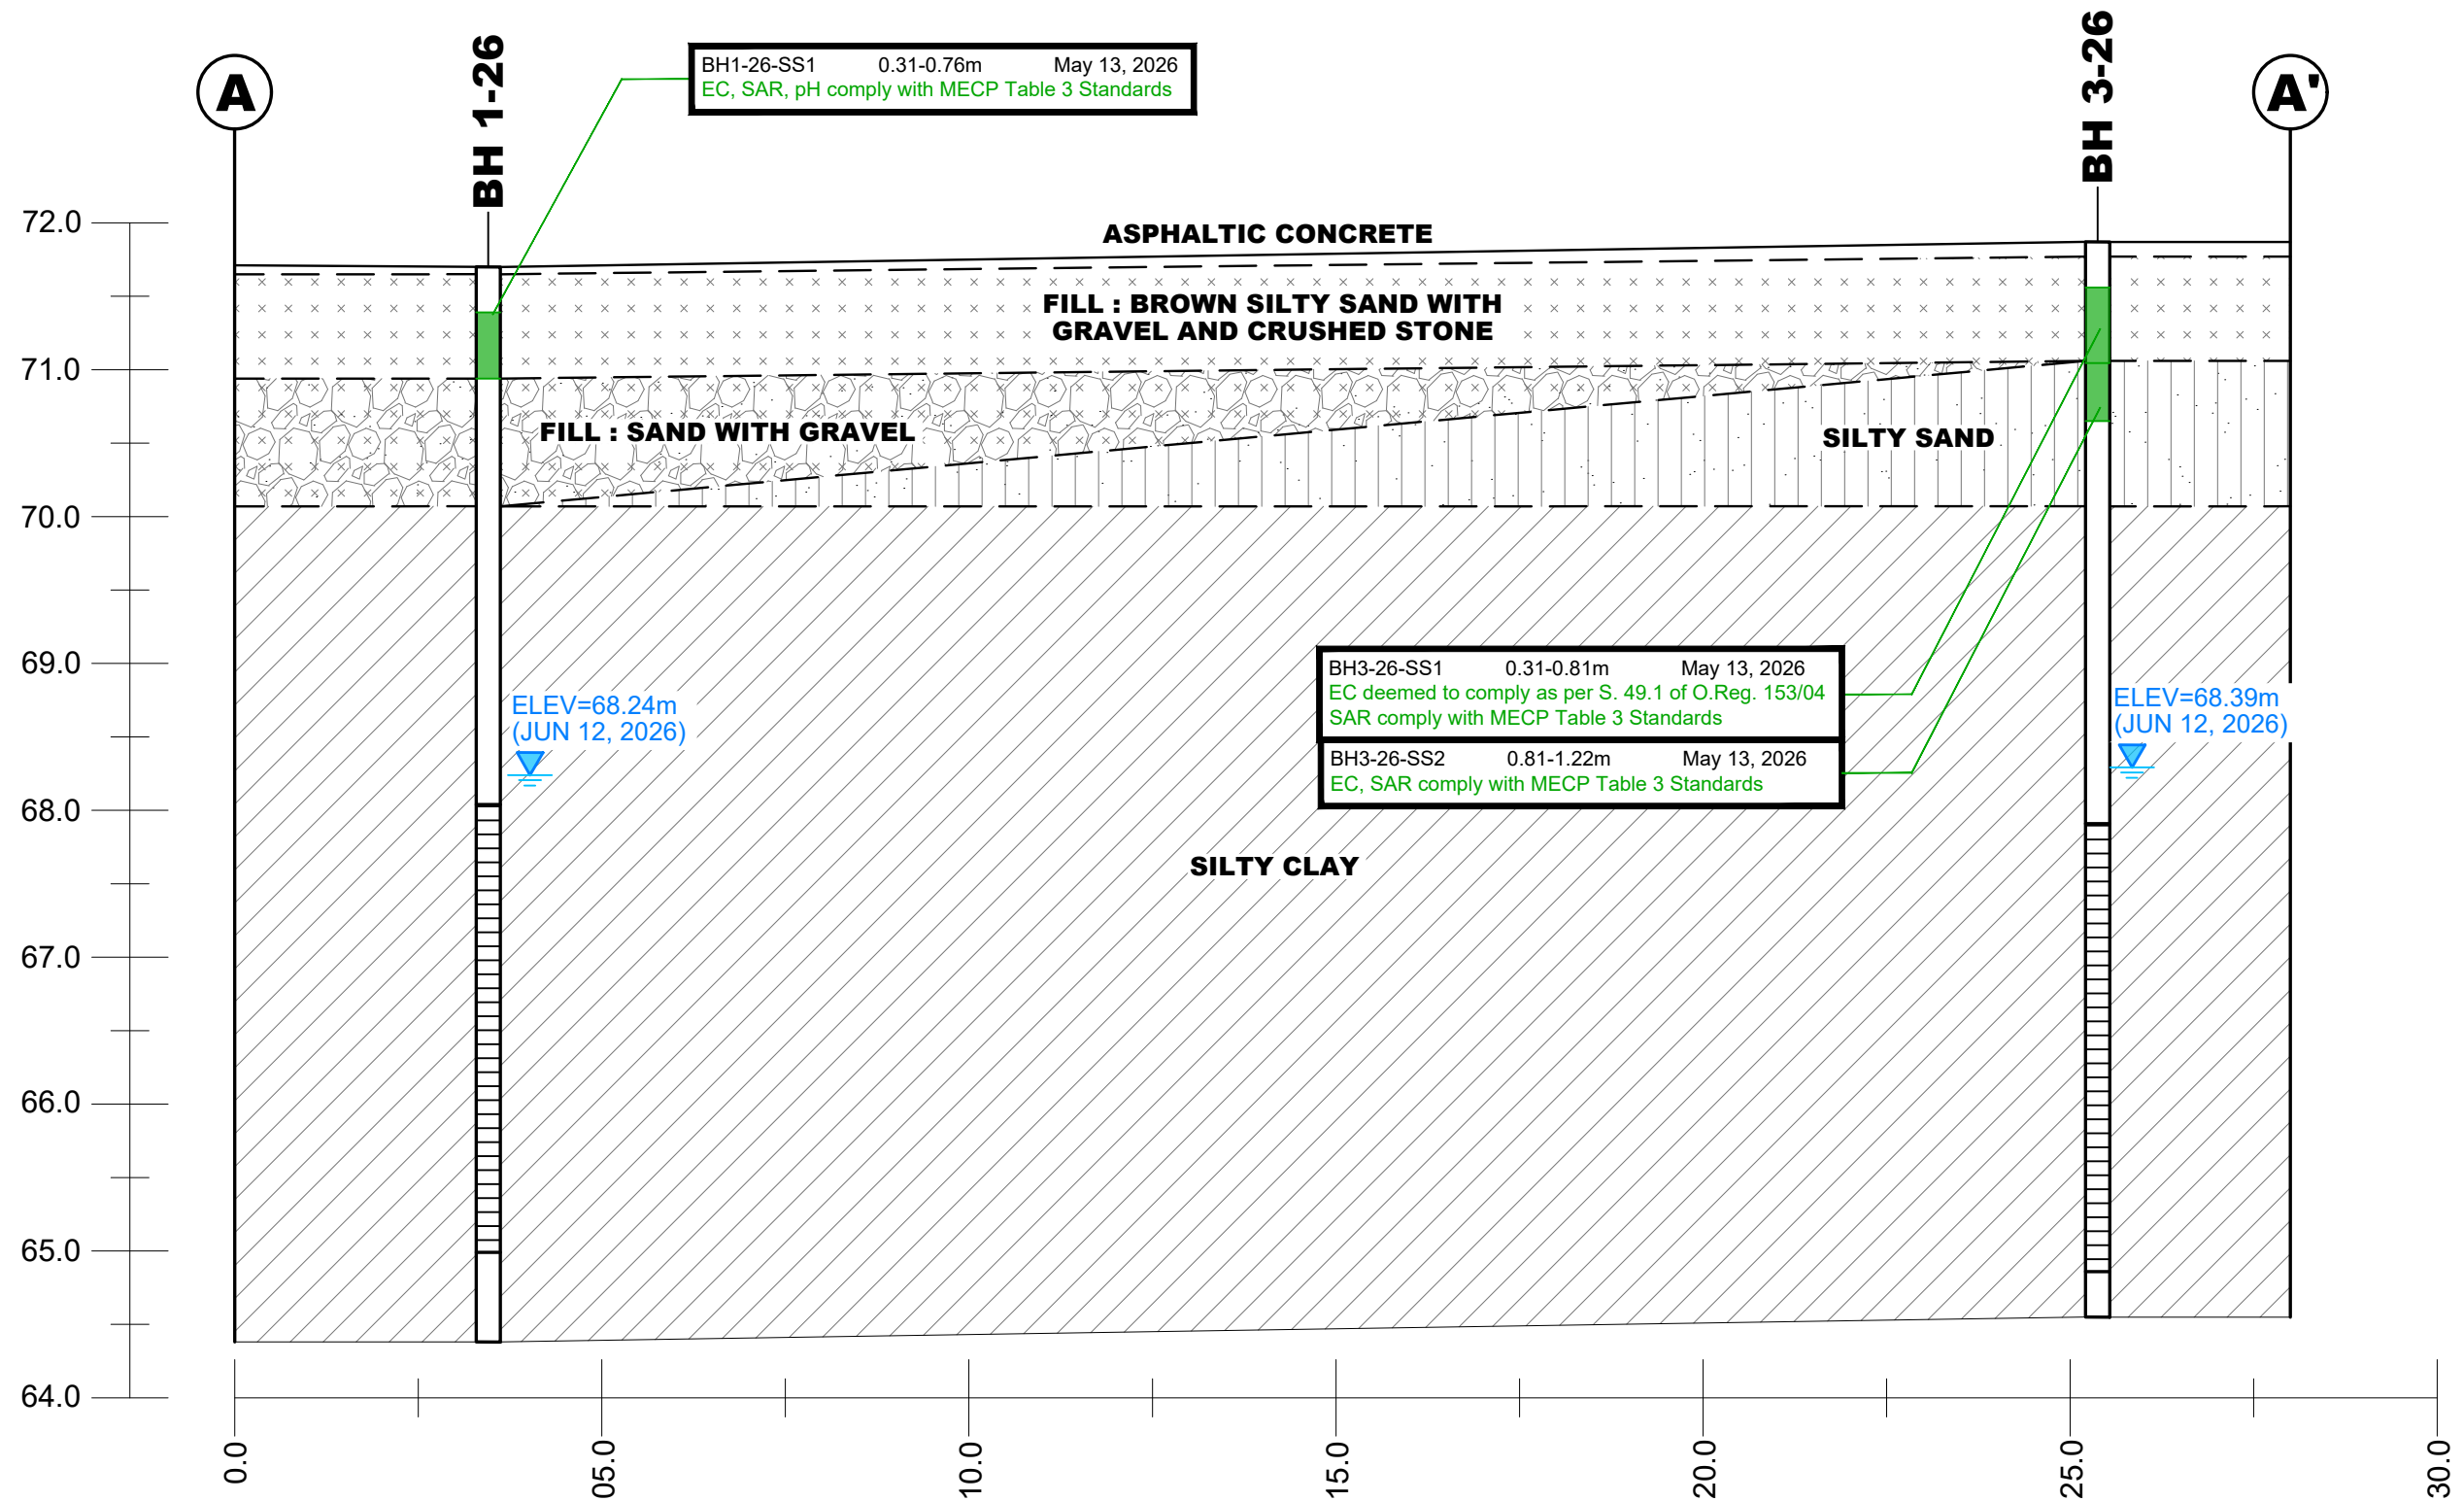
| Checked by: | NS | Dwg. No.: | PE7414-7 |

The electrical conductivity level detected in BH3-26-SS1 was found to be in excess of the selected Standards. This elevated level is considered to be the result of the application of road salt on the Phase II Property during snow and ice conditions and thus, as per Section 49.1 of O. Reg 153/04, does not represent a contaminant issue.

The electrical conductivity level detected in Sample BH3-26-SS1 exceeds the selected MECP Table 3 Coarse-Grained Residential Soil Standards. This elevated level is considered to be the result of the application of road salt on the Phase II Property during snow and ice conditions and thus, as per Section 49.1 of O. Reg 153/04, does not represent a contaminant issue.

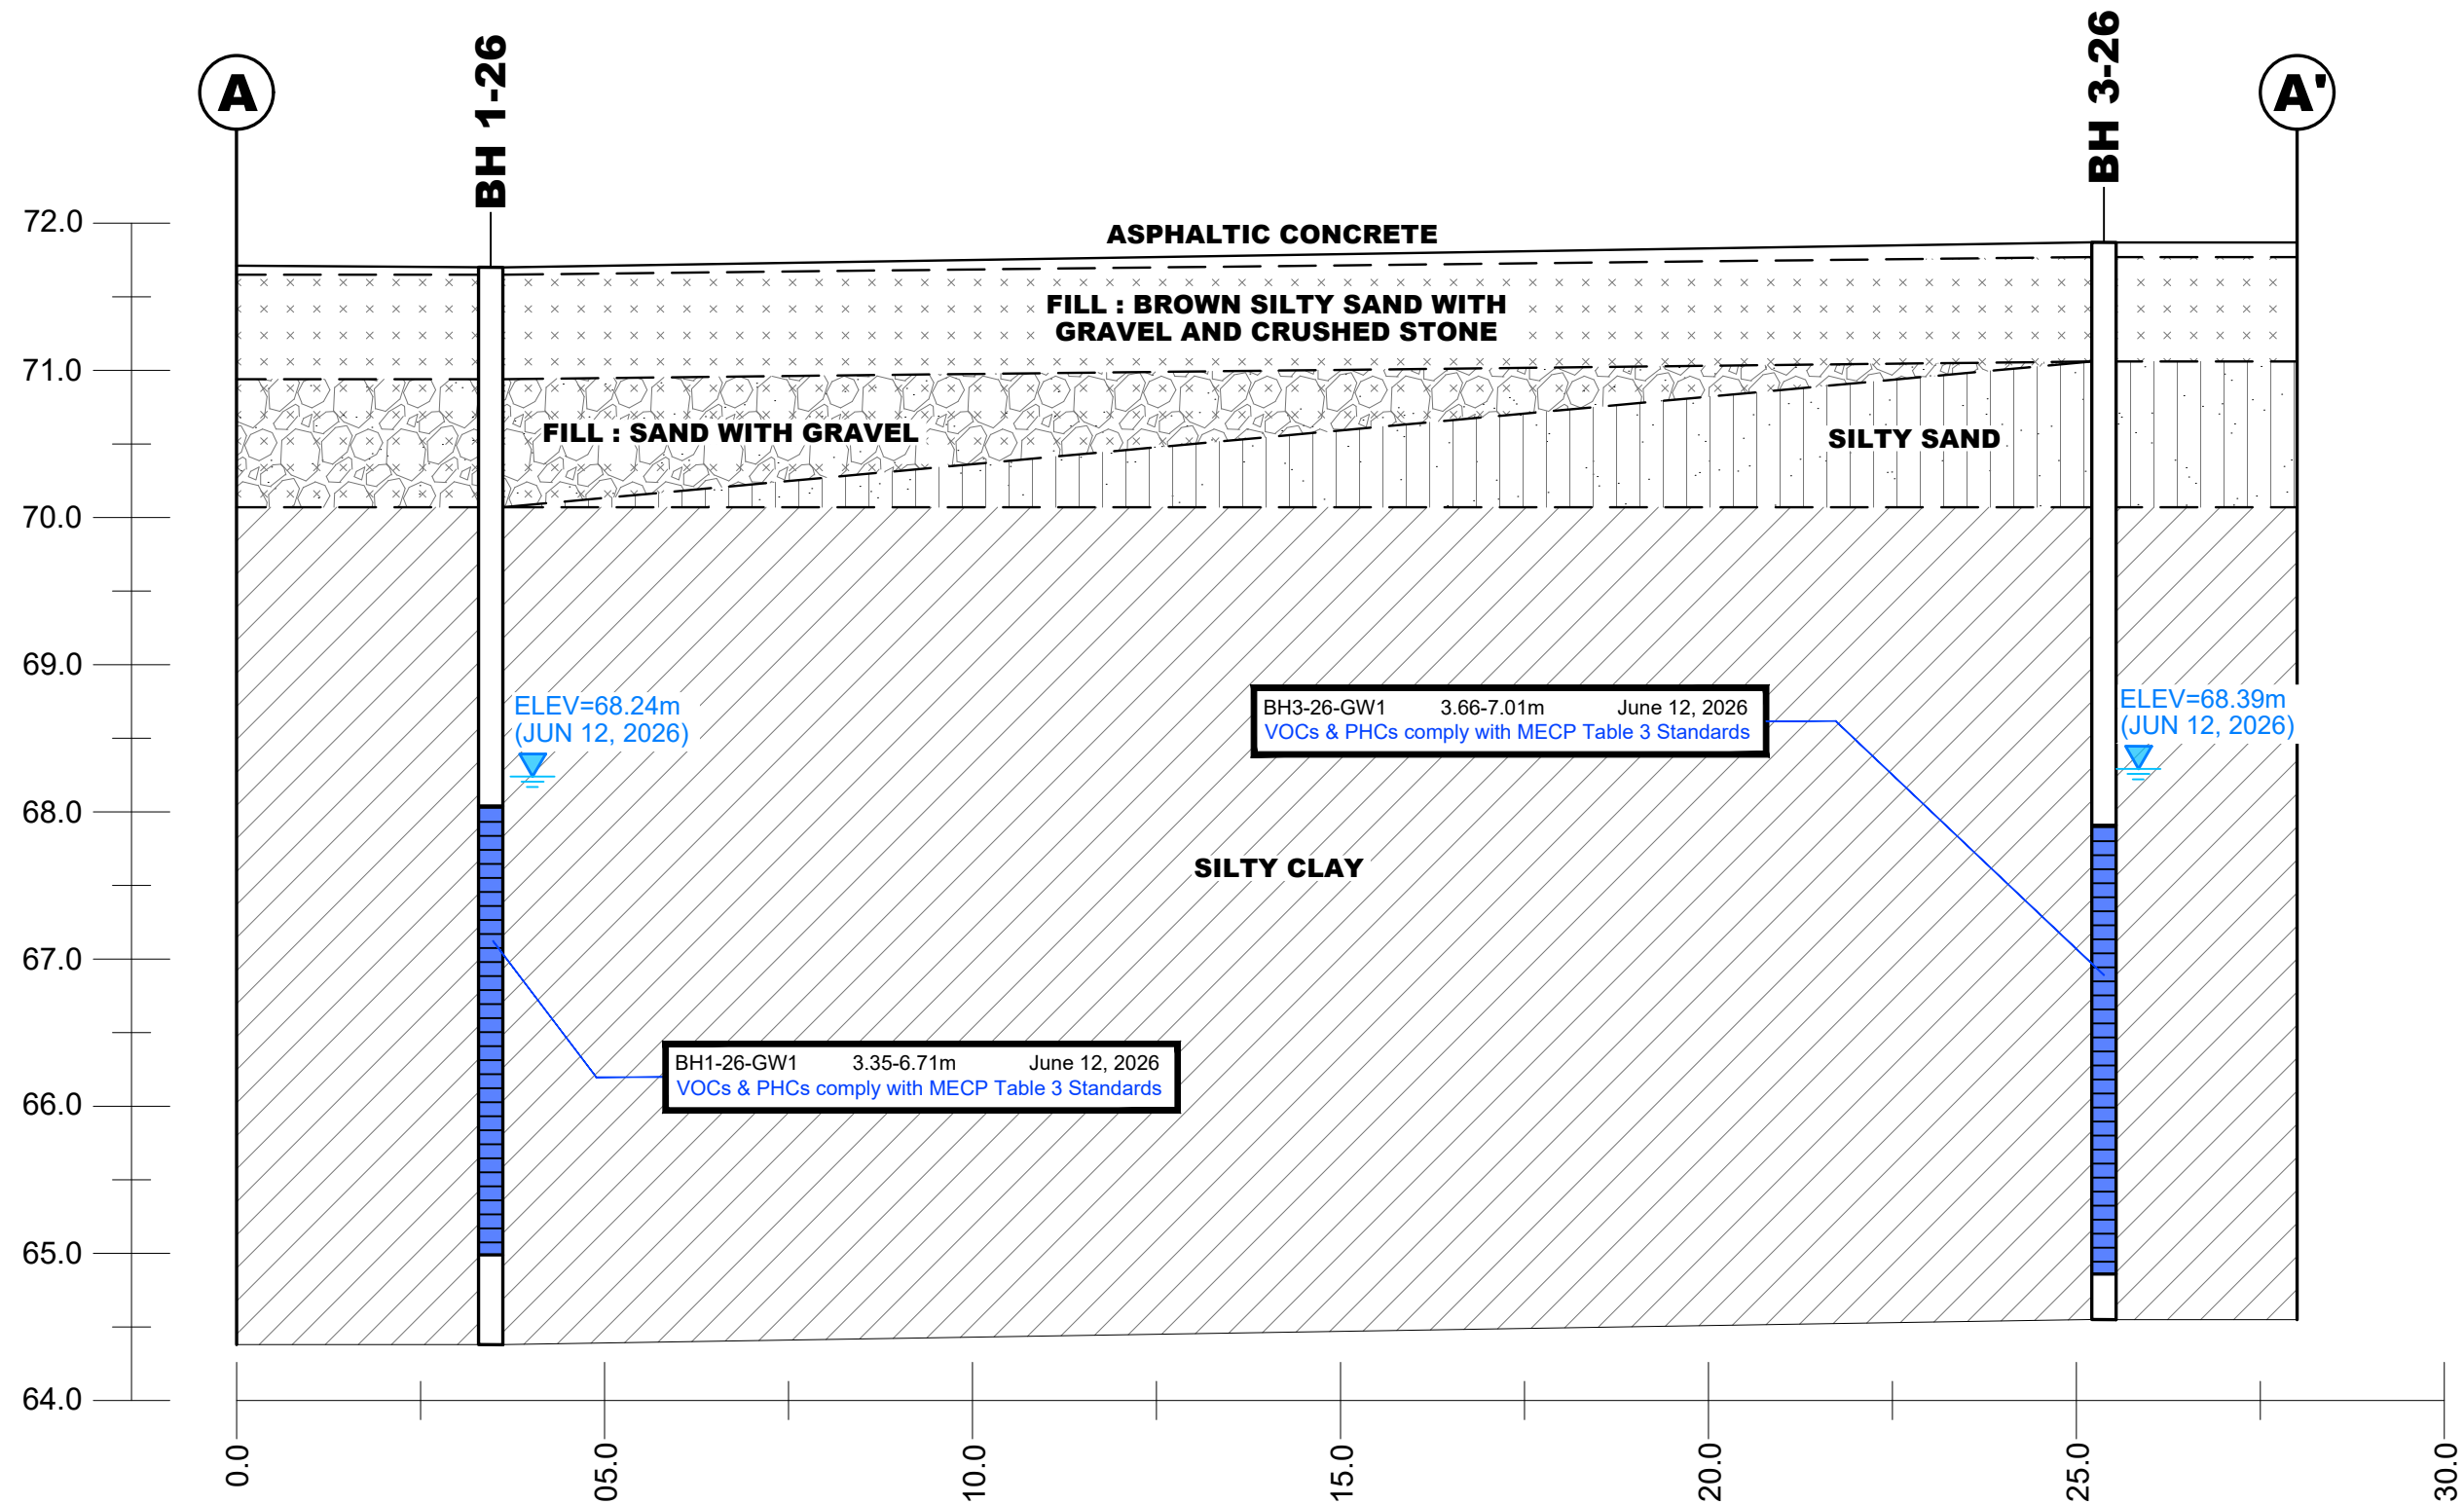
| | | | | ANALYTICAL TESTING PLAN - GROUNDWATER | | | | | |

Three groundwater samples were submitted for laboratory analysis of VOCs and PHC parameters. All detected parameter concentrations in the groundwater samples analyzed complied with the selected MECP Table 3 Non-Potable Groundwater Standards.

If the groundwater monitoring wells installed on-site are not going to be used in the future, or will be destroyed during future construction activities, then they must be decommissioned in accordance with O. Reg. 903/90 (Ontario Water Resources Act). Further information can be provided upon request in this regard. It is recommended that the monitoring wells be maintained for future sampling purposes. The monitoring wells will be registered with the MECP under this regulation.

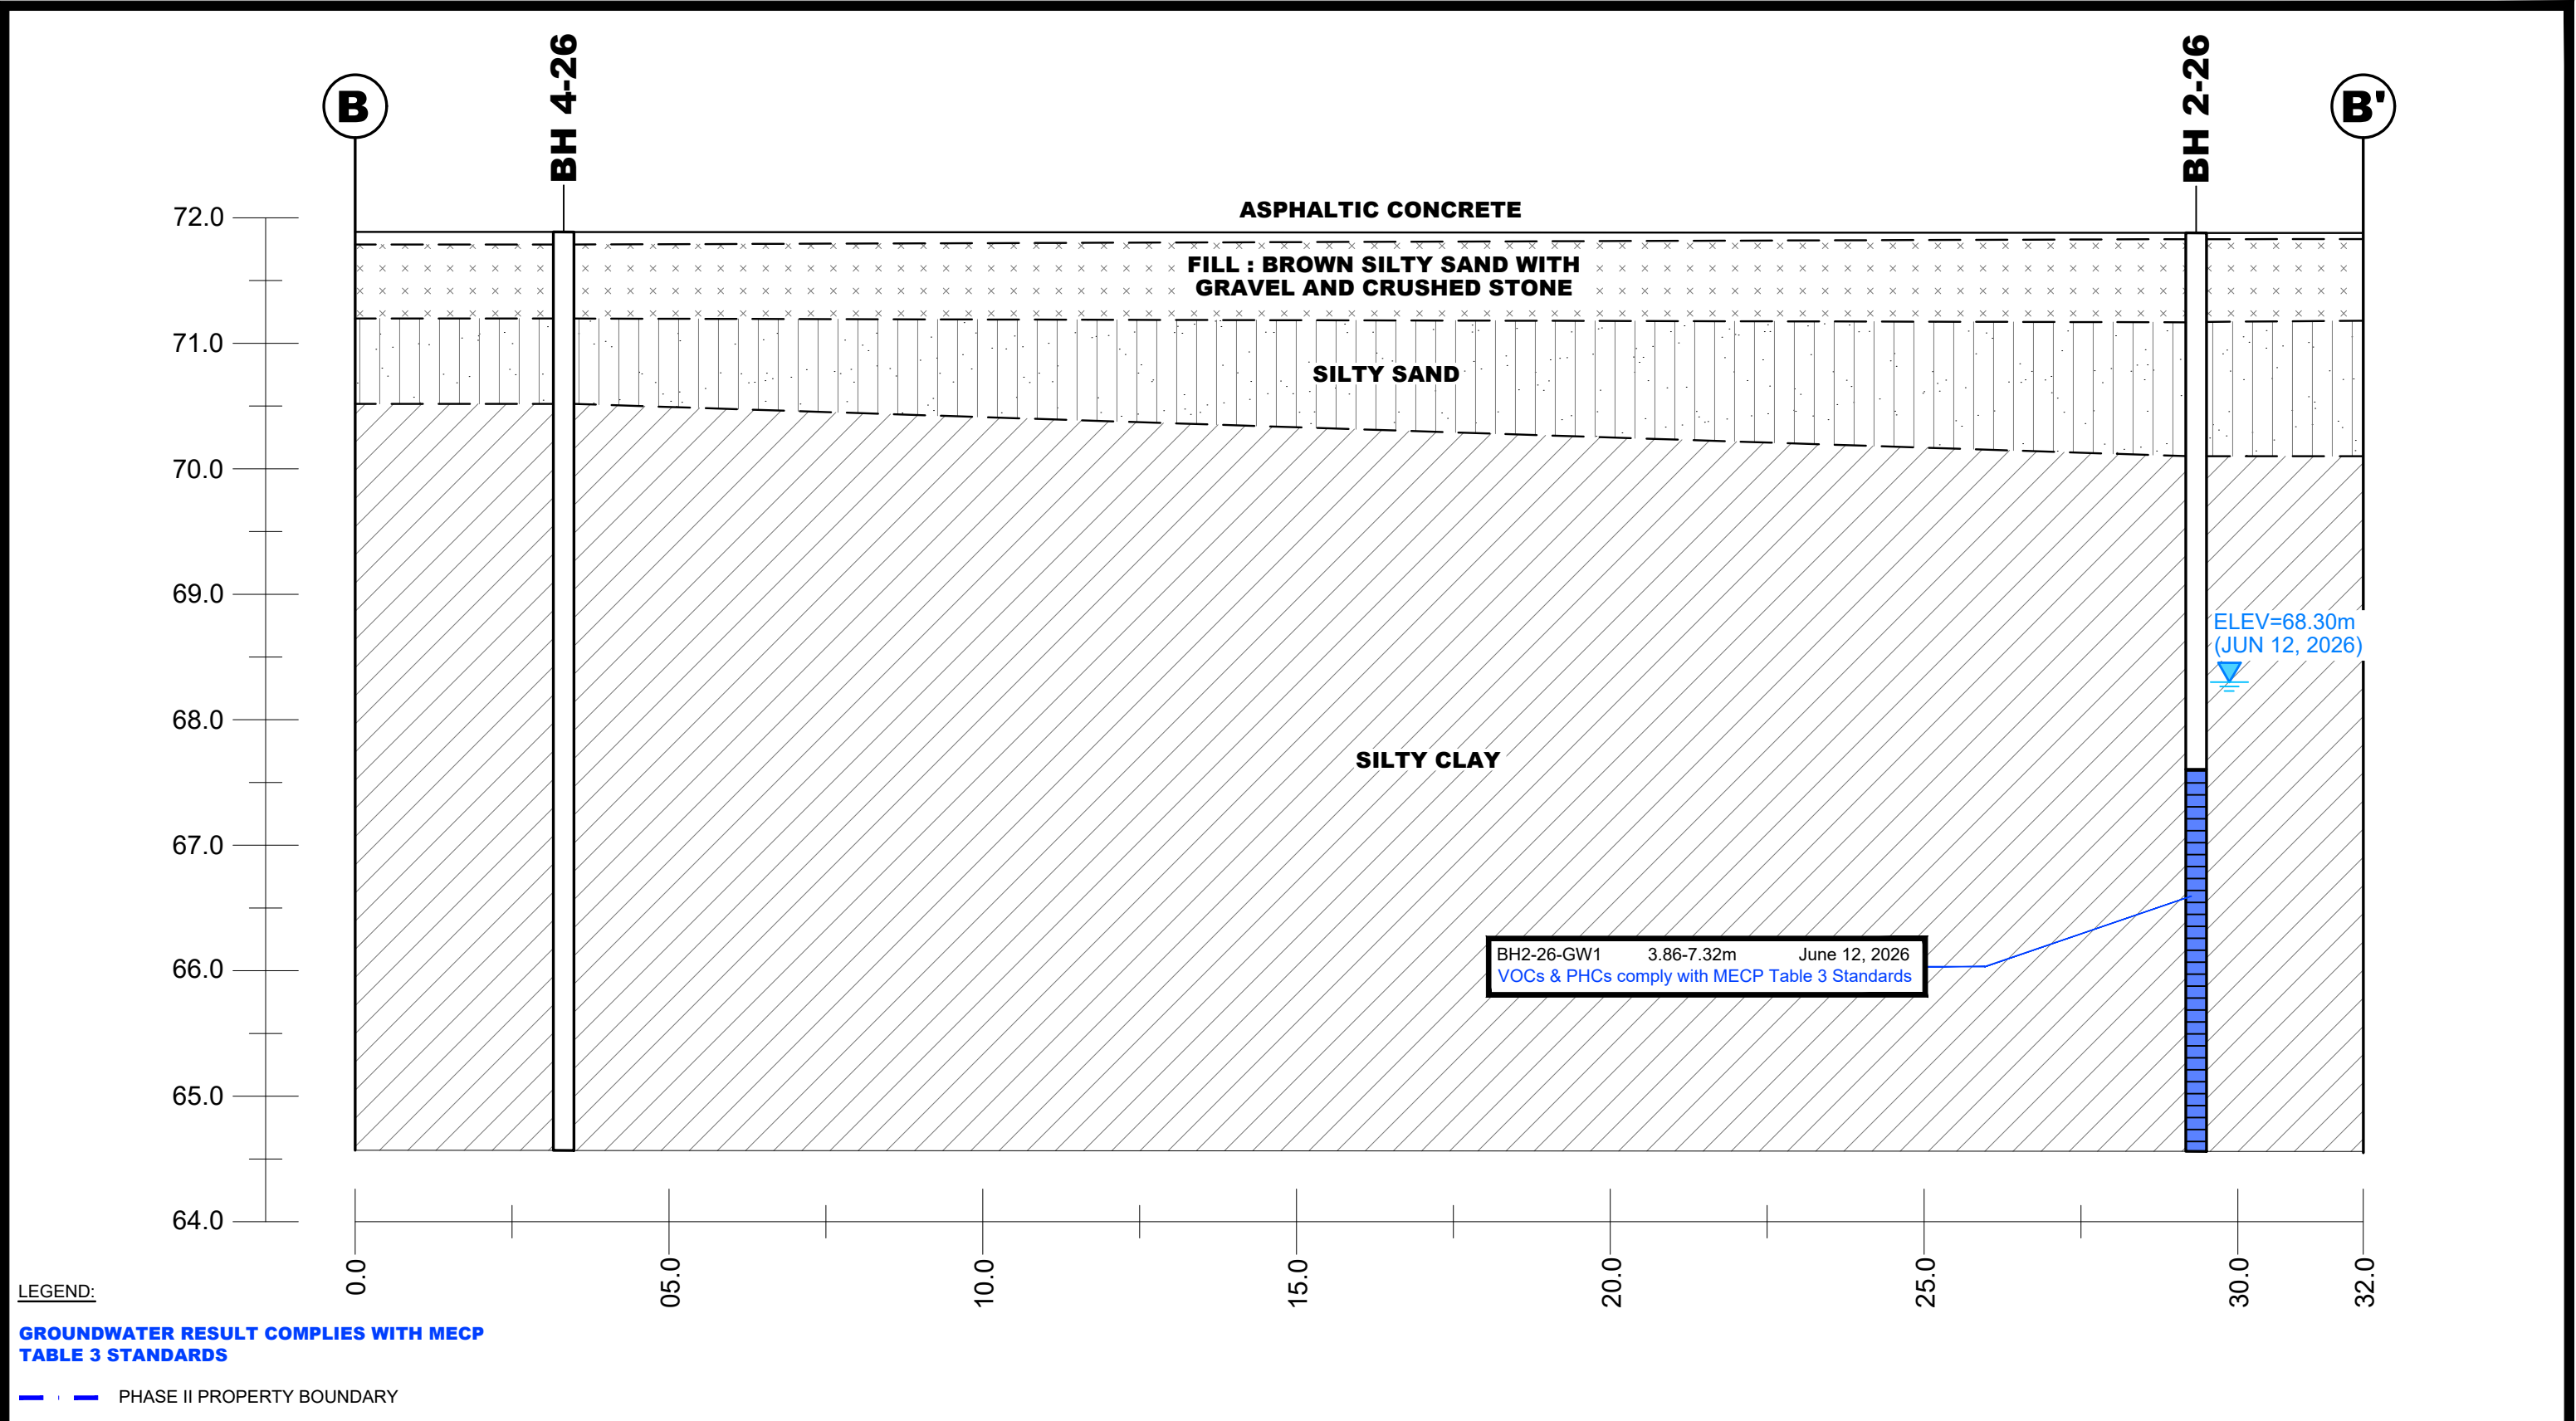
**DRAWING PE7414-8B – CROSS SECTION B-B' – GROUNDWATER**

In general, the subsurface soil profile encountered at the borehole locations consists of a surficial layer of asphalt over top of fill material (brown silty sand with some gravel and crushed stone), underlain by native layers of brown silty sand followed by brown silty clay which was noted to transition to grey at approximately 3.5 m below ground surface. Bedrock was not encountered in any of the boreholes at the time of the field drilling program. The groundwater beneath the Phase II Property was encountered within the overburden at depths ranging from approximately 3.5 m to 3.6 m below ground surface.

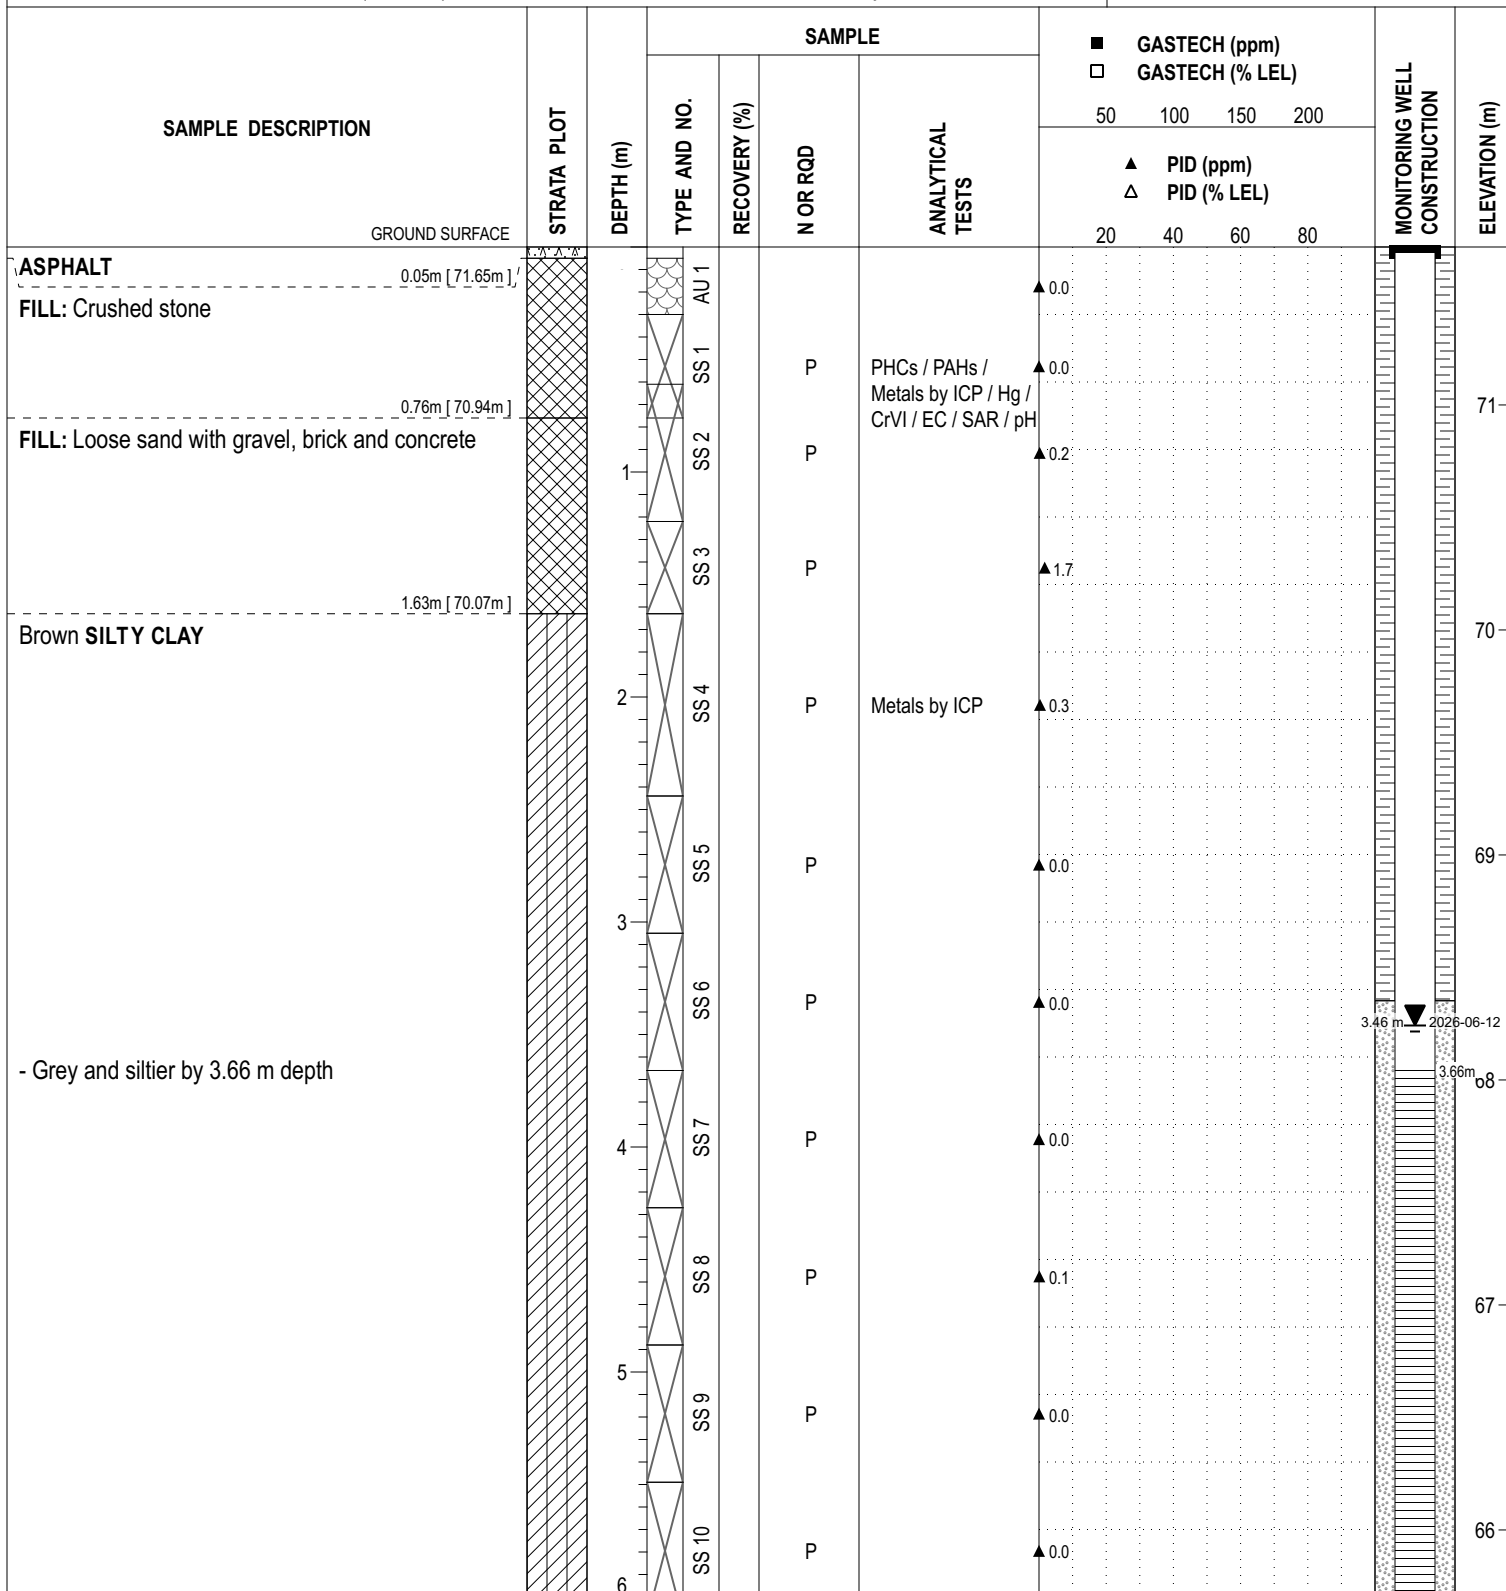
**HOLE NO. :** BH 1-26

In general, the subsurface soil profile encountered at the borehole locations consists of a surficial layer of asphalt over top of fill material (brown silty sand with some gravel and crushed stone), underlain by native layers of brown silty sand followed by brown silty clay which was noted to transition to grey at approximately 3.5 m below ground surface. Bedrock was not encountered in any of the boreholes at the time of the field drilling program. The groundwater beneath the Phase II Property was encountered within the overburden at depths ranging from approximately 3.5 m to 3.6 m below ground surface.
