RE: TREE CONSERVATION REPORT FOR 1746 CARLING AVENUE, OTTAWA

This Tree Conservation Report (TCR) was prepared on behalf of The Properties Group in support of their zoning and site plan application in relation to the development of 1746 Carling Avenue in Ottawa. The need for this report is related to trees protected under the City of Ottawa's Tree Protection By-law (By-law No. 2020-340). The proposed development includes three multi-storey buildings with surface and underground parking.

DRAWING: Tree Conservation Plan

PROJECT: 1746 CARLING AVENUE
CITY OF OTTAWA

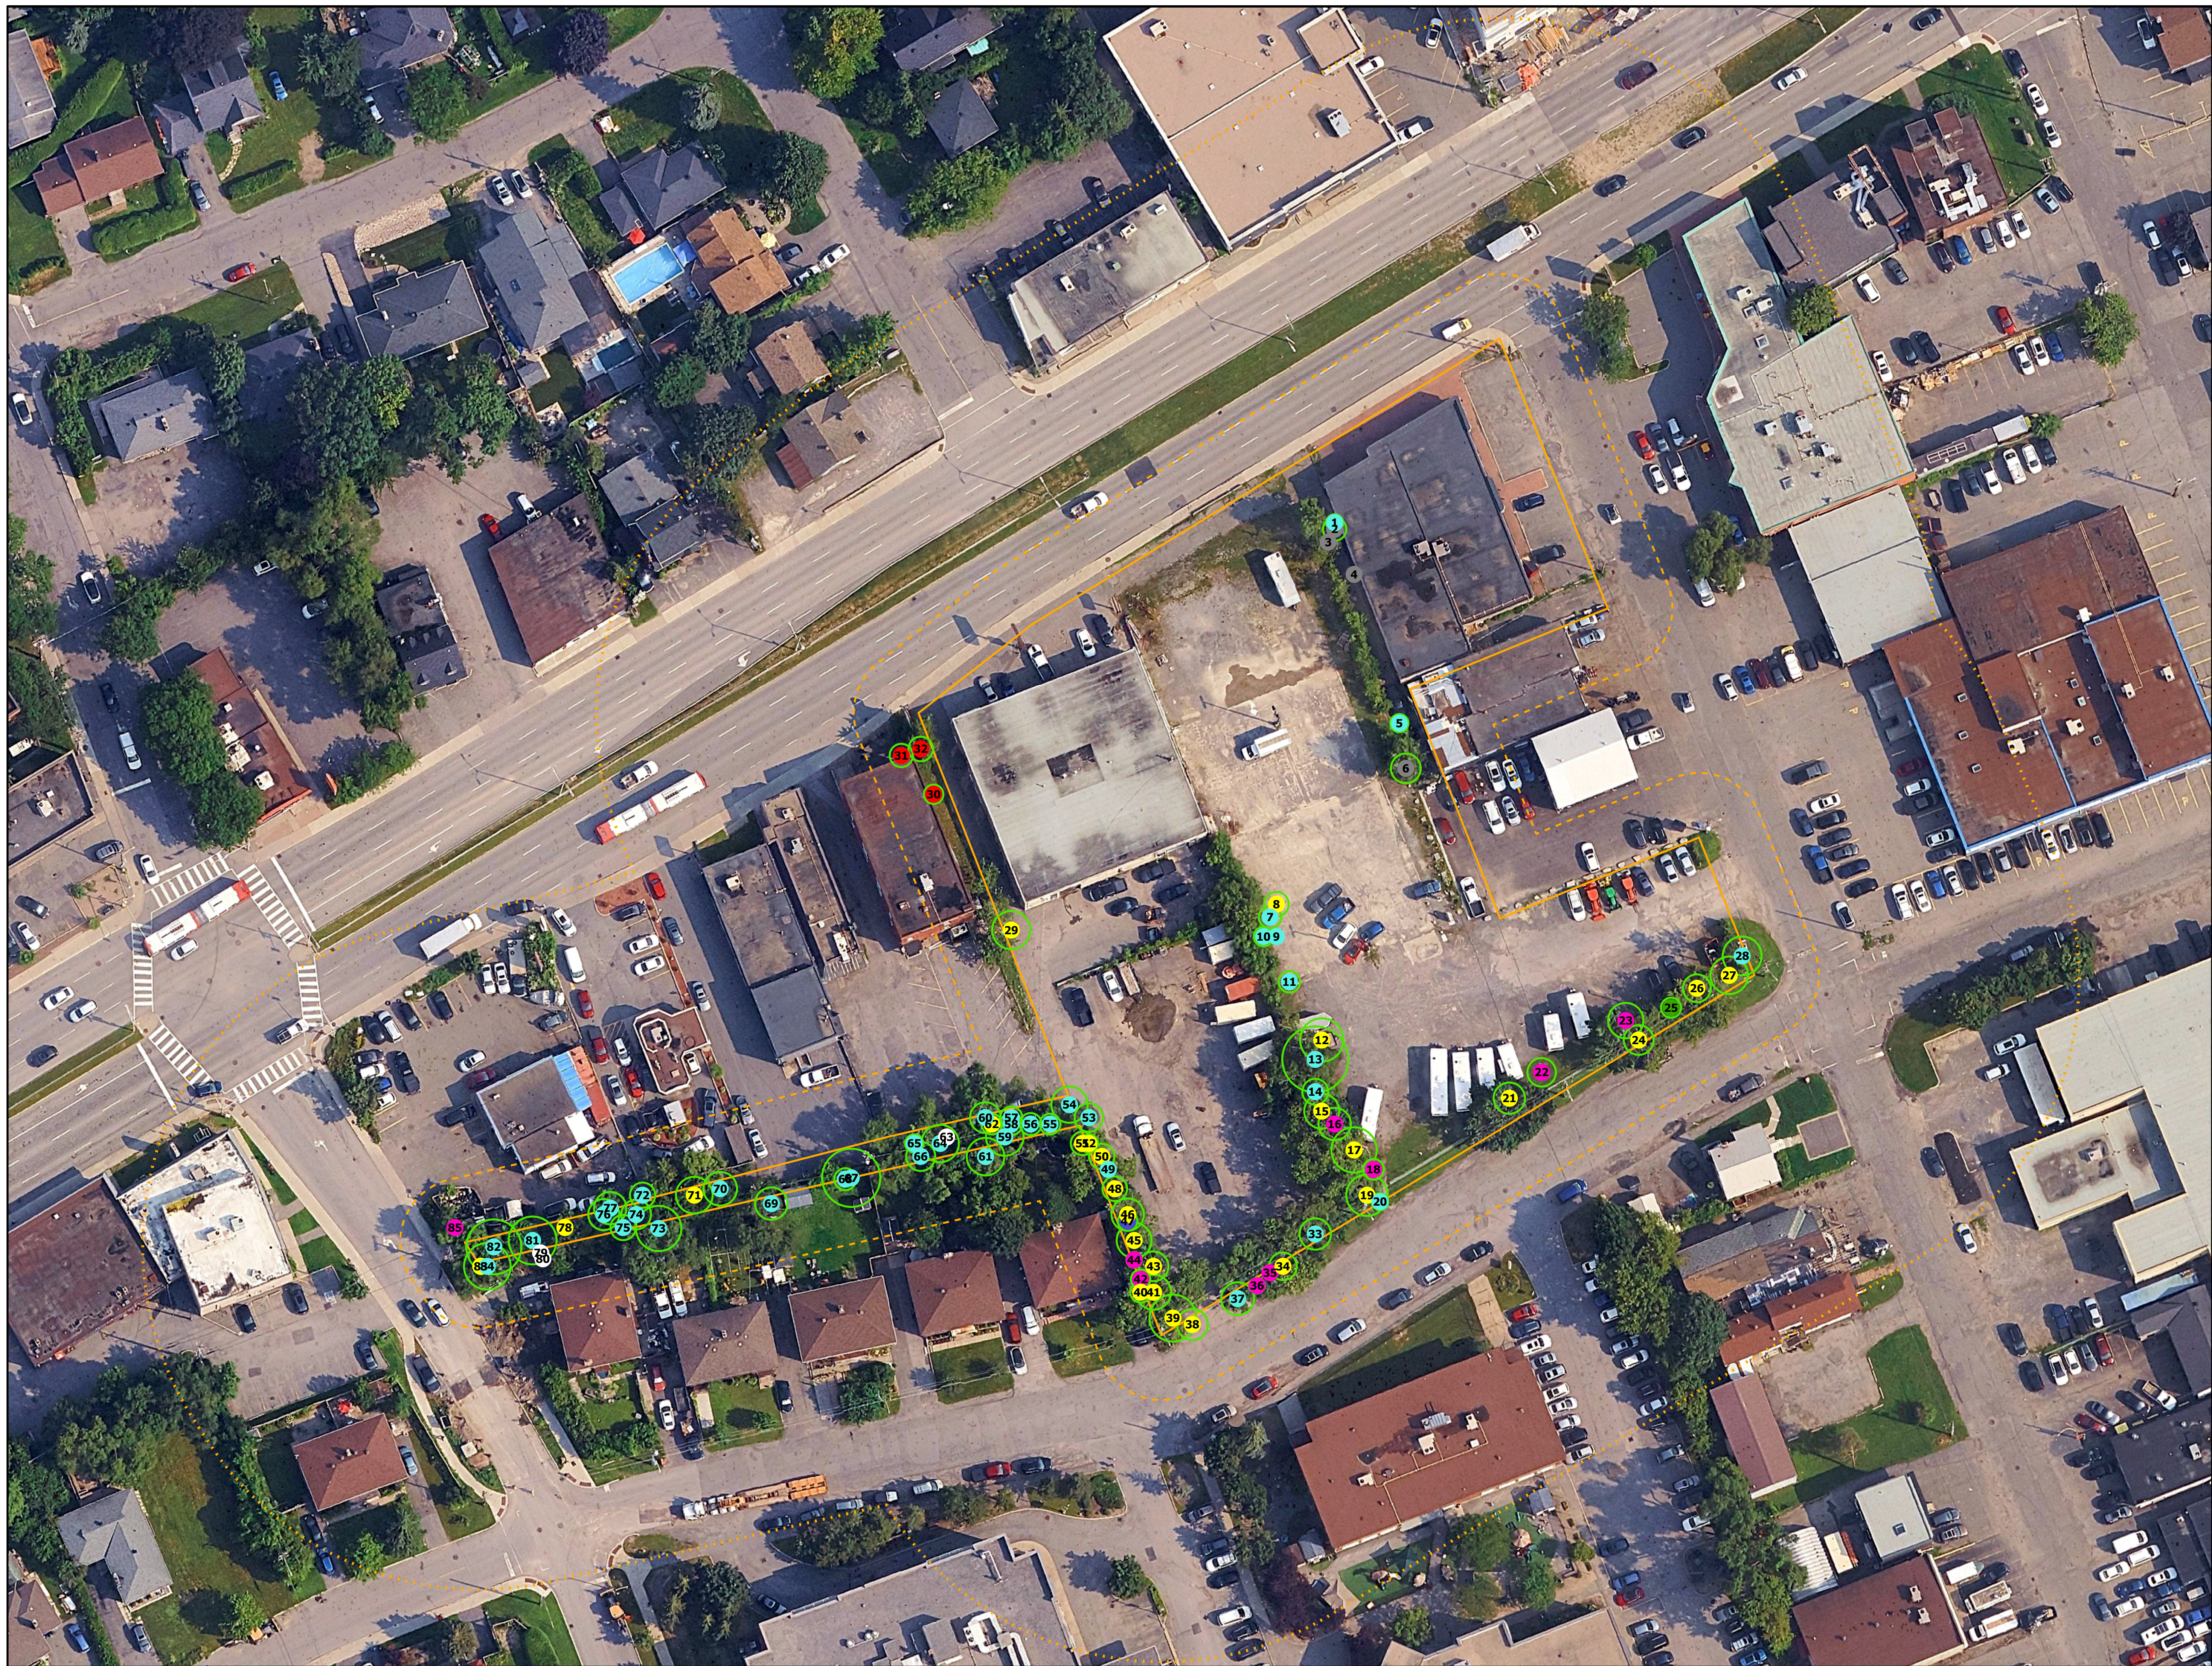
Table 1 on pages 5 through 9 of this report details the species, condition, size (diameter) and status of individual and groups of trees on the subject property, adjacent private neighbouring property and nearby City of Ottawa property. Each of these is referenced by the numbers plotted on the tree conservation plans on pages 10, 11 and 12 of this report.
