Phase I – Environmental Site Assessment

71 Russell Avenue
Ottawa, Ontario

Prepared for Jersey Developments Inc.

Report: PE7209-1
October 22, 2025

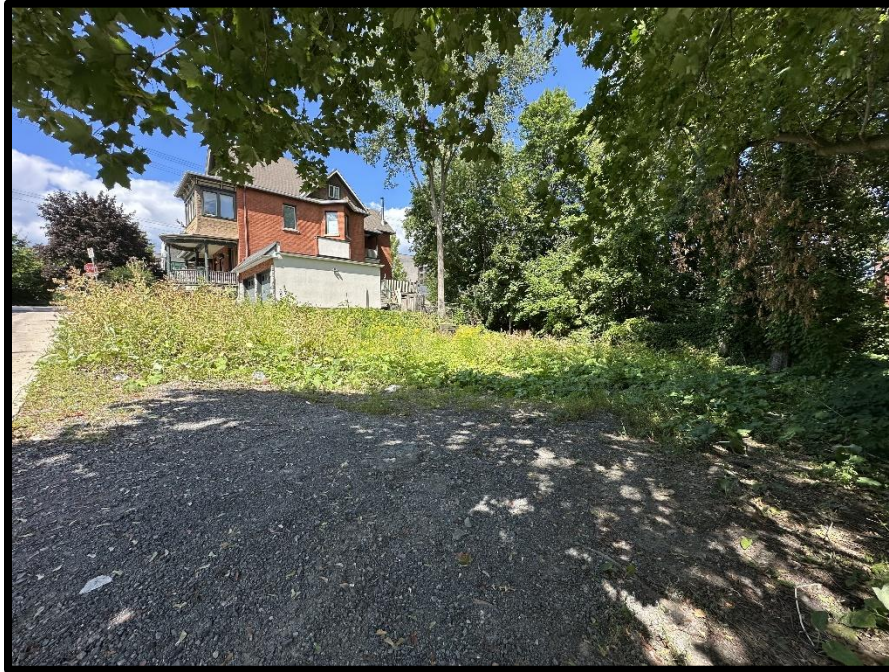
Photograph 1: View of the Phase I Property and adjacent property to the north, facing north, from the southwestern corner of the Phase I Property.

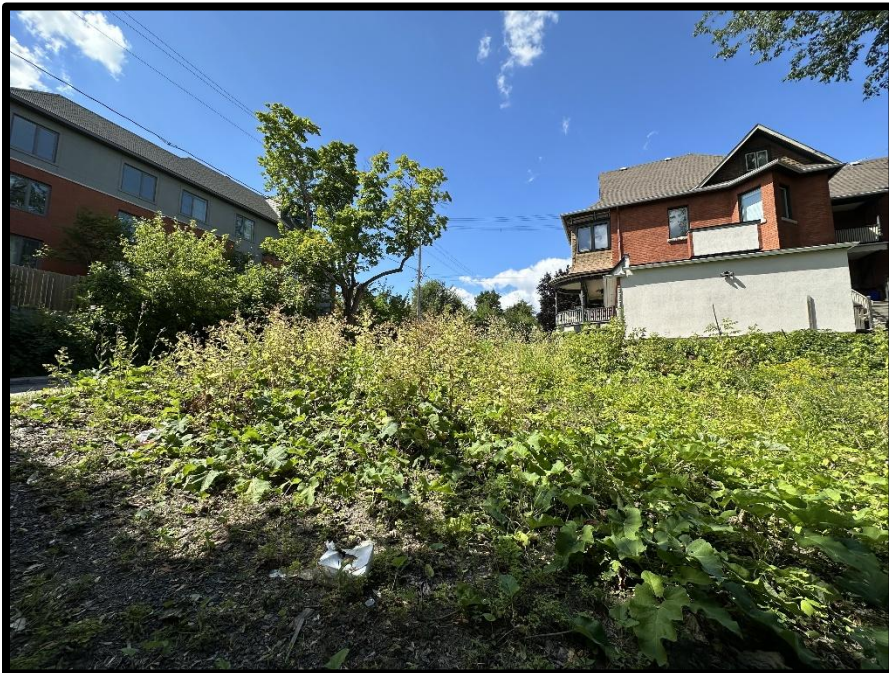
Photograph 2: View of the western portion of the Phase I Property and the adjacent properties to the north and west, facing northwest, from the southern property boundary.

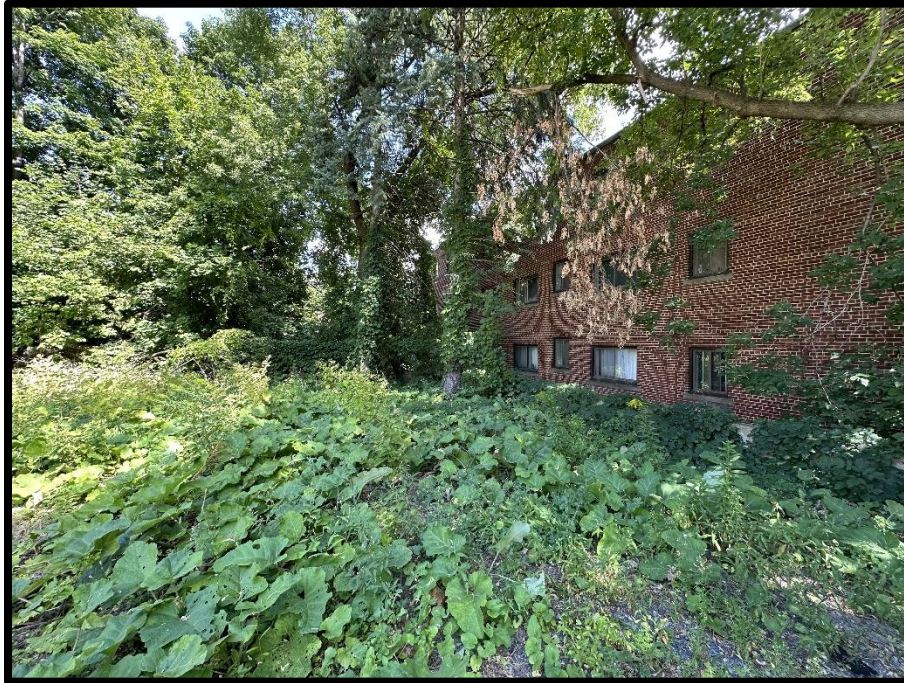
Photograph 3: View of the southern portion of the Phase I Property, from the center of the Phase I Property, facing southeast.

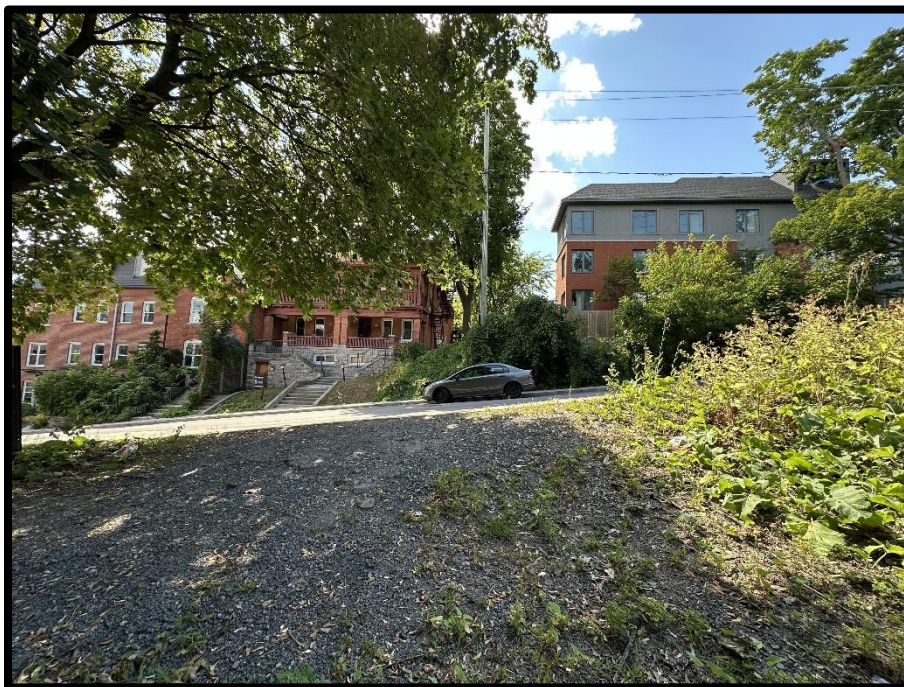
Photograph 4: View of the southwestern portion of the Phase I Property and adjacent properties to the west, facing west from the southwestern portion of the Phase I Property.
