Phase One Environmental Site Assessment
1770 Heatherington Road, Ottawa, Ontario
City of Ottawa

Project Name:
Phase One Environmental Site Assessment
1770 Heatherington Road, Ottawa, Ontario

Project Number:
OTT-00018293-J8

Prepared By:
EXP Services Inc.
100-2650 Queensview Drive
Ottawa, ON K2B 7H6
t: 1.613.688.1899
f: 1.613.255.7337

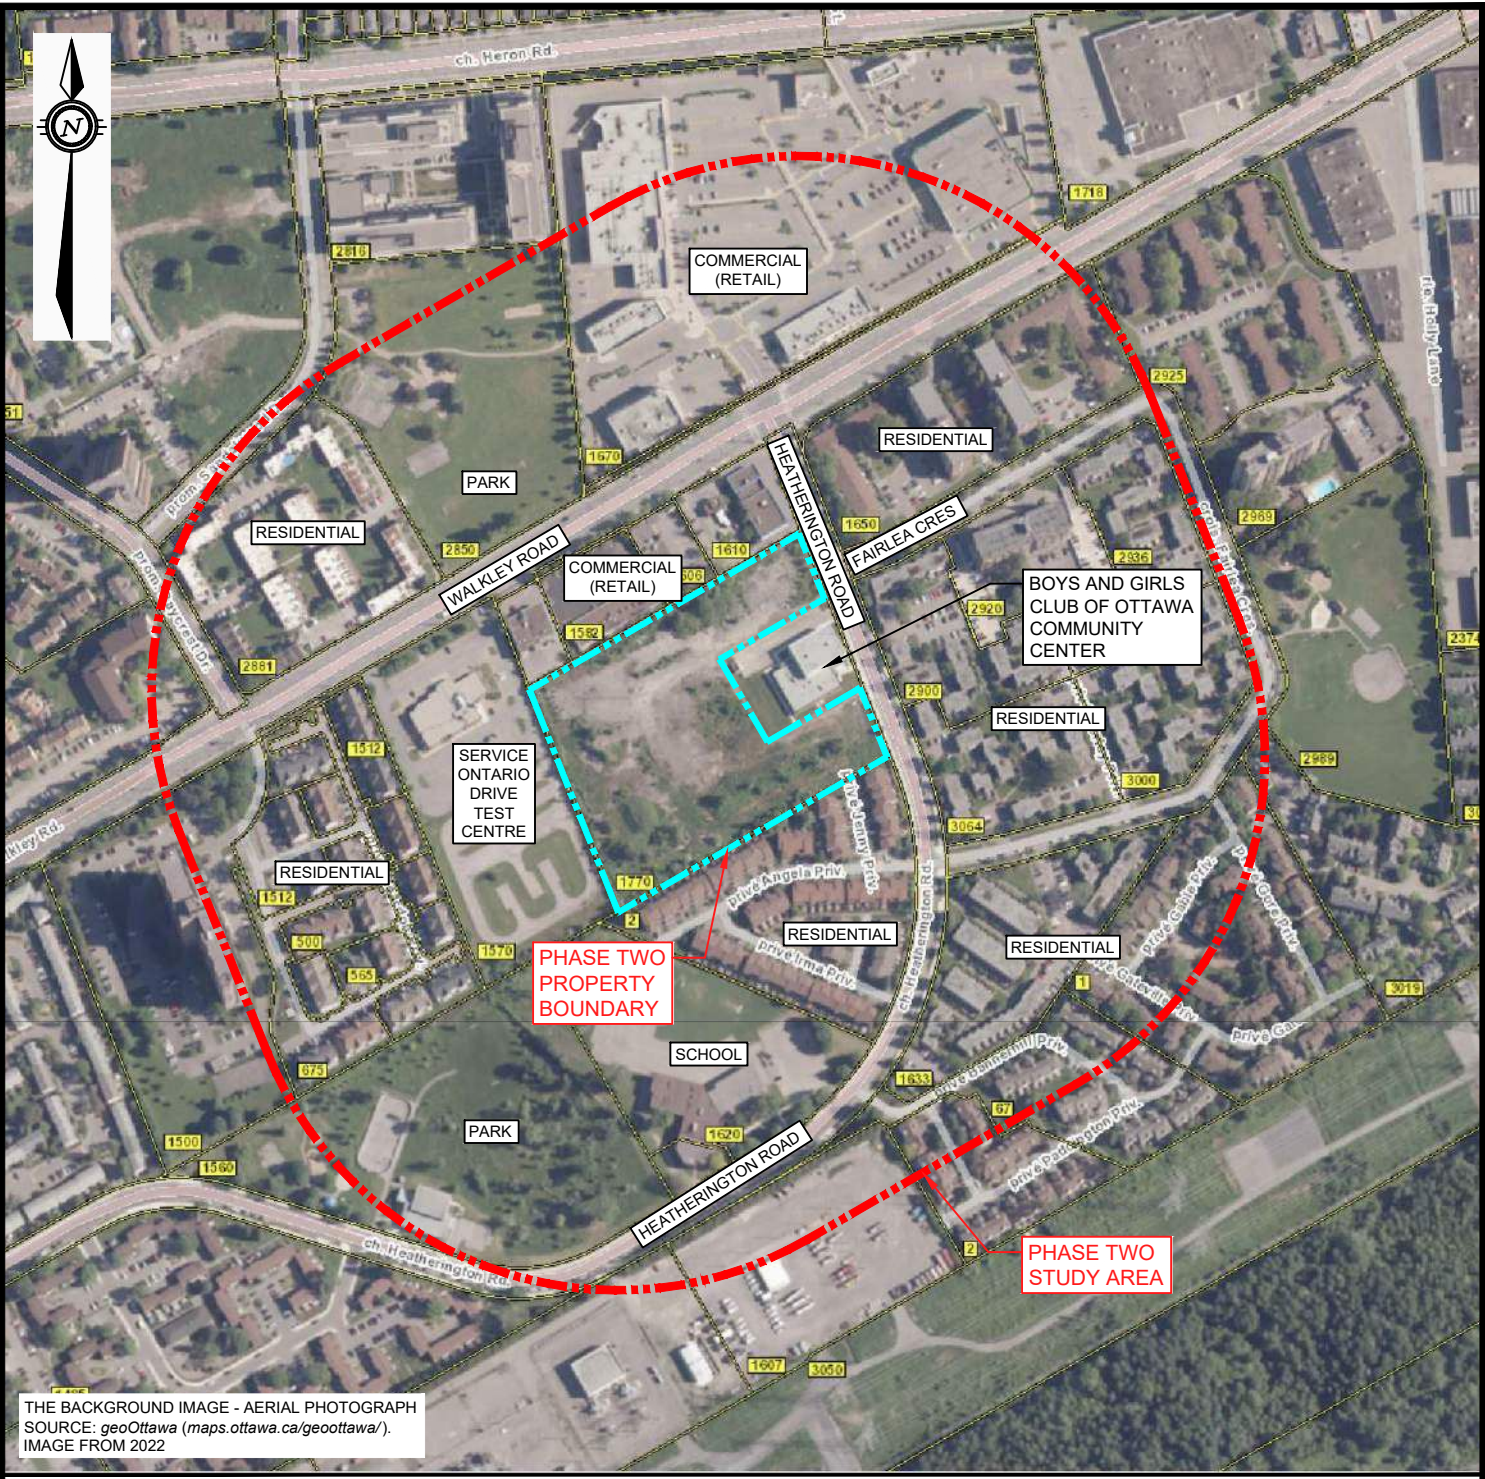
| | | FILE NO OTT-00018293-J5 | | FIG 2 |

Based on the current visual inspection, no present-day sources of potential environmental concern that could impact the subject site were identified on the adjacent and surrounding properties (Figure 2). It is additionally noted that the off-Site operations noted to constitute Potentially Contaminating Activity (PCA) IDs 5 through 9, are based on historical activities that occurred between the 1960s and the 1990s along the north adjacent property boundary. Several prior environmental investigations have been conducted at the Site to address the off-Site PCAs and no soil or groundwater impacts have been identified in relation to the off-Site PCAs constituting on-Site Areas of Potential Environmental Concern (APECs). A figure depicting the location of test pits, monitoring wells and borehole locations utilized as part of the prior environmental investigations is provided as Figure 5.

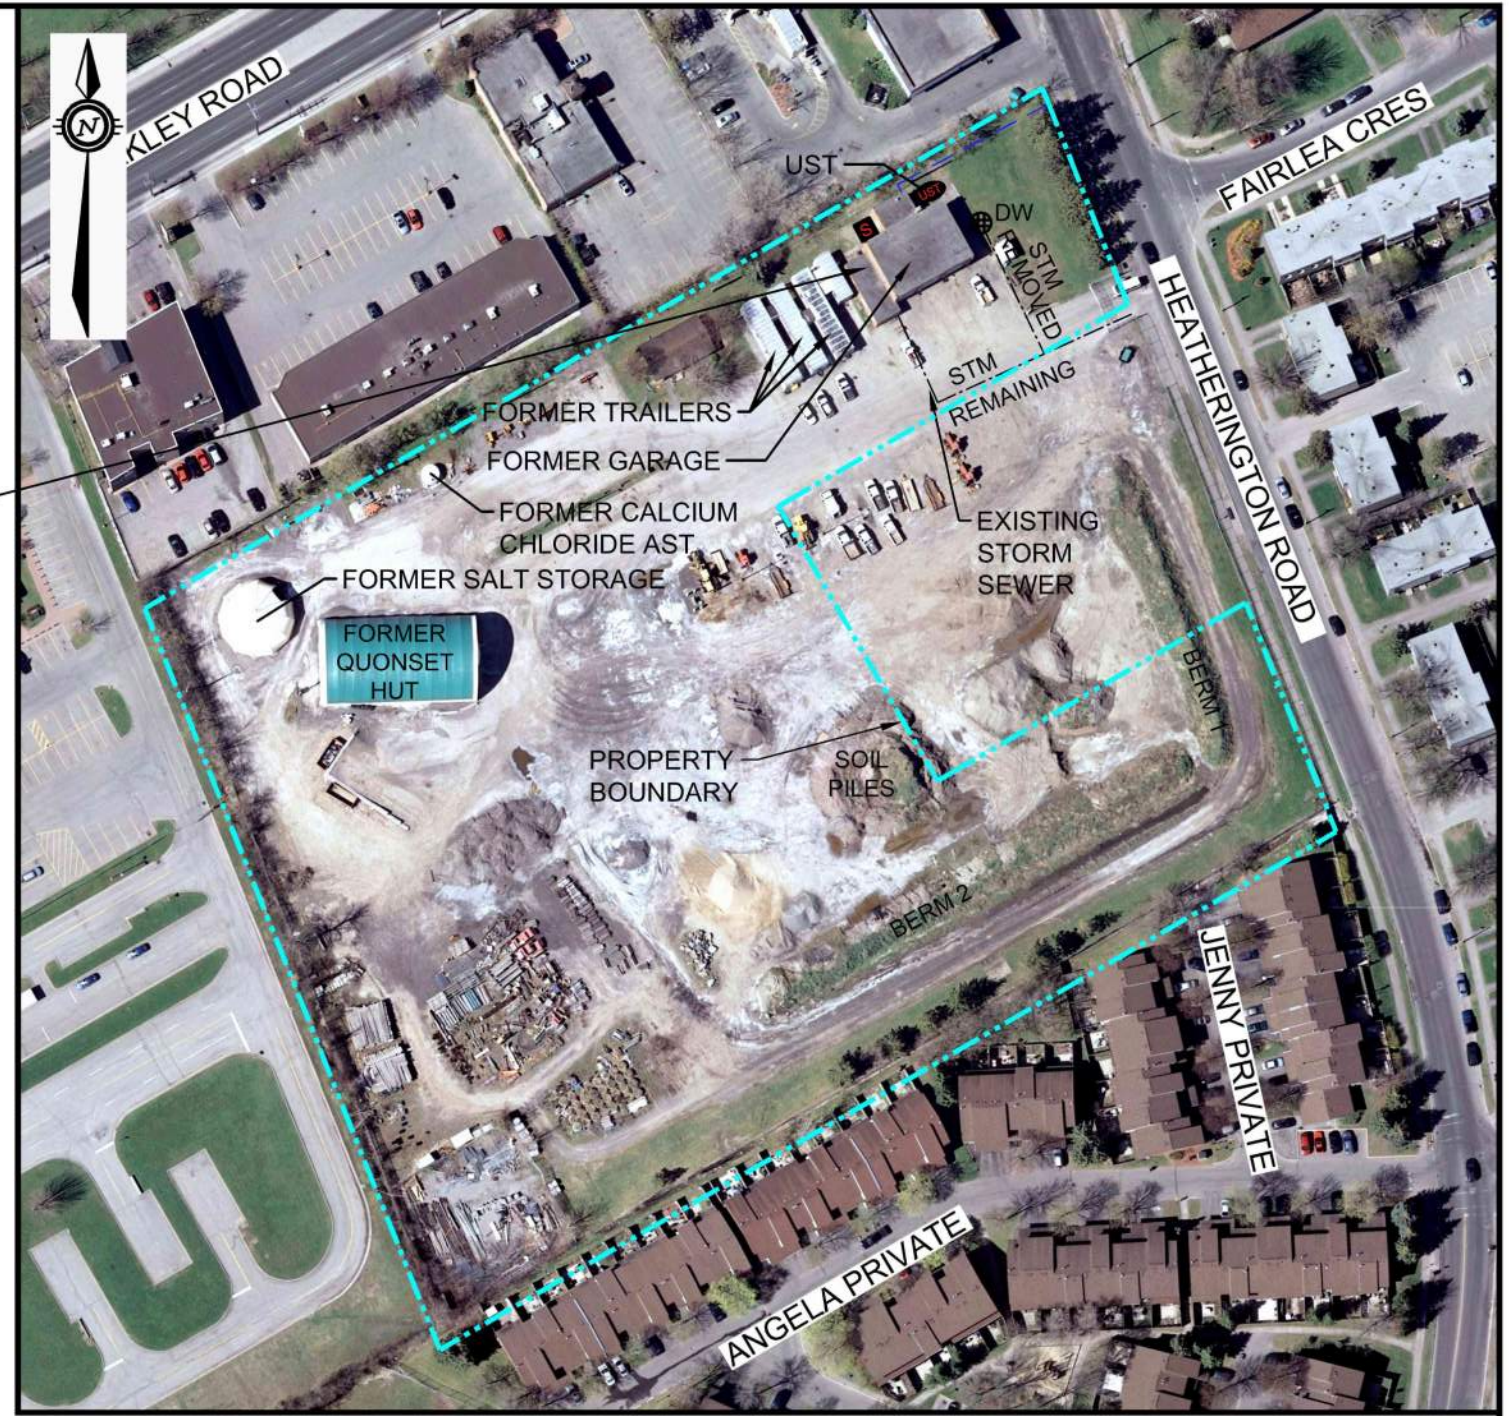
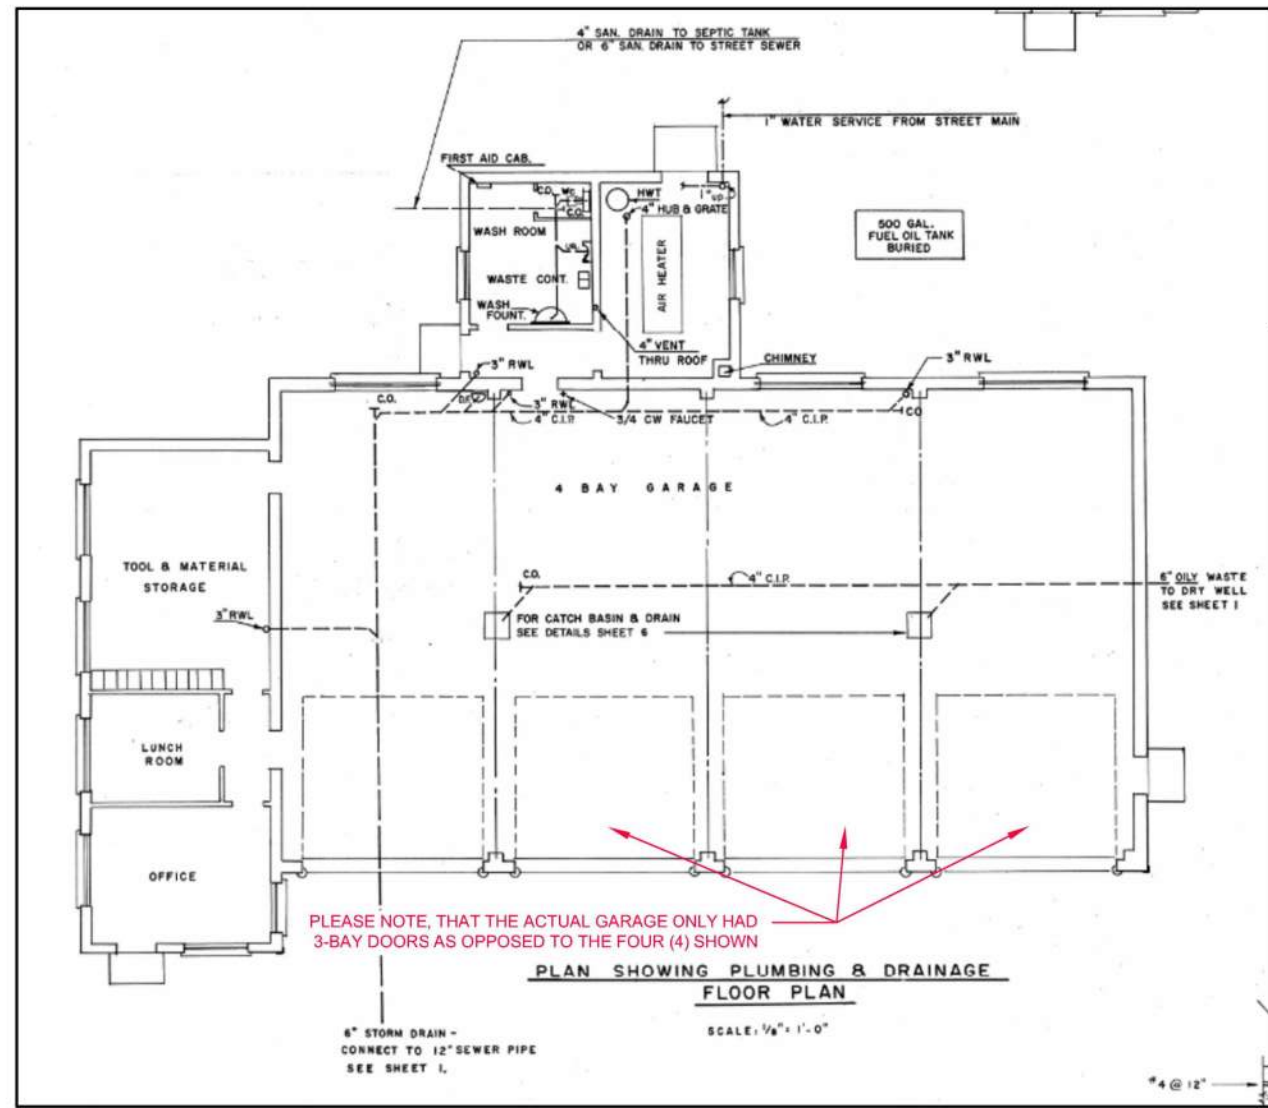
| | | DATE APRIL 2024 | SITE PLAN (FORMER CONDITIONS) | FIG 3B |

Although no drains, pits or sumps were observed during the site visit, the former maintenance garage to the north had floor drains that were connected to a dry-well located east of the building. These features were removed along with surrounding soils during the 2012 site remediation activities.

FORMER GARAGE LAYOUT
 (APPROXIMATE SCALE: ~1:200)

- - - PROPERTY BOUNDARY
- - - WATER LINE
- - - STORM SEWER LINE
- DW DRY WELL
- FORMER FURNACE OIL TANK
- FORMER SEPTIC TANK

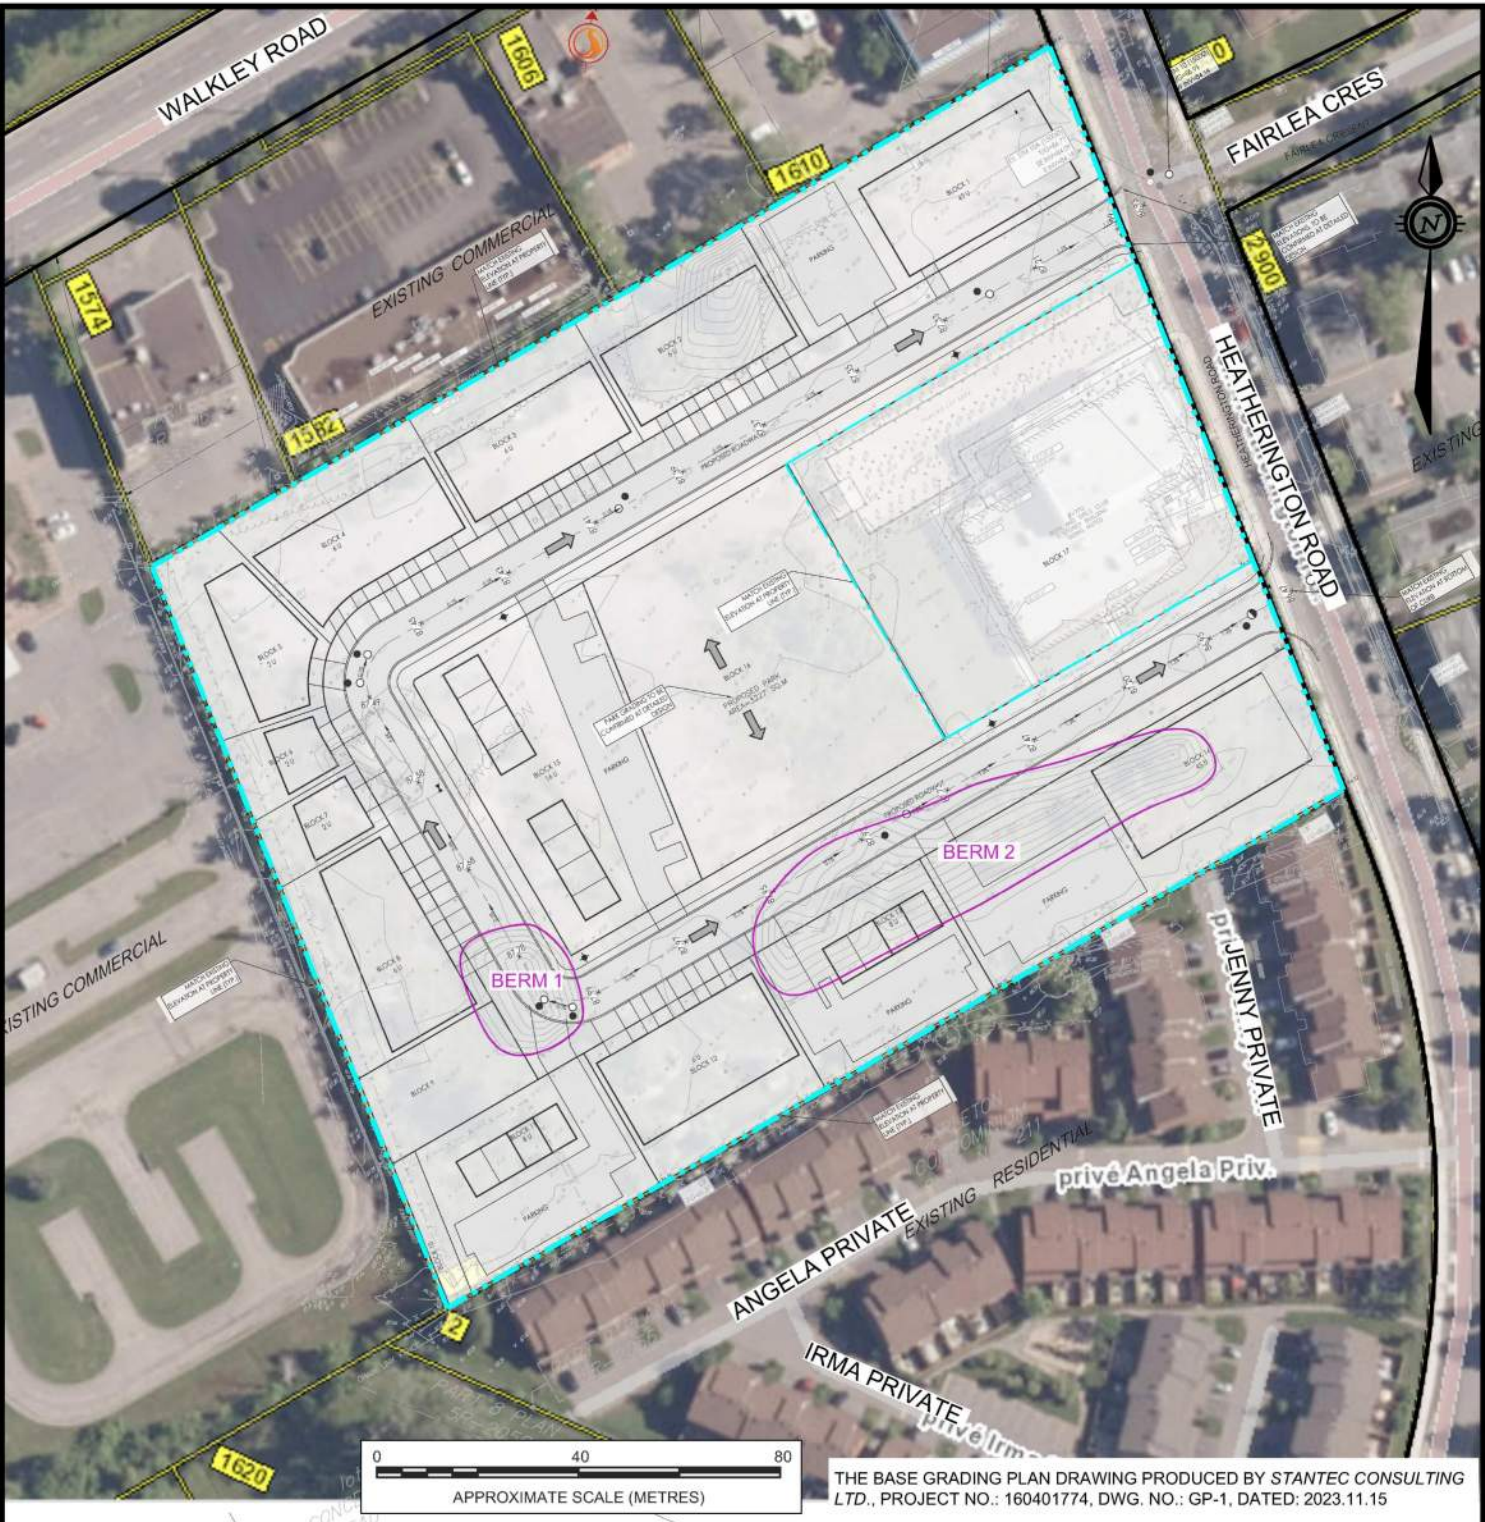
SCALE 1:1,500
 SKETCH NO
FIG 3C

THE BASE GRADING PLAN DRAWING PRODUCED BY STANTEC CONSULTING LTD., PROJECT NO.: 160401774, DWG. NO.: GP-1, DATED: 2023.11.15

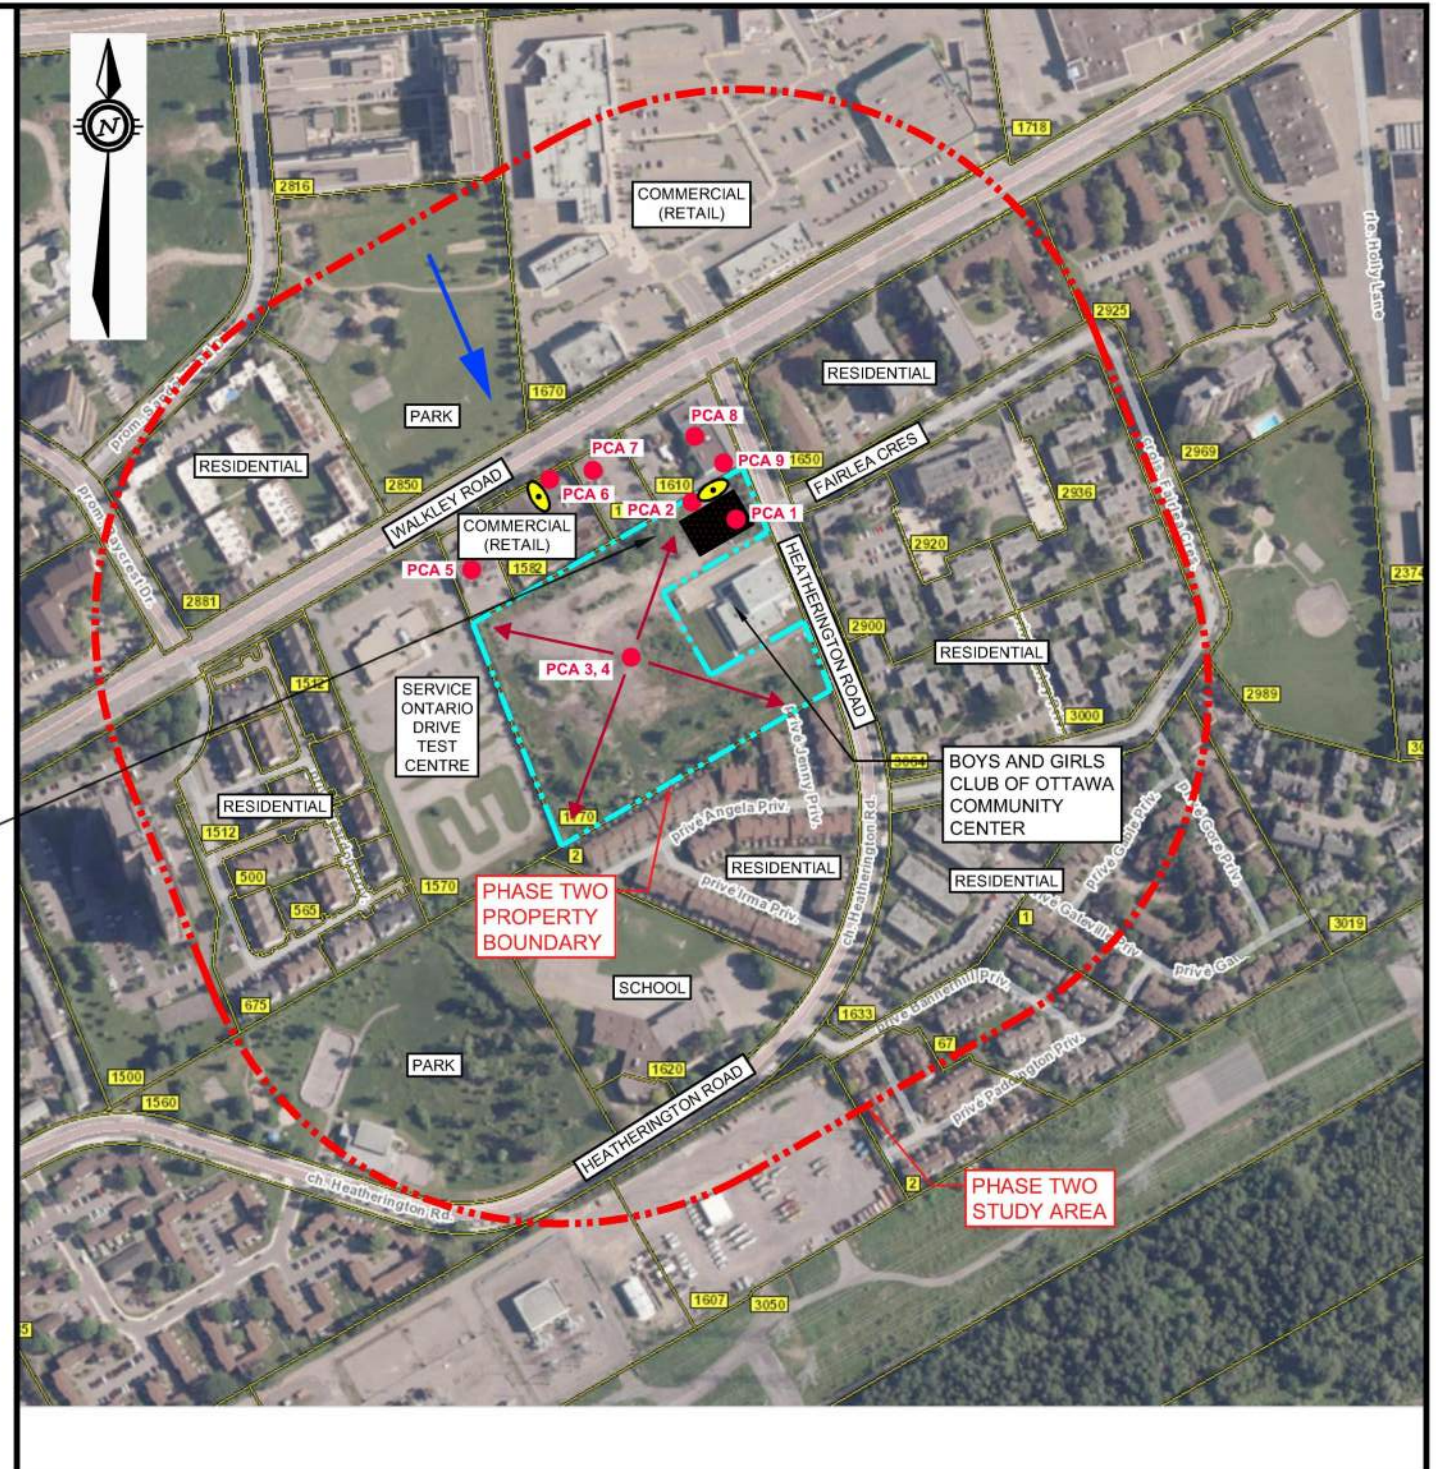
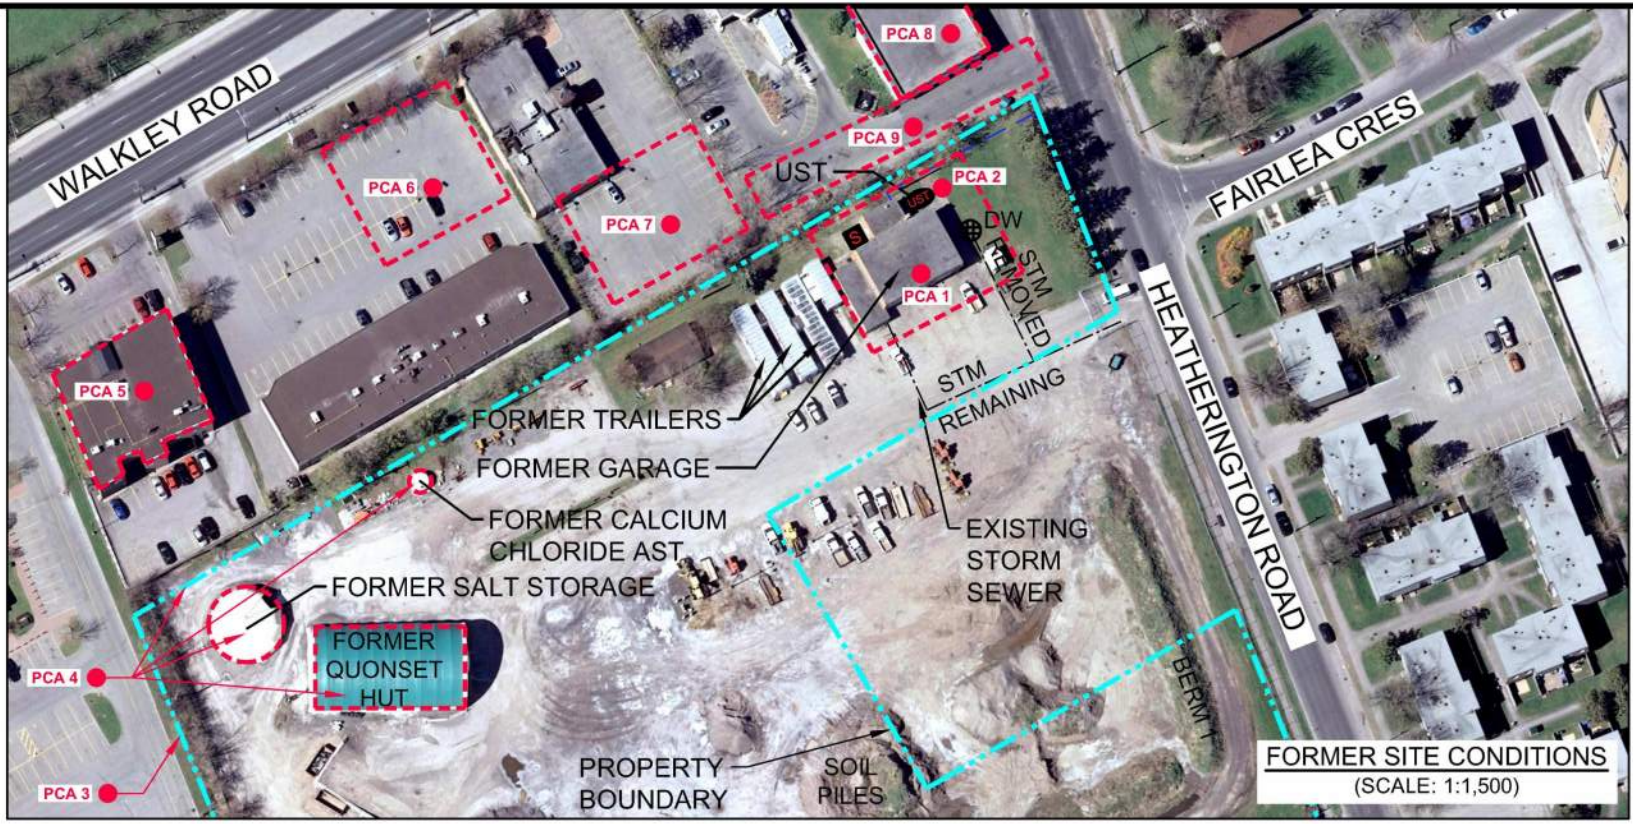
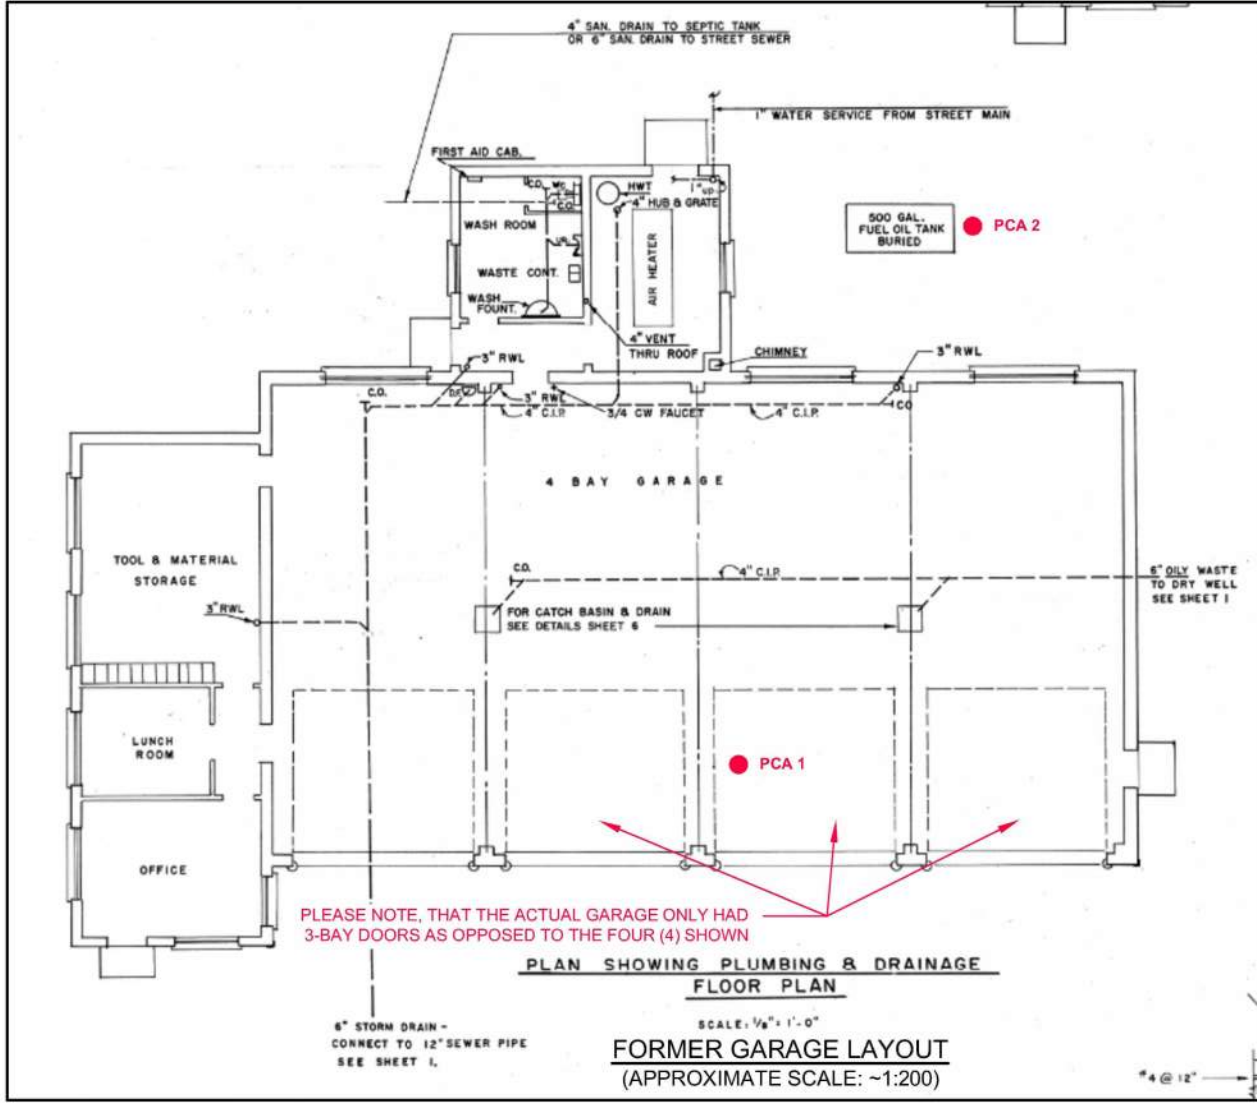
Former previous off-site land use is shown in Figure 4. Based on the above, a Phase II ESA was recommended to address on-site and off-site PCAs.

Several monitoring wells were observed at the site. The monitoring wells were installed during earlier Phase II ESAs and following the 2012 and 2014 remedial excavations. They are illustrated in Figure 4.

- PCA LIST DESCRIPTION:**
- PCA #1 - FORMER AUTO-MOTIVE GARAGE
 - PCA #2 - FORMER UST LOCATION
 - PCA #3 - STORAGE, PLACEMENT AND USE OF FILL MATERIALS OF UNKNOWN QUALITY (ENTIRE SITE)
 - PCA #4 - SALT STORAGE, APPROXIMATE AND IDENTIFIED SALT IMPACTS (ENTIRE SITE)
 - PCA #5 - FORMER BETTY BRITE DRY-CLEANERS (OFF-SITE)
 - PCA #6 - APPROXIMATE LOCATION OF FORMER UST (OFF-SITE)
 - PCA #7 - APPROXIMATE LOCATION OF FORMER TRIANGLE PUMP (OFF-SITE)
 - PCA #8 - LOCATION OF FORMER AUTO-MOTIVE DEALERSHIP (OFF-SITE)
 - PCA #9 - ASSUMED LOCATION OF FORMER MOTOR OIL SPILL (OFF-SITE)

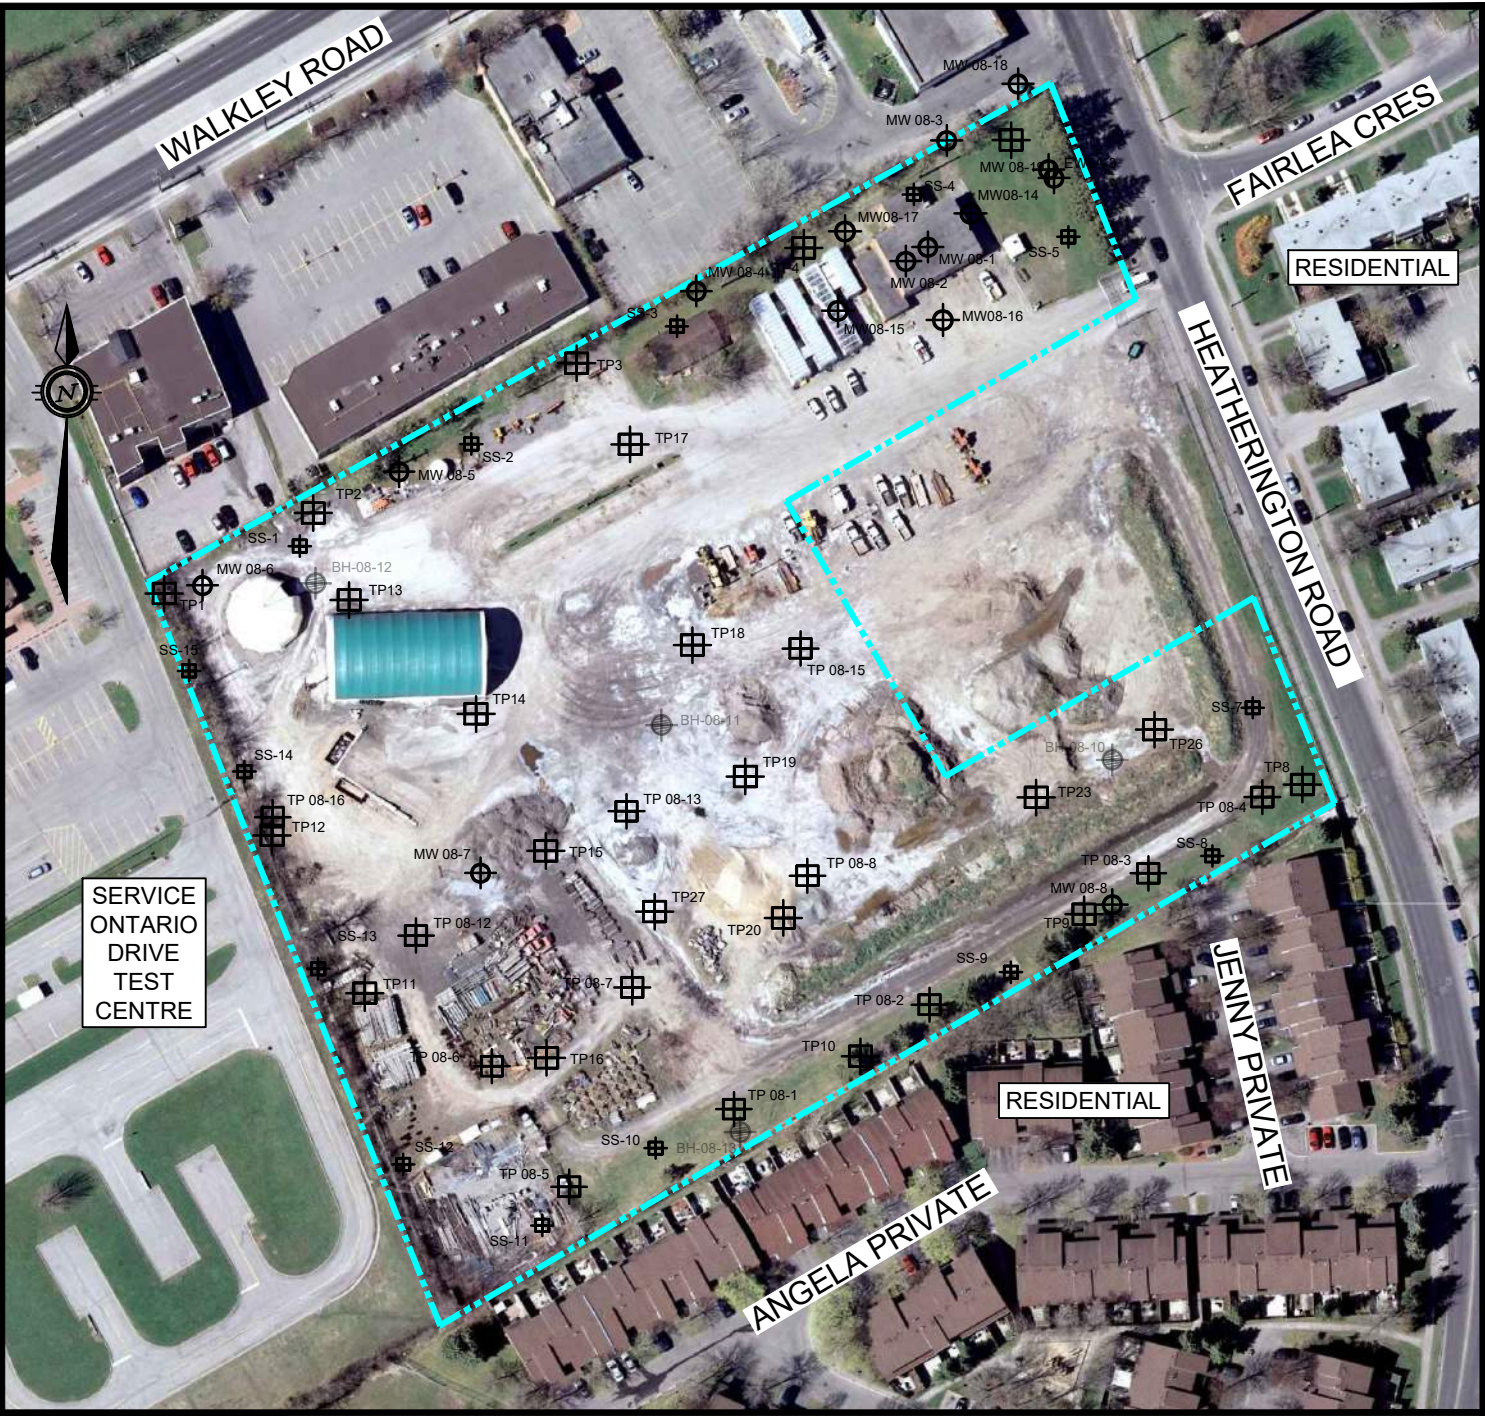
SCALE 1:1,500
 SKETCH NO
FIG 5

Figure 5 illustrates the location of the former remedial efforts. Table 3.1 provides a summary of the specific excavations advanced on-site. It is noted that the EC/SAR impacts in soil and the Na/Cl impacts in groundwater remain on the Phase One Property and will be managed as a part of the Tier III Risk assessment.

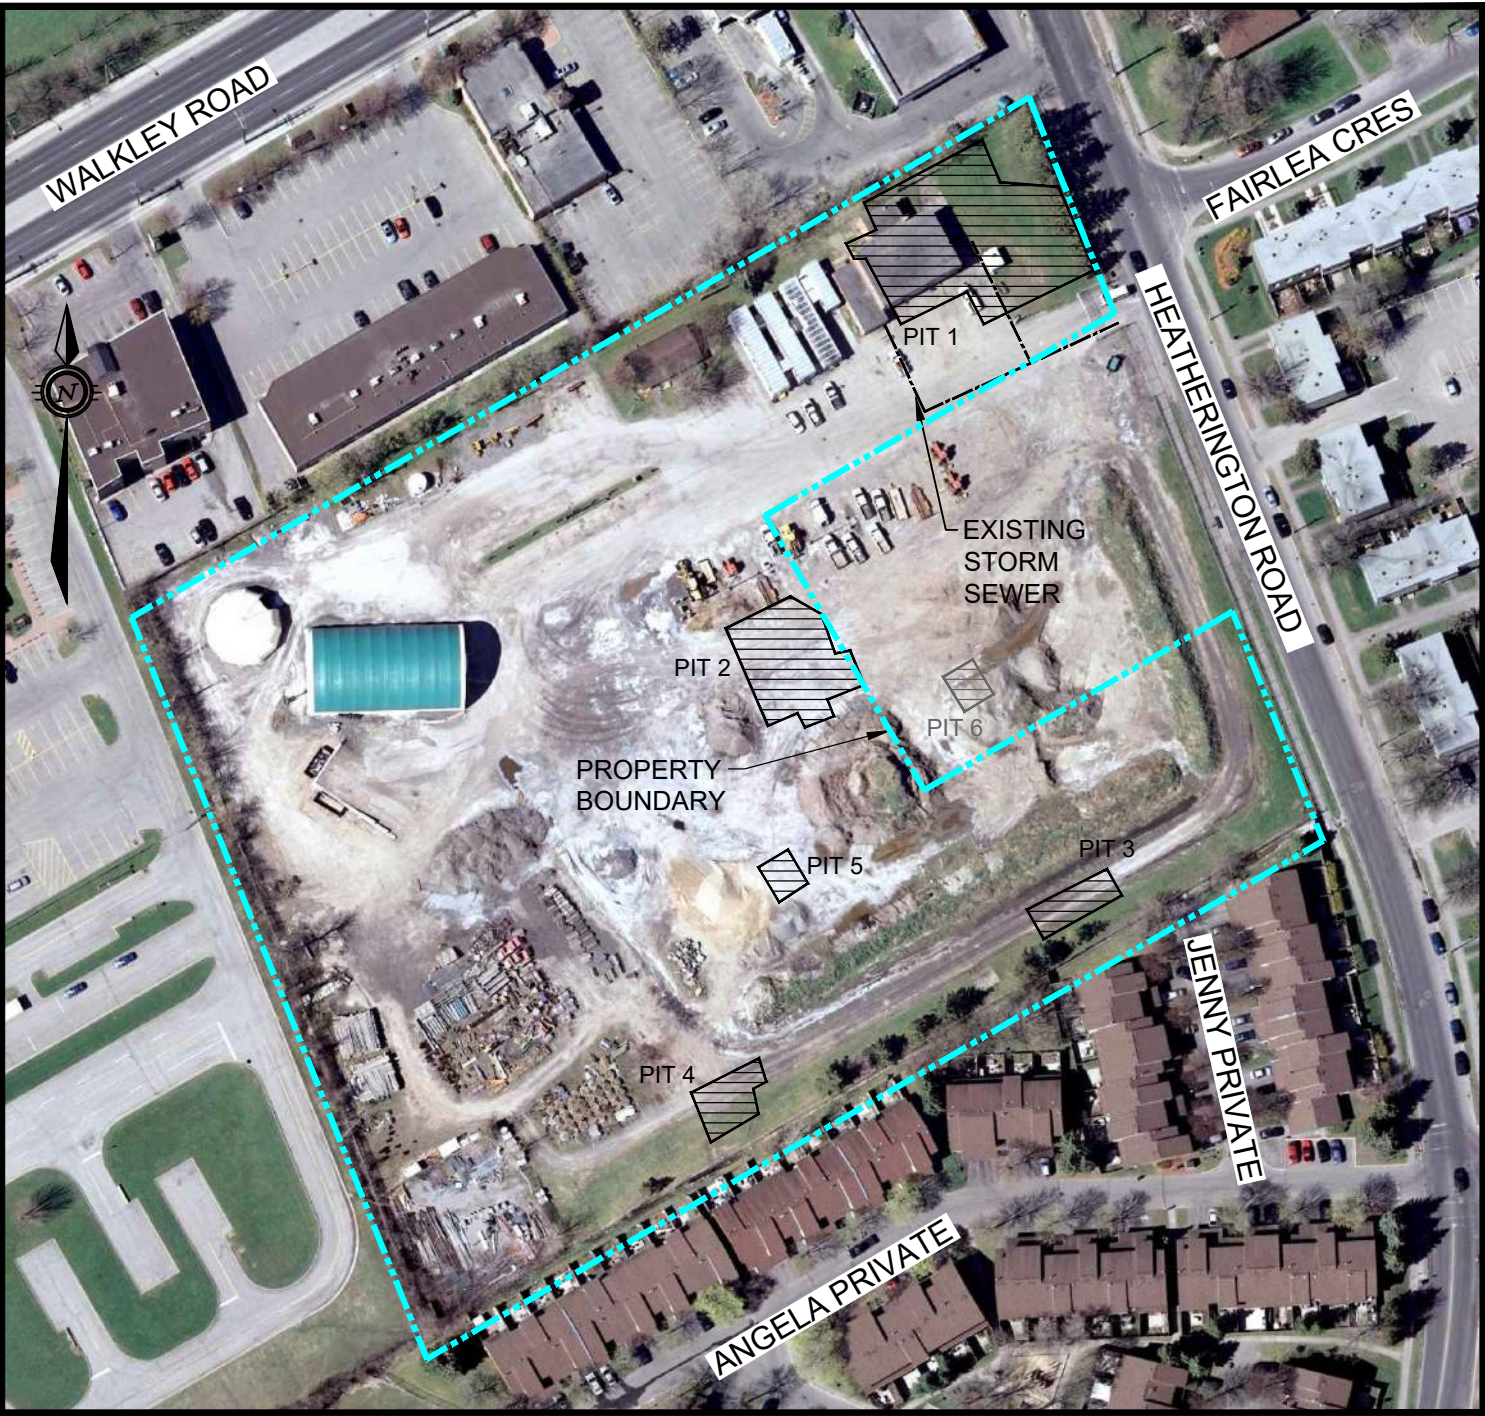
SCALE 1:1,500
 SKETCH NO
FIG 6

- PROPERTY BOUNDARY
- EXP EXCAVATION AREA
- *PIT 6 WAS COMPLETED OFF-SITE, AND IS SHOWN FOR REVIEWER REFERENCE.

FORMER REMEDIATION BOUNDARY
