# HERITAGE IMPACT ASSESSMENT

## Soeurs de la Visitation Monastery 114 Richmond Road, Westboro, Ottawa

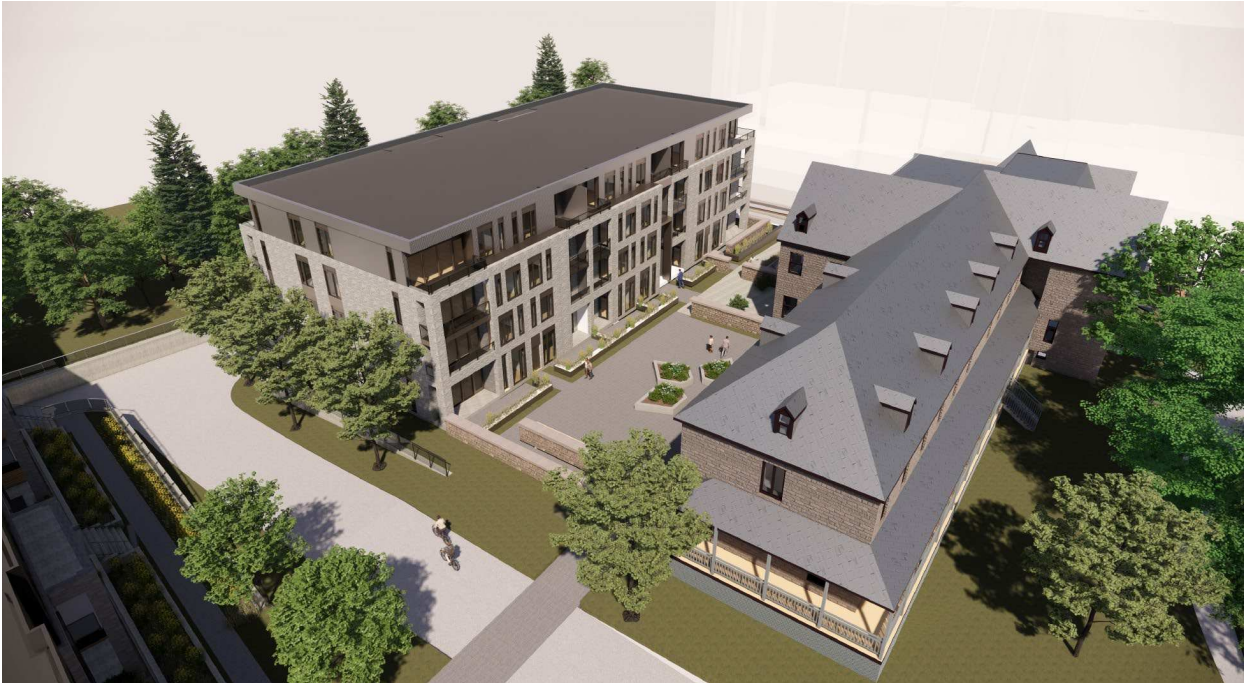
Figure 23: Bird’s eye view of proposed redevelopment including the four-story apartment building and rehabilitated Gothic Revival house and convent wings. (Project1 Studio)

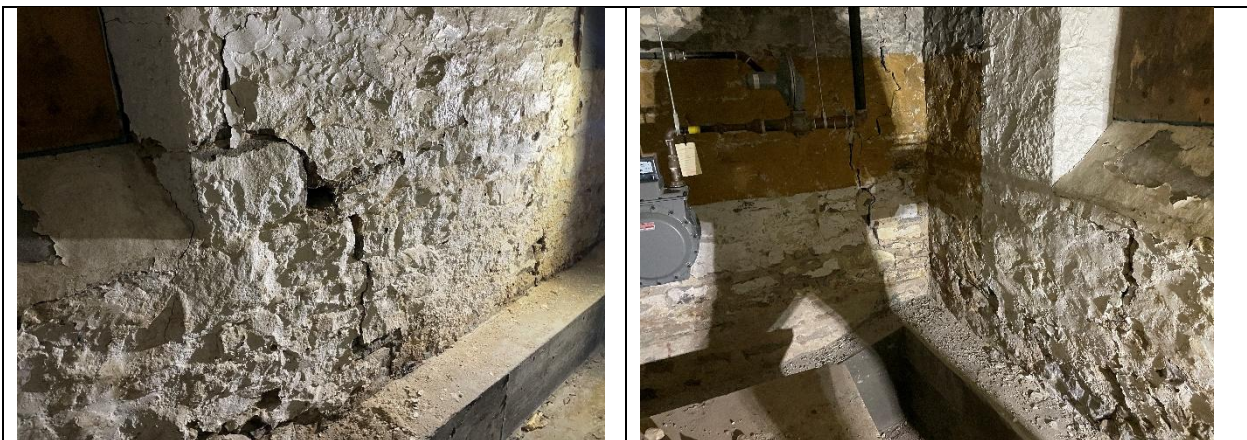
Photo 1: Crack in east chapel wall – basement level concrete benching.

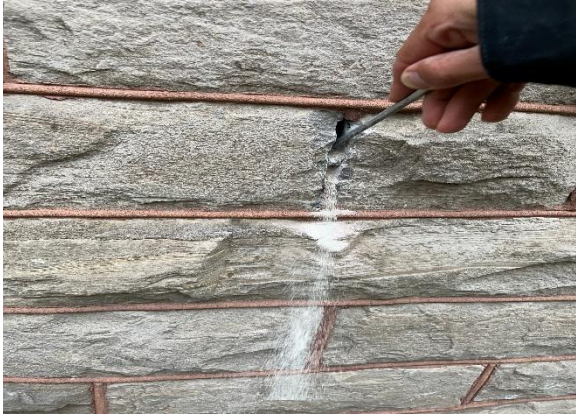
Photo 3: West wall of Convent. Hard pink Portland pointing mortar still bonded to stone. Back up mortar is reduced to sand.

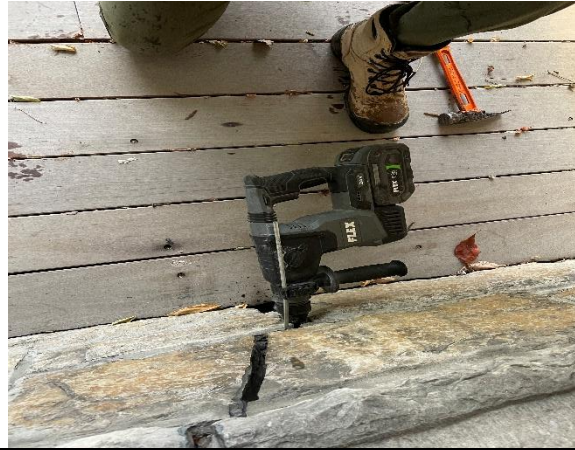
Photo 4: East wall of House. Fracture at window. Hard grey Portland pointing mortar. Sand and voids in fracture.

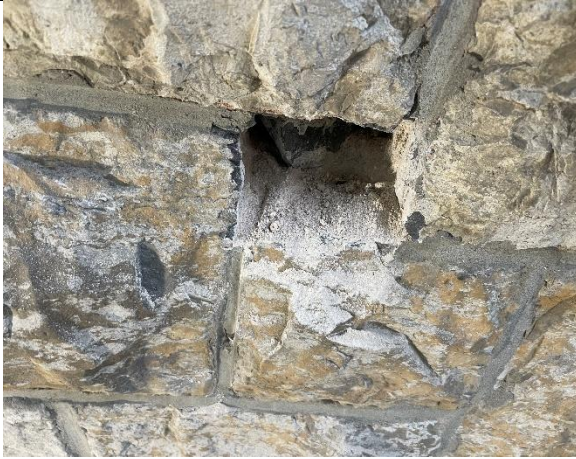
Photo 5: West wall of House. Core behind small stone has soft lime mortar bonded to adjacent stones.

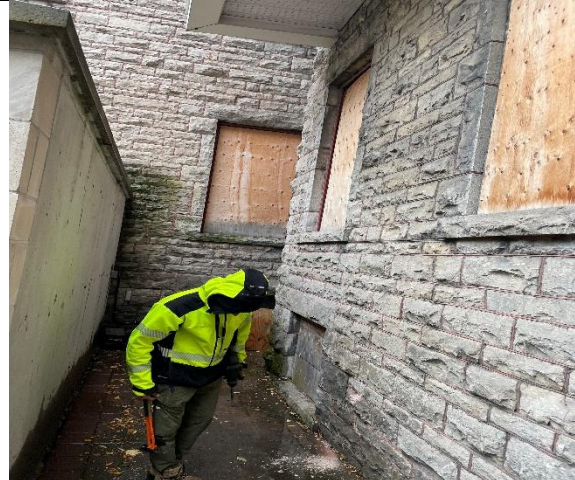
Photo 6: East chapel wall. Condition as Photo 4. Sand in joints up to 250mm deep.

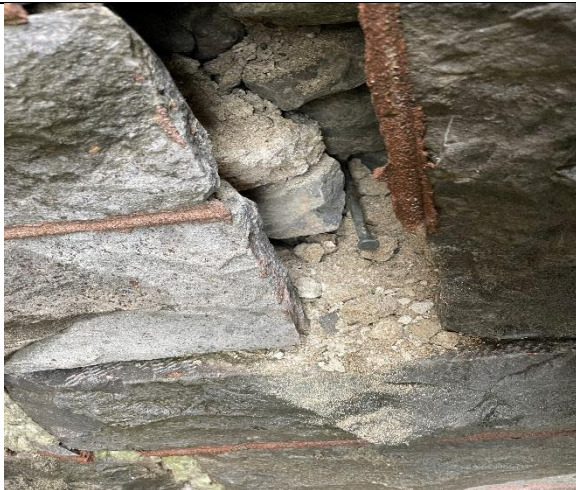
Photo 8: Large fracture on east wall of north annex at chapel. Large voids, loose stone gallets and sand in wall core.

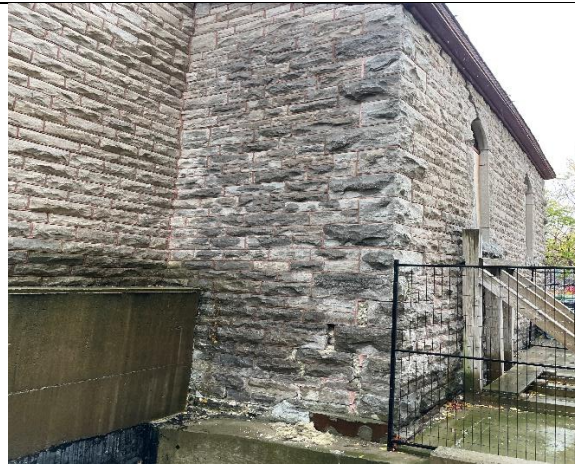
Photo 9: Bulge on north wall of Annex. Wall is braced. Little evidence of movement in past two years.
