## **Phase II – Environmental Site Assessment**

1209 Michael Street North  
Ottawa, Ontario

Prepared for Inside Edge Properties

Report: PE7253-2  
January 22, 2026

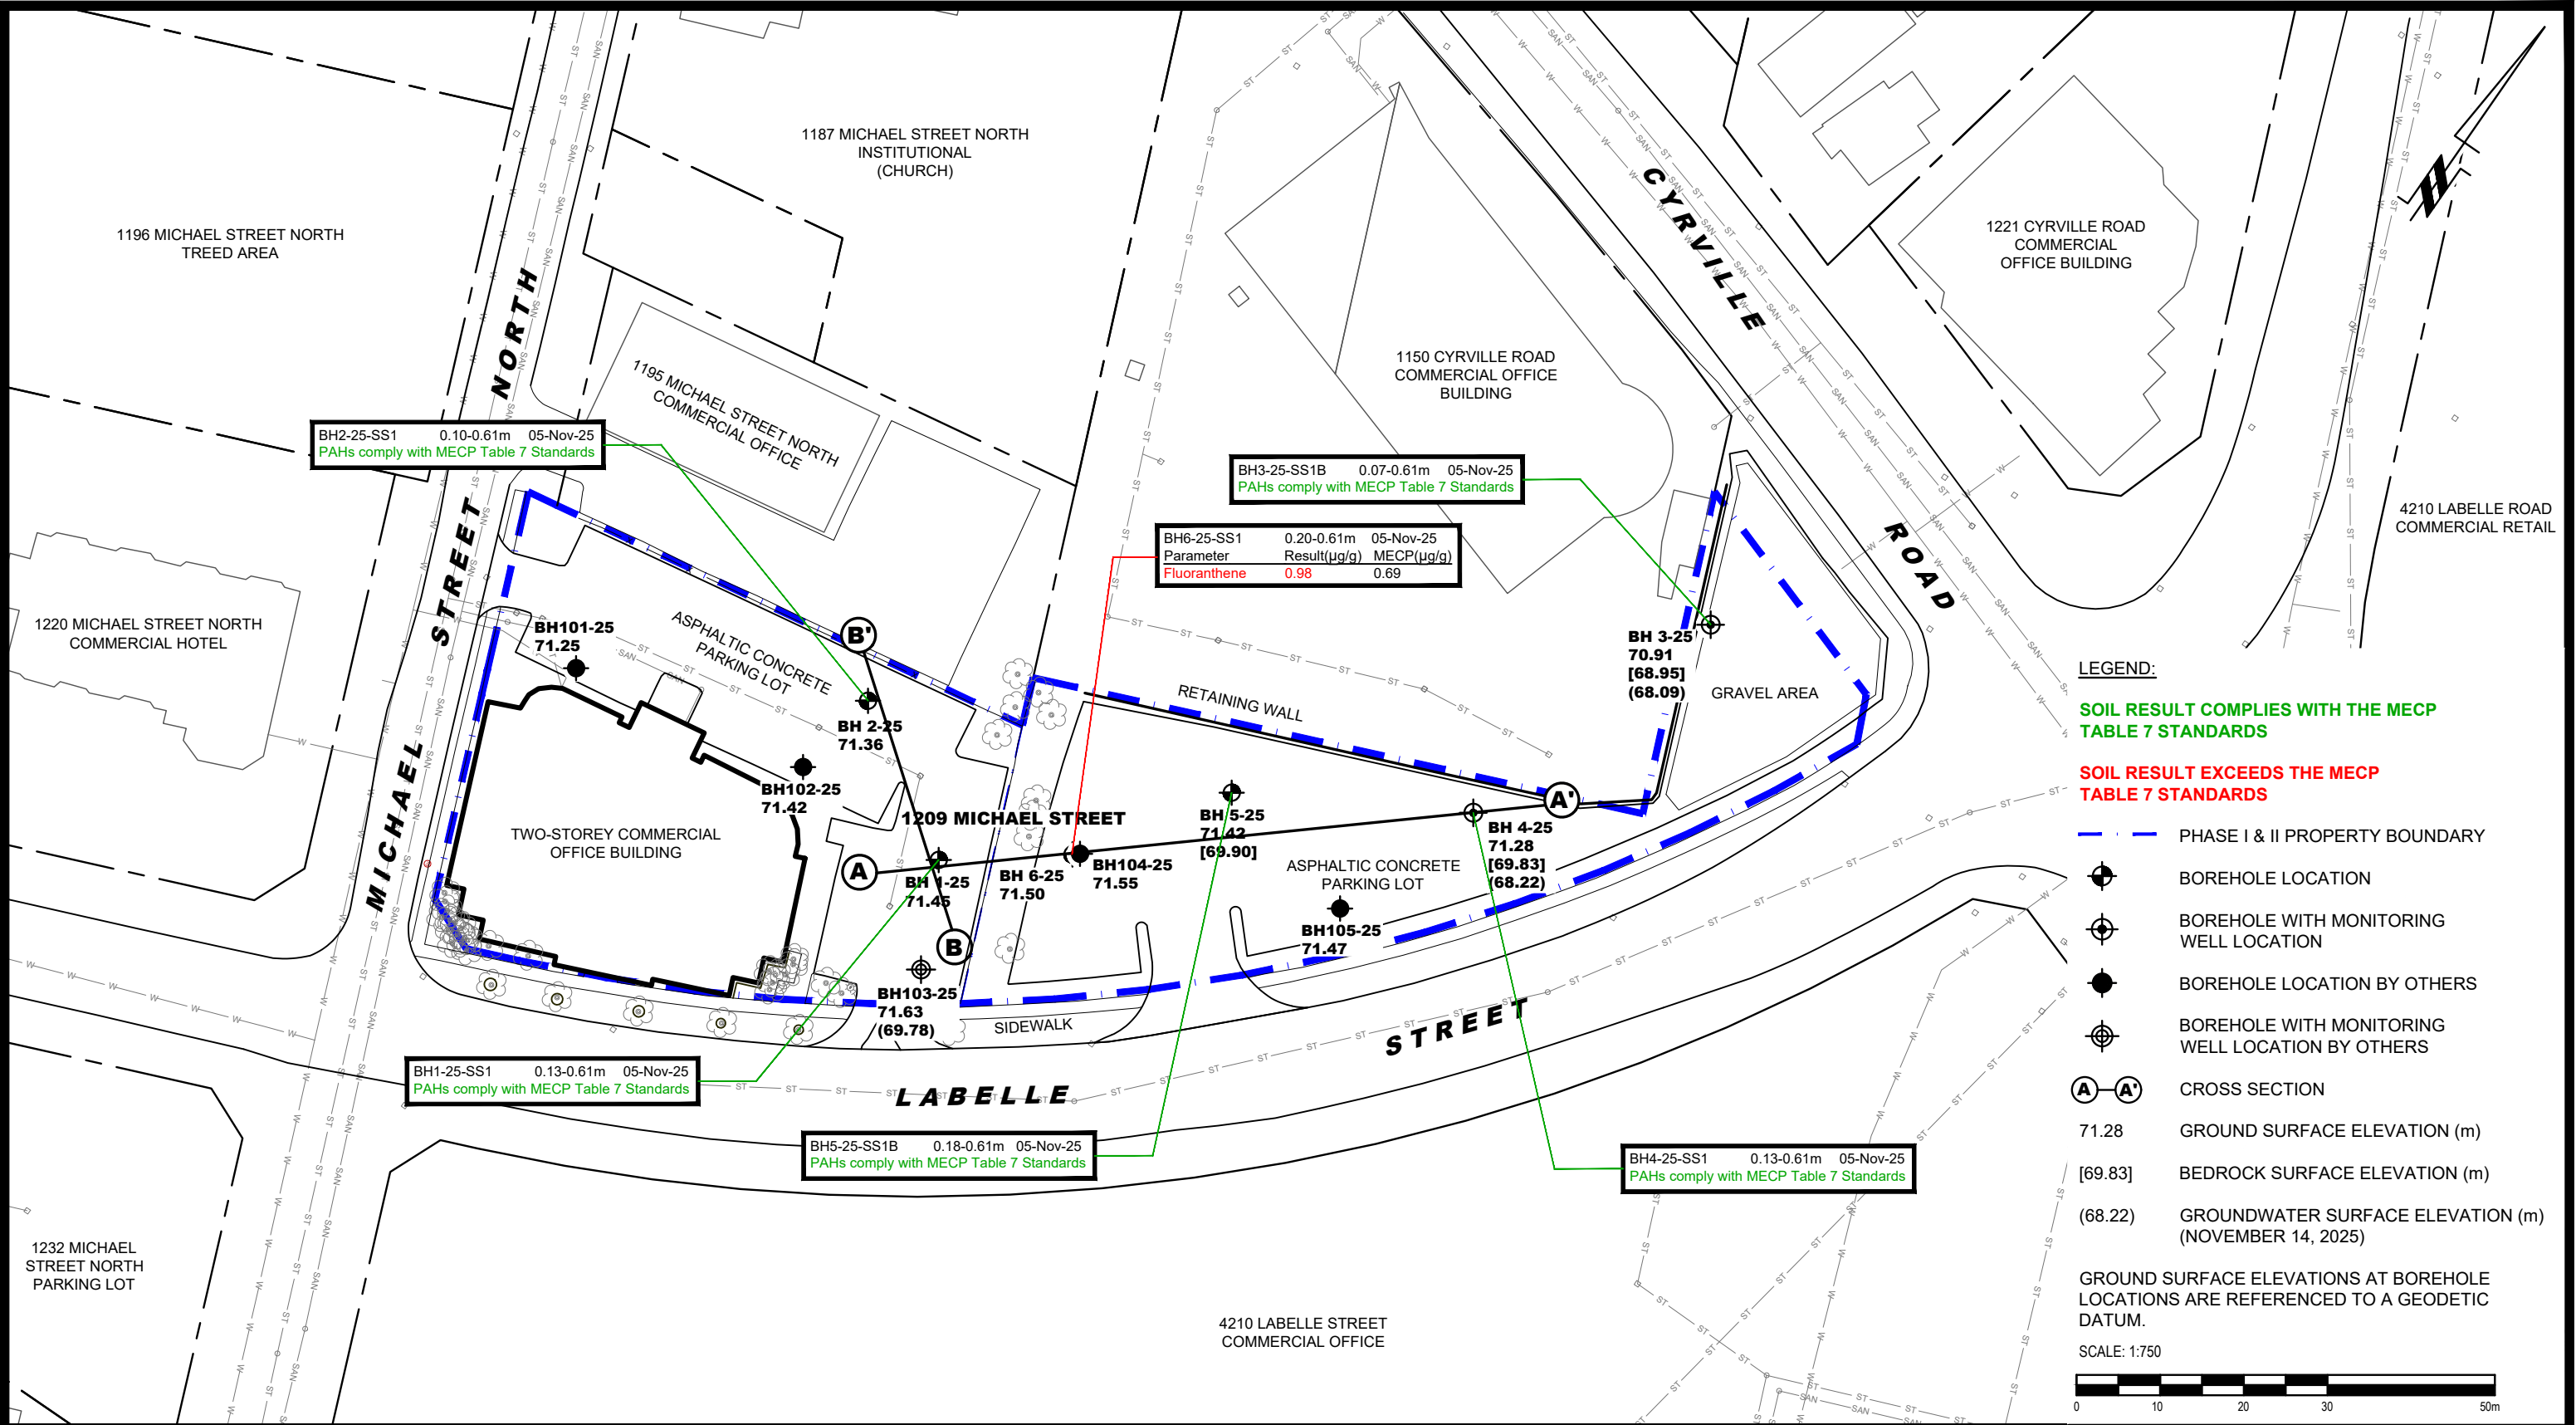
- LEGEND:**
- SOIL RESULT COMPLIES WITH THE MECP TABLE 7 STANDARDS**
- SOIL RESULT EXCEEDS THE MECP TABLE 7 STANDARDS**
- PHASE I & II PROPERTY BOUNDARY
  - BOREHOLE LOCATION
  - BOREHOLE WITH MONITORING WELL LOCATION
  - BOREHOLE LOCATION BY OTHERS
  - BOREHOLE WITH MONITORING WELL LOCATION BY OTHERS
  - CROSS SECTION
  - 71.28 GROUND SURFACE ELEVATION (m)
  - [69.83] BEDROCK SURFACE ELEVATION (m)
  - (68.22) GROUNDWATER SURFACE ELEVATION (m) (NOVEMBER 14, 2025)
- GROUND SURFACE ELEVATIONS AT BOREHOLE LOCATIONS ARE REFERENCED TO A GEODETIC DATUM.
- SCALE: 1:750

Based on the findings of this assessment, the fill material encountered beneath the surficial layer of asphalt at BH1-25 and BH2-25, located within the western parking lot, as well as at BH6-25, located within the eastern parking lot, is contaminated with metals (barium) and PAHs (fluoranthene). As the Phase II Property is to be redeveloped in the future, it is our recommendation that the contaminated soil be remediated in conjunction with site excavation activities. At such a time, the contaminated soil will be excavated from the site and transported to a licensed waste disposal facility.

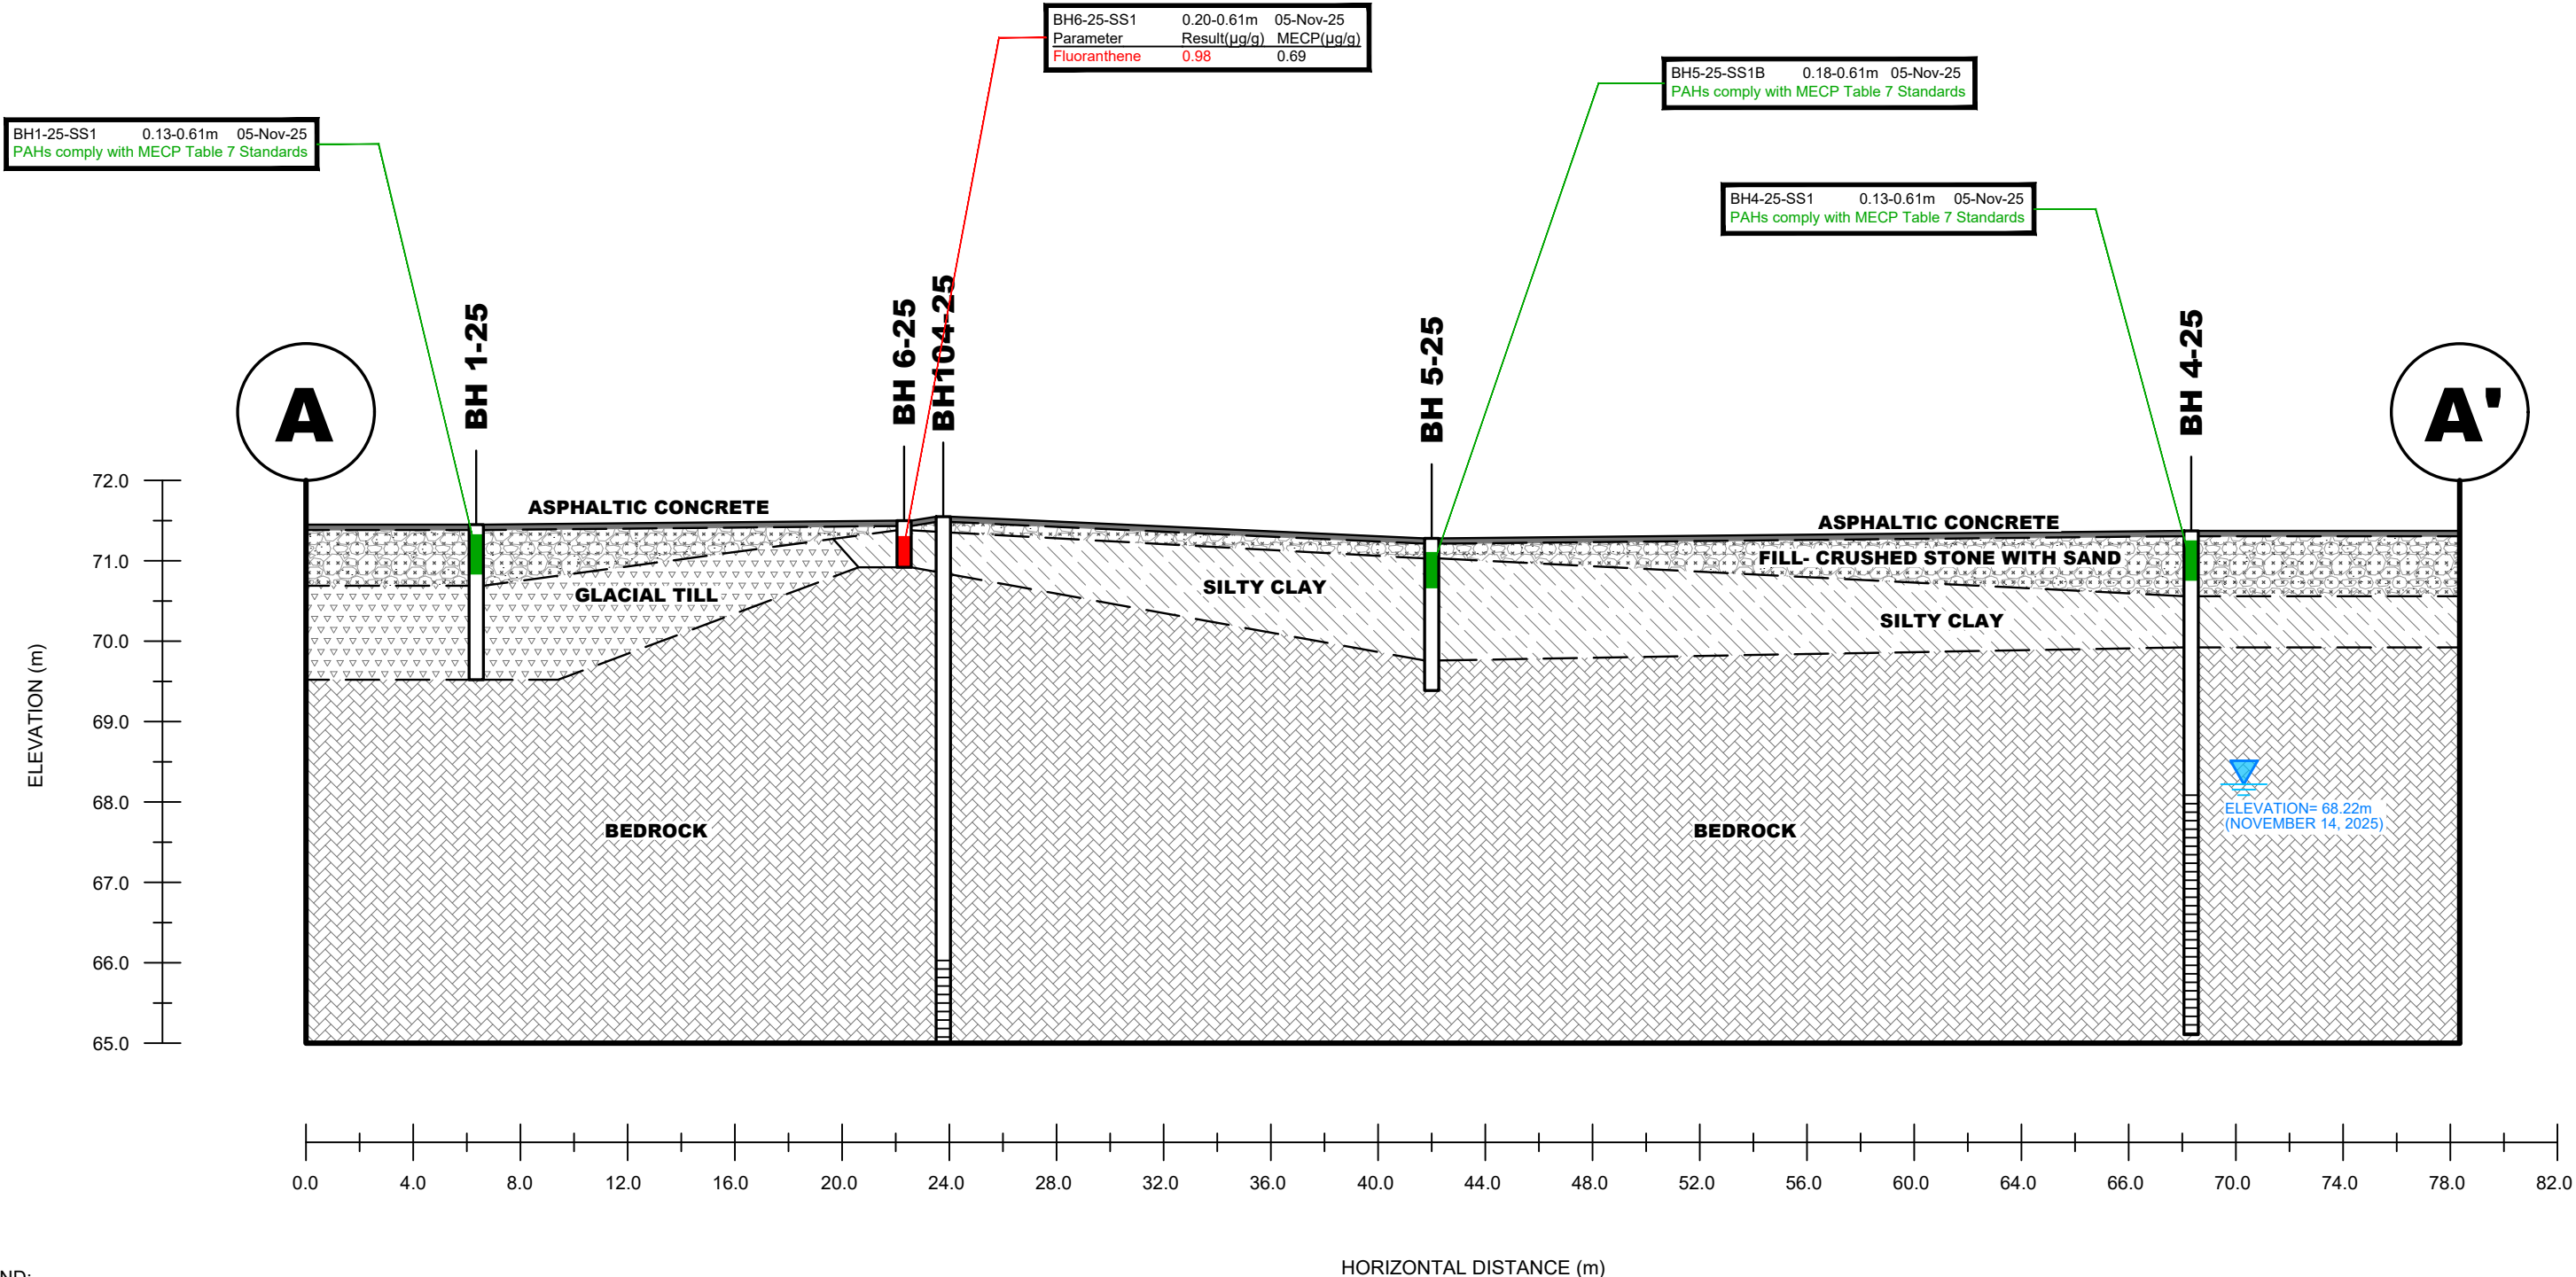
| Checked by: NS | Dwg. No.: PE7253-4A |

LEGEND:

SOIL RESULT COMPLIES WITH THE MECP TABLE 7 STANDARDS

SOIL RESULT EXCEEDS THE MECP TABLE 7 STANDARDS

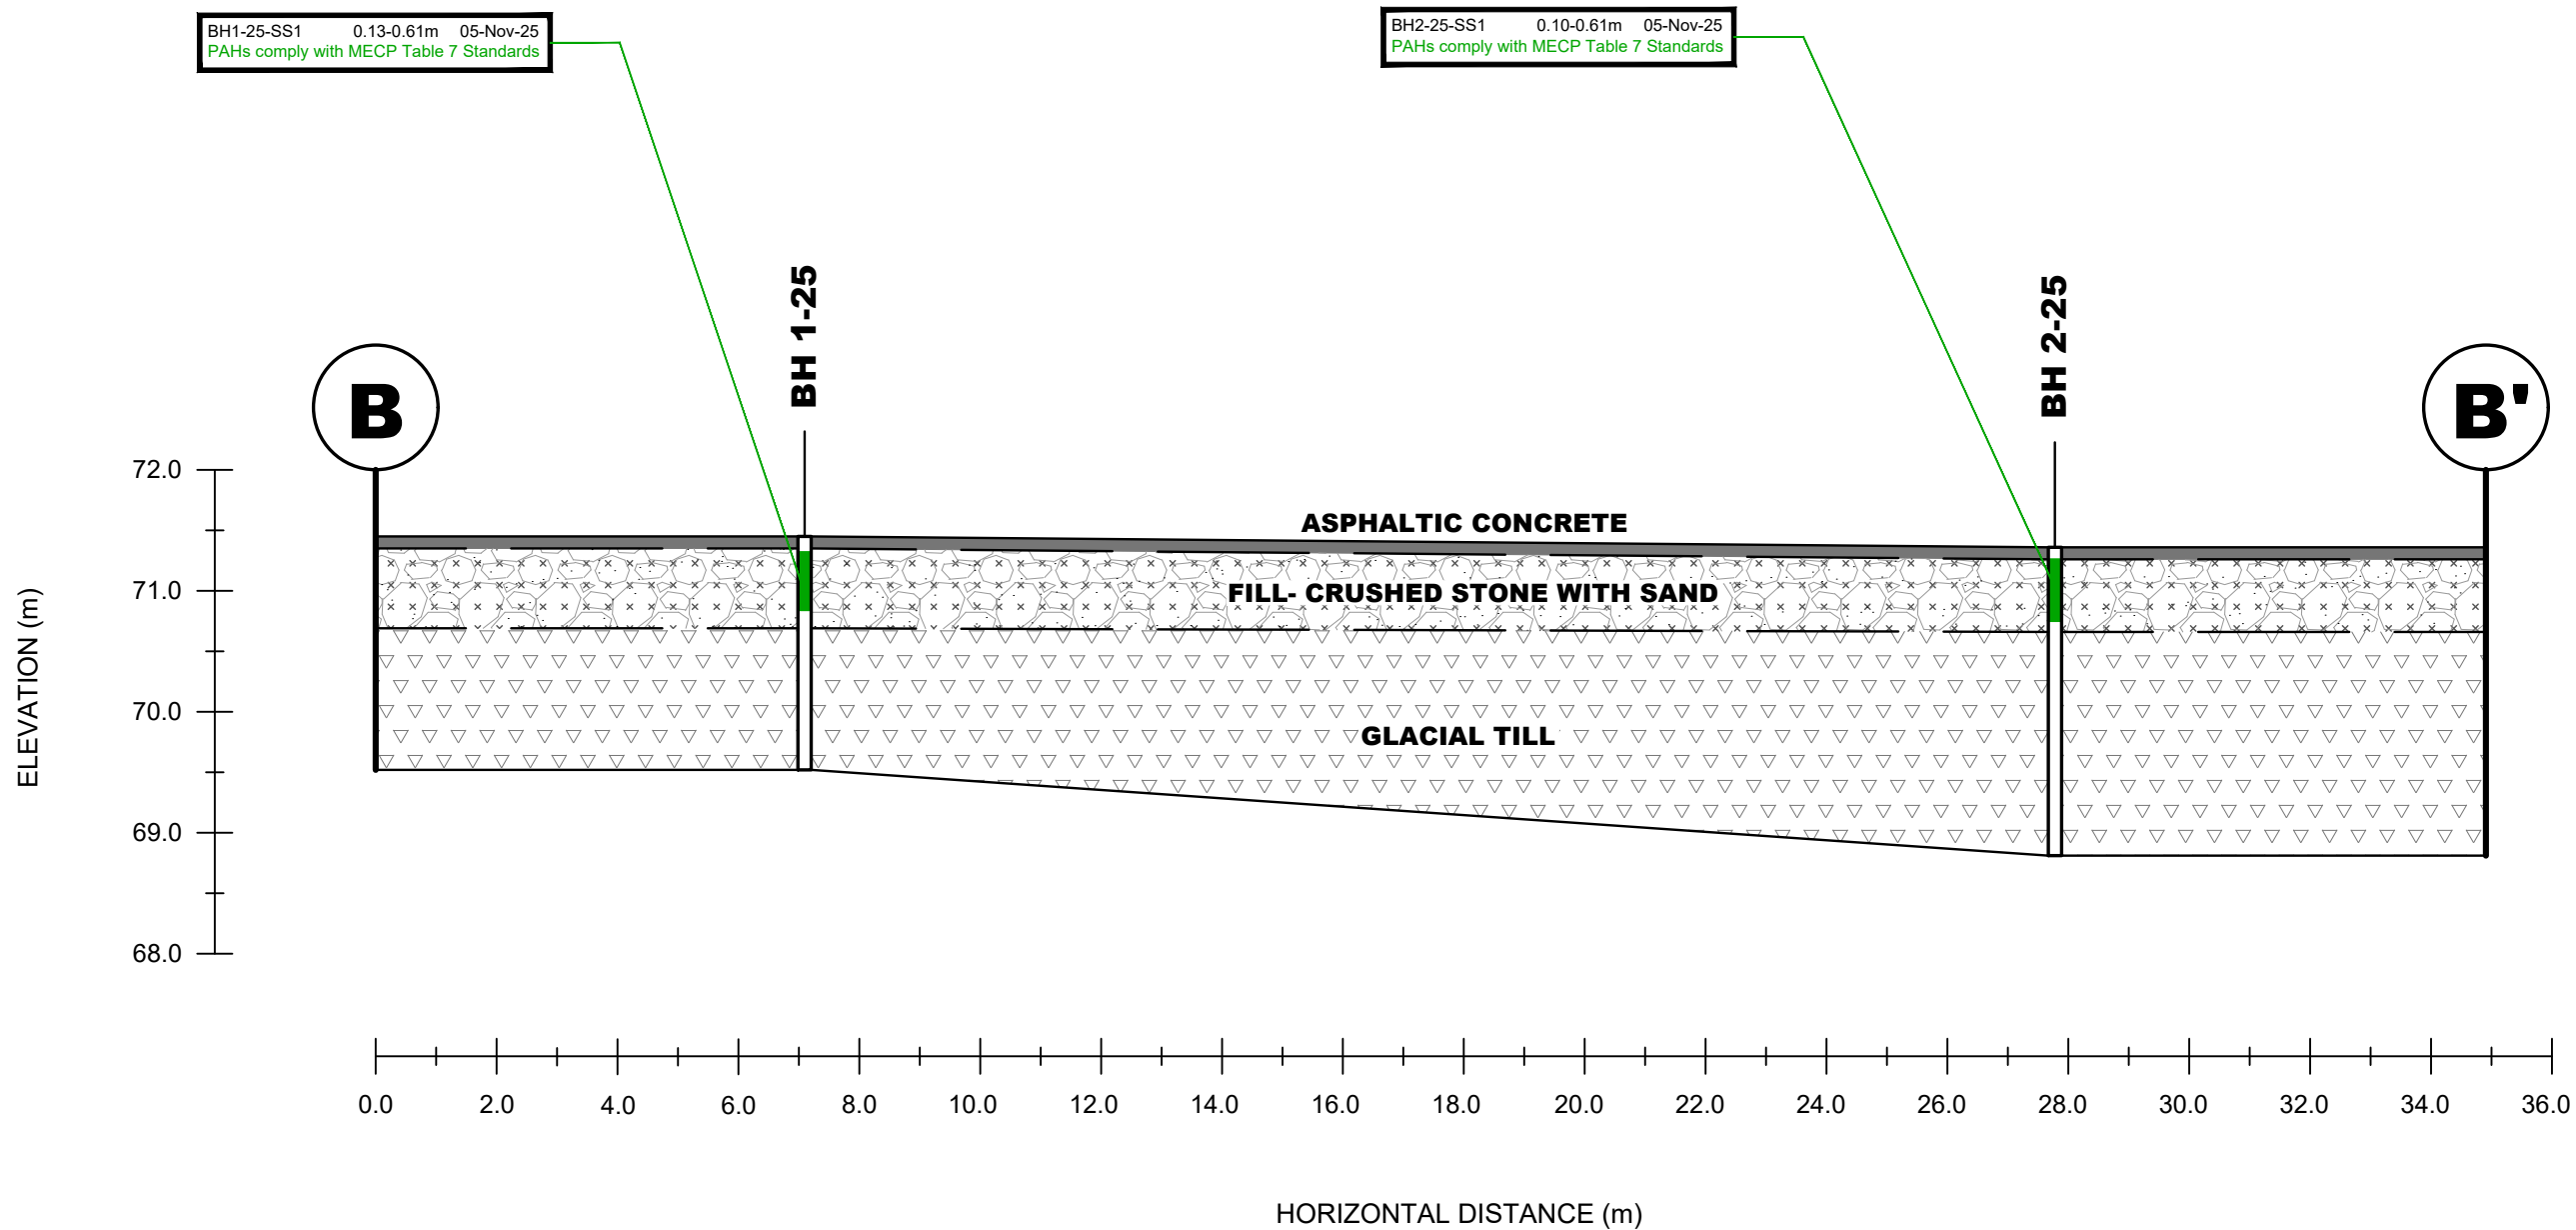
| Checked by: | NS | Dwg. No.: | PE7253-4B |

LEGEND:

SOIL RESULT COMPLIES WITH THE MECP  
TABLE 7 STANDARDS

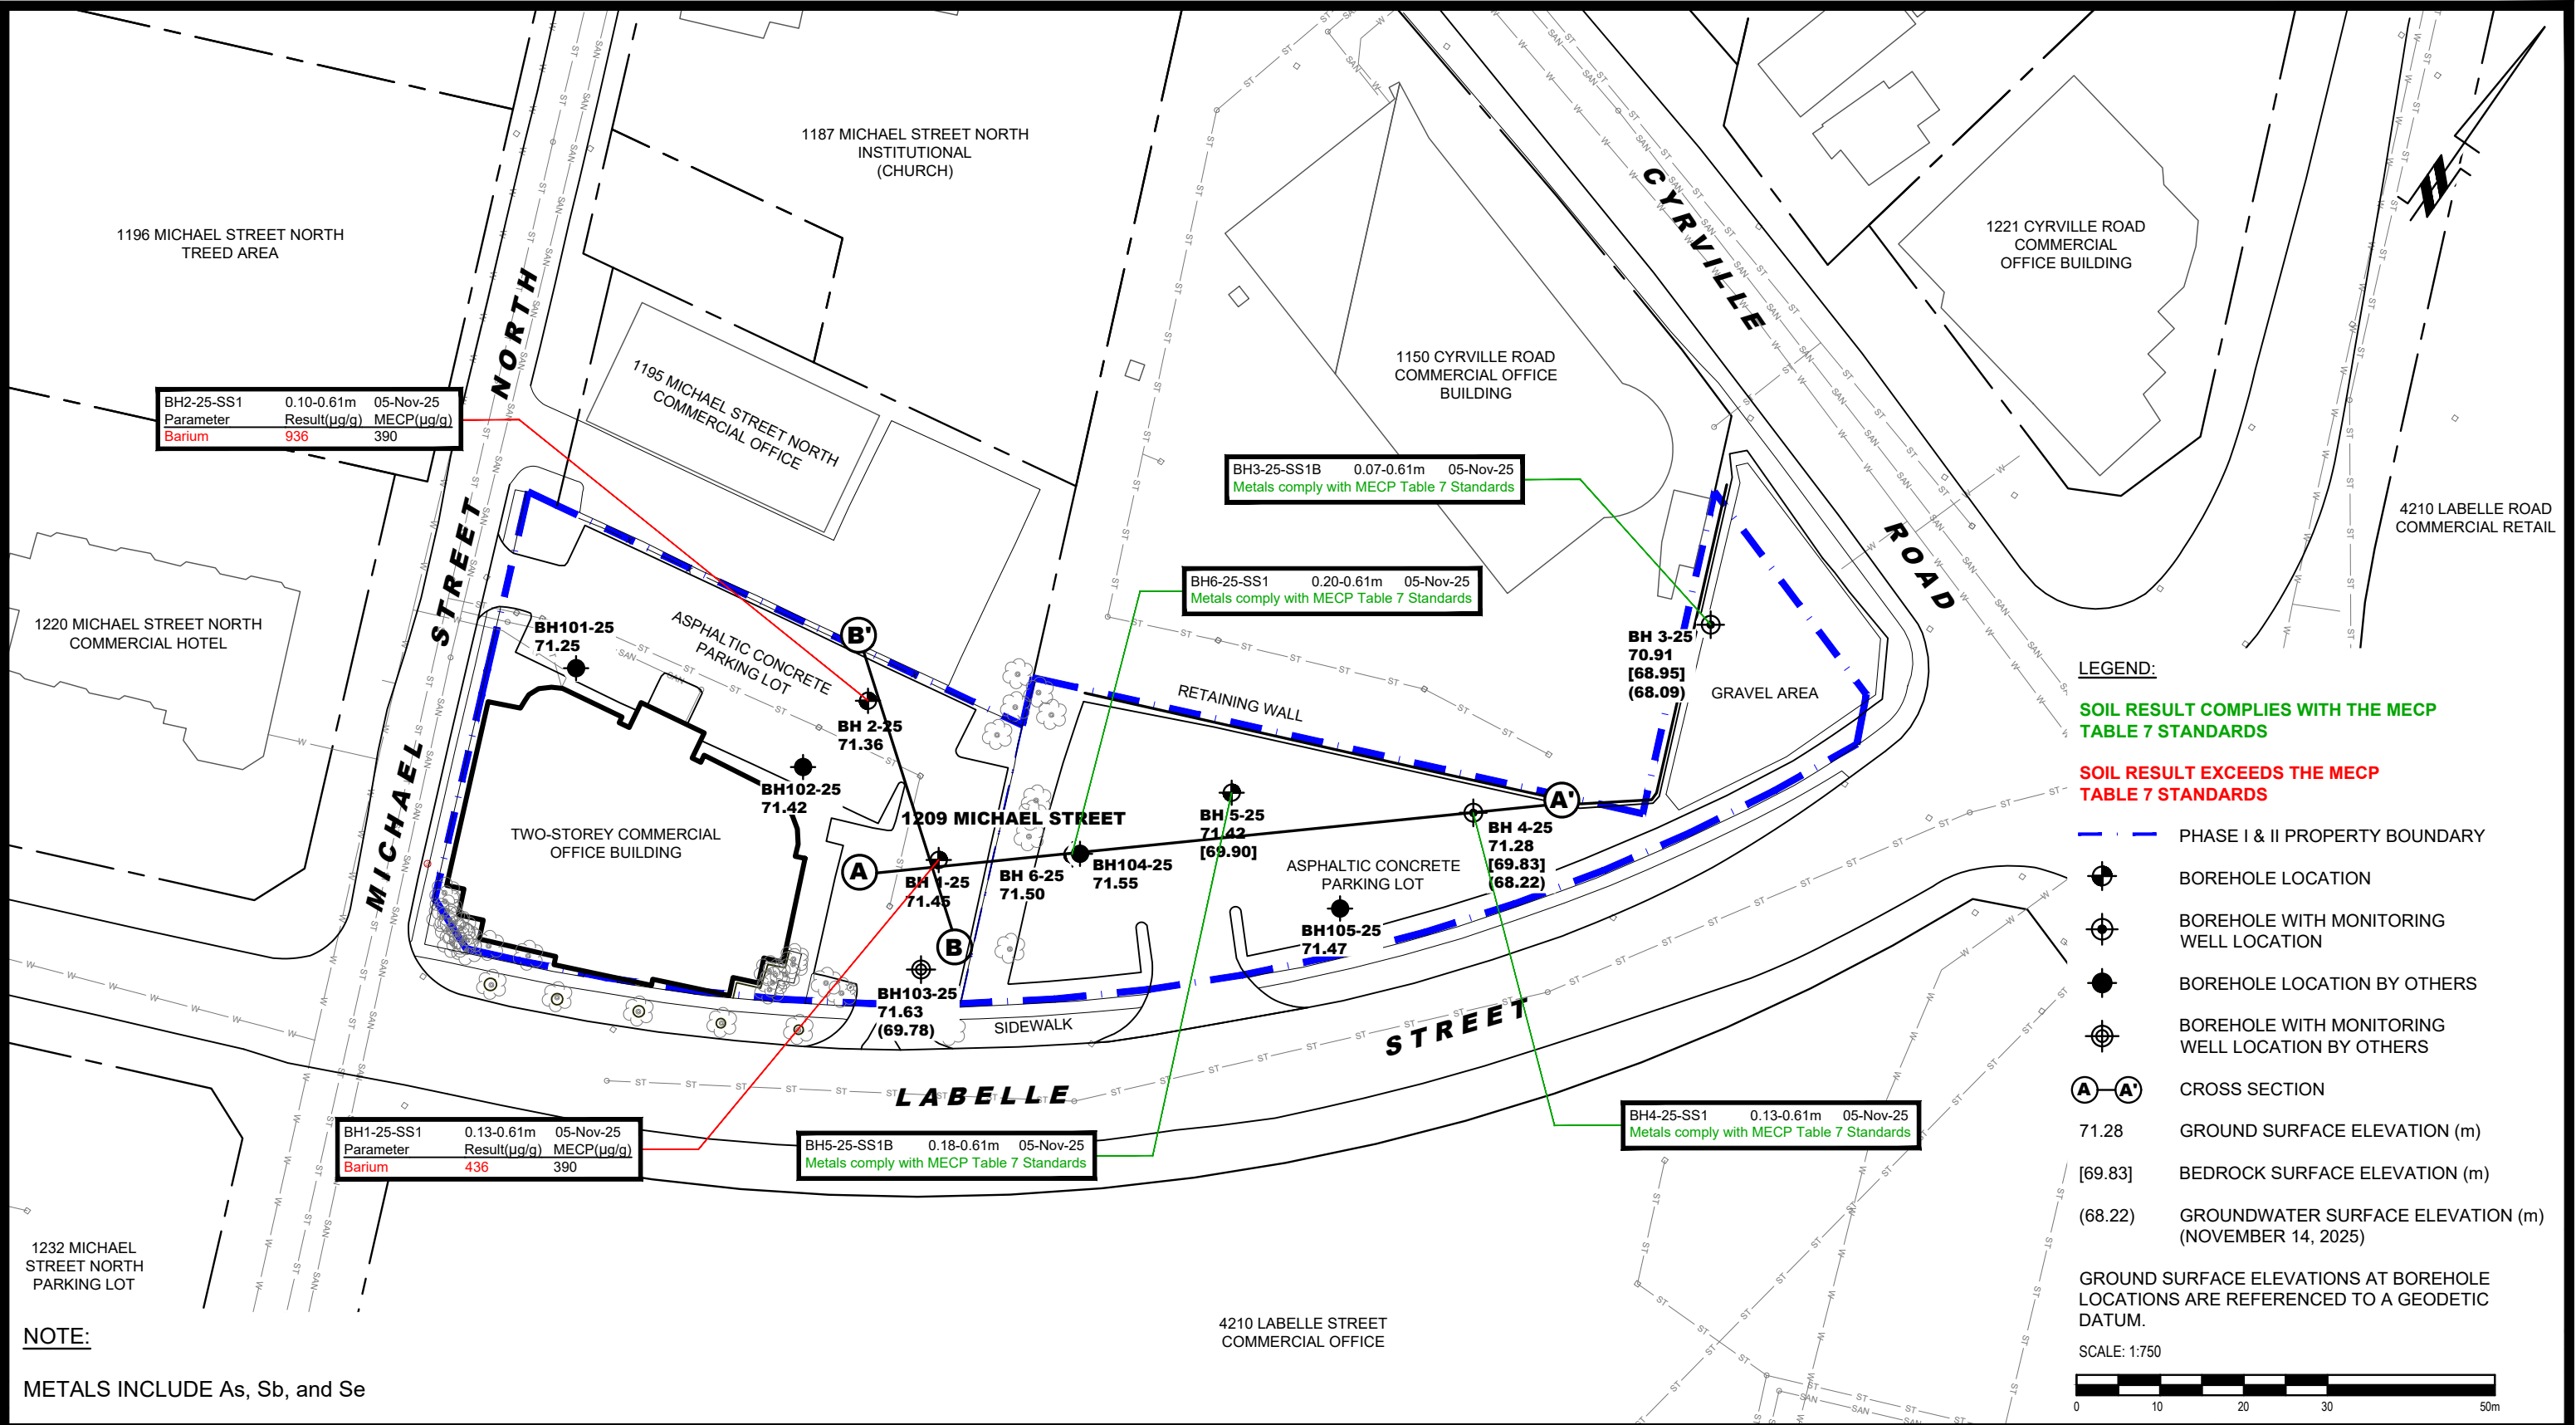
| Checked by: | NS | Dwg. No.: | <b>PE7253-5</b> |

**NOTE:**  
METALS INCLUDE As, Sb, and Se

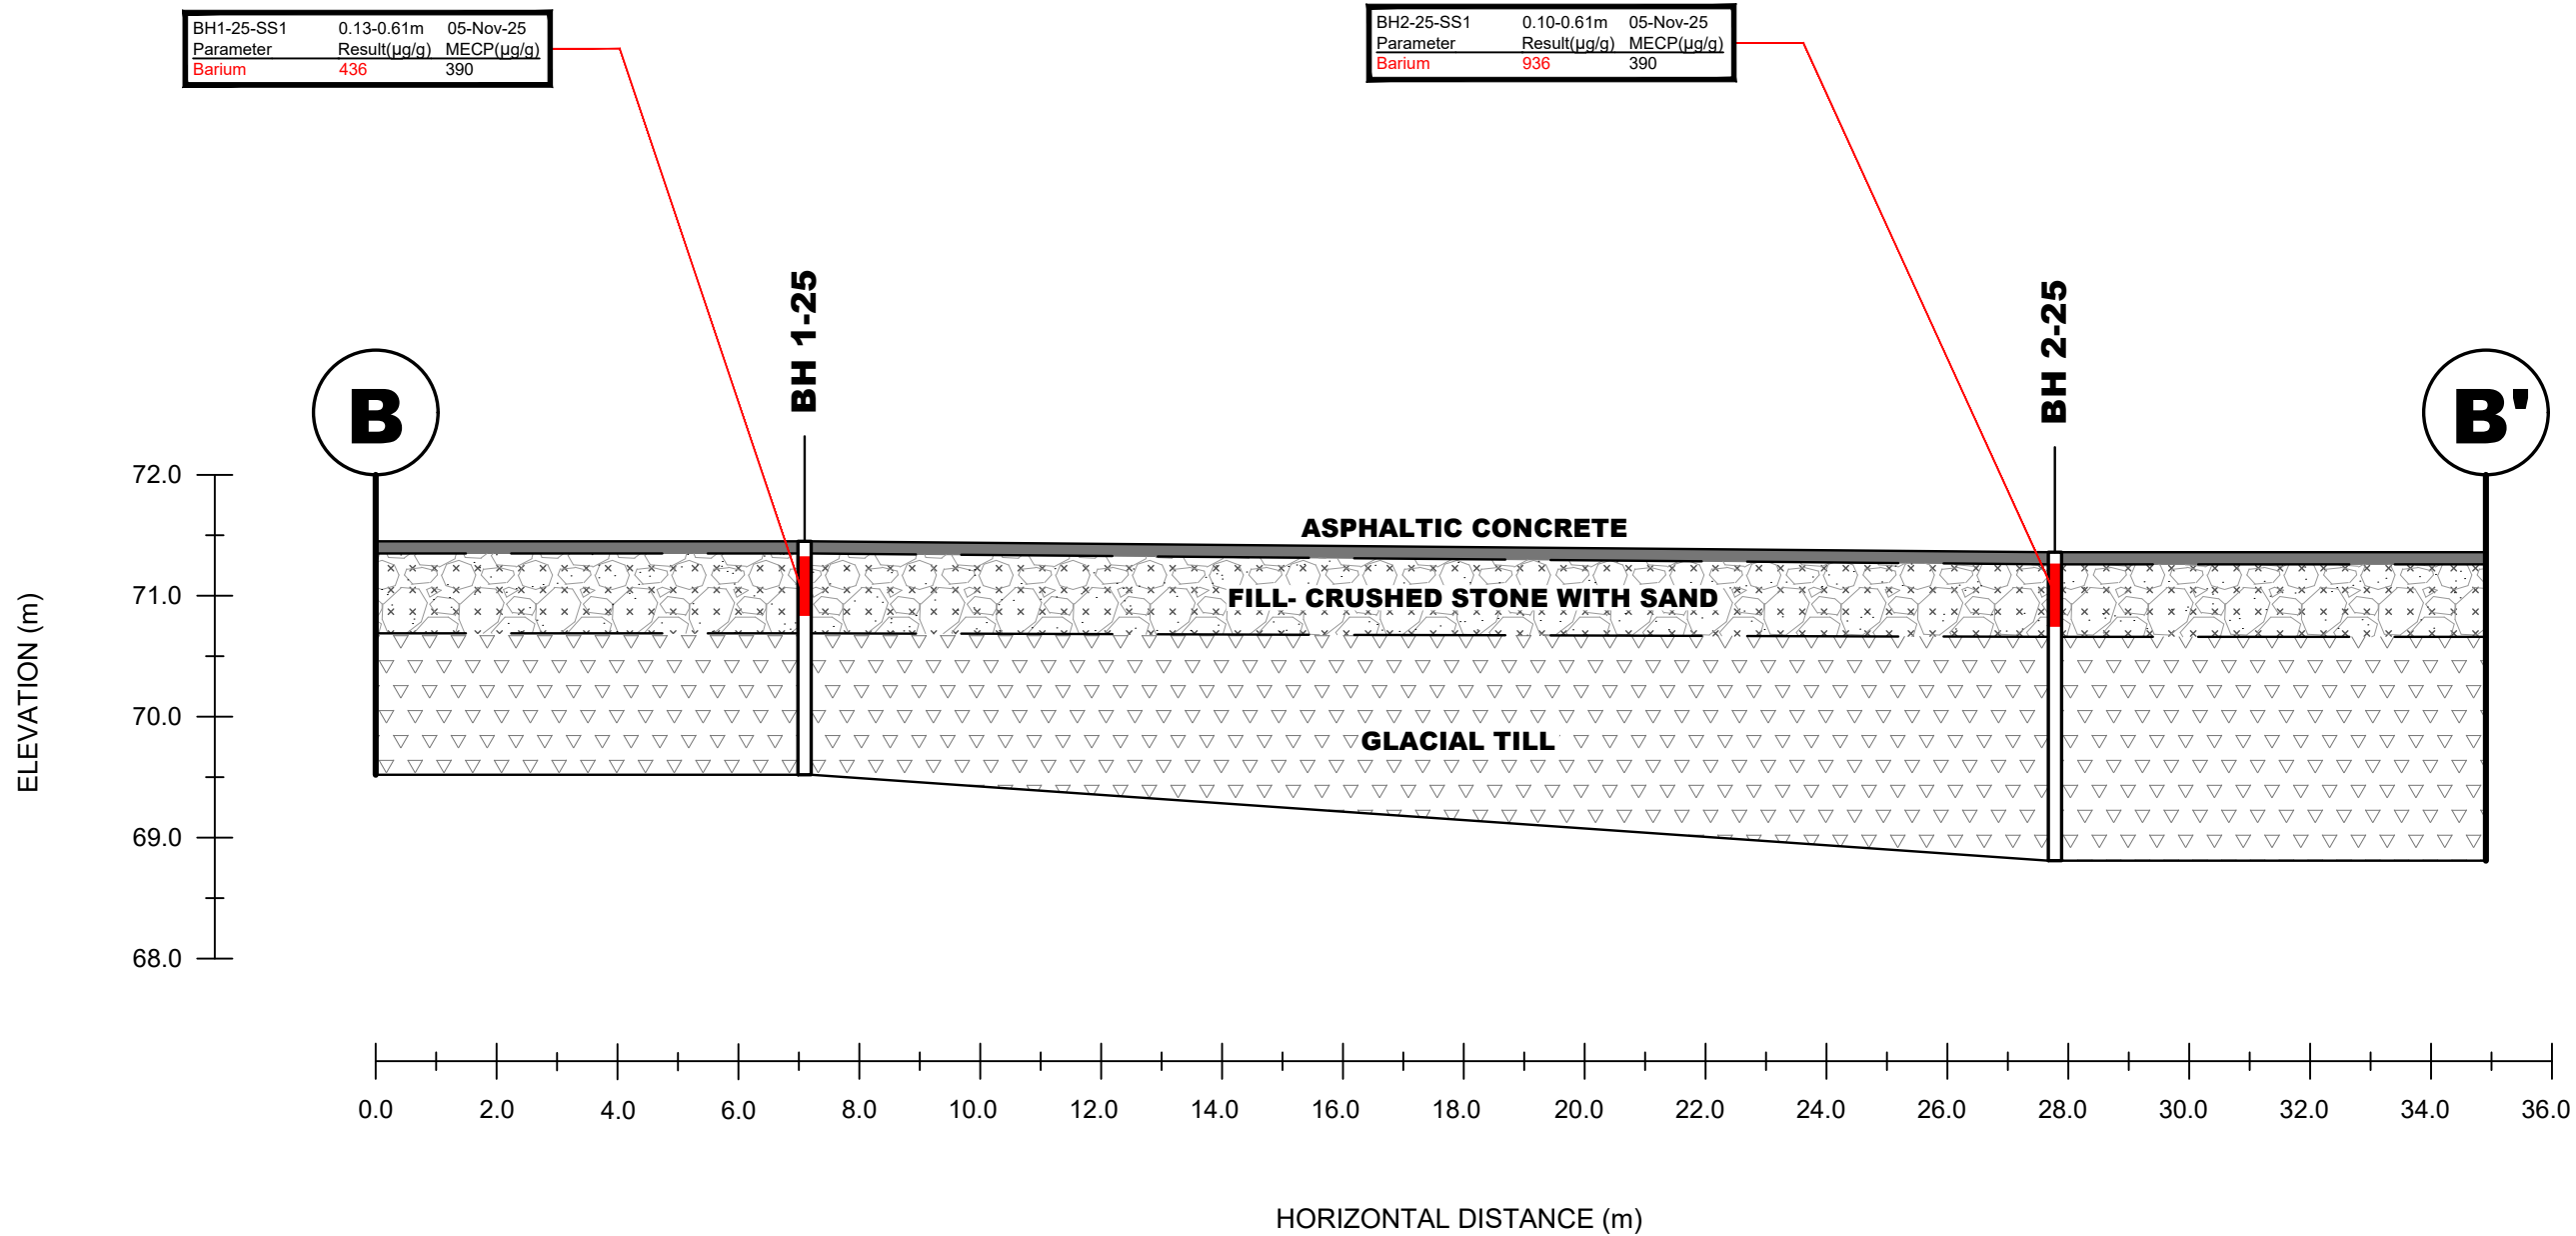
| Checked by: | NS | Dwg. No.: | PE7253-5B |

LEGEND:

SOIL RESULT COMPLIES WITH THE MECP  
TABLE 7 STANDARDS

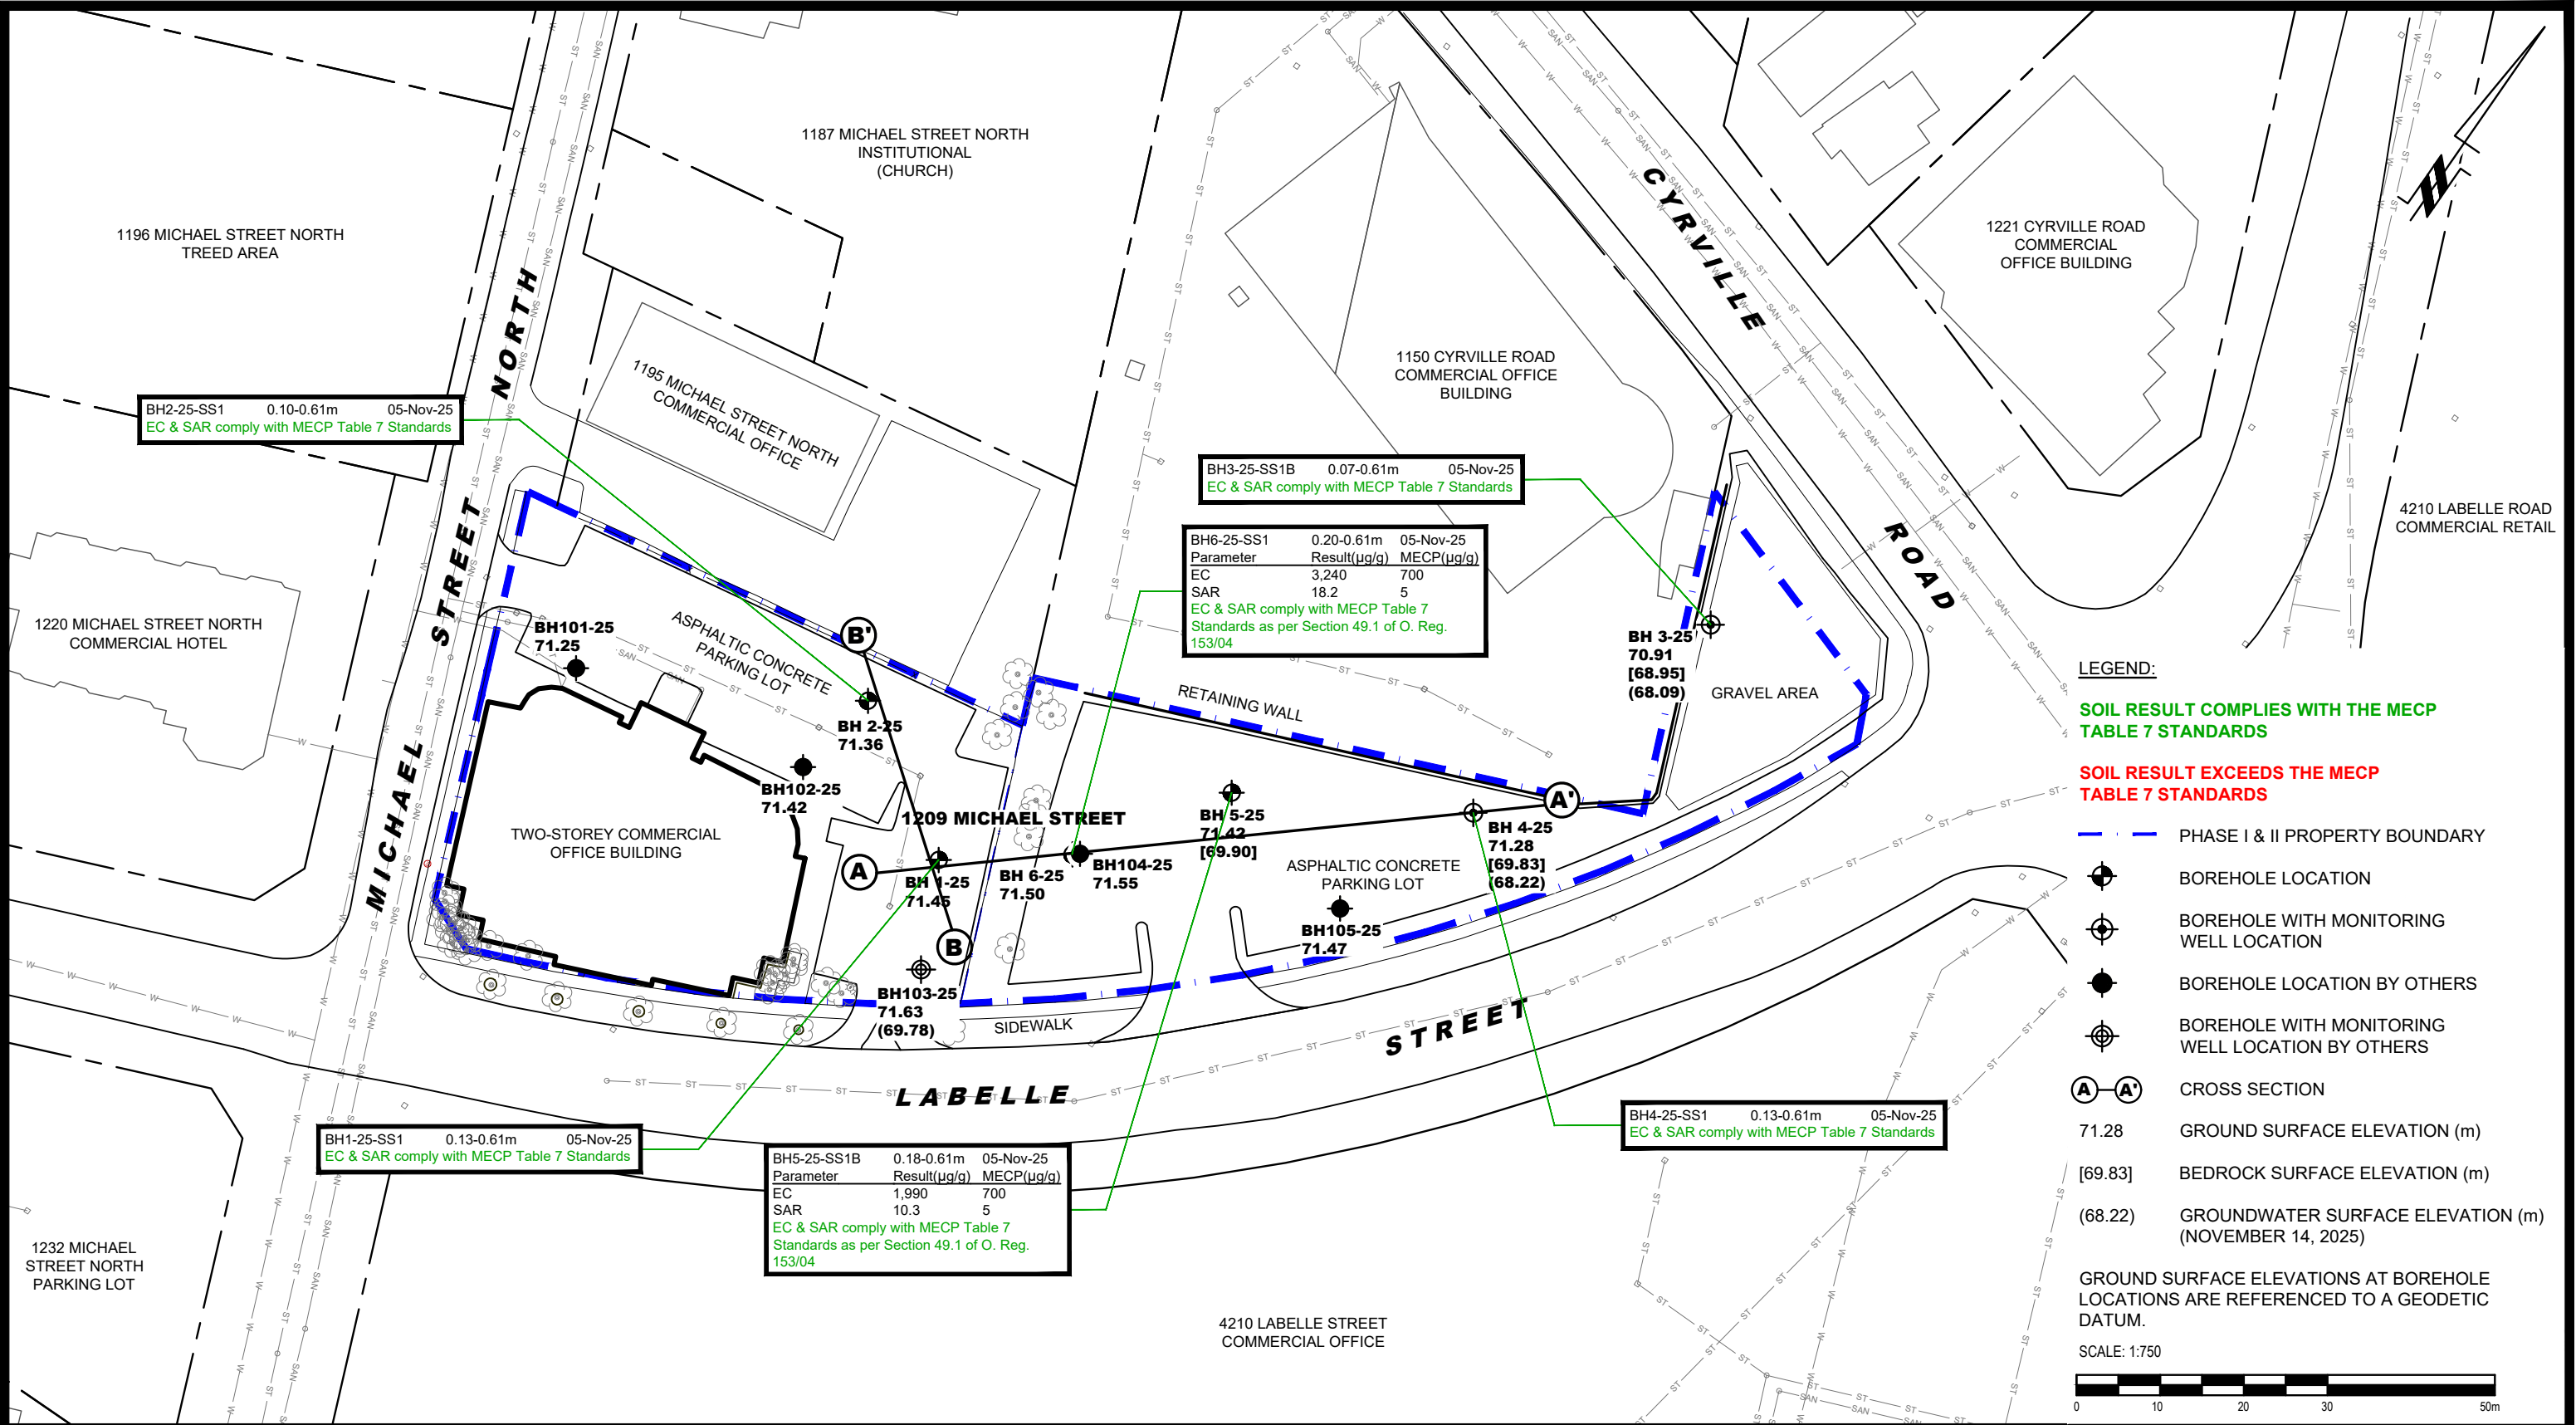
- LEGEND:**
- SOIL RESULT COMPLIES WITH THE MECP TABLE 7 STANDARDS**
- SOIL RESULT EXCEEDS THE MECP TABLE 7 STANDARDS**
- PHASE I & II PROPERTY BOUNDARY
  - BOREHOLE LOCATION
  - ⊕ BOREHOLE WITH MONITORING WELL LOCATION
  - BOREHOLE LOCATION BY OTHERS
  - ⊕ BOREHOLE WITH MONITORING WELL LOCATION BY OTHERS
  - Ⓐ-Ⓐ' CROSS SECTION
  - 71.28 GROUND SURFACE ELEVATION (m)
  - [69.83] BEDROCK SURFACE ELEVATION (m)
  - (68.22) GROUNDWATER SURFACE ELEVATION (m) (NOVEMBER 14, 2025)
- GROUND SURFACE ELEVATIONS AT BOREHOLE LOCATIONS ARE REFERENCED TO A GEODETIC DATUM.
- SCALE: 1:750

| BH4-25-SS1 | 0.13-0.61m | 05-Nov-25 |
| EC & SAR comply with MECP Table 7 Standards | | |

The EC and SAR levels detected in Samples BH5-25-SS1B and BH6-25-SS1 are in excess of the selected MECP Table 7 Coarse-Grained Residential Soil Standards. These elevated EC and SAR levels detected at boreholes BH5-25 and BH6-25 are suspected to be the result of the application of road salt on the Phase II Property during snow and ice conditions and thus, as per Section 49.1 of O. Reg 153/04, does not represent a contaminant issue.
