## **Phase II – Environmental Site Assessment**

1209 Michael Street North  
Ottawa, Ontario

Prepared for Inside Edge Properties

Report: PE7253-2  
January 22, 2026

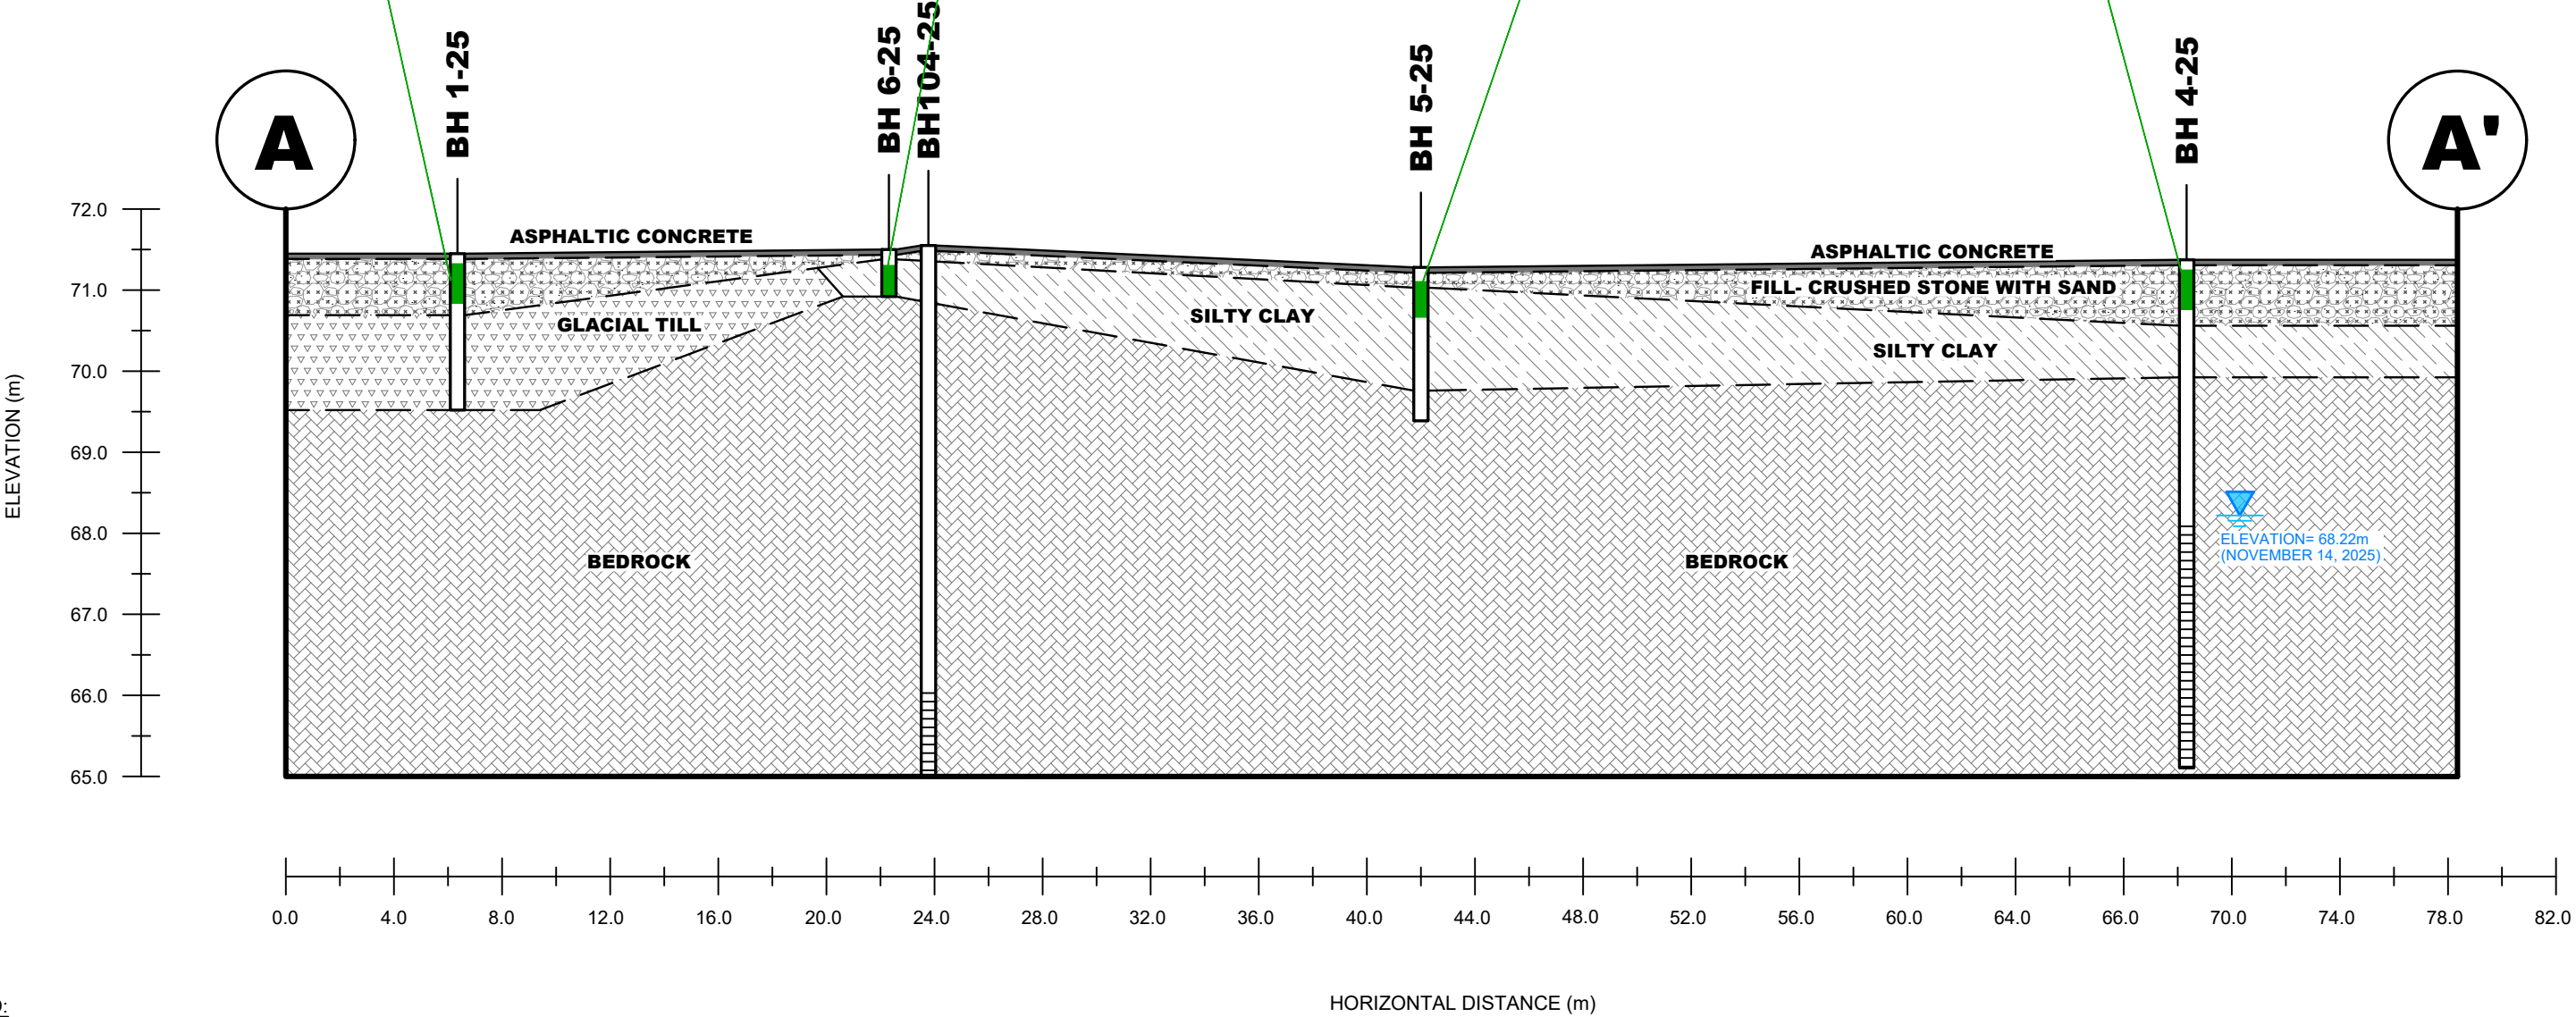
| Checked by: | NS | Dwg. No.: | PE7253-6A |

LEGEND:

SOIL RESULT COMPLIES WITH THE MECP  
TABLE 7 STANDARDS

SOIL RESULT EXCEEDS THE MECP  
TABLE 7 STANDARDS

The EC and SAR levels detected in Samples BH5-25-SS1B and BH6-25-SS1 are in excess of the selected MECP Table 7 Coarse-Grained Residential Soil Standards. These elevated EC and SAR levels detected at boreholes BH5-25 and BH6-25 are suspected to be the result of the application of road salt on the Phase II Property during snow and ice conditions and thus, as per Section 49.1 of O. Reg 153/04, does not represent a contaminant issue.

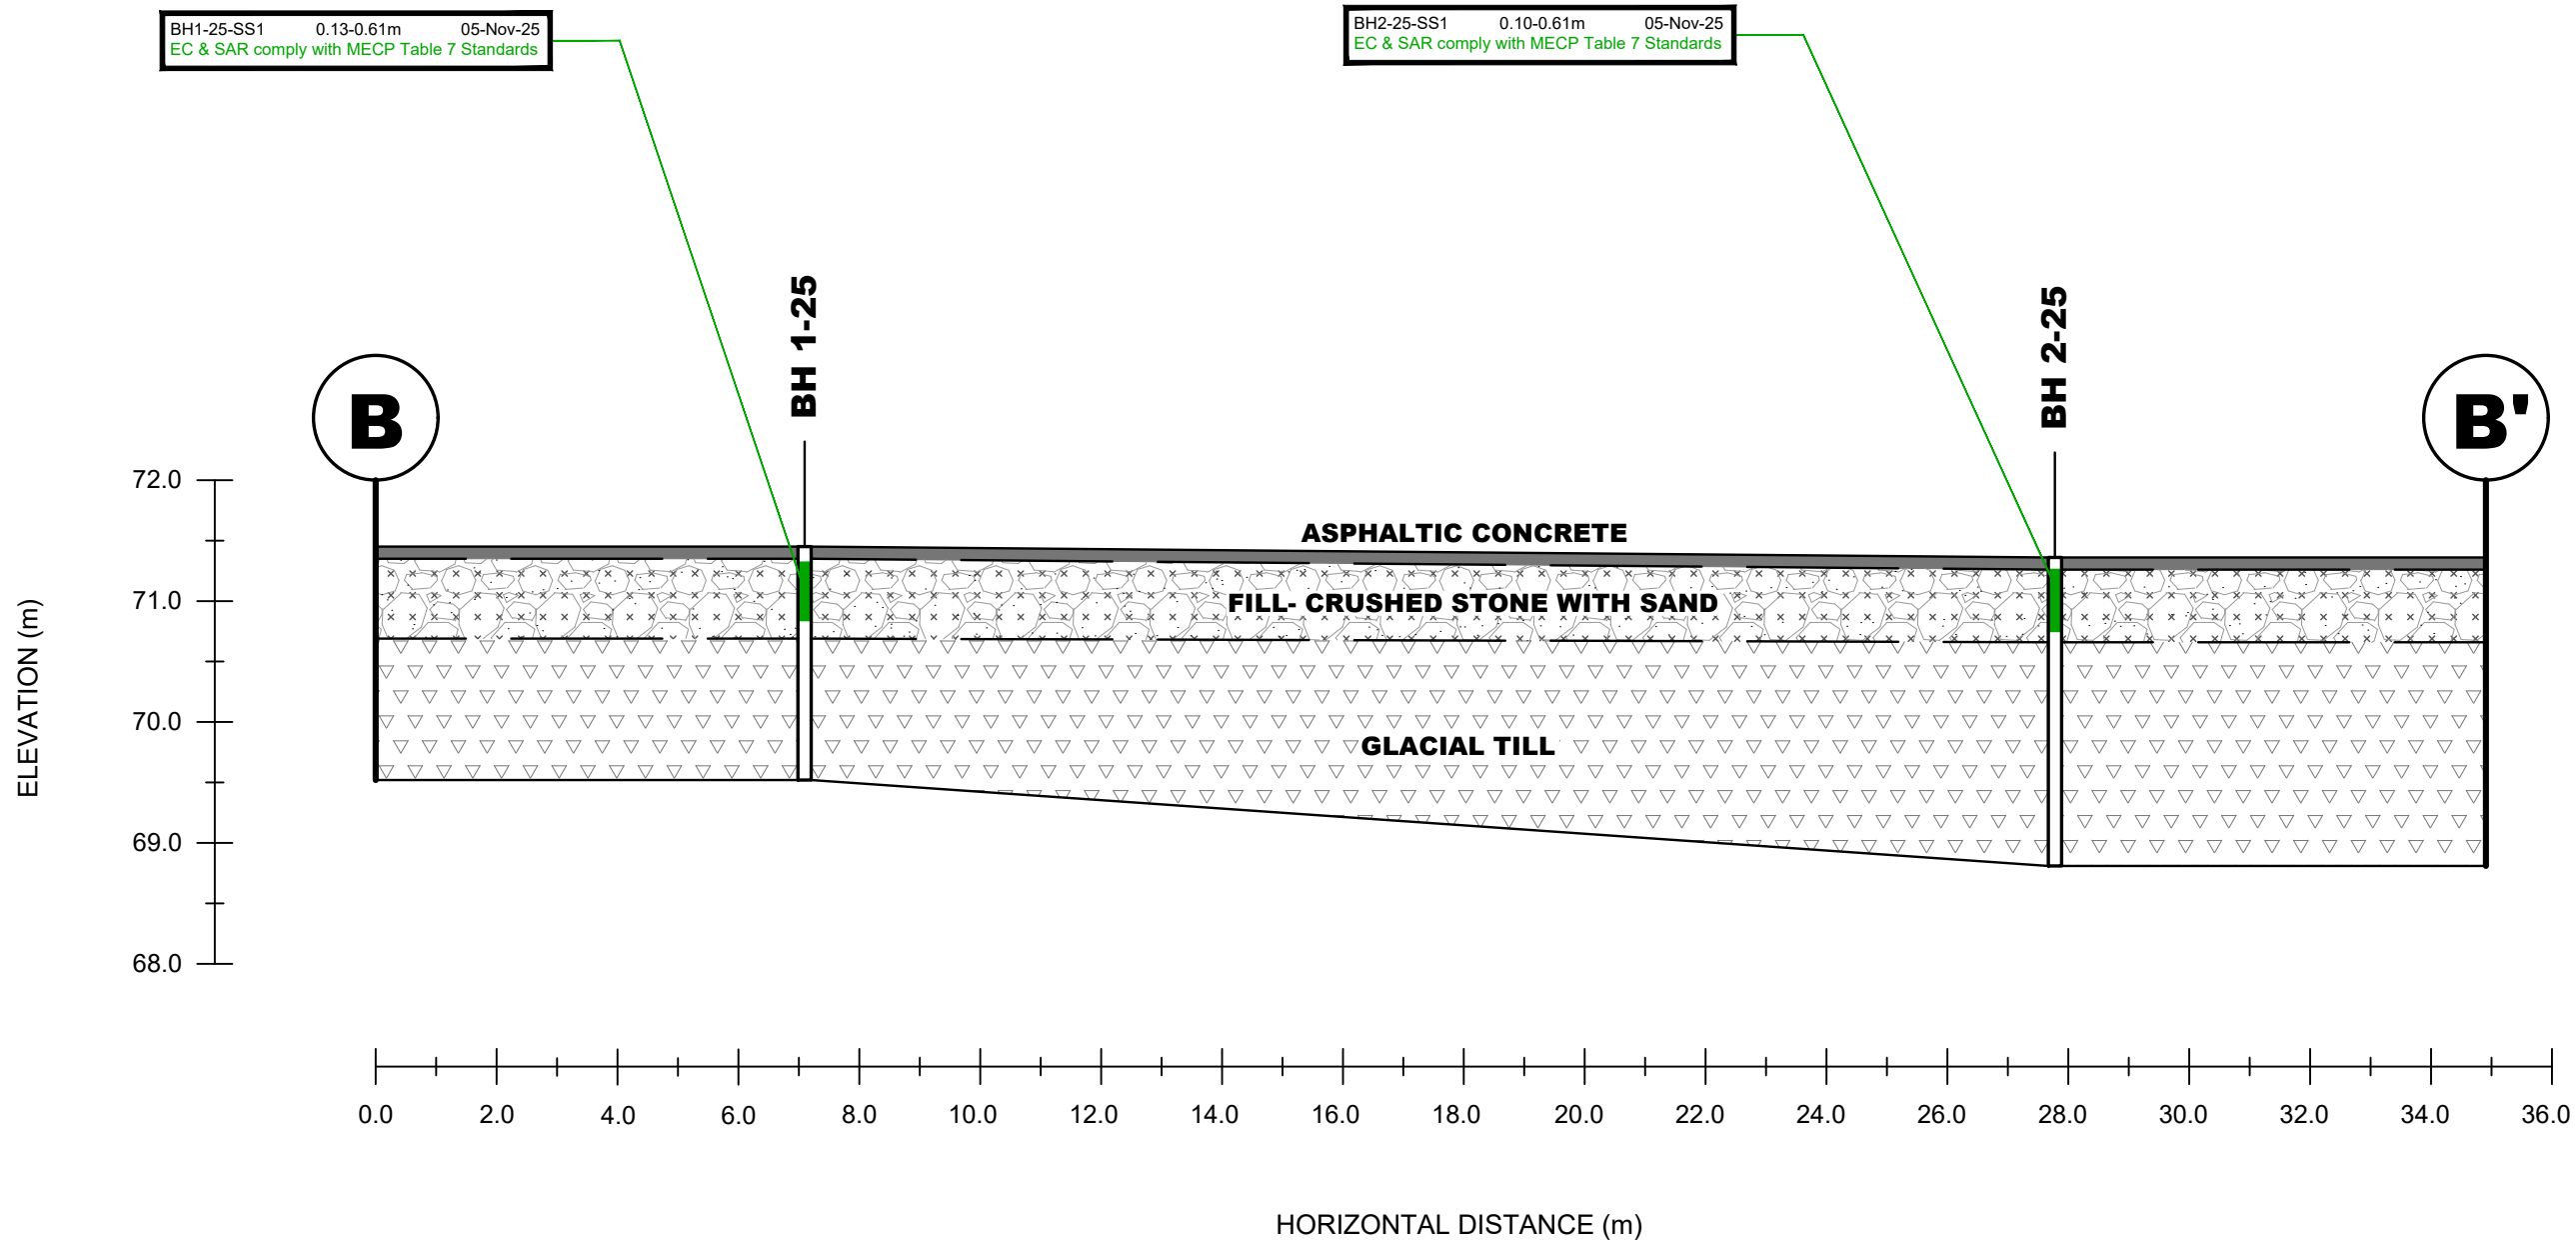
**LEGEND:**

SOIL RESULT COMPLIES WITH THE MECP  
TABLE 7 STANDARDS

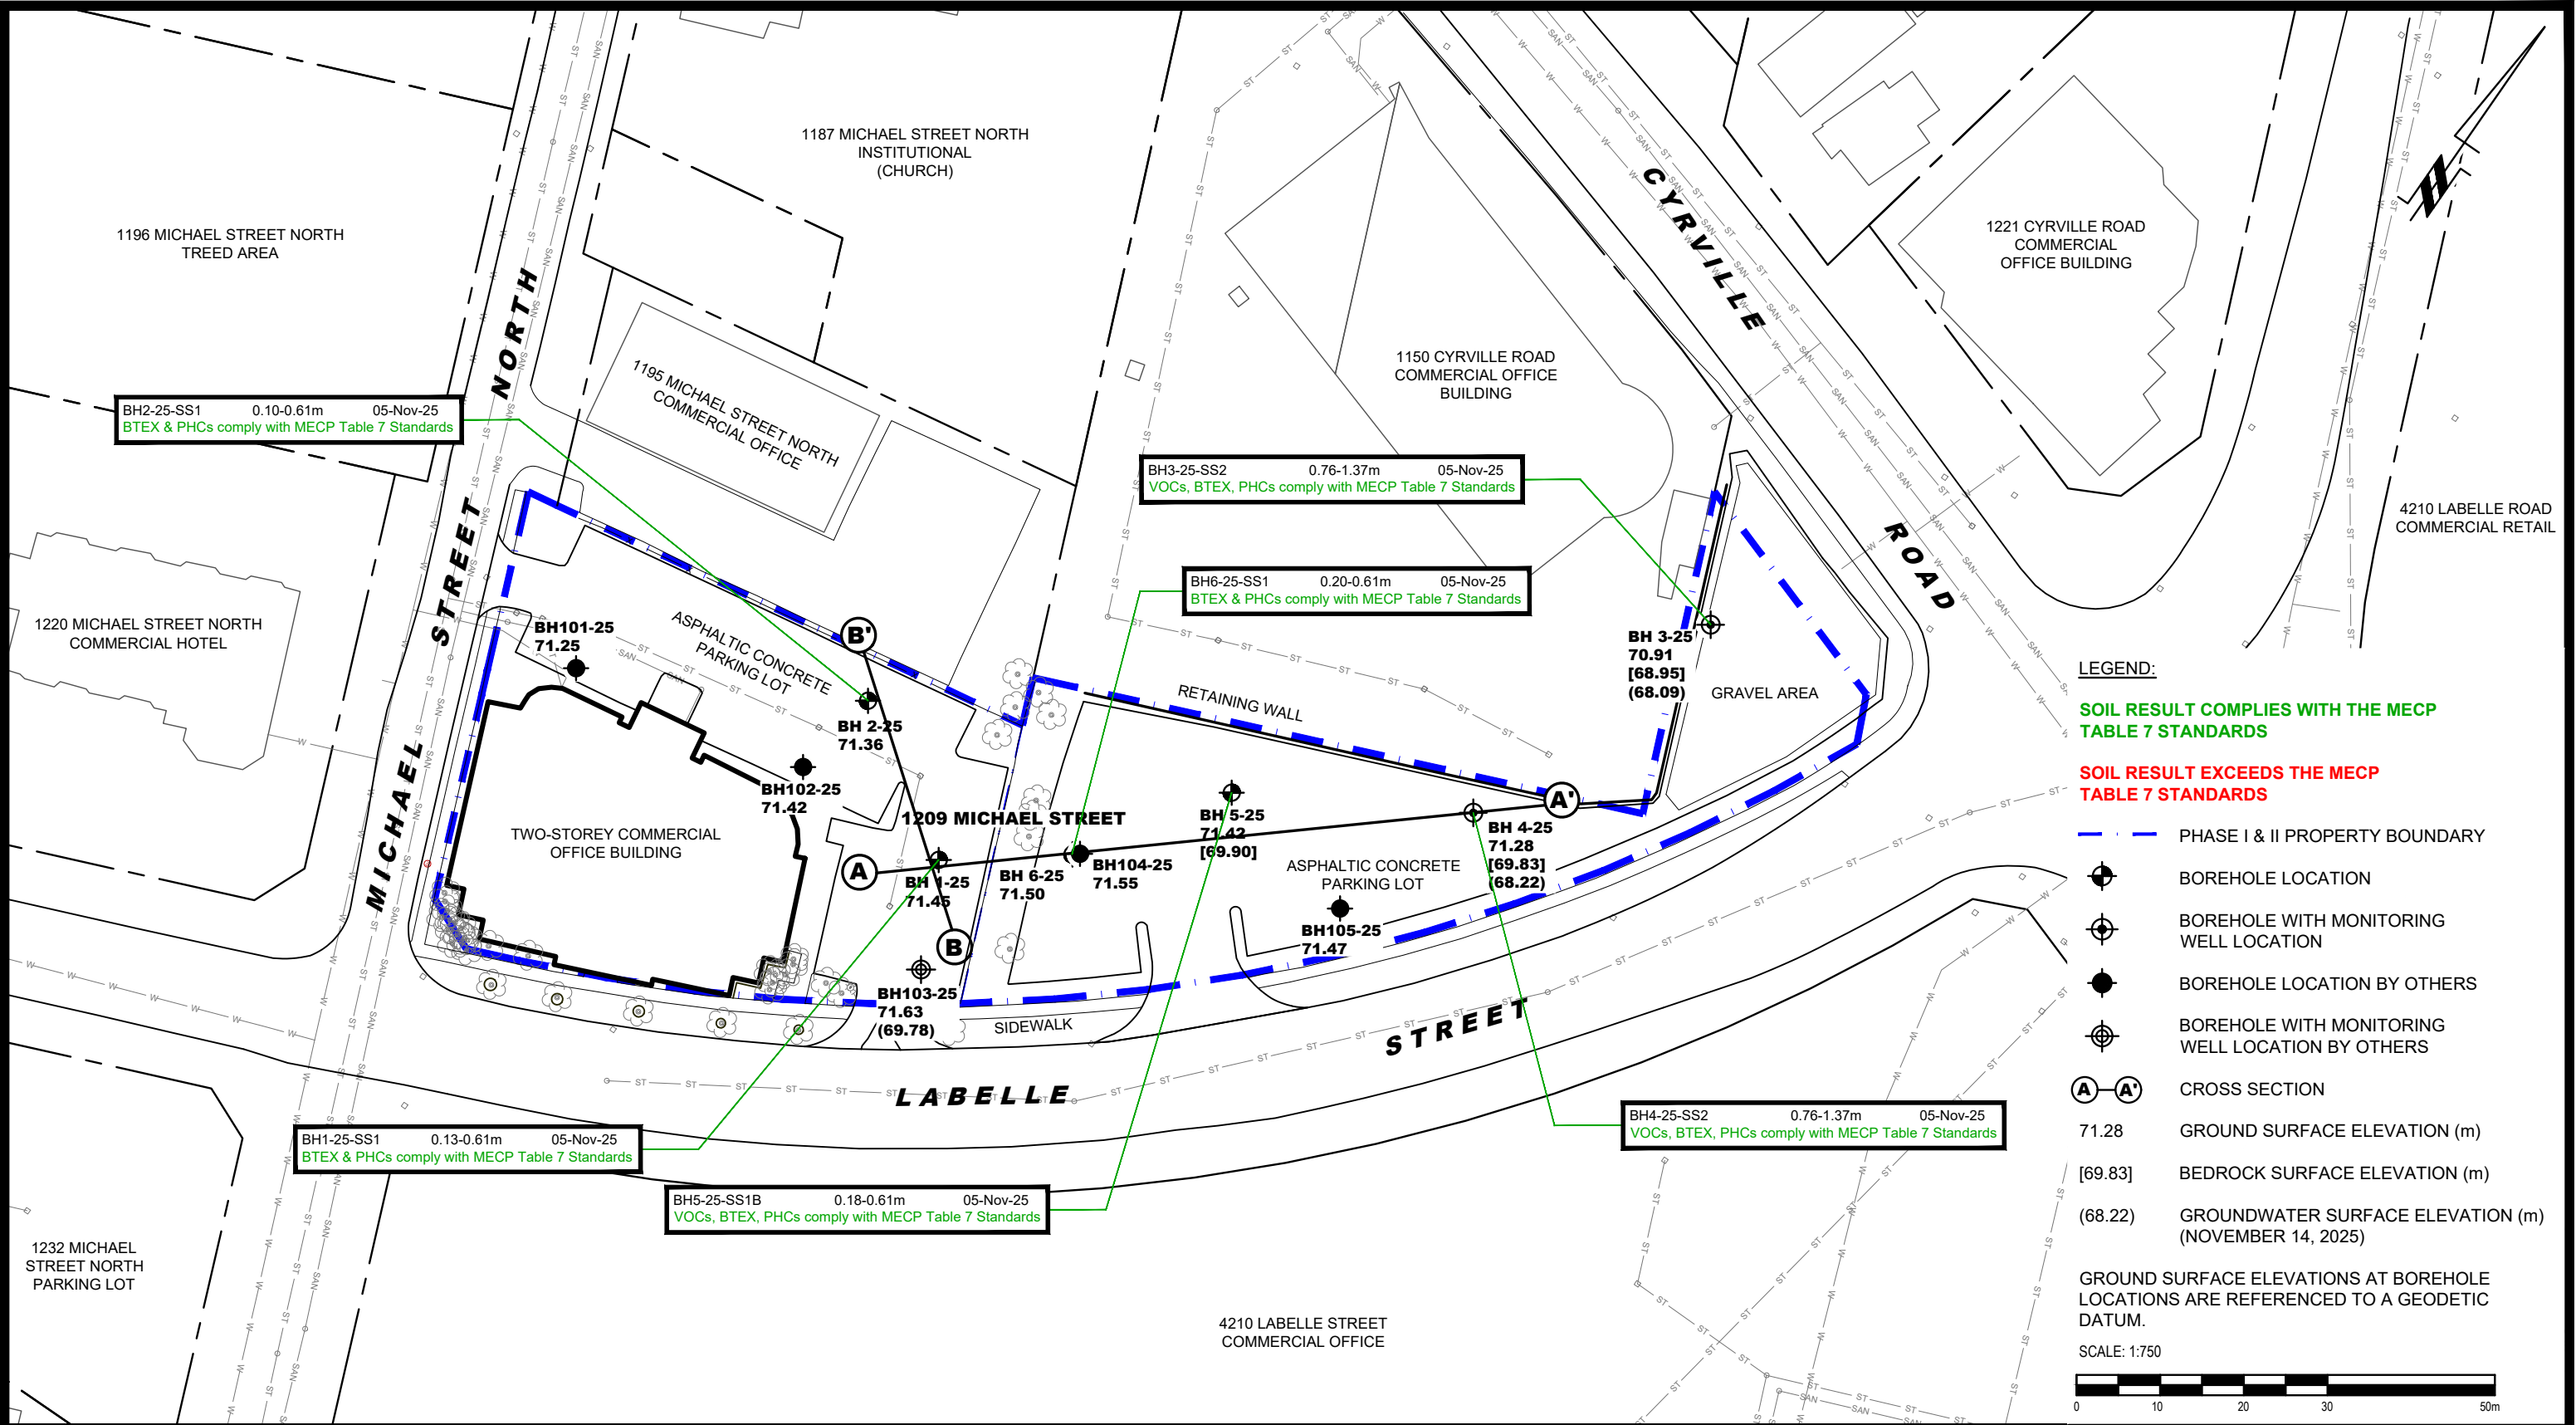
- LEGEND:**
- SOIL RESULT COMPLIES WITH THE MECP TABLE 7 STANDARDS**
- SOIL RESULT EXCEEDS THE MECP TABLE 7 STANDARDS**
- PHASE I & II PROPERTY BOUNDARY
  - BOREHOLE LOCATION
  - BOREHOLE WITH MONITORING WELL LOCATION
  - BOREHOLE LOCATION BY OTHERS
  - BOREHOLE WITH MONITORING WELL LOCATION BY OTHERS
  - CROSS SECTION
  - 71.28 GROUND SURFACE ELEVATION (m)
  - [69.83] BEDROCK SURFACE ELEVATION (m)
  - (68.22) GROUNDWATER SURFACE ELEVATION (m) (NOVEMBER 14, 2025)
- GROUND SURFACE ELEVATIONS AT BOREHOLE LOCATIONS ARE REFERENCED TO A GEODETIC DATUM.
- SCALE: 1:750

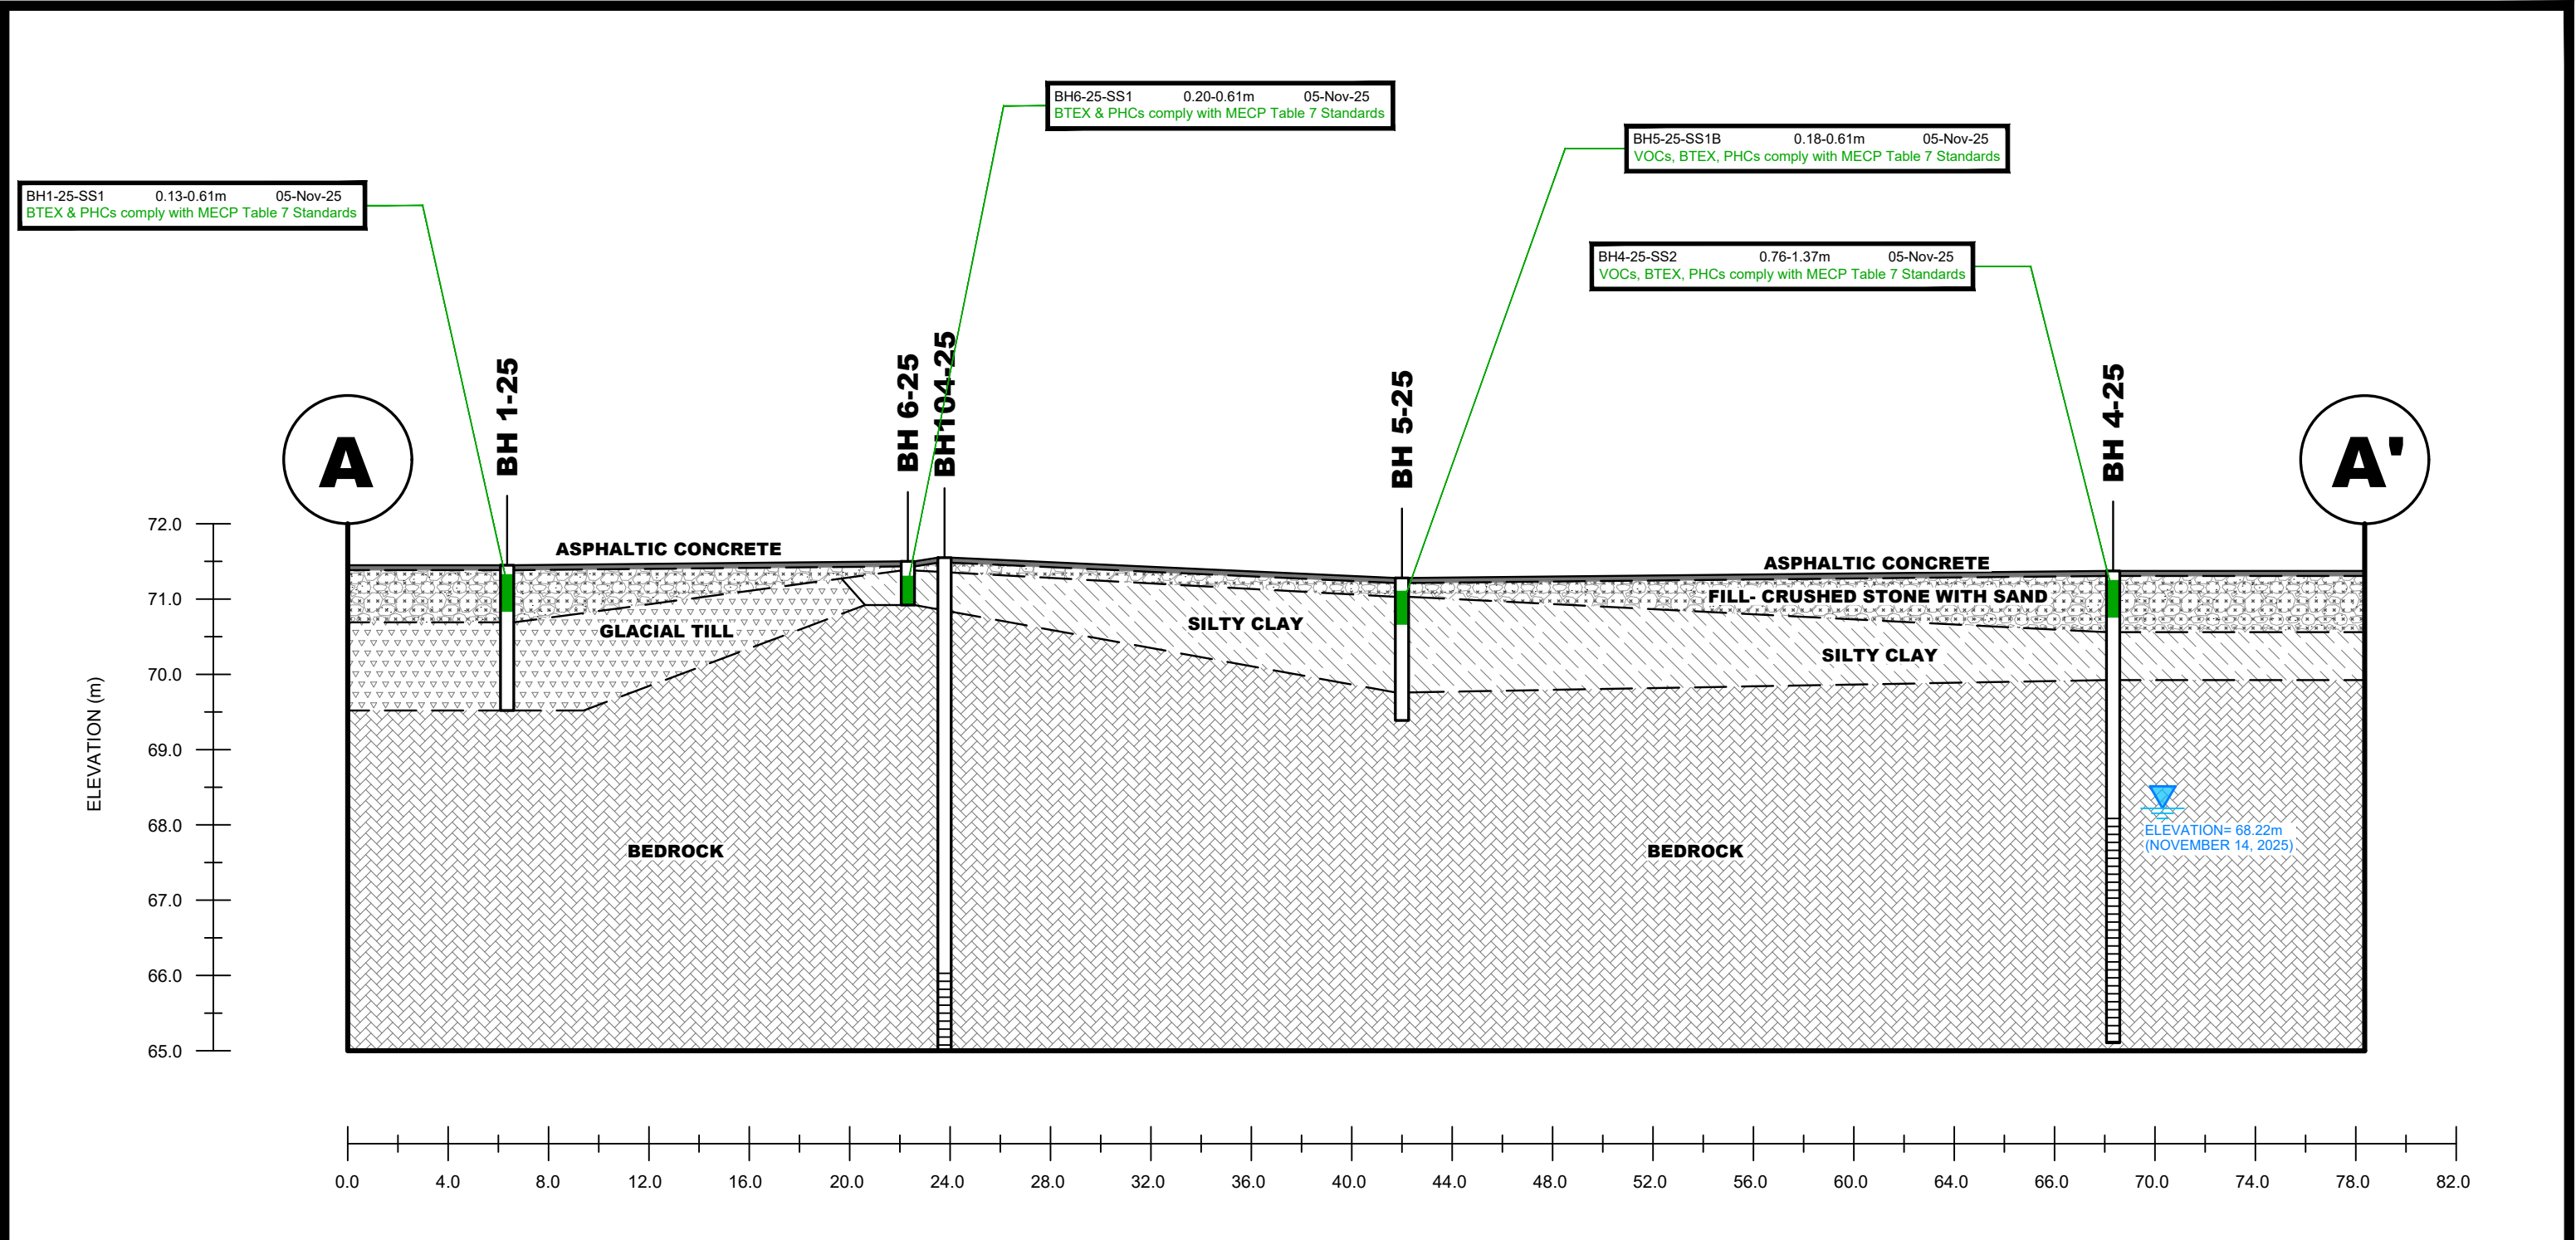
**LEGEND:**

SOIL RESULT COMPLIES WITH THE MECP  
TABLE 7 STANDARDS

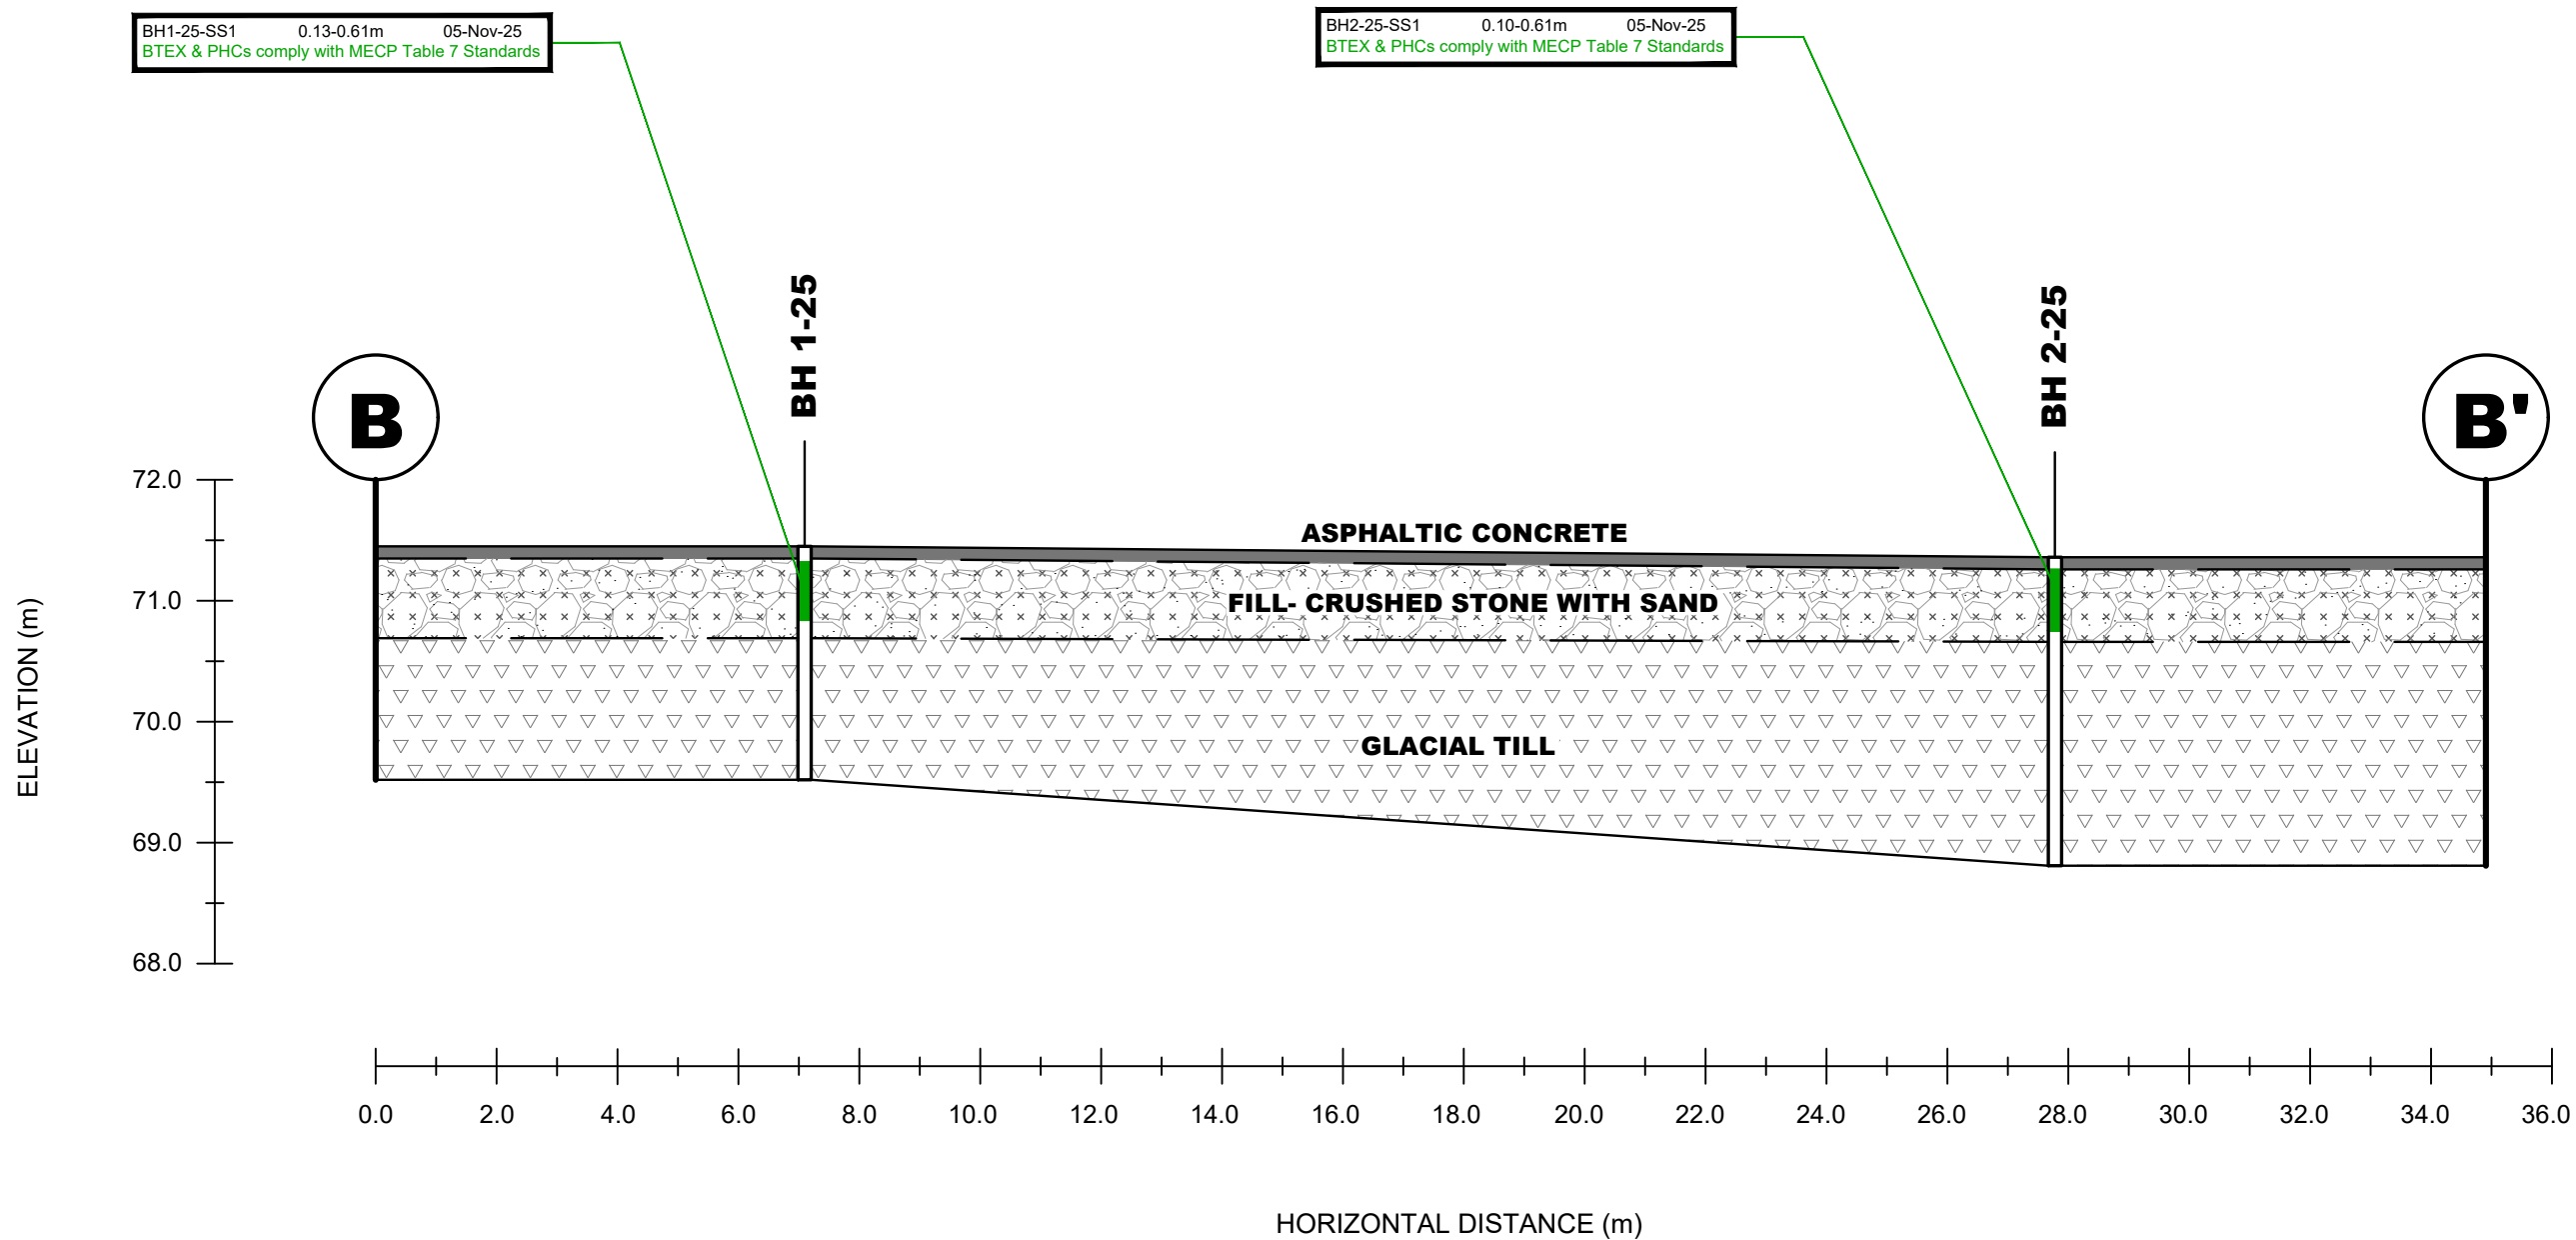
**LEGEND:**

SOIL RESULT COMPLIES WITH THE MECP  
TABLE 7 STANDARDS

SOIL RESULT EXCEEDS THE MECP  
TABLE 7 STANDARDS

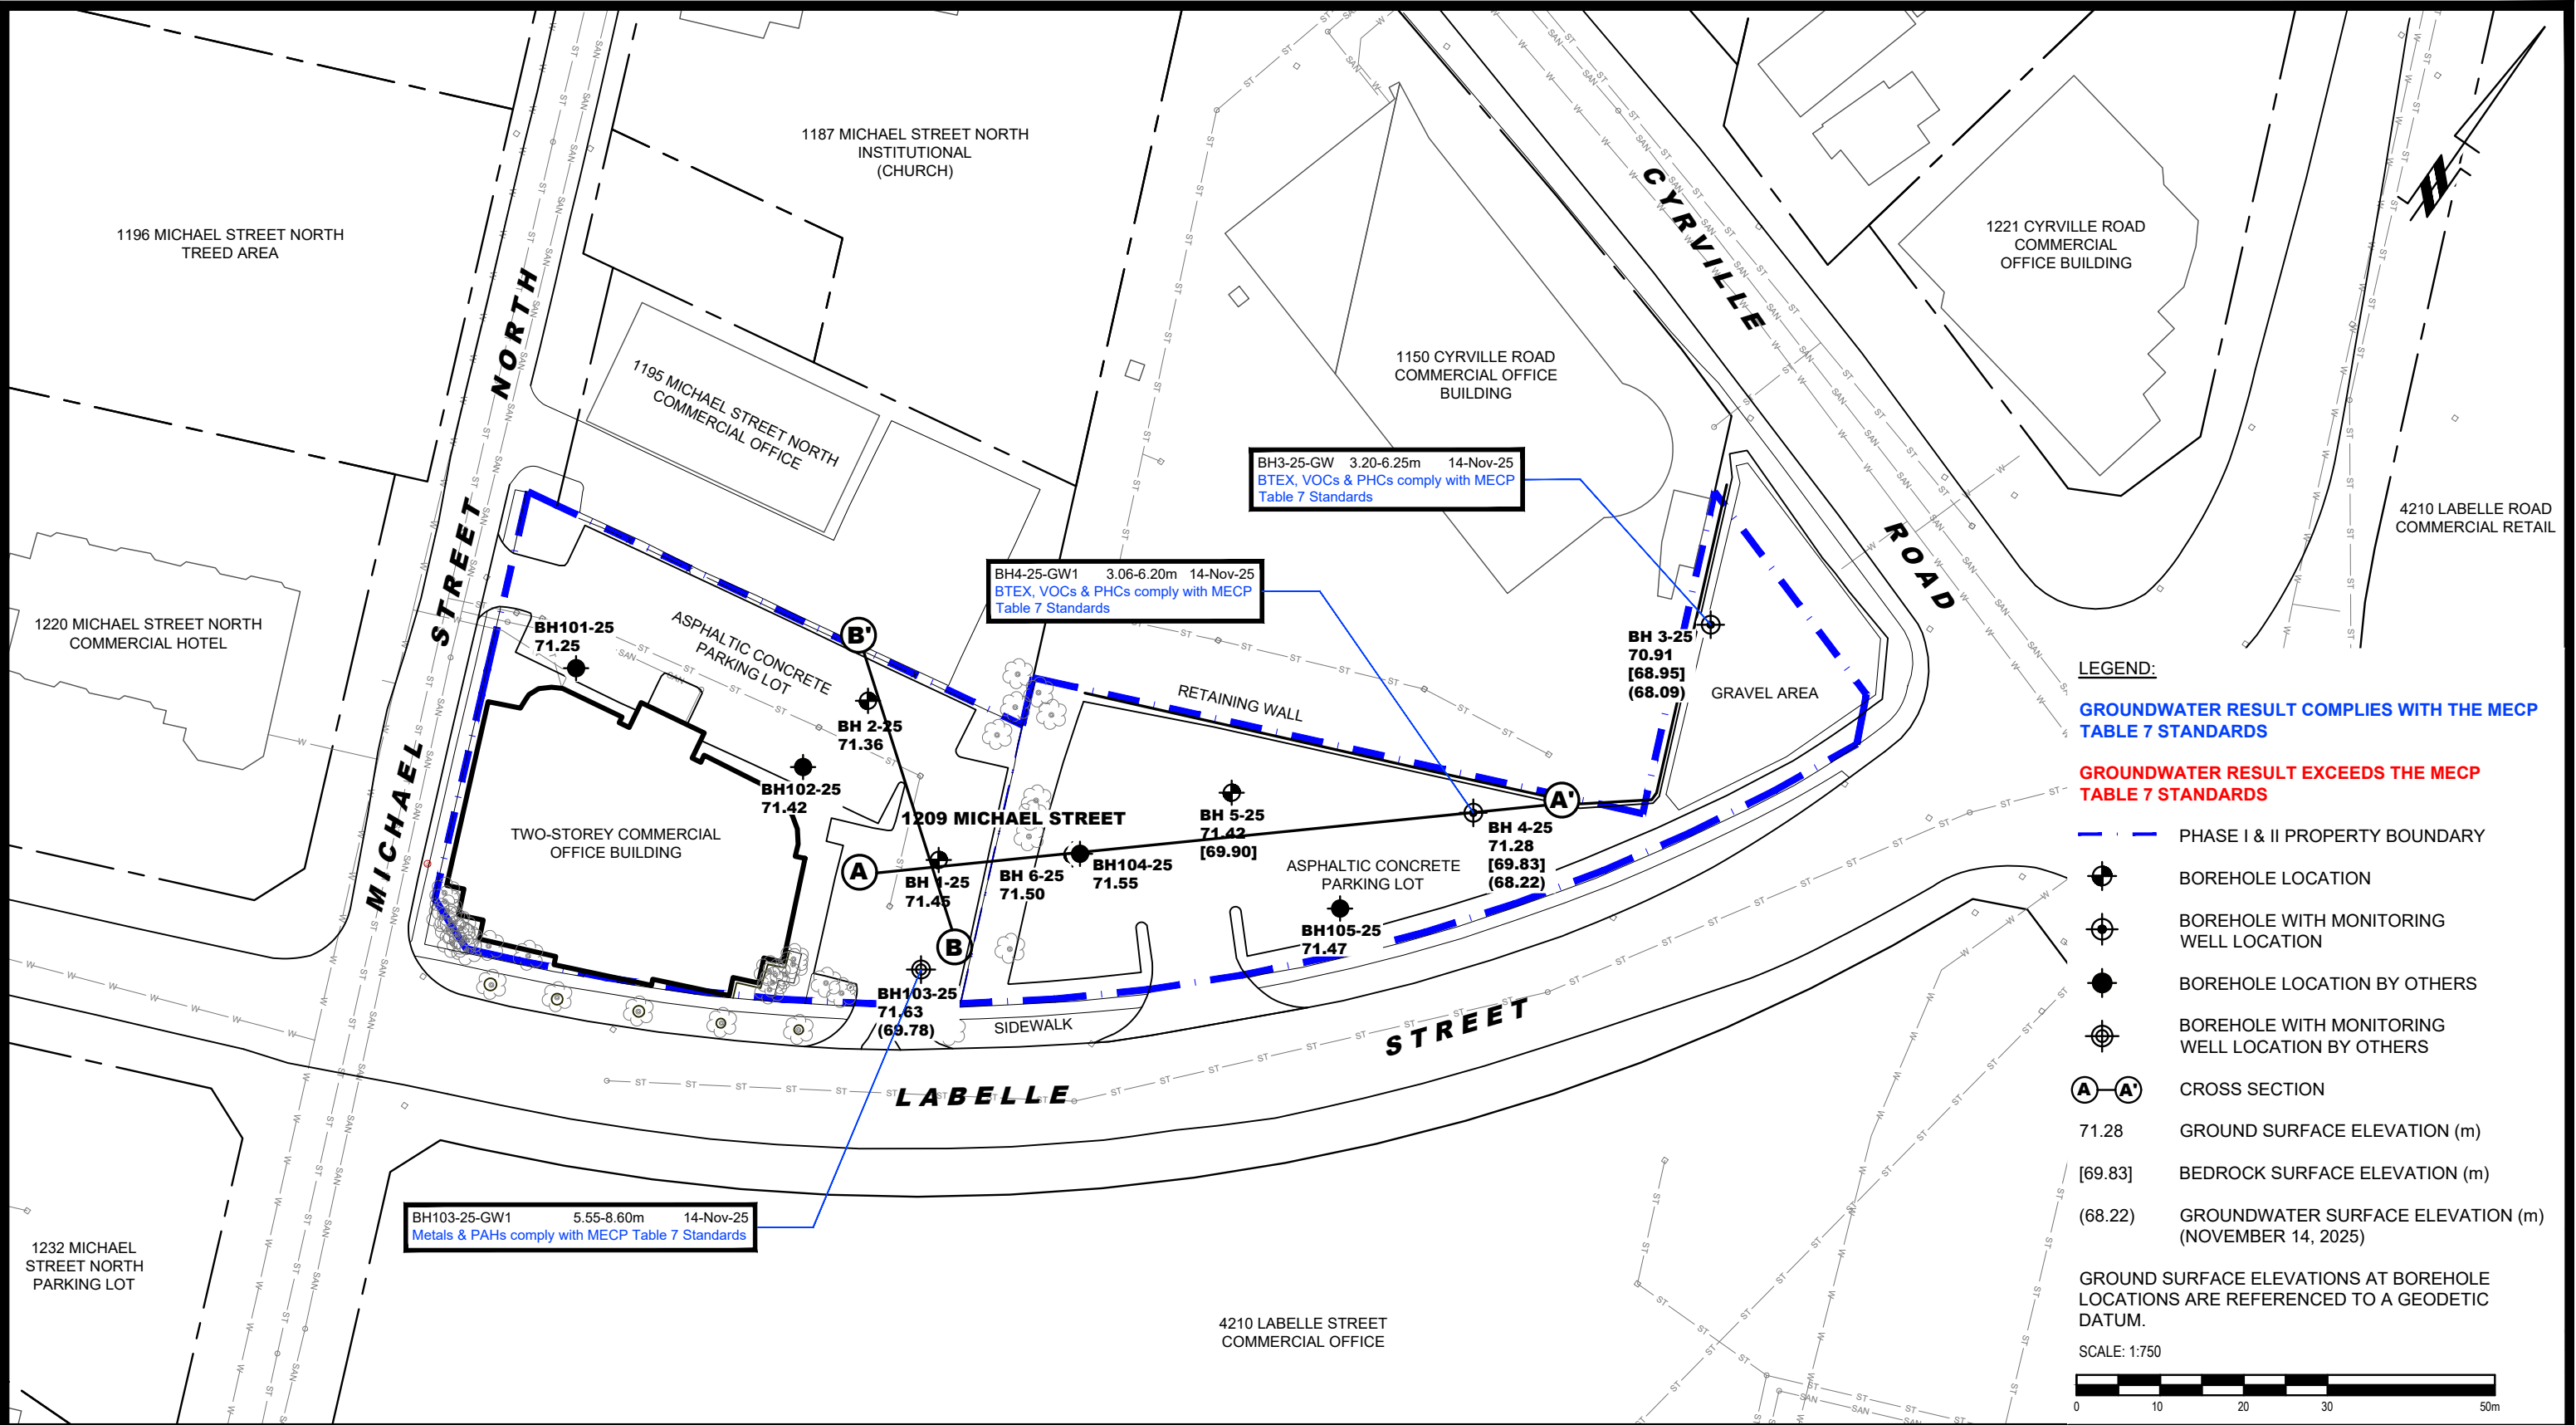
- LEGEND:**
- GROUNDWATER RESULT COMPLIES WITH THE MECP TABLE 7 STANDARDS**
- GROUNDWATER RESULT EXCEEDS THE MECP TABLE 7 STANDARDS**
- PHASE I & II PROPERTY BOUNDARY
  - ⊕ BOREHOLE LOCATION
  - ⊕ BOREHOLE WITH MONITORING WELL LOCATION
  - BOREHOLE LOCATION BY OTHERS
  - ⊕ BOREHOLE WITH MONITORING WELL LOCATION BY OTHERS
  - ⊕ A — A' CROSS SECTION
  - 71.28 GROUND SURFACE ELEVATION (m)
  - [69.83] BEDROCK SURFACE ELEVATION (m)
  - (68.22) GROUNDWATER SURFACE ELEVATION (m) (NOVEMBER 14, 2025)
- GROUND SURFACE ELEVATIONS AT BOREHOLE LOCATIONS ARE REFERENCED TO A GEODETIC DATUM.
- SCALE: 1:750
- 0 10 20 30 40 50m

The concentration of sodium in Sample BH103-25-GW1 is in excess of the selected MECP Table 7 Non-Potable Groundwater Standards. All remaining parameters detected in the groundwater sample analyzed comply with the standards. The elevated sodium level is suspected to be the result of the application of road salt on the Phase II Property during snow and ice conditions and thus, as per Section 49.1 of O. Reg 153/04, does not represent a contaminant issue.

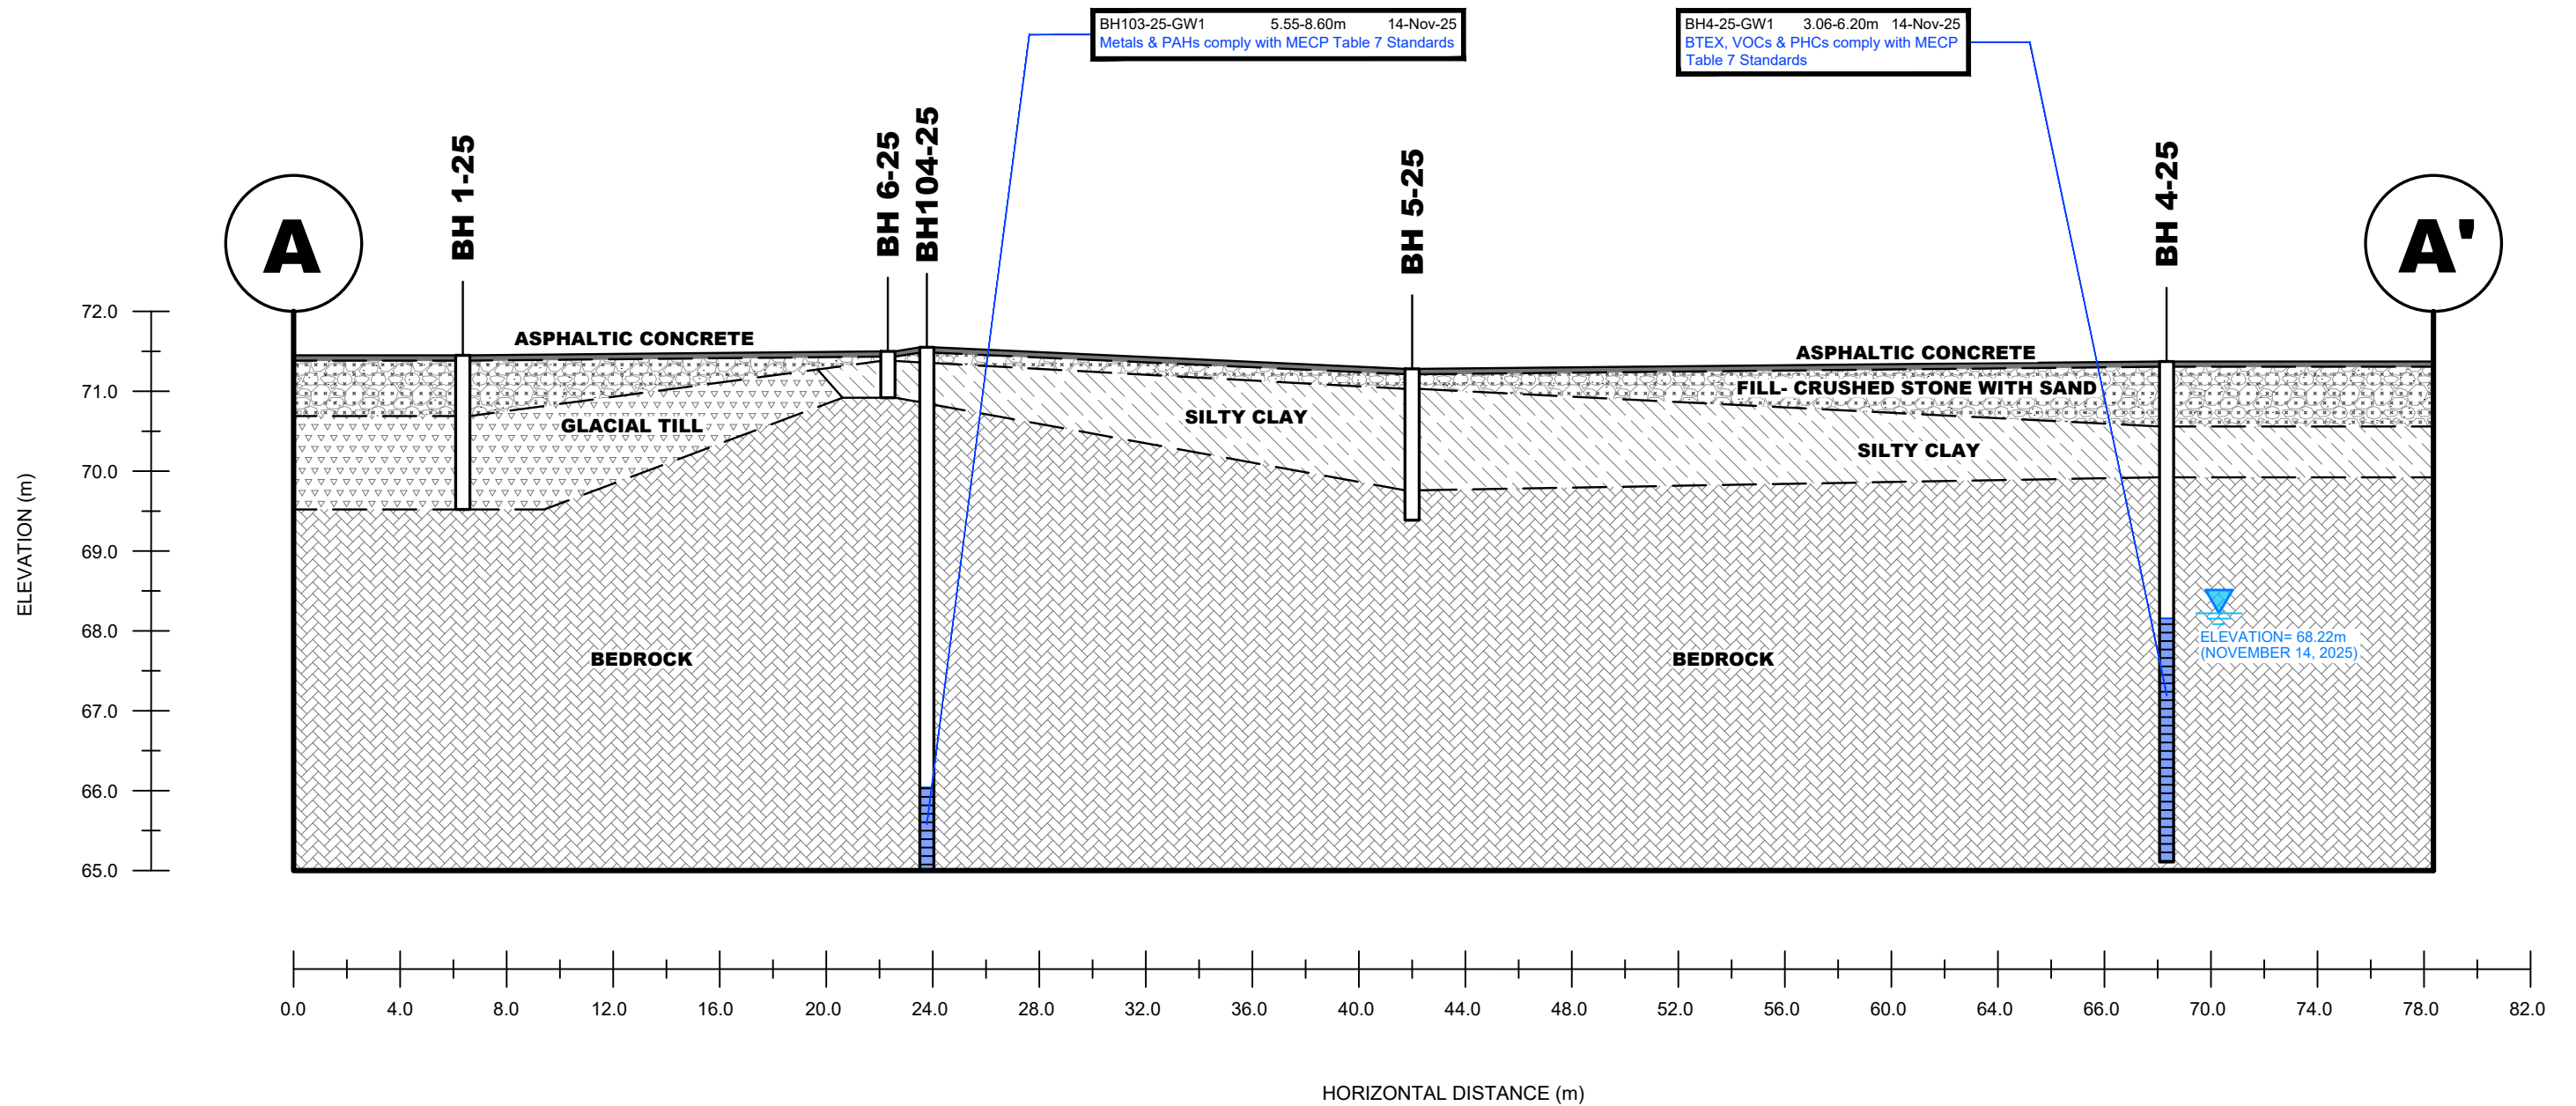
| Checked by: | NS | Dwg. No.: | PE7253-8A |

LEGEND:

GROUNDWATER RESULT COMPLIES WITH THE MECP TABLE 7 STANDARDS

GROUNDWATER RESULT EXCEEDS THE MECP TABLE 7 STANDARDS
