## **Phase II – Environmental Site Assessment**

1209 Michael Street North  
Ottawa, Ontario

Prepared for Inside Edge Properties

Report: PE7253-2  
January 22, 2026

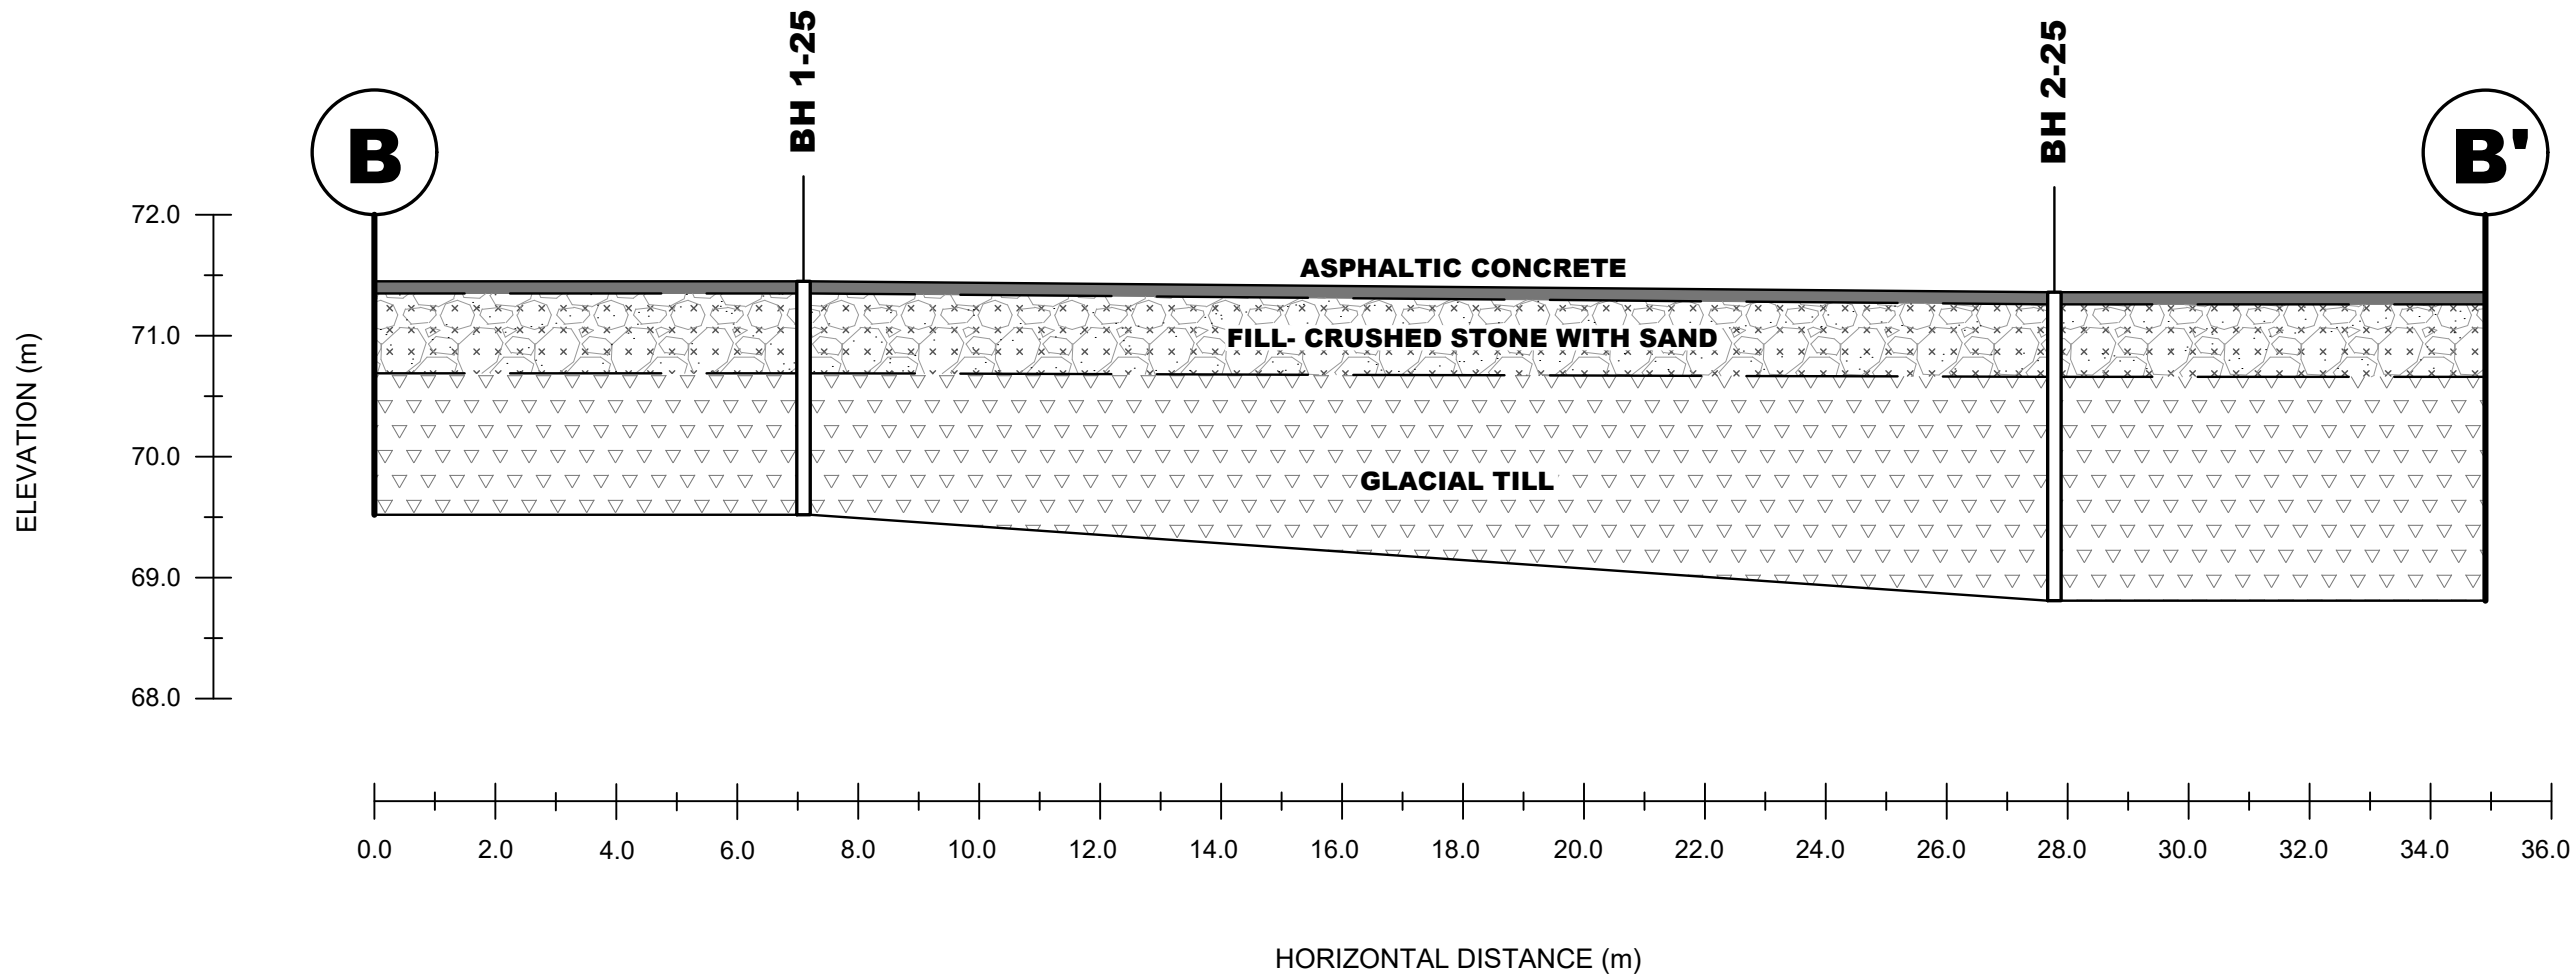
**DRAWING PE7253-8B – CROSS SECTION B-B' – GROUNDWATER**

LEGEND:

GROUNDWATER RESULT COMPLIES WITH  
THE MECP TABLE 7 STANDARDS
