August 28, 2026  
PG7849-LET.01

**Subject: Geotechnical Desktop Slope Stability Assessment**  
Proposed Residential Development  
6772 Rocque Street  
Ottawa, Ontario

Further to your request and authorization, Paterson Group (Paterson) prepared the present letter report to provide our geotechnical desktop slope stability assessment of the existing escarpment slope located to the southeast of the subject site between St. Joseph Boulevard and Notre Dame Street.

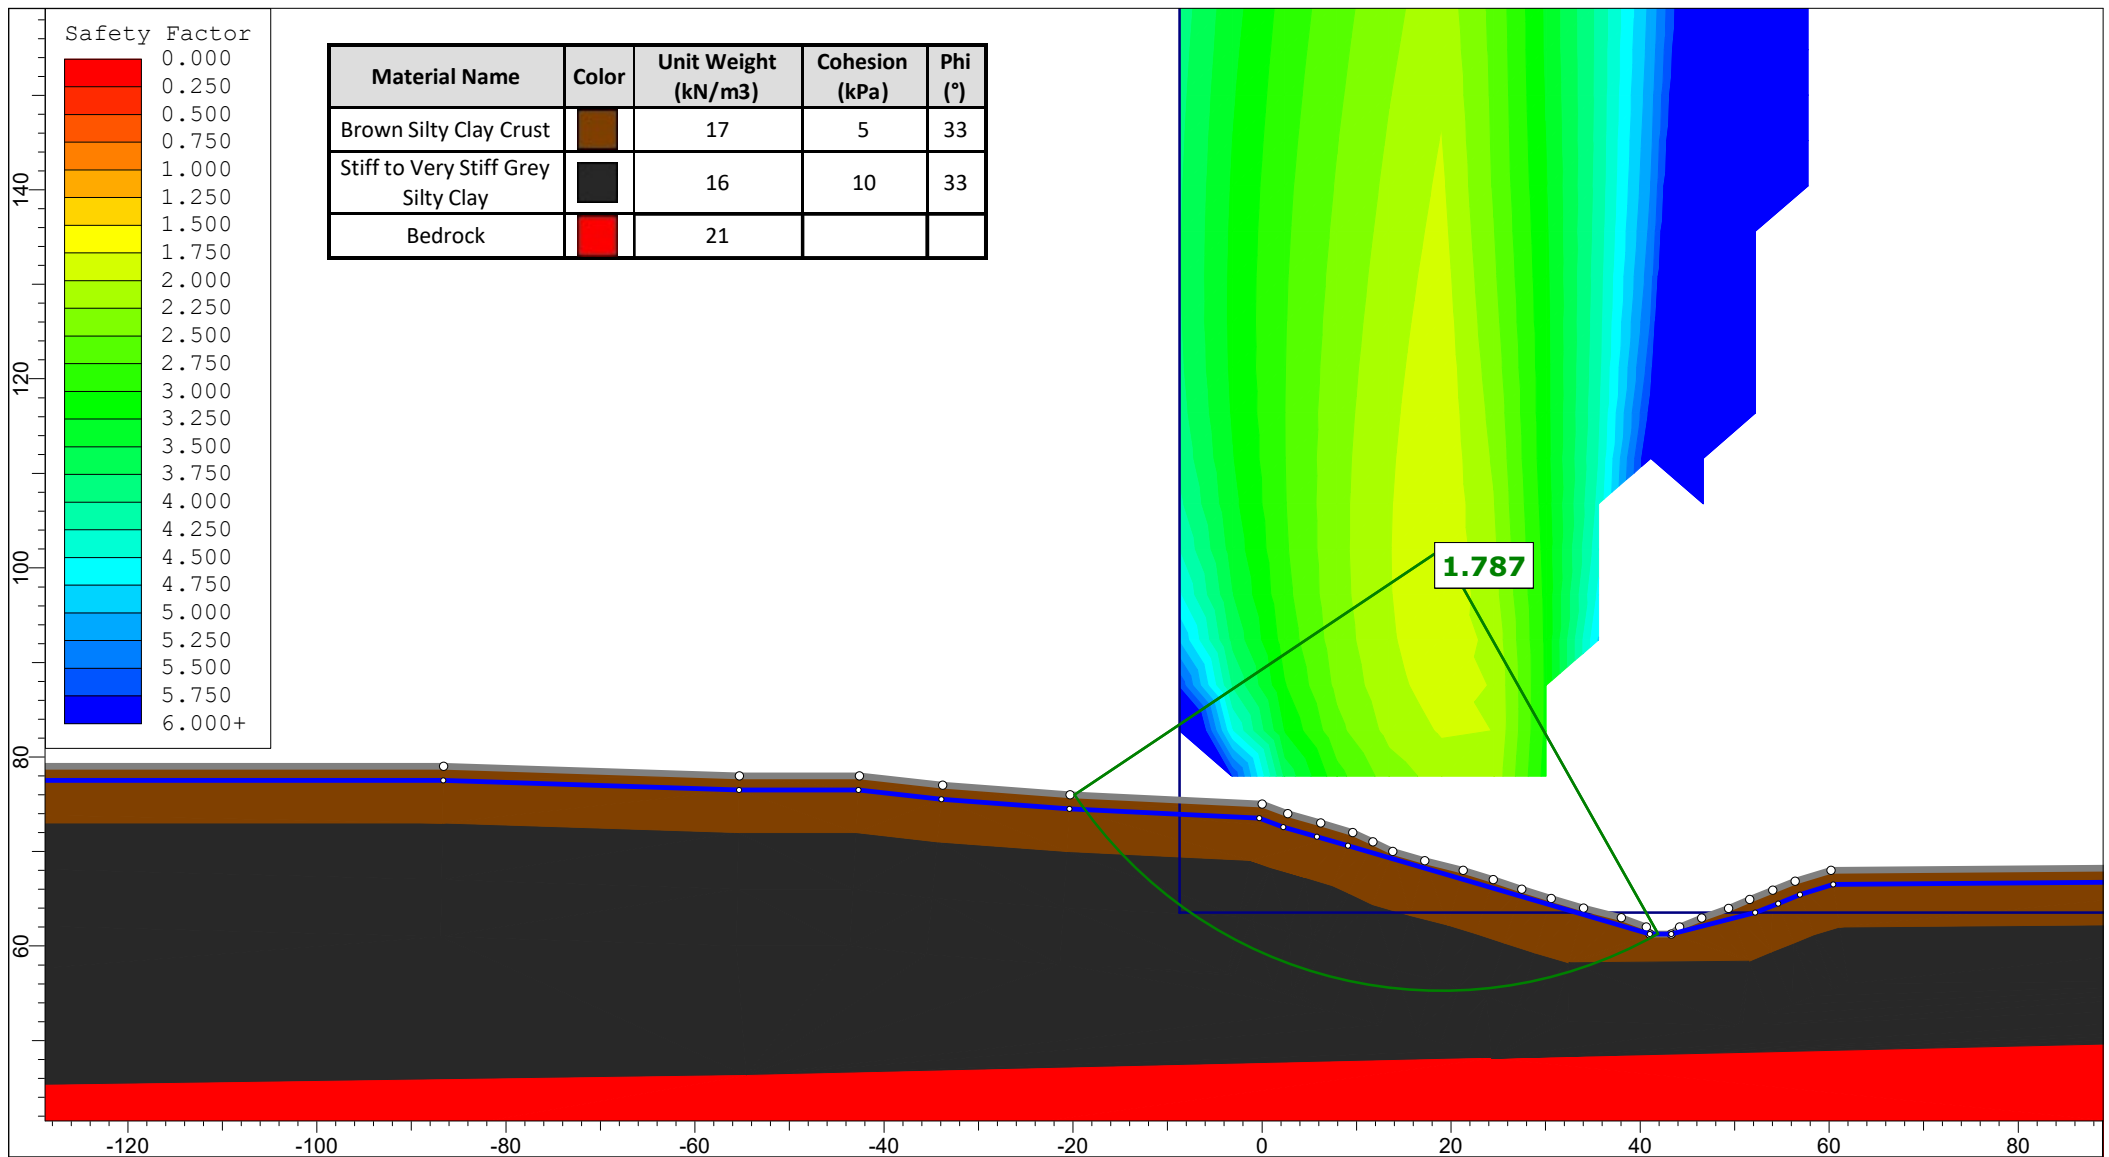
The results of the existing escarpment slope under static loading conditions at Section A are shown in Figure 1A attached to the present report. The overall slope stability factor of safety for the subject section was found to be greater than 1.5. As such, a stable slope allowance setback is not required for the subject escarpment slope under static conditions.

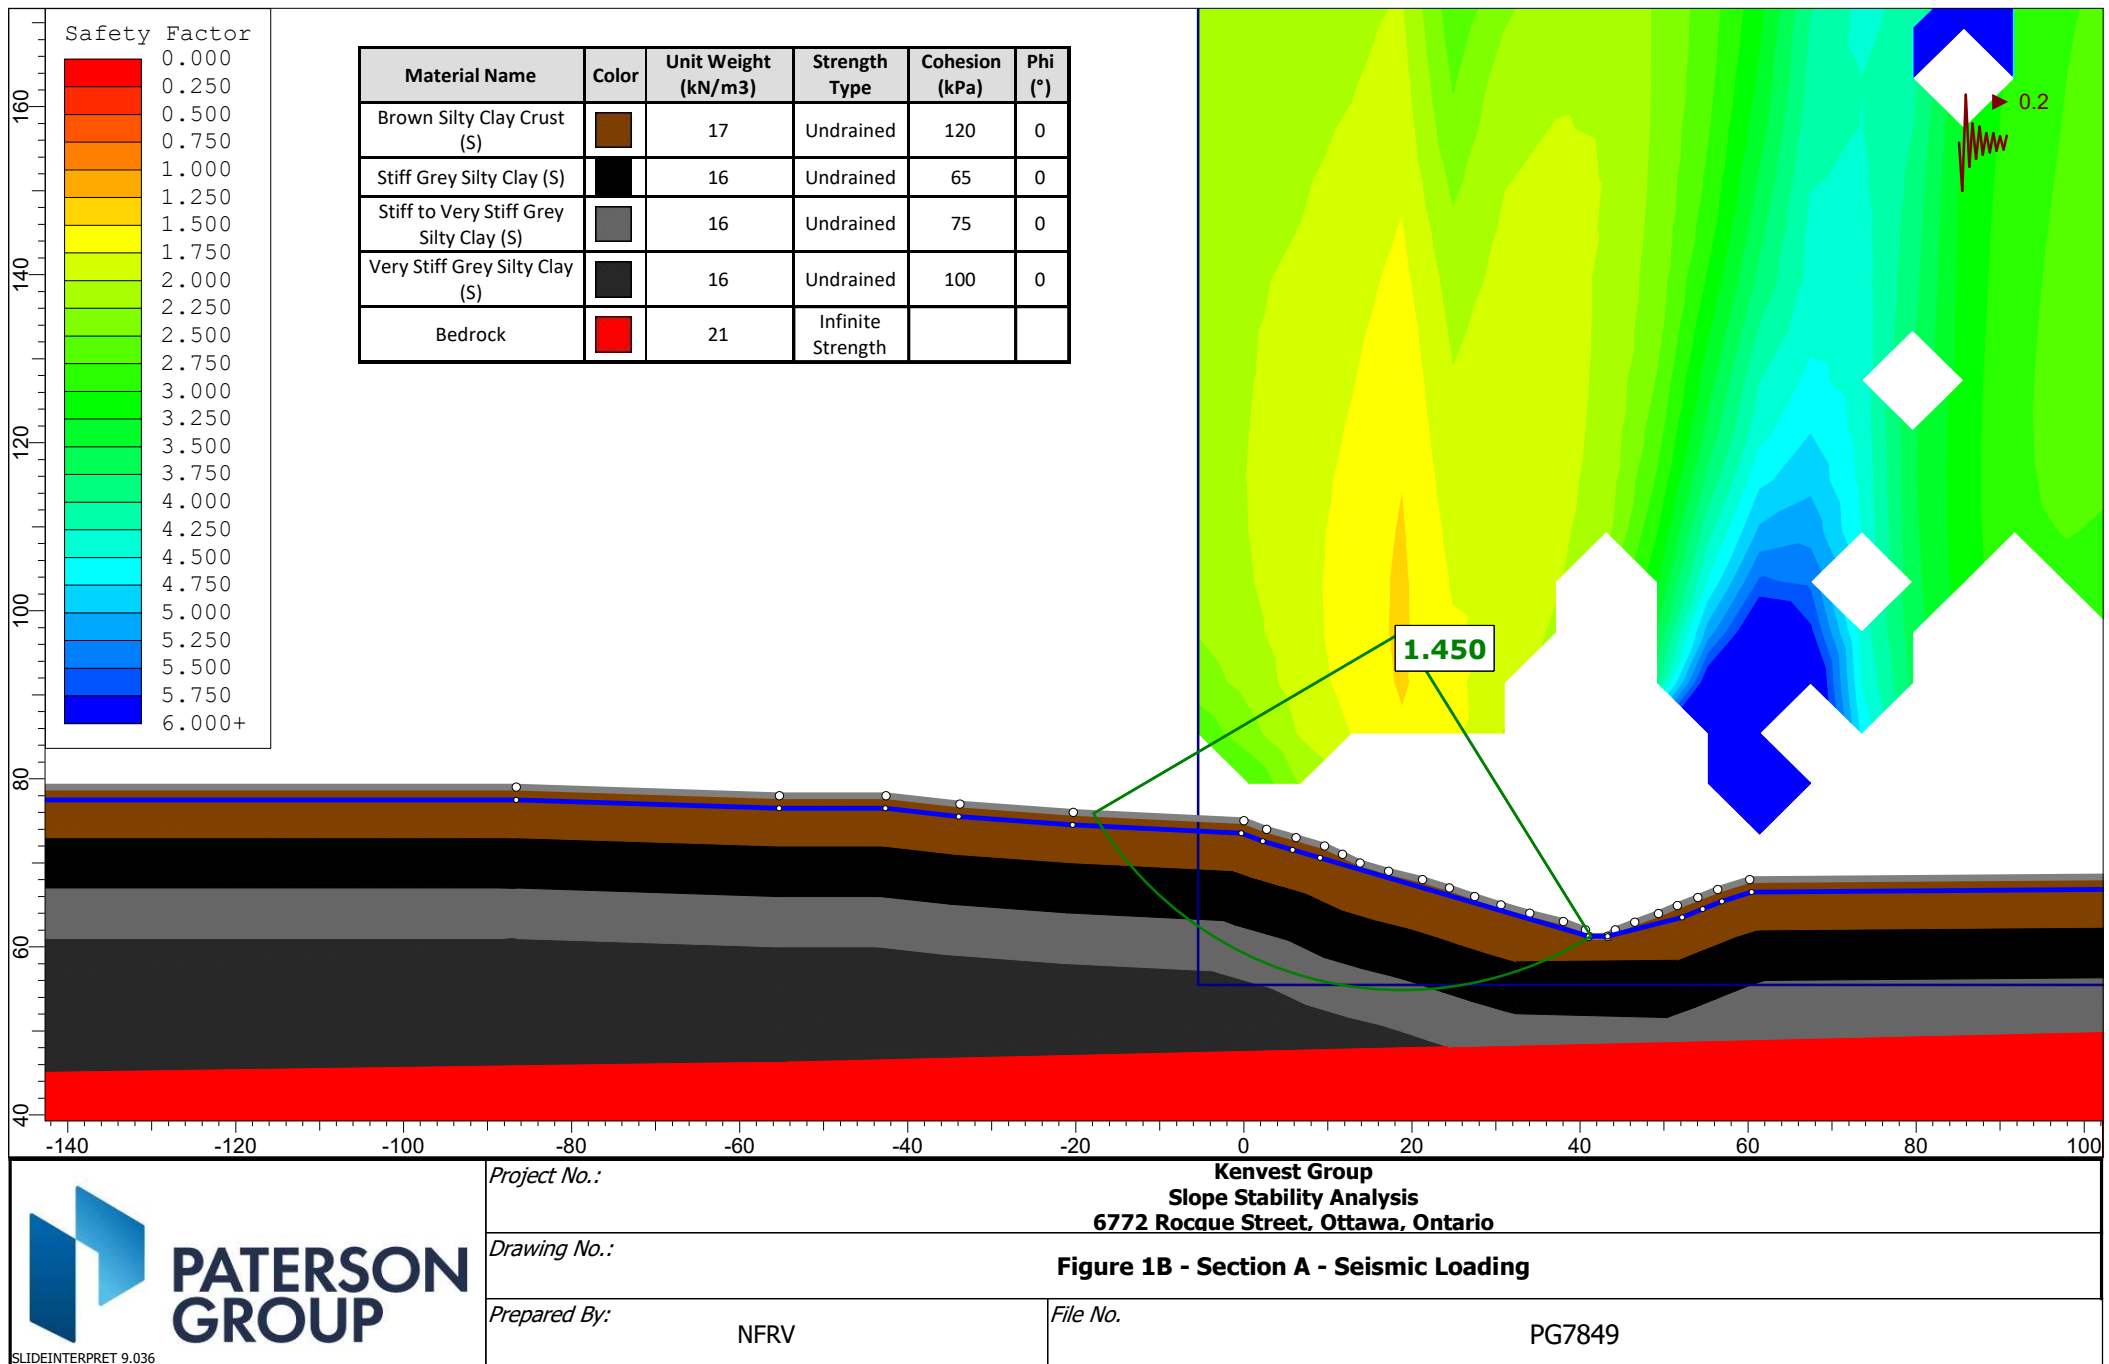
An analysis considering seismic loading was also completed as part of the slope stability analysis. A horizontal seismic loading acceleration,  $K_h$ , of 0.2g was considered for the analyzed section. The results of the existing escarpment slope under seismic loading conditions at Section A are shown in Figure 1B attached to the present report. The overall slope stability factor of safety for the subject section was found to be greater than 1.1. As such, a stable slope allowance setback is not required for the subject escarpment slope under seismic conditions.

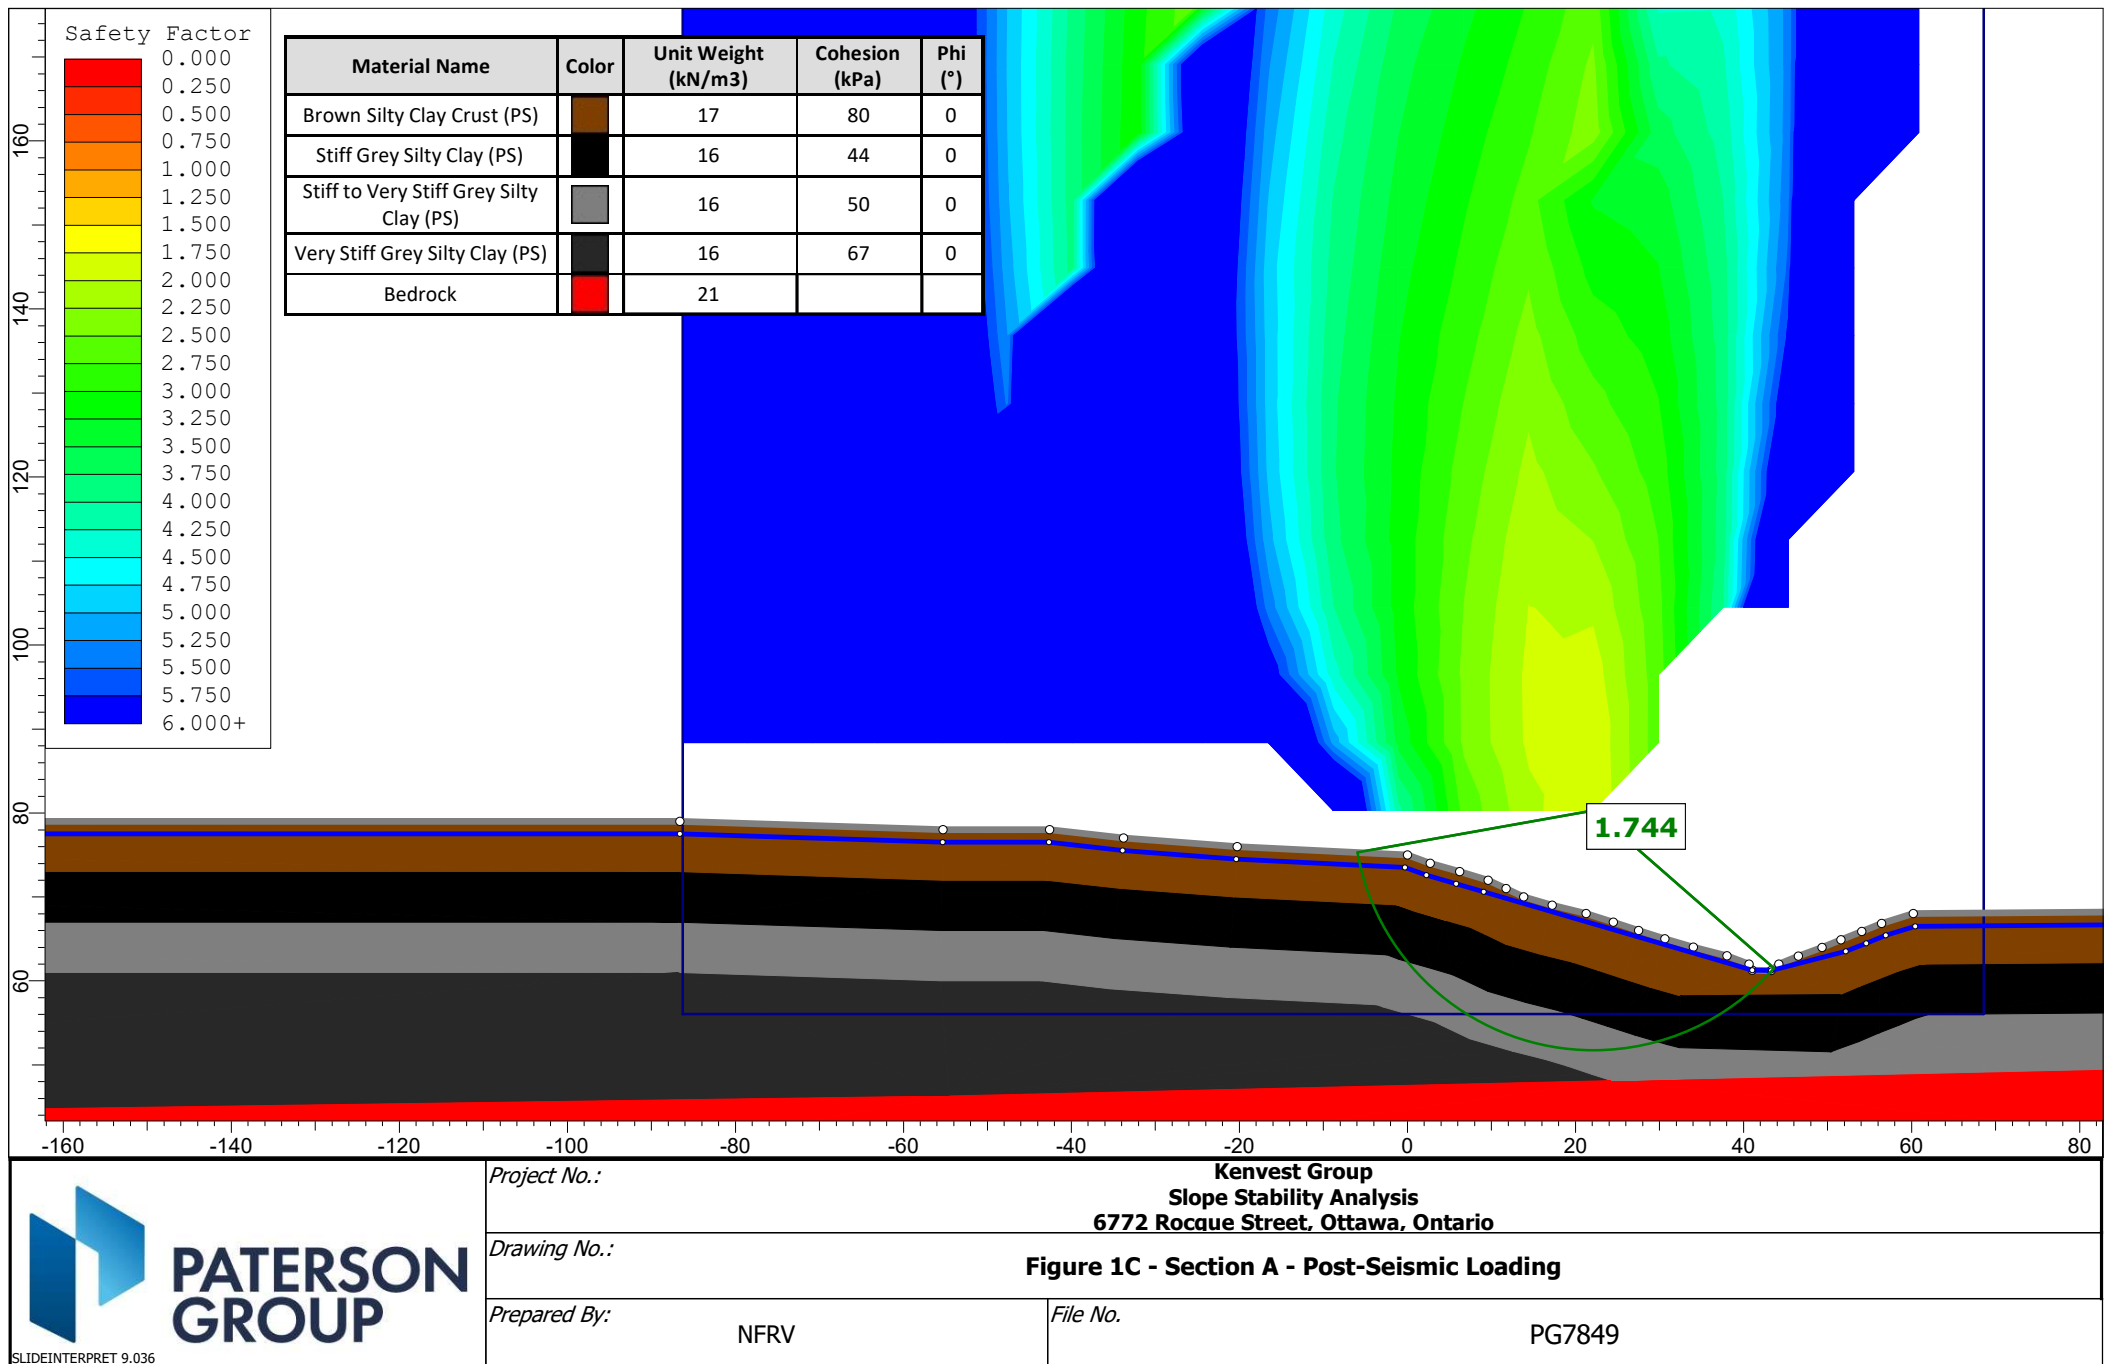
An analysis considering post-seismic loading was also completed as part of the slope stability analysis. Reduced undrained shear strength values were considered for the analyzed section, as discussed in previous sections of the present report. The results of the existing escarpment slope under post-seismic loading conditions at Section A are shown in Figure 1C attached to the present report. The overall slope stability factor of safety for the subject section was found to be greater than 1.3. As such, a stable slope allowance setback is not required for the subject escarpment slope under post-seismic conditions.

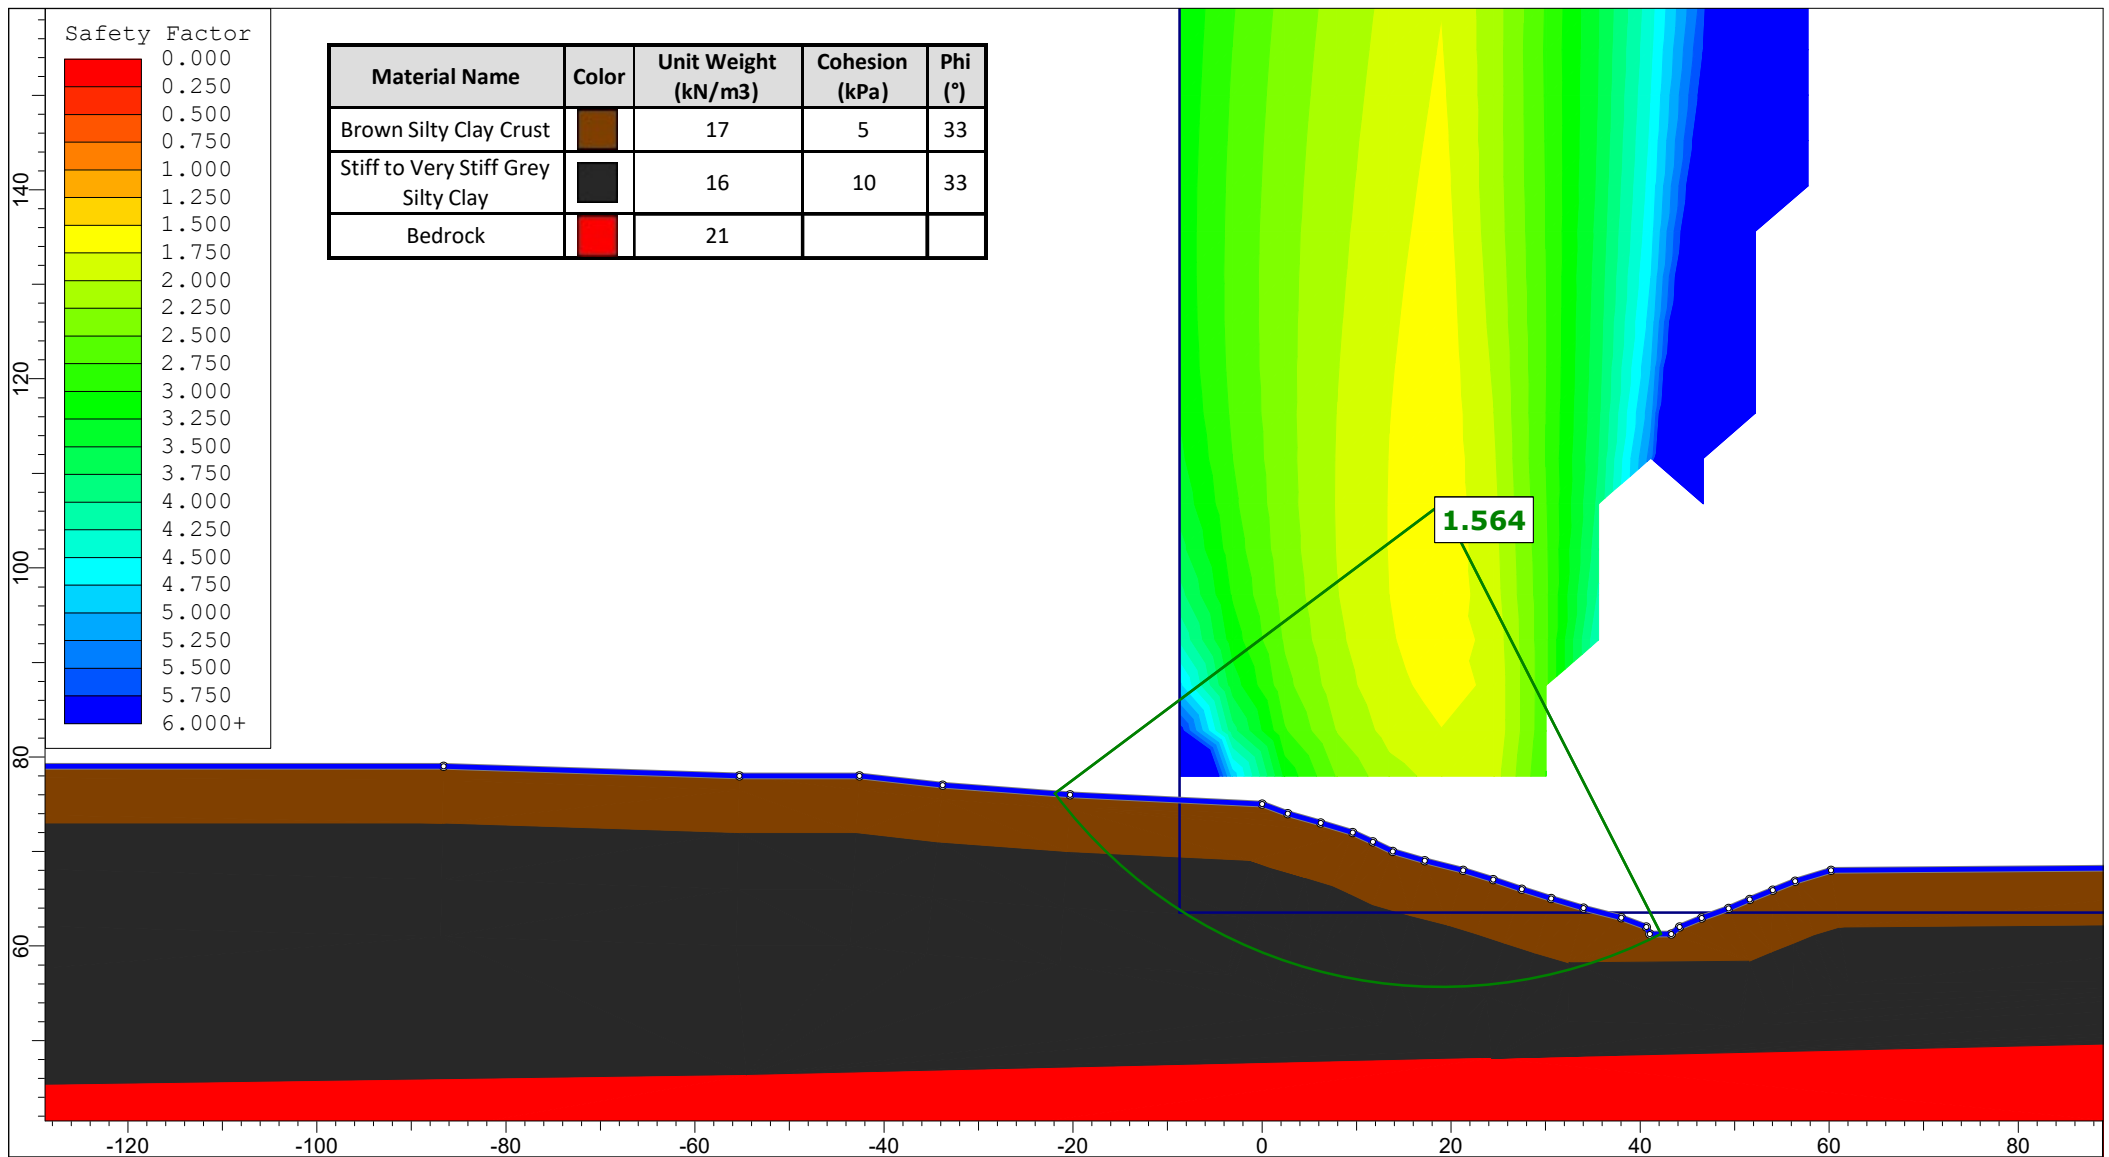
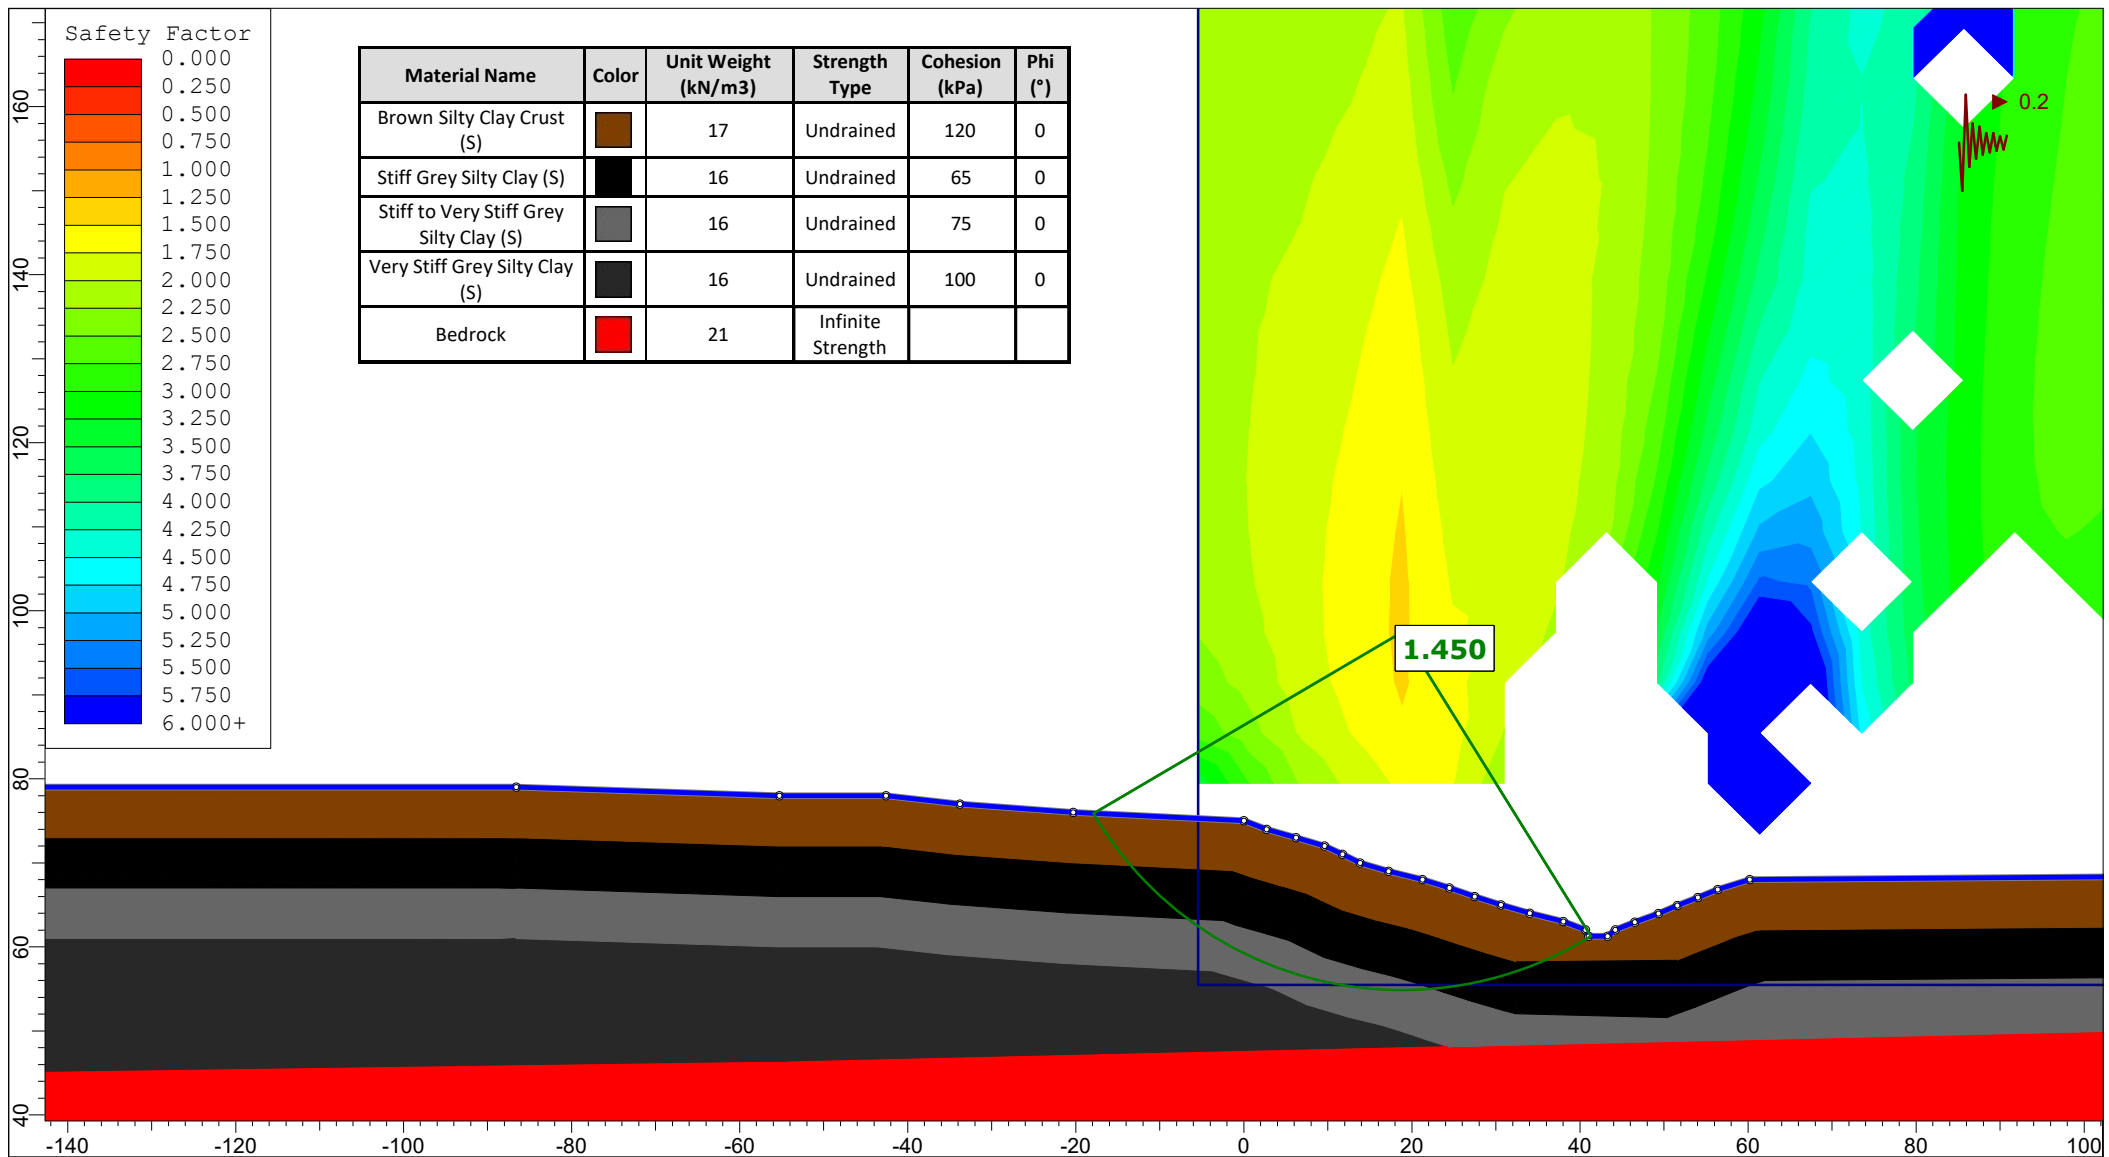
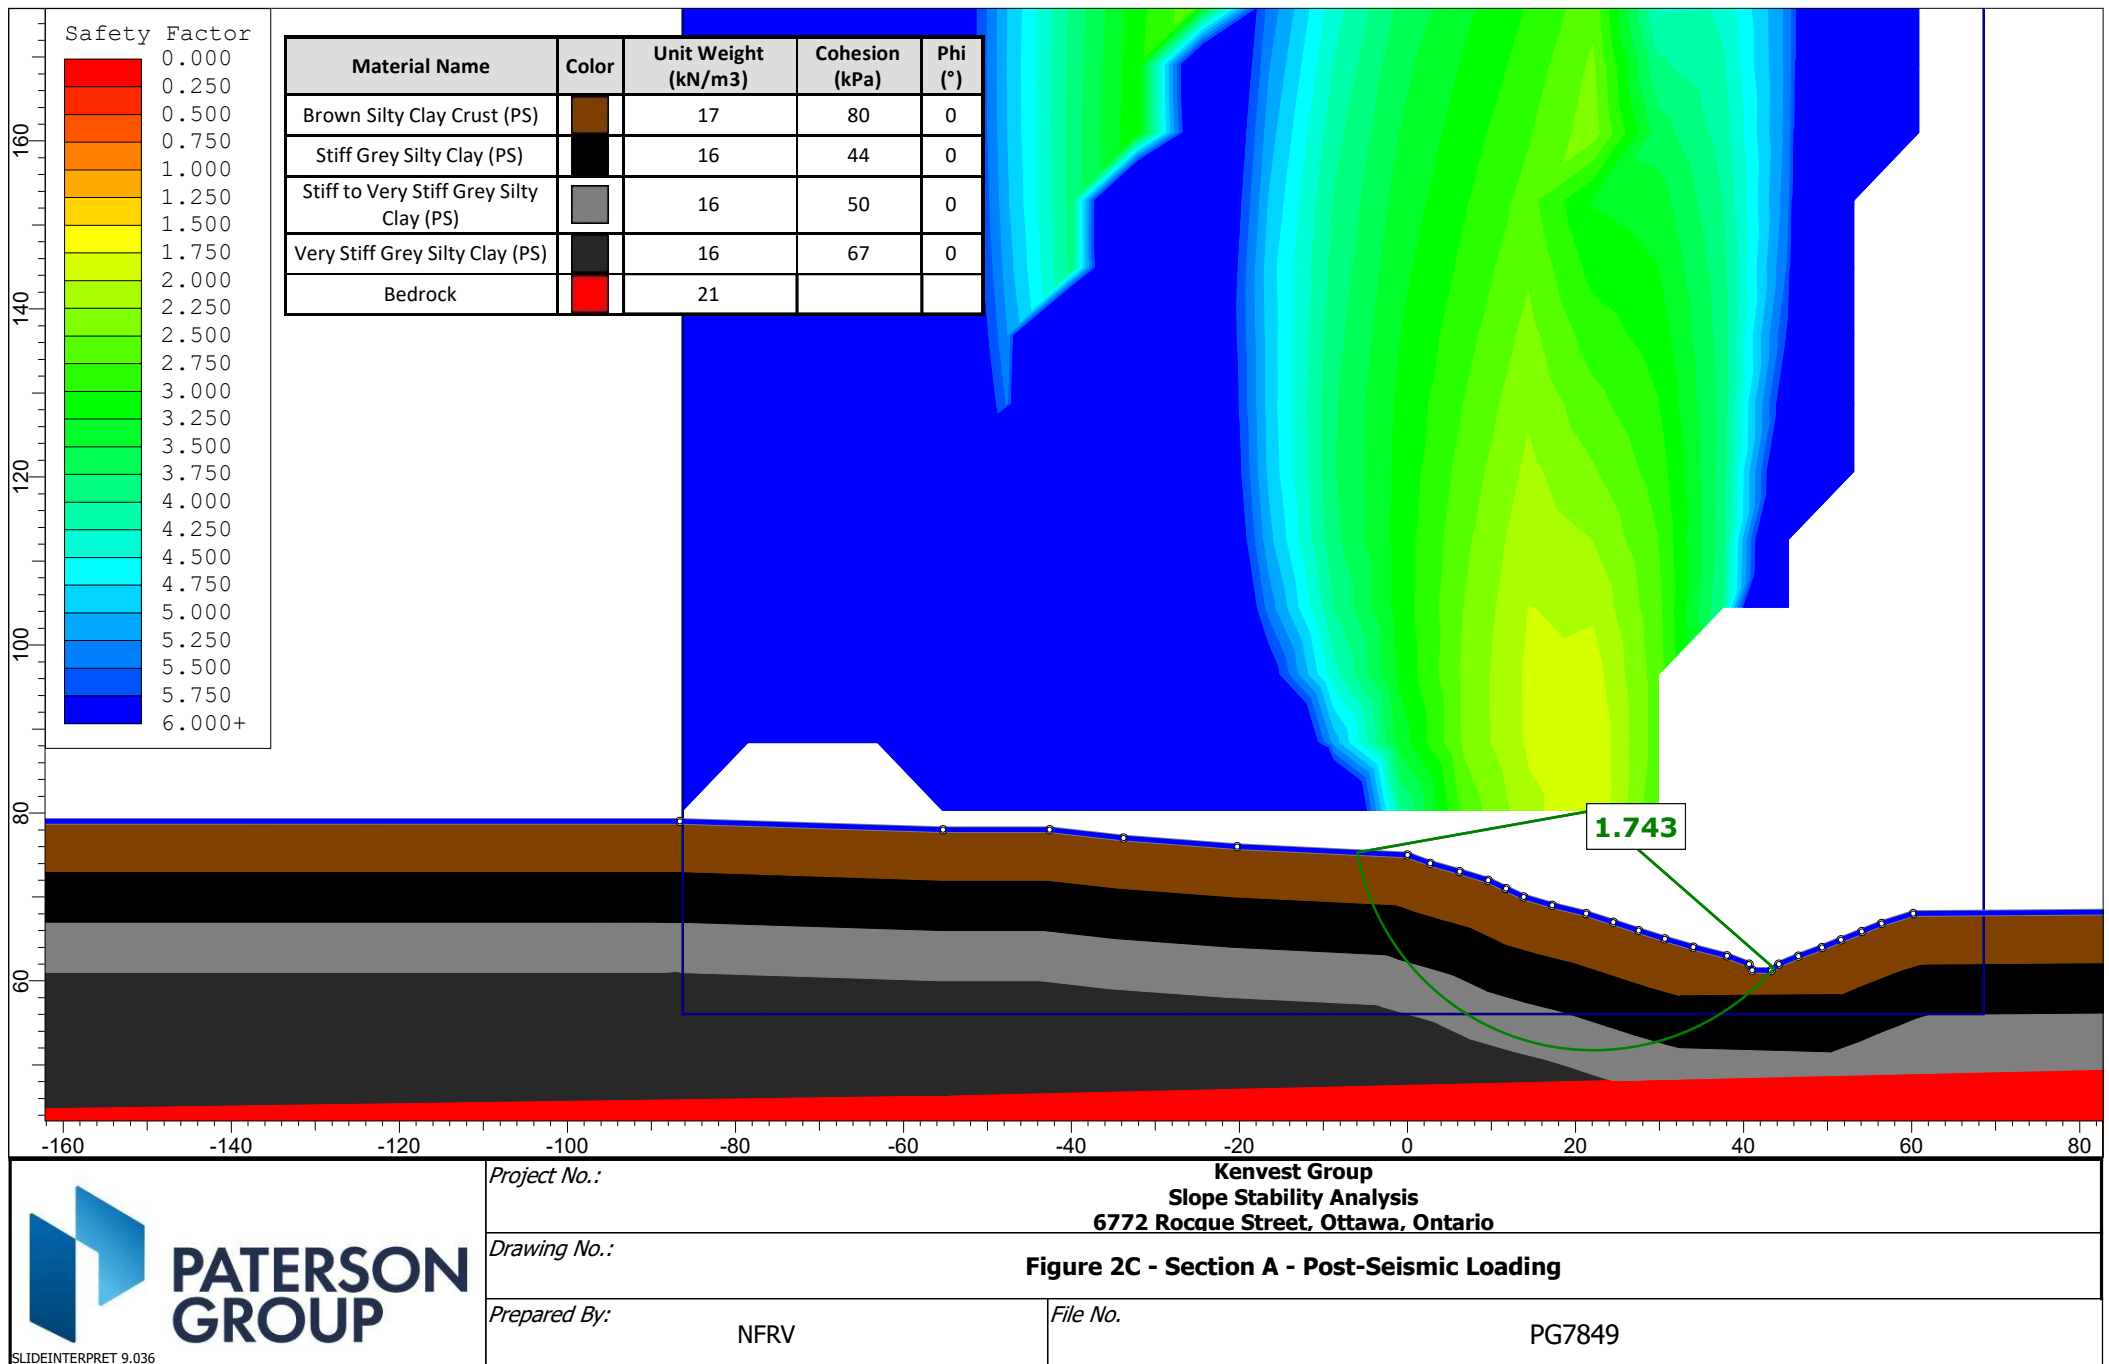
| | <i>Drawing No.:</i> | | | <b>Figure 2B - Section A - Seismic Loading</b> | | |

A high groundwater sensitivity analysis was completed with the groundwater table placed at the existing ground surface to assess the potential influence of adverse groundwater conditions that may occur during periods of significant snowmelt or precipitation. The results of the analyses completed using both groundwater conditions indicated that the calculated factors of safety remained above the minimum values required by the Guidance letter. The results of the high-groundwater scenario analysis yielded factors of safety of 1.56, 1.45, and 1.74 under static, seismic, and post-seismic loading conditions, respectively. Reference should be made to Figures 2A to 2C attached to the present report.

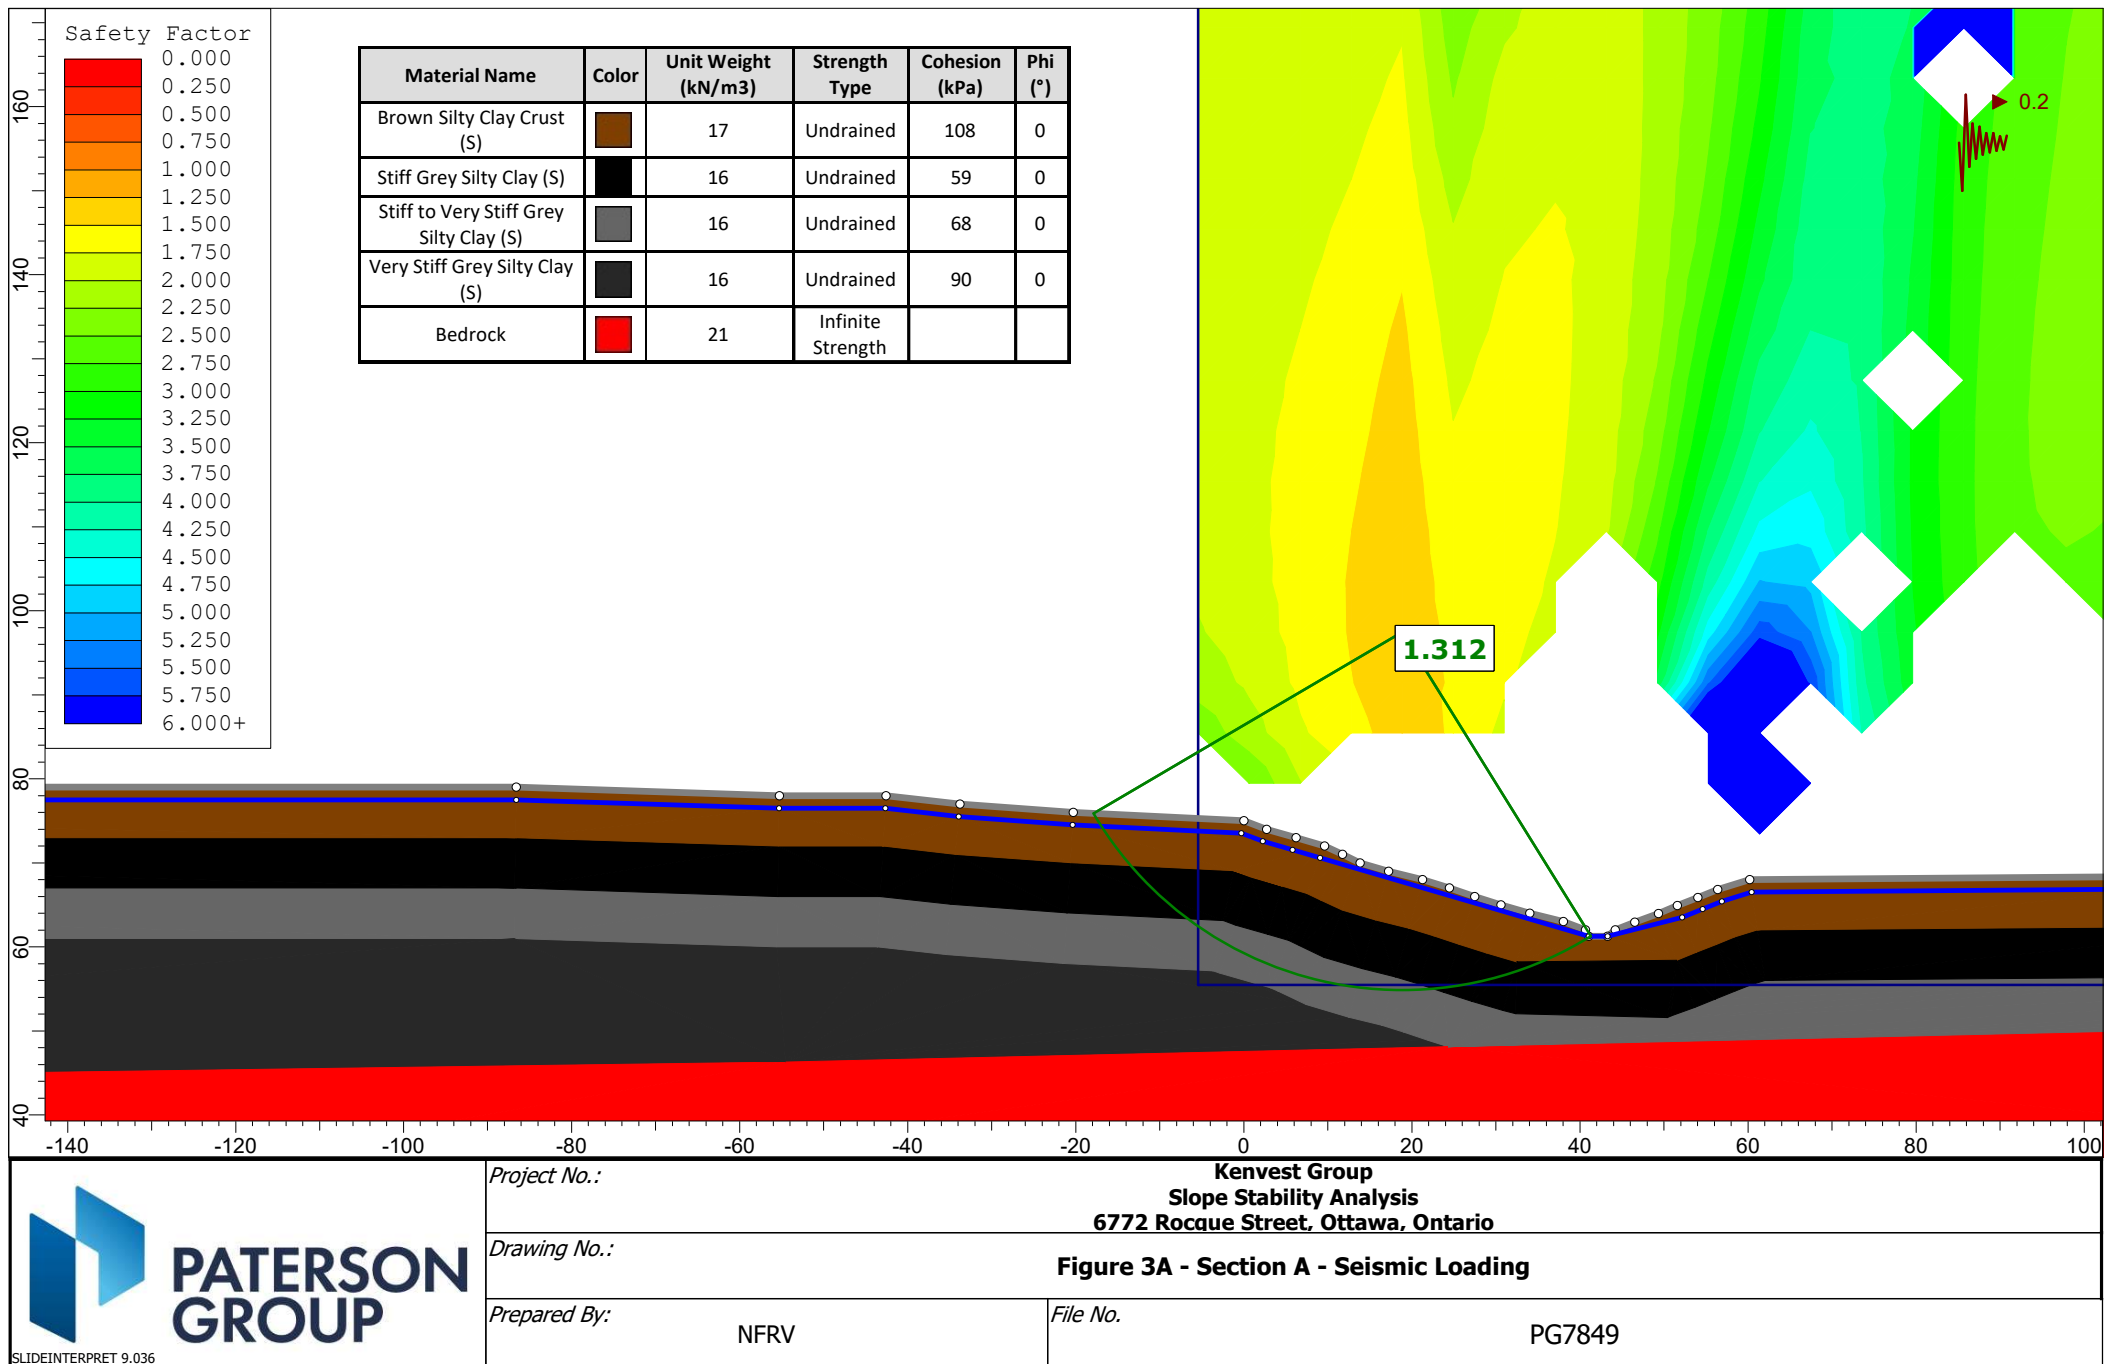
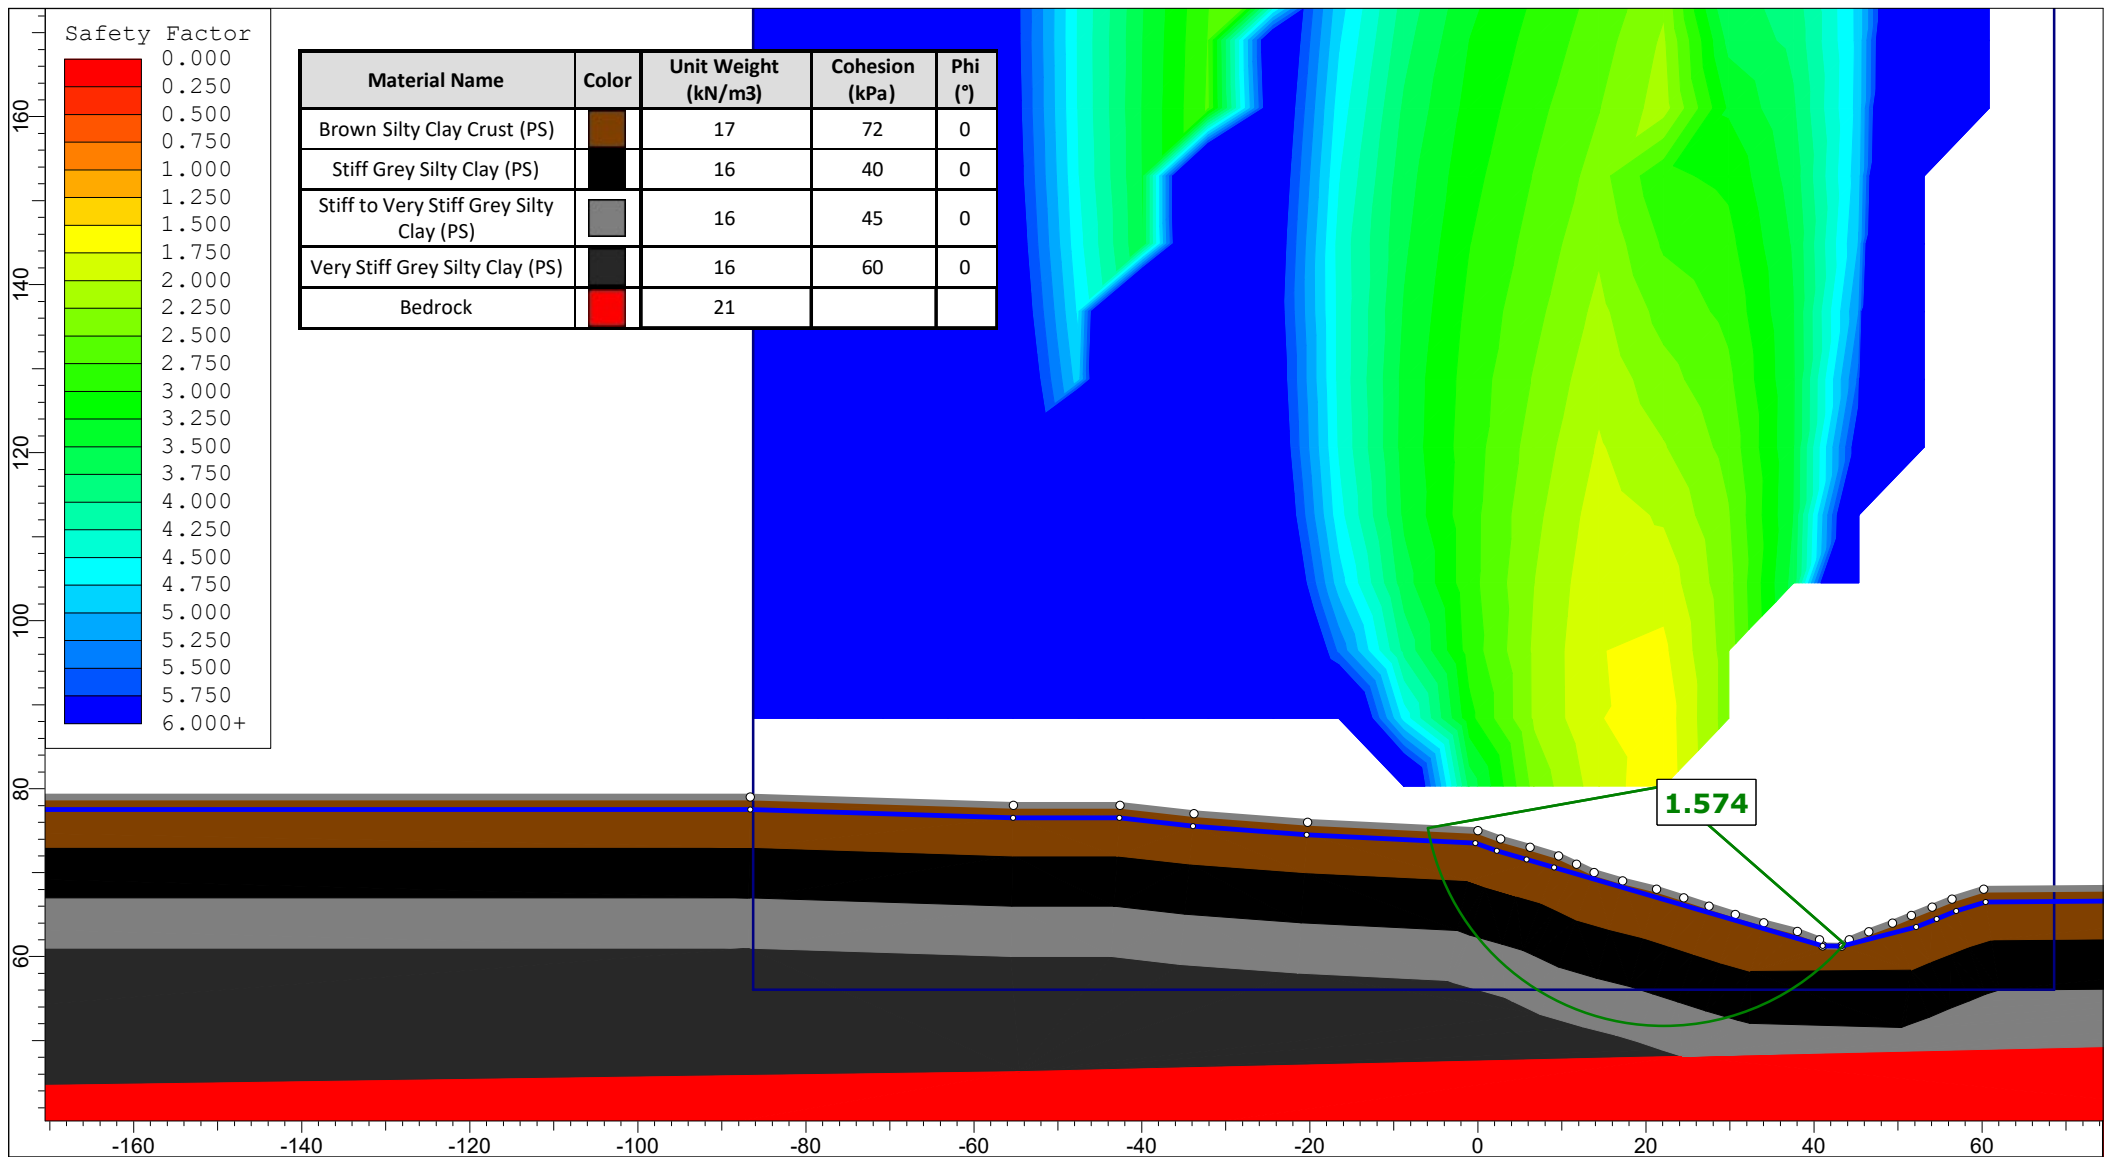
The results of the reduced undrained shear strength analysis yielded factors of safety of 1.31 and 1.57 under seismic and post-seismic conditions, respectively. Both results are greater than the minimum values required by the Guidance letter under seismic and post-seismic conditions. Reference should be made to Figures 3A to 3B attached to the present report.

Sensitivity analyses were also completed to assess the influence of the adopted undrained shear strength profile. As mentioned in previous sections of this report, the undrained shear strength values were developed from a statistical interpretation of the available field vane test data and were conservatively selected as the mean value less one standard deviation for each interpreted layer of the deposit. To further assess the reliability of the stability results, an additional sensitivity analysis was completed using an additional 10% reduction in the already conservatively selected undrained shear strength values for the seismic and post-seismic loading conditions.
