August 28, 2026  
PG7849-LET.01

**Subject: Geotechnical Desktop Slope Stability Assessment**  
Proposed Residential Development  
6772 Rocque Street  
Ottawa, Ontario

Further to your request and authorization, Paterson Group (Paterson) prepared the present letter report to provide our geotechnical desktop slope stability assessment of the existing escarpment slope located to the southeast of the subject site between St. Joseph Boulevard and Notre Dame Street.

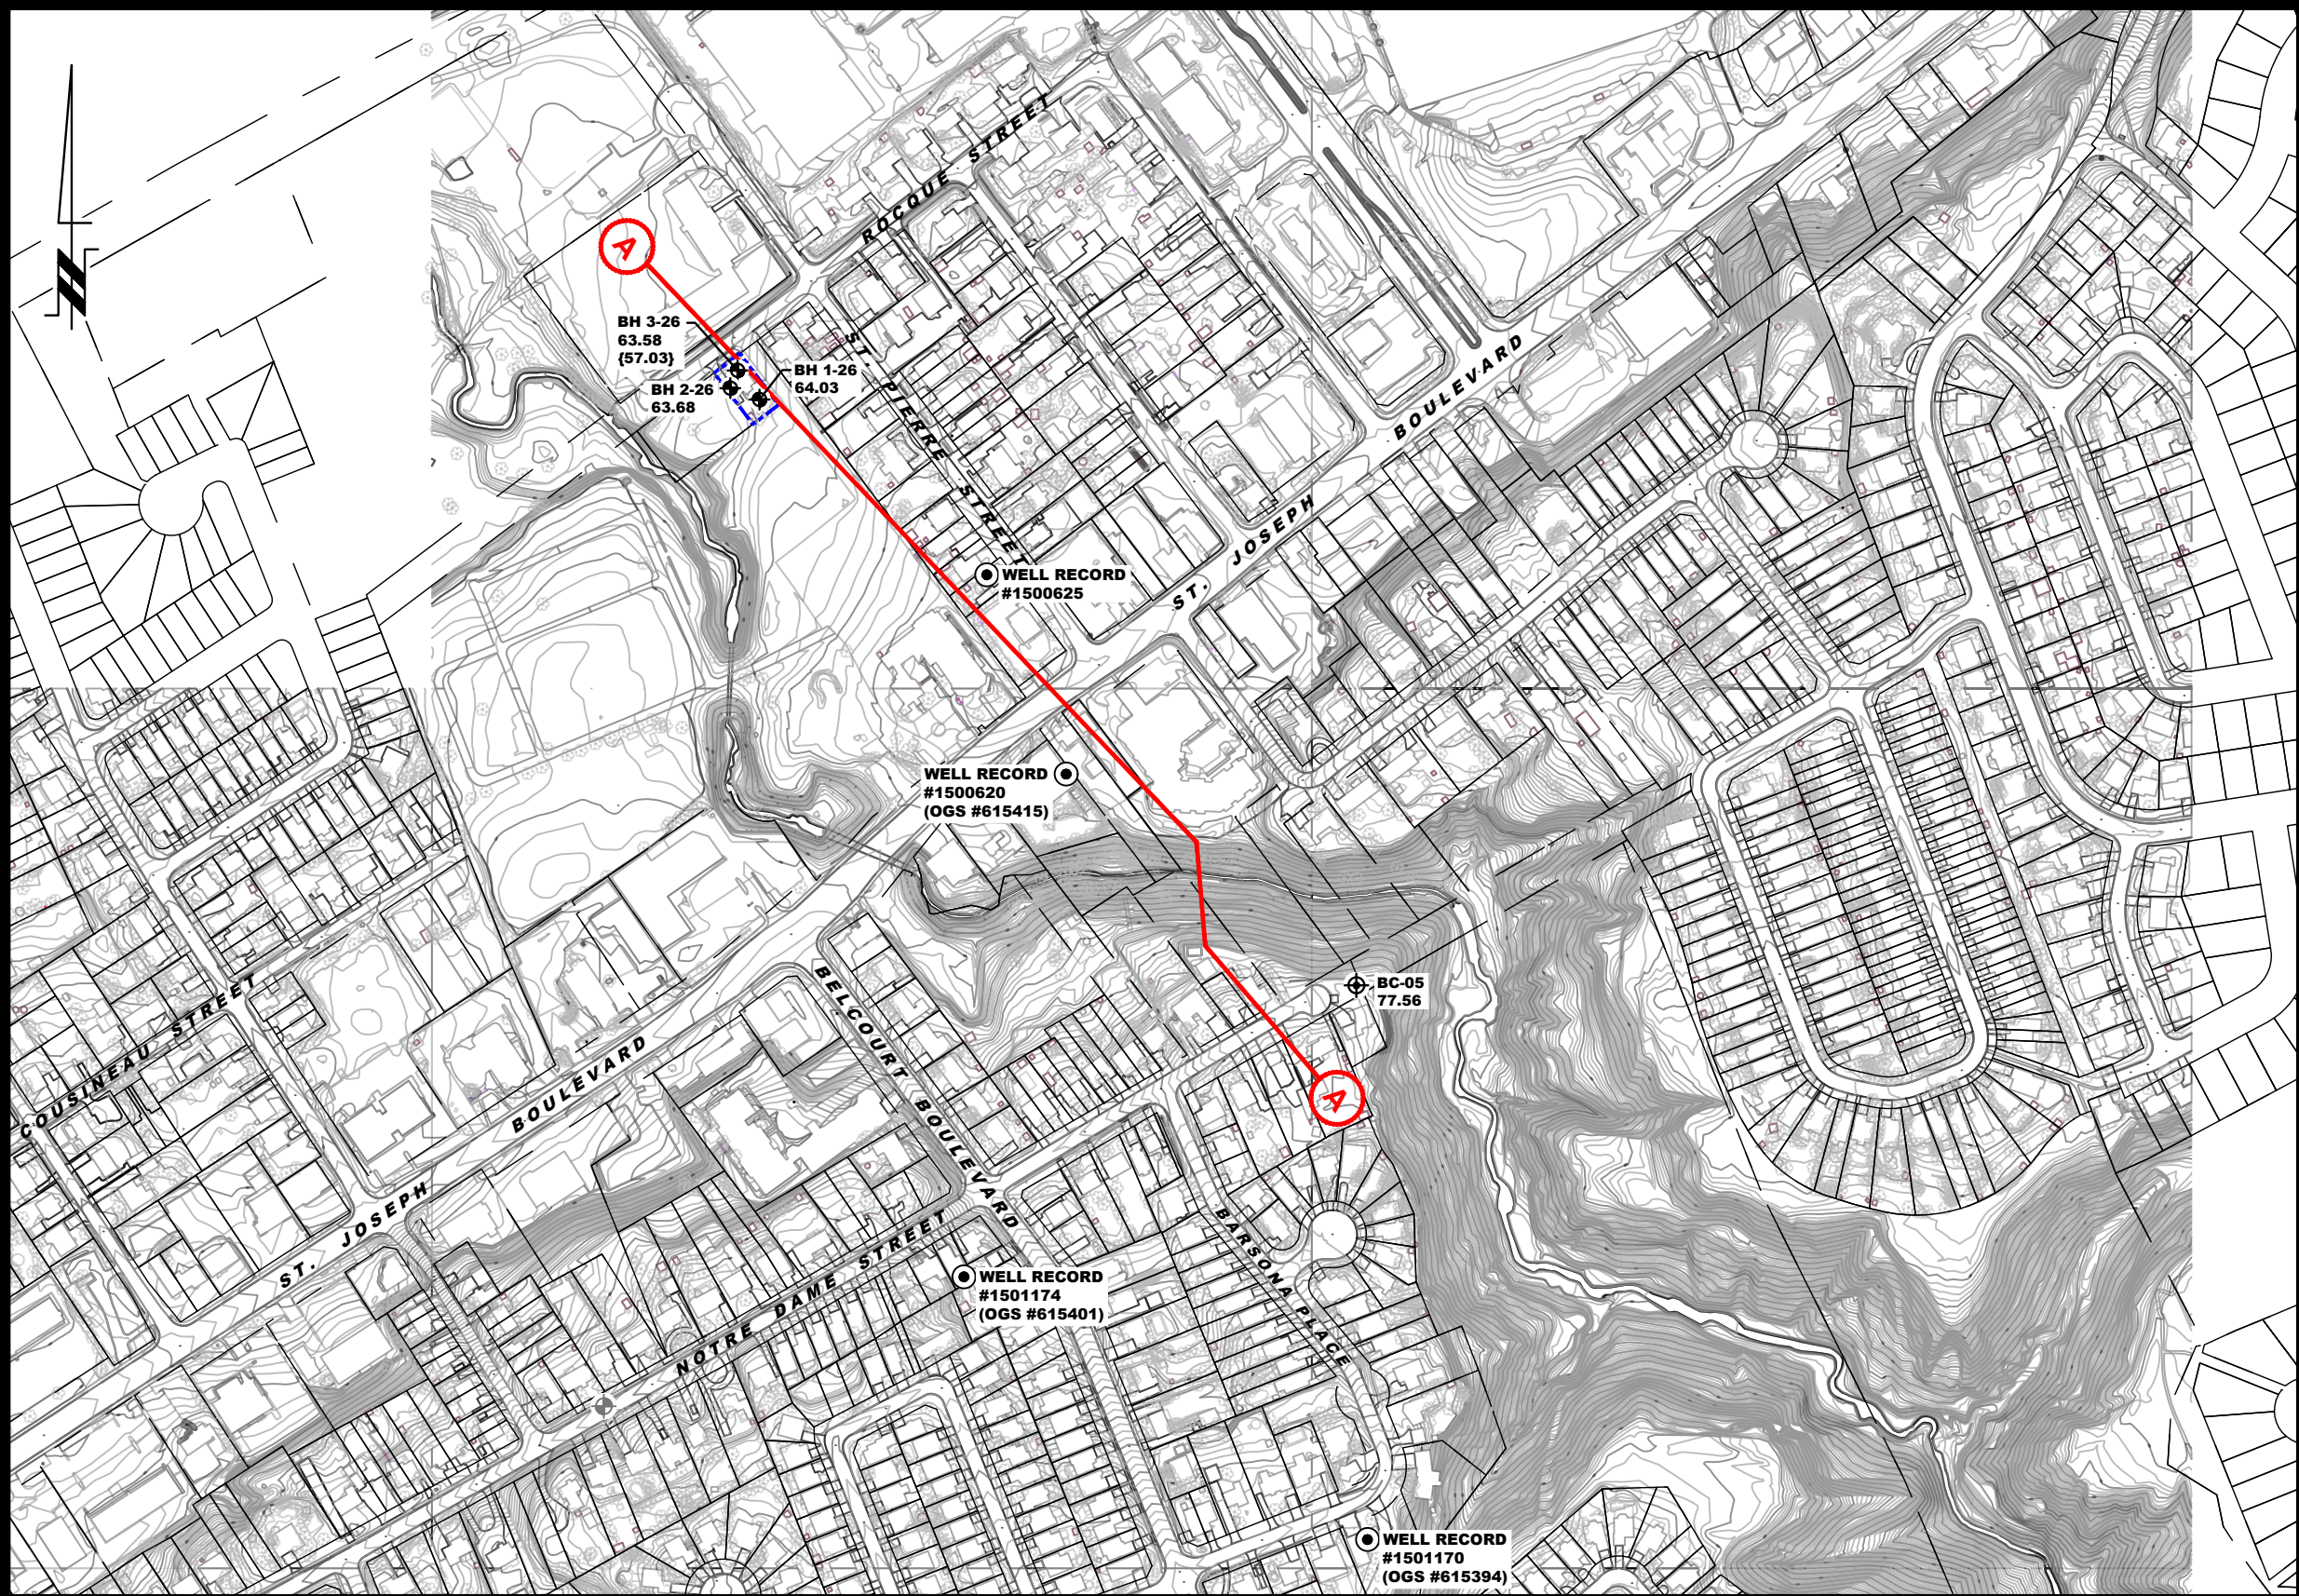
| Checked by: | NFRV | Dwg. No.: | PG7849-2 |

One (1) cross-section (Section A) was studied as a worst-case scenario. The location of Section A was selected to model the slope in its unsupported state rather than relying on the potential stability increase that the various existing retaining walls along the subject escarpment slope toe would provide. The cross-section location is presented on Drawing PG7849-2 – Test Hole Location Plan, attached to the present report.

The analysis approach adopted herein incorporates conservative assumptions regarding both soil strength and bedrock geometry. Reference should be made to Drawings *PG7849-2 – Test Hole Location Plan* and *PG7849-3 Extrapolated Borehole Data Cross-Section* attached to the present report for the approximate borehole locations considered in our assessment.

Reference should be made to Drawings PG7849-2 – Test Hole Location Plan and PG7849-3 Extrapolated Borehole Data Cross-Section attached to the present report for the approximate test hole locations considered in our assessment when modelling the bedrock surface.

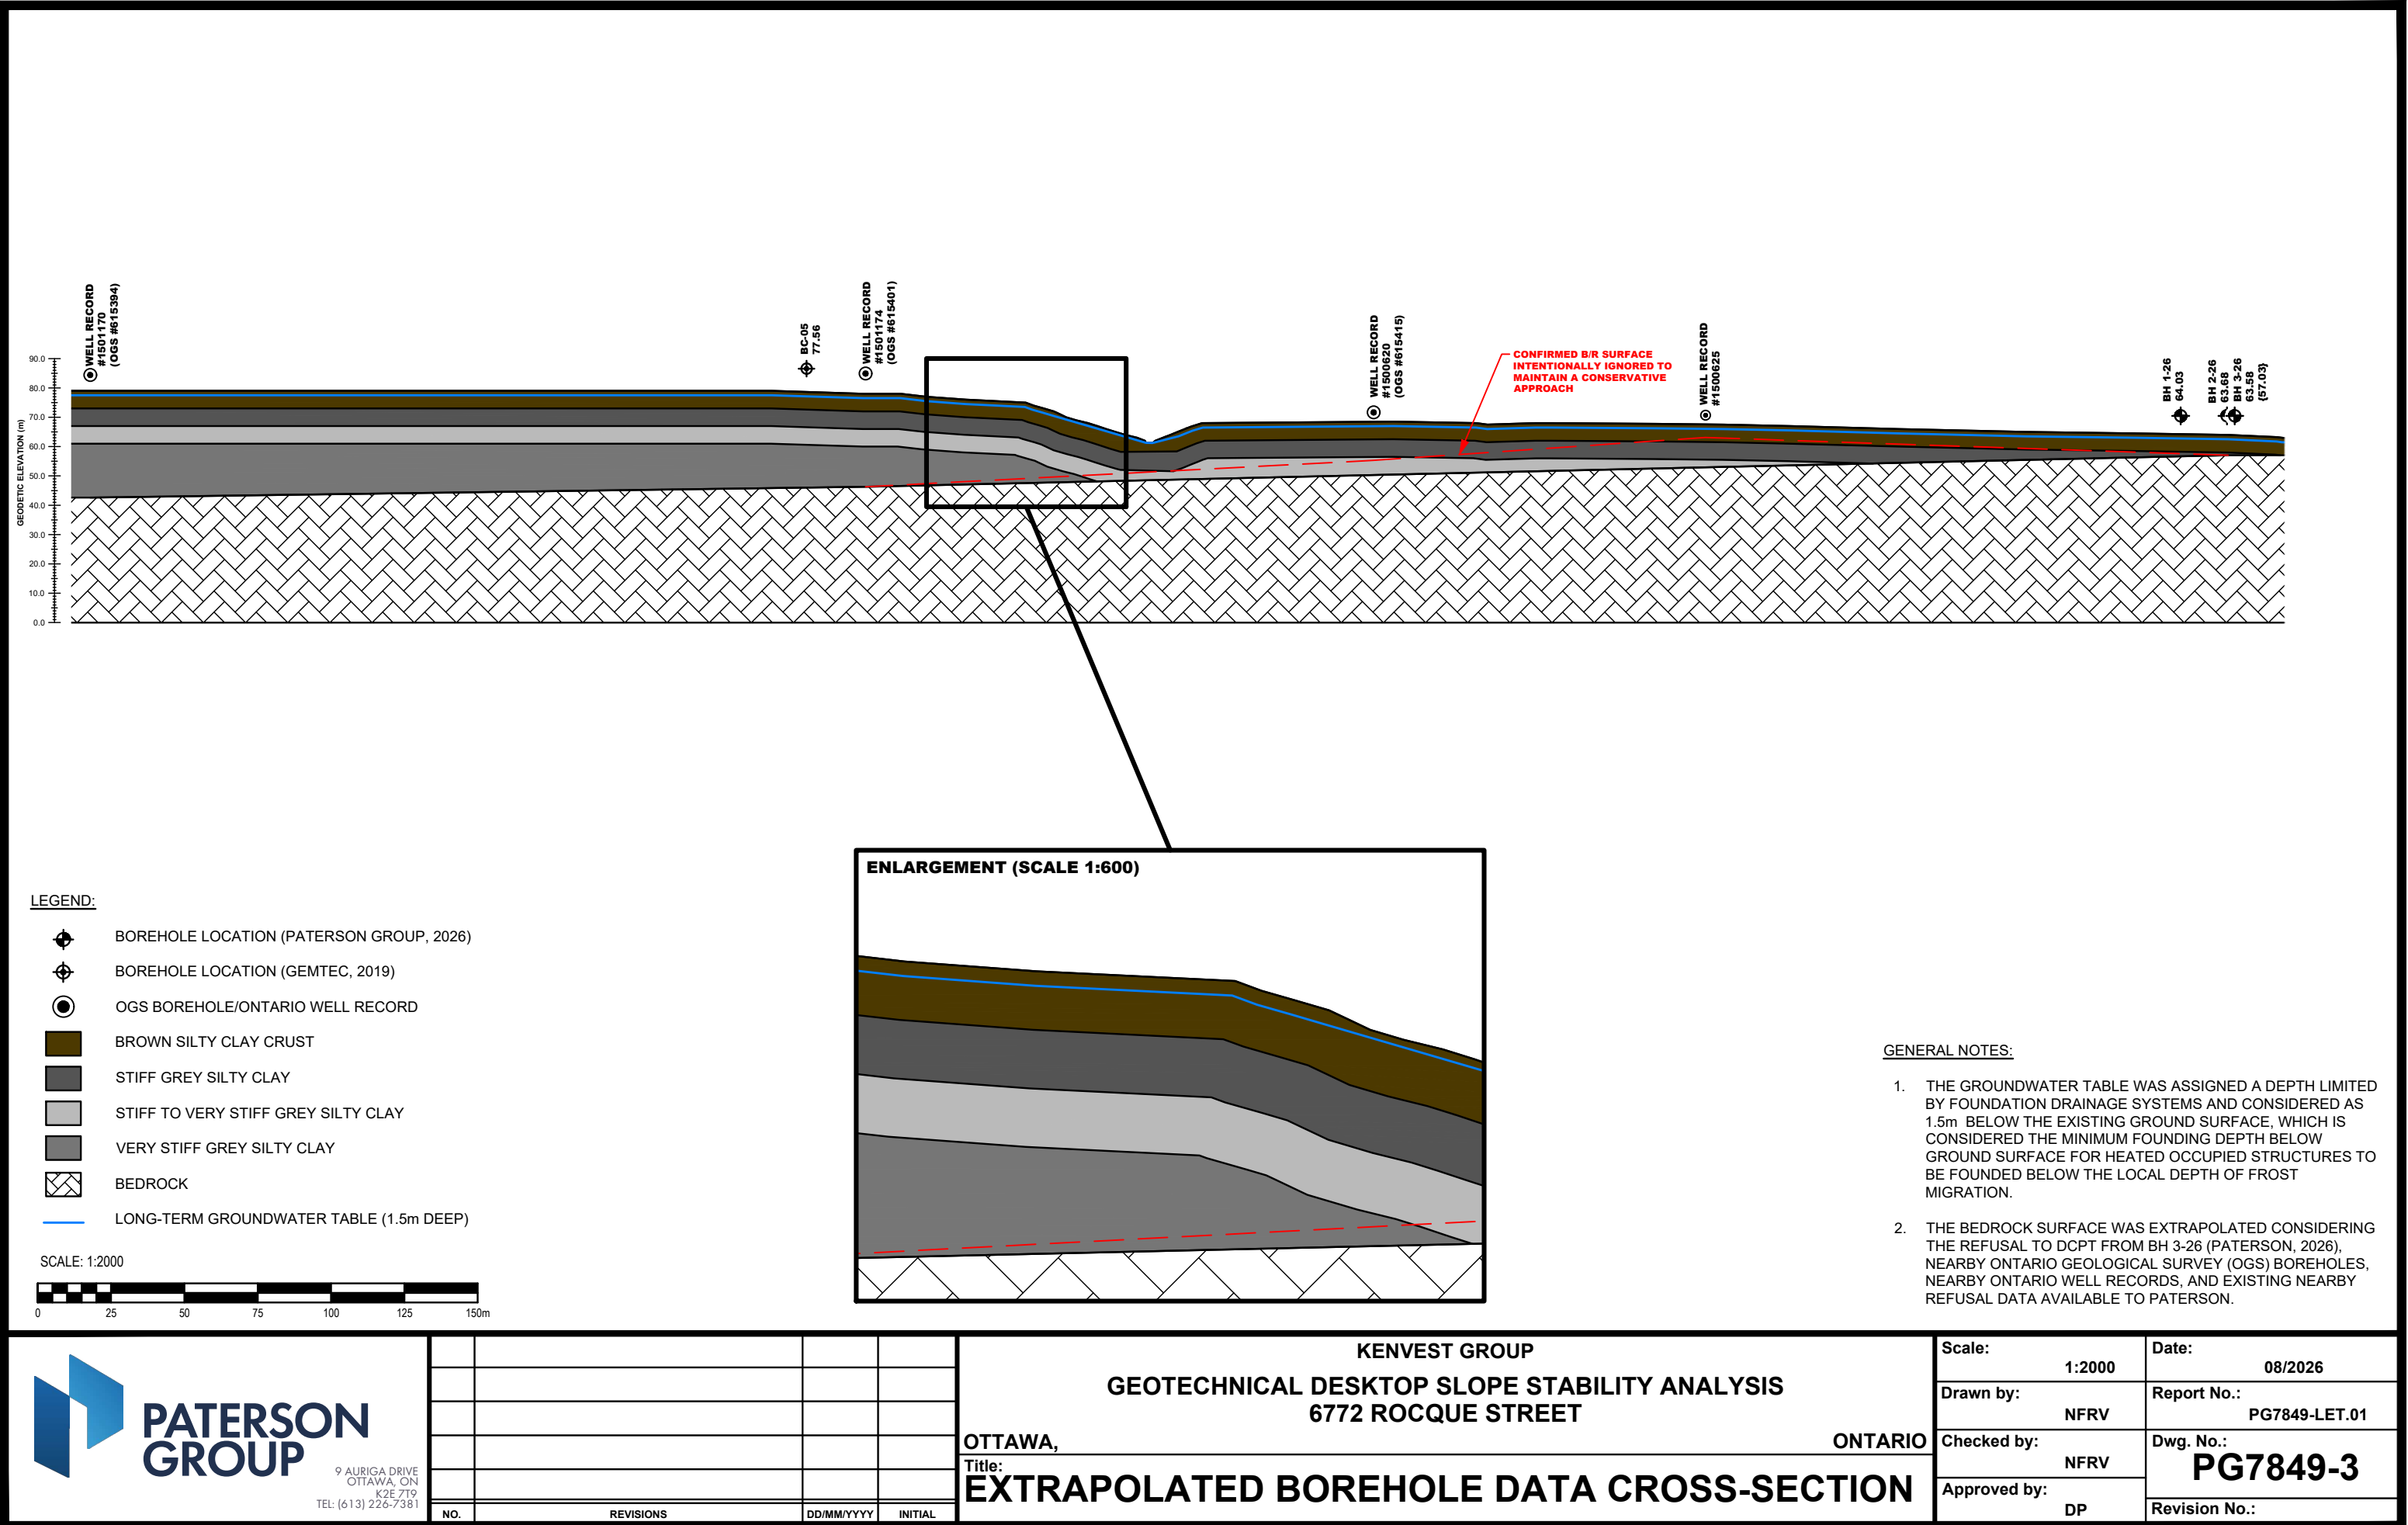
The slope stability analysis considers a bedrock surface elevation tapering from north to south between approximate elevation 57 m beyond the toe of slope (within the subject site boundary), and 42 m beyond the top of slope (towards the south). These interpolated bedrock surface elevations are based on DCPT refusal encountered at the test hole advanced within the subject site boundary during the current investigation, and available Ontario Well Record bedrock data. Nearby Ontario Well Record data indicates that the bedrock surface north of the subject escarpment slope generally rises toward the north. Nevertheless, the bedrock surface adopted in the analysis was conservatively interpolated at a greater depth, thereby omitting the stabilizing benefit associated with shallower bedrock and allowing for the evaluation of a broader range of potential slip surfaces within the deeper soil profile.
