# **Phase I Environmental Site Assessment**

6408 Renaud Road  
Ottawa, Ontario

Prepared for NCTL Homes Inc.

**Report: PE6788-1**

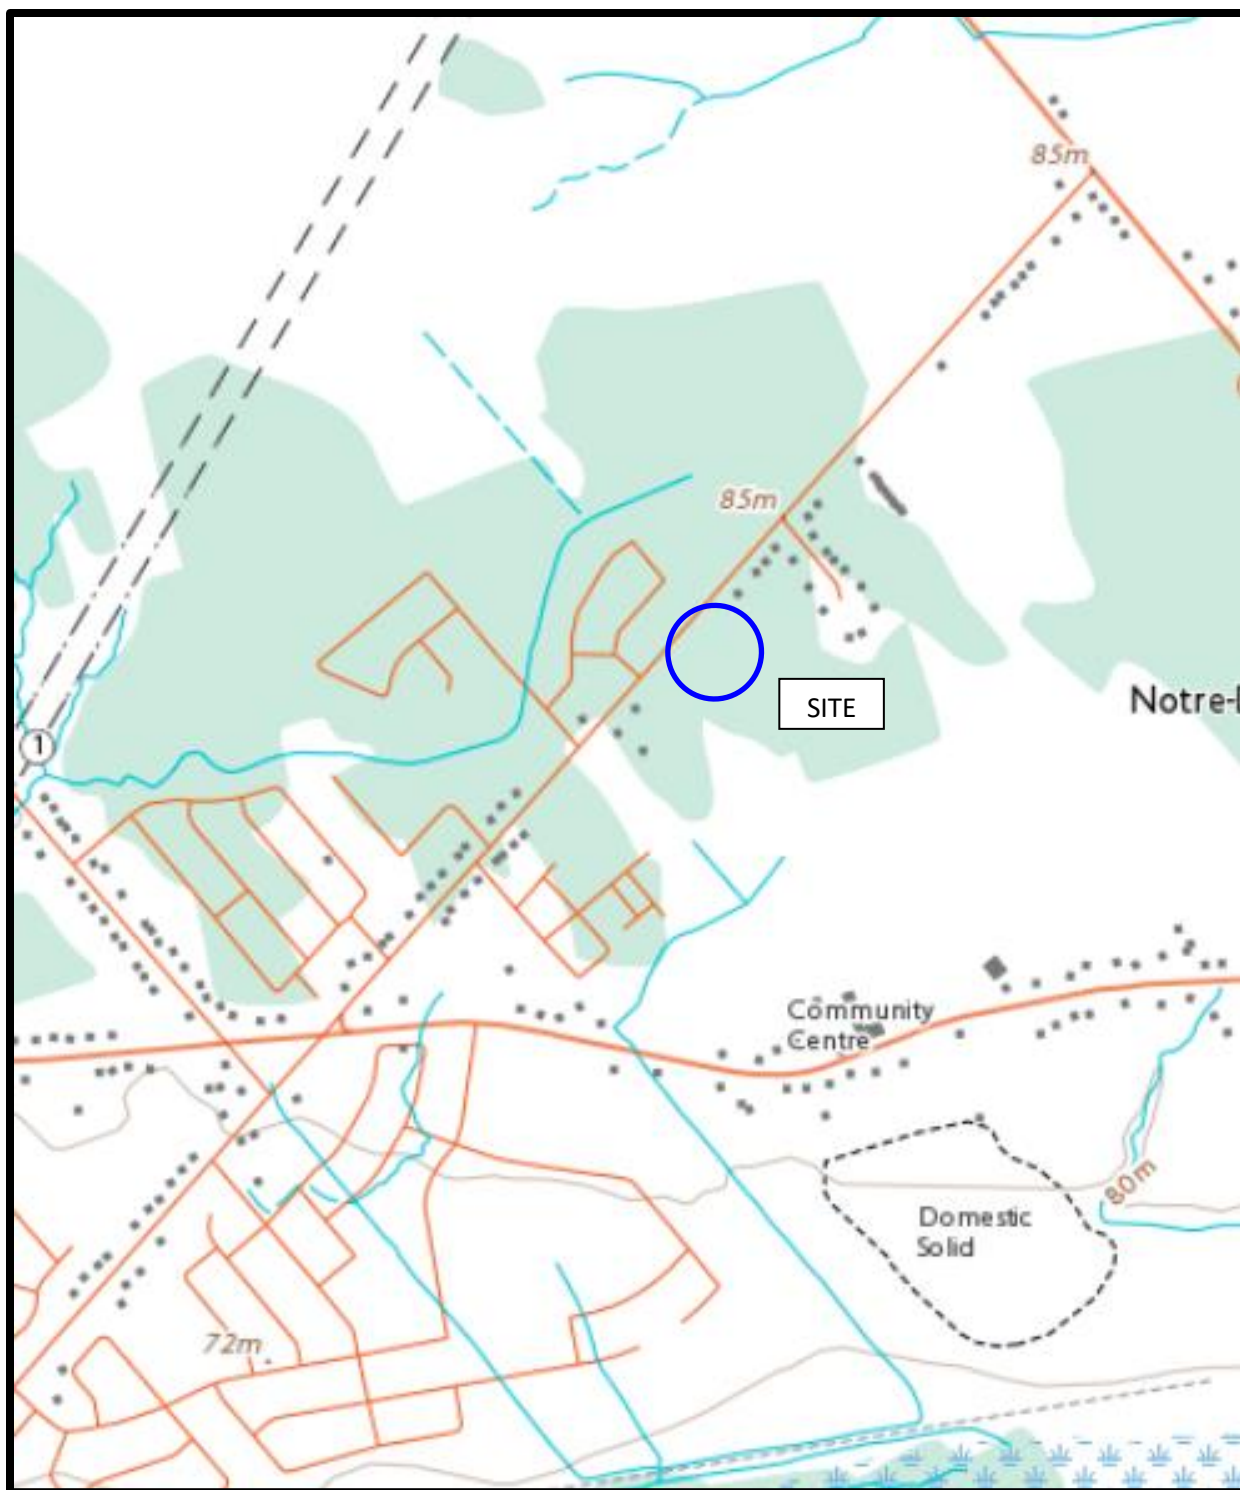
FIGURE 2

TOPOGRAPHIC MAP

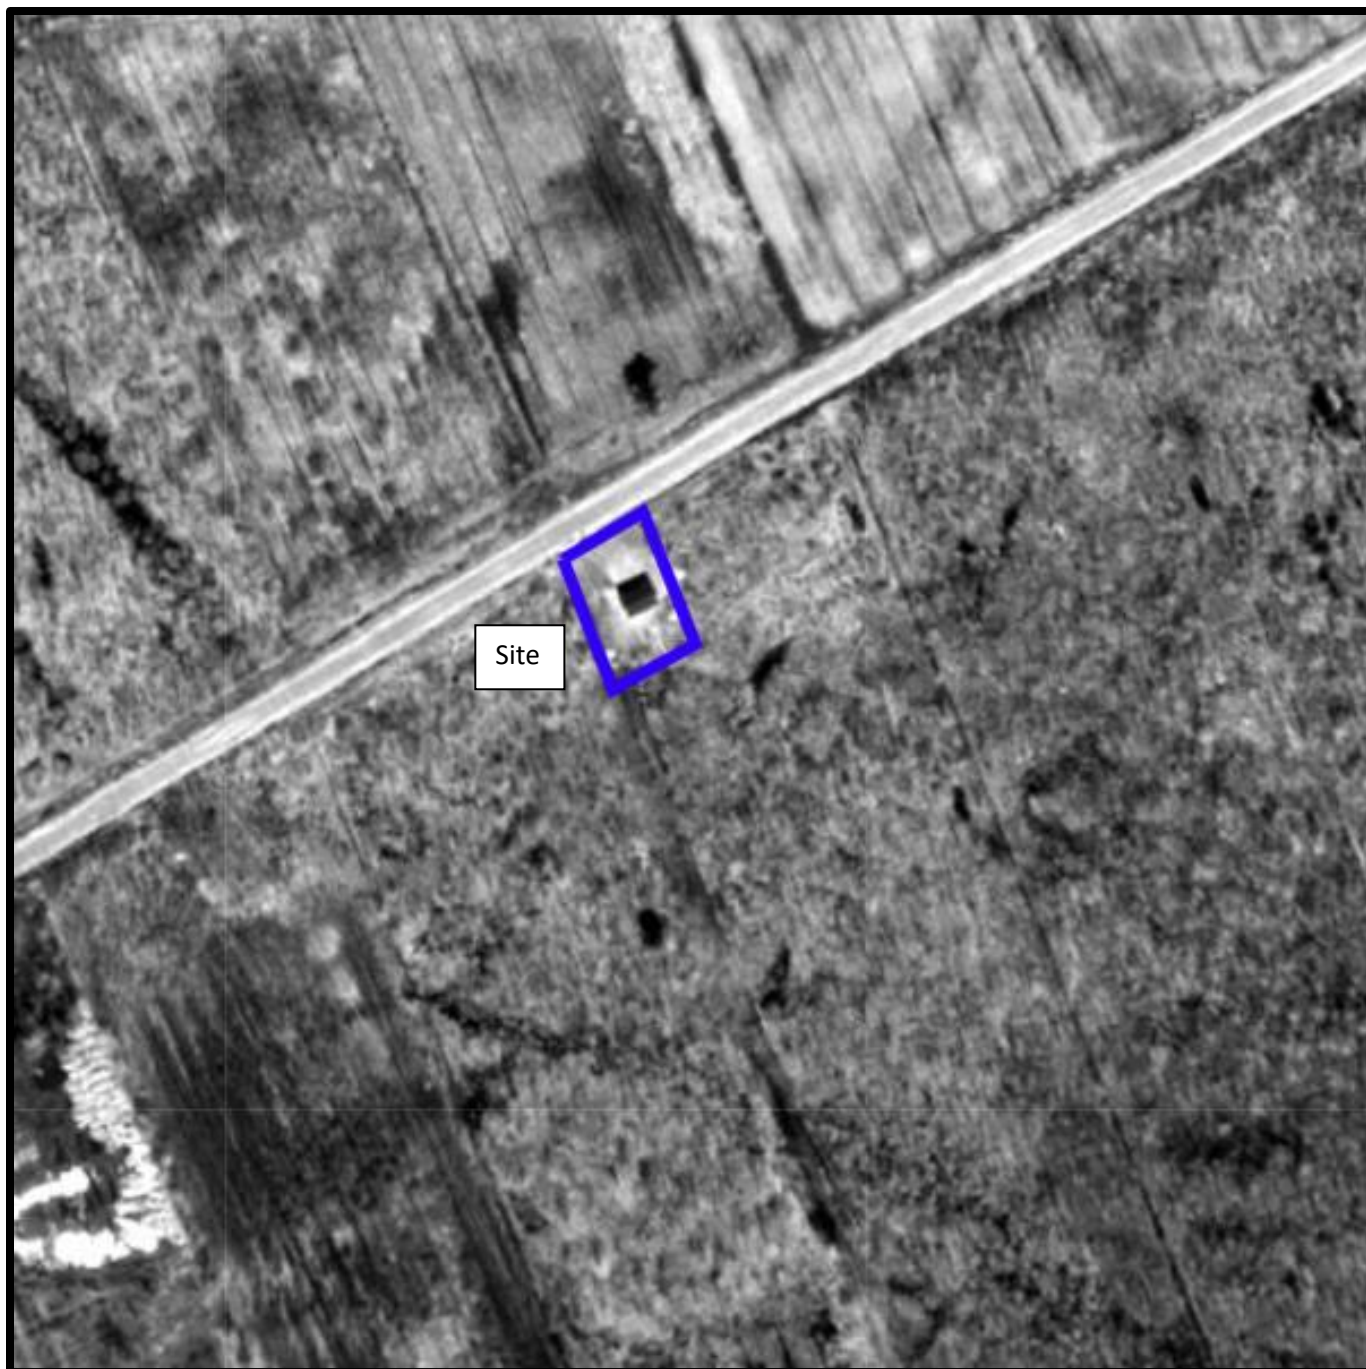
AERIAL PHOTOGRAPH  
1965

| 1965 | The Phase I Property is occupied by a residential dwelling. Renaud Road is observed adjacent to north of the Phase I Property. The surrounding properties consist of vacant/agricultural lands. |

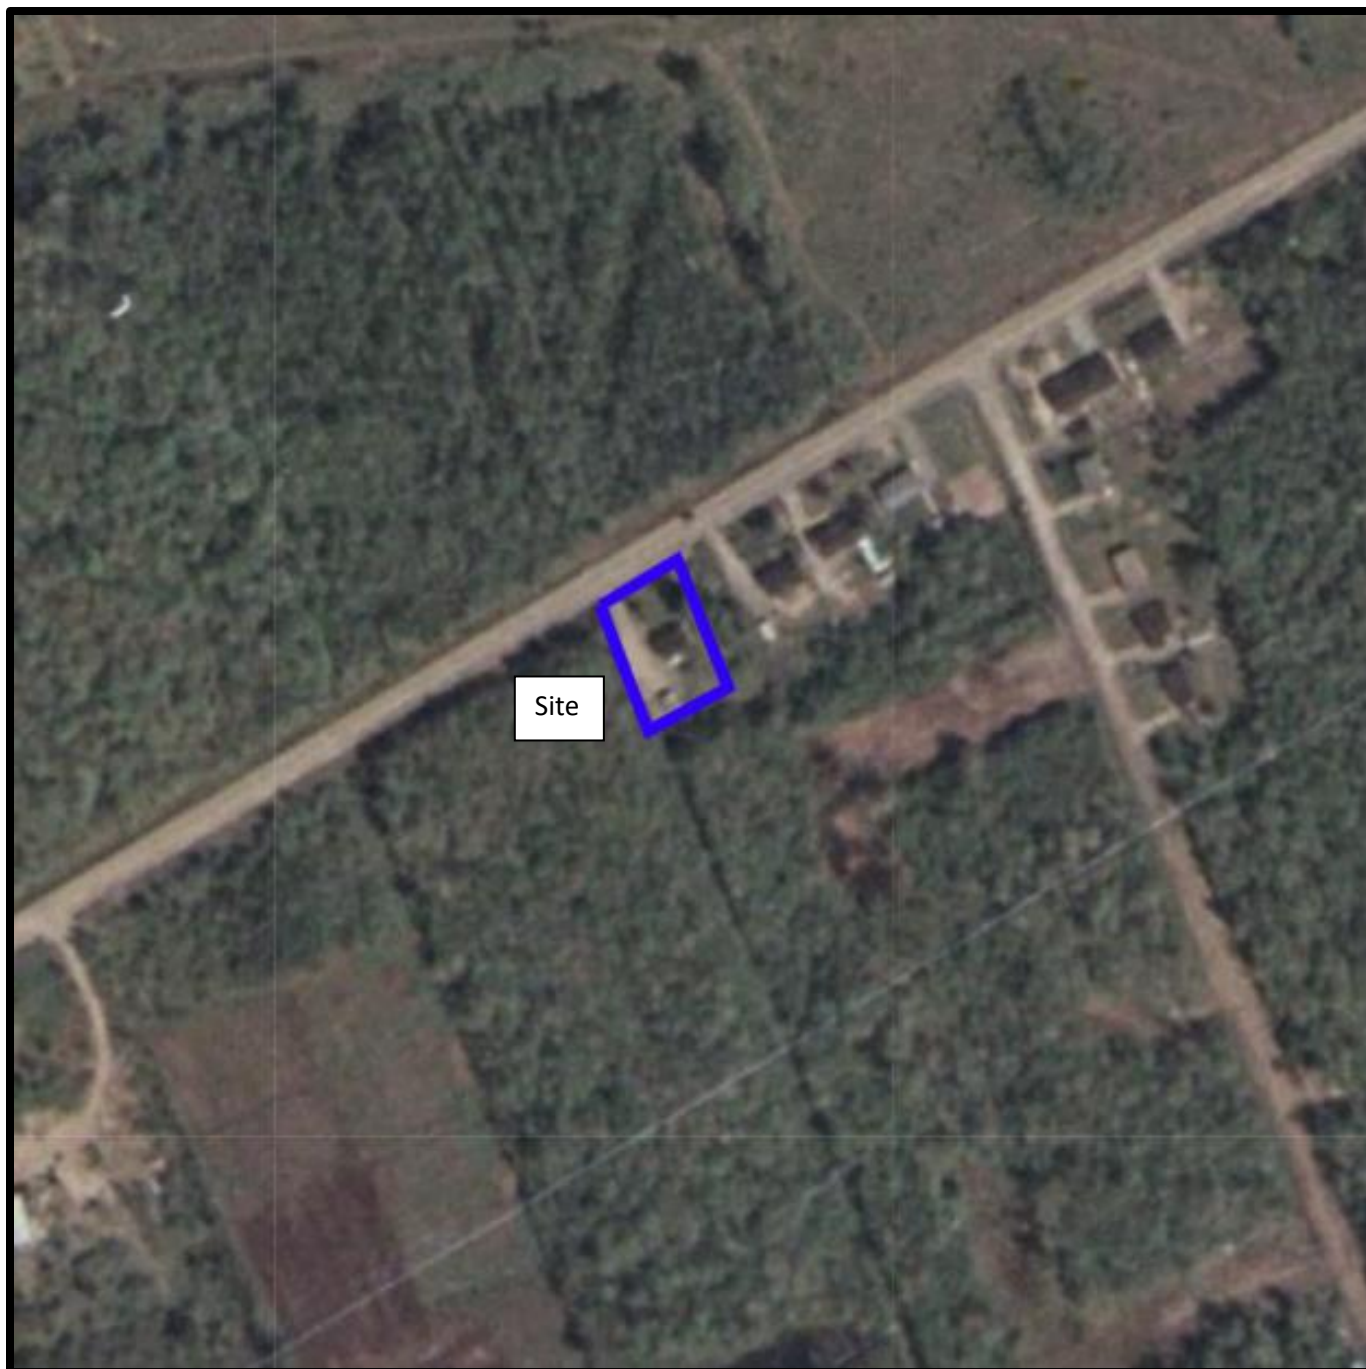
AERIAL PHOTOGRAPH  
1976

| 1976 | A private car garage is constructed in the southwest portion of the Phase I Property. The properties to the east and southeast of the Phase I Property are developed with residential dwellings along White Street and Renaud Road. White Street is observed constructed to the east of the Phase I Property. |

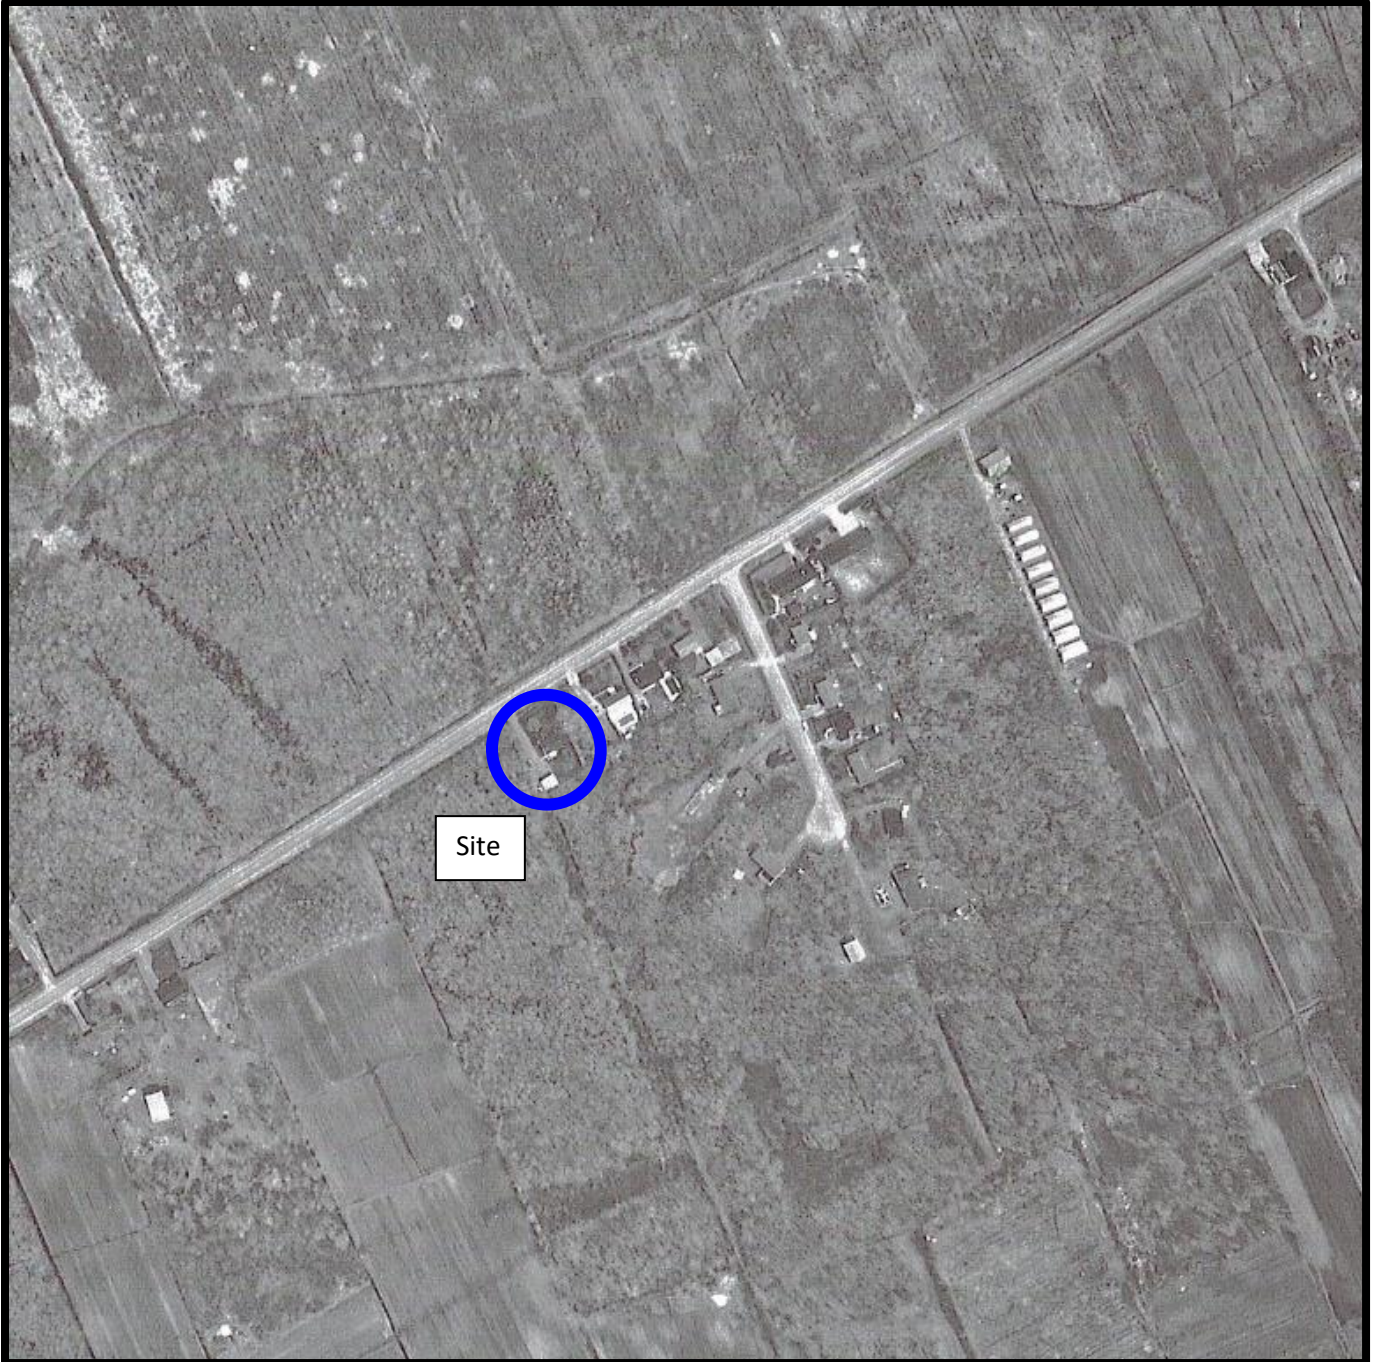
AERIAL PHOTOGRAPH  
1988

| 1988 | (Poor Scale) No significant changes are apparent with regard to the Phase I Property. Further residential development is observed to the southeast of the Phase I Property, along White Street. |

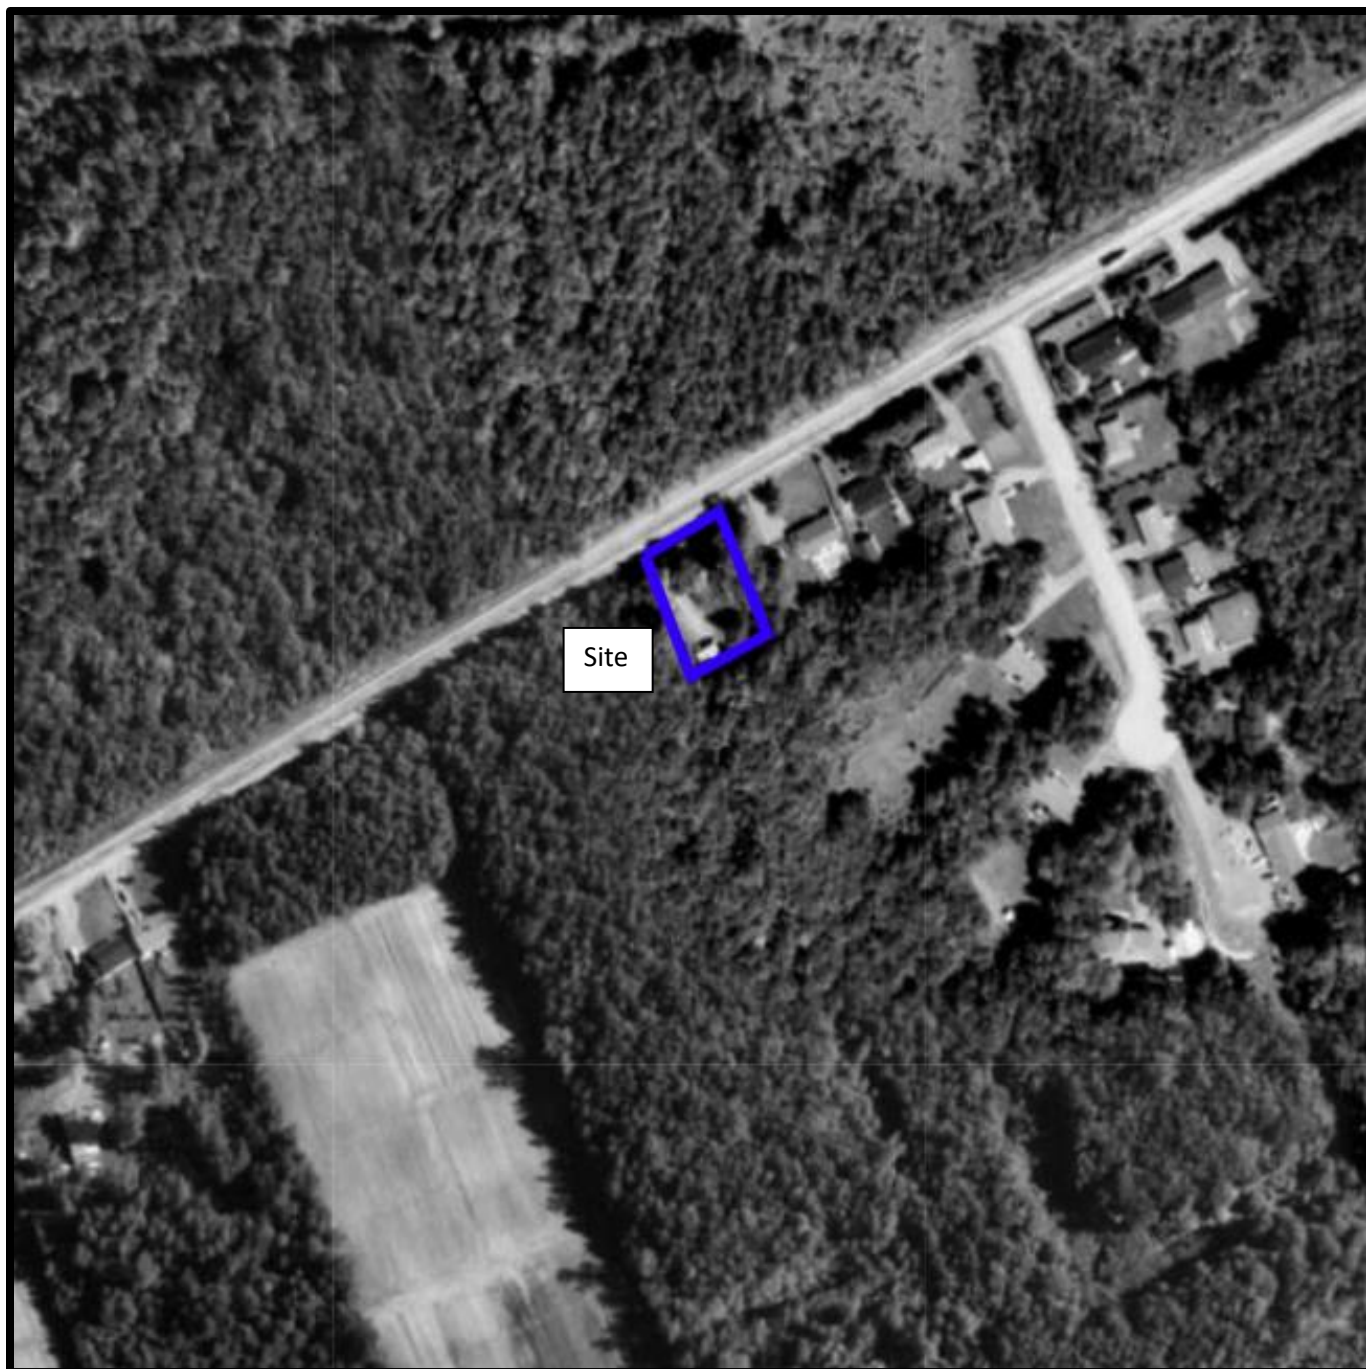
AERIAL PHOTOGRAPH  
1991

| 1991 | An addition to the former residential dwelling is observed on the Phase I Property. No significant changes are apparent with regard to the surrounding properties. |

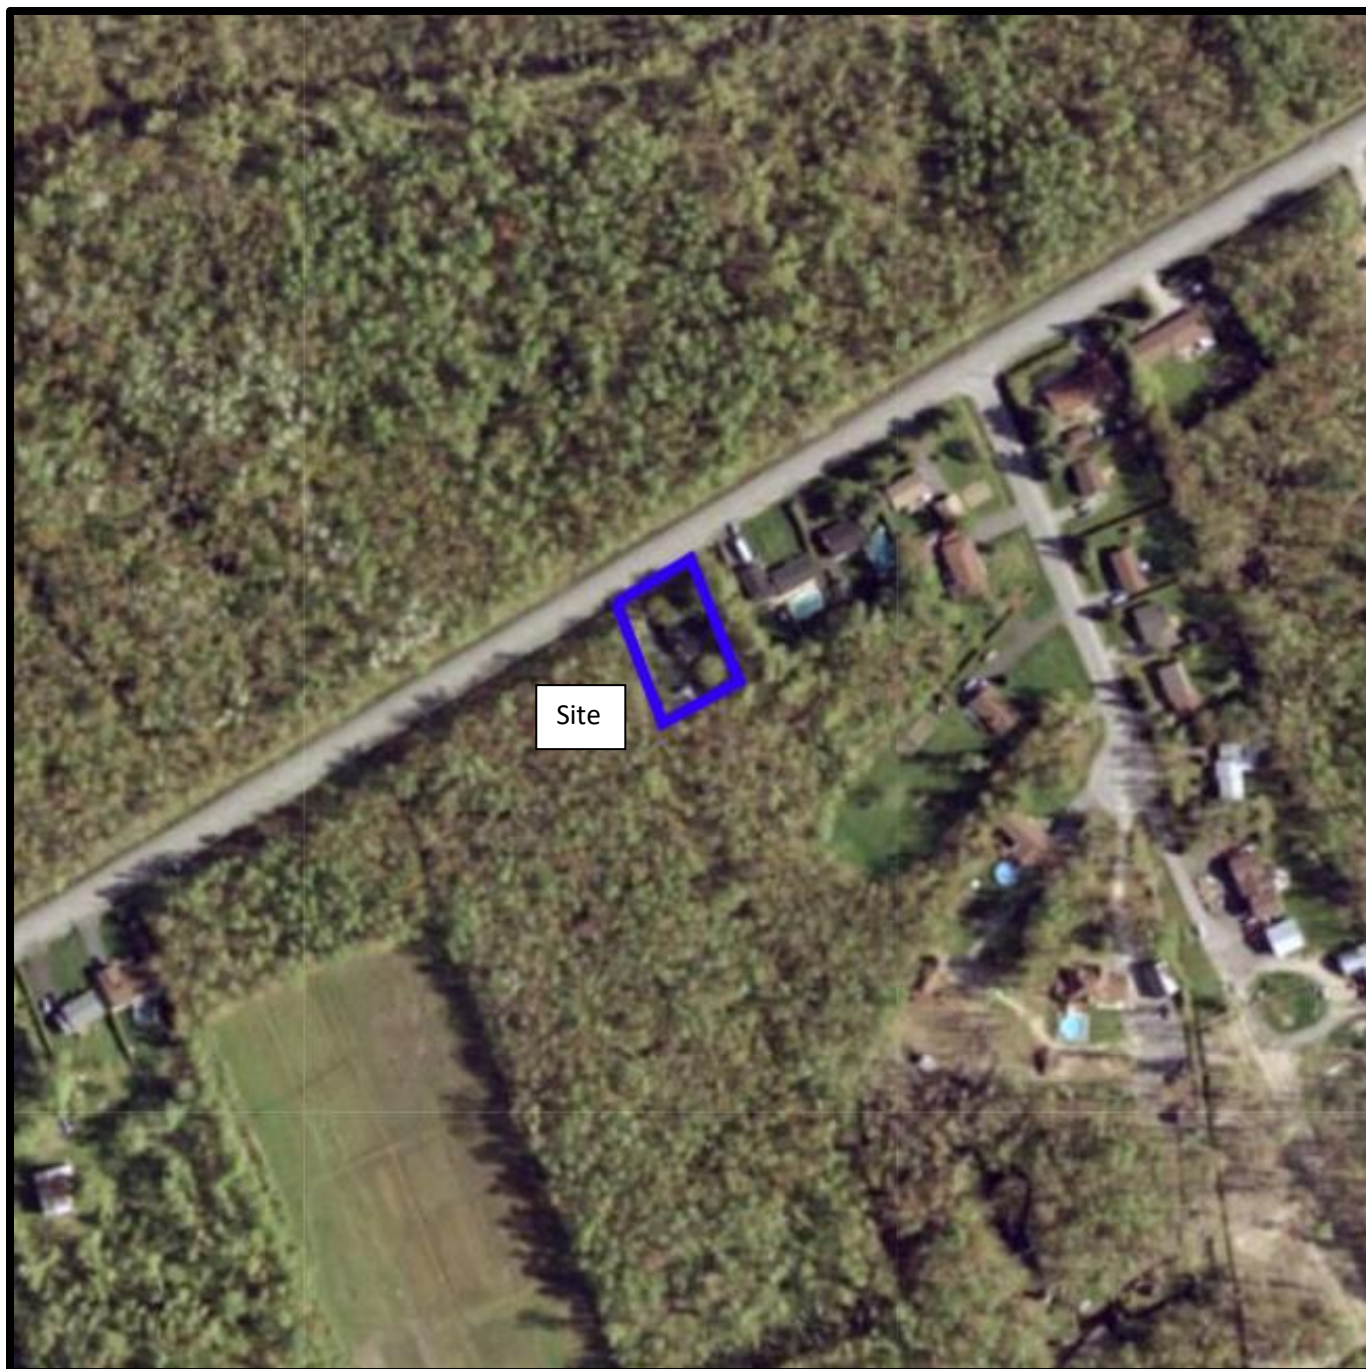
AERIAL PHOTOGRAPH  
2002

| 2002 | No significant changes are apparent with regard to the Phase I Property. Further residential development is observed to the southeast of the Phase I Property, along White Street. |

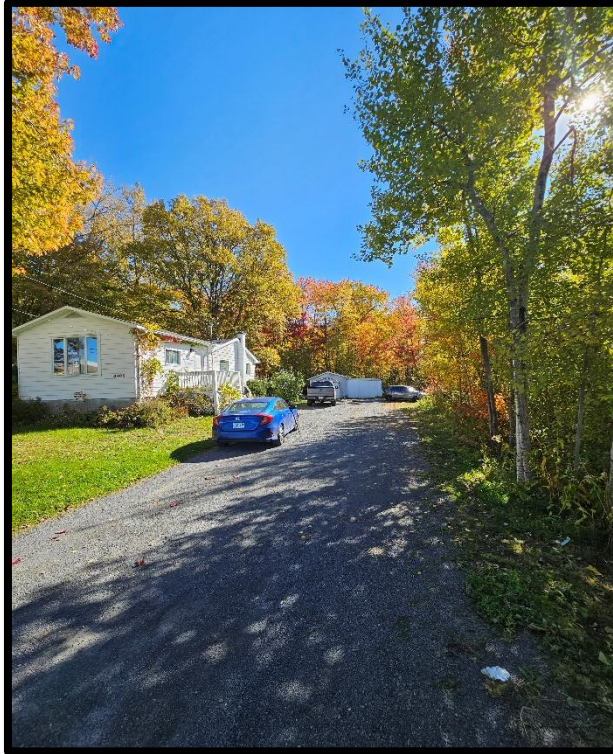
Photograph 1: View of the northwestern portion of the Phase I Property, facing south.

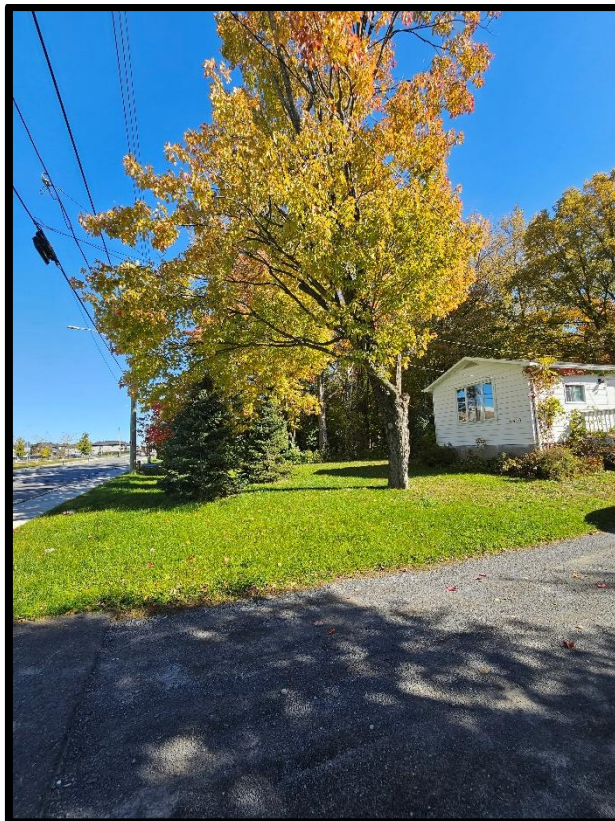
Photograph 2: View of the northern portion of the Phase I Property, facing east.
