June 25, 2026  
File: PE6465-LET.03

Subject: **Phase I - Environmental Site Assessment Update  
S-1 Lands (Quinn's Pointe Phase 6-8) -  
Part of 3882 Barnsdale Road and  
3933 Borrisokane Road  
Ottawa, Ontario**

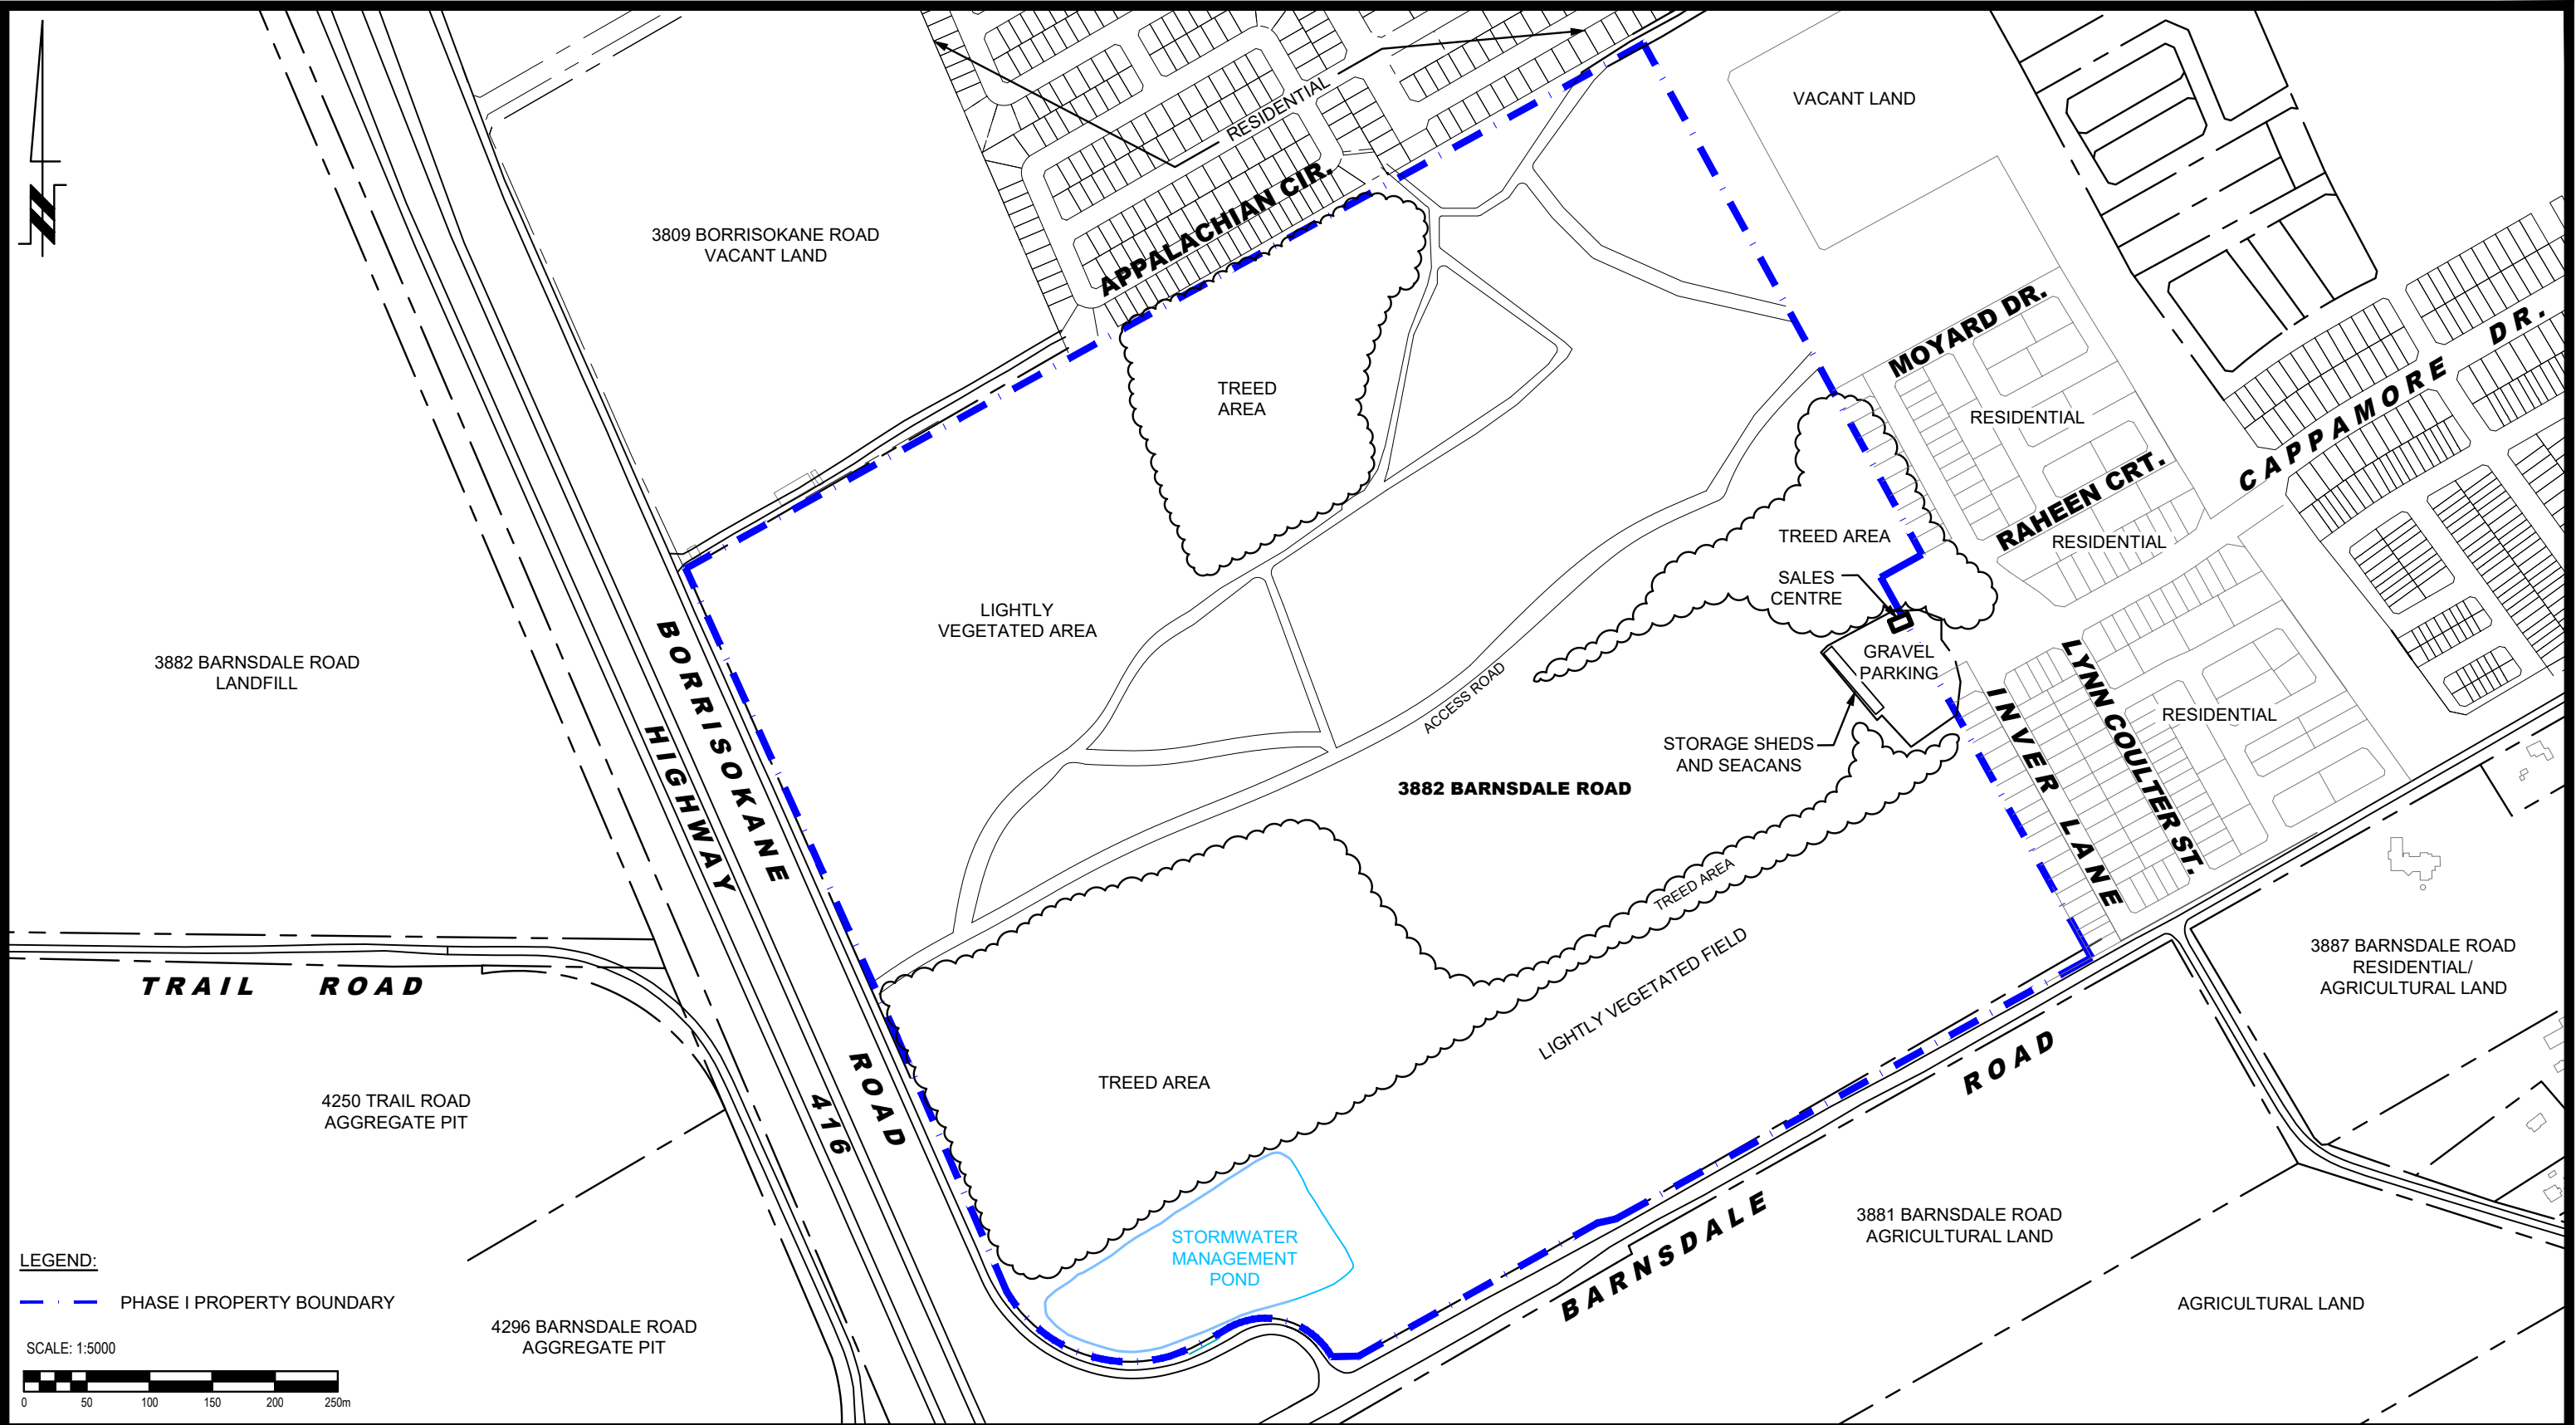
The above-noted site features are shown on Drawing PE6465-1R - Site Plan.

No permanent buildings or structures were observed on the Phase I Property however, a temporary sales centre was observed on the east-central portion of the Phase I Property. Additionally, several seacans and storage sheds were identified on the east-central portion of the Phase I Property.

Several monitoring wells were observed across the Phase I Property during the site visit. The monitoring wells were confirmed to have been recently installed as part of hydrogeological and geotechnical investigations on the Phase I Property. No potable wells or private sewage systems were observed on site, nor are any expected to be present, as the site has never been formally developed.

Stockpiles of native sand were observed in the eastern portion of the Phase I Property. The stockpiled material is not considered to represent an environmental concern on the Phase I Property.
