April 30, 2024  
File: PE6465-LET.01

Subject: **Phase I - Environmental Site Assessment Update  
Quinn's Pointe S1 Lands -  
Part of 3960 Greenbank Road and  
3882 Barnsdale Road  
Ottawa, Ontario**

Further to your request, Paterson Group (Paterson) conducted a Phase I - Environmental Site Assessment (Phase I ESA) Update for the aforementioned property. This report is an update of the previous Phase I ESA for the property addressed Part of 3960 Greenbank Road, completed by Paterson Group and dated November 25, 2022 and the Phase I ESA for the property addressed 3882 Barnsdale Road, completed by Paterson Group, dated November 25, 2022, and is intended to meet the requirements of a Phase I ESA Update, as per the MECP Standard O.Reg. 153/04, as amended, under the Environmental Protection Act. This report is to be read in conjunction with the previous reports.

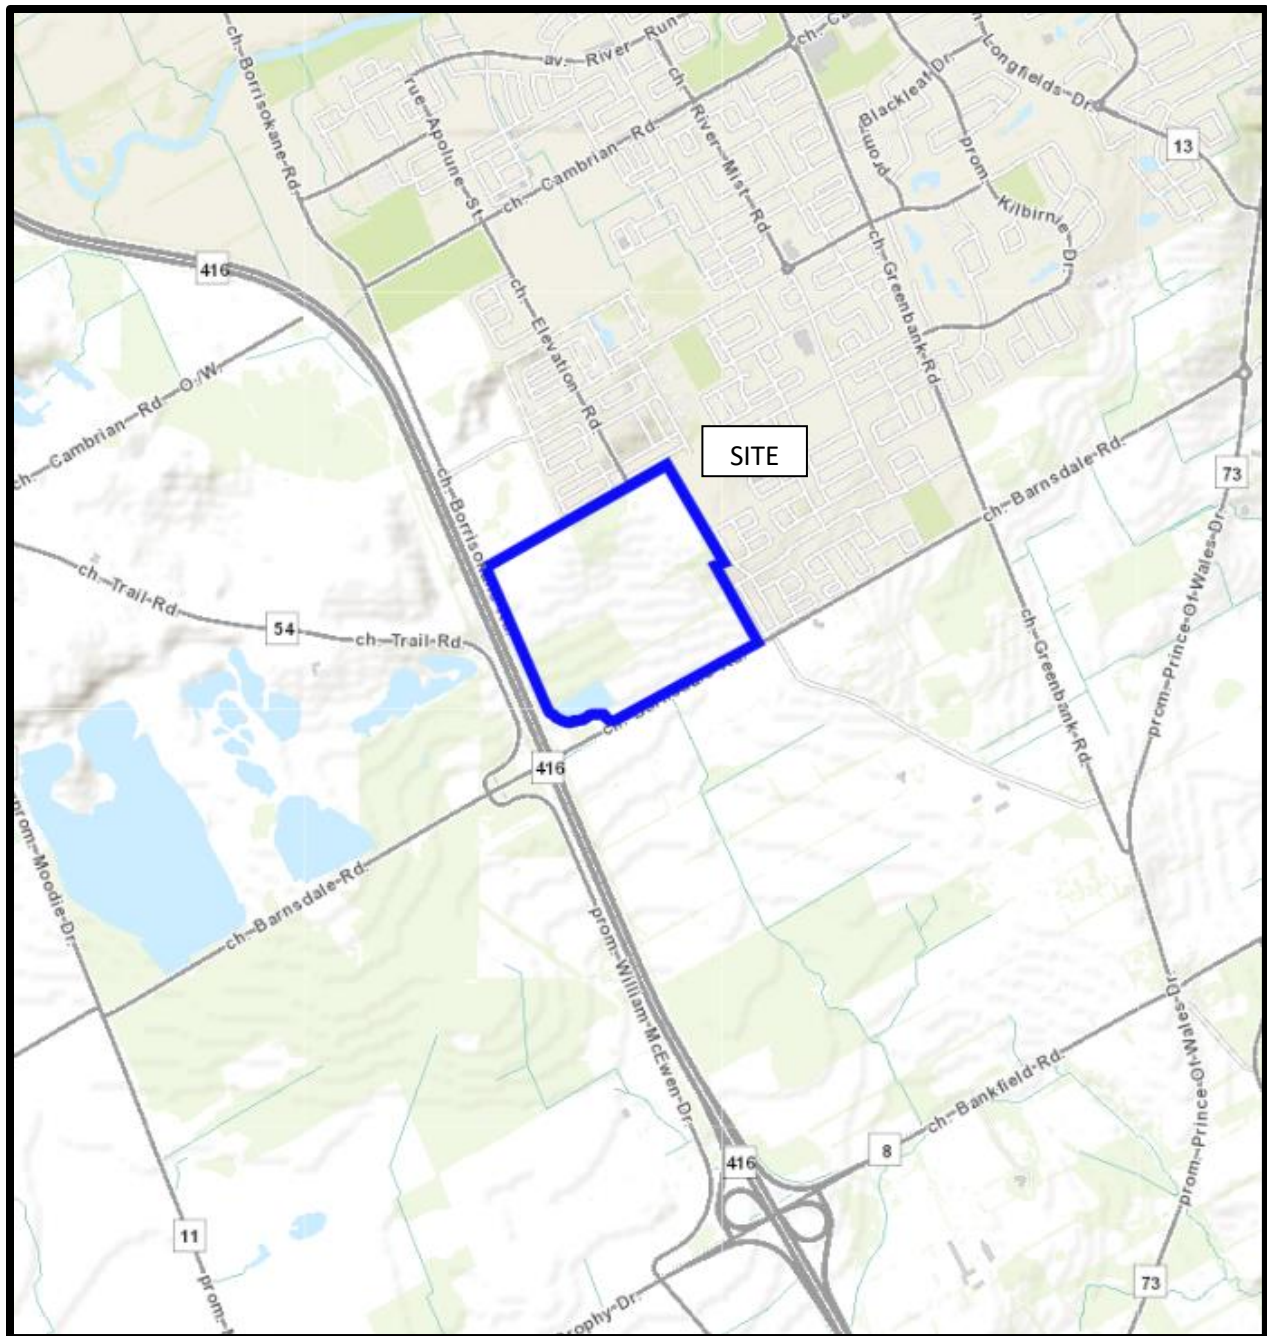
FIGURE 1  
**KEY PLAN**

The Phase I Property is located on the north side of Barnsdale Road and is bounded by Barnsdale Road and Borrisokane to the south and west, respectively, in the City of Ottawa, Ontario.
