Phase Two Environmental Site Assessment 133 Forward Avenue, Ottawa, Ontario

In-Harmony Developments Inc.

OTT-25011403-A0

2025-10-06

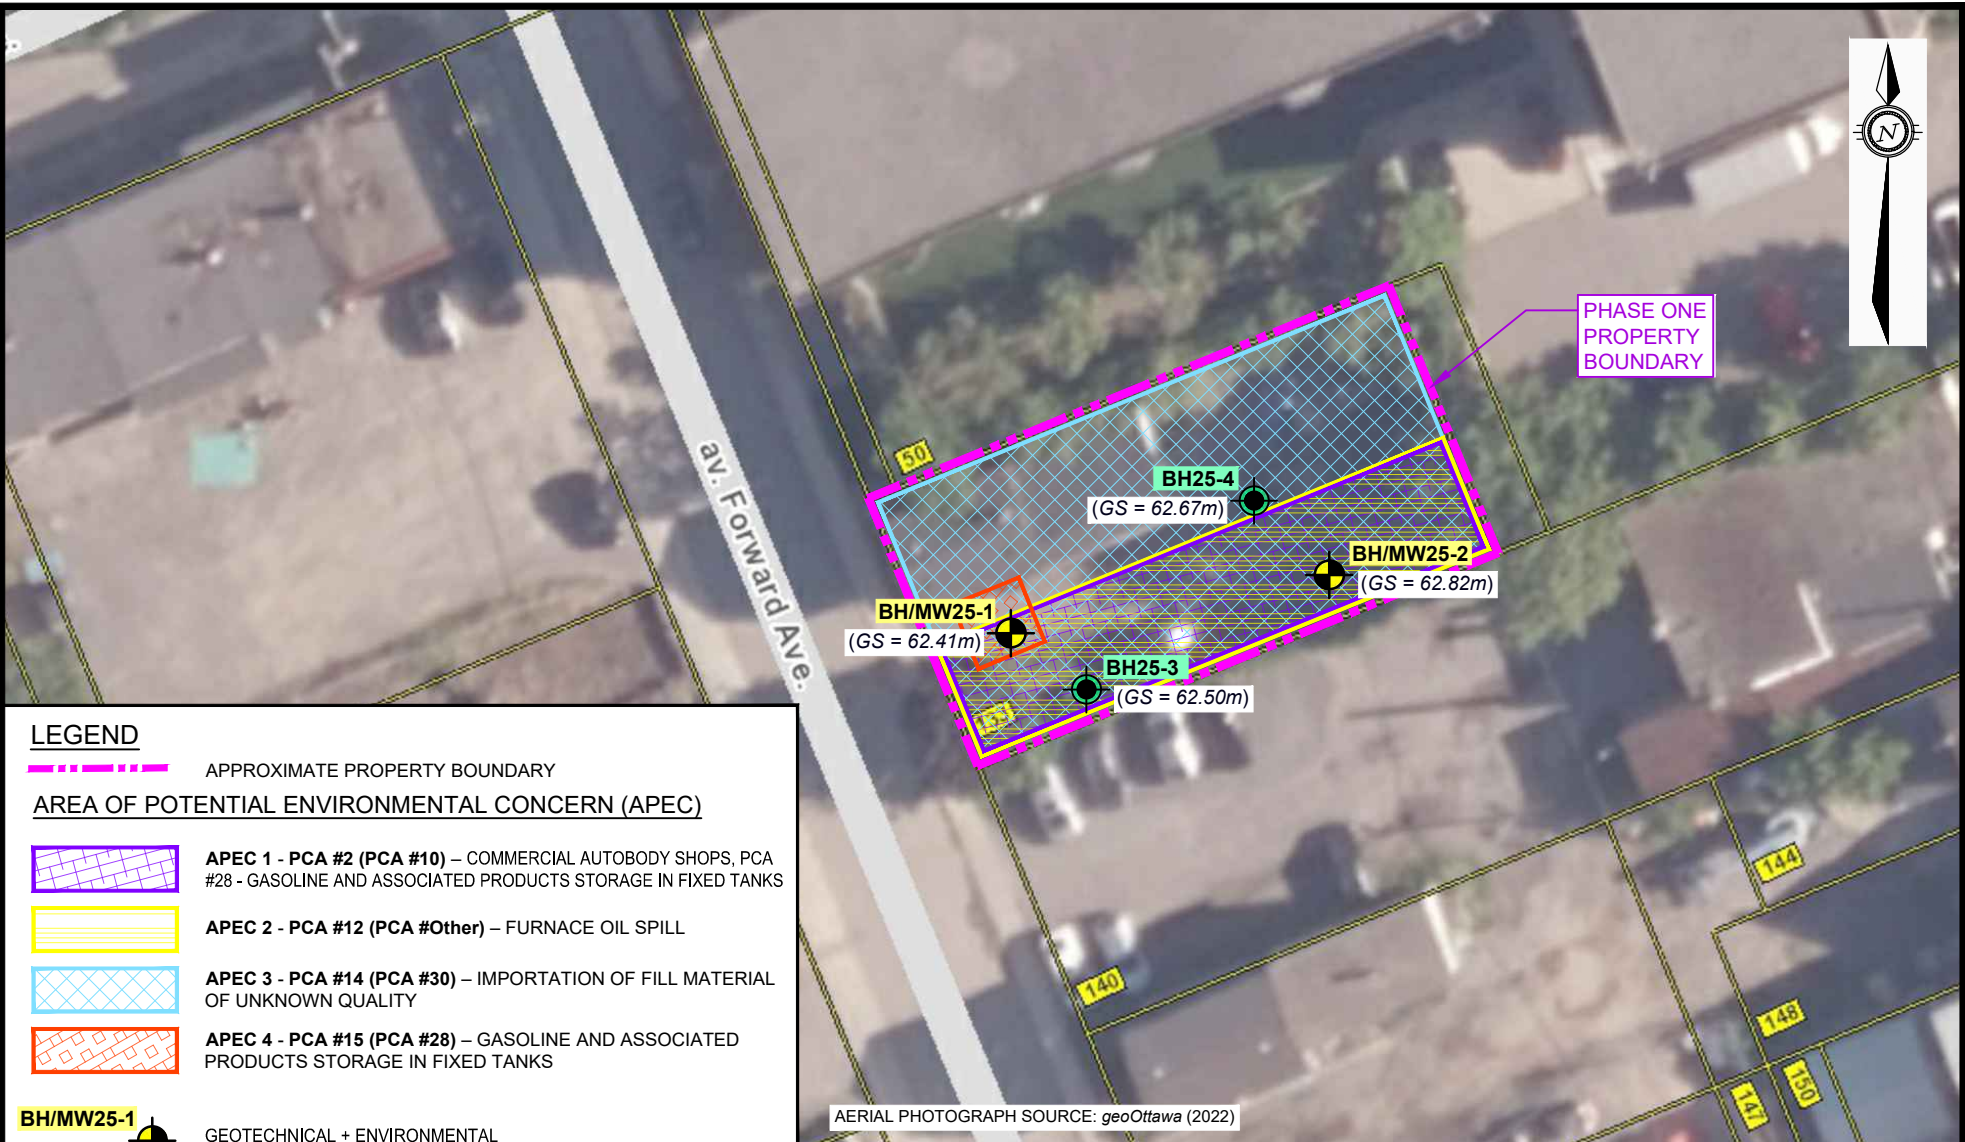
- APPROXIMATE PROPERTY BOUNDARY
- AREA OF POTENTIAL ENVIRONMENTAL CONCERN (APEC)**
- APEC 1 - PCA #2 (PCA #10)** – COMMERCIAL AUTOBODY SHOPS, PCA #28 - GASOLINE AND ASSOCIATED PRODUCTS STORAGE IN FIXED TANKS
- APEC 2 - PCA #12 (PCA #Other)** – FURNACE OIL SPILL
- APEC 3 - PCA #14 (PCA #30)** – IMPORTATION OF FILL MATERIAL OF UNKNOWN QUALITY
- APEC 4 - PCA #15 (PCA #28)** – GASOLINE AND ASSOCIATED PRODUCTS STORAGE IN FIXED TANKS
