**Phase I - Environmental Site Assessment**  
146 Mountshannon Drive  
Ottawa, Ontario

Prepared For  
Richcraft Homes

June 10, 2004  
Report: PE0248-1

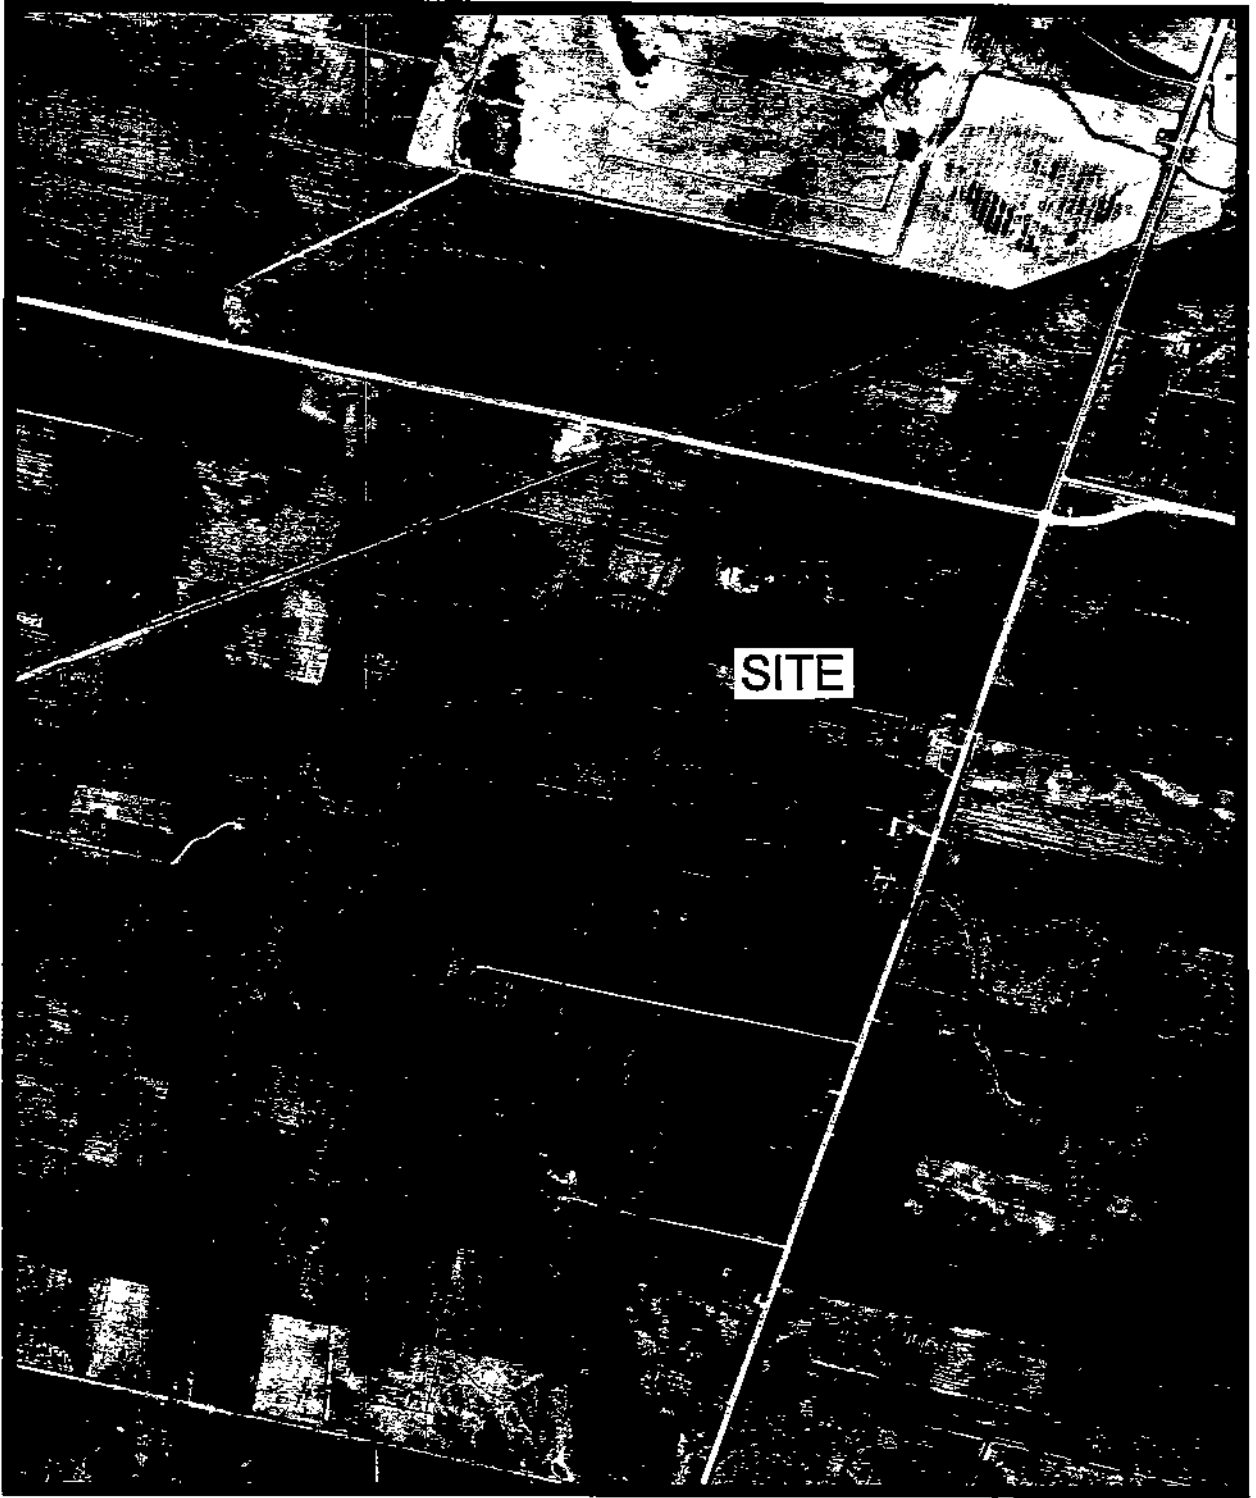
AERIAL PHOTOGRAPH  
1963

- 1963            No significant changes have been made to the subject or neighbouring properties, however, a residential dwelling with barns now exists north of the railway line.

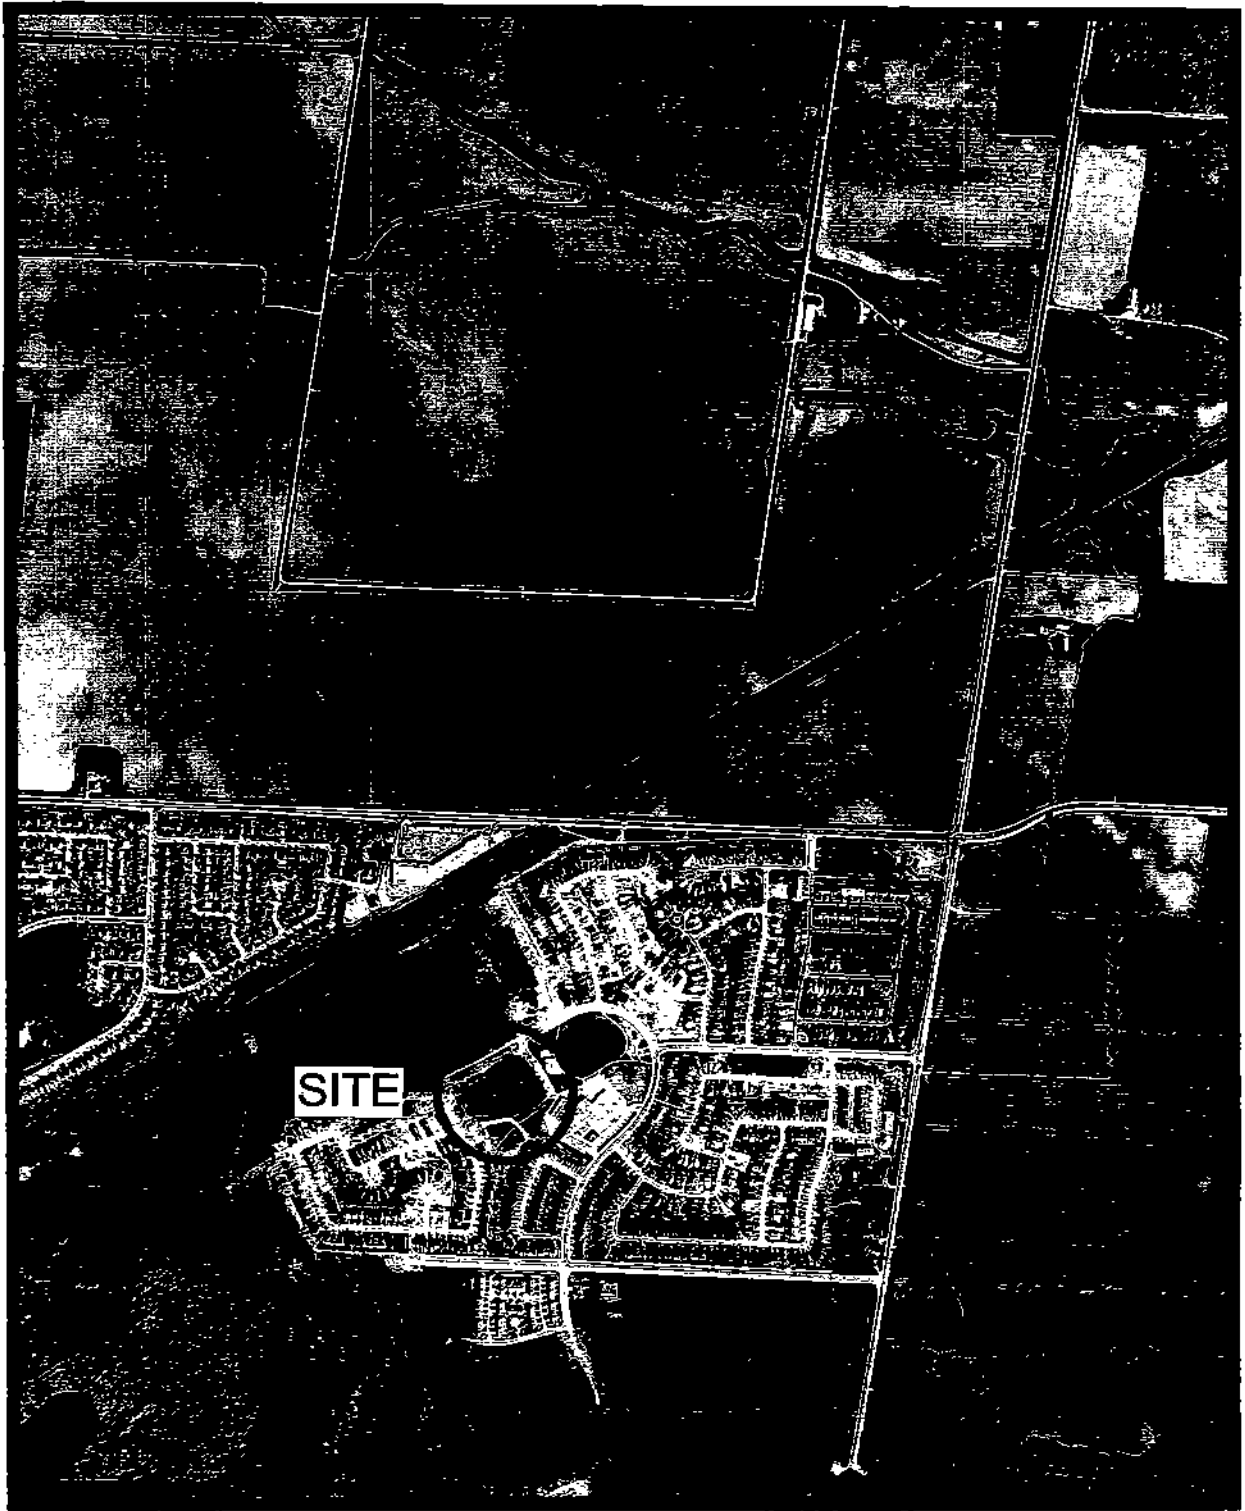
AERIAL PHOTOGRAPH  
1996

- 1996            Much of the land around the subject property has been developed with residences and school. The subject property is vacant.
