# Phase One Environmental Site Assessment

211 Centrum Boulevard  
Orleans, Ontario

Le Groupe Maurice

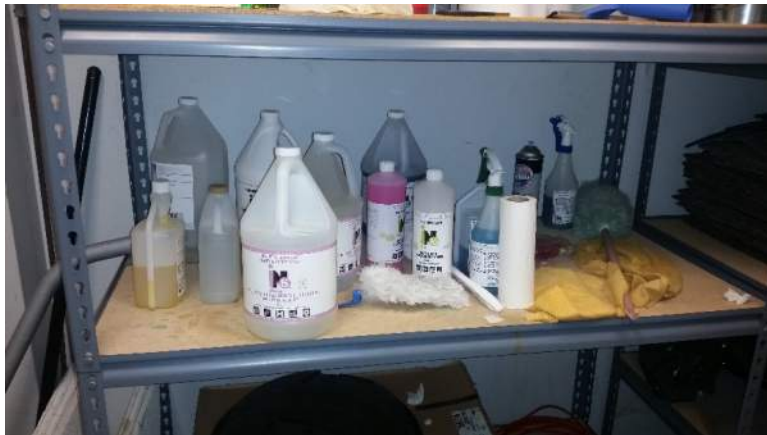
Photo 14 – First floor of the RBC, janitorial room. General cleaners and soaps.

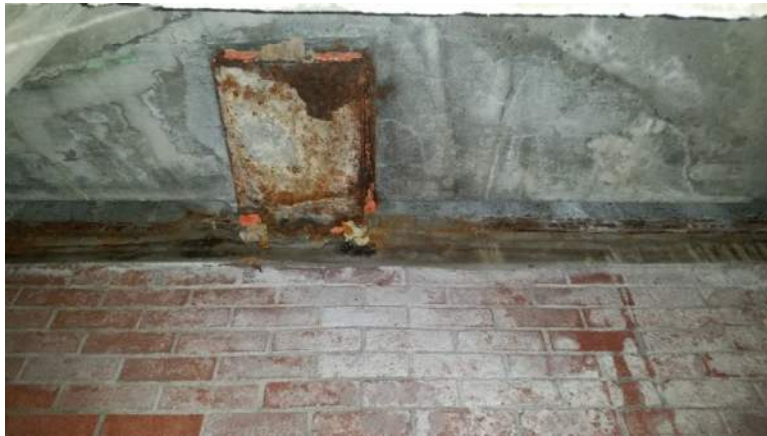
Photo 15 – Salt staining on the wall of an empty storage room on the first floor of the parking structure.

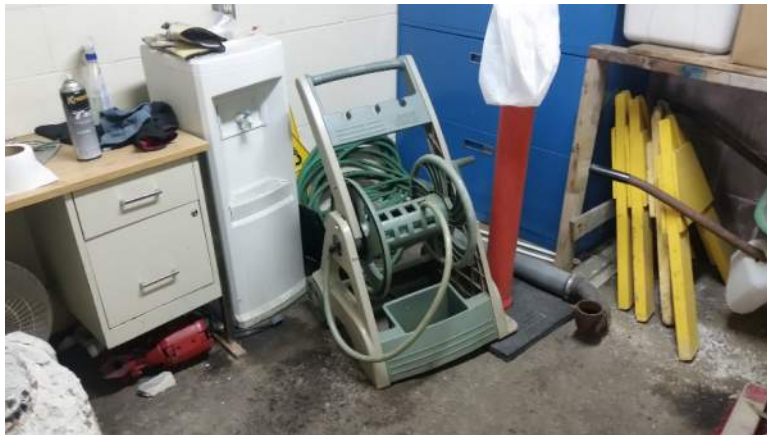
Photo 16 – Morguard janitorial room on the first floor of the parking garage. Minor staining on the concrete floor which appeared to be in good condition (ie. no cracks). General maintenance chemicals in small volumes.

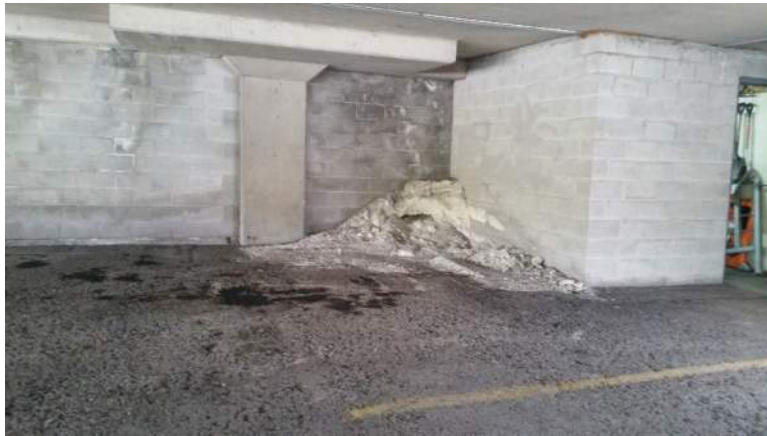
Photo 17 – Salt in the first floor of the parking garage (facing north).

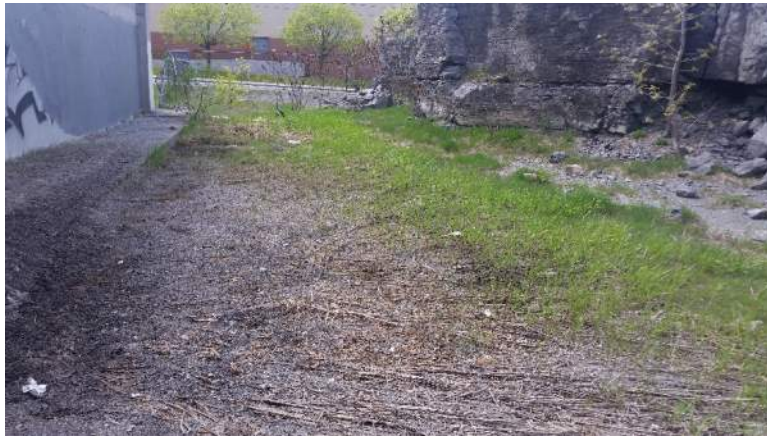
Photo 19 – South wall of the parking structure and exposed bedrock (facing west).

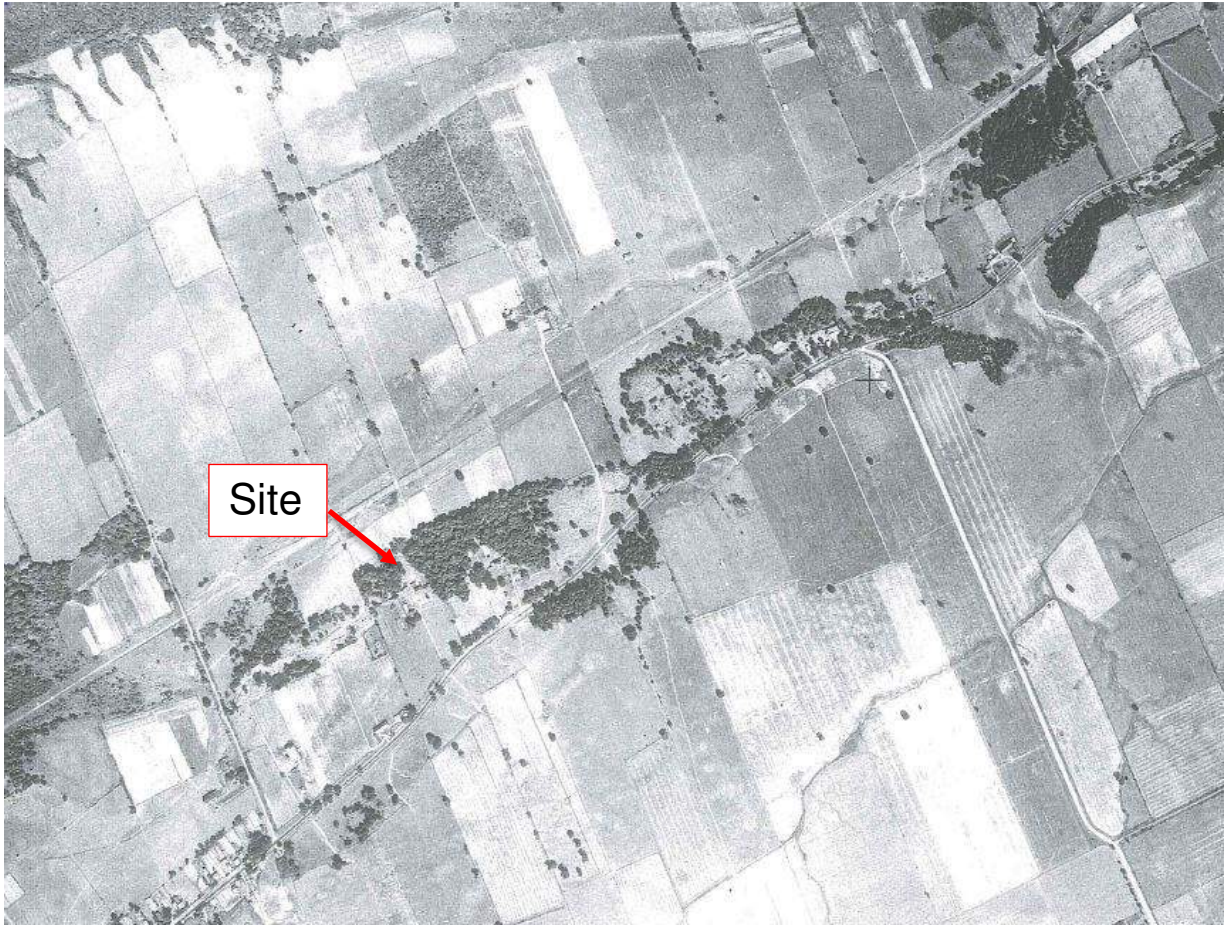
**Year 1946**

Review of the 1946 aerial photograph indicates that no significant changes in land use on the Site or surrounding properties were observed relative to the 1927 aerial photograph, with the exception of a possible small rectangular structure north of the existing structures on the Site. There is no evidence of on-Site solid waste disposal or fill areas on the 1946 aerial photograph.

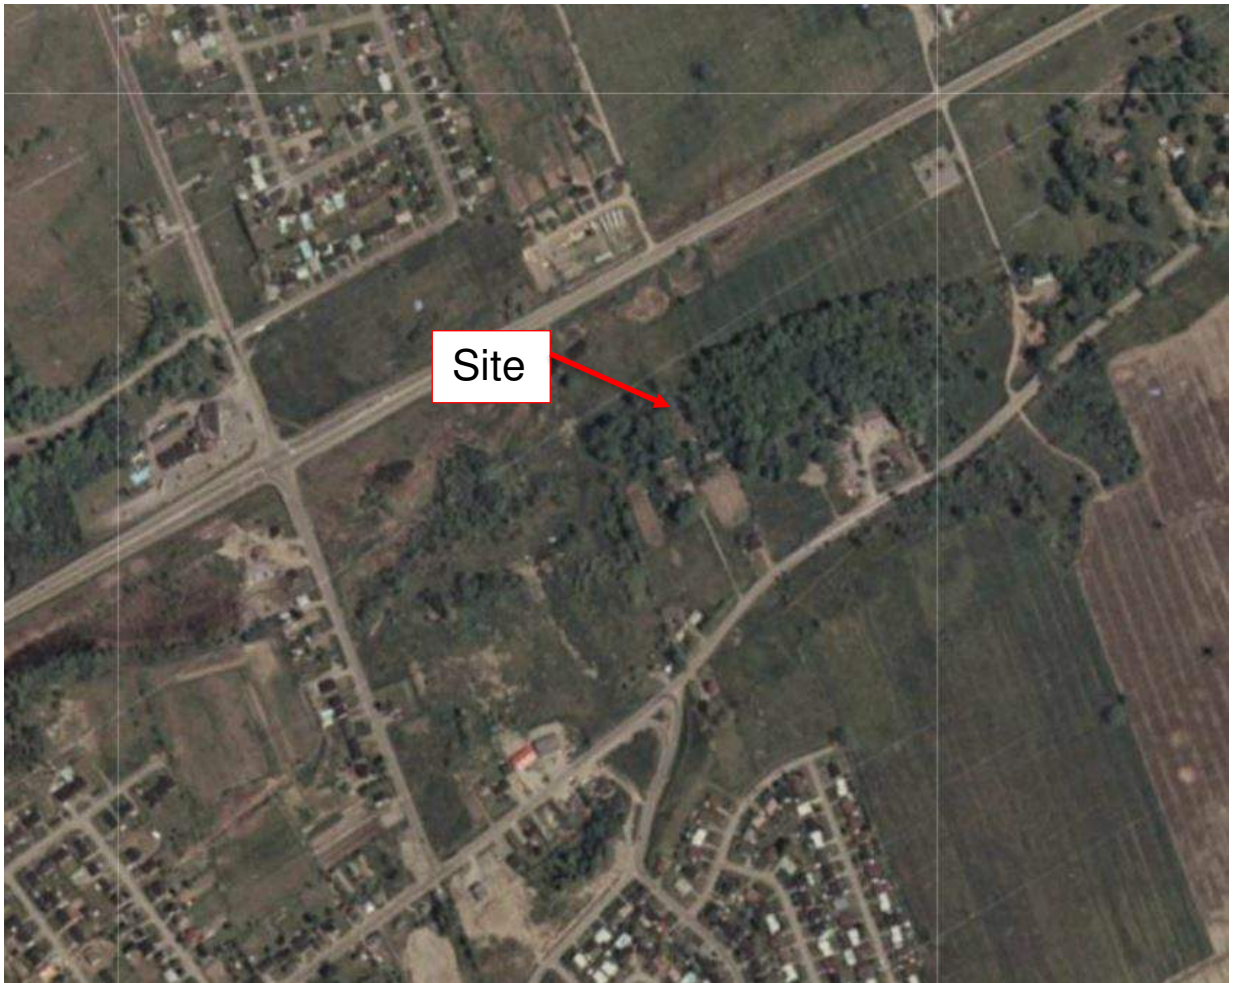
Year 1976

Review of the 1976 aerial photograph indicates that no significant changes in land use on the Site or adjacent properties were observed relative to the 1946 aerial photograph, with the exception of additional residential structures to the south of the Site along current St. Joseph Boulevard. New residential developments are visible south of St. Joseph Boulevard and north of Regional Road 174. There is no evidence of on-Site solid waste disposal or fill areas on the 1976 aerial photograph.

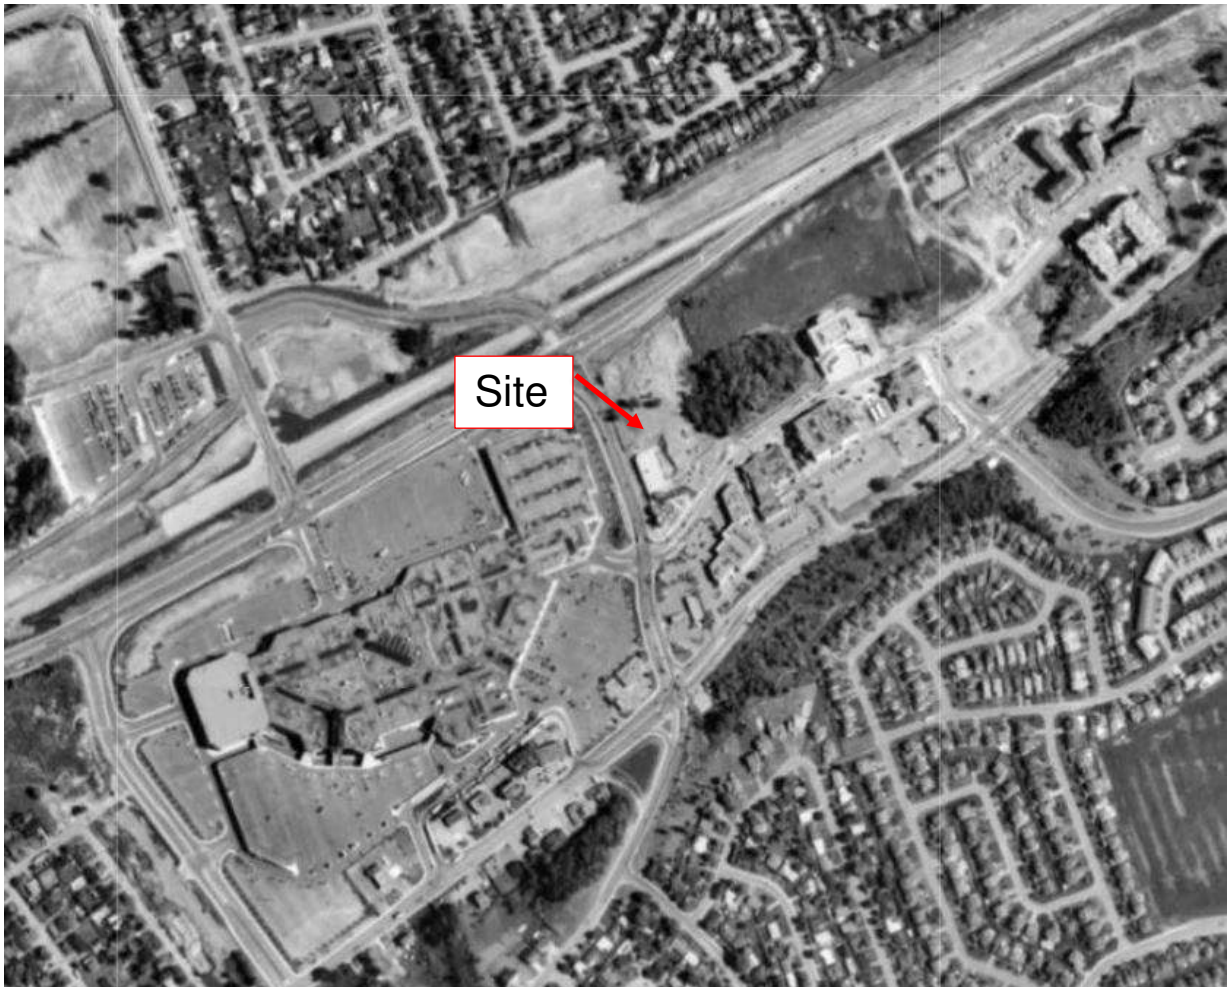
Year 1991

Review of the 1991 aerial photograph indicates significant changes in land use on the Site and surrounding properties were observed relative to the 1976 aerial photograph. The original residential/agricultural buildings have been removed and the Site has been developed with the present day commercial building and parking structure in the southwest corner of the Property. An excavated area surrounds the east and north sides of the parking structure. Excavators are visible on the Site suggesting that development of the Site is in progress. Stockpiled soil or aggregate is visible along the northern Property boundary. There is no evidence of on-Site solid waste disposal on the 1946 aerial photograph.

Based on a review of historical information, fill material was potentially placed on the northern portion of the Property prior to the construction of the current on-Site buildings (observed in the 1991 aerial photograph). The existence of fill material was confirmed by Golder during a 1989 Subsurface Investigation, as discussed in Section 4.1.6. The Subsurface Investigation identified localized deposits of fill material across the northern and central portions of the Site, ranging in thickness from 0.1 to 1.2 m. The fill material was described as consisting of loose silty sand to sandy silt with some clay, gravel, cobbles, and boulders. Concrete, metal, and organic materials were also identified within the fill material. The placement of fill material on the northern portion of the Property is considered a PCA in accordance with O. Reg. 153/04 (importation of fill material of unknown quality) and is considered to represent an APEC for the Site (APEC #2).

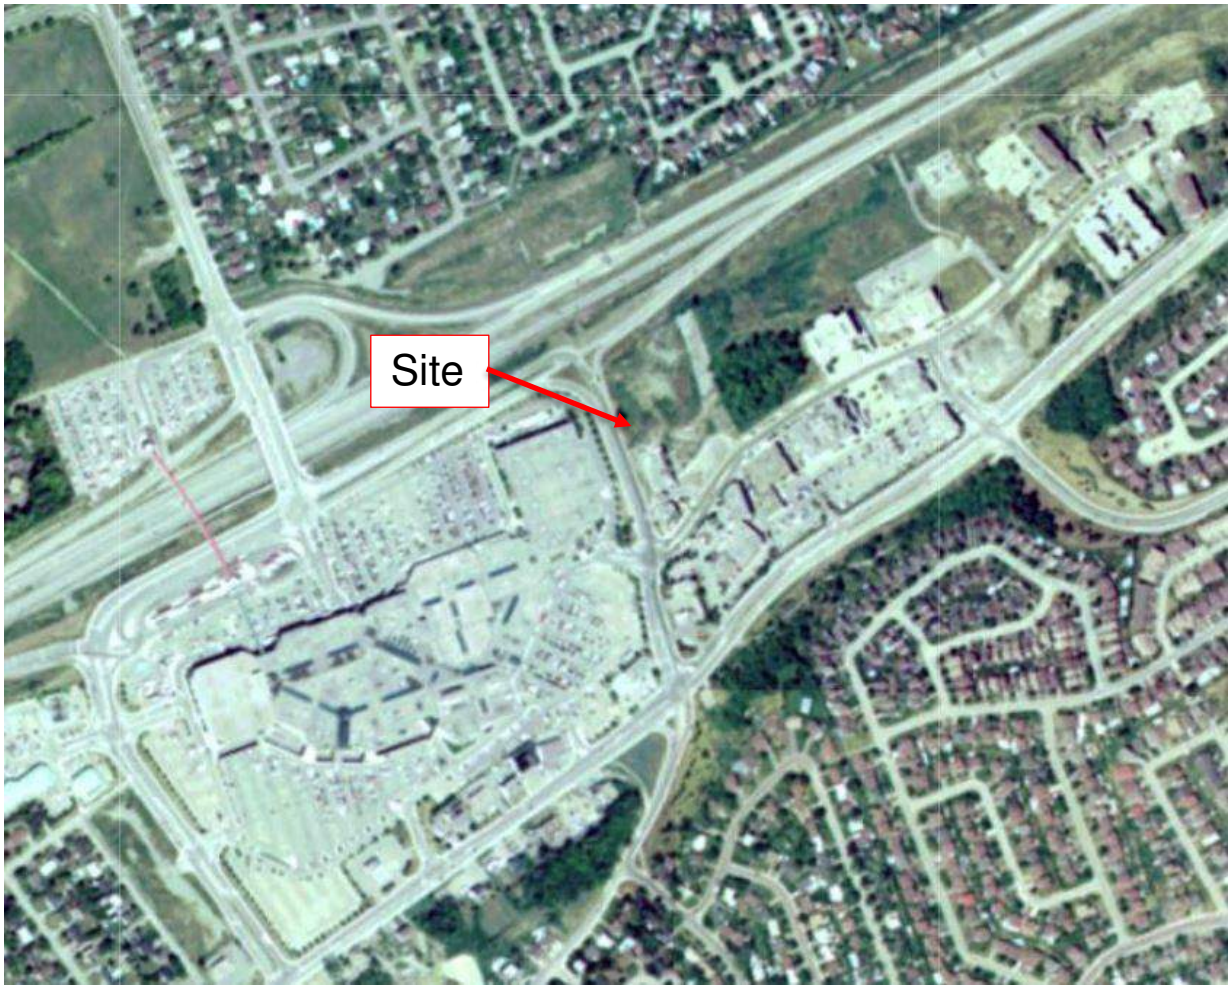
Year 1999

Review of the 1999 aerial photograph indicates that no significant changes in land use on the Site were observed relative to the 1991 aerial photograph, with the exception of the addition of a parking area in the southeast corner of the Site and regrowth of vegetation on the northern half of the Property. Properties surrounding the Site are relatively unchanged. A strip of land to the east of the Site has been cleared of vegetation. In addition, the gasoline service station located northwest of the intersection of Place d'Orleans Drive and St. Joseph Boulevard has been removed. There is no evidence of on-Site solid waste disposal or fill areas on the 1999 aerial photograph.

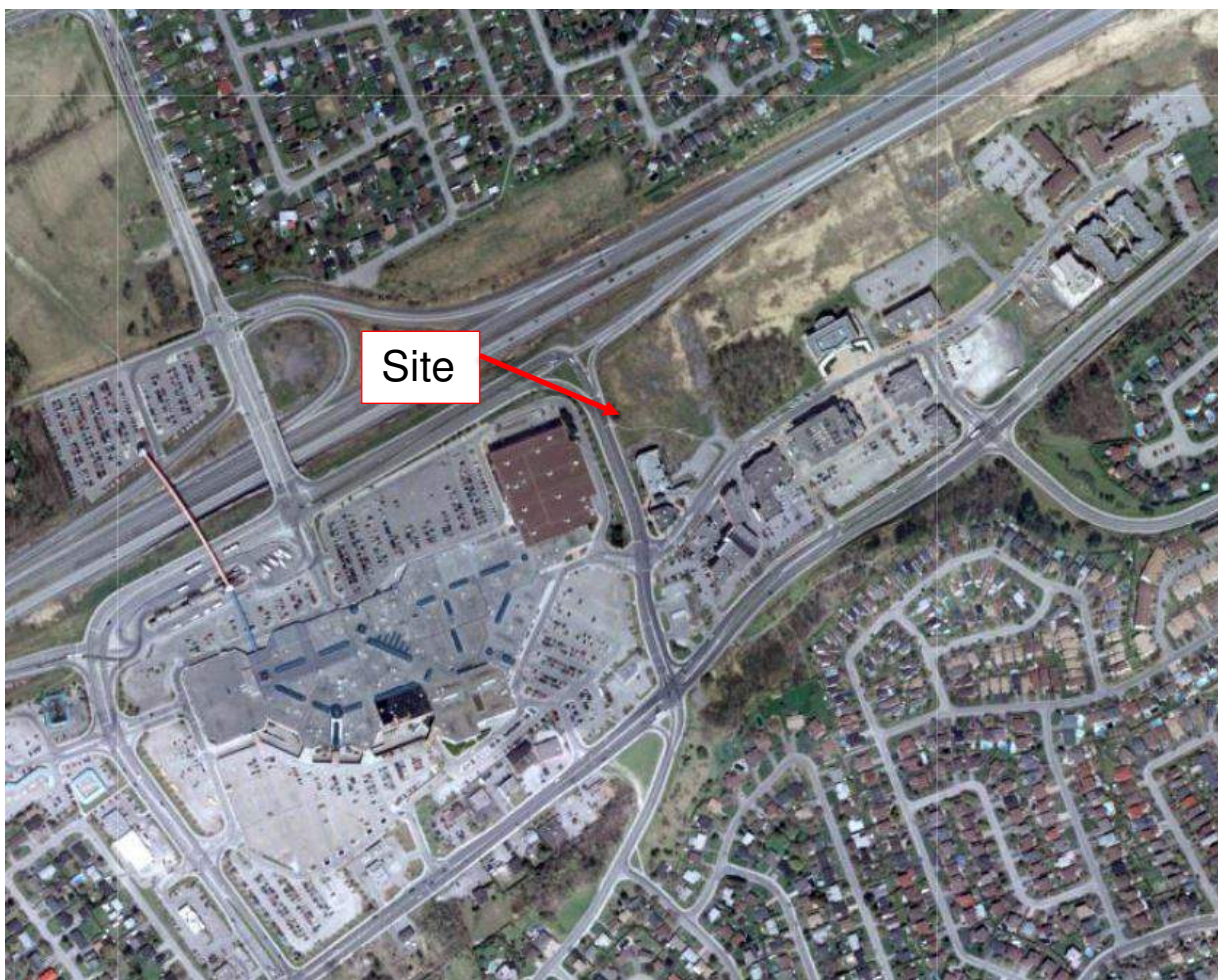
Year 2007

Review of the 2007 aerial photograph indicates that that no significant changes in land use on the Site and surrounding properties were observed relative to the 1999 aerial photograph, with the exception of a foot path across the centre of the Property between Place d'Orleans Drive and Centrum Boulevard. There is no evidence of on-Site solid waste disposal or fill areas on the 2007 aerial photograph.

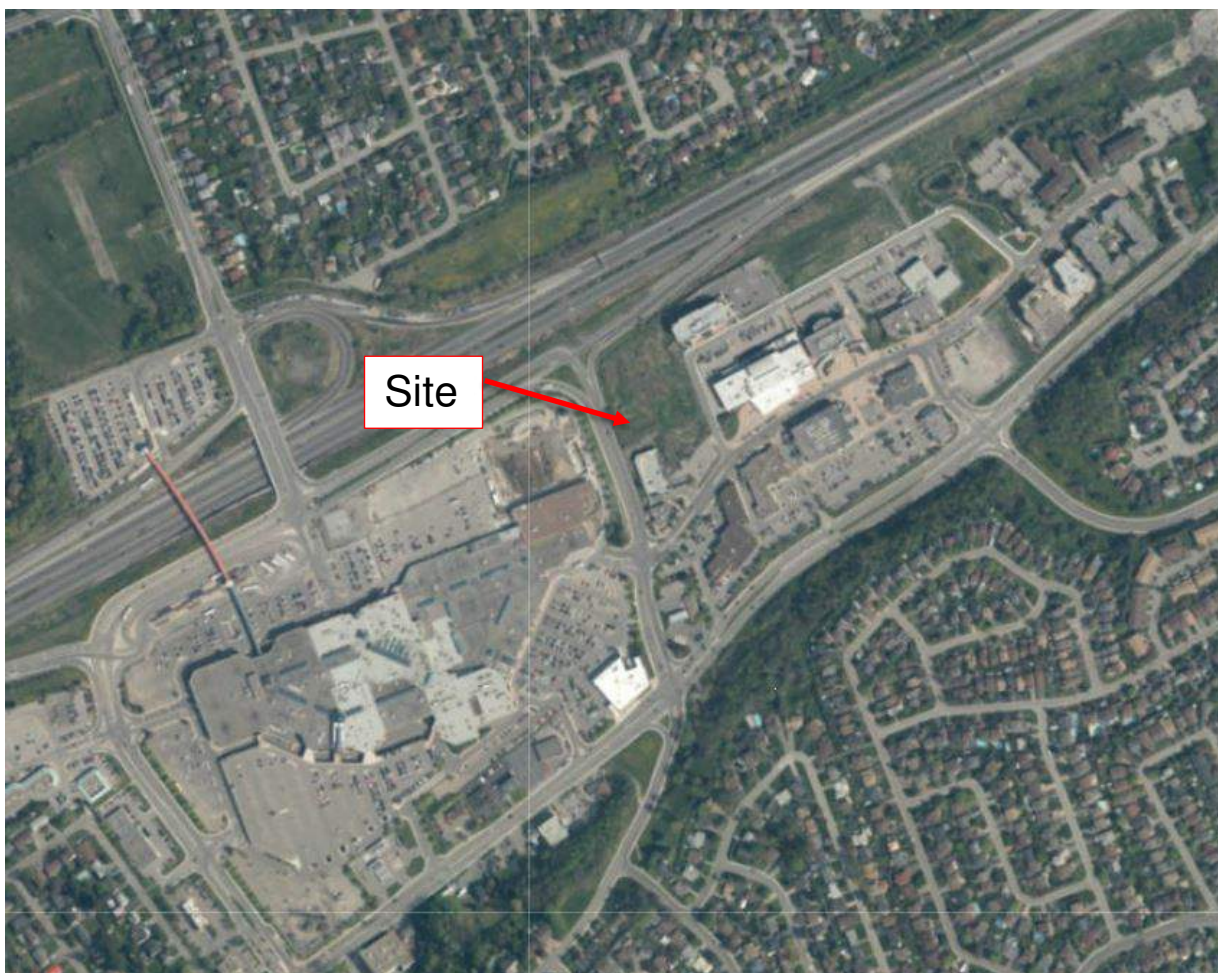
Year 2017

Review of the 2017 aerial photograph indicates that no significant changes in land use on the Site or surrounding properties to the north and south of the Site were observed relative to the 2007 aerial photograph. A portion of the Place d'Orleans Shopping Centre west of the Site has been demolished and an irregular shaped building was constructed northwest of the intersection of St. Joseph Boulevard and Place d'Orleans Drive, in the location of the former gasoline services station. Brisebois Crescent has been constructed to the east of the Site along with two multi-storey buildings. There is no evidence of on-Site solid waste disposal or fill areas on the 2017 aerial photograph.

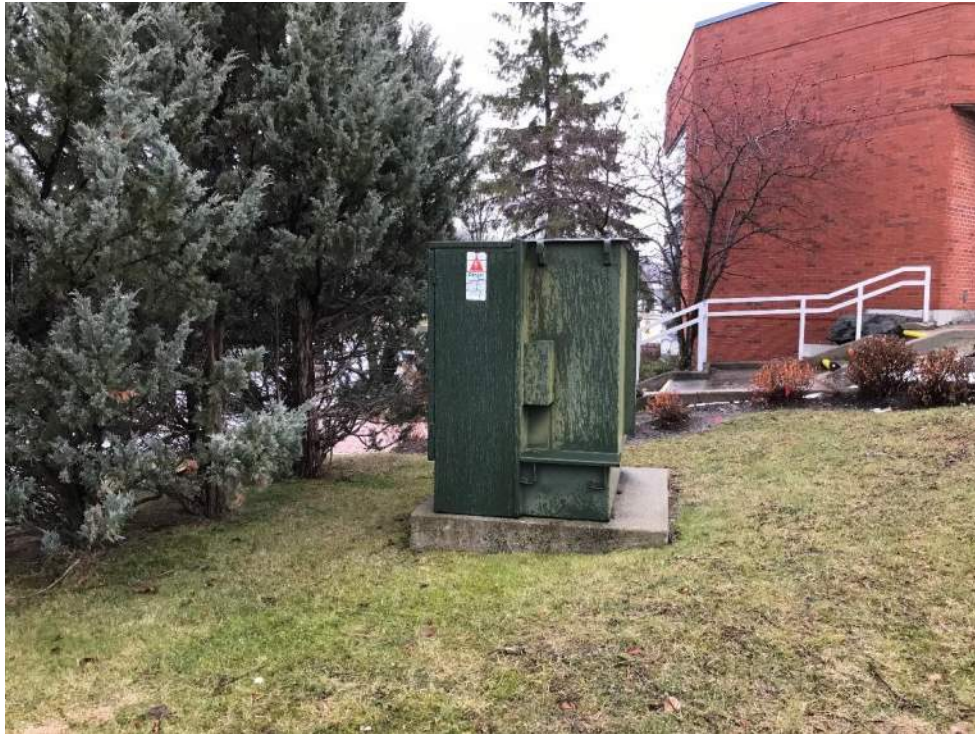
Two pad-mounted electrical transformers were observed on the Site along the southeastern property boundary, and are potentially PCB-containing. The transformers appears to be in good condition and no staining was observed on the concrete pads or surrounding ground surface.

Photo 3 – Photo showing the pad mounted transformer east of the building

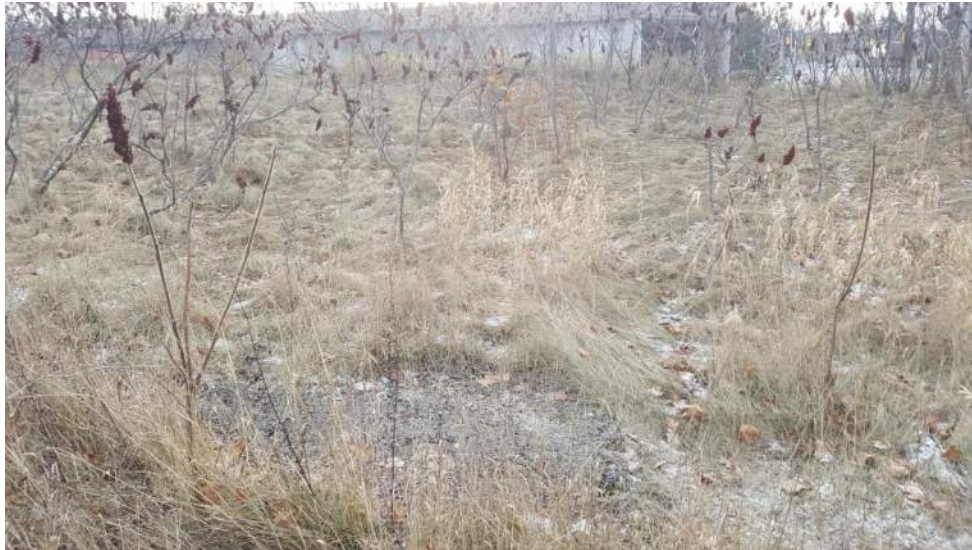
3. Site – Gasoline and Associated Products Storage in Fixed Tanks | A release of an unknown quantity of cement and fuel from a cement truck was reported to have occurred in the western portion of the Site on March 28, 2017. GHD observed concrete on the ground surface in the general area where the release was reported to have occurred. No visual or olfactory

evidence of a fuel release was noted in the area during the Site visit; however, the reported release of fuel has been identified as a PCA in accordance with O. Reg. 153/04 (gasoline and associated products storage in fixed tanks) and based on the reported location of the release (on the western portion of the Site) this PCA has been included as APEC #3 for the Site.

Photo 21 - View of concrete observed on the ground surface in the western portion of the Site

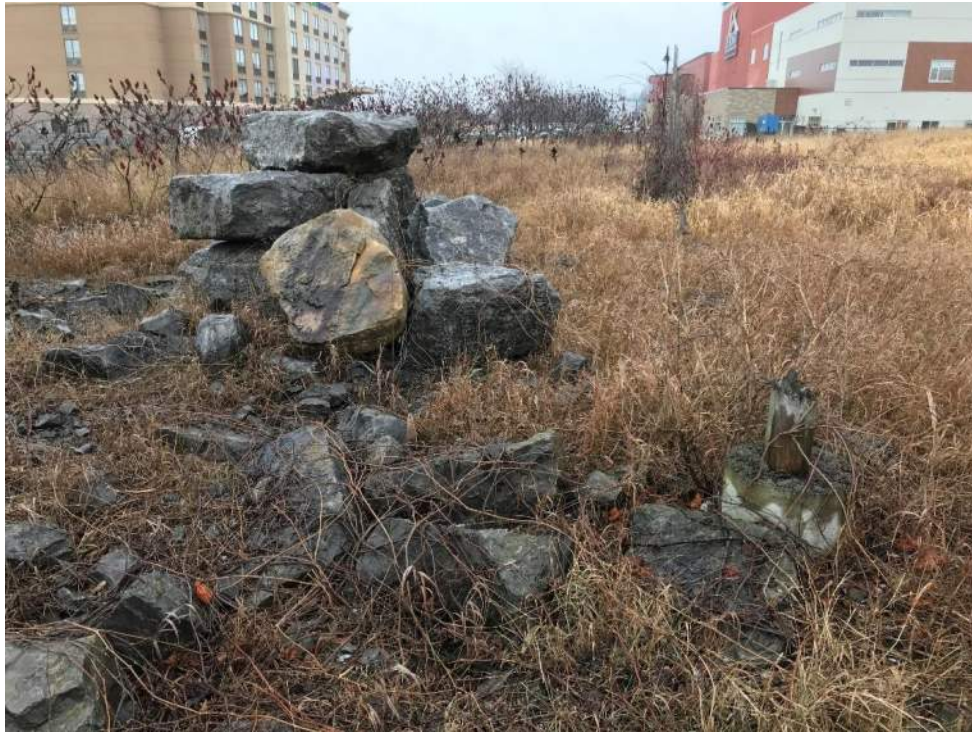
Photo 23 - View of aggregate fill material in the central portion of the Site

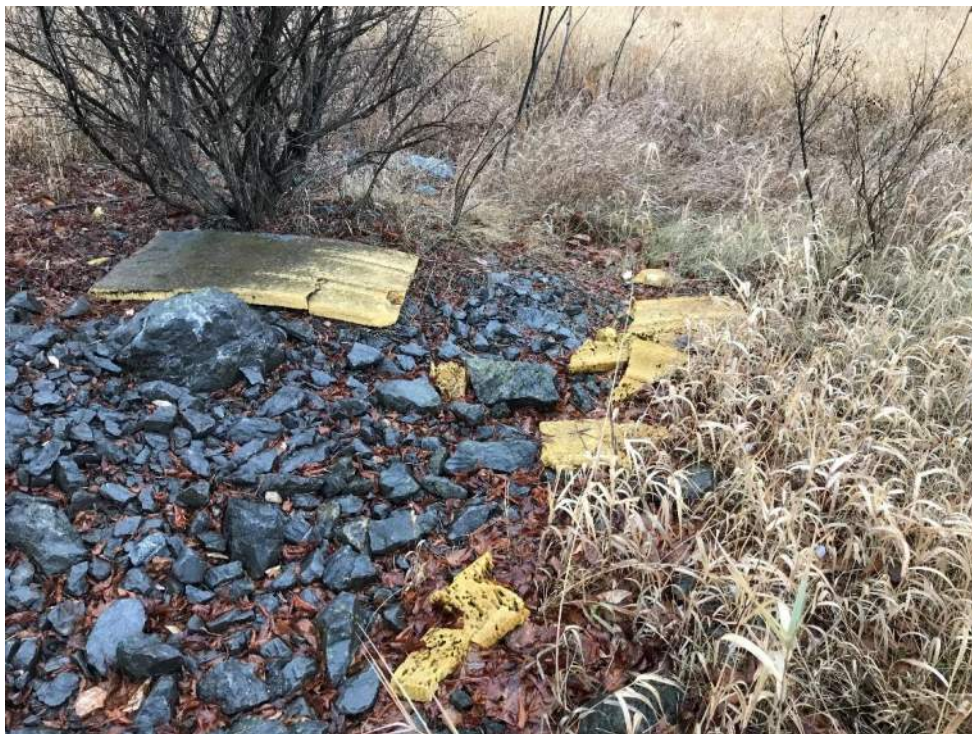
Photo 24 - View of fill material and construction debris in the northern portion of the Site

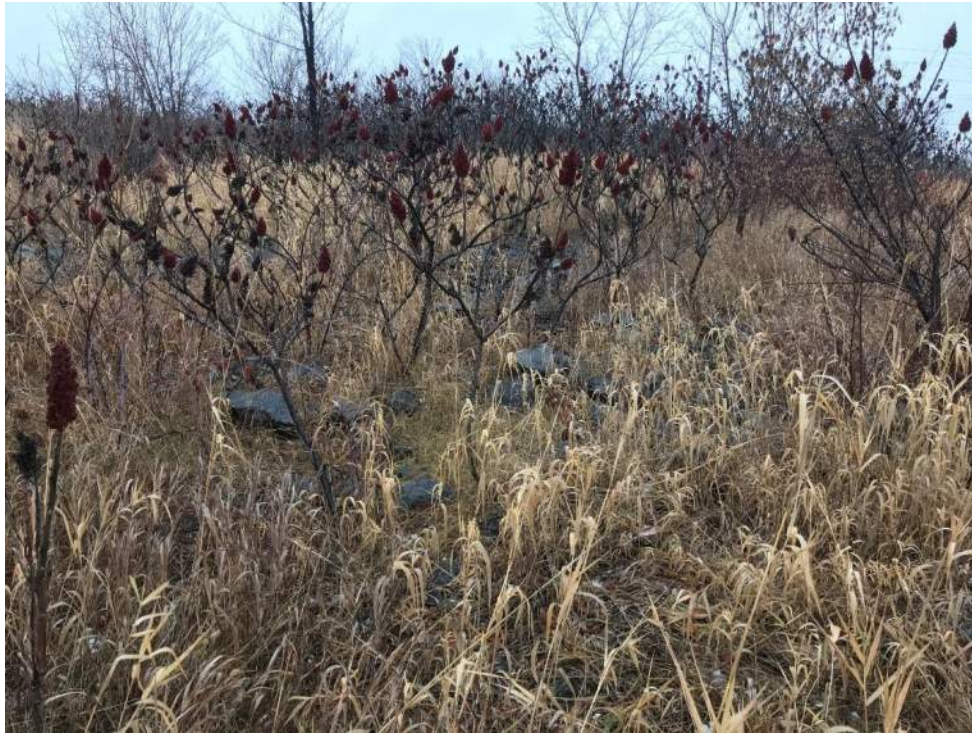
North of the parking area and parking garage is vegetated with sumac trees and overgrown vegetation. Bedrock outcroppings are visible in the central portion of the Site. The majority of the Site slopes gradually to the north with a steeper slope in the northern portion near Regional Road 174. Buried aggregate and boulders were observed in the northern portion of the Site.

Photo 25 - View of buried aggregate in the northern portion of the Site

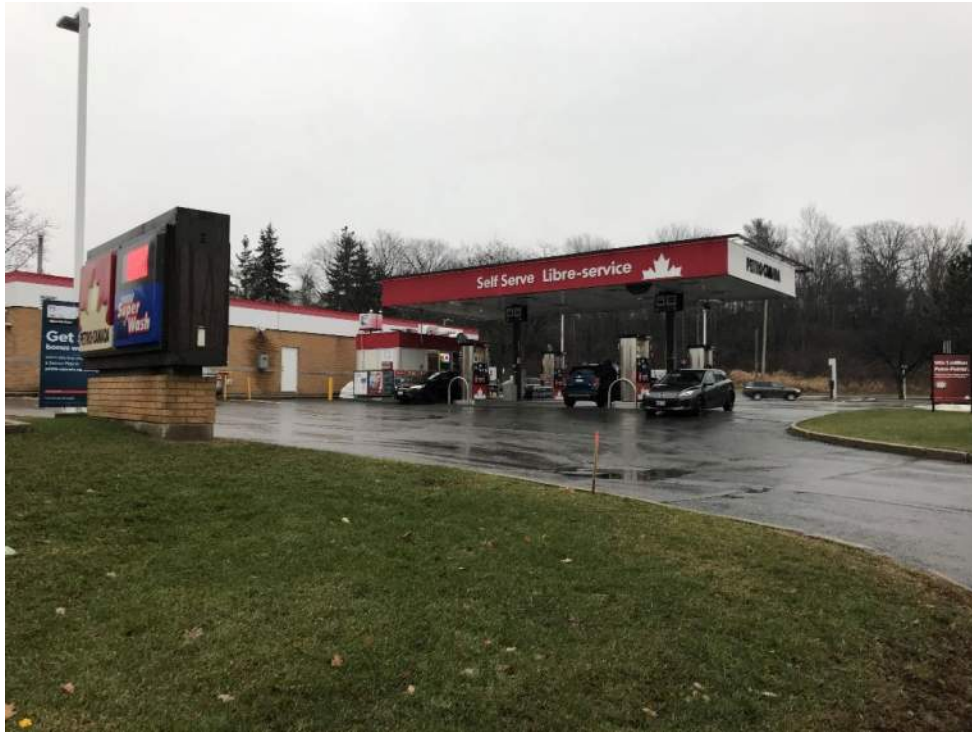
Photo 29 - View of the Petro Canada gasoline service station located 50 m south of the Site
