Project:
Le Groupe Maurice Centrum Retirement

211 Centrum Blvd
OTTAWA, ONTARIO

Drawing:
Tree Conservation Report

Project Number: 2051-01 Sheet Number: TCR 1.0

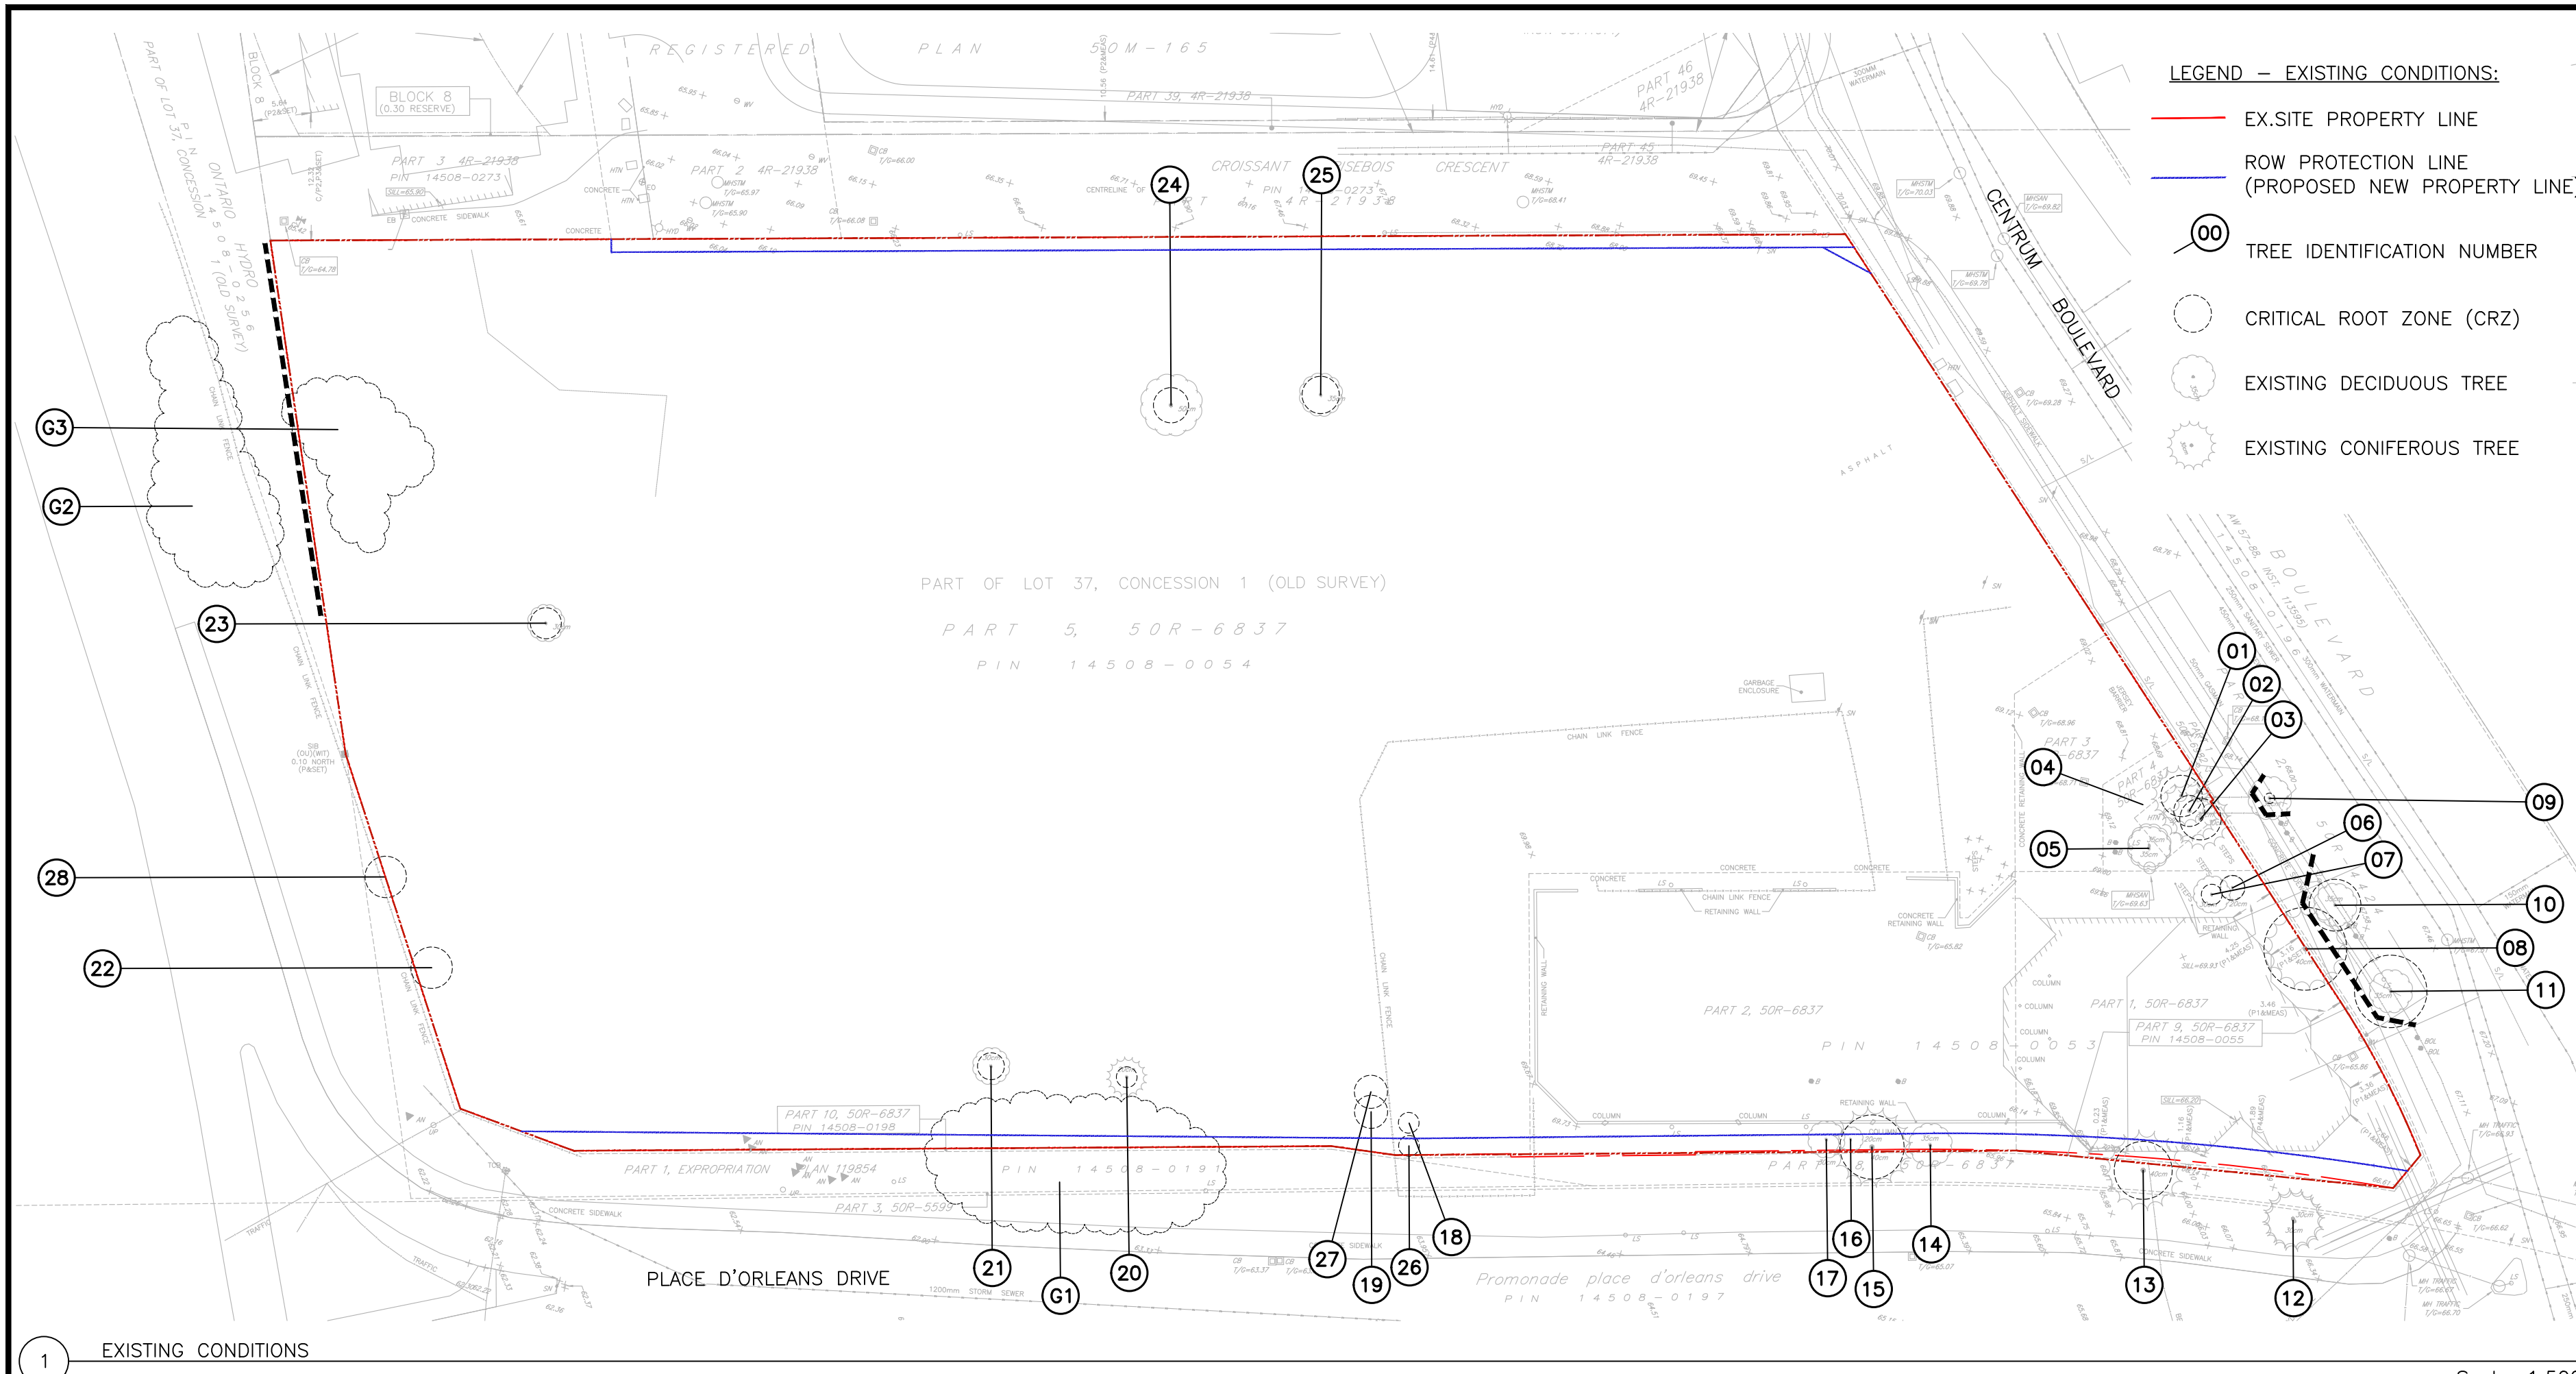
1 EXISTING CONDITIONS

- NOTES:**
- 1.0 THE EXISTING PROPERTY CONTAINS A 2-STORY BUILDING, PARKING GARAGE, AND SURFACE PARKING, LOCATED AT THE SOUTH-END OF THE SITE ADJACENT TO CENTRUM BOULEVARD. THE NORTHERN PORTION OF THE SITE IS CURRENTLY UNDEVELOPED AND CONSISTS OF SLOPING TOPOGRAPHY WITH ROCKY TERRAIN. EXISTING VEGETATION IS PRIMARILY COMPRISED OF SUMAC, AND OTHER RUDDERAL TREE/SHRUB SPECIES, WITH THE EXCEPTION OF TREES THAT WERE PLANTED ADJACENT TO THE EXISTING STRUCTURES (SOUTH-WEST OF SITE), ALONG CENTRUM BOULEVARD AND PLACE D'ORLEANS DRIVE.

- APPROXIMATELY 1600 m² OF THE SITE IS CURRENTLY OCCUPIED BY AN EXISTING BUILDING AND CONCRETE PARKING STRUCTURE.
 - APPROXIMATELY 4878 m² TO BE COVERED BY THE PROPOSED BUILDING FOOTPRINTS.

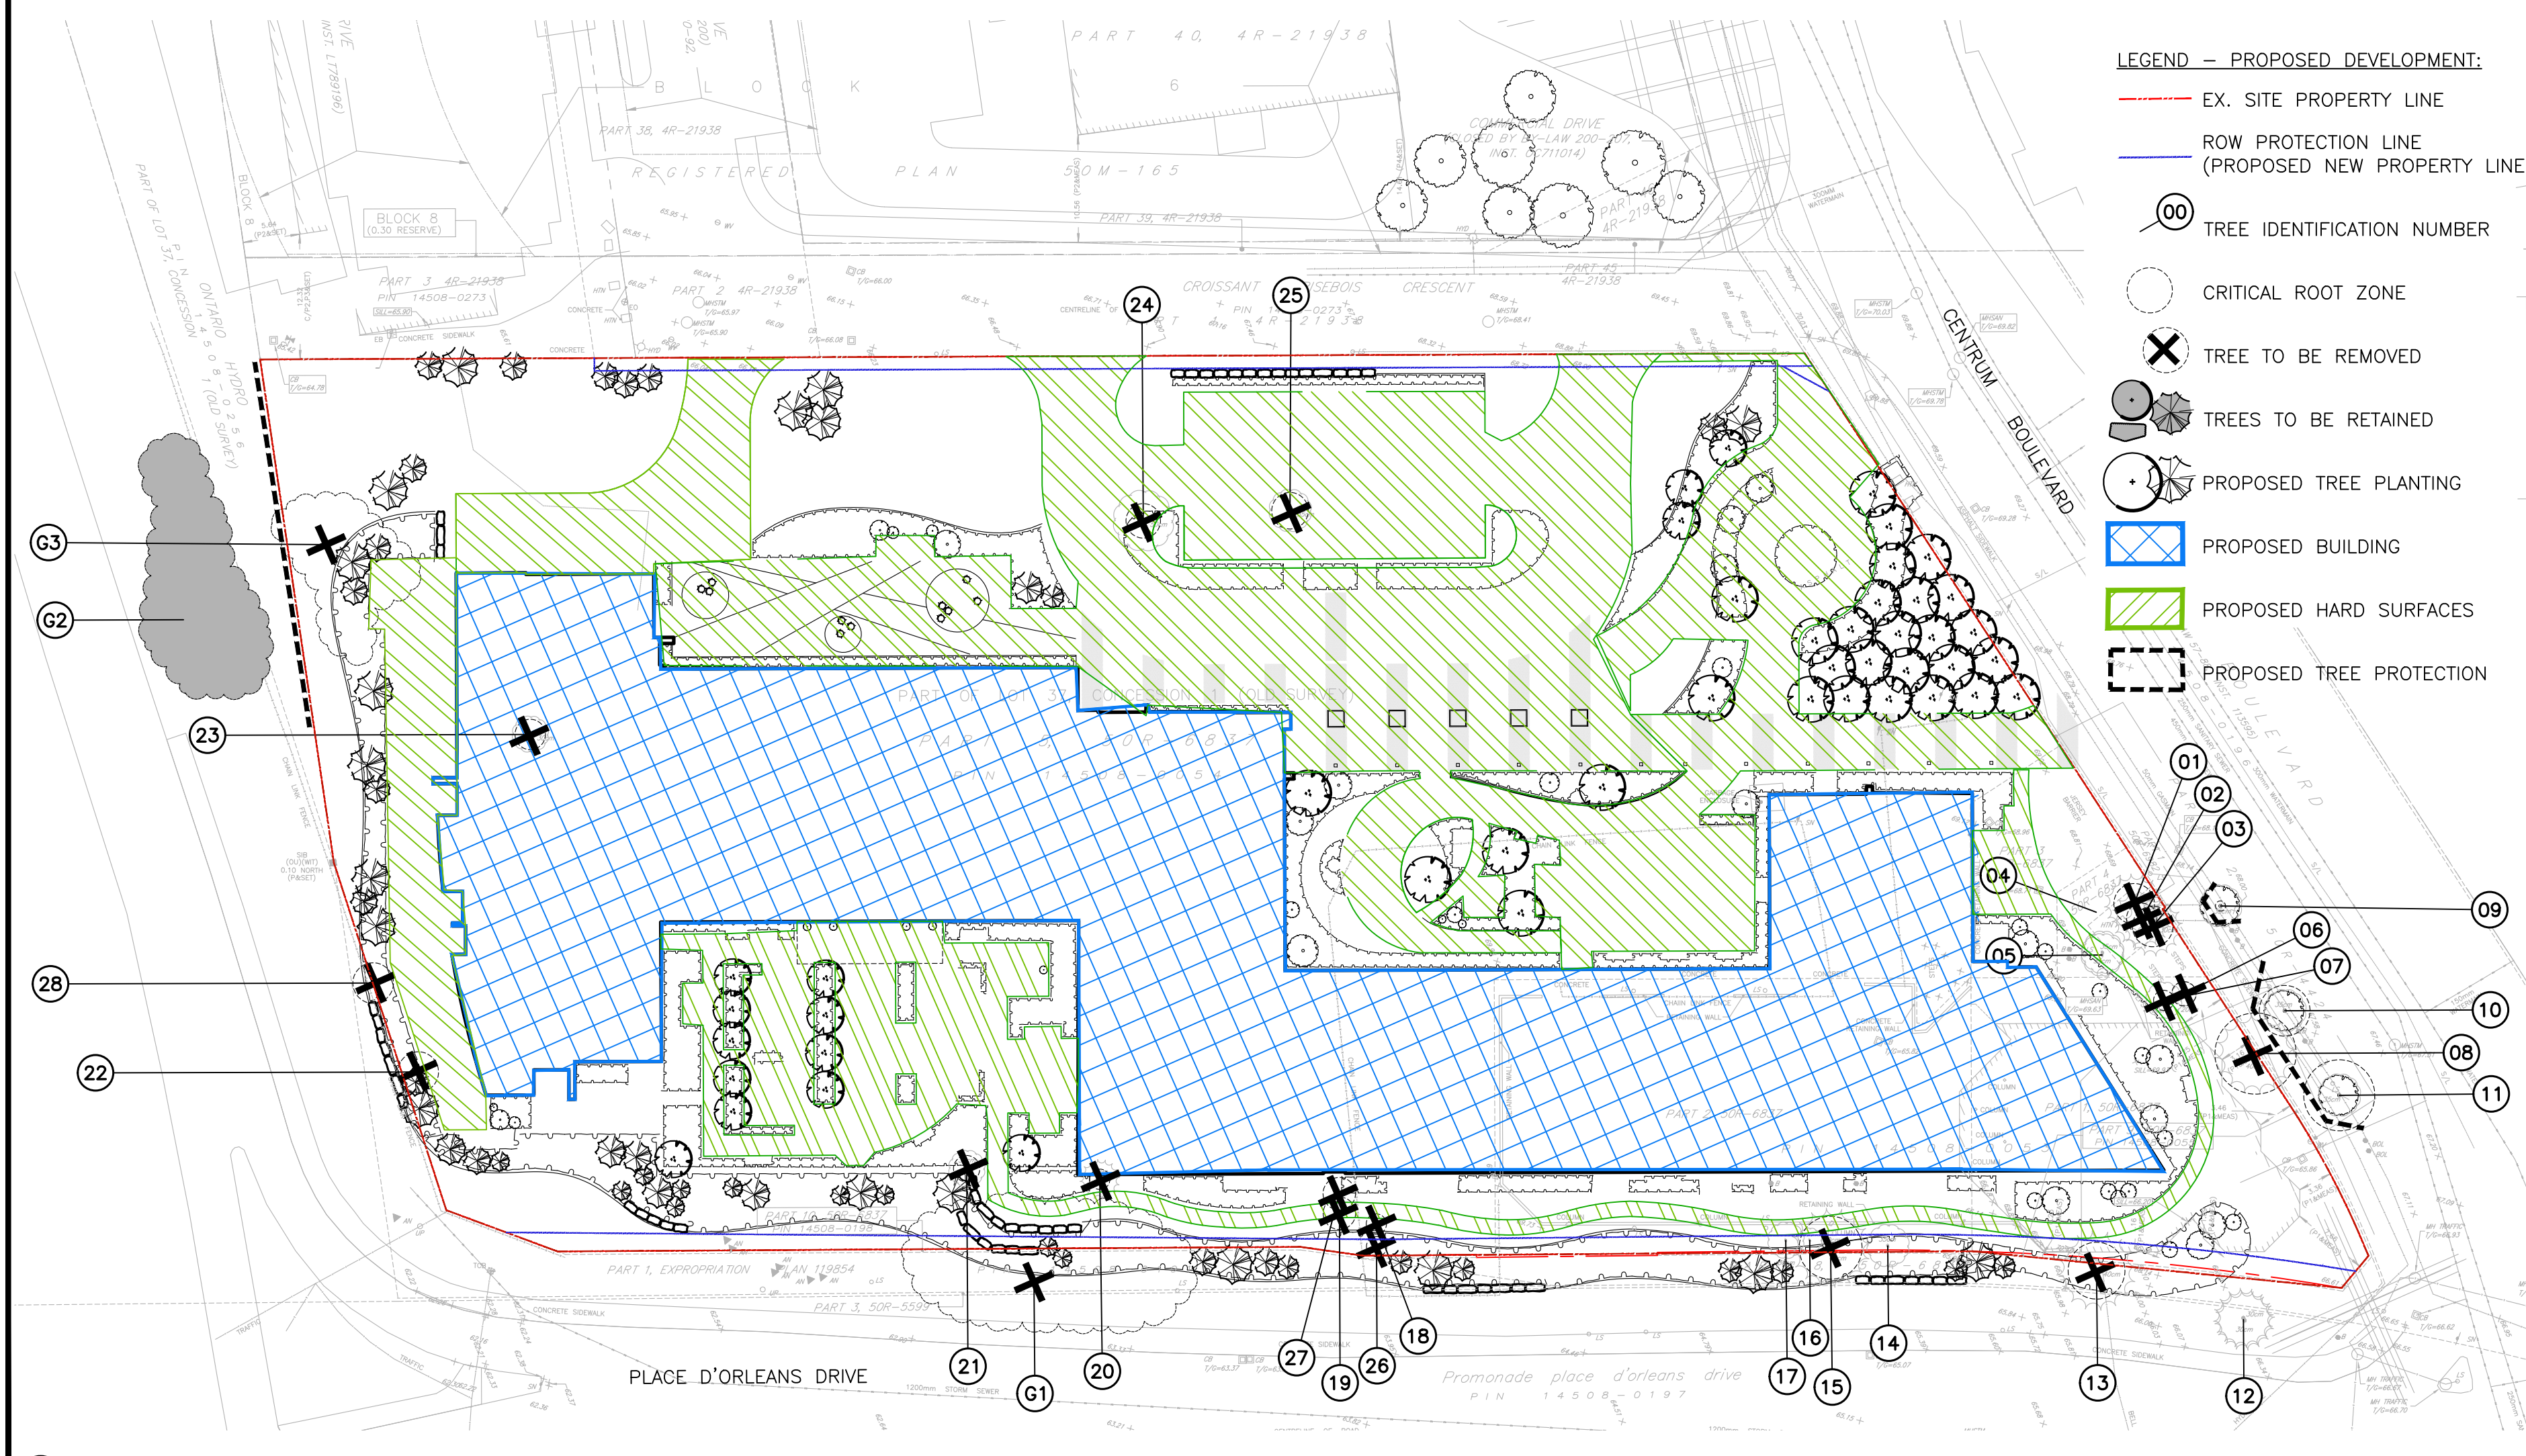
2 PROPOSED DEVELOPMENT

- APPROXIMATELY 5294 m² TO BE HARD SURFACES.
 - 2.0 THE PROPOSED DEVELOPMENT REQUIRES THE REMOVAL OF TWENTY-THREE (21) TREES.
 - 3.0 A TOTAL OF ONE HUNDRED AND NINETY NINE (199) NEW TREES ARE PROPOSED TO BE PLANTED REFER TO LANDSCAPE PLAN L1.0 FOR TREE SPECIES.

- 4.0 FOR RETAINED TREES:
 - ERECT A FENCE AT THE CRITICAL ROOT ZONE (CRZ) OF TREES;
 - DO NOT PLACE ANY MATERIAL OR EQUIPMENT WITHIN THE CRZ OF THE TREE;

- DO NOT ATTACH ANY SIGNS, NOTICES OR POSTERS TO ANY TREE;
 - DO NOT RAISE OR LOWER THE EXISTING GRADE WITHIN THE CRZ WITHOUT APPROVAL;
 - TUNNEL OR BORE WHEN DIGGING WITHIN THE CRZ OF A TREE

- DO NOT DAMAGE THE ROOT SYSTEM, TRUNK OR BRANCHES OF ANY TREE;
 - ENSURE THAT EXHAUST FUMES FROM ALL EQUIPMENT ARE NOT DIRECTED TOWARDS ANY TREE'S CANOPY.

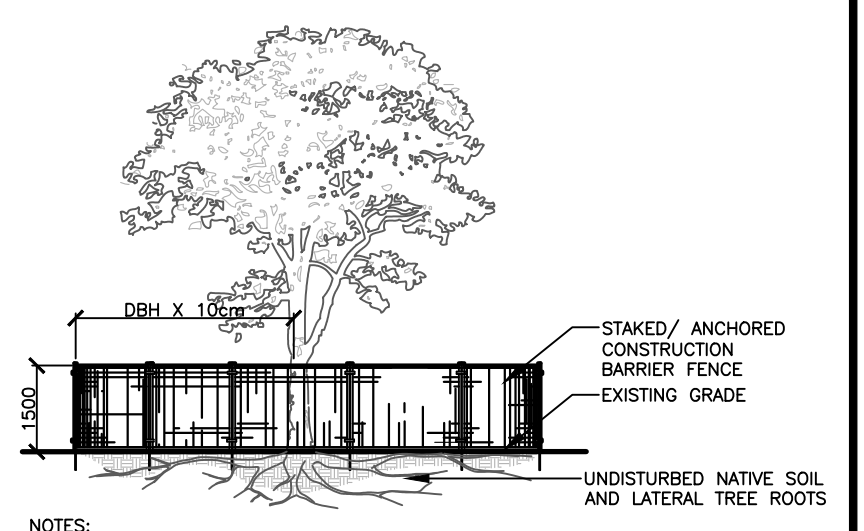
2 TREE PROTECTION N.T.S.

- NOTES:**
1. UNDER THE GUIDANCE OF AN ARBORIST, ERECT A FENCE AT THE CRITICAL ROOT ZONE (CRZ) OF TREES WHERE THE CRZ IS ESTABLISHED AS BEING 10 CENTIMETERS FROM THE TRUNK FOR EVERY CENTIMETER OF TRUNK DIAMETER AT BREAST HEIGHT. THE CRZ IS CALCULATED AS DBH X 100m.
 2. DO NOT PLACE ANY MATERIAL OR EQUIPMENT WITHIN THE CRZ OF THE TREE
 3. DO NOT ATTACH ANY SIGNS, NOTICES OR POSTERS TO ANY TREE
 4. DO NOT RAISE OR LOWER THE EXISTING GRADE WITHIN THE CRZ WITHOUT APPROVAL
 5. TUNNEL OR BORE WHEN DIGGING WITHIN THE CRZ OF A TREE
 6. DO NOT DAMAGE THE ROOT SYSTEM, TRUNK OR BRANCHES OF ANY TREE
 7. ENSURE THAT EXHAUST FUMES FROM ALL EQUIPMENT ARE NOT DIRECTED TOWARDS ANY TREE CANOPY
