**PH4720-LET.02.REV.01**

Subject: **Hydrogeological Assessment and Terrain Analysis**  
Proposed Church Building Addition  
1981 Century Road, North Gower (Ottawa), Ontario

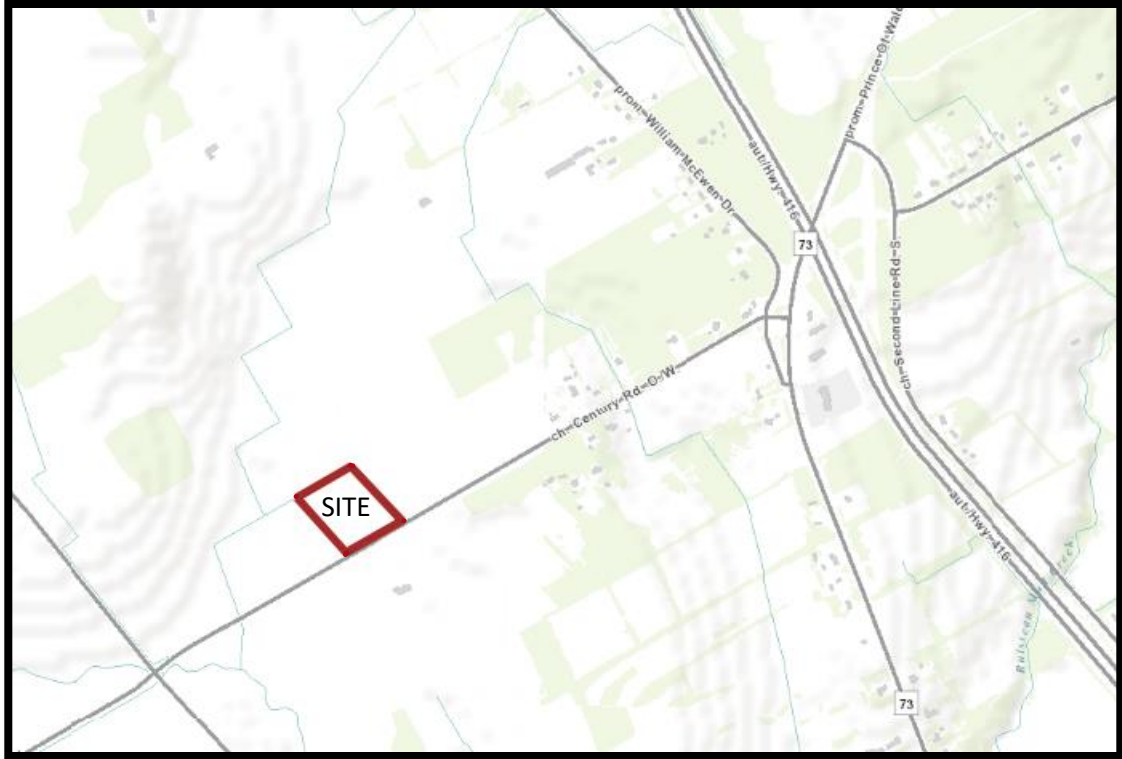
## FIGURE 1

### KEY PLAN

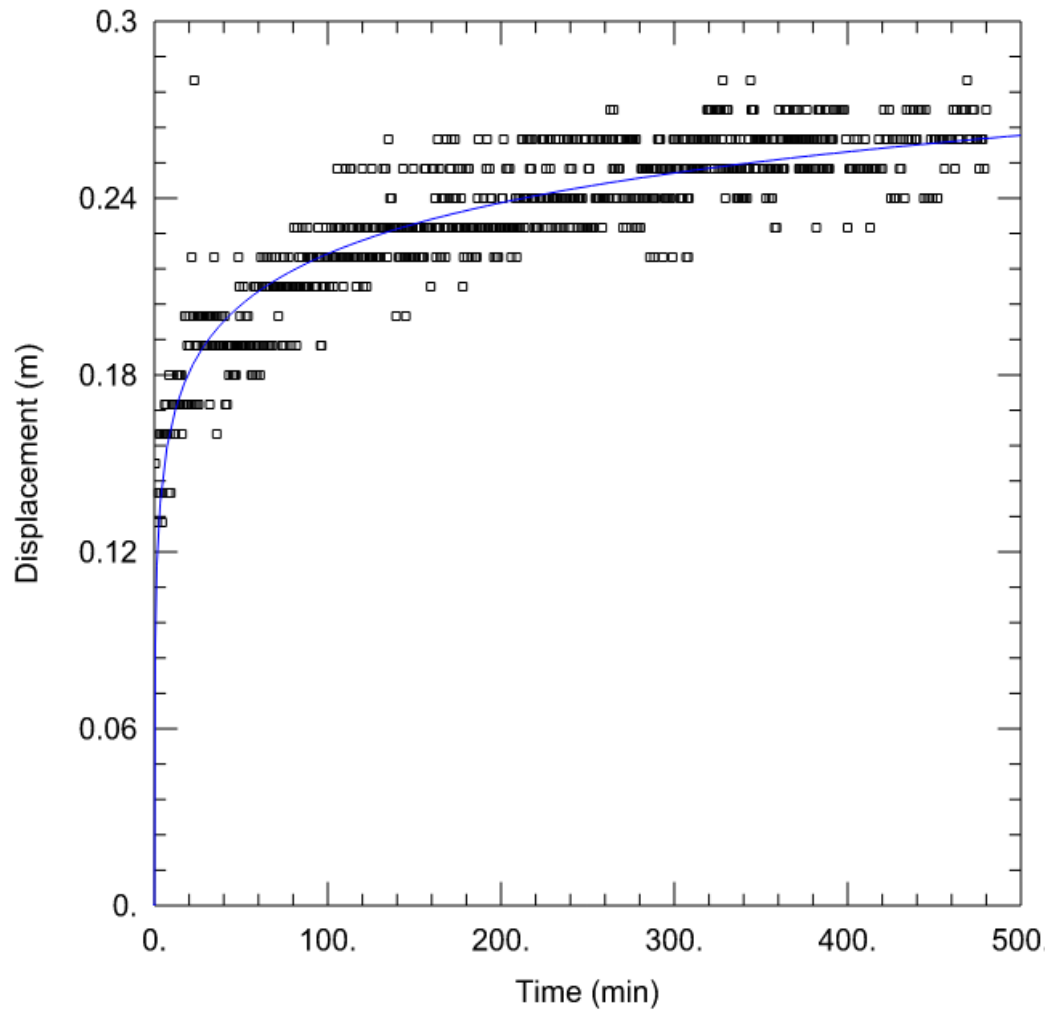
**Pumping Test Analysis Report**

| Site Address: | 1981 Century Road | Discharge Rate (L/min) | 80 |

The pumping test results show that TW1 has a high yield to support the water demands that may be required. Overall maximum drawdown at a constant pumping rate for a period of 8 hours was approximately 0.3 m (0.55% of the available drawdown). It should be noted that 95% recovery was measured at approximately 1 hour and 50 min after the end of the pumping test.

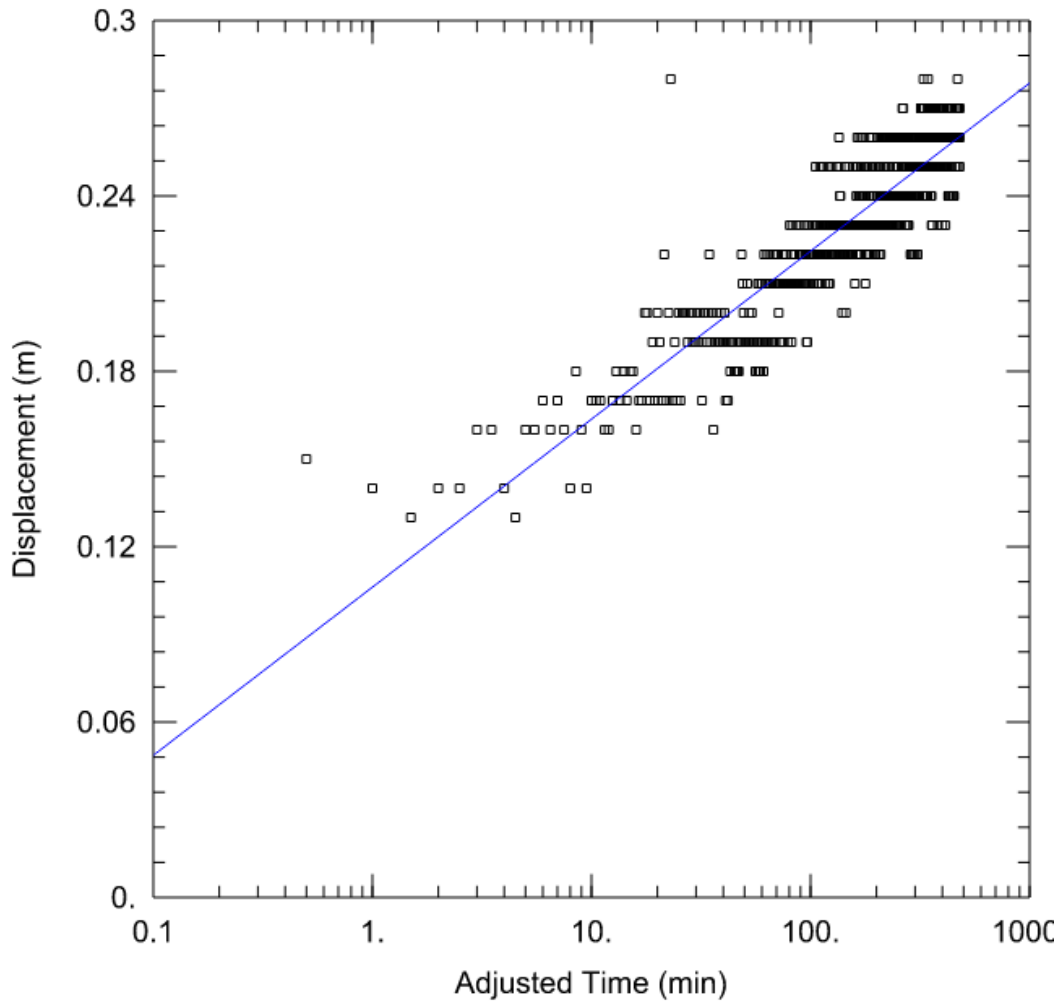
**Pumping Test Analysis Report**

File No. PH4720  
Date: Thursday, June 1, 2023  
Client: Brunstad Christian Church  
Site Address: 1981 Century Road  
Project: Proposed Commercial  
Development
