# **Phase I Environmental Site Assessment**

561 Somme Street  
Ottawa, Ontario

Prepared for Blackstone Granite

Report: PE6672-1  
September 27, 2024

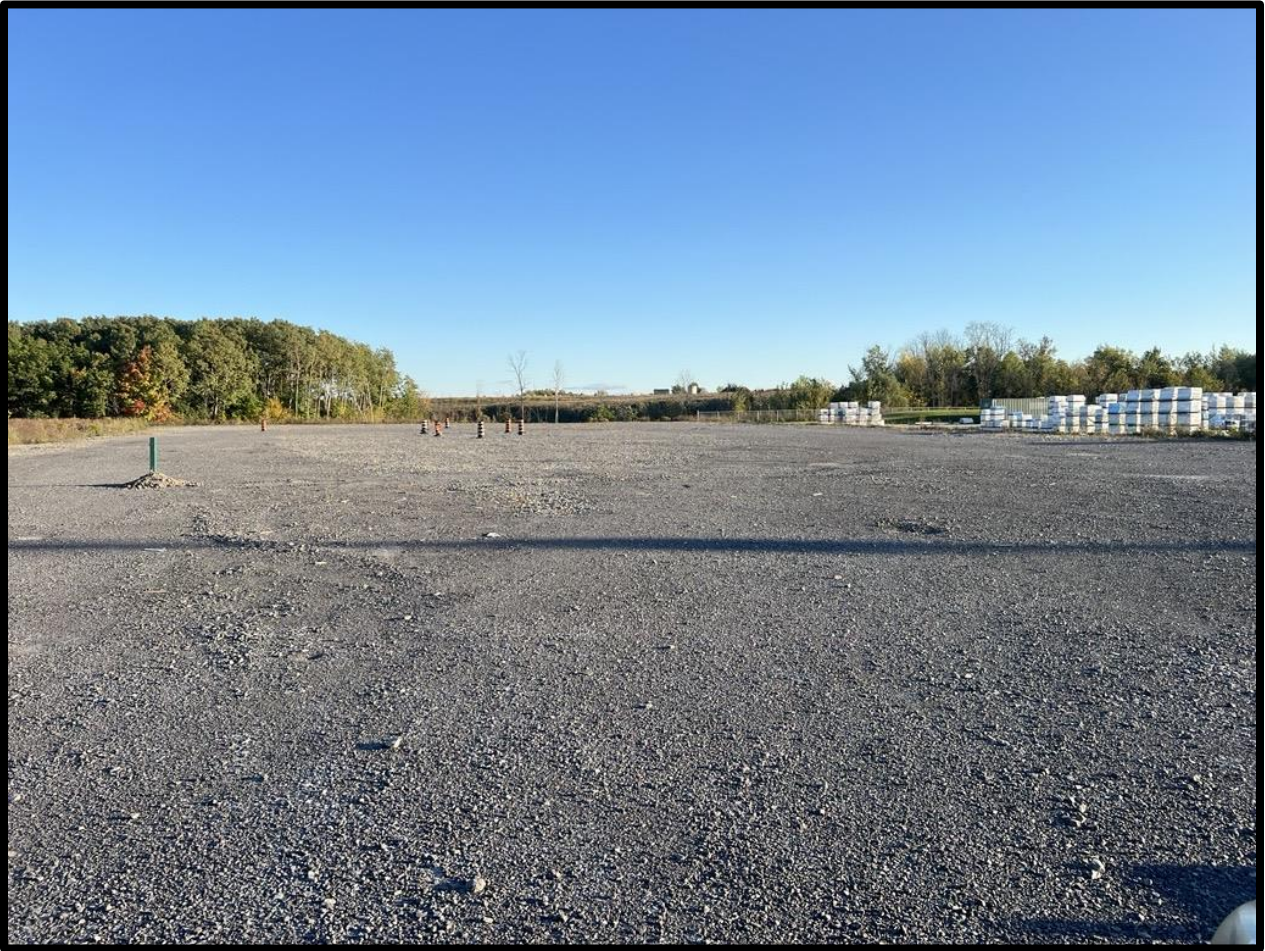
Photograph 1: View of the northern portion of the Phase I Property, facing south.

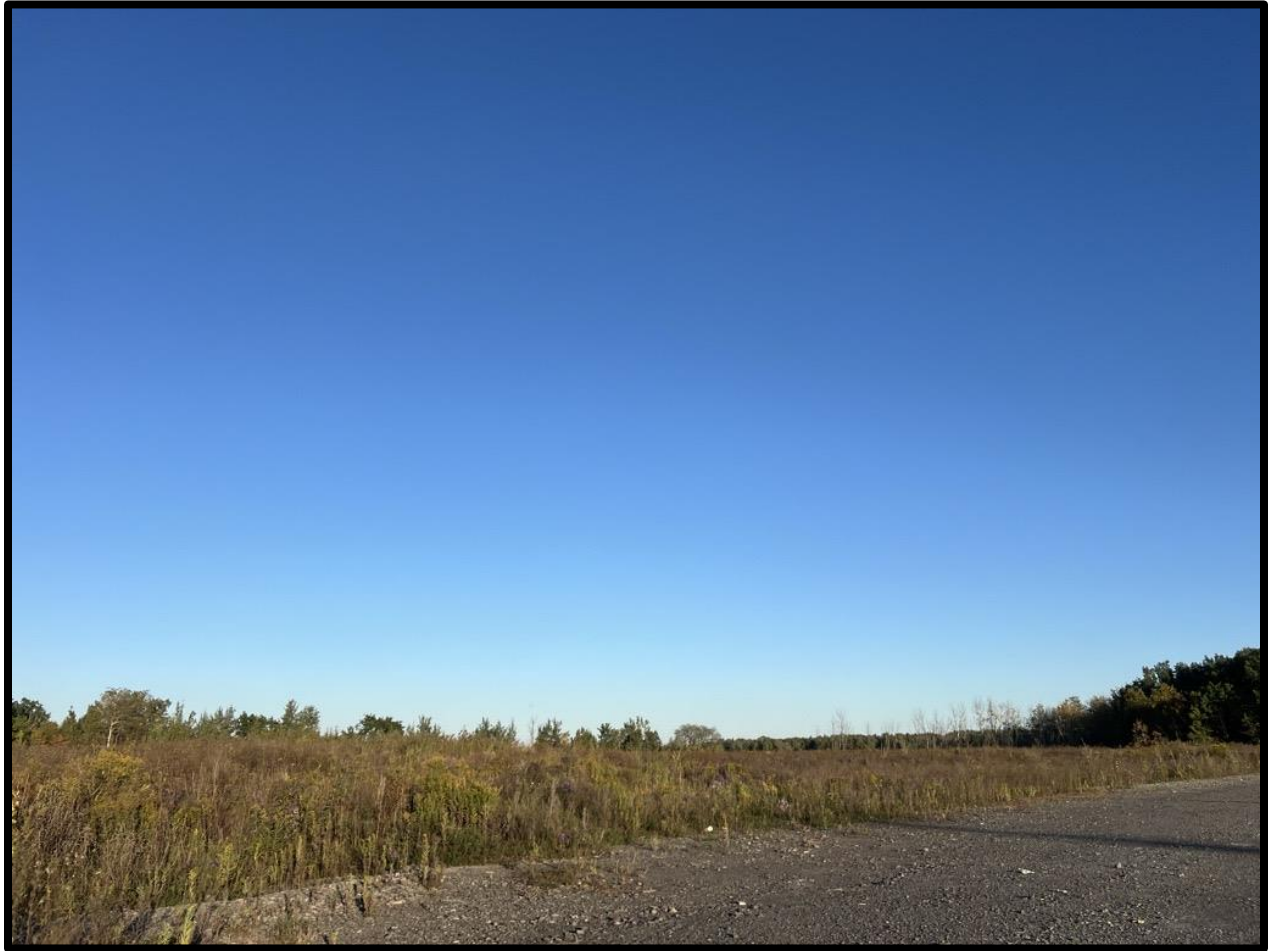
Photograph 2: View of the central portion of the Phase I Property, facing southwest.

Imported fill material was observed across the northern portion of the Phase I Property. As mentioned in the Previous Engineering Reports section, the fill material was tested as part of the 2020 Phase II ESA and is not considered to pose a potential environmental concern on the Phase I Property.
