Memorandum

Date: June 26, 2025
To: RioCan Holdings Inc.
From: Berend Velderman, Geosyntec Consultants International, Inc.
Subject: **Supplemental Hydrogeological Memorandum
1309 Carling Avenue, Ottawa, Ontario**

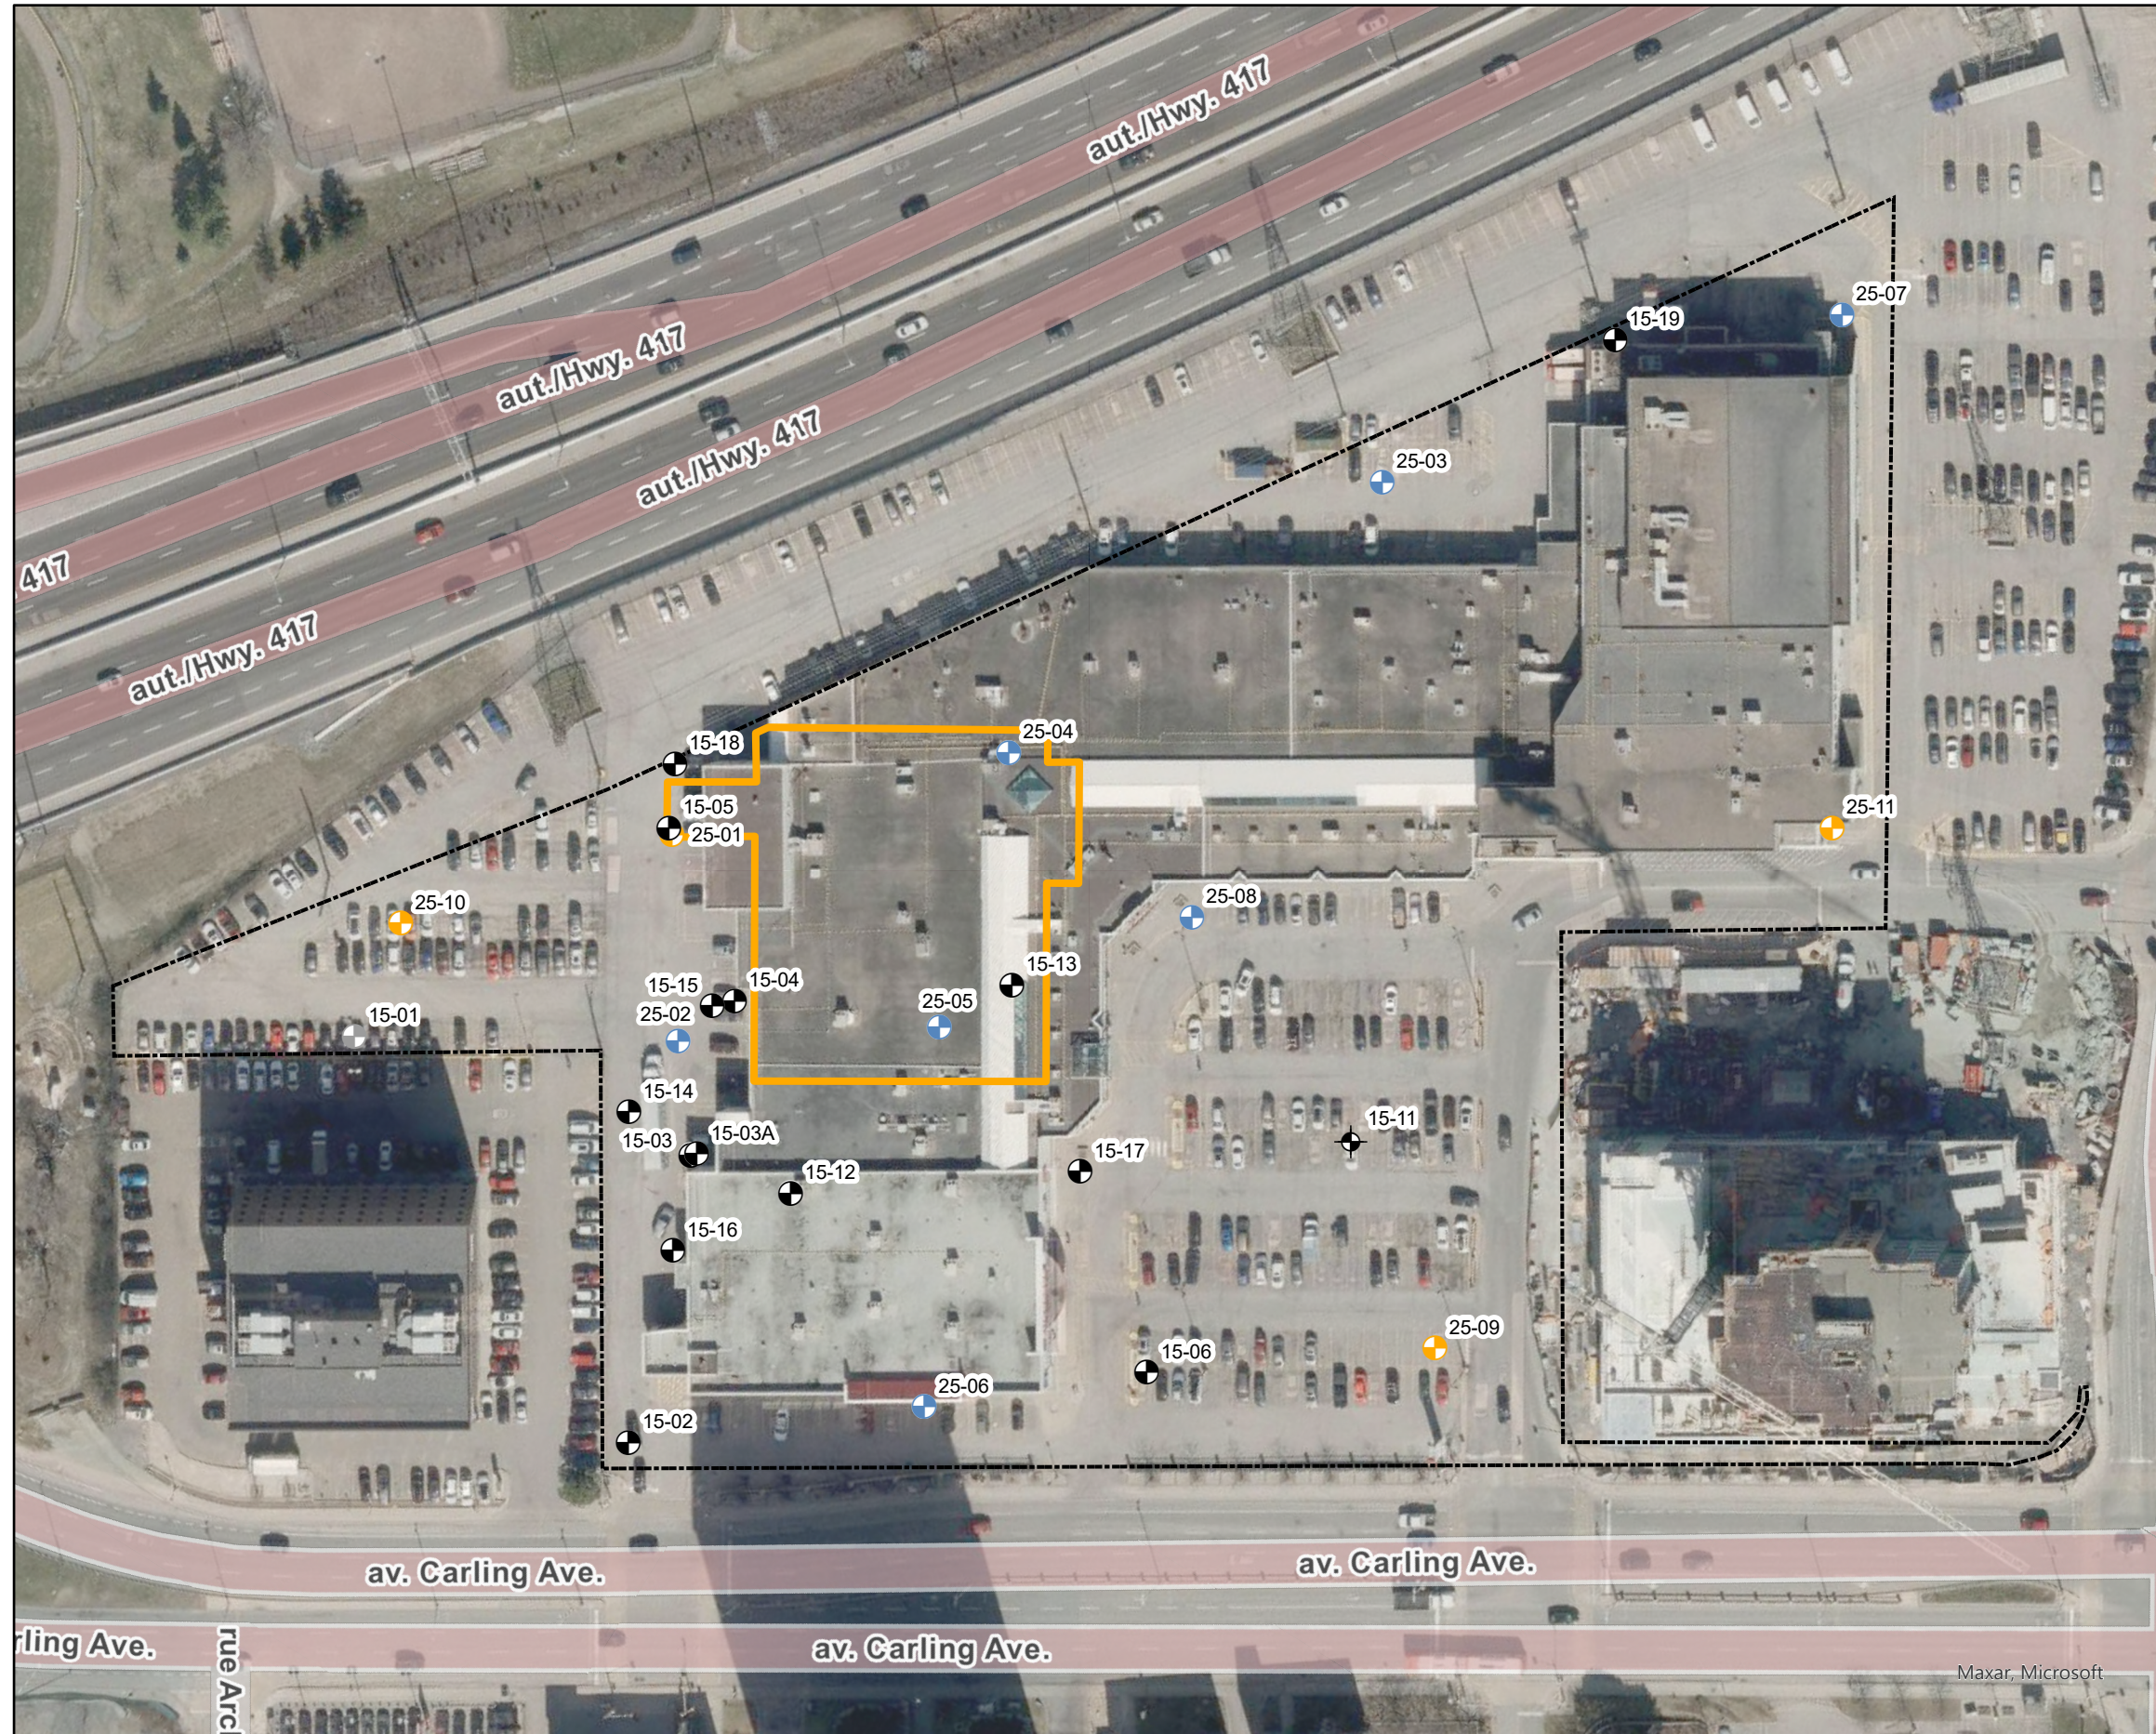
FIGURE 2
BOREHOLE LOCATION PLAN -
PHASE TWO ESA AND GEOTECHNICAL
INVESTIGATION
 1309 CARLING AVENUE
 OTTAWA, ONTARIO

- Legend:**
- Borehole (Geosyntec)
 - Monitoring Well (Geosyntec)
 - Previous Borehole (Golder)
 - Previous Monitoring Well (Golder)
 - Unlocatable Previous Monitoring Well (Golder)
 - Phase Two Property Boundary
 - Building Footprint (approximate)

Four monitoring wells were installed in the completed geotechnical boreholes located near or within the proposed building footprint. Additionally, three monitoring wells installed as part of the environmental site assessment, located elsewhere on the property, are also referenced in this memorandum. These monitoring wells were constructed using flush-threaded, Schedule 40, clean polyvinyl chloride (PVC) casings with slotted well screens. The exterior wells had a diameter of 50-millimeter (mm) (2 inches), except for well 25-02, which had a 38 mm (1.5 inches) diameter PVC casing. The interior wells had a diameter of 31 mm (1.25 inches). The screens ranged from 0.61 to 3.0 meters (m) in length and were installed to intersect the water table. Detailed information about the installed monitoring wells can be found in the relevant borehole logs in **Appendix A**.

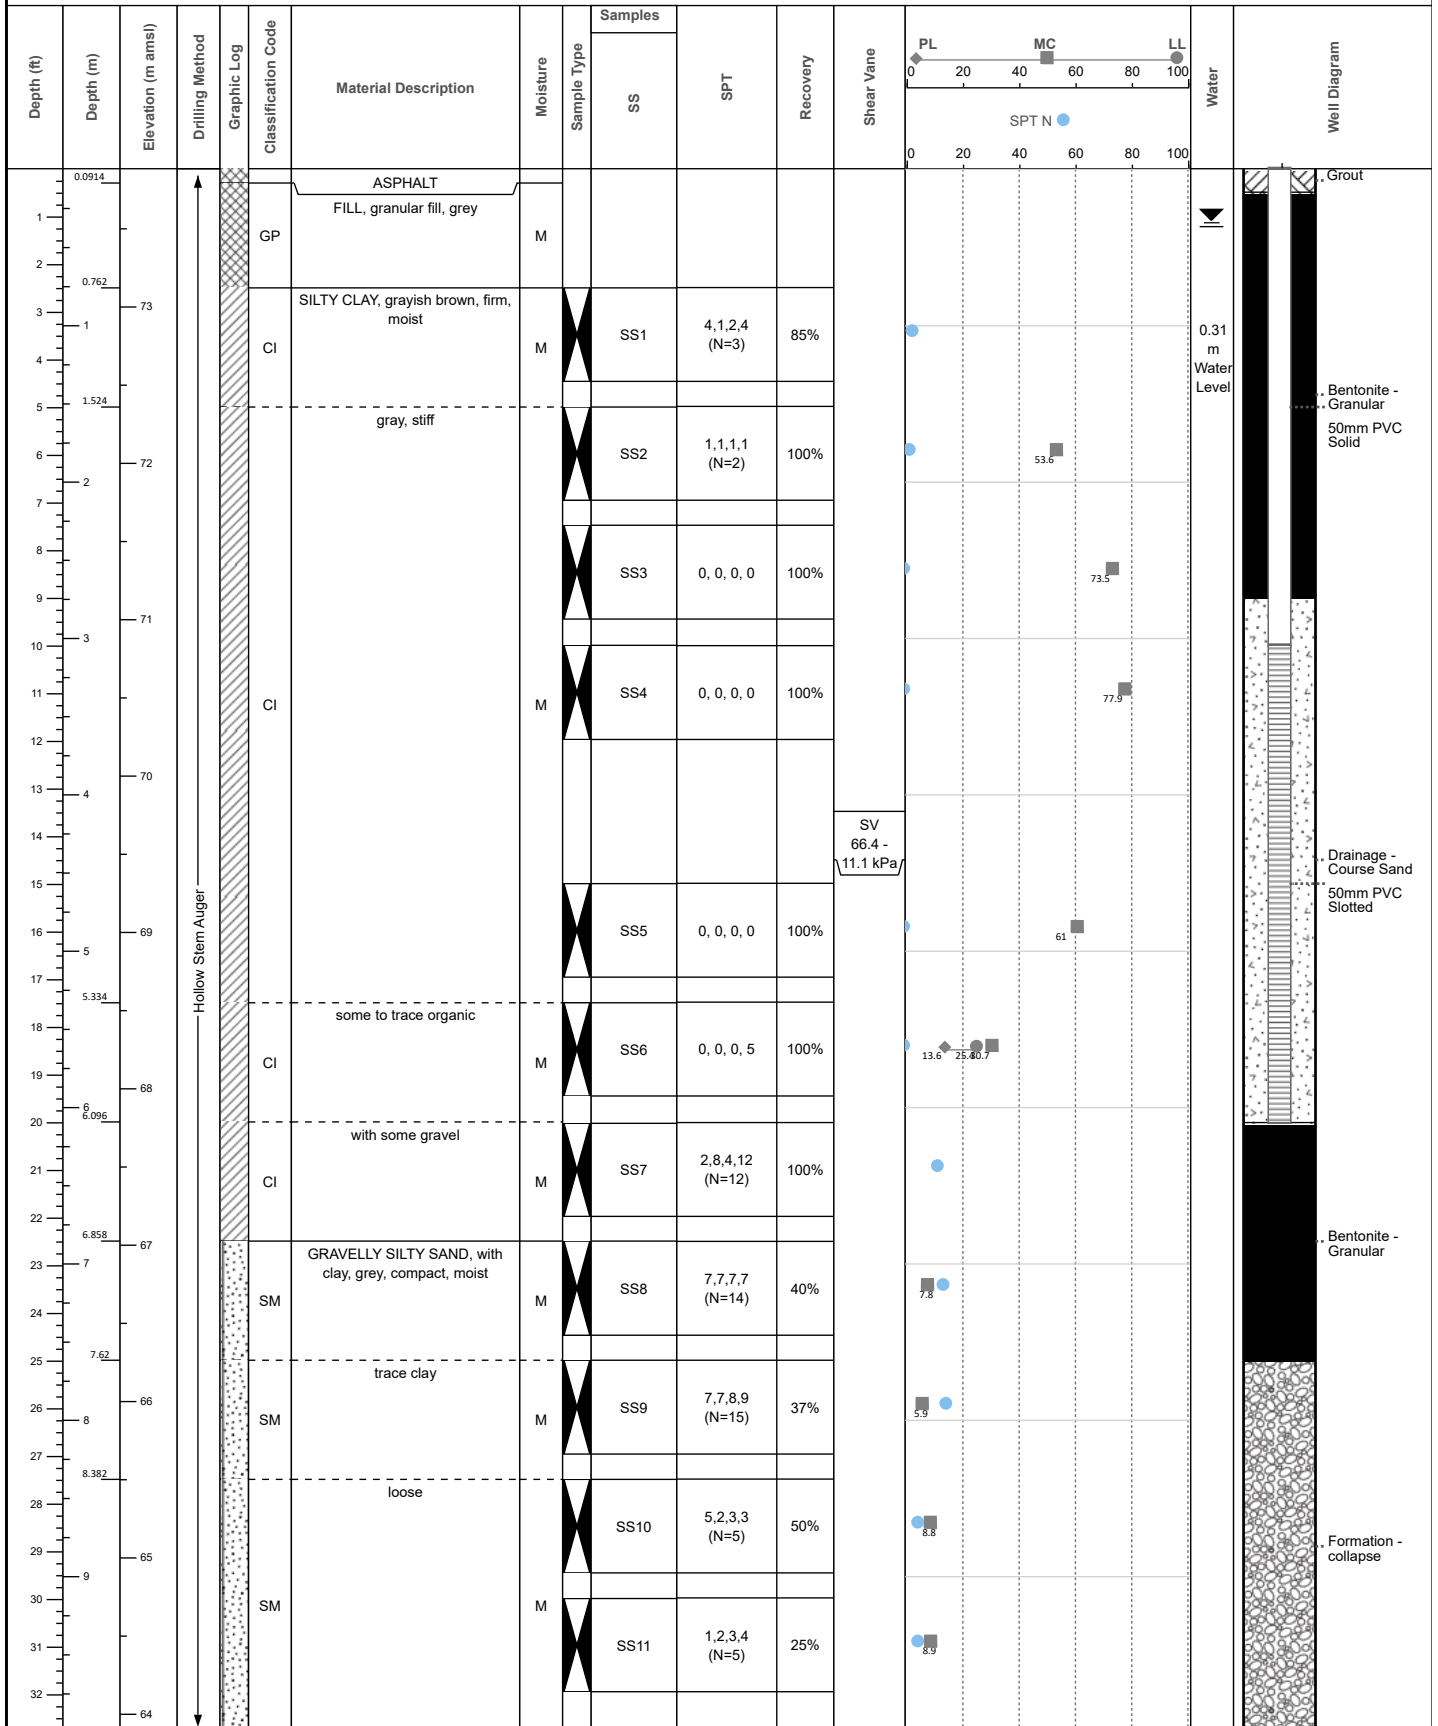
25-08 Terminated at 20.57m (upon reaching target depth Monitoring well installed.)

Depth (ft)	Depth (m)	Elevation (m amsl)	Drilling Method	Graphic Log	Classification Code	Material Description	Moisture	Sample Type	Samples		SPT	Recovery	Shear Vane	Liquid Limit / Plasticity Chart			Water	Well Diagram	
									SS	N				PL	MC	LL			
34			Hollow Stem Auger		SM	loose	M												
35	10.668	63			SM	compact, wet	W		SS12	4,9,12 (N=R)	60%			12.9					
36	11																		
37	11.2776							boulder											
38																			
39	12	62																	
40																			
41					SM		W												
42		61																	
43	13																		
44																			
45	13.72	60			SM	GRAVELLY SAND, with some silt and trace clay, grey, dense, wet	W	SS13	18,16,22,8 (N=38)	40%			8.9						
46	14																		
47																			
48		59																	
49	15																		
50																			
51	15.54					more gravel and less sand		SS14	8,11,19,17 (N=30)	25%			9.9						
52	16	58

Depth (ft)	Depth (m)	Elevation (m)	Drilling Method	Graphic Log	Classification Code	Material Description	RQD% and TCR%		Water	Well Diagram
							RQD%	TCR%		
34										
35										
36	11	63								
37										
38										
39	12	62								
40										
41										
42										
43	13	61								
44										
45										
46	14	60								
47										
48										
49	15	59								
50										
51										
52	16	58								
53										
54										
55										
56	17	57								
57										
58										
Commenced Coring at 17.83m										
59	18	56	 NMLC Coring	 LIMST	LIMSTONE: grey limestone with shale interbeds, highly weathered and fractured, fine grain, thinly to medium bedded, very poor quality	RQD = 0%				
60						good quality, very strong	RQD = 80%			
61										
62	19	55								
63										
63.468	19.35									
64										
65		54

LIMST	good quality, very strong	RQD = 80%
