## **Phase Two Environmental Site Assessment**

5360 Bank Street  
Ottawa, Ontario

GEMTEC Project: 100227.101

October 2, 2023  
GEMTEC Project: 100227.101

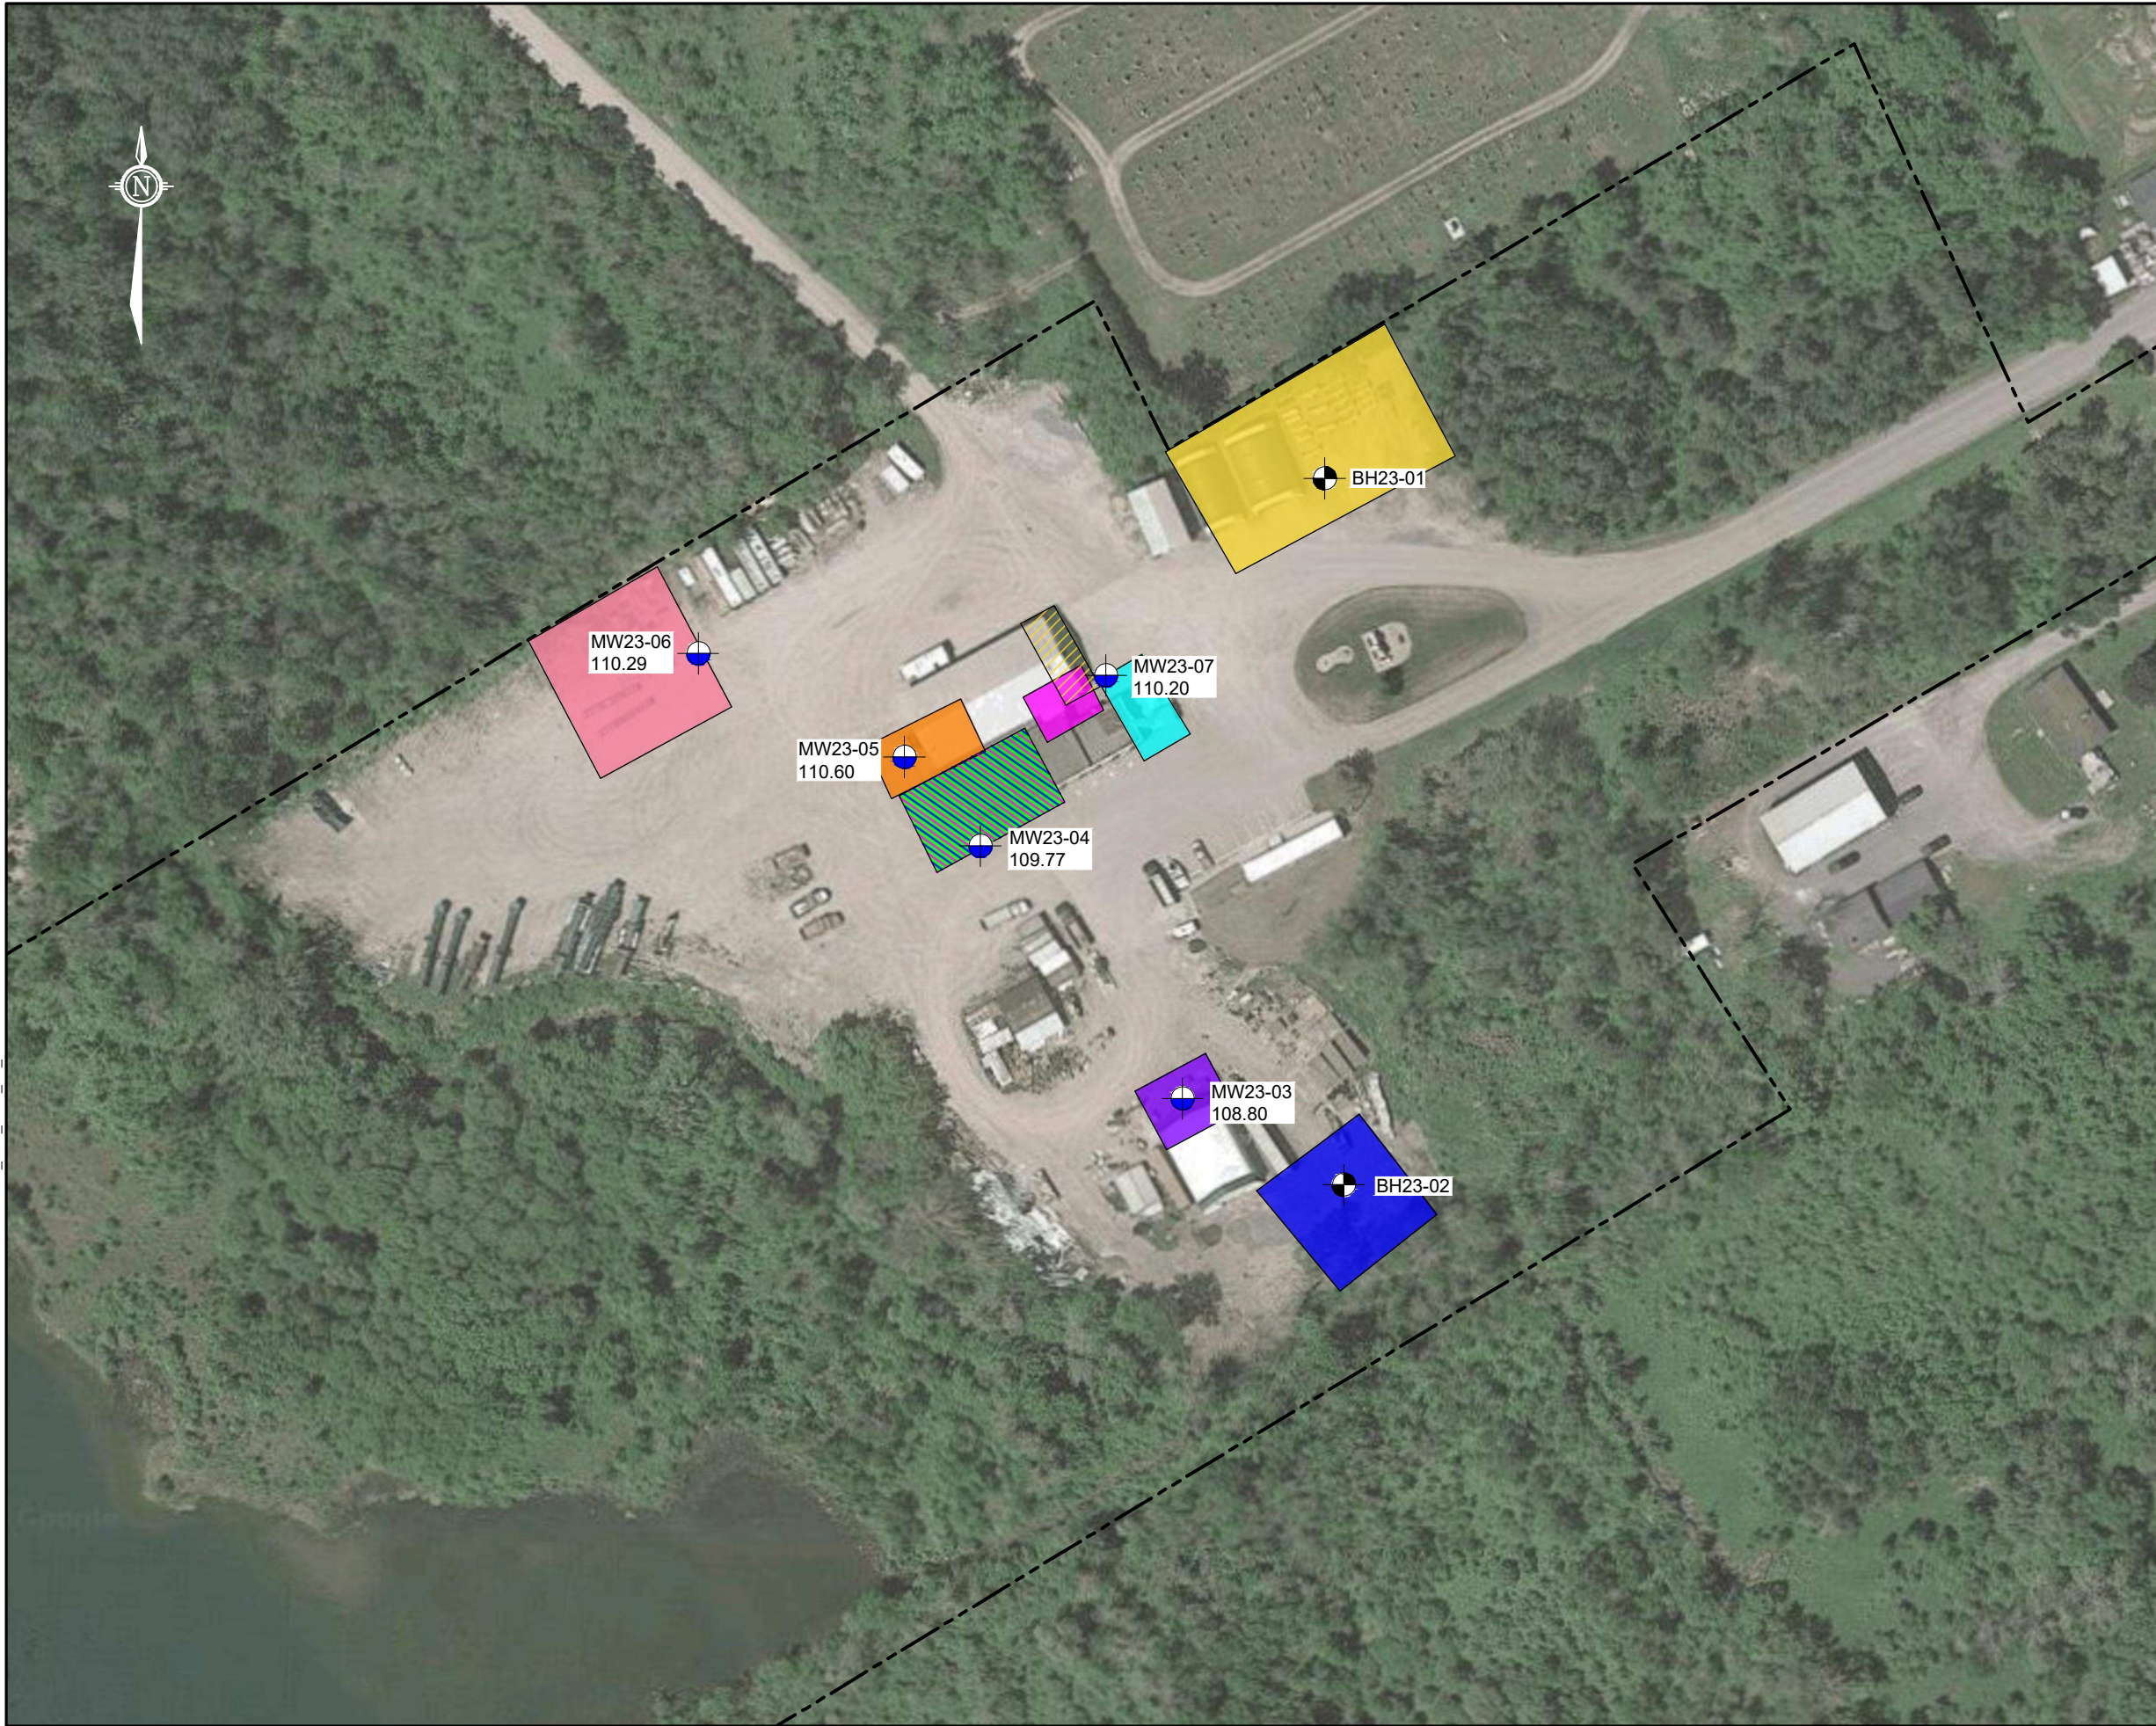
| DATE<br>SEPTEMBER 2023 | FIGURE NO.<br>FIGURE A.4 |

| <b>BH/ MW #</b> | BOREHOLE/ MONITORING WELL ID |

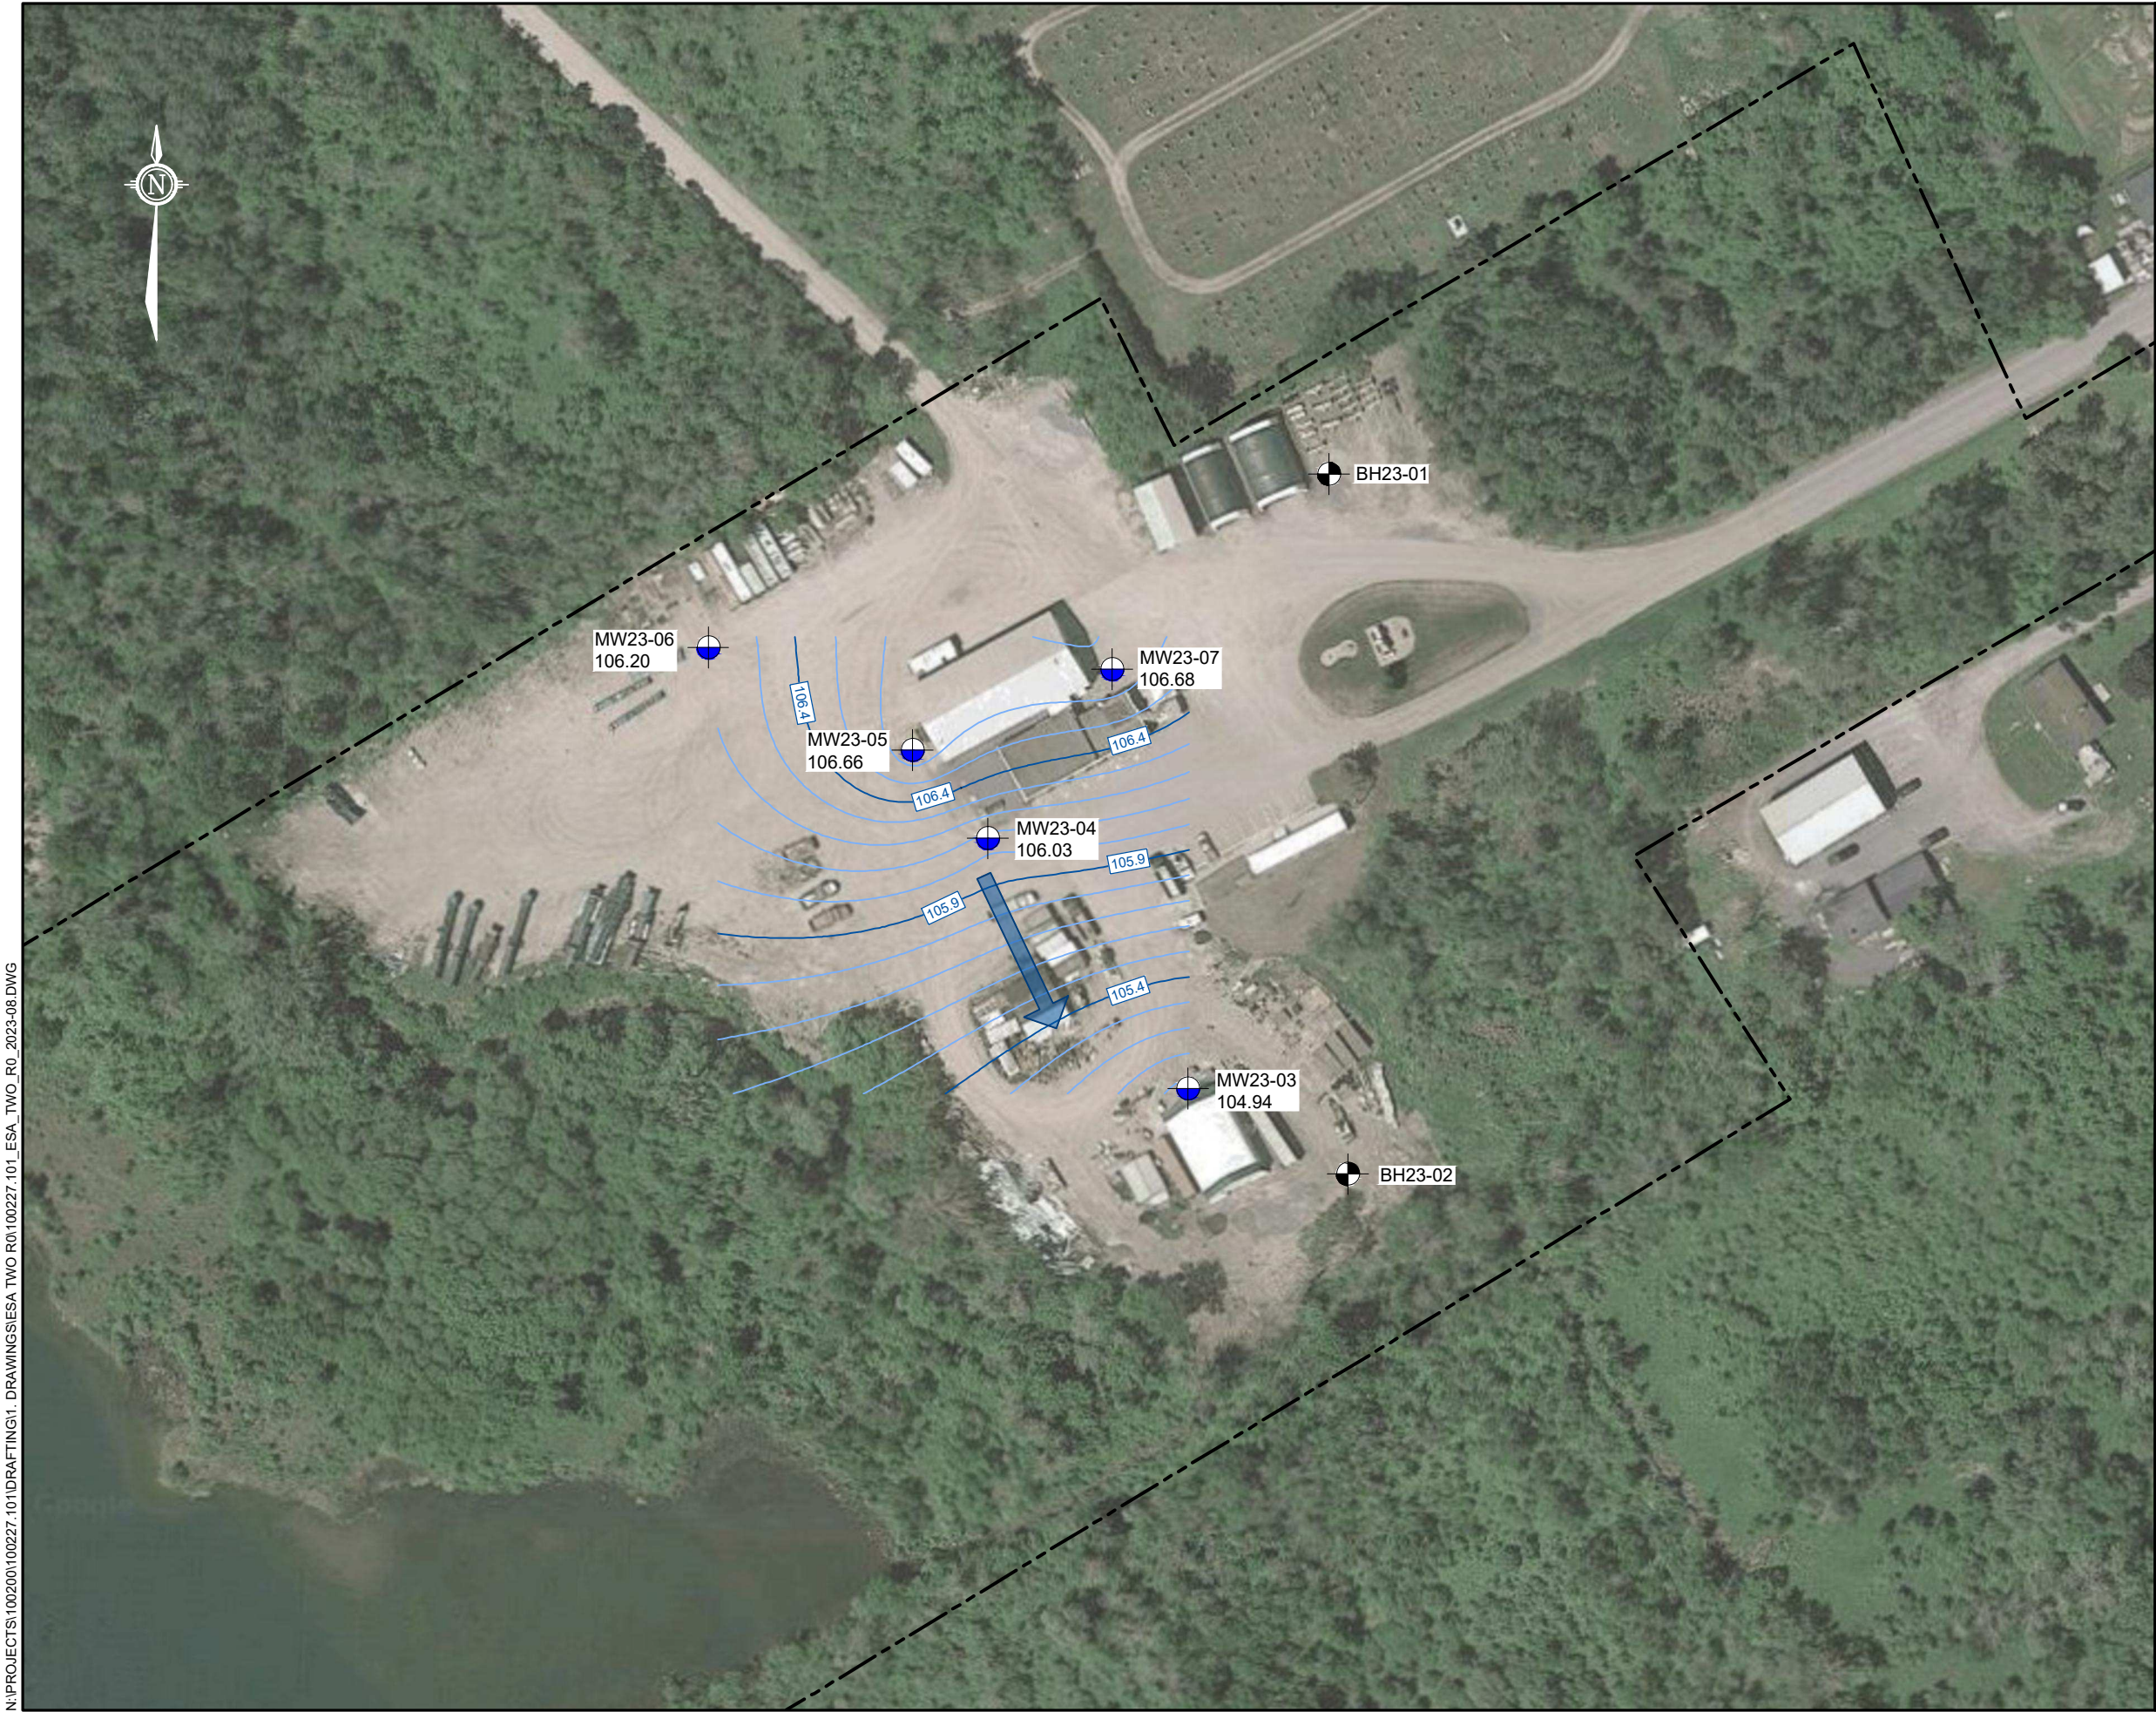
- BH/MW #** — BOREHOLE/ MONITORING WELL ID  
**XX.XX** — GROUND WATER ELEVATION (AUGUST 25, 2023), IN METRES, GEODETIC DATUM
- BOREHOLE LOCATION**  
(current investigation by GEMTEC)
- MONITORING LOCATION**  
(current investigation by GEMTEC)
- **PHASE TWO PROPERTY**
- 100** **MAJOR GROUNDWATER CONTOUR (AUGUST 25, 2023), IN METRES**
- MINOR GROUNDWATER CONTOUR (AUGUST 25, 2023), IN METRES**
- APPROXIMATE GROUNDWATER DIRECTIONAL FLOW**

The average horizontal hydraulic gradient for shallow groundwater conditions measured on August 25, 2023 was 0.022 m/m. Vertical hydraulic gradient for shallow groundwater conditions were not calculated as nesting monitoring wells were not installed at the Site.
