# VUZE Construction

1015 Tweddle Road

## TREE CONSERVATION REPORT

CIMA+ file number: Z0018492  
22 August 2025 - Review 000

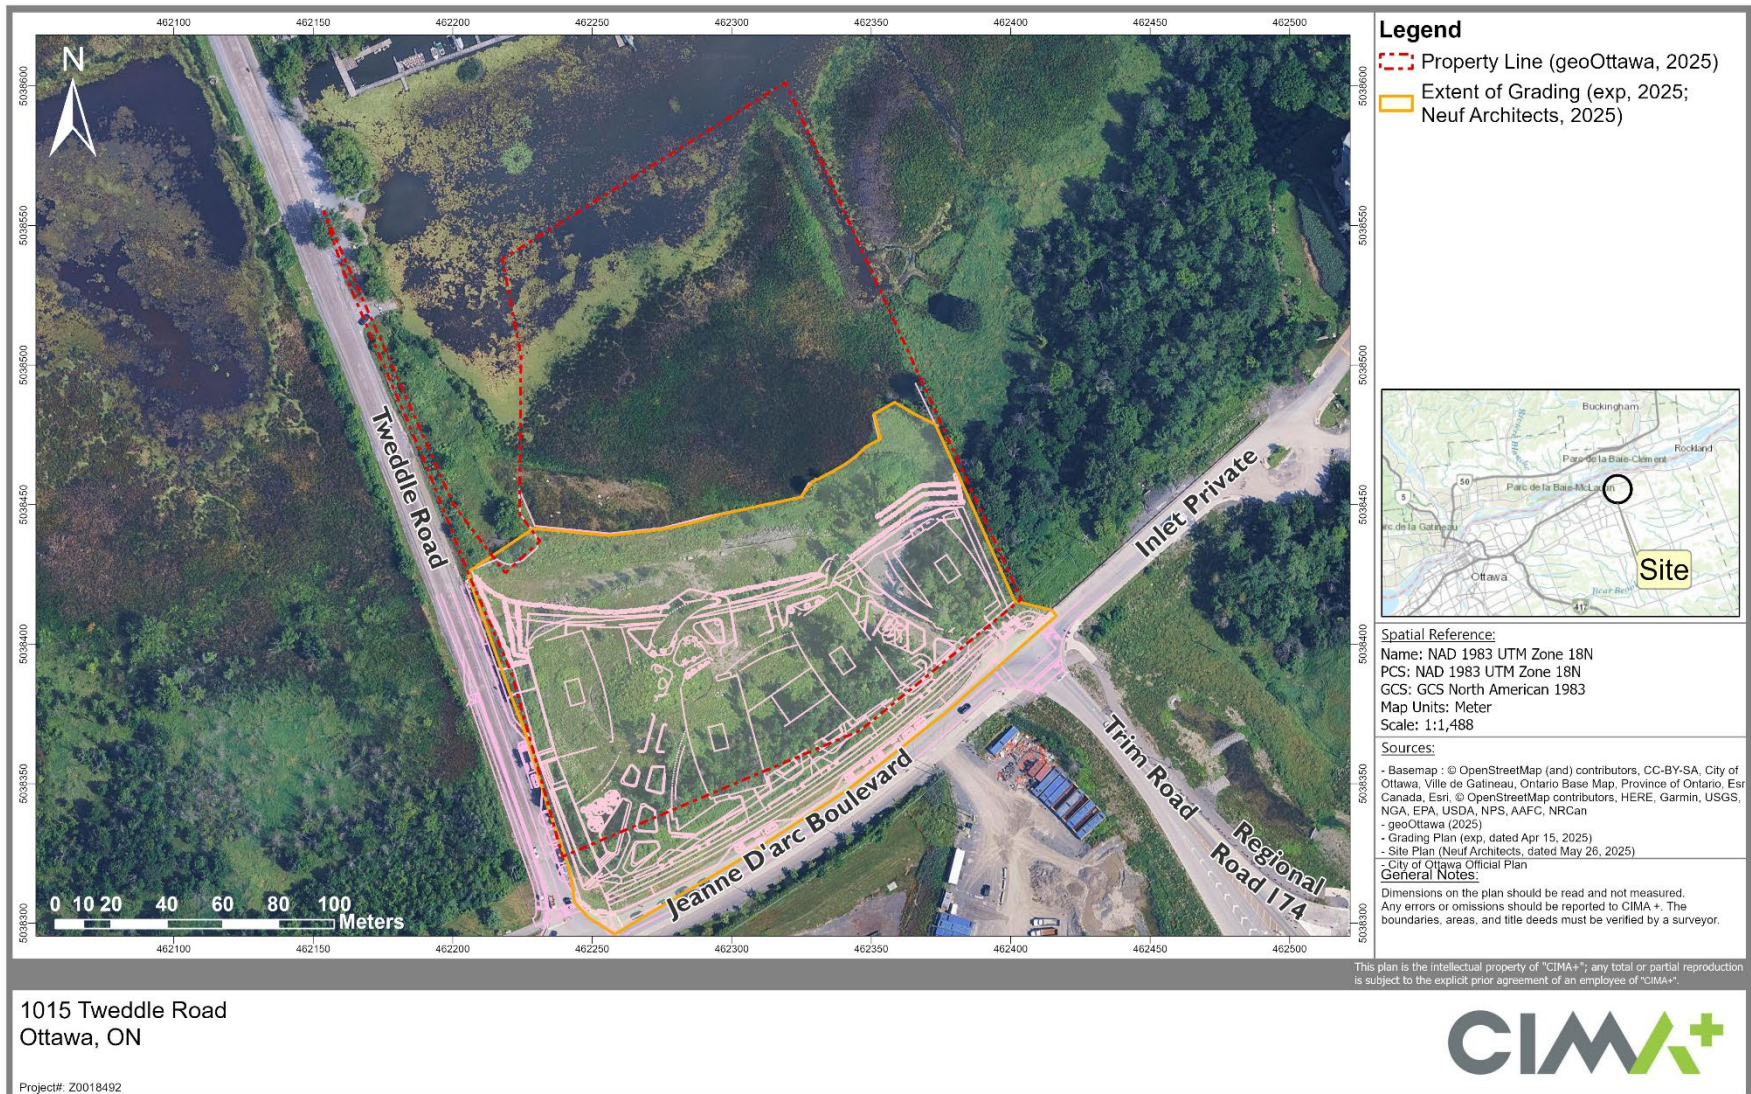
Figure 1: Property Location and Proposed Works

VUZE Construction, hereafter referred to as the proponent, intends to develop the property at 1015 Tweddle Road (the “Property”), situated at the northeast corner of the intersection at Tweddle Road and Jeanne d’Arc Boulevard North. As of 2022, Bowfin merged its services with CIMA+ who has taken over the mandate of updating this Tree Conservation Report (TCR) as per the City of Ottawa’s Tree Conservation Report Guidelines (2021).

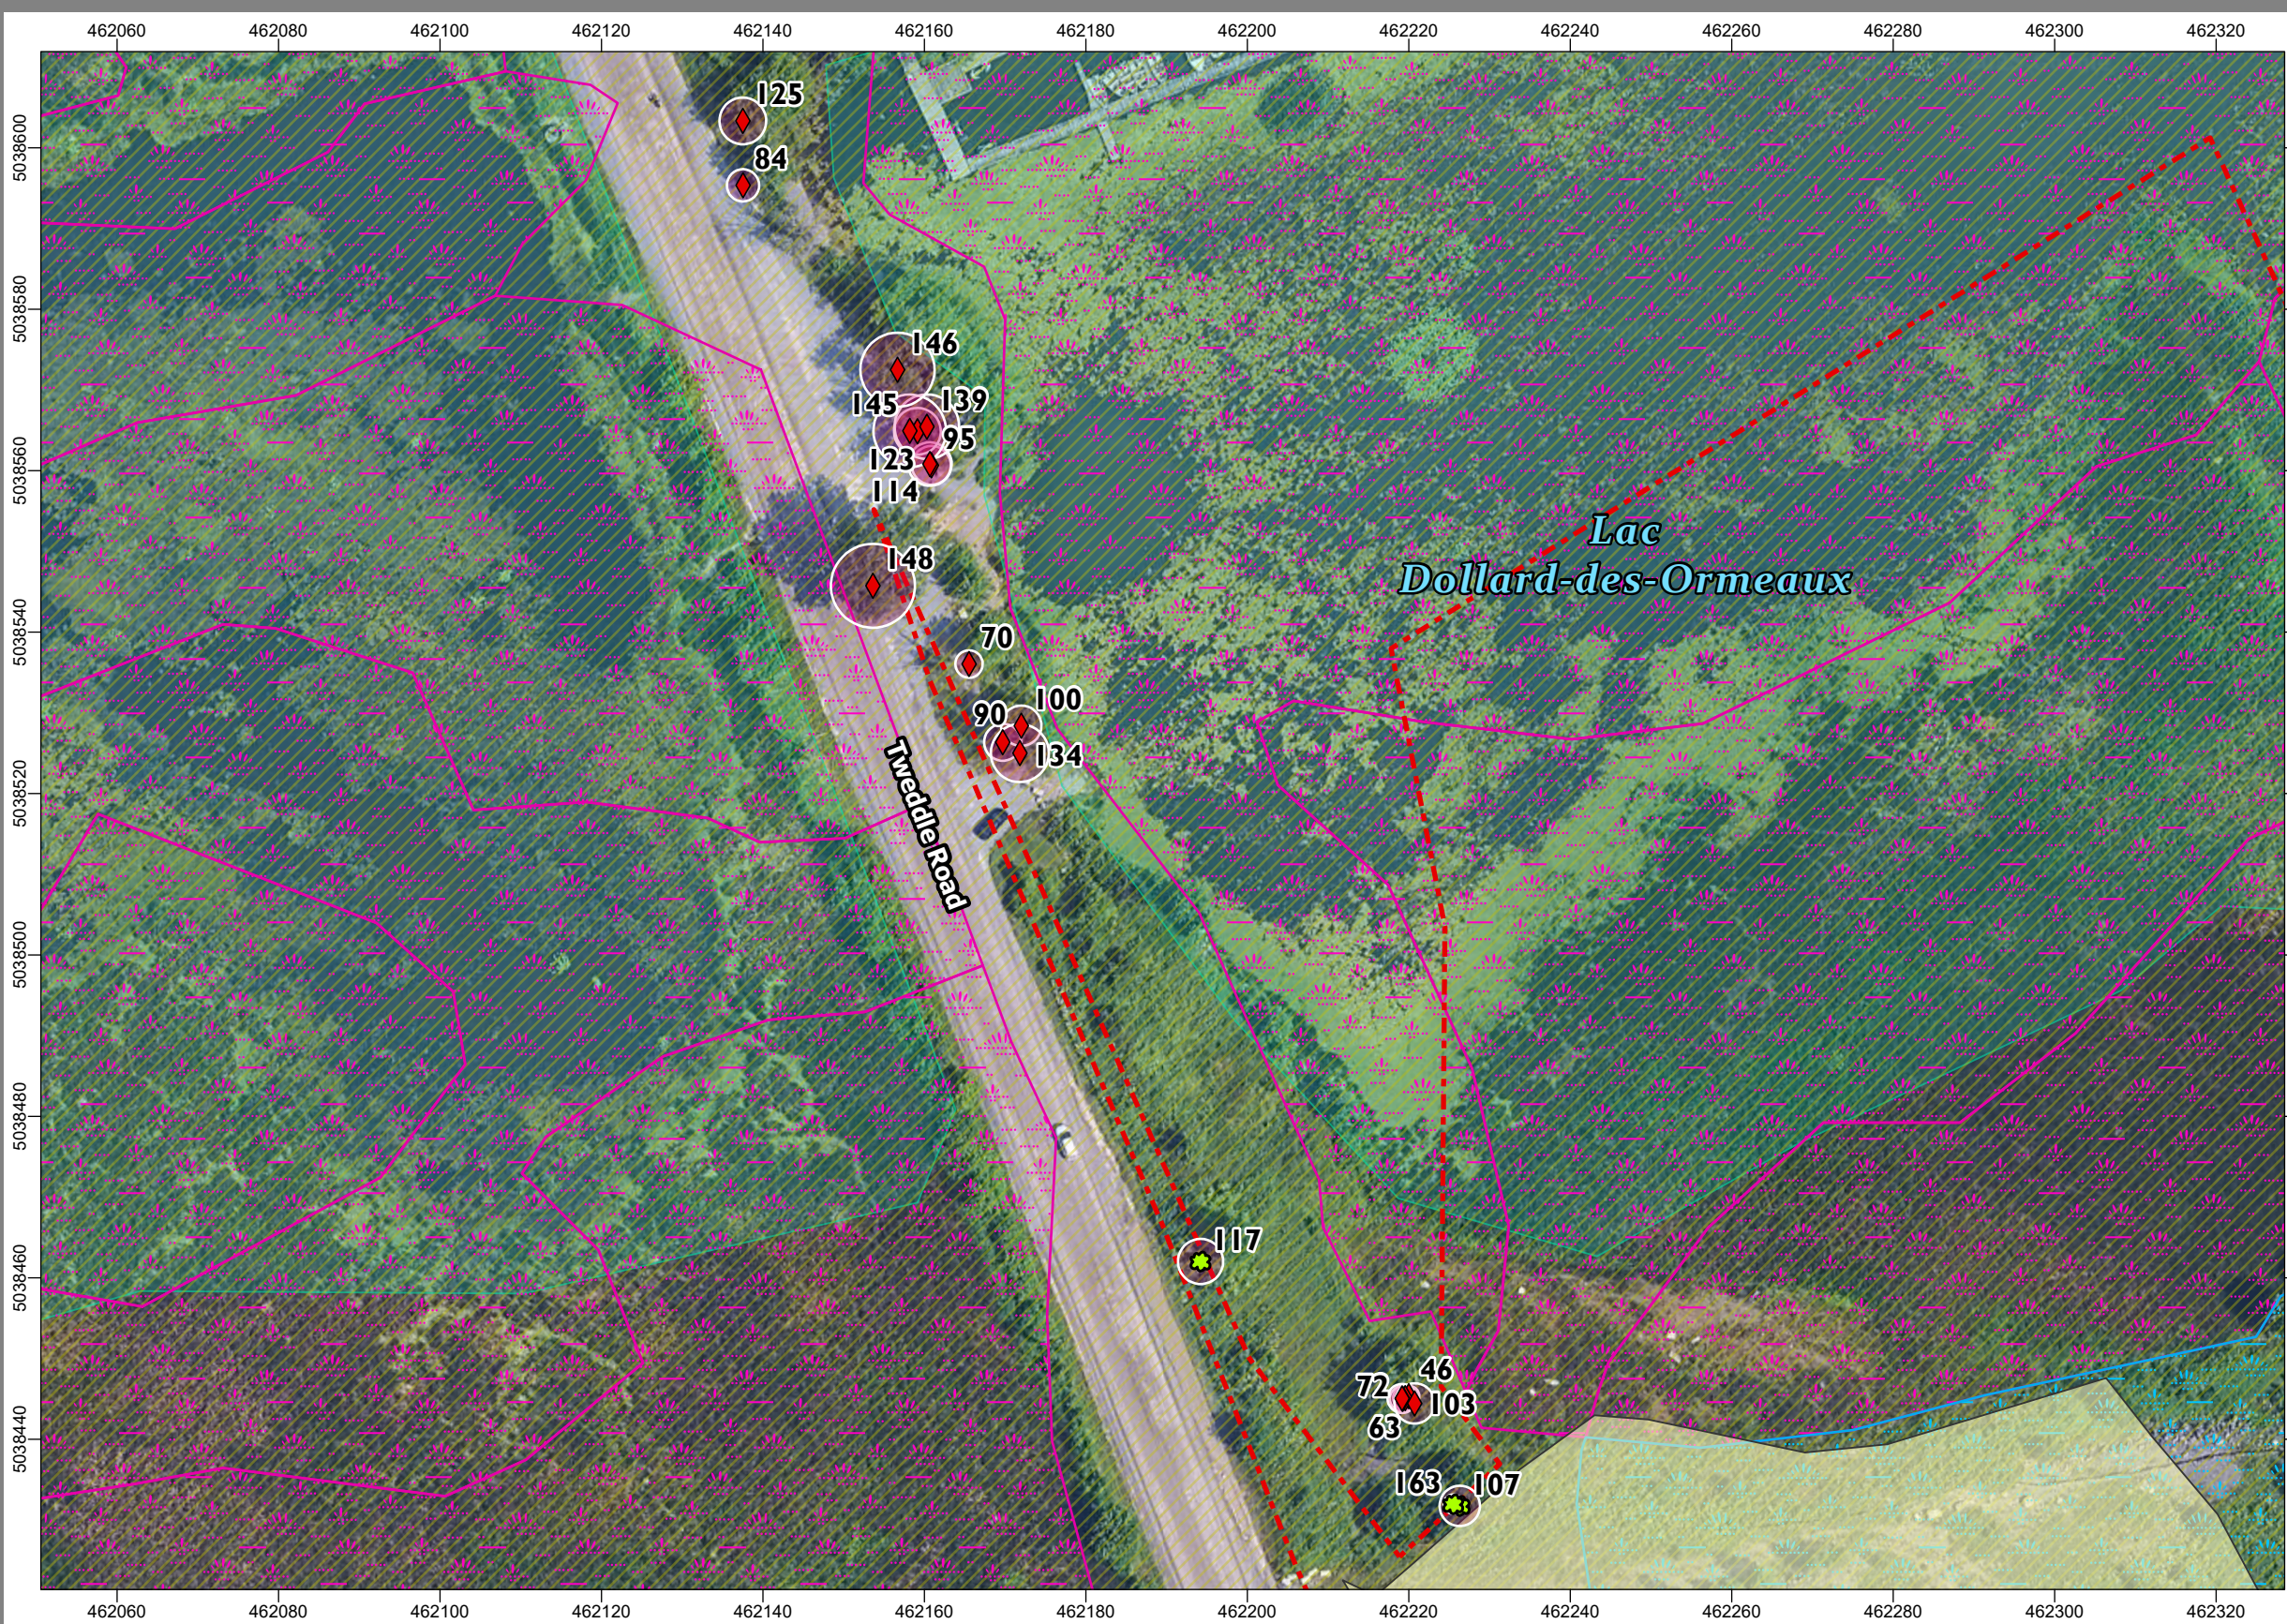
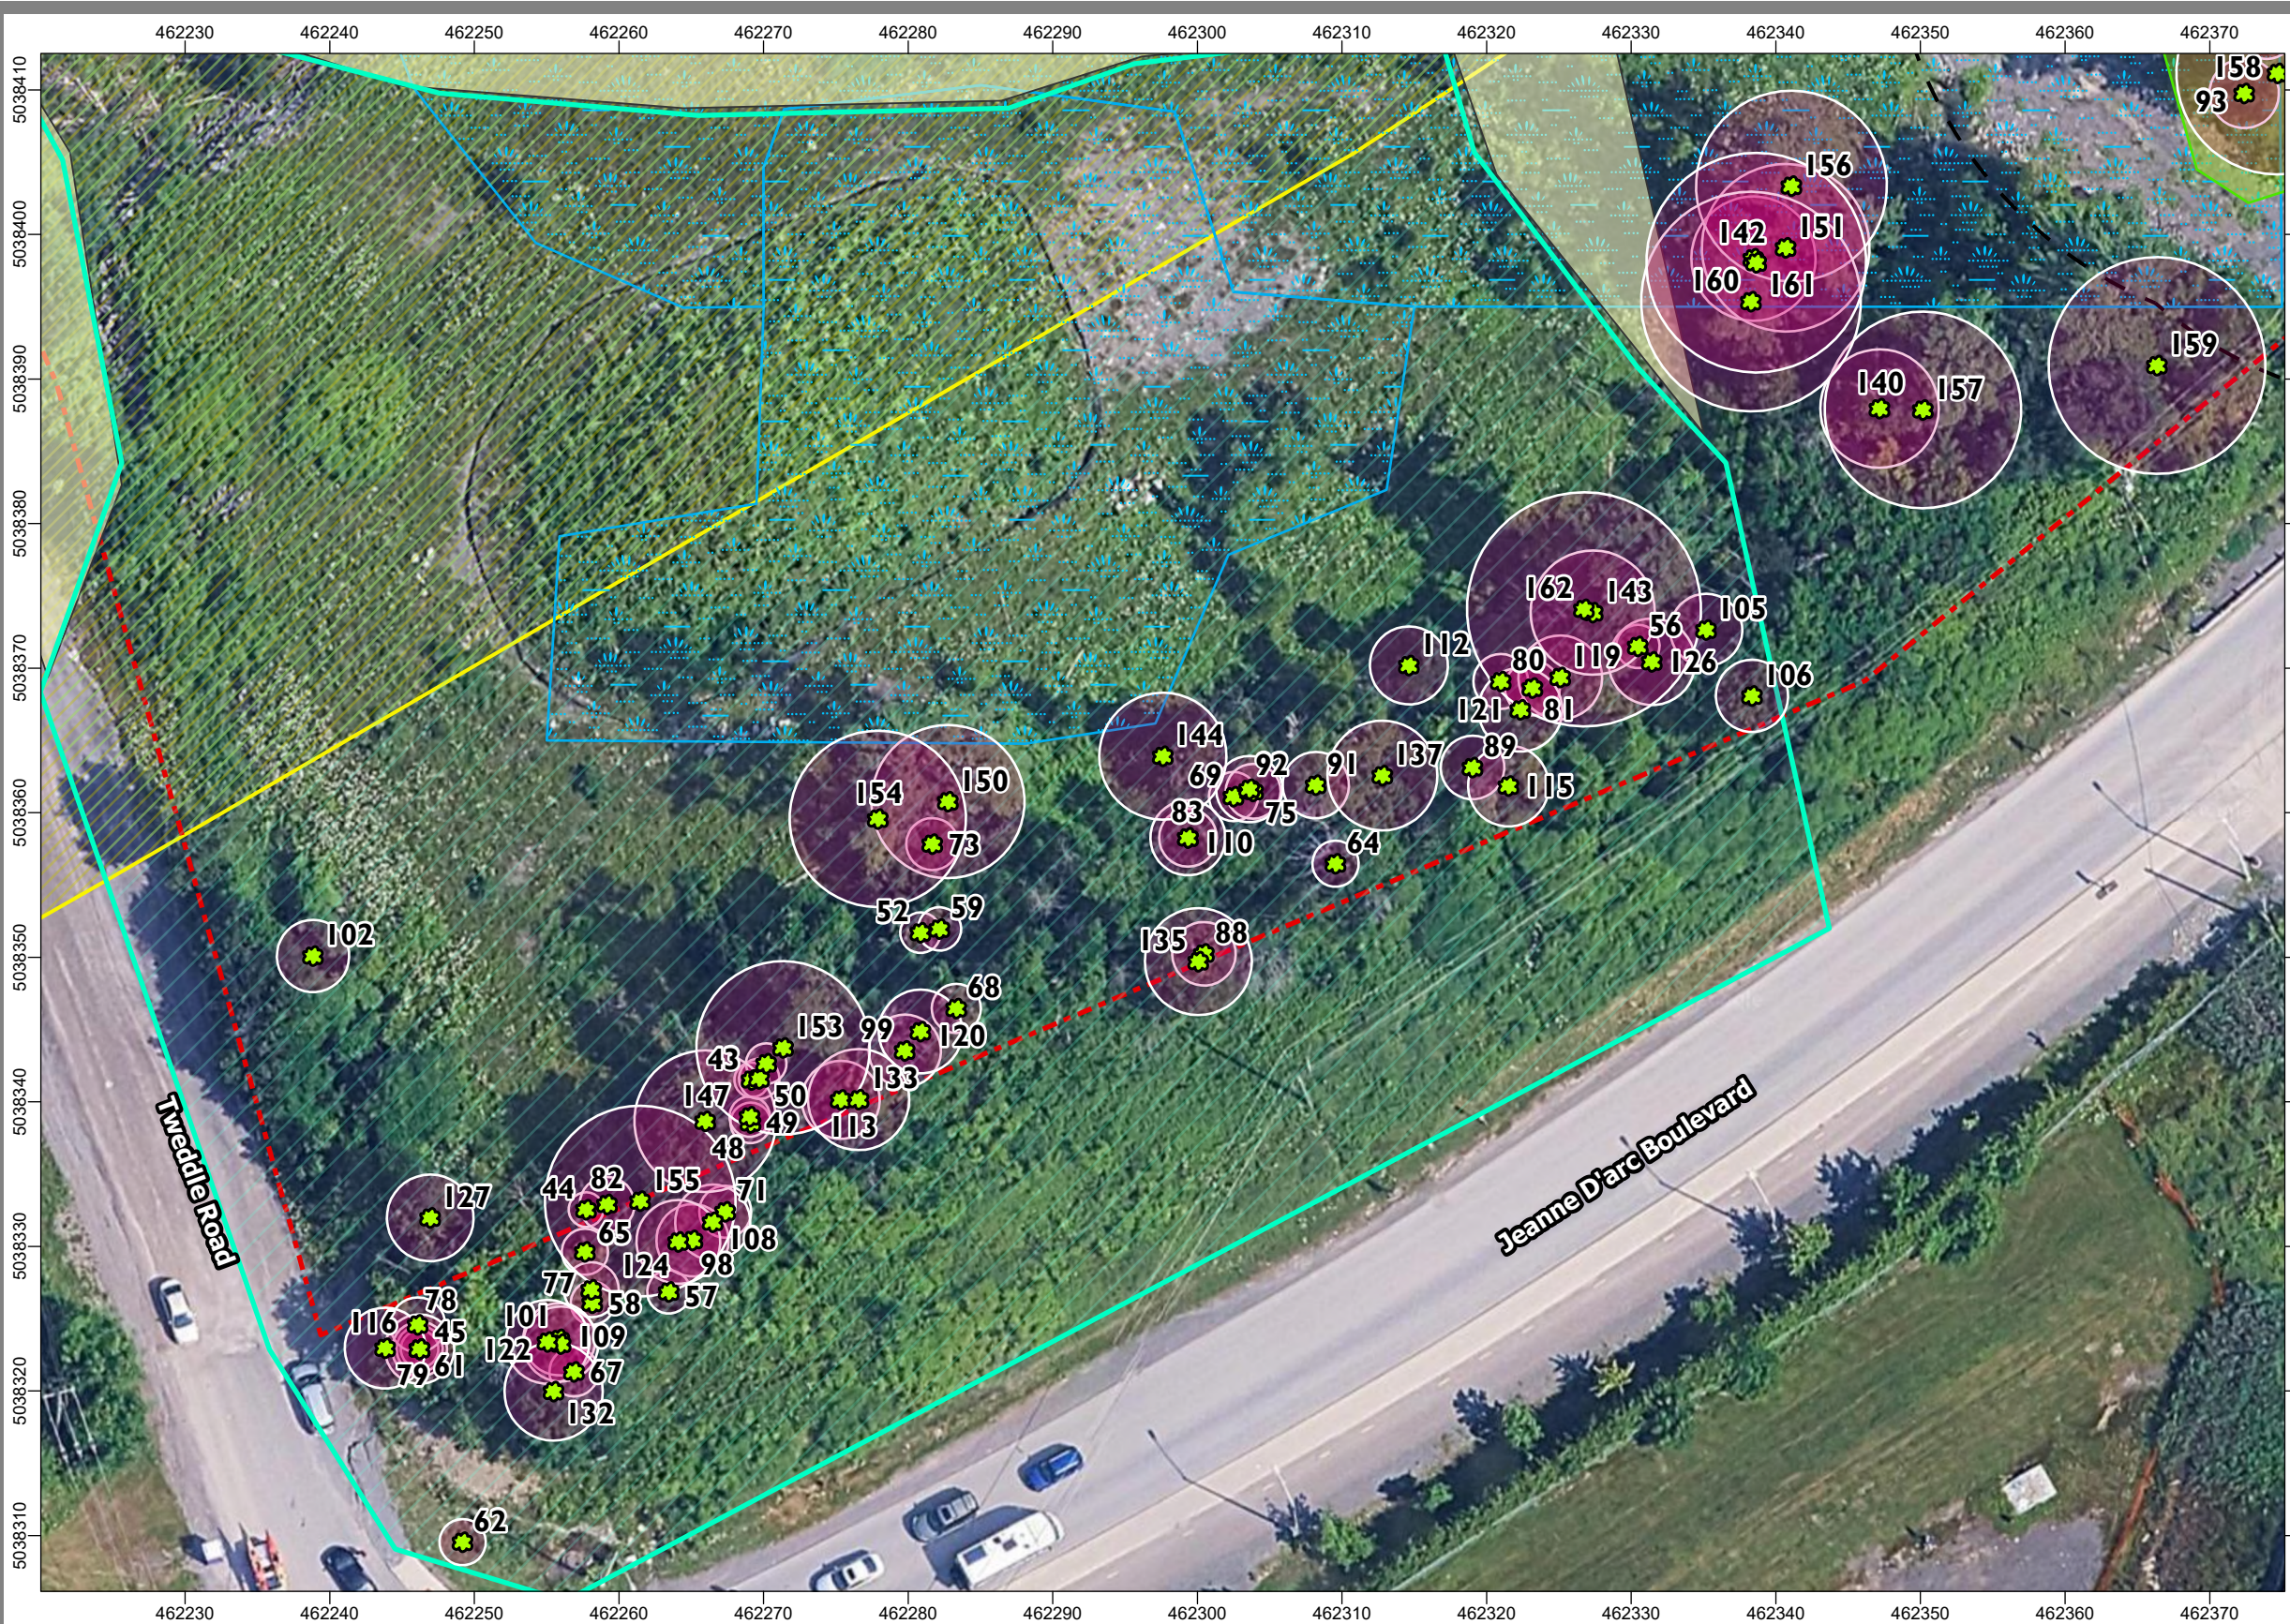
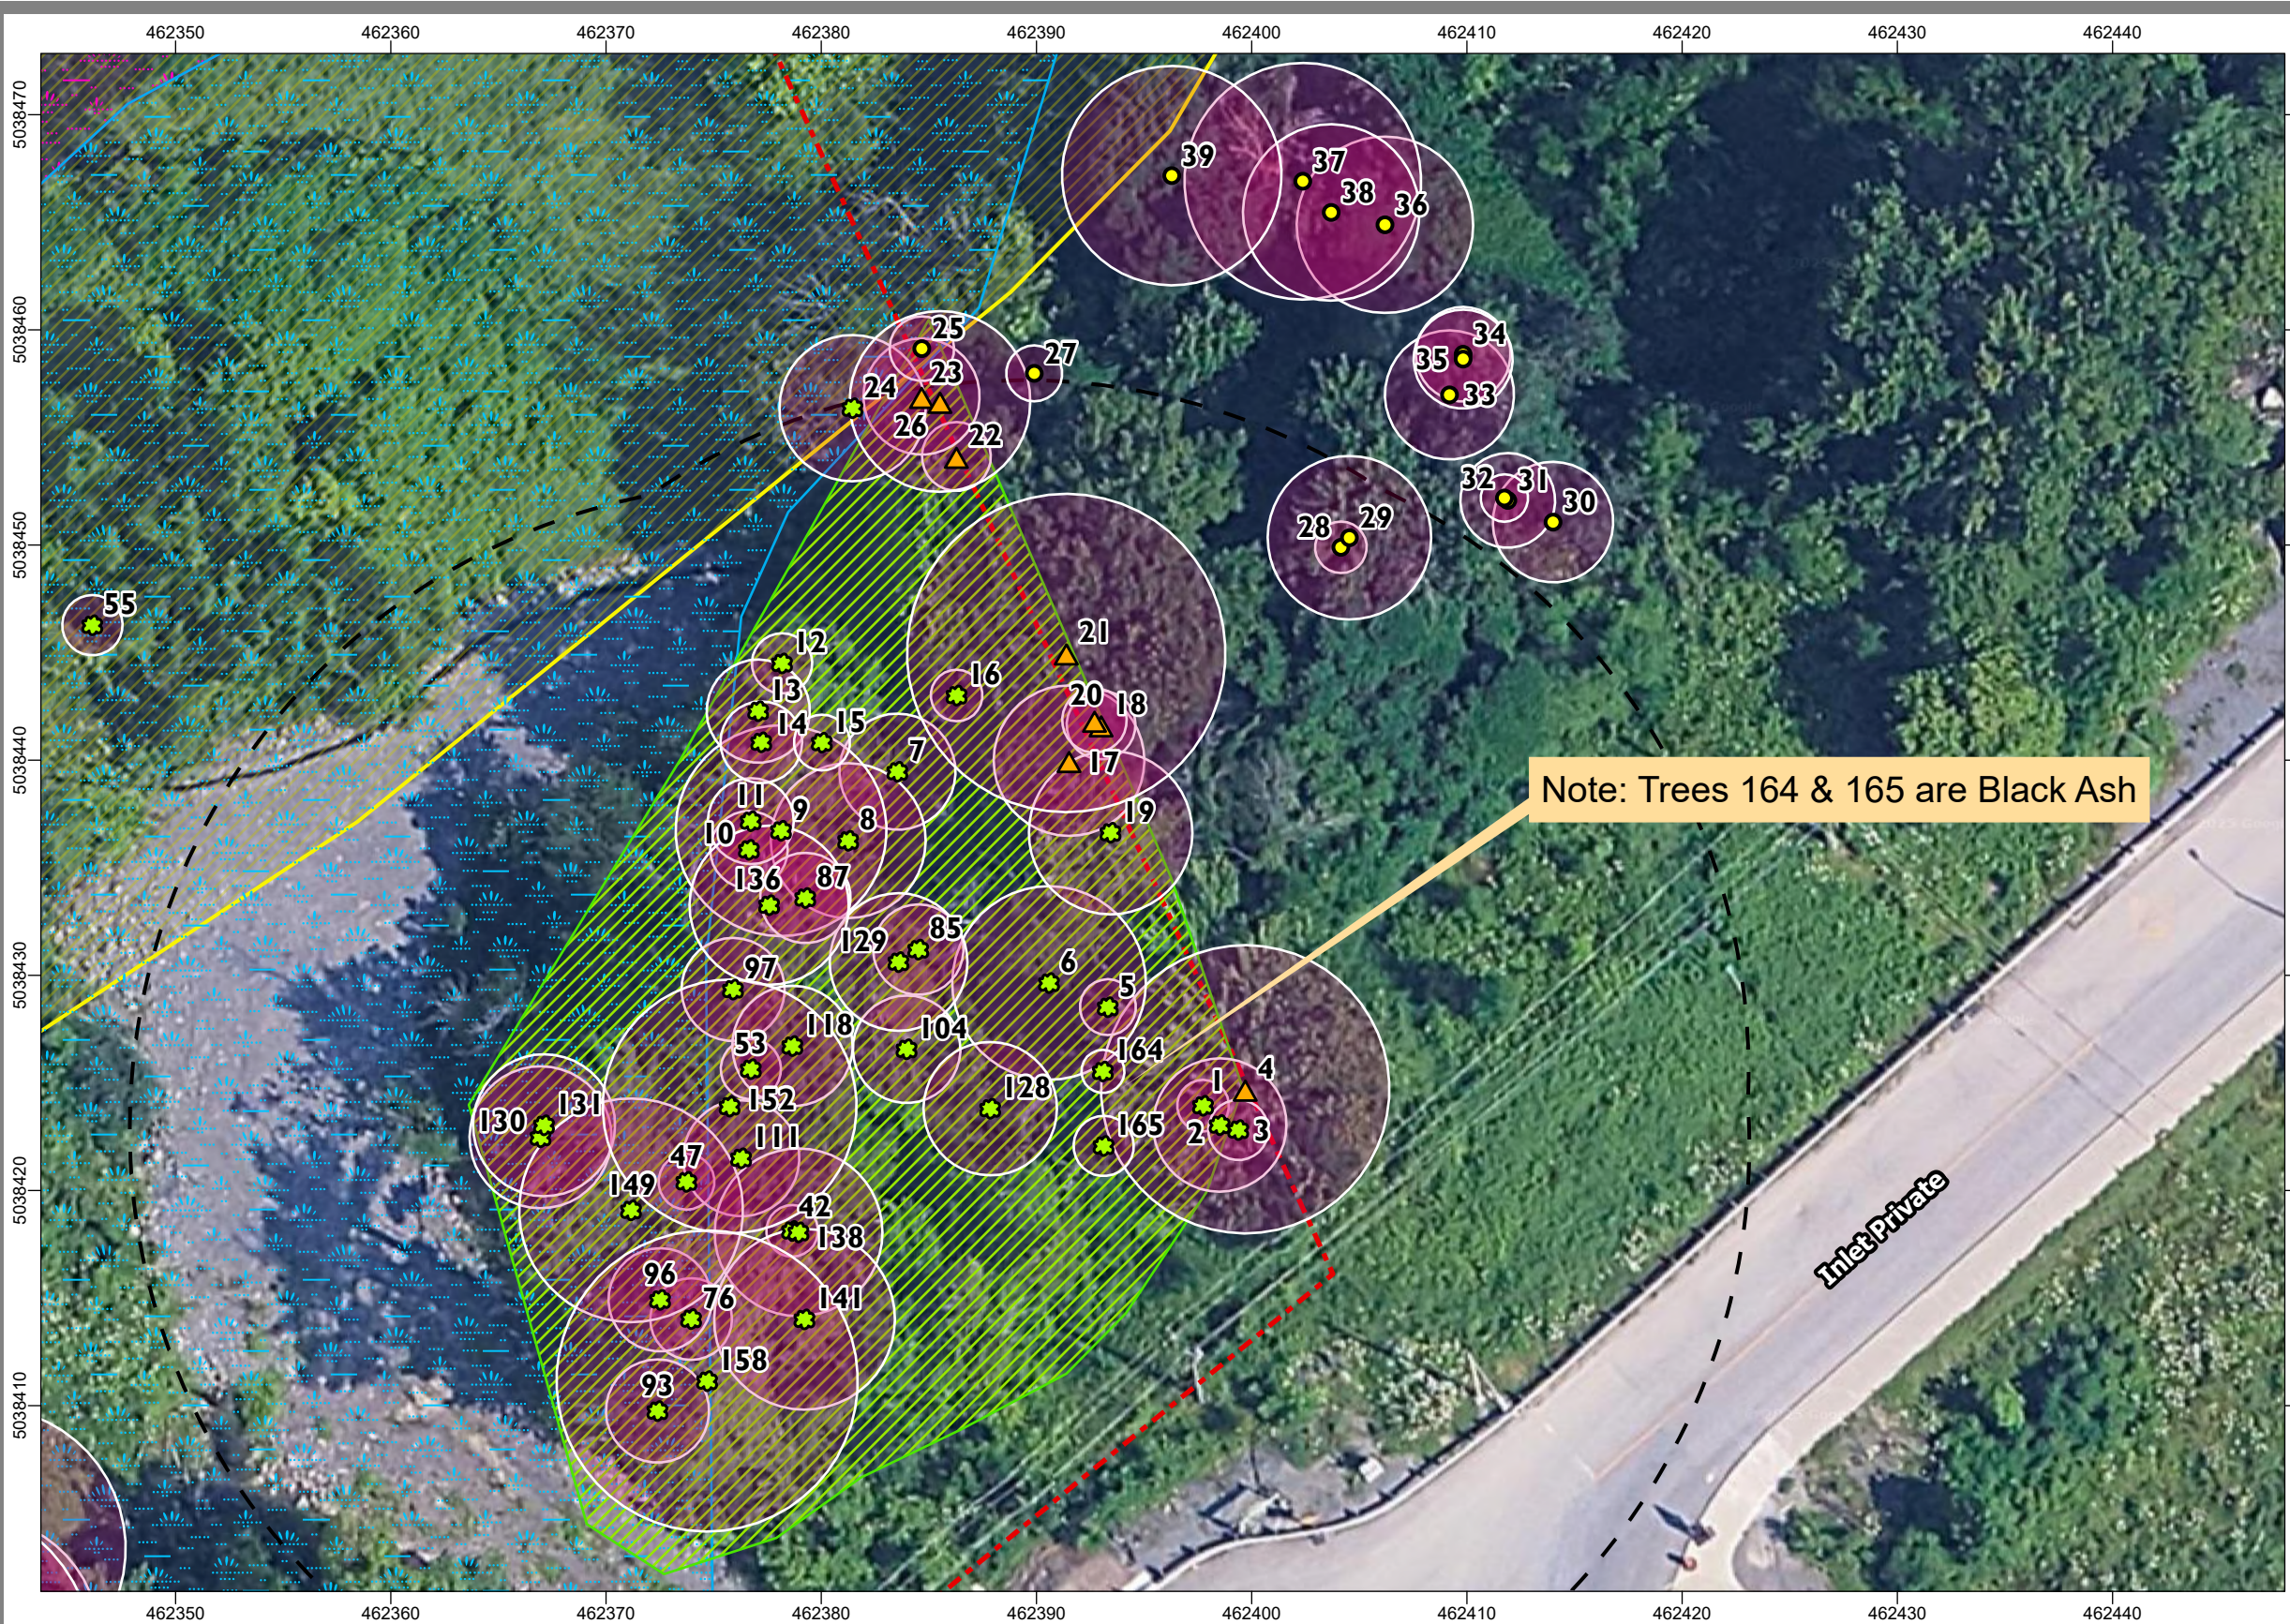
## Appendix A Map 1

The location of individual trees are depicted on Map 1 and Map 2 (Appendix A, Appendix B).

This development area consists primarily of fill area, some of which is revegetated with cultural meadow communities with inclusions of windrows, cultural thickets, mixed forests, along Tweddle Road and Inlet Private. The vegetation was dominated by bird's foot trefoil, common sow thistle, white sweet clover, wild carrot, cow vetch, burdock, viper's bugloss, field bindweed, smooth brome, coltsfoot, and common mullein, as well as young, scattered Eastern Cottonwood individuals. A patch of regenerating woody vegetation was present on the east side. The upper layer was 1-6 m tall (50% cover) and included Eastern Cottonwood, Staghorn Sumac, Manitoba Maple and Green Ash. The ground layer (90% cover) contained reed canary grass, Canada goldenrod, cow vetch, wild carrot, bird's-foot trefoil, common ragweed, and grasses. Several natural heritage features were identified on the Property or adjacent lands on provincial databases and further verified in-field (Appendix A):

- Provincially significant wetland on the north side of the Property
- Habitat of endangered and threatened species
  - Two (2) SAR Black Ash trees were found (Trees 164, 165) with dbh of 10 and 14 cm. These were located on the southeast corner of the Property.
