# VUZE Construction

1015 Tweddle Road

## TREE CONSERVATION REPORT

CIMA+ file number: Z0018492  
22 August 2025 - Review 000

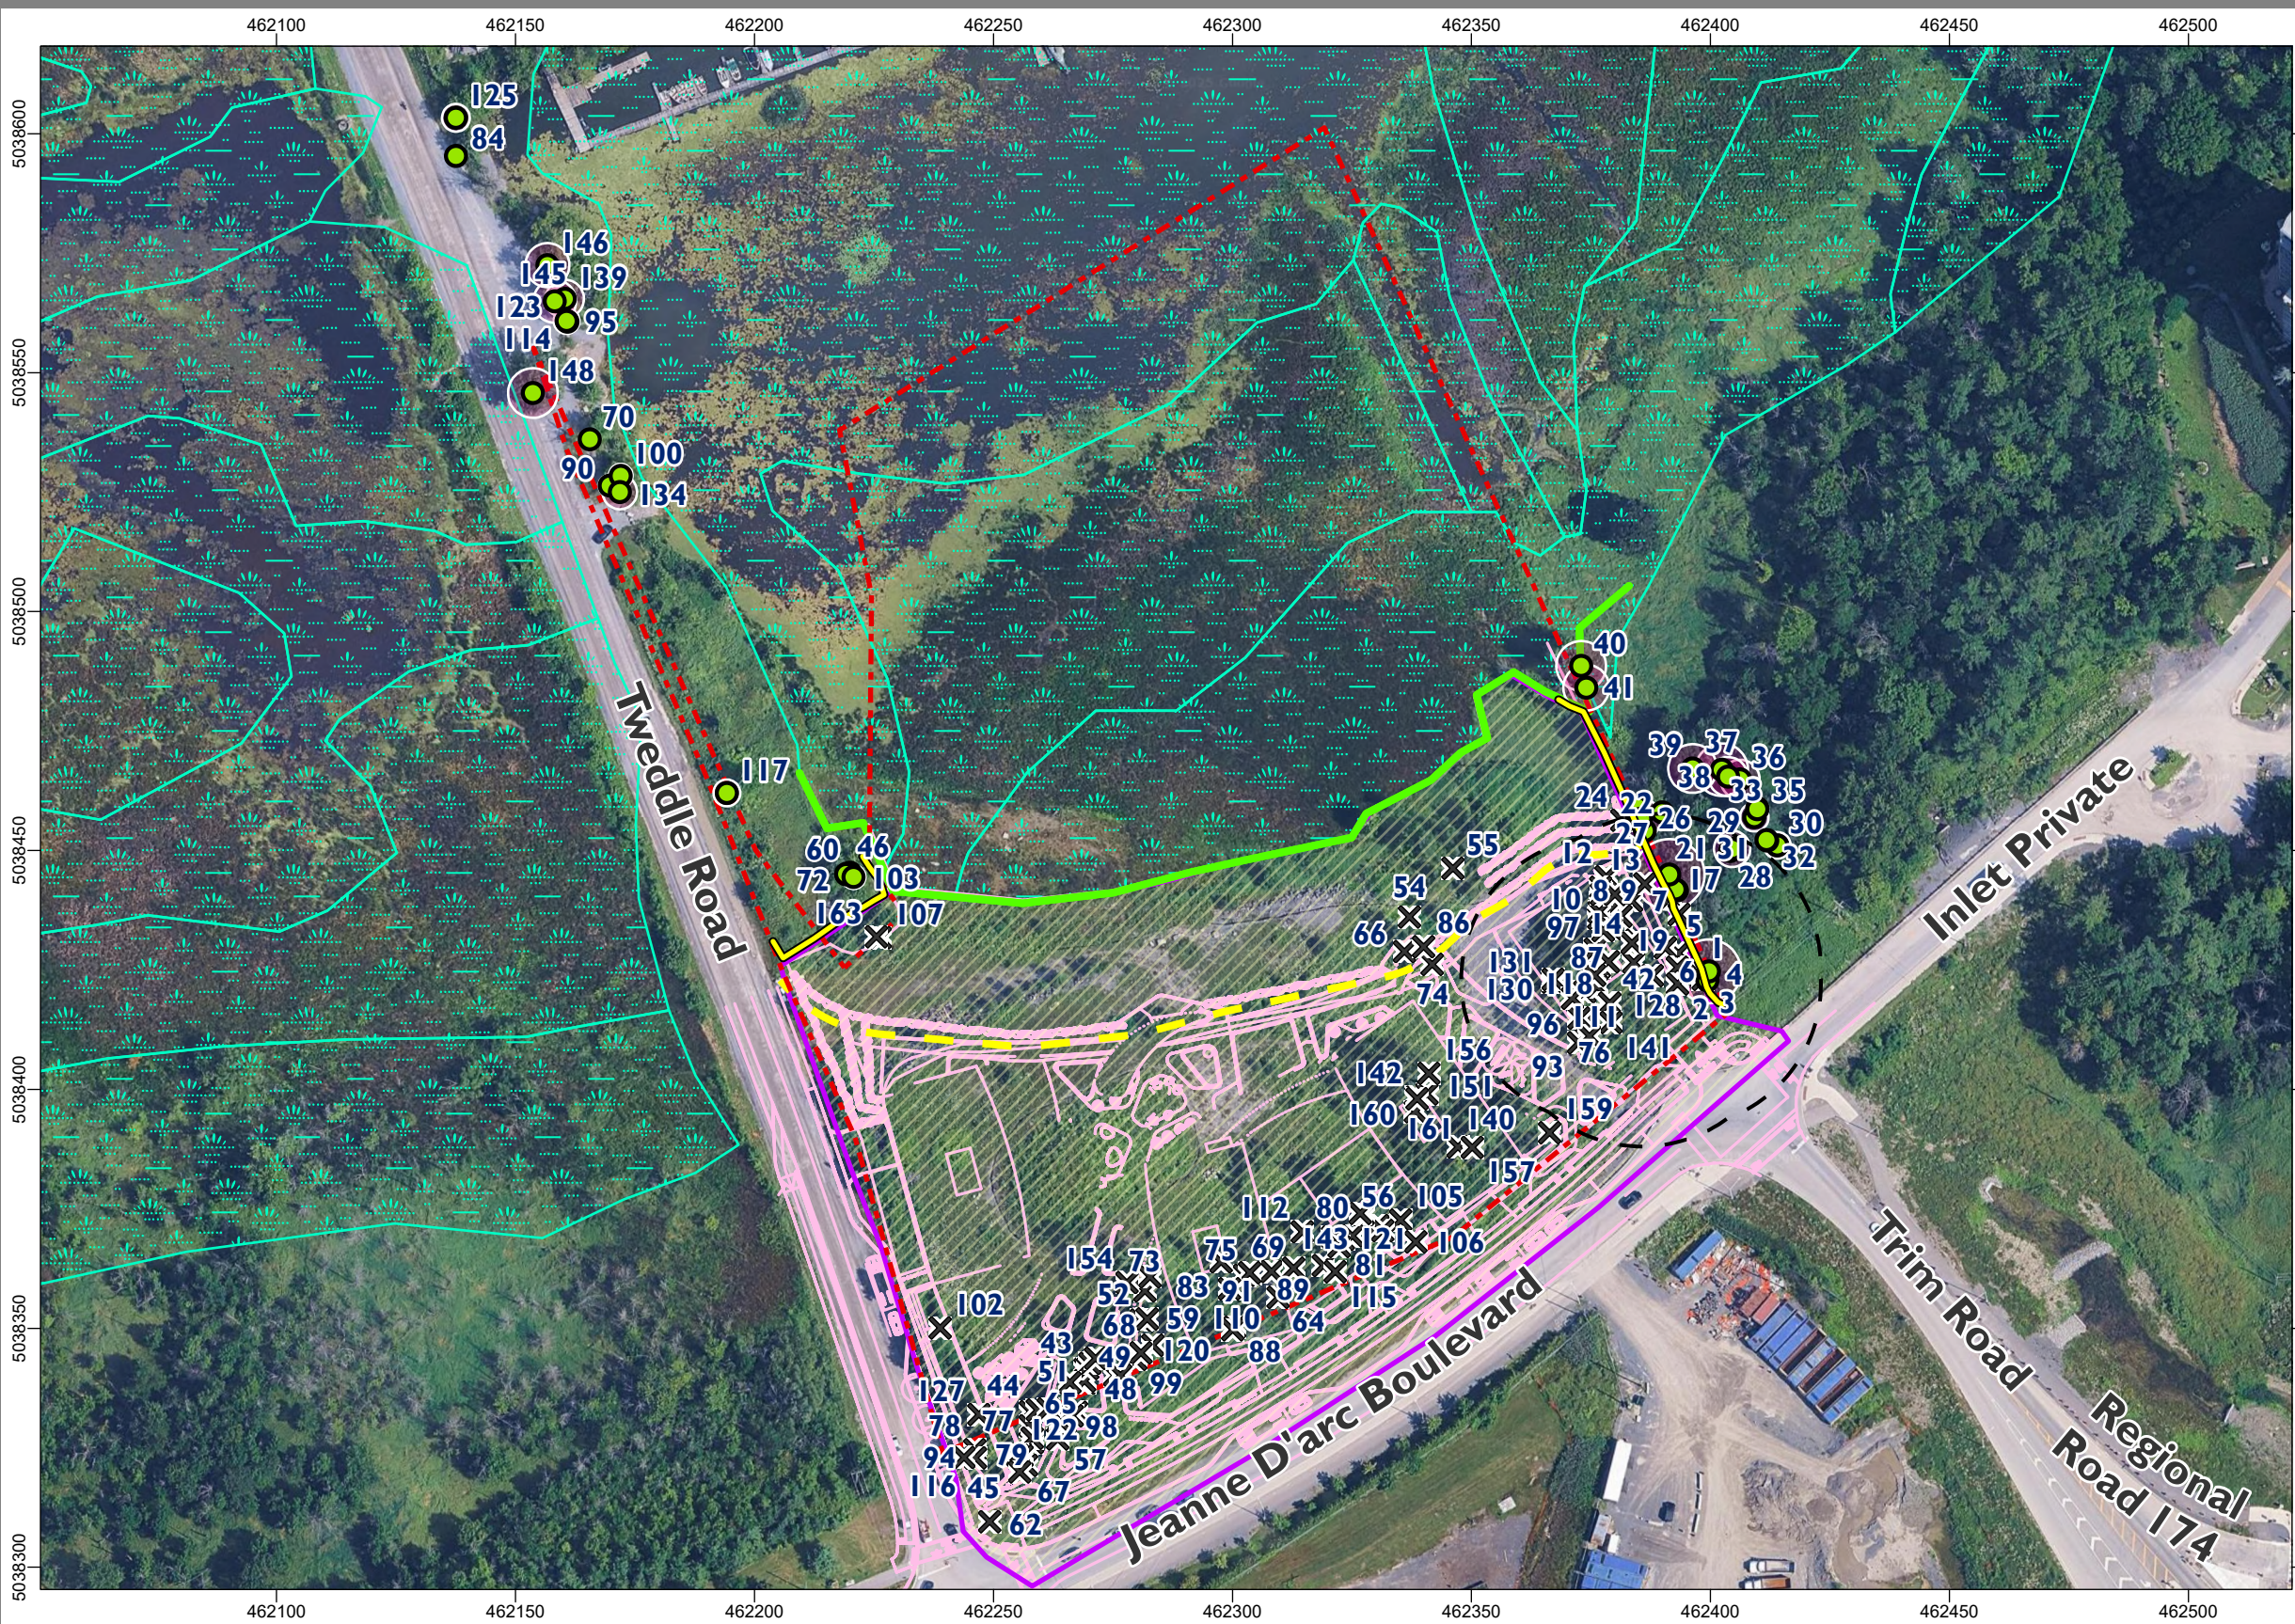
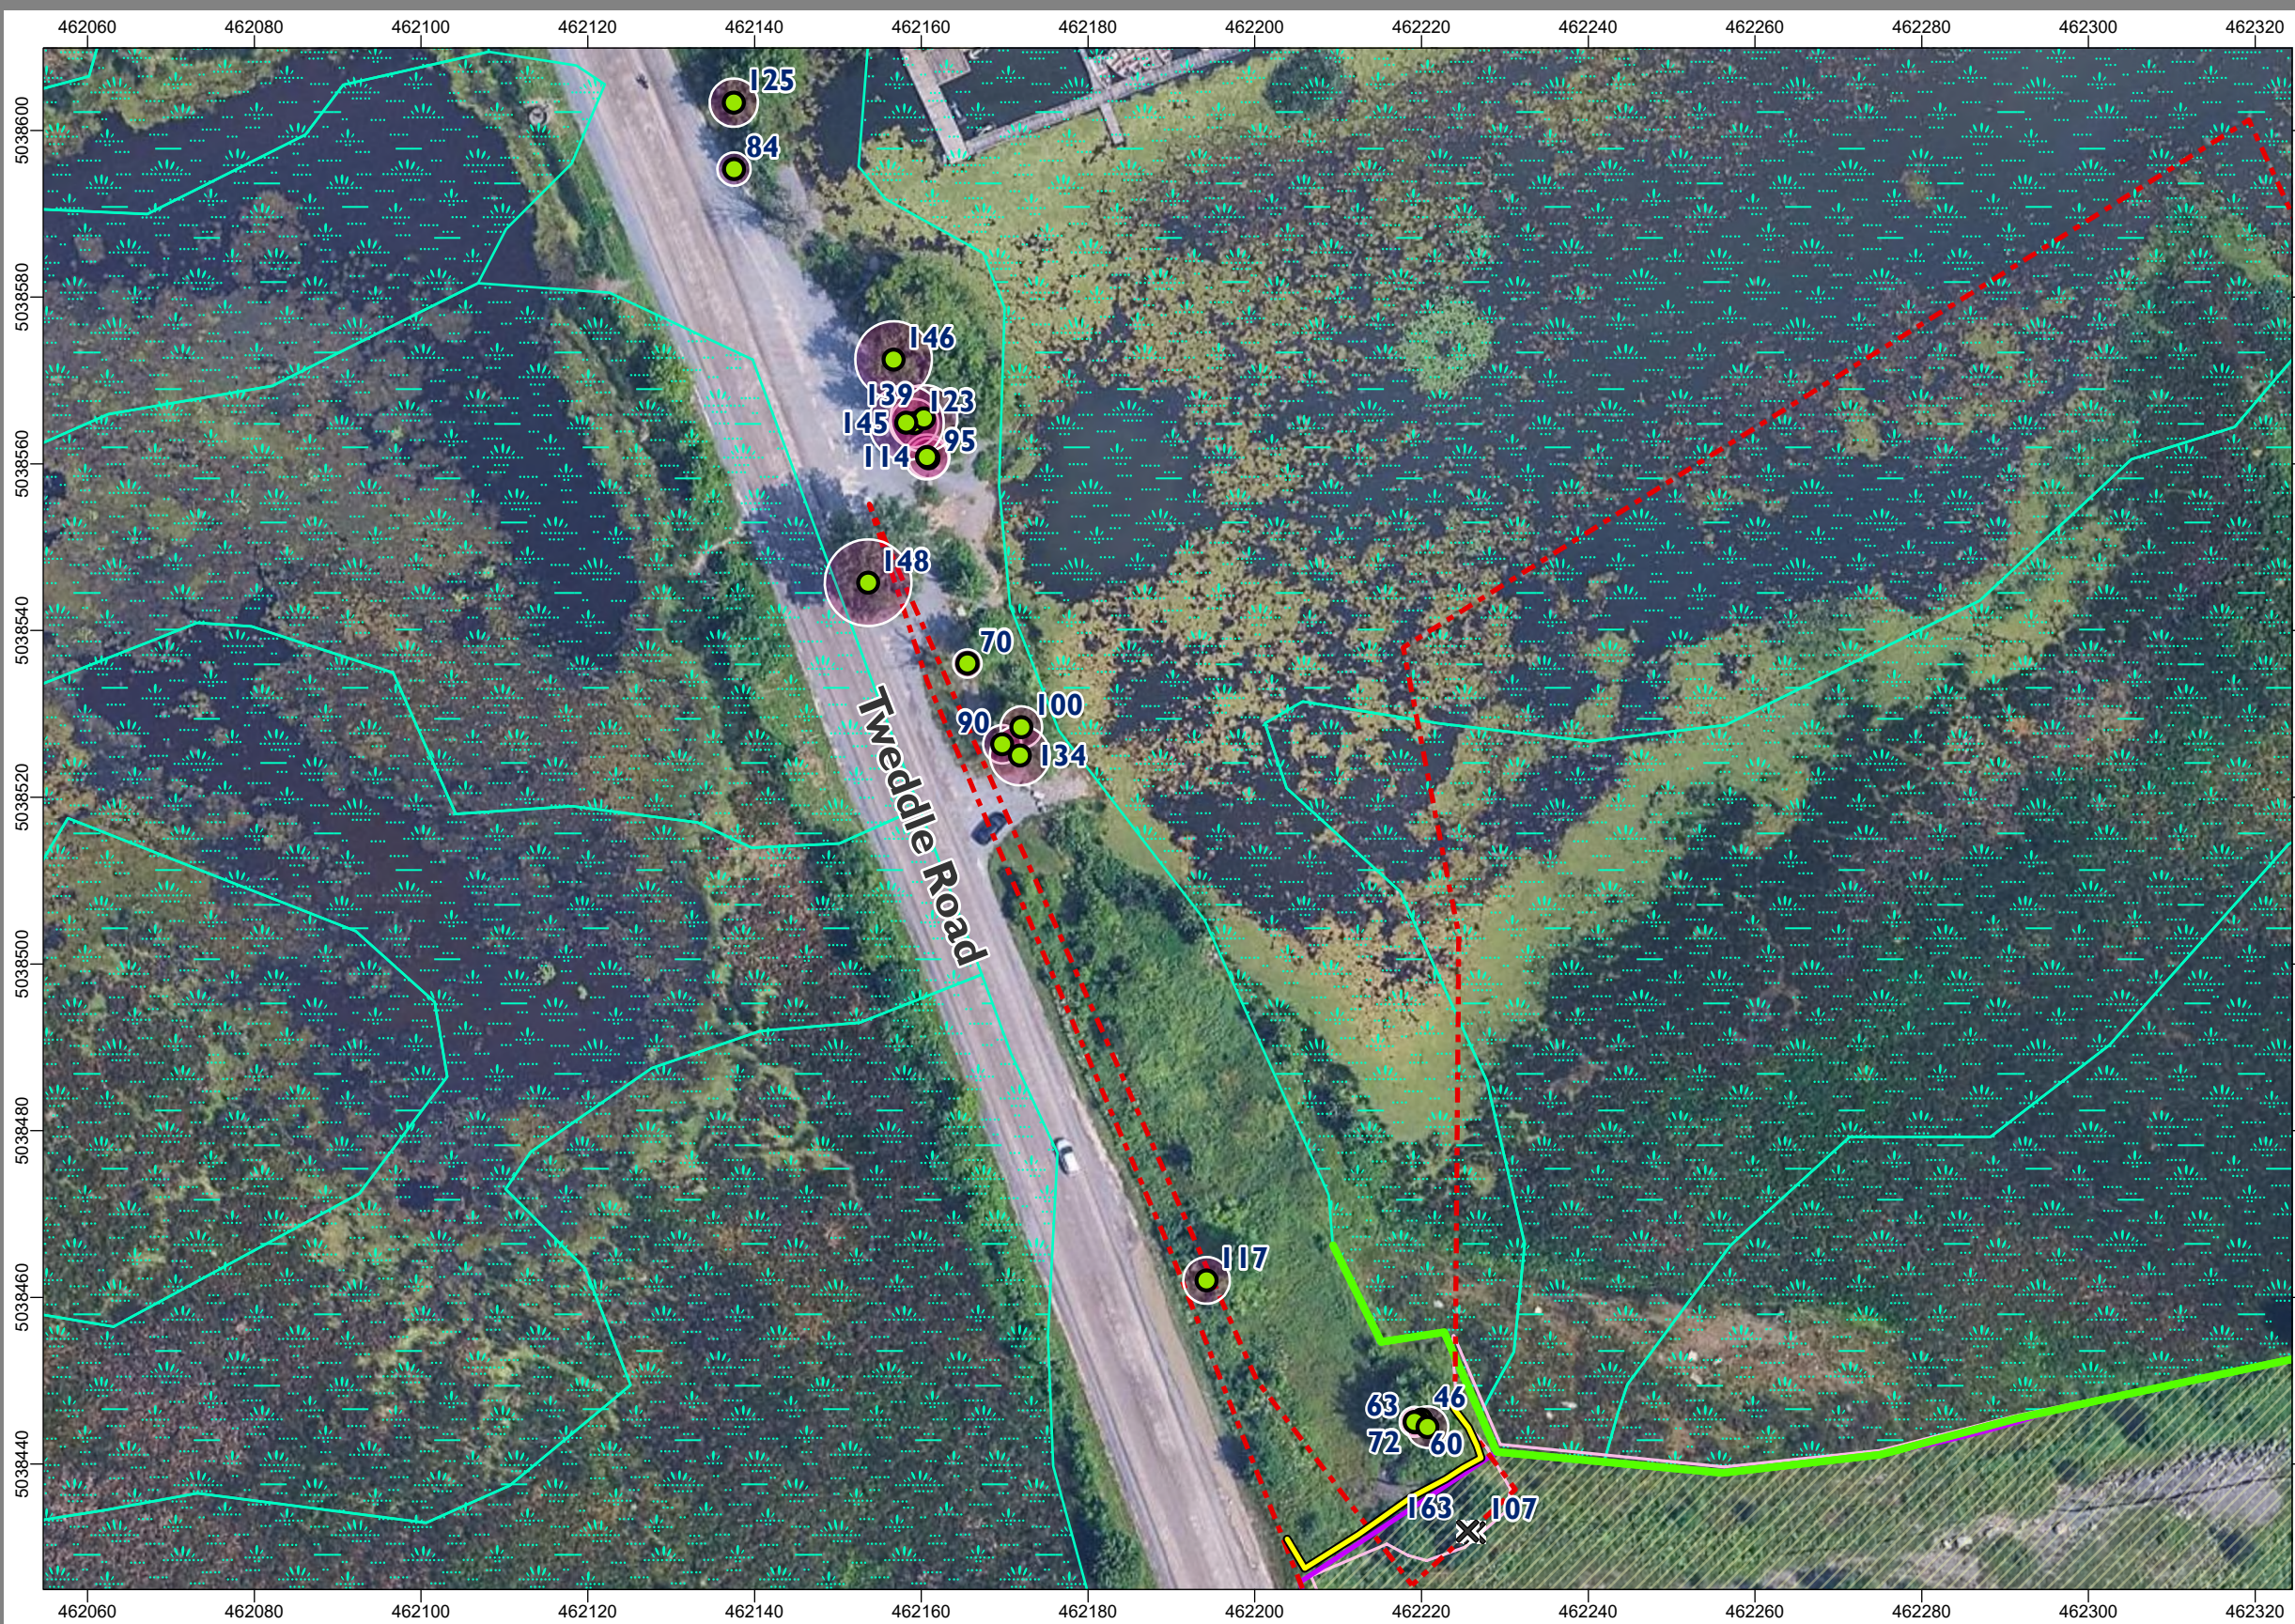
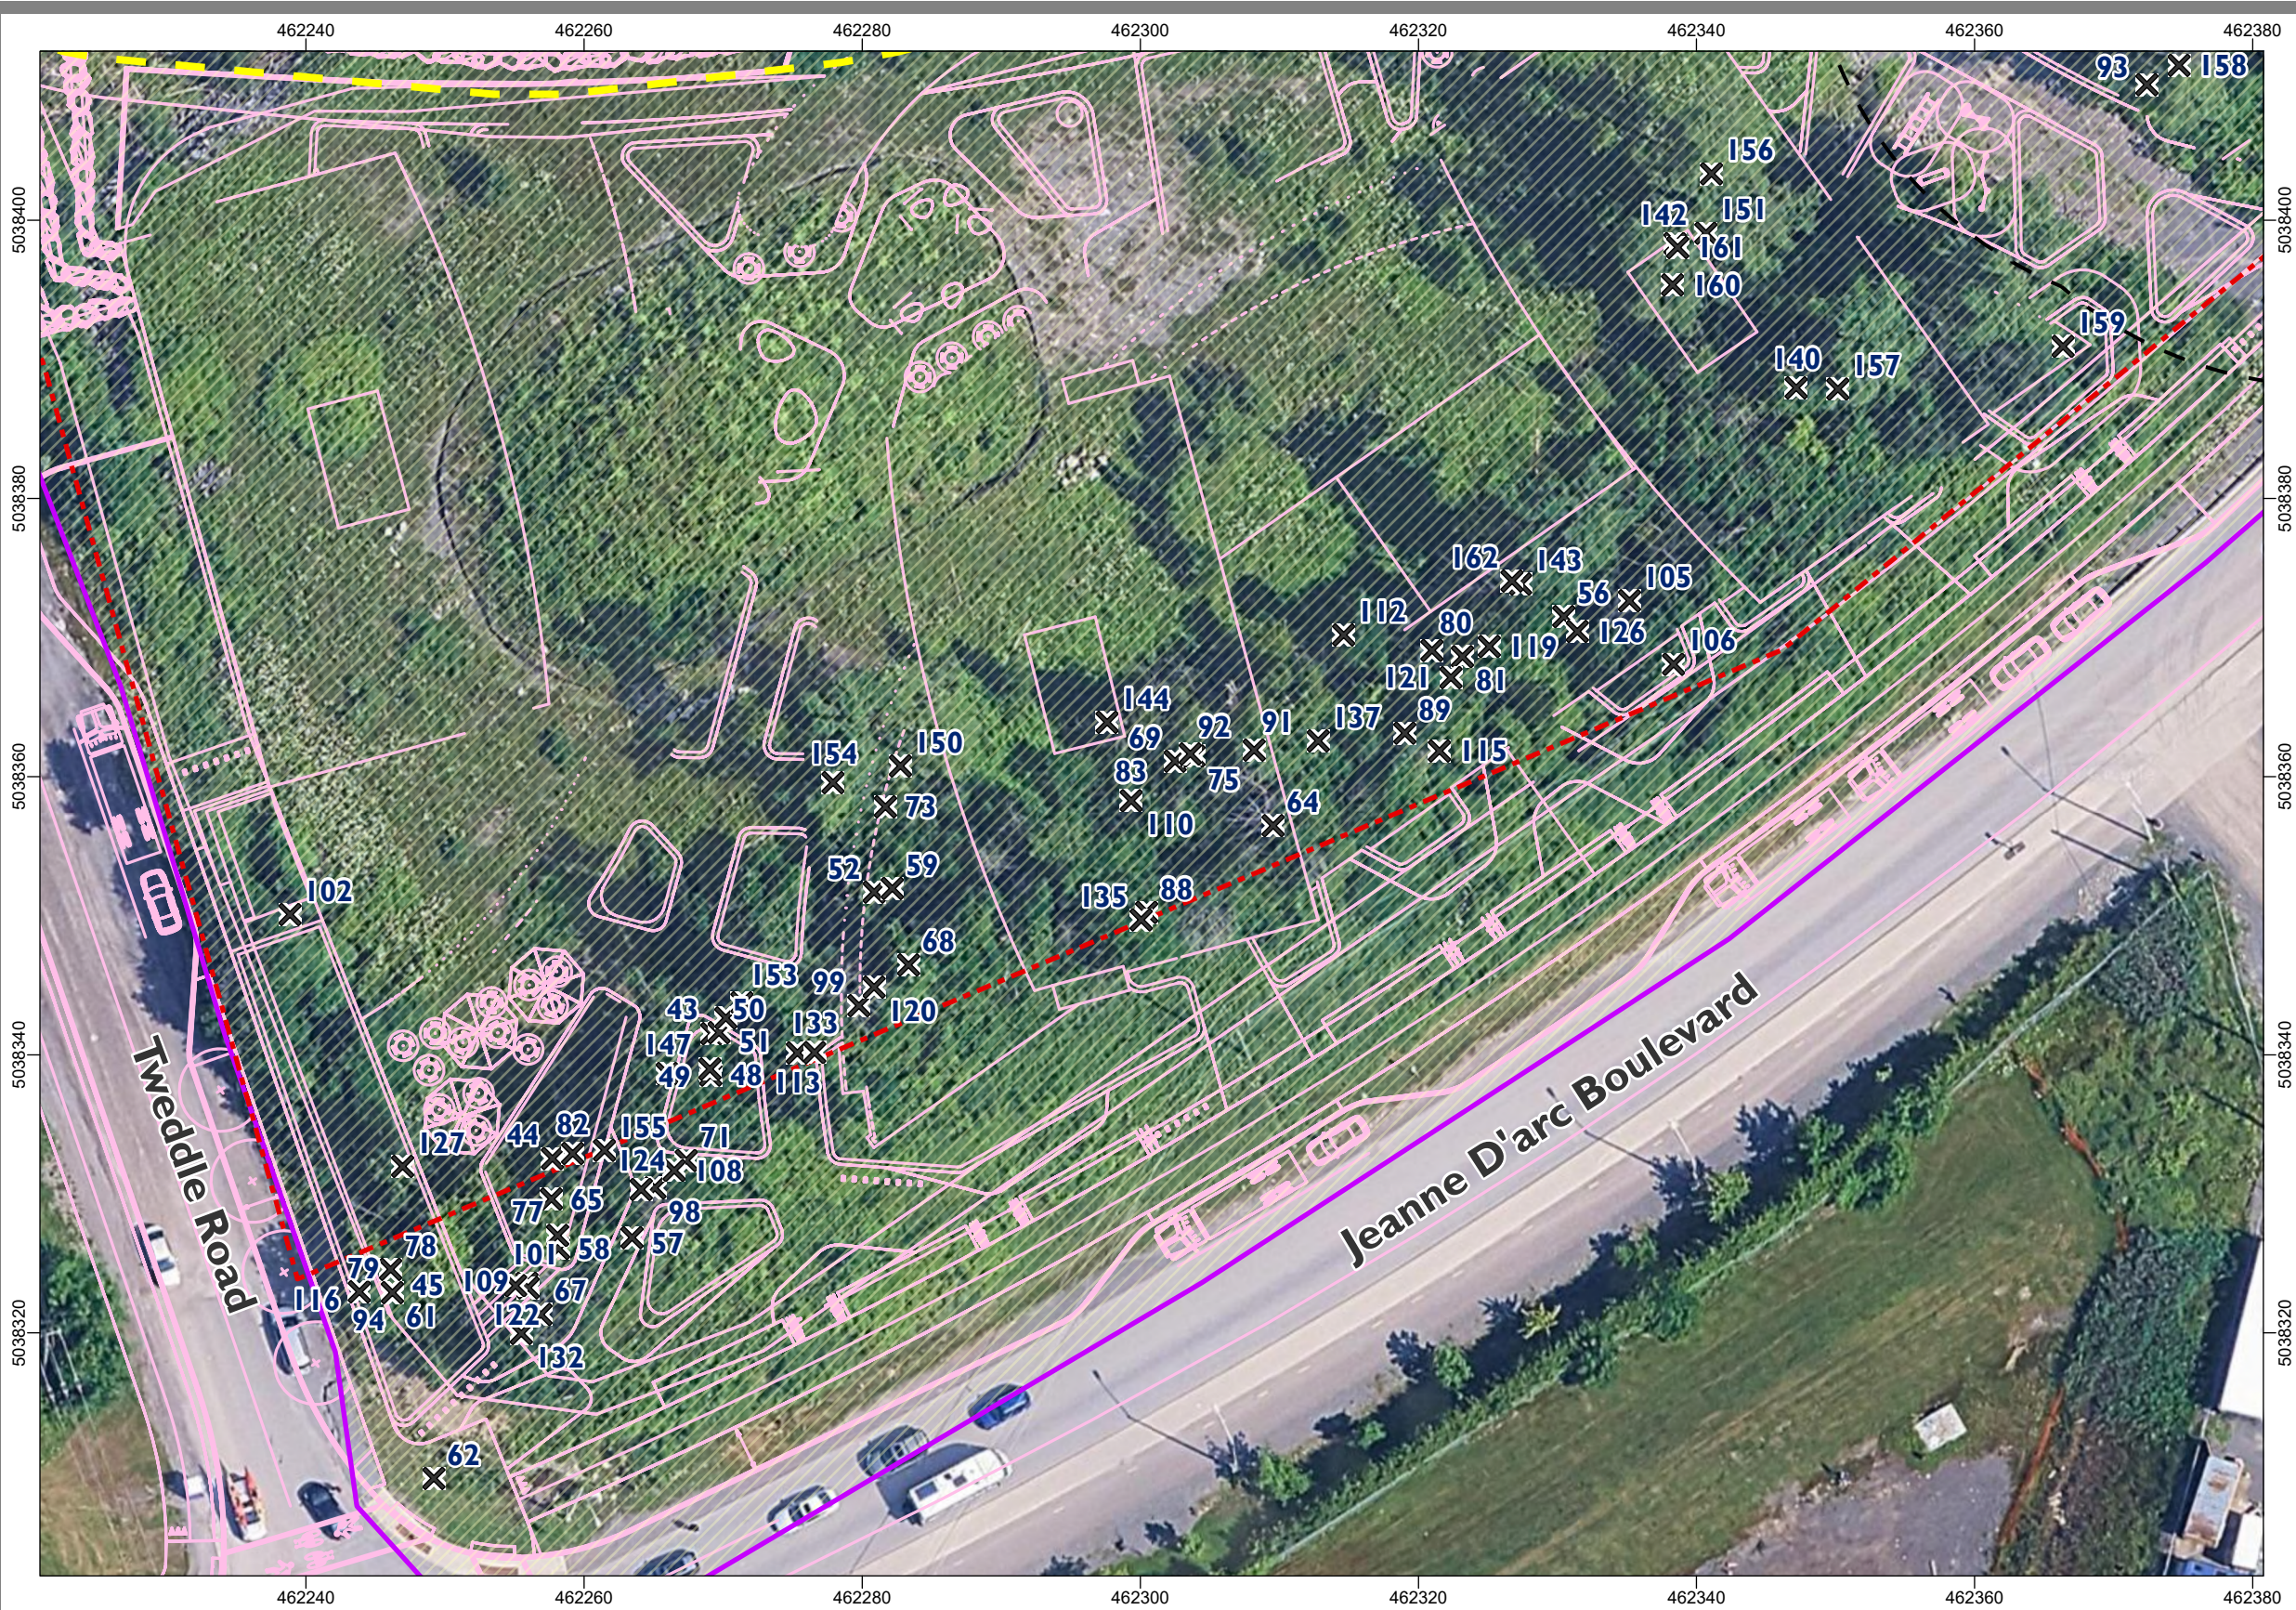
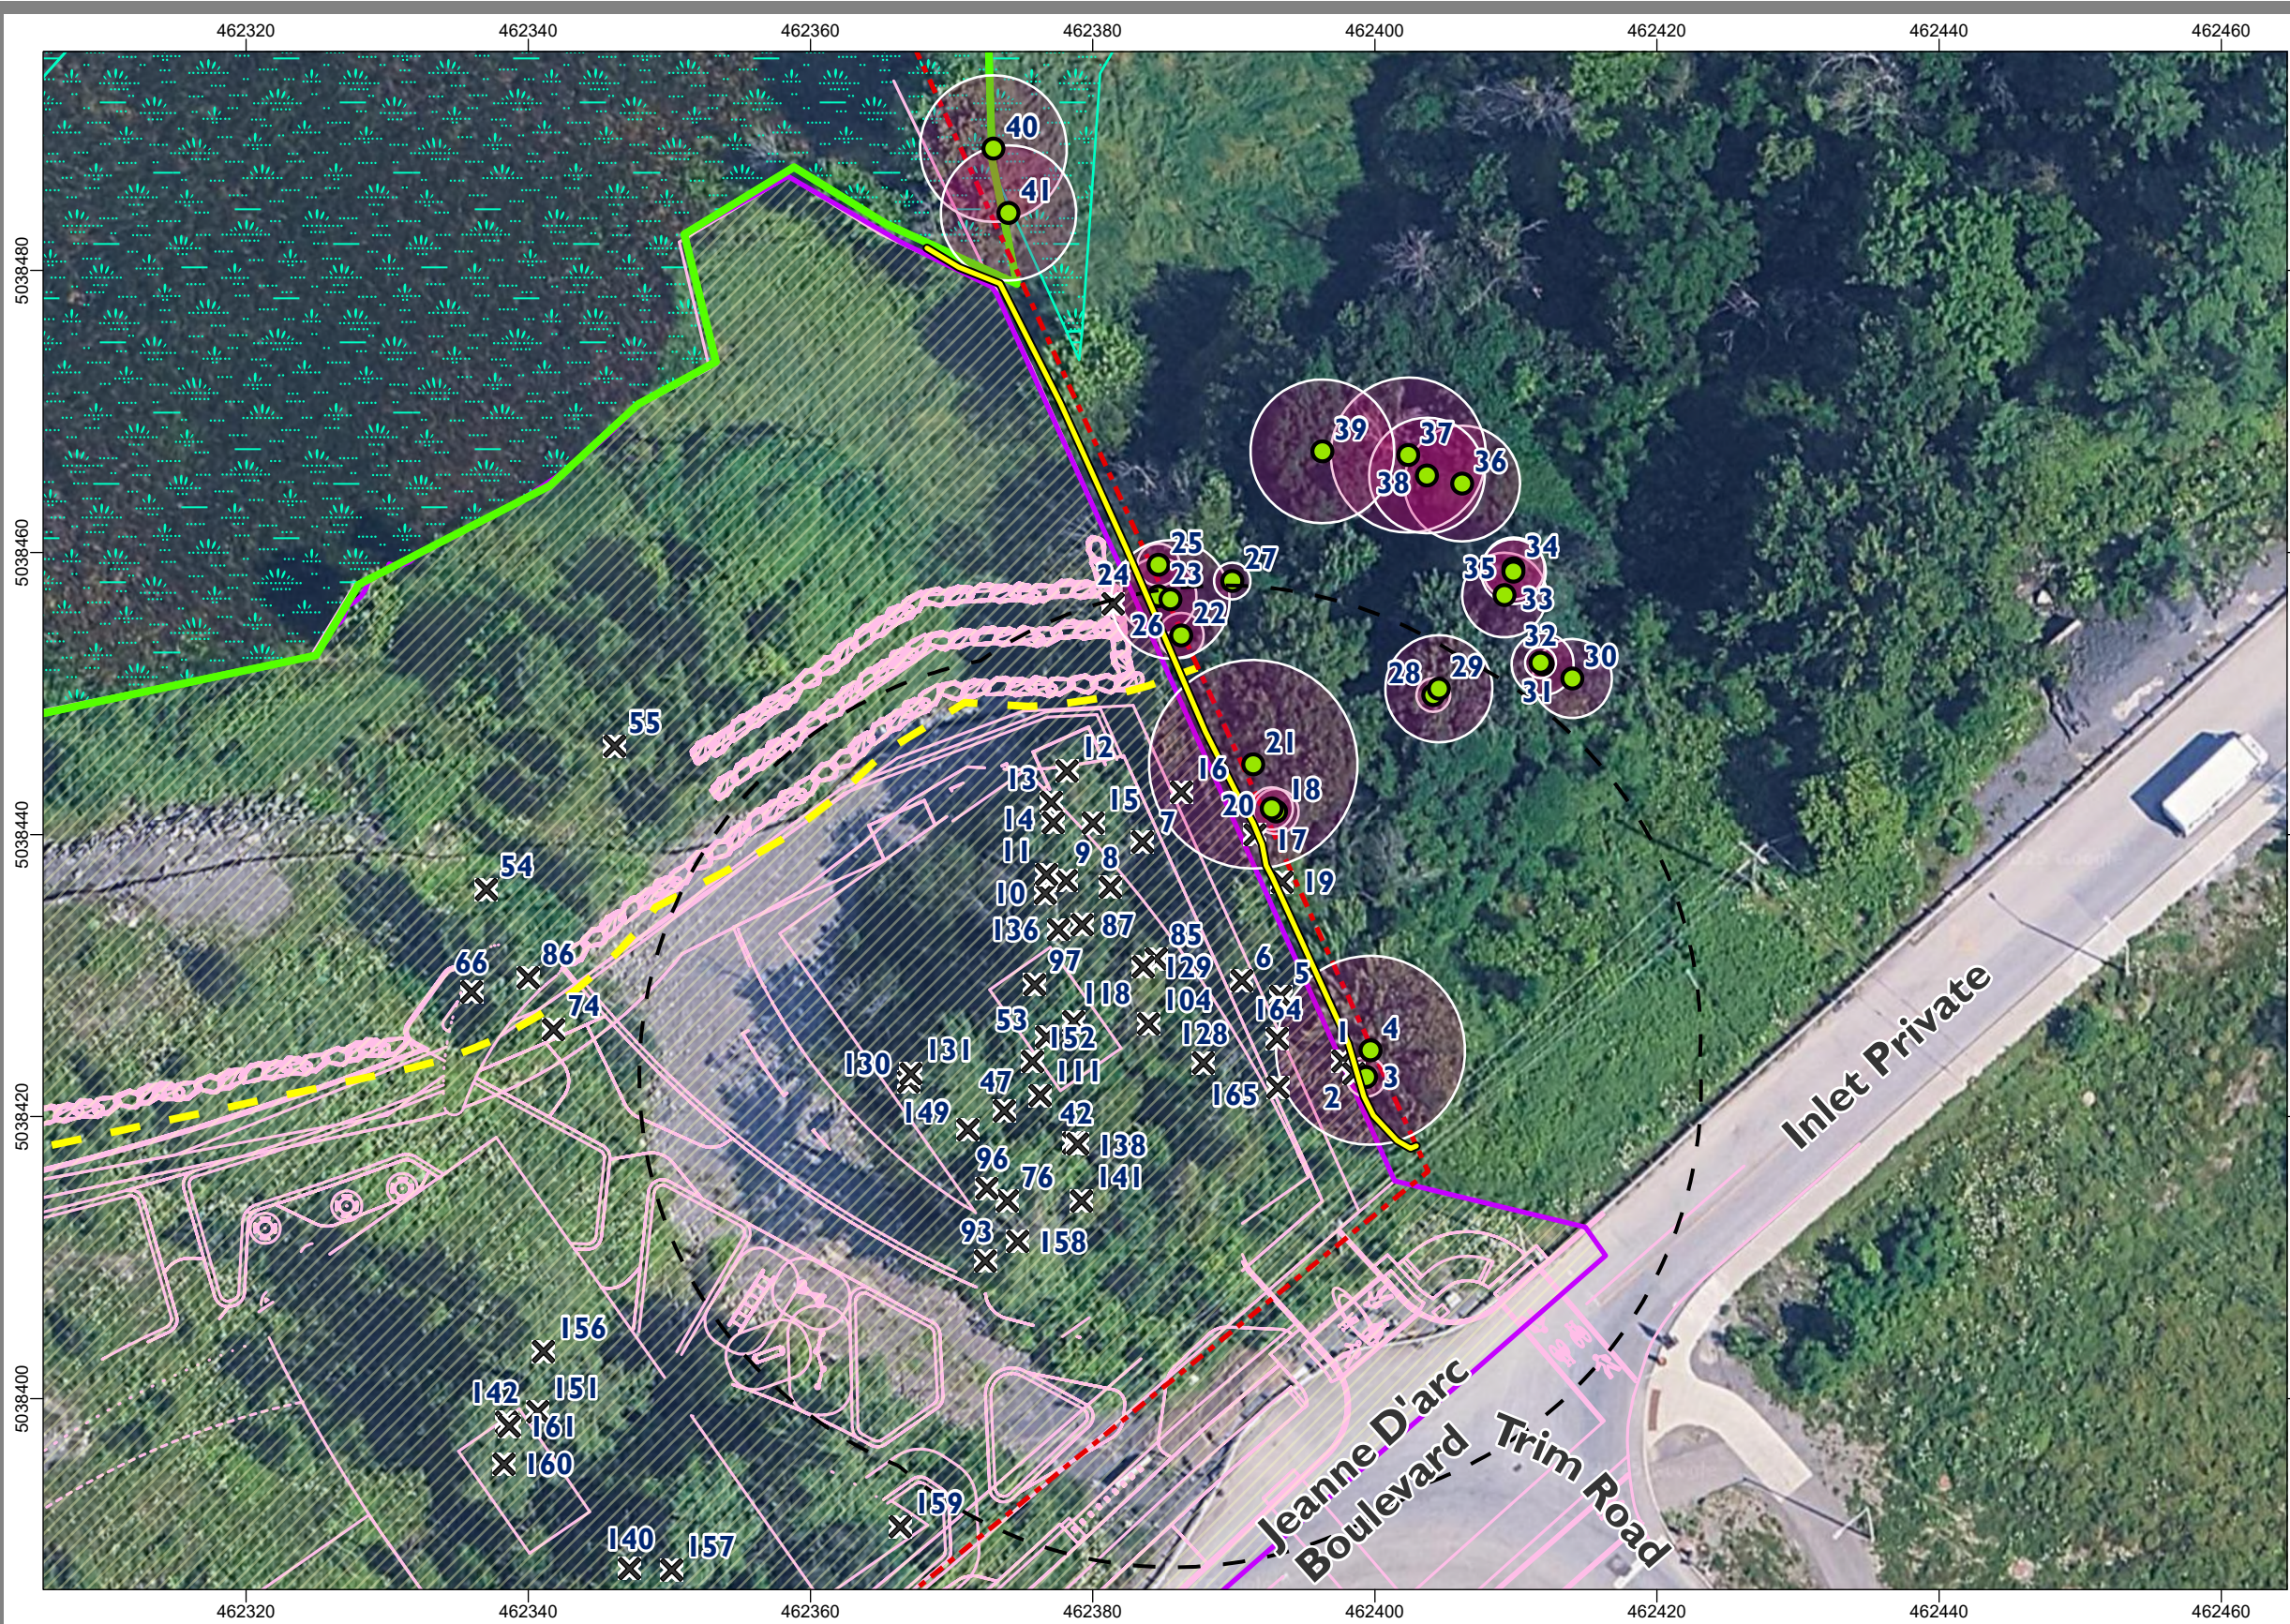
## Appendix B Map 2

Of the 165 individuals inventoried, **122 trees** are anticipated to be removed (Appendix B).

Of the 165 individual trees identified, **43 trees** are proposed for retention (Appendix B).

An impact assessment was undertaken to determine impacts to trees on the Property as a result of the project’s activities. Trees within the extent of grading are all recommended for removal.

- Trees 21, 23 and 26 are recommended for retention and pruning, as grading will occur within their CRZs.
  - Tree 21 is a Bur Oak with dbh 74 cm
  - Tree 23 is an American Elm with dbh 23 cm.
  - Tree 26 is a Bur Oak with dbh 42 cm.
  - Both trees fall near the property line and are of shared ownership.

Three trees of shared ownership are proposed for retention and/or pruning as needed (Tree 21, 23, 26), as their minimum CRZ fall within the grading limits.
