May 1, 2025  
File: PE6587-LET.01

Subject: **Phase I-Environmental Site Assessment Update**  
**6259, 6267, 6271 and 6273 Renaud Road**  
**Ottawa, Ontario**

Further to your request, Paterson Group (Paterson) carried out a Phase I Environmental Site Assessment (ESA) Update for the aforementioned properties. This report updates four previous Phase I ESAs prepared for the Phase I Property in 2022, 2023 and 2024. This report is intended to meet the requirements of a Phase I ESA Update, as per the MECP Standard O.Reg. 153/04, as amended, under the Environmental Protection Act. This report is to be read in conjunction with the previous reports.

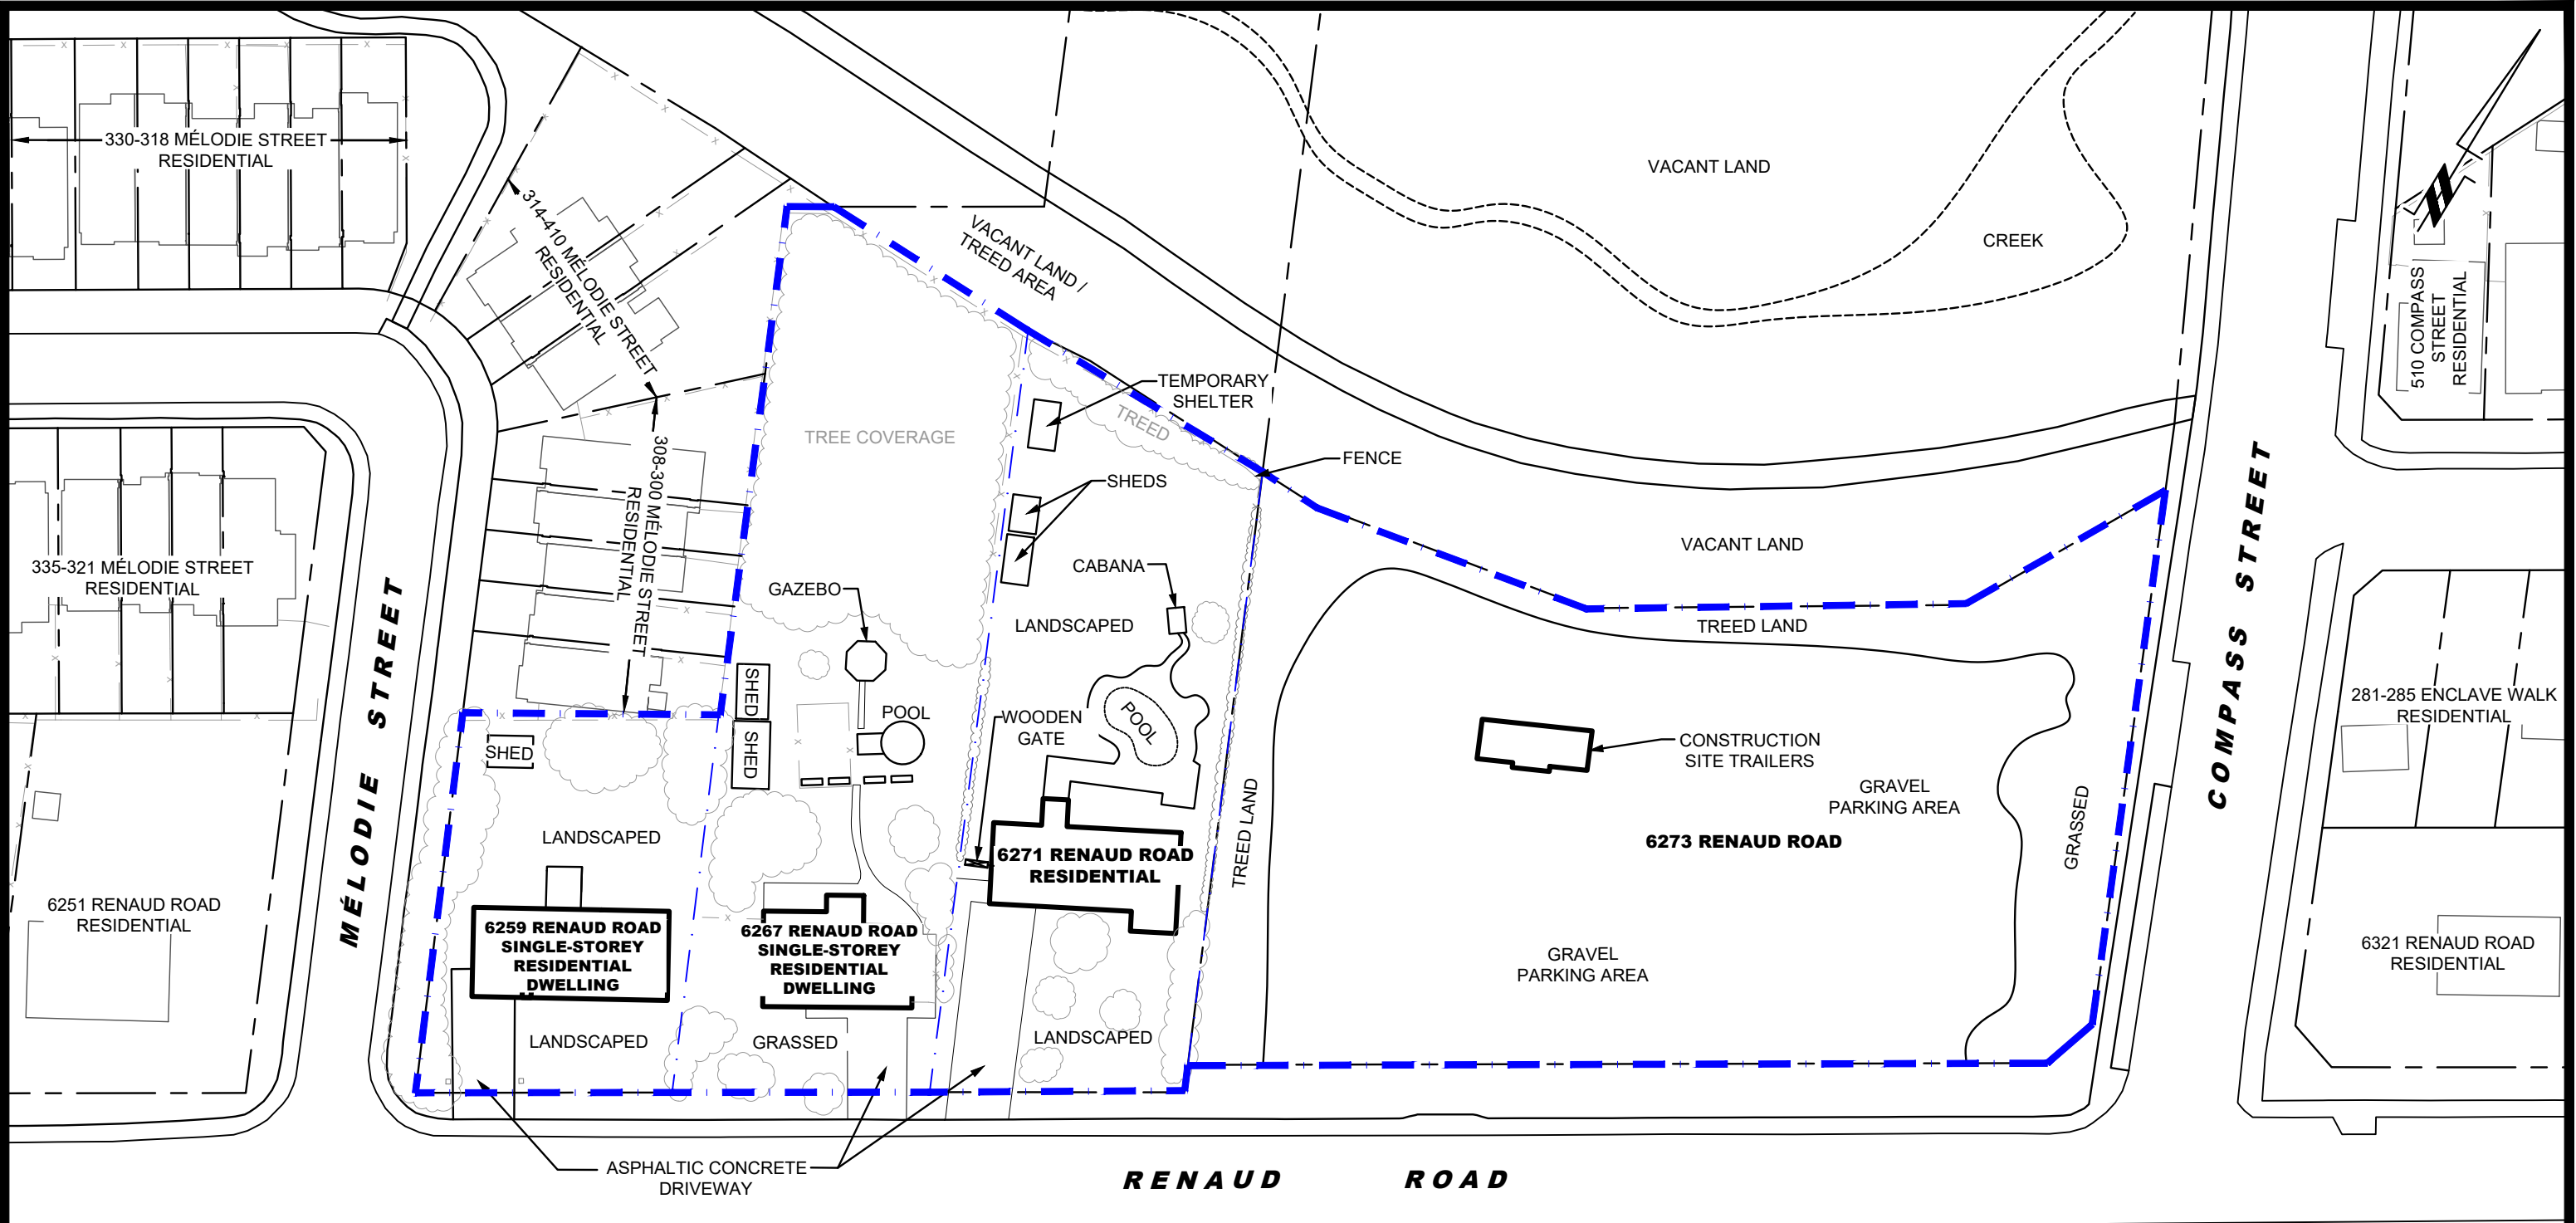
The Phase I Property is occupied by three residential dwellings on the central and western portions of the site, while the eastern portion of the site is vacant. The Phase I Property is located at the northwest corner of the Compass Street and Renaud Road intersection, in the City of Ottawa, Ontario. The Phase I property is an irregular lot in an IA1– Minor Institutional Zone and in a DR - Development Reserve Zone. The property is surrounded by residential, parkland and institutional properties. The Phase I Property is situated in a municipally serviced area. The configuration of the Phase I Property is shown on Drawing PE6587-2 - Site Plan, which is appended to this report.
