Phase One Environmental Site Assessment Part of 1500 Saint Laurent Boulevard, Ottawa, Ontario

City of Ottawa

Phase One Environmental Site Assessment

OTT-22007382-A0

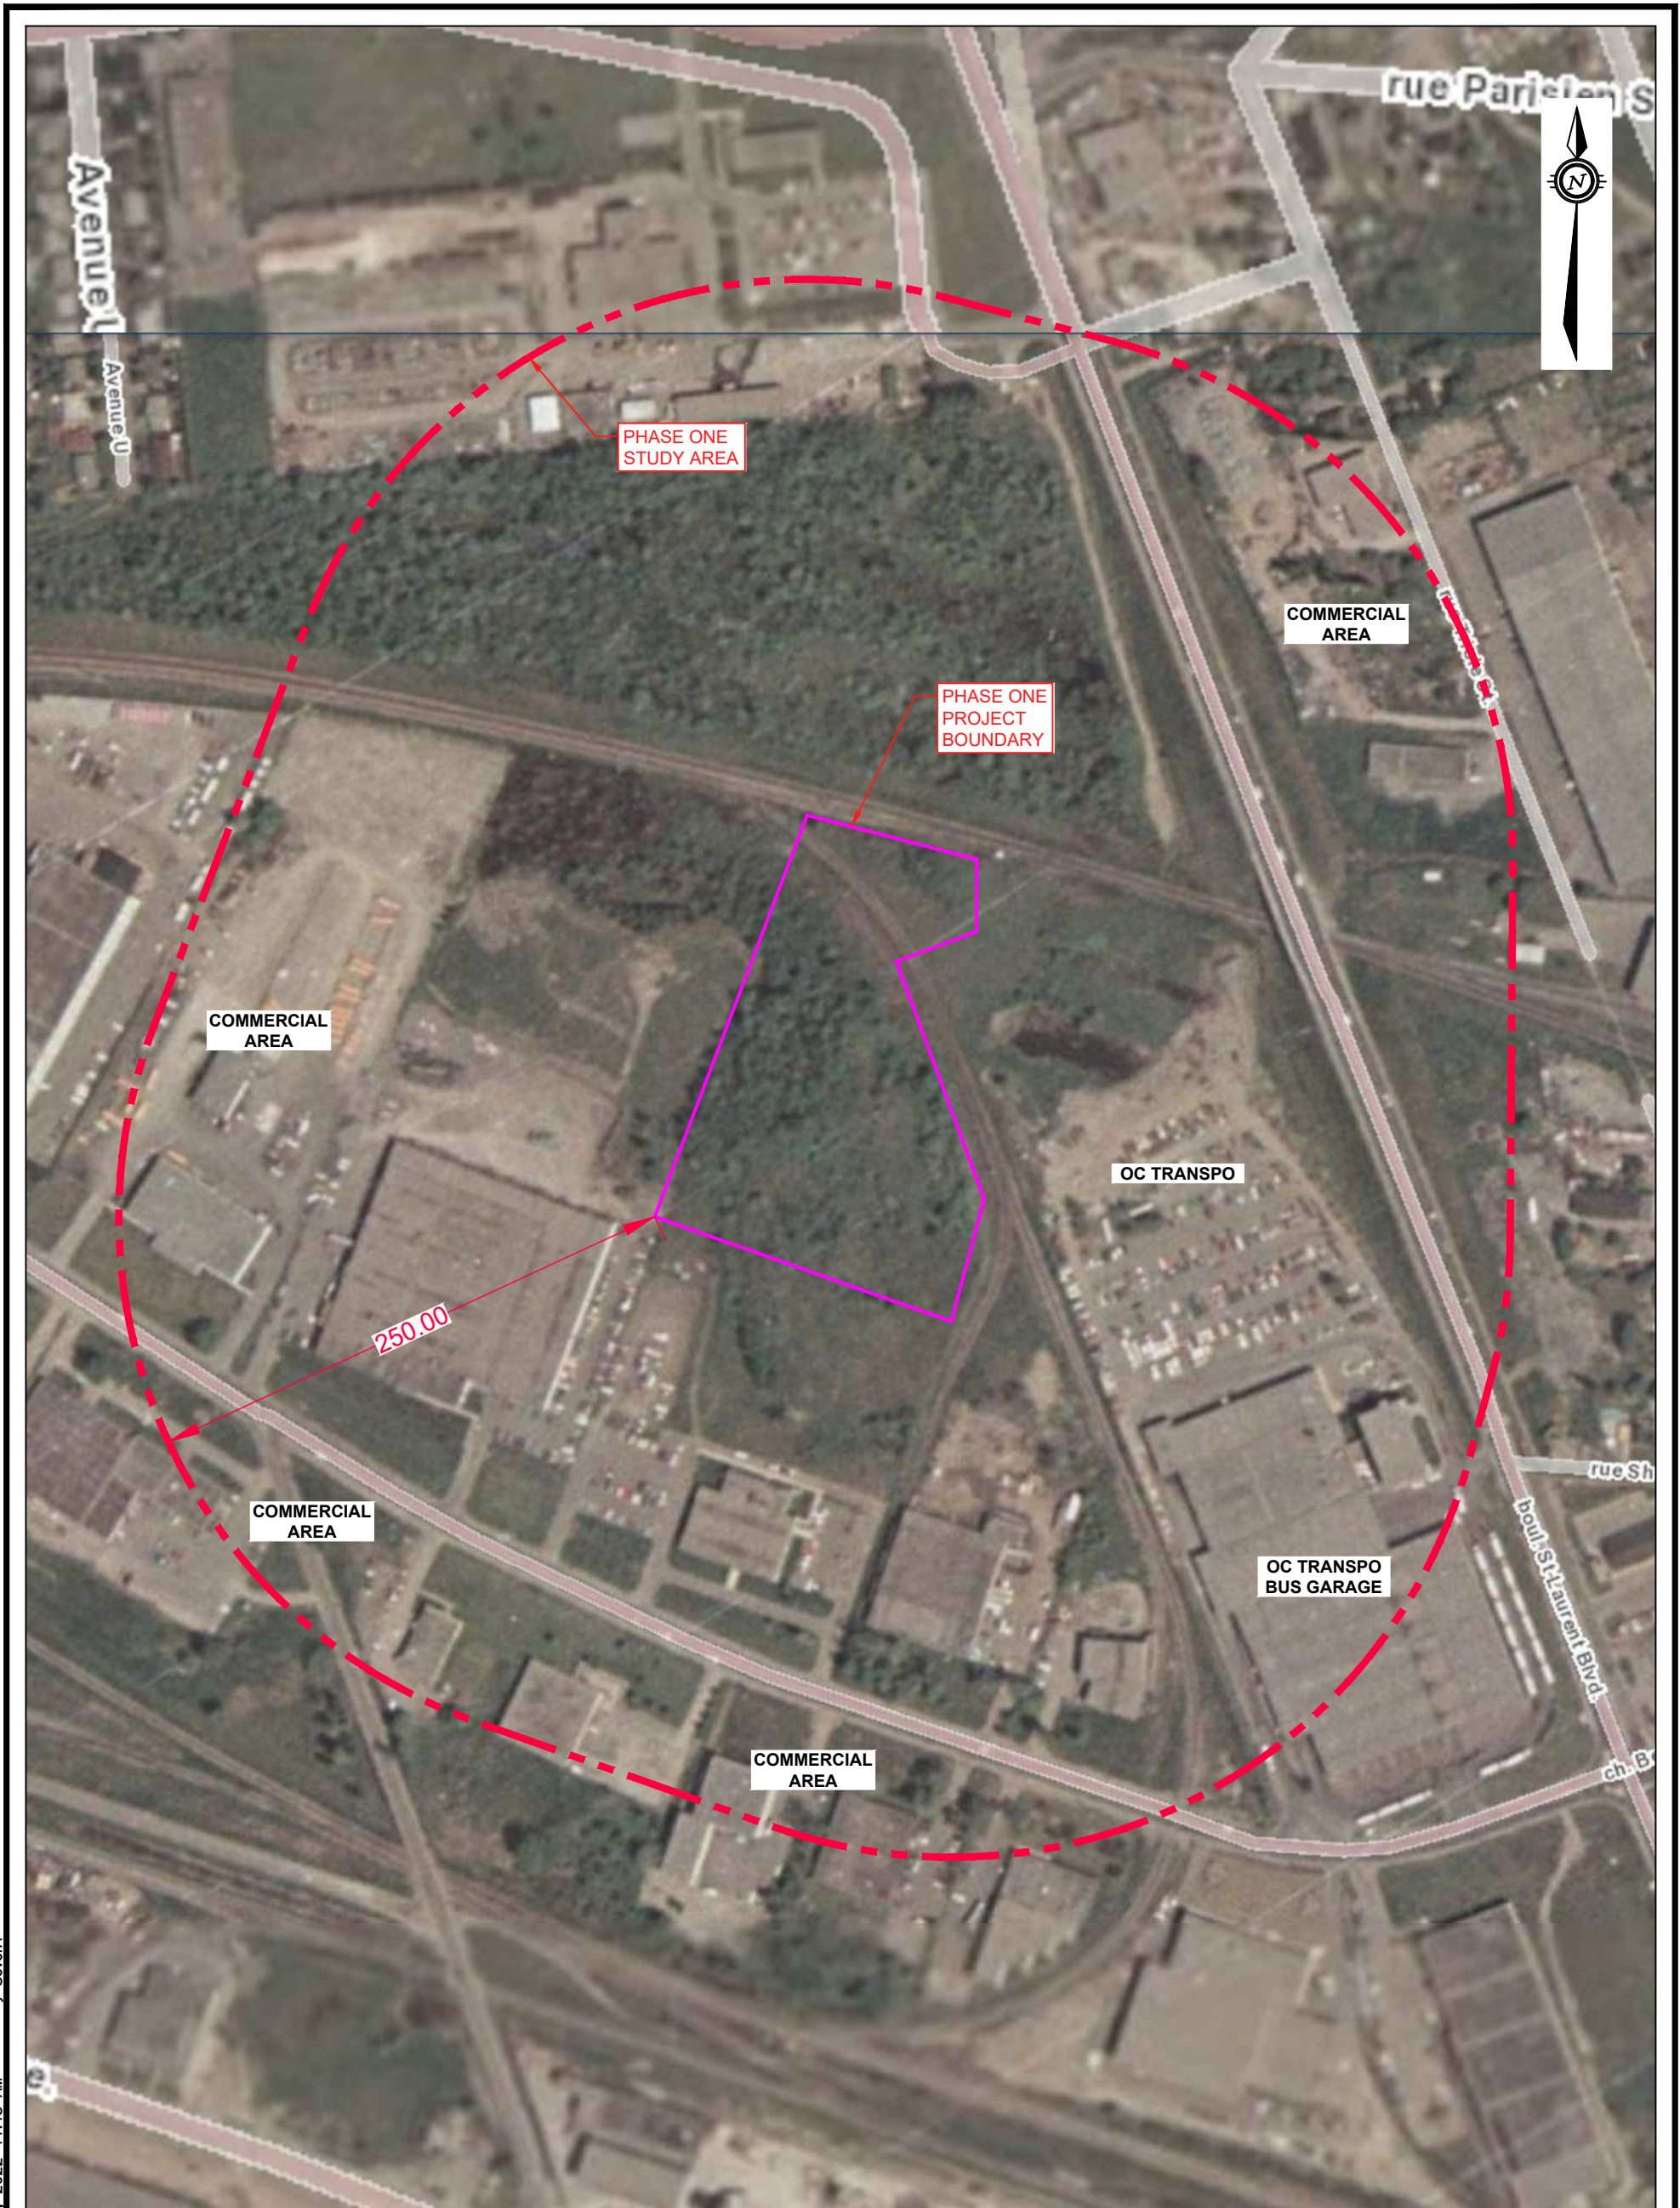
DESIGN MM/LW	PHASE ONE ENVIRONMENTAL SITE ASSESSMENT (NEW BUS GARAGE) 1500 ST. LAURENT BLVD. OTTAWA, ON	SCALE 1:3,000
		DRAWN AS		SKETCH NO
		DATE OCTOBER 2022	1976 AERIAL PHOTOGRAPH	FIG F-3
		FILE NO OTT-22007382-A0

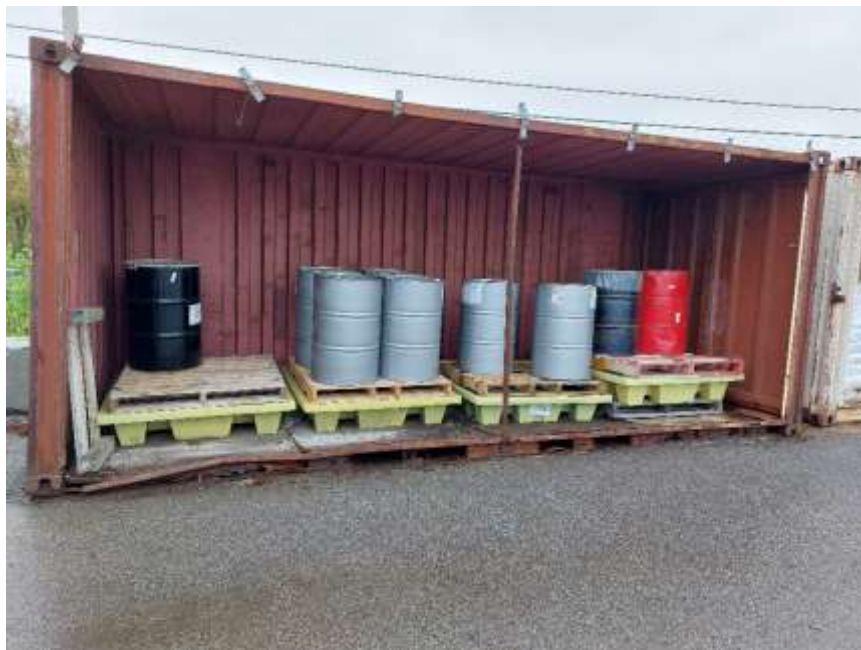
Photograph No. 3

View of new gear oil drums on spill pallets.

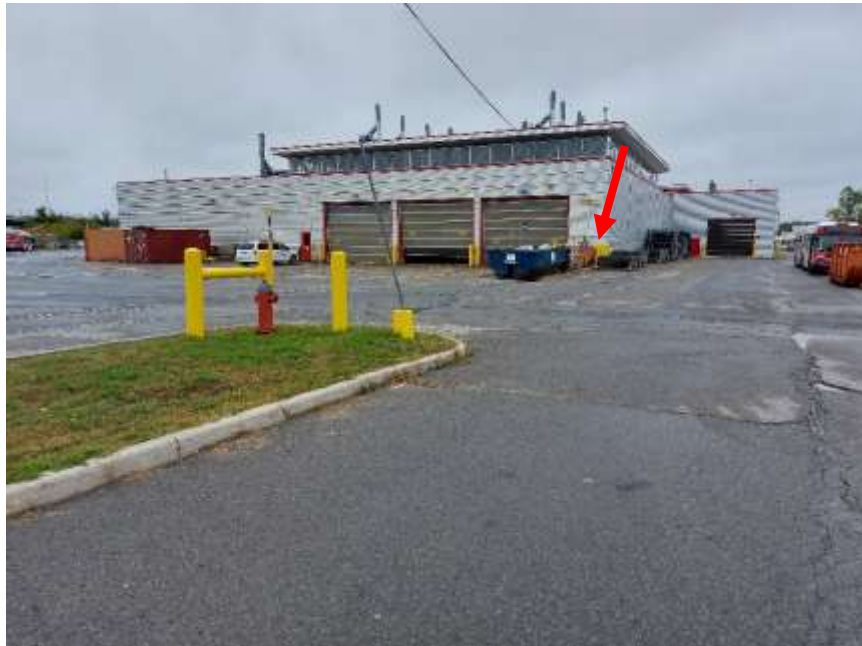
Photograph No. 4

A waste oil AST was observed on the north side of the north garage building at 1500 St. Laurent Boulevard.

View of the waste oil AST on the north side of the north garage.

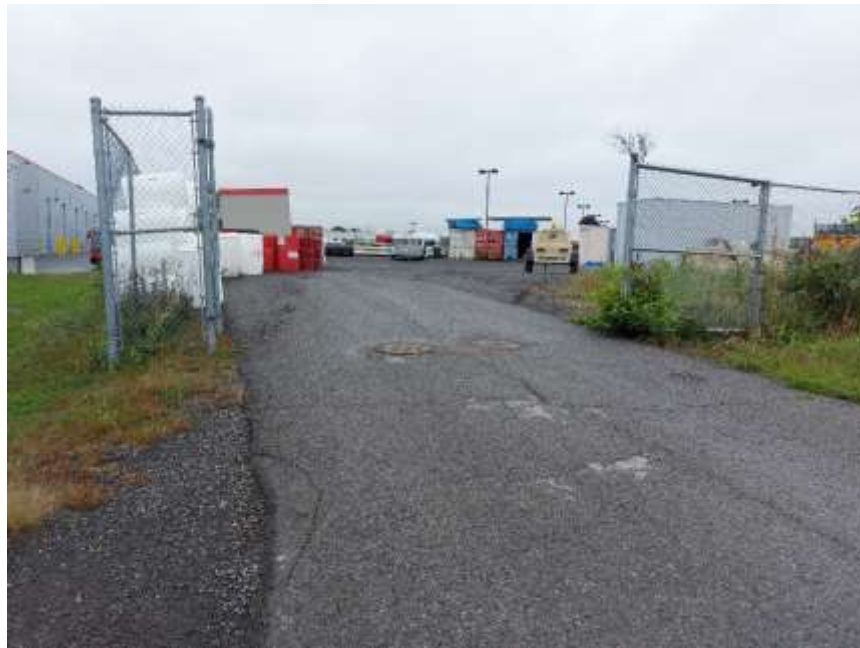
Photograph No. 5

View of the storage area at the centre of the Phase One property.

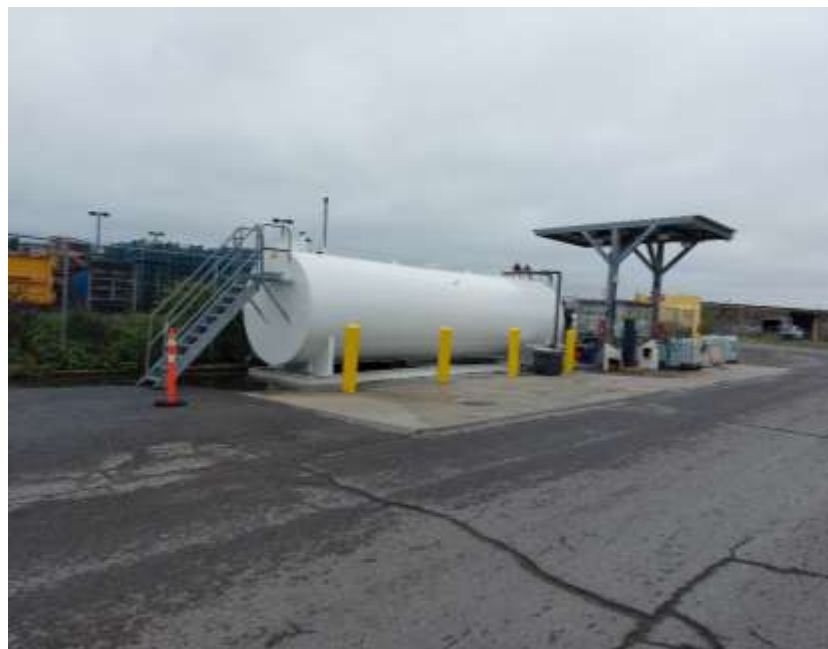
Photograph No. 6

A diesel fuel AST is located near the centre of the Phase One property. The AST is made of double walled steel and has a capacity of approximately 10,000 litres. No signs of leakage were observed during the site visit.

View of the fuel AST and pumps.
