Report

South March Battery Energy Storage System (BESS) Fluvial Geomorphology Assessment

H375142-0000-2B0-066-0001

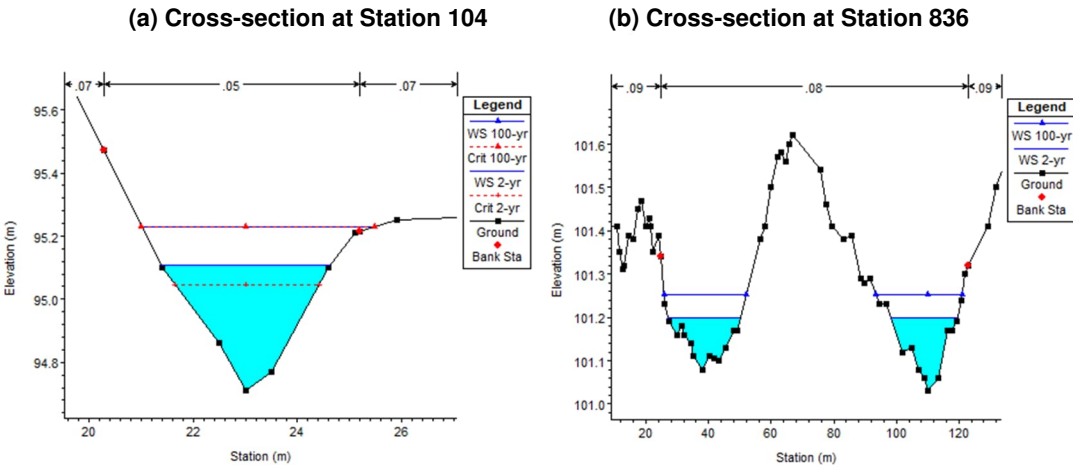
Figure 4-3: Existing Condition Cross-sections with Peak Flow for 2- and 100-year Storm Events

The flow in all cross-sections is subcritical ($F_r < 1$) for both storm events, except at station 104, where the flow is critical ($F_r = 1$) for the 5-year storm event. This location corresponds to a small waterfall with an approximate drop of 7 cm, as observed at location S15 (Photos 19, 20, and 21 in Appendix B). Figure 4-3 shows the water levels in two cross-sections for the 100-year storm event.

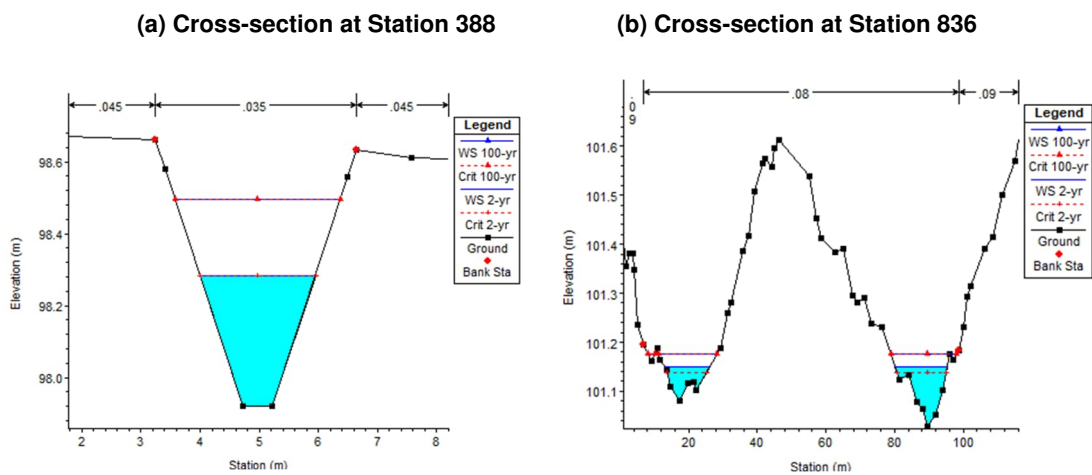
Figure 4-6: Proposed Condition Cross-sections with Peak Flow for 2- and 100-year Storm Events

The flow in all cross-sections is subcritical ($F_r < 1$) for both storm events, except at stations 388 and 836, where the flow is critical ($F_r = 1$) for the 100-year storm event. Figure 4-3 shows the water levels in two cross-sections for the 2- and 100-year storm events.

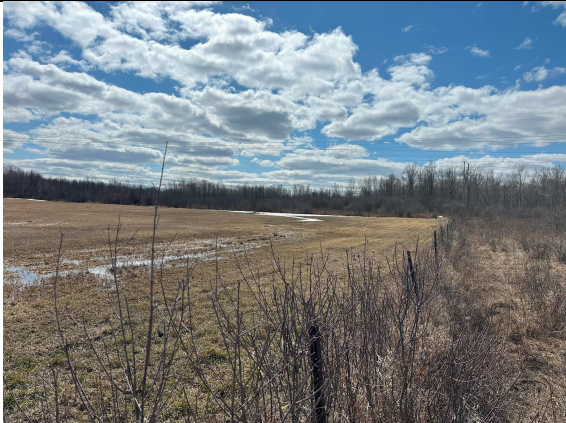
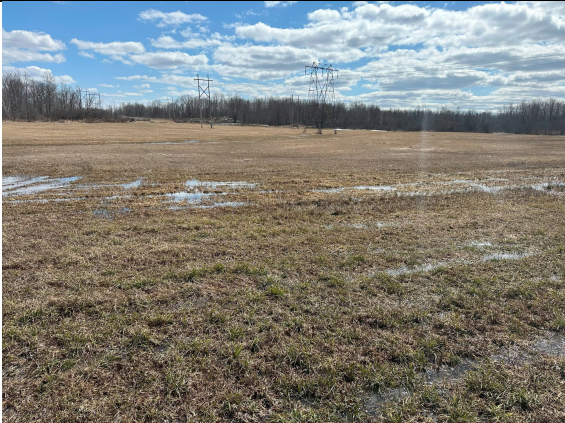
Photo 1: View looking south (Upstream) at location S1 (Figure 3-1) on April 7, 2025.

Photo 2: View looking southeast (Upstream) at location S1 (Figure 3-1) on April 7, 2025.

At the southeast boundary of the Project site, stagnant water was observed within two upstream branches of the Creek, as shown in Photos 1 to 4 (Appendix B) from locations S1 and S2. The presence of standing water outside the defined channel zone may suggest backwater effects during wet periods, although no well-defined channel was visible in this area. These observations are consistent with the high groundwater table identified in the borehole data from the geotechnical investigation (Hatch, 2025). The lack of defined banks suggests low channel confinement, with water dispersing laterally across the adjacent field. These conditions are characteristic of weak channelization and reduced hydraulic capacity, with potential for overland flow contributions during high-flow events.

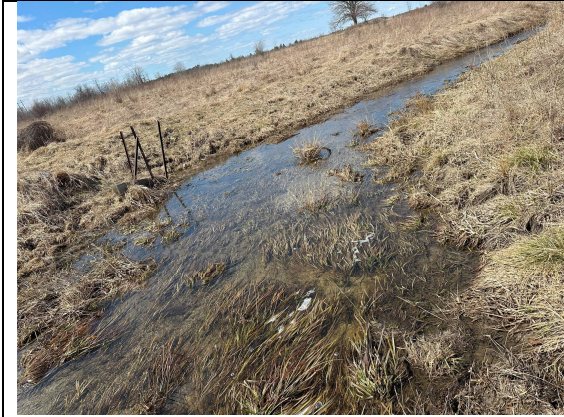
Photo 7: View looking north (downstream) at location S5 (Figure 3-1) on April 7, 2025.

At location S5 (Photos 7 and 8), the watercourse temporarily widens to approximately 3 m, with a shallow depth of about 5 cm. The adjacent land in this section was dry and showed no signs of soil saturation.

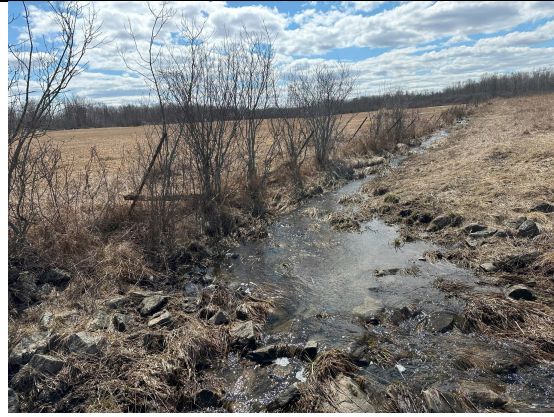
Photo 8: View looking south (Upstream) at location S5 (Figure 3-1) on April 7, 2025.

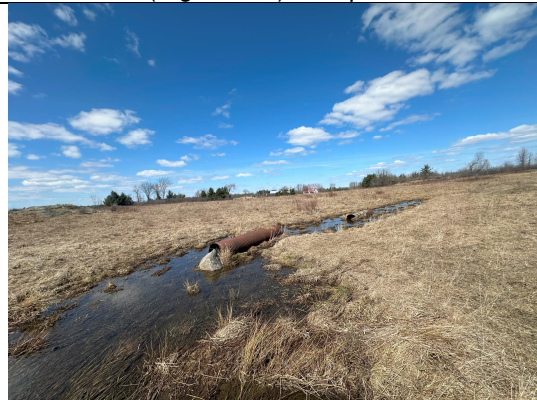
Photo 12: View looking northeast (downstream) at location S9 (Figure 3-1) on April 7, 2025.

Two culverts installed in series, each is 80 cm in diameter and 3.5 m in length (Photo 12 in Appendix B) were observed along the Creek corridor. These culverts convey flow into a large wet pond located along the northern portion of the Creek, shown in Photo 13 (Appendix B). Given their placement within a wide section of the channel, where flow is also conveyed around the culverts, their influence on overall channel hydraulics and fluvial processes appears to be marginal.

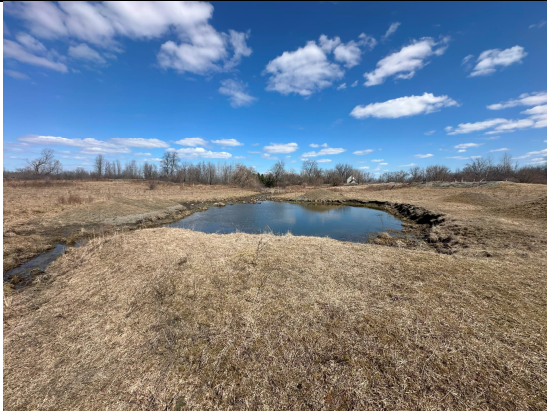
Photo 13: View looking northeast (Downstream) at location S10 (wet pond) (Figure 3-1) (minor sinuosity) on April 7, 2025.

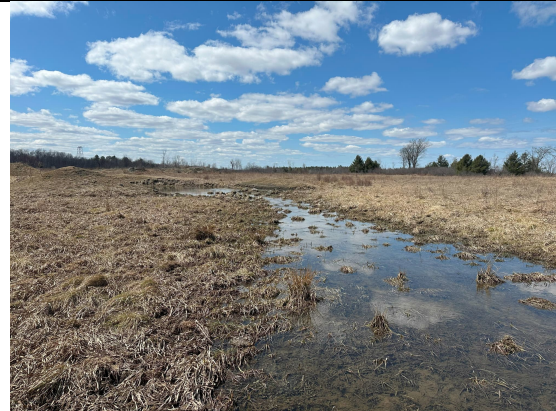
Photo 14: View looking west (Upstream) at location S11 (Figure 3-1) (minor sinuosity) on April 7, 2025.

Evidence of localized channel widening was noted in two areas within the confined portion of the Creek at locations S5, S11, and S12 (Appendix B). Instances of channel adjustment and planform variability were also observed. At location S14, the Creek exhibits minor sinuosity, with lateral deflections in the low-flow path suggesting limited but active fluvial processes. These changes in flow alignment are likely the result of small-scale bank erosion and scour along the outer edges of developing meander features. Such features may indicate the early formation of a meander belt within this reach of the channel.

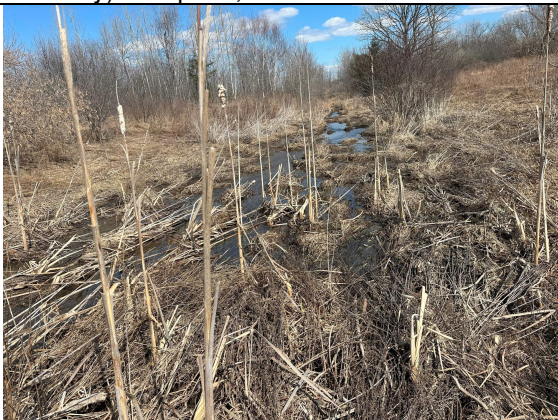
Photo 15: View looking northeast (downstream) at location S12 (Figure 3-1) on April 7, 2025.

Further downstream at location S10, the Creek discharges into a large wet pond, where the water surface was approximately 1 m below the surrounding ground elevation. At locations S11 and S12 (Photos 14 and 15), the Creek again widens slightly to approximately 2 m with a shallow depth of 5 cm, before narrowing to about 0.5 m wide and deepening to roughly 25 cm. A small 7 cm-high waterfall is present along the Creek at location S15.

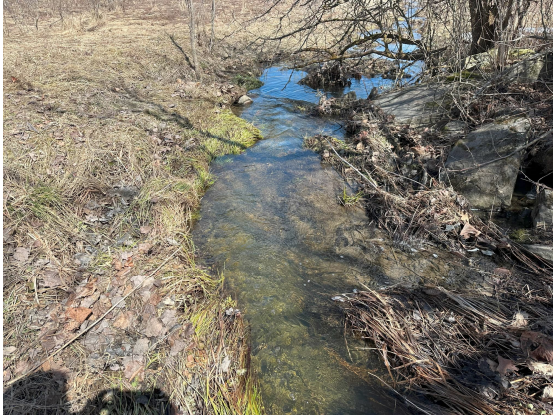
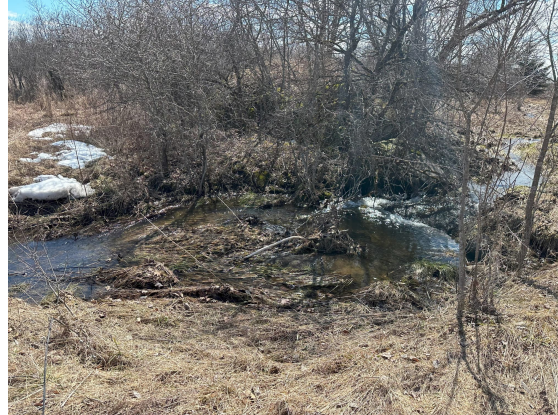
Photo 19: View looking northeast (Downstream) at location S15 (Small waterfall) (Figure 3-1) on April 7, 2025.

Photo 20: View looking southwest (Upstream) at location S15 (Small waterfall) (Figure 3-1) on April 7, 2025.

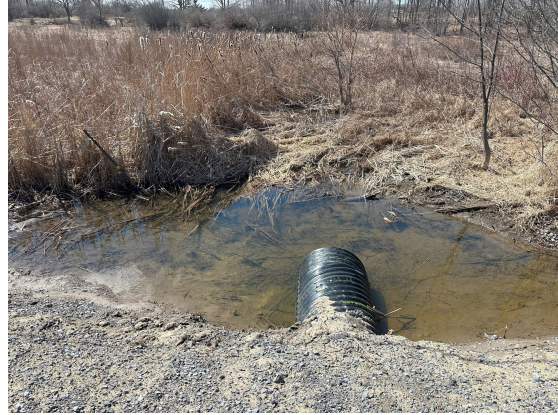
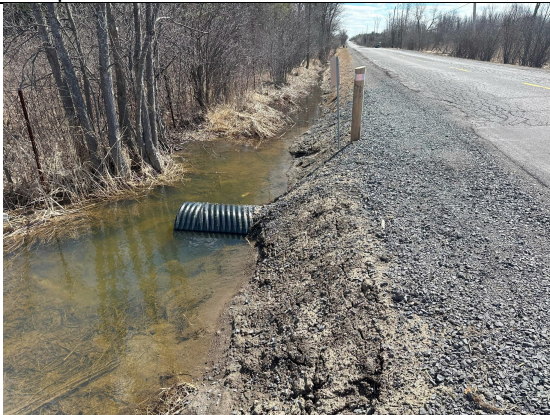
Photo 26: View looking southwest (Upstream) at location S18 (Figure 3-1) on April 7, 2025.

Photo 27: Side view at location S18 (Figure 3-1) on April 7, 2025.

Active flow was observed during the site visit, with ponded water present within the upstream ponded/spreading water section, and continuous flow through the downstream channelized reach. At the northeast property boundary, the Creek drains through a 70 cm diameter culvert crossing Marchurst Road, discharging to the northeast (Photos 26 and 27 in Appendix B).

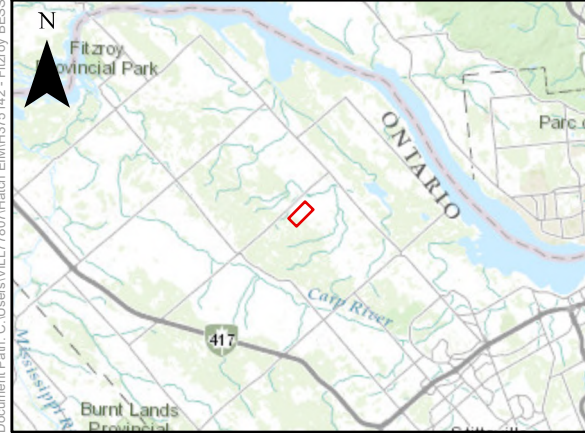
PROJECT: South March BESS Fluvial Geomorphology Assessment				
FIGURE TITLE: Erosion Hazard Limits of the Proposed Confined and Unconfined System Reaches				
CLIENT: Brookfield Corp.				
DWG BY: J. VILLELLA	CHK BY: M. KHAFAQY	APP.: E	REV NO.: 1	PROJ No.: H-375142
DATE: 01/08/25	PAGE: 1

Erosion Hazard Limits for Proposed Condition

Figure 4-11 illustrates the erosion hazard limit for the proposed diversion ditch. Notably, the hazard limit encroaches upon the southwest boundary of the development area. To mitigate this, it is recommended that the diversion ditch be shifted by at least 5.5 meters along this side to avoid potential impacts.
