Report

South March Battery Energy Storage System (BESS) Fluvial Geomorphology Assessment

H375142-0000-2B0-066-0001

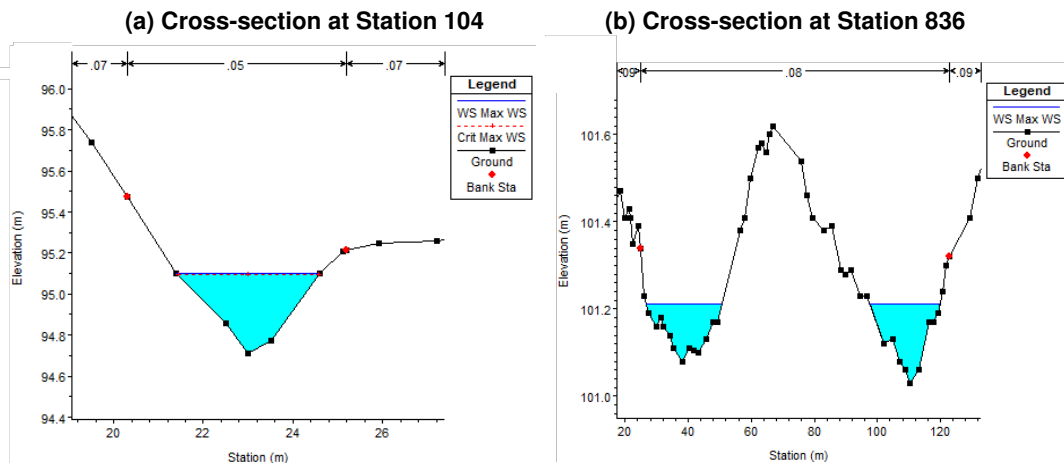
Figure 4-2: Cross-sections with Critical Flow for 100-year Storm Event

summary of HEC-RAS hydraulic results is provided in Appendix C. A normal depth boundary condition was applied at the downstream end, with slope of 0.87% which aligns with the channel bed slope at the downstream cross-section. Note that the flow in all cross-sections is subcritical ($F_r < 1$) for both storm events, except at station 104, where the flow is critical ($F_r = 1$) for the 100-year storm event. This location corresponds to a small waterfall with an approximate drop of 7 cm, as observed at location S15 (Photos 19, 20, and 21 in Appendix B). **Figure 4-2** shows the water levels in two cross-sections for the 100-year storm event.

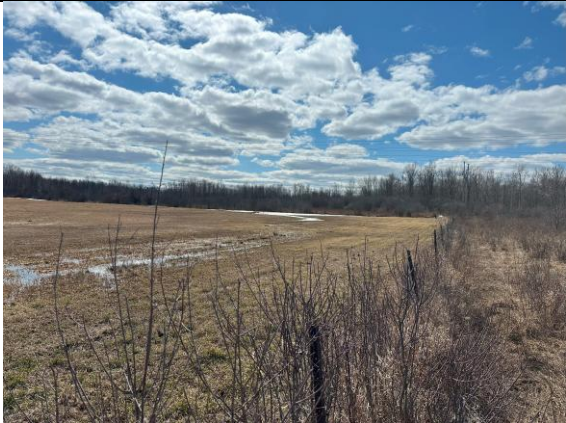
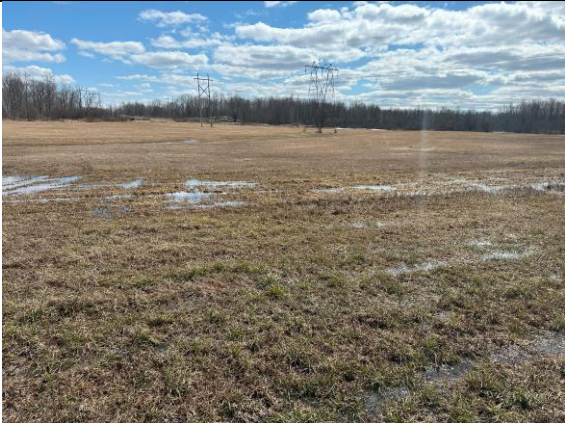
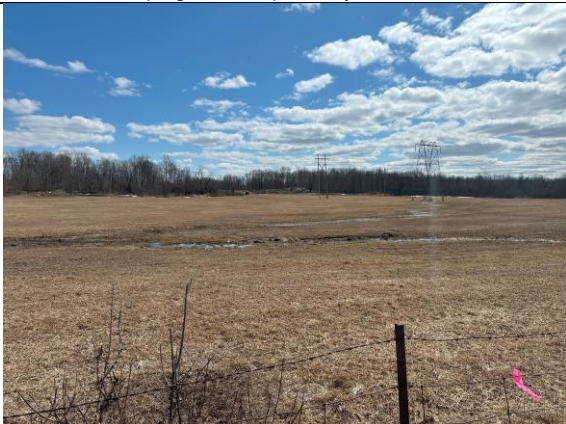
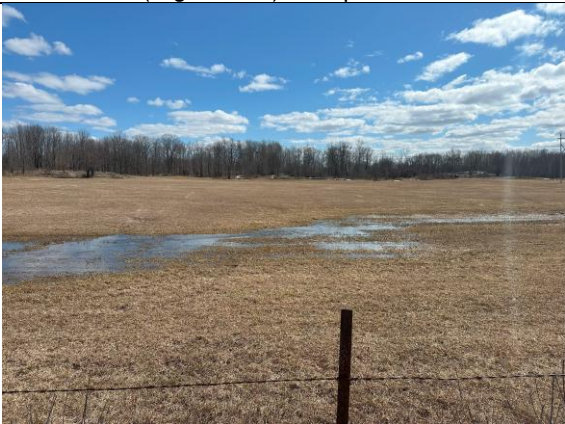
At the southeast boundary of the Project site, stagnant water was observed within two upstream branches of the creek, as shown in Photos 1 to 4 (Appendix B) from locations S1 and S2. The presence of standing water outside the defined channel zone may suggest backwater effects during wet periods, although no well-defined channel was visible in this area. These observations are consistent with the high groundwater table identified in the borehole data from the geotechnical investigation (Hatch, 2025). The lack of defined banks suggests low channel confinement, with water dispersing laterally across the adjacent field. These conditions are characteristic of weak channelization and reduced hydraulic capacity, with potential for overland flow contributions during high-flow events.

Photo 1: View looking south (Upstream) at location S1 (Figure 3-1) on April 7, 2025.

Photo 2: View looking southeast (Upstream) at location S1 (Figure 3-1) on April 7, 2025.

Photo 3: View looking southeast (Upstream) at location S2 (Figure 3-1) on April 7, 2025.

Photo 4: View looking southeast (Upstream) at location S3 (Figure 3-1) on April 7, 2025.

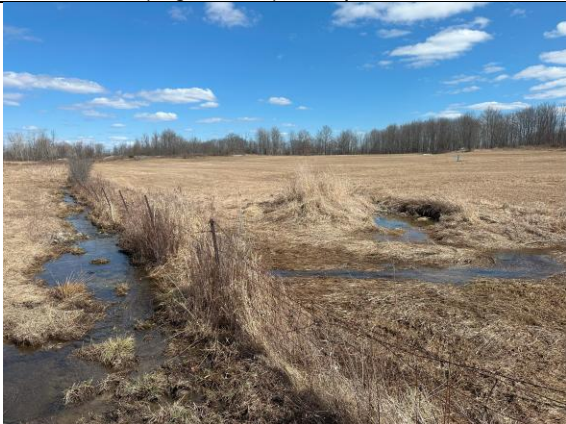
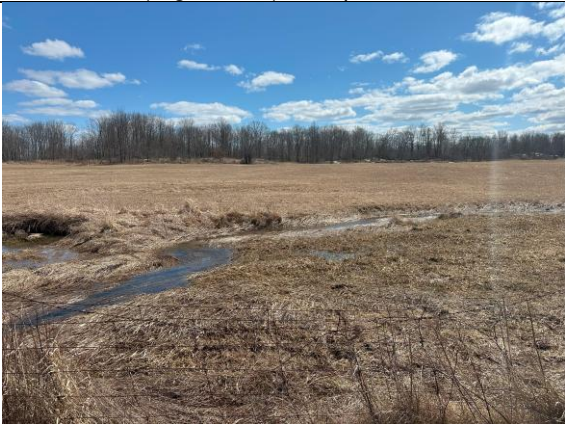
From location S4, the watercourse flows through a vegetated corridor with yellowing grasses and mild side slopes (approximately 3:1). The channel bed consists primarily of fine sediments, organic debris, and high grass. Riparian vegetation includes shrubs, saplings, and deadfall along both banks. No signs of bank slumping or undercutting were observed, and no erosion control measures (e.g., riprap or engineered stabilization) were noted. These conditions support classifying this section of the creek as a stable, shallow, confined system, with minimal erosion activity and limited potential for channel migration under current hydrologic conditions.

Photo 5: View looking northeast (Downstream) at location S4 (Figure 3-1) on April 7, 2025.

Photo 6: View looking south (Upstream) at location S4 (Figure 3-1) on April 7, 2025.

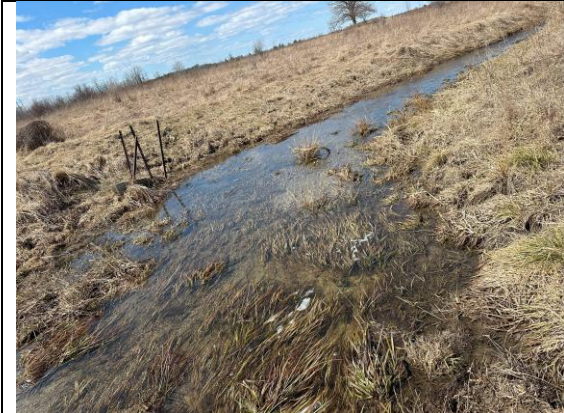
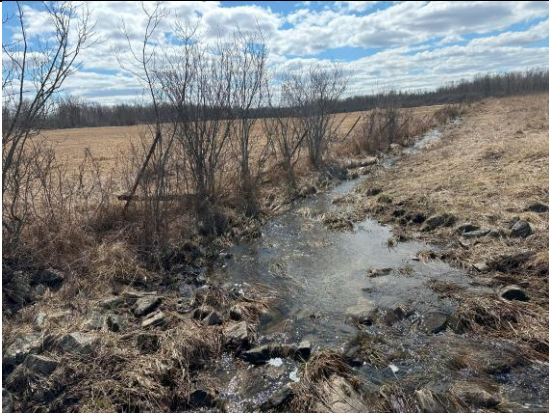
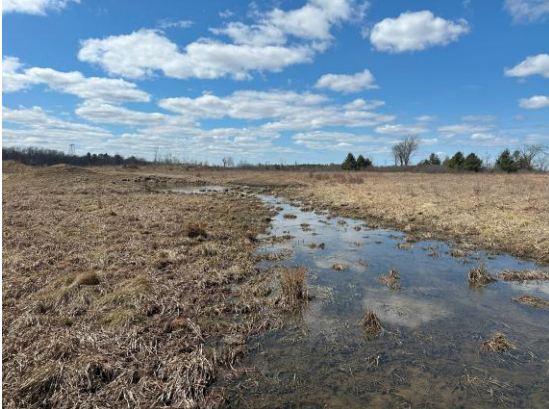
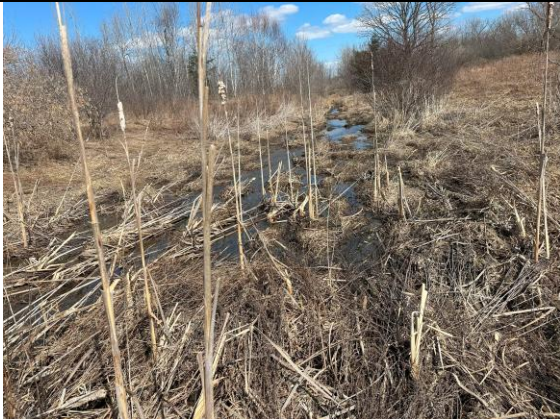
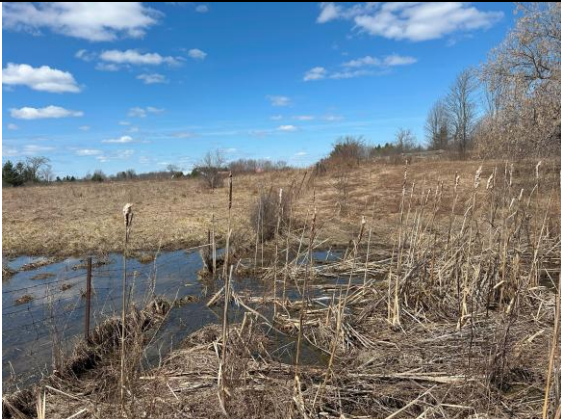
Evidence of localized channel widening was noted in two areas within the confined portion of the creek at locations S5, S11, and S12 (Appendix B). Instances of channel adjustment and planform variability were also observed. At location S14, the creek exhibits minor sinuosity, with lateral deflections in the low-flow path suggesting limited but active fluvial processes. These changes in flow alignment are likely the result of small-scale bank erosion and scour along the outer edges of developing meander features. Such features may indicate the early formation of a meander belt within this reach of the channel.

Photo 7: View looking north (downstream) at location S5 (Figure 3-1) on April 7, 2025.

Photo 8: View looking south (Upstream) at location S5 (Figure 3-1) on April 7, 2025.

Photo 14: View looking west (Upstream) at location S11 (Figure 3-1) (minor sinuosity) on April 7, 2025.

Photo 15: View looking northeast (downstream) at location S12 (Figure 3-1) on April 7, 2025.

Photo 16: Side view at location S12 (Figure 3-1) on April 7, 2025.

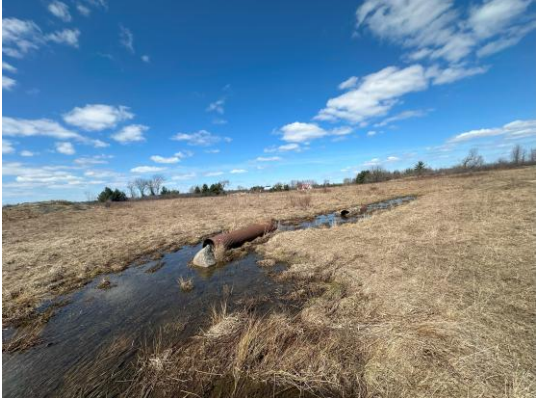
Two culverts installed in series, each is 80 cm in diameter and 3.5 m in length (Photo 12 in Appendix B) were observed along the creek corridor. These culverts convey flow into a large wet pond located along the northern portion of the Creek, shown in Photo 13 (Appendix B).

Photo 12: View looking northeast (downstream) at location S9 (Figure 3-1) on April 7, 2025.

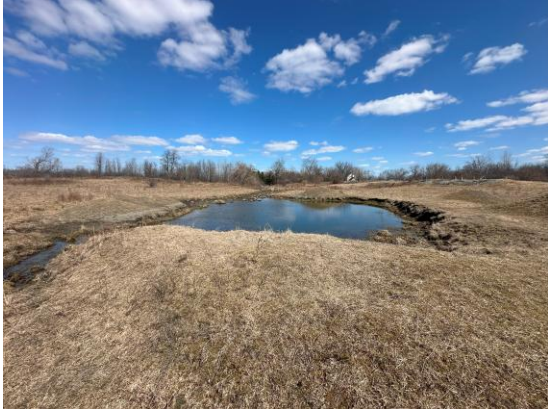
Photo 13: View looking northeast (Downstream) at location S10 (wet pond) (Figure 3-1) (minor sinuosity) on April 7, 2025.

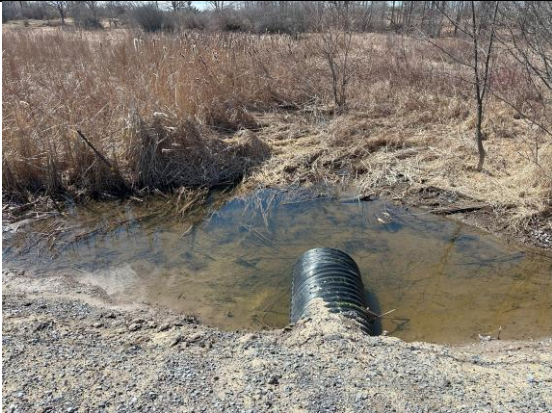
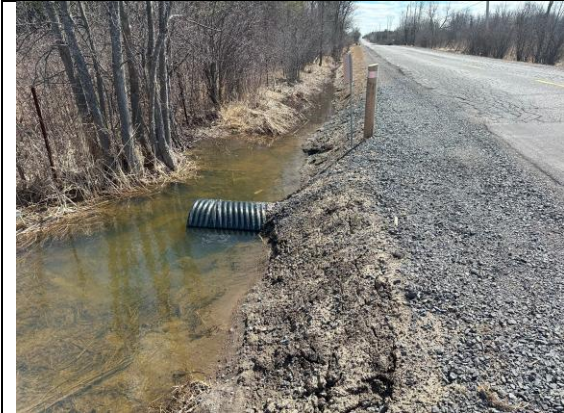
Active flow was observed during the site visit, with ponded water present within the upstream ponded/spreading water section, and continuous flow through the downstream channelized reach. At the northeast property boundary, the Creek drains through a 70 cm diameter culvert crossing Marchurst Road, discharging to the northeast (Photos 26 and 27 in Appendix B).

Photo 26: View looking southwest (Upstream) at location S18 (Figure 3-1) on April 7, 2025.

Photo 27: Side view at location S18 (Figure 3-1) on April 7, 2025.
