South March Battery Energy Storage System (BESS) Tree Conservation Report

April 17, 2026

Hatch Project #375142

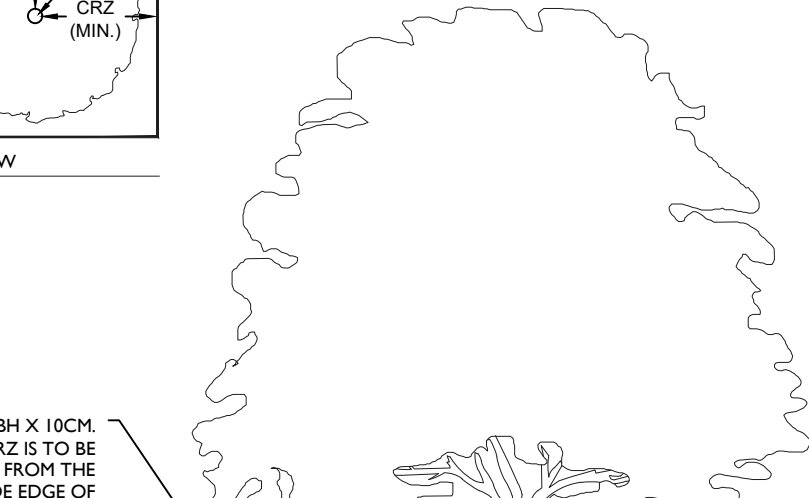
TREE PROTECTION FENCING

CRZ = DBH X 10CM.
CRZ IS TO BE MEASURED FROM THE OUTSIDE EDGE OF THE TREE BASE

TREE PROTECTION SIGNAGE AS PER S141

1.2M MIN. HIGH TREE PROTECTION

POSTS TO BE SPACED AT 2.4M O/C MAX WITH A RIGID TOP FRAME

- ◆ Do not extend hard surface or significantly change landscaping.
- Tree protection fencing must be at least 1.2 m in height and constructed of rigid or framed materials (e.g. moduloc – steel, plywood hoarding, or snow fence on a 2"x4" wood frame) with posts 2.4 m apart, such that the fence location cannot be altered. All supports and bracing must be placed outside of the CRZ, and installation must minimise damage to existing roots. (see detail).

Where critical root zones are not impacted by the initial clearing activities, critical root zones will be protected by a 1.2 m fence around the outer edge of the critical root zones prior construction to ensure any impacts from grading, laydown, expansion of hard surfaces or any other activities will not impact individual trees. On Roadside ROW where existing fencing was observed, Hatch believes that impacts to retained trees will be mitigated by the existing fencing given it will act as a barrier to damage critical root zones.
