## **Phase I - Environmental Site Assessment**

Northern Part of 5123 Hawthorne Road (formerly)  
And now readdressed  
301 Somme Street  
Ottawa, Ontario

November 20, 2020

Report: PE5100-1R

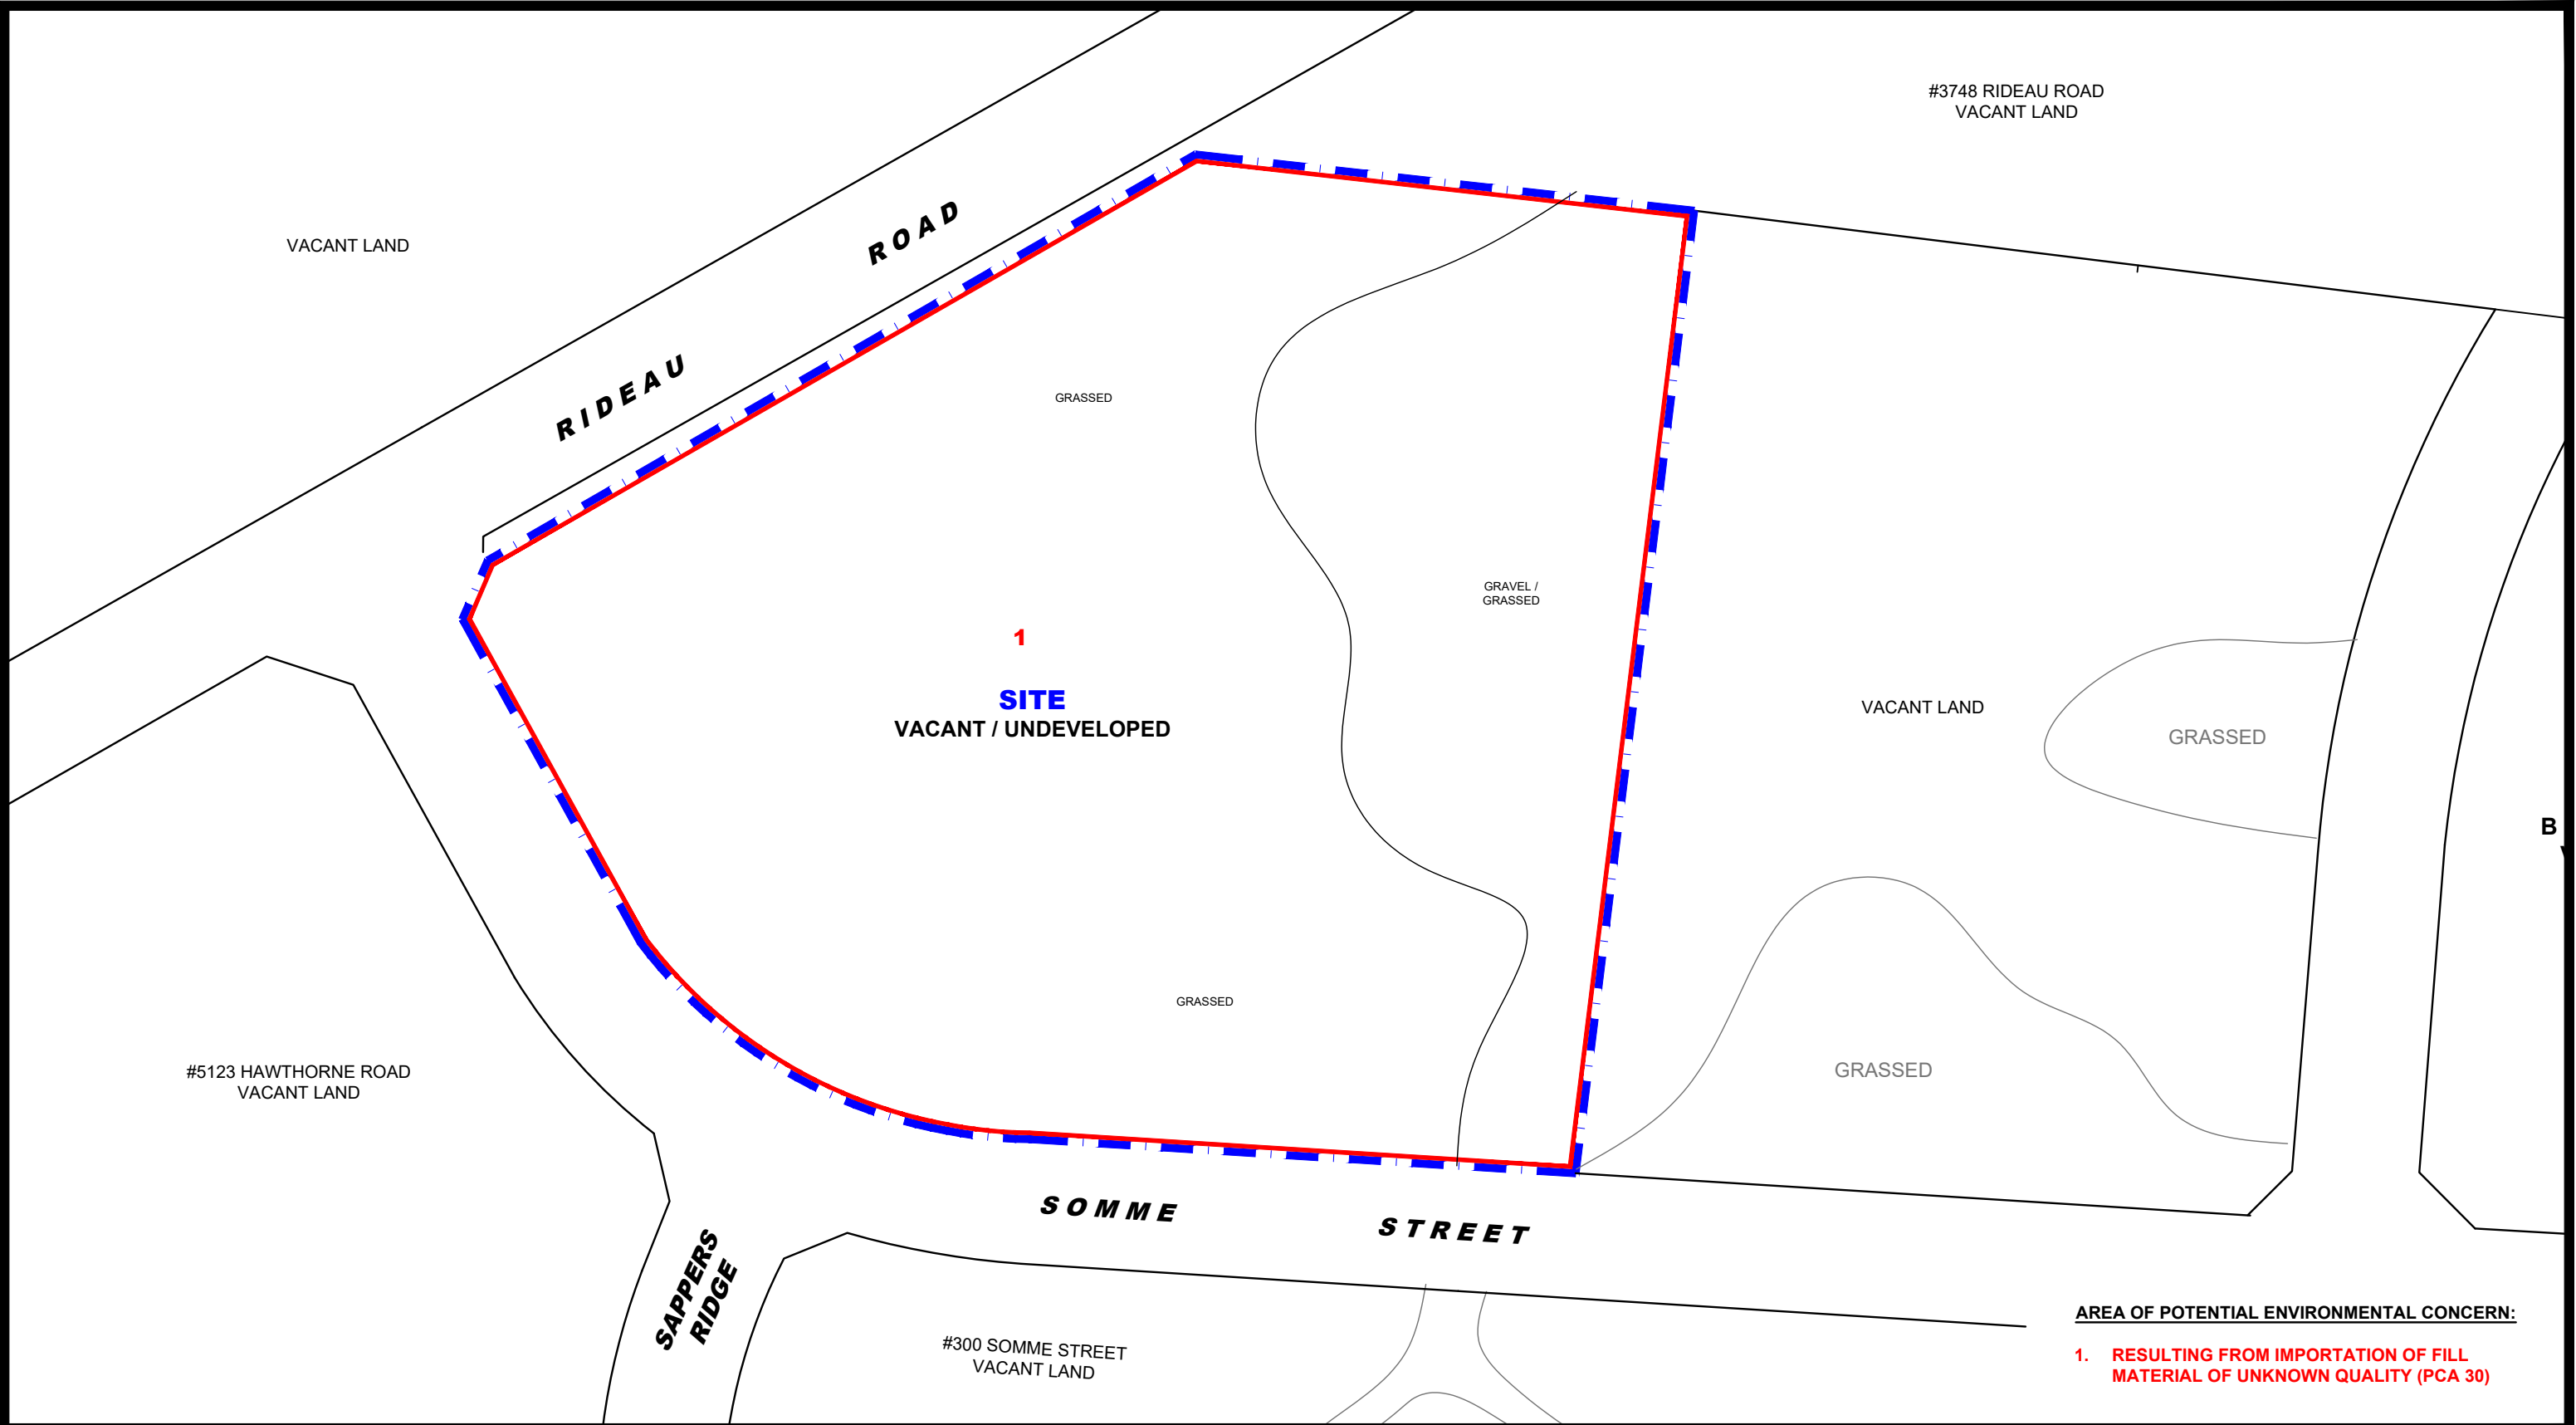
**DRAWING PE5100-1 – SITE PLAN**

Site drainage on the Phase I Property consists primarily of surface infiltration throughout the property. No ponded water was observed on the subject site. No signs of staining or indications of potential sub-surface contamination were observed at the time of the site visit. A depiction of the Phase I Property is presented on Drawing PE5100-1 – Site Plan, in the Figures section of this report.

Imported fill material was observed across the Phase I Property. The unknown quality of the fill material imported on-site between 2002 to 2014 represents an APEC on the Phase I Property.

**AREA OF POTENTIAL ENVIRONMENTAL CONCERN:**  
**1. RESULTING FROM IMPORTATION OF FILL MATERIAL OF UNKNOWN QUALITY (PCA 30)**

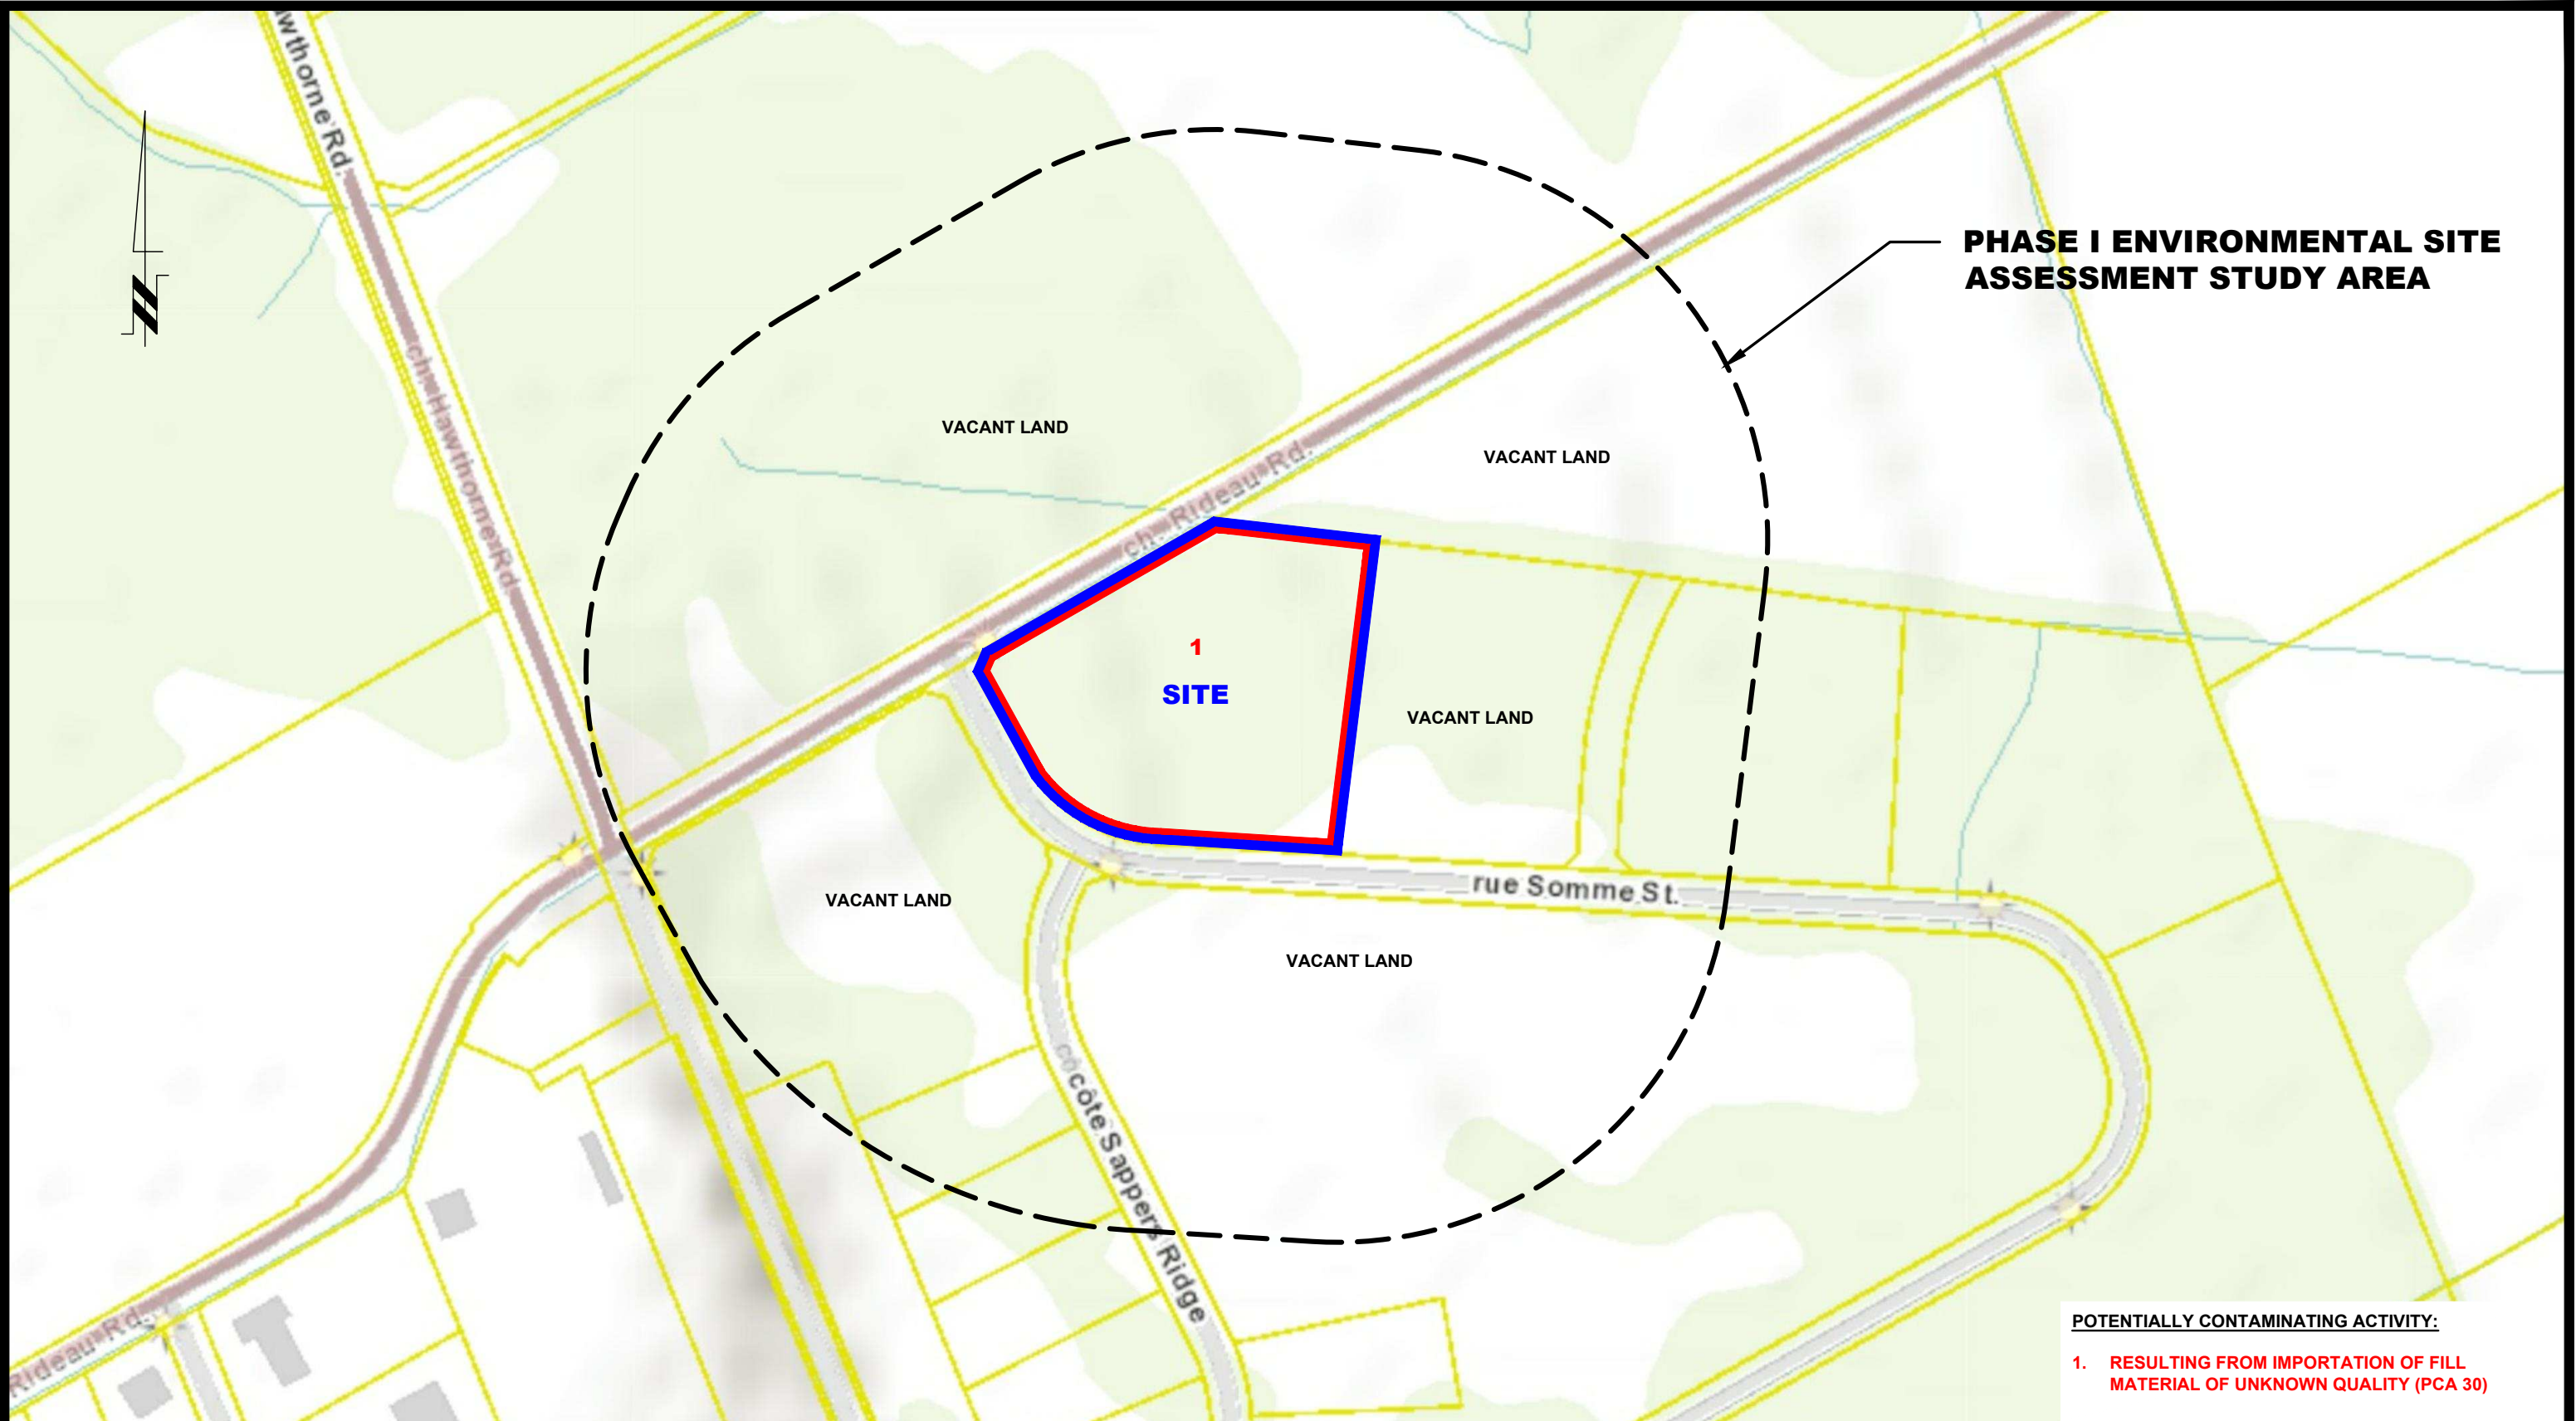
**DRAWING PE5100-2 – SURROUNDING LAND USE PLAN**

**PHASE I ENVIRONMENTAL SITE ASSESSMENT STUDY AREA**

**POTENTIALLY CONTAMINATING ACTIVITY:**  
**1. RESULTING FROM IMPORTATION OF FILL MATERIAL OF UNKNOWN QUALITY (PCA 30)**
