**RE: Retirement Residence Addition  
1541 St Joseph Boulevard, Orleans  
Environmental Impact Statement and Tree Conservation Report – Update**

**EIS/TREE CONSERVATION REPORT  
Existing Vegetation**

EIS/TREE CONSERVATION REPORT  
Proposed Conserved Vegetation

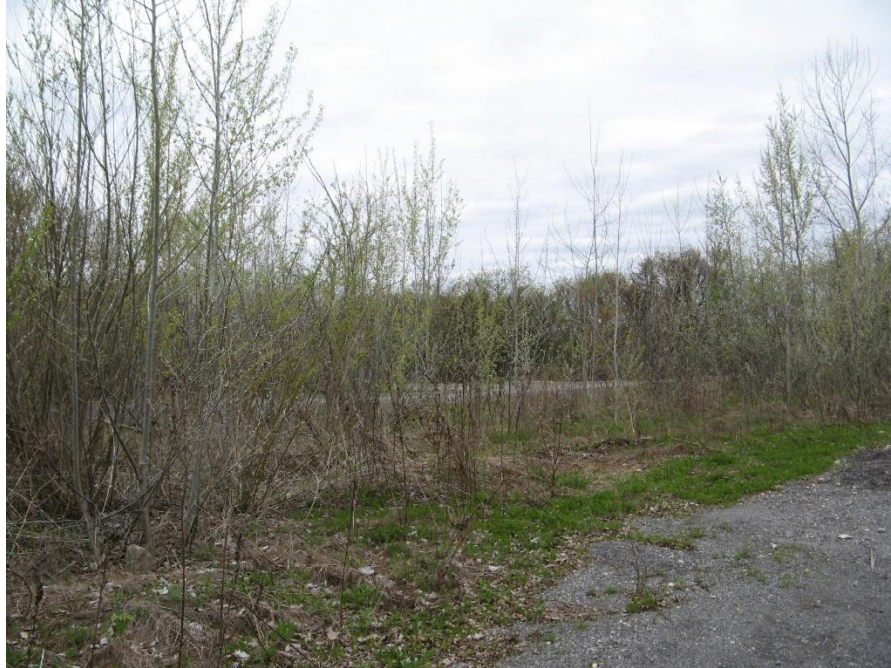
*Photo 1 – West portion of the proposed building area for retirement residence addition.  
View looking north from north of St. Joseph Boulevard*

The proposed development area is highly disturbed as it is the location of a former long-term care facility (Photo 1). Cultural meadow vegetation that has grown on the disturbed ground includes bluegrass, crabgrass, common dandelion, wild grape, horseweed, common strawberry, evening primrose, common milkweed, wild carrot, bull thistle, rough-fruited cinquefoil, common burdock, Canada goldenrod, ox-eye daisy, common mullein, Canada thistle, red clover, and white bedstraw, along with staghorn sumac, common buckthorn, red-osier dogwood, tartarian honeysuckle, red raspberry, and slender willow shrubs and regenerating trembling aspen, Manitoba maple, white elm, and white poplar stems. Where regenerating tree stems greater than 10cm diameter at breast height (dbh) are present and in a higher density, the vegetation community is identified as a cultural woodland (Tree group 'G', Photo 6) on Map 1, with a cultural thicket noted where the shrub cover is greater than 25 percent.

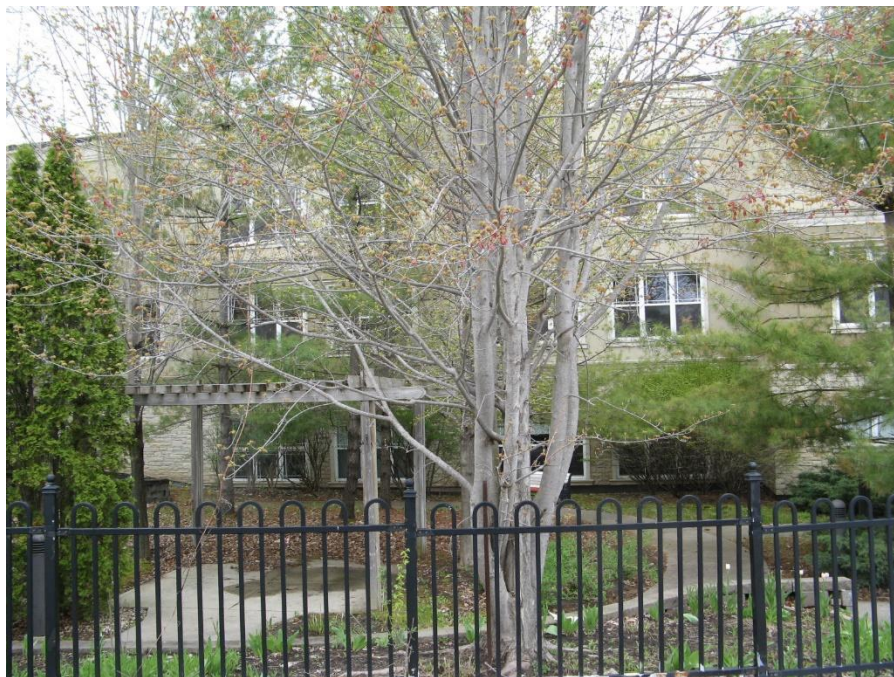
*Photo 2- Planted red maple (Tree Group 'A') is proposed for removal in the east portion of the retirement residence addition. View looking northeast to existing building*

Tree Letter	Species	dbh (cm)	Condition and Comments	Fate
A	Red maple White cedar and pine	18 < 10	Planted trees (Photo 2). Coppice red maple with significant trunk damage but good leaf-out. Smaller planted conifers appear to be in good condition	Maple and conifers to be retained
B	White spruce	18 and 20	Plantings appear to be in good condition (Photo 3)	To be removed
C	Red maple White pine	48 up to 25	Good leaf-out and condition though lack a dominant leader and strong lateral branching (Photo 4). Three planted white pines to the east. Some yellowing on pine needles.	Maple not retained. Pines to be retained where possible

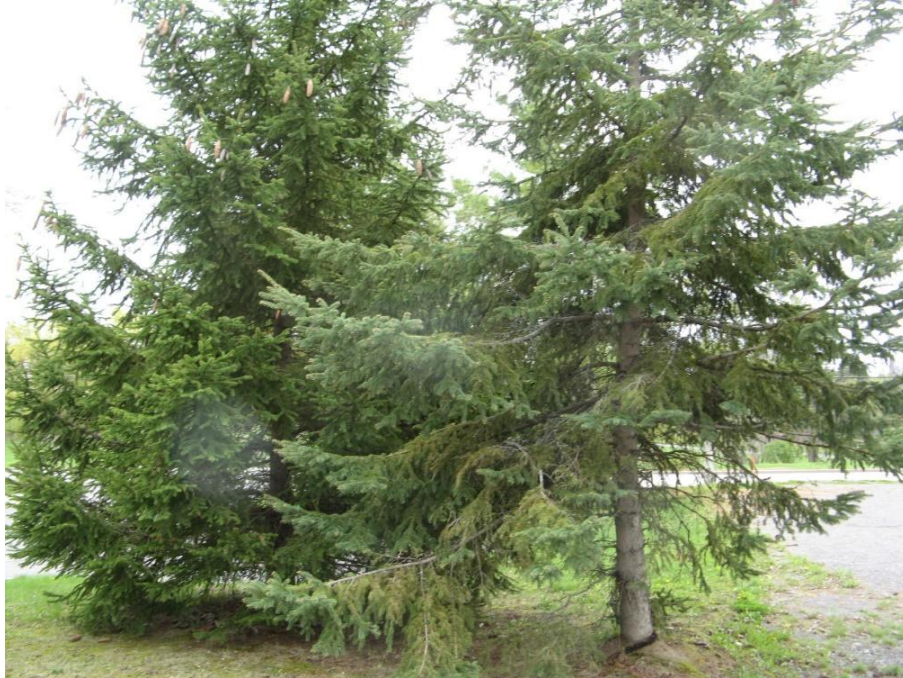
*Photo 3- Planted white spruce (Tree Group 'B') is proposed for removal in the central-east portion of the retirement residence addition. View looking northwest*

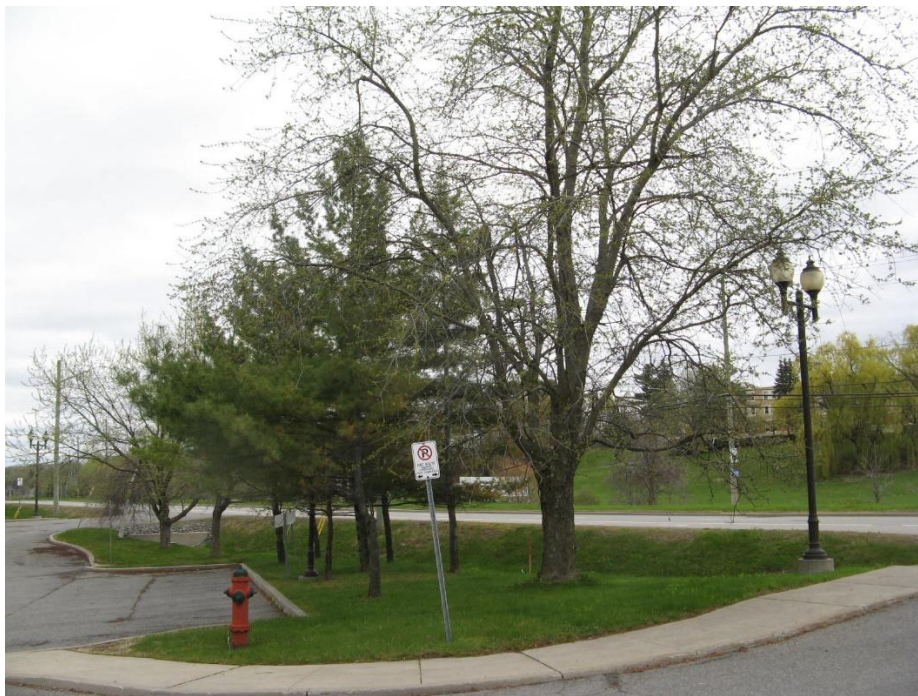
*Photo 4 - Planted red maple (Tree Group 'C') is proposed for removal as the central entrance off St. Joseph Boulevard is modified. The adjacent pines are anticipated to be retained. View looking southeast to St. Joseph Boulevard*

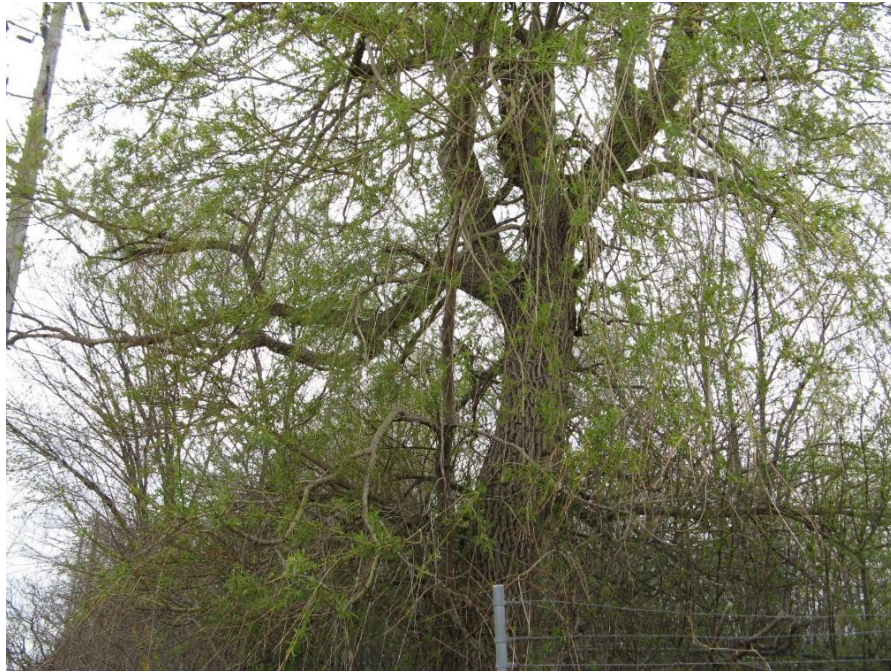
*Photo 5 – Weeping willow (Tree ‘F’) in the southwest corner of the redevelopment area, north of St. Joseph Boulevard, is proposed for removal for new west entrance off St. Joseph Boulevard*

Tree Letter	Species	dbh (cm)	Condition and Comments	Fate
D	White pine	25, 26, and 28	Planted white pines are in generally good condition	To be removed
E	Trembling aspen	up to 18	Regenerating stems, most with trunk leaning	To be removed
F	Weeping willow	72	One of the main trunks historically cut. Lack strong leader, some dead limbs, and extensive suckering, but good leaf-out (Photo 5)	To be removed
G	Trembling aspen Manitoba maple White poplar	up to 32 up to 15 up to 12	Regenerating cultural woodland (Photo 6). Many of the poplars have angled stems. Tartarian honeysuckle and staghorn sumac shrubs also present. Trembling aspen up to 20cm in the northwest portion can be retained	To be removed
H	Norway maple	65	Historically pruned. Significant bark and trunk damage and many larger branches appear dead, with no budding in the upper half of the tree (Photo 7). Other branches have reduced leaf-out	Recommended for removal and replaced with new plantings

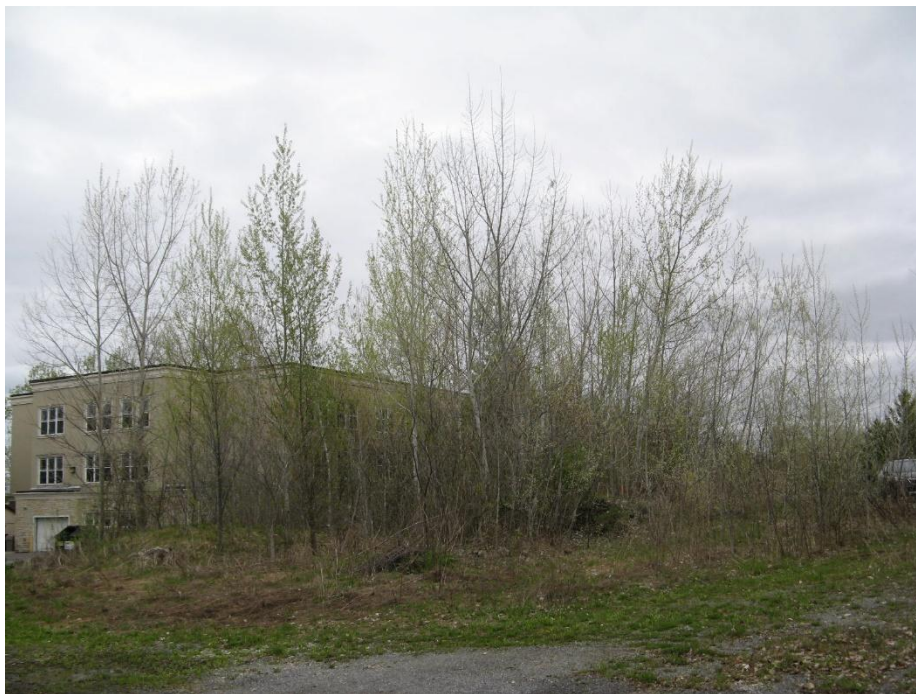
*Photo 6 - Regenerating cultural woodland dominated by poplar (Tree Group ‘G’) mostly to be removed in the northeast portion of the redevelopment*

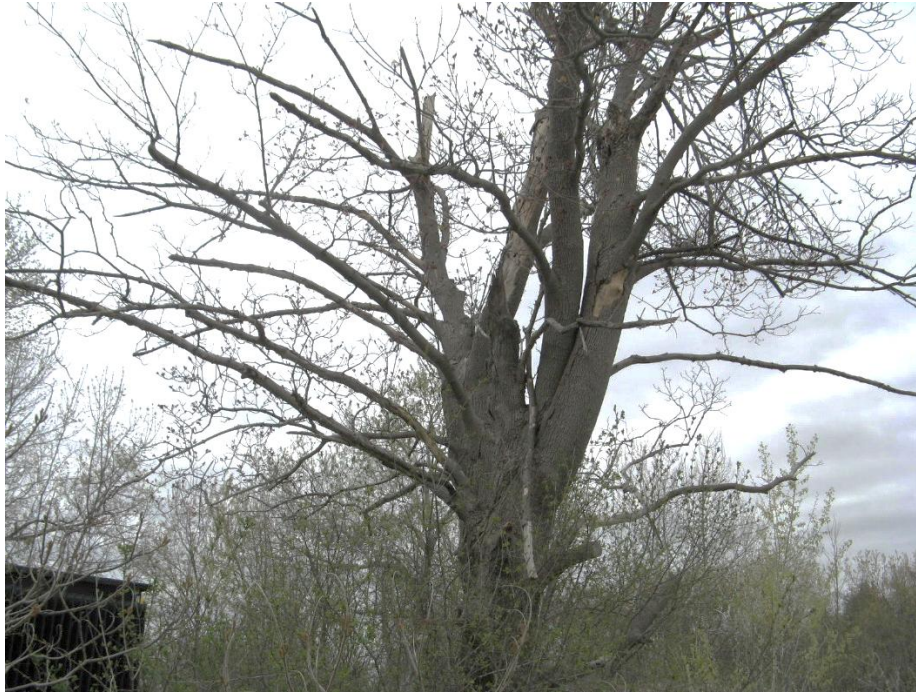
*Photo 7 - Norway maple (Tree 'H') in poor condition in the north portion of the redevelopment area is recommended for removal. View looking northwest*

A 28cm dbh white cedar identified in the central portion of the proposed development area in 2013 has been removed when the north portion of the surface parking was constructed in 2018. A 60cm dbh Norway maple (Tree 'H', Photo 7) identified for retention in 2013 is in poor condition and is not recommended for retention as it will be immediately adjacent to surface parking. There was no budding in the upper portion of the Norway maple in 2025 and many branches were broken. Several maple and coniferous plantings in the east portion of the redevelopment area are proposed for removal (Photos 2 – 4).

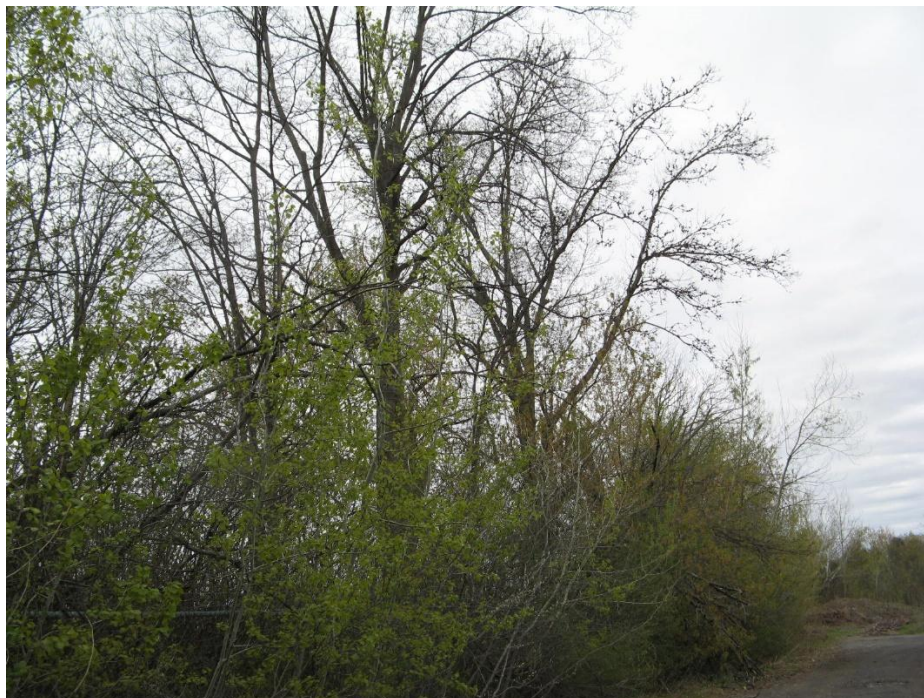
*Photo 8 – Deciduous hedgerow to west (left) of property line will be retained. View looking northwest from north of St. Joseph Boulevard*

An existing chain-link fence is along or adjacent to the south, east, and north portions of the proposed development area. A deciduous hedgerow of eleven trees is adjacent to the west property line and existing chain-link fencing (Photo 8). The tree trunks in the hedgerow are immediately adjacent to the west property line. Many of the trees are in the range of 35-45cm dbh, with the largest trees up to 65cm dbh and include basswood, red maple, trembling aspen, black cherry, white ash, and Manitoba maple. Many of the trees are in poor condition with truncated trunks, broken major limbs, and fungal growth. Except for the south tree, these trees will need to be removed due to the grading and retaining wall required along the west property line. A 72cm dbh weeping willow is in the southwest corner of the proposed development area, immediately north of the property line (Tree 'F', Photo 5). Some of the limbs on the willow appear dead and there is extensive suckering. A major lateral branch towards the south has been removed. The willow tree is proposed for removal in conjunction with construction of the new west entrance.

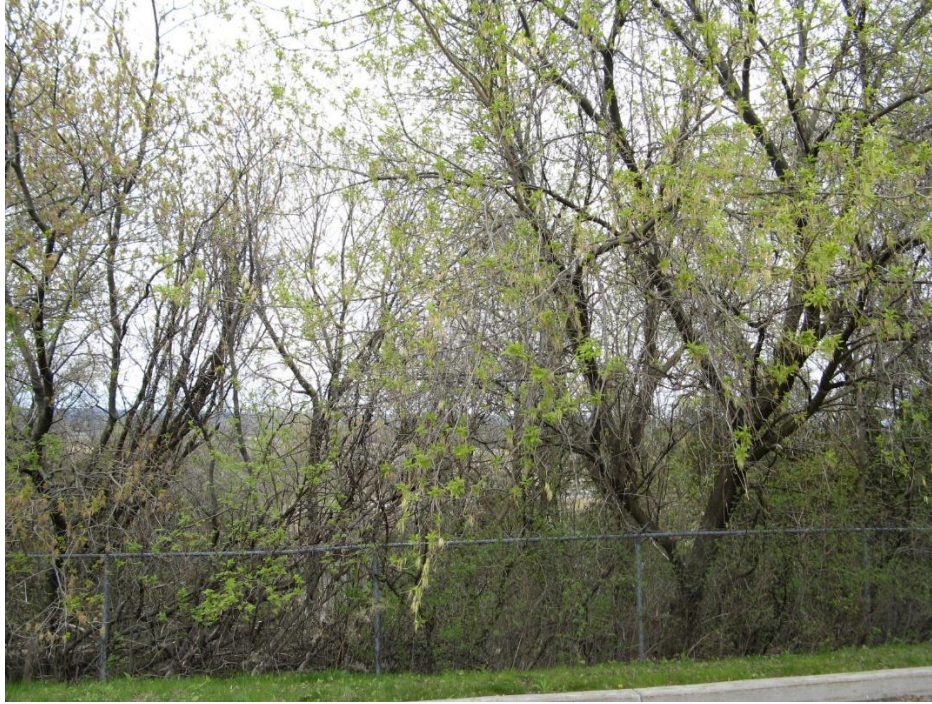
*Photo 9 – Woody vegetation to north of the redevelopment area to be retained within the south portion of the adjacent deciduous forest. View looking north.*

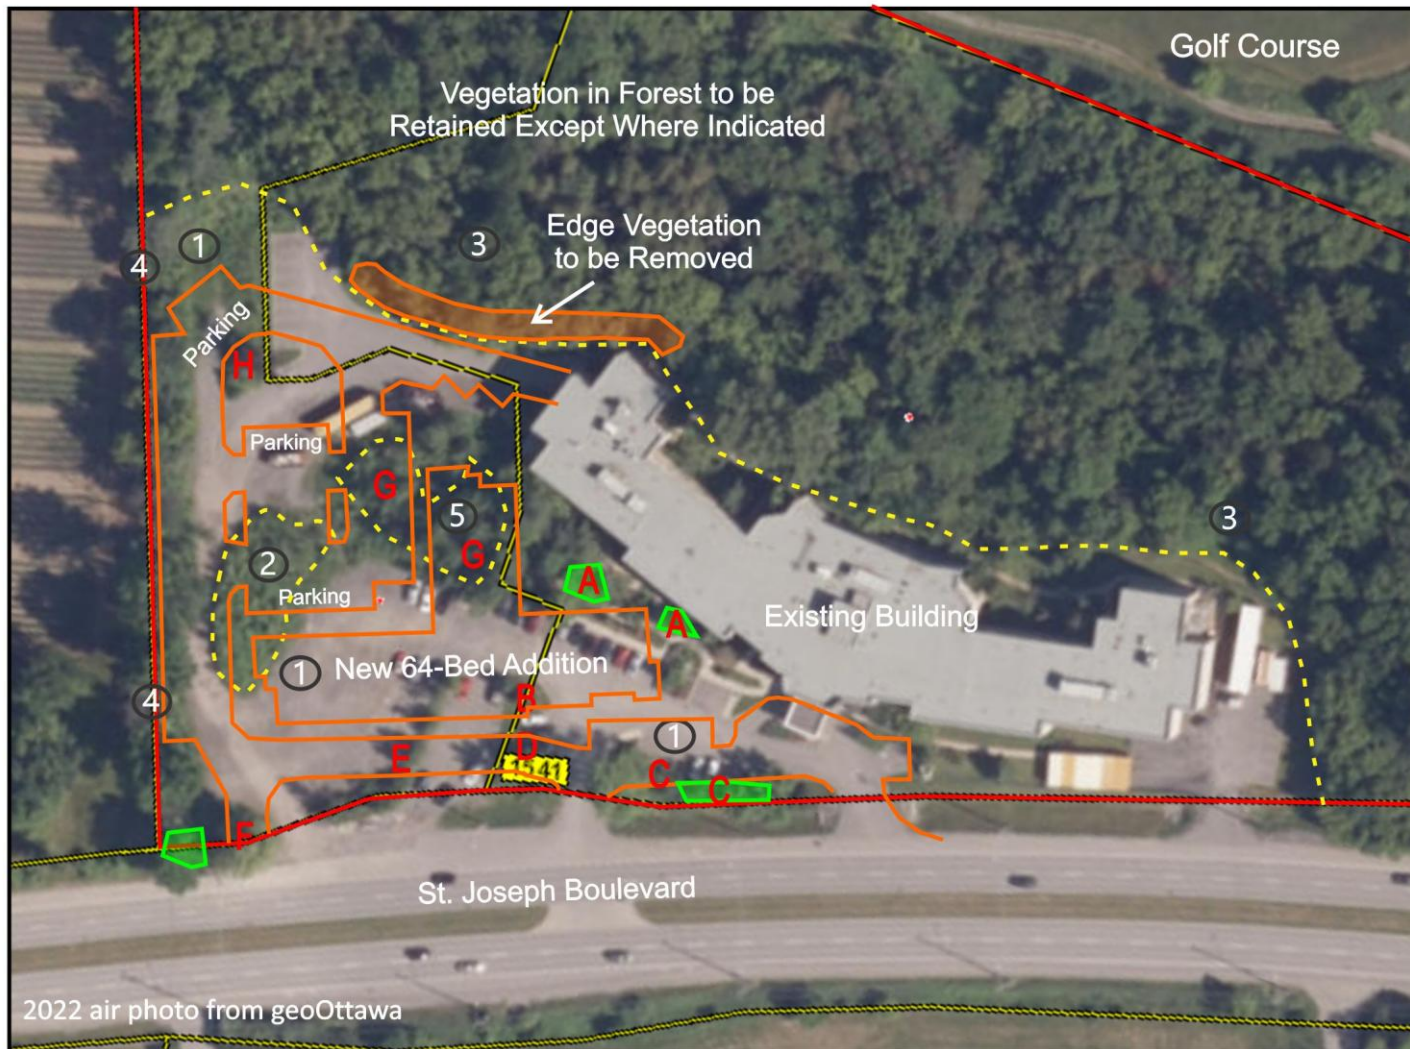
## Map 2

The trees proposed for removal are shown on Map 2, with the trees described in Table 1 below. There are no tree trunks in the St. Joseph Boulevard allowance adjacent to the proposed development and co-owned trees do not appear to be present.

The closest point of the development to the top-of-slope and forest edge to the north is the delivery access and north portion of the surface parking, a pathway extension, and associated retaining wall. This installation of the pathway extension and retaining wall will require removal of an approximately five metre width of the south forest edge, which is dominated by Manitoba maple, as shown with orange shading on Map 2.

1. Sturdy protective fencing, at least 1.3 metres in height, is recommended around the tree retention areas shown on Map 2. Note that if the existing chain link fence is left in place along the west property line and the top-of-slope along the south boundary of the deciduous forest to the north this will provide suitable protection for the adjacent woody vegetation. It is important that the fencing be properly installed and maintained. Signs, notices or posters are not to be attached to any tree. No grading, heavy machinery traffic, stockpiling of material, machinery maintenance and refueling, or other activities that may cause soil compaction is to occur on the development side of the protective fencing. The root system, trunk, and branches of the trees to be retained are to be protected and not damaged unless necessary. Any roots that must be cut are to be cut cleanly to facilitate healing and as far from the tree as possible. Exhaust fumes from all equipment during construction will not be directed towards the canopy of the retained trees.
