Phase One Environmental Site Assessment

1533 and 1541 St. Joseph Blvd, Orleans, Ontario

Sienna Senior Living

20 February 2026

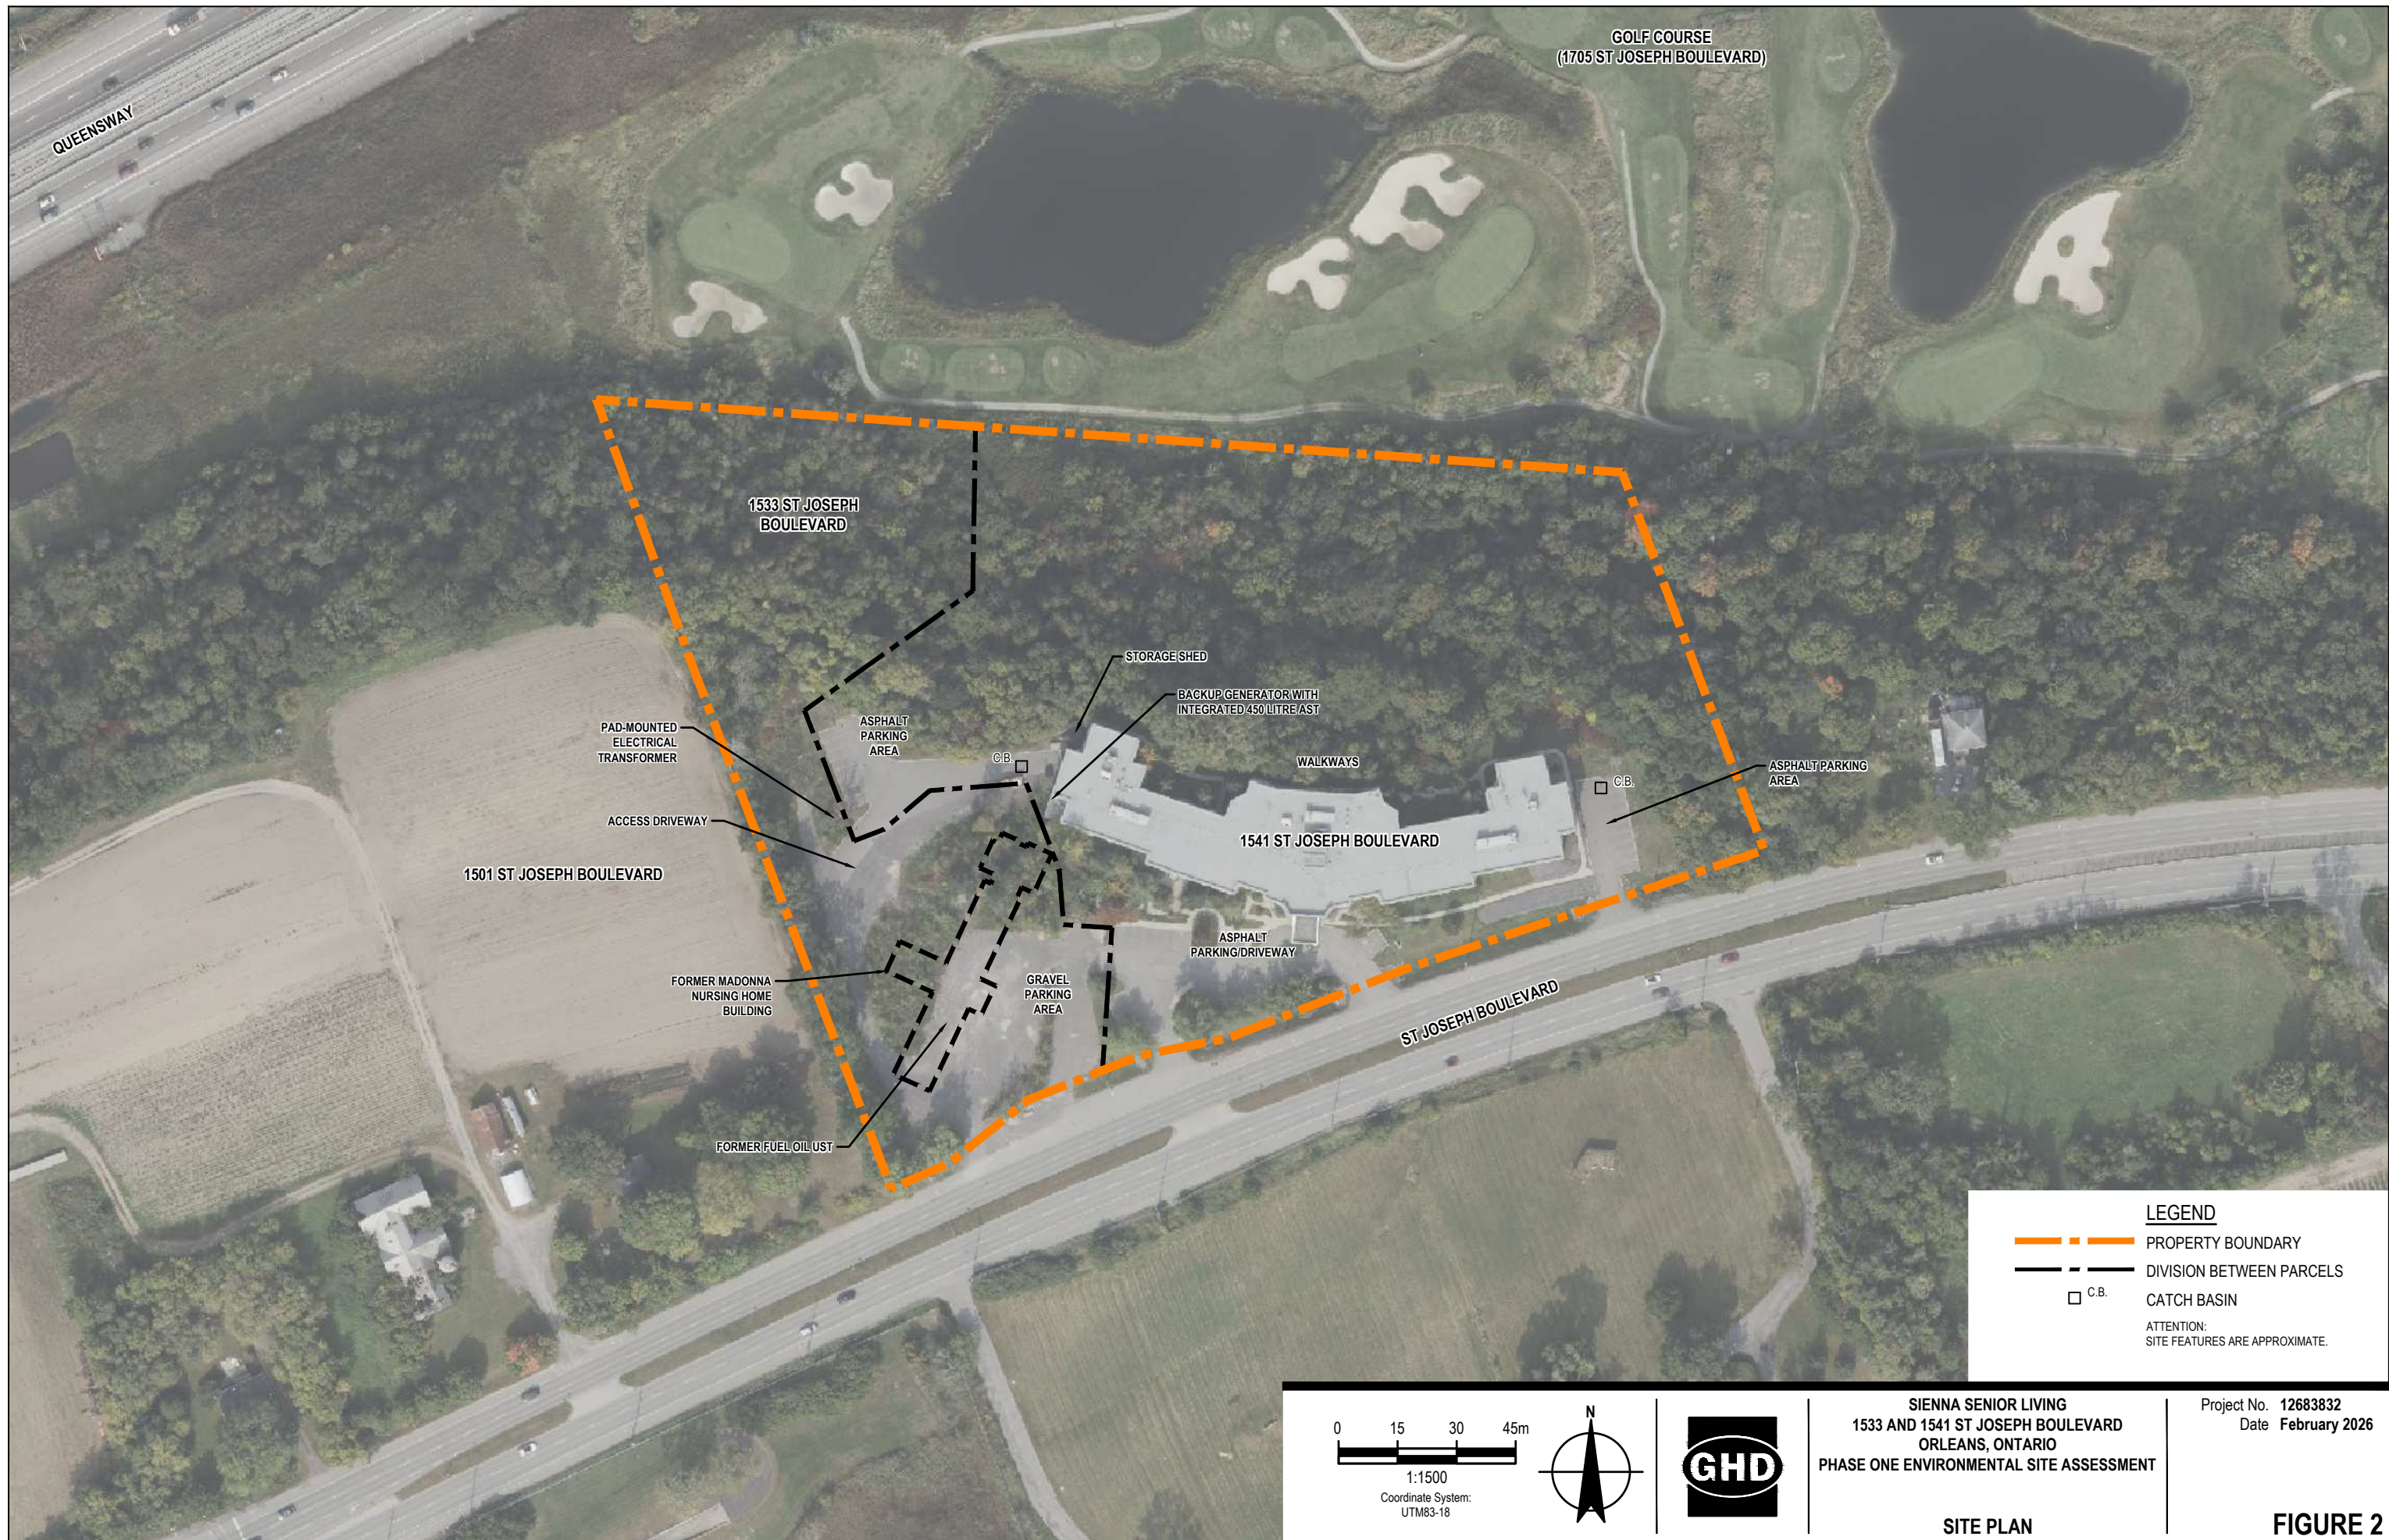
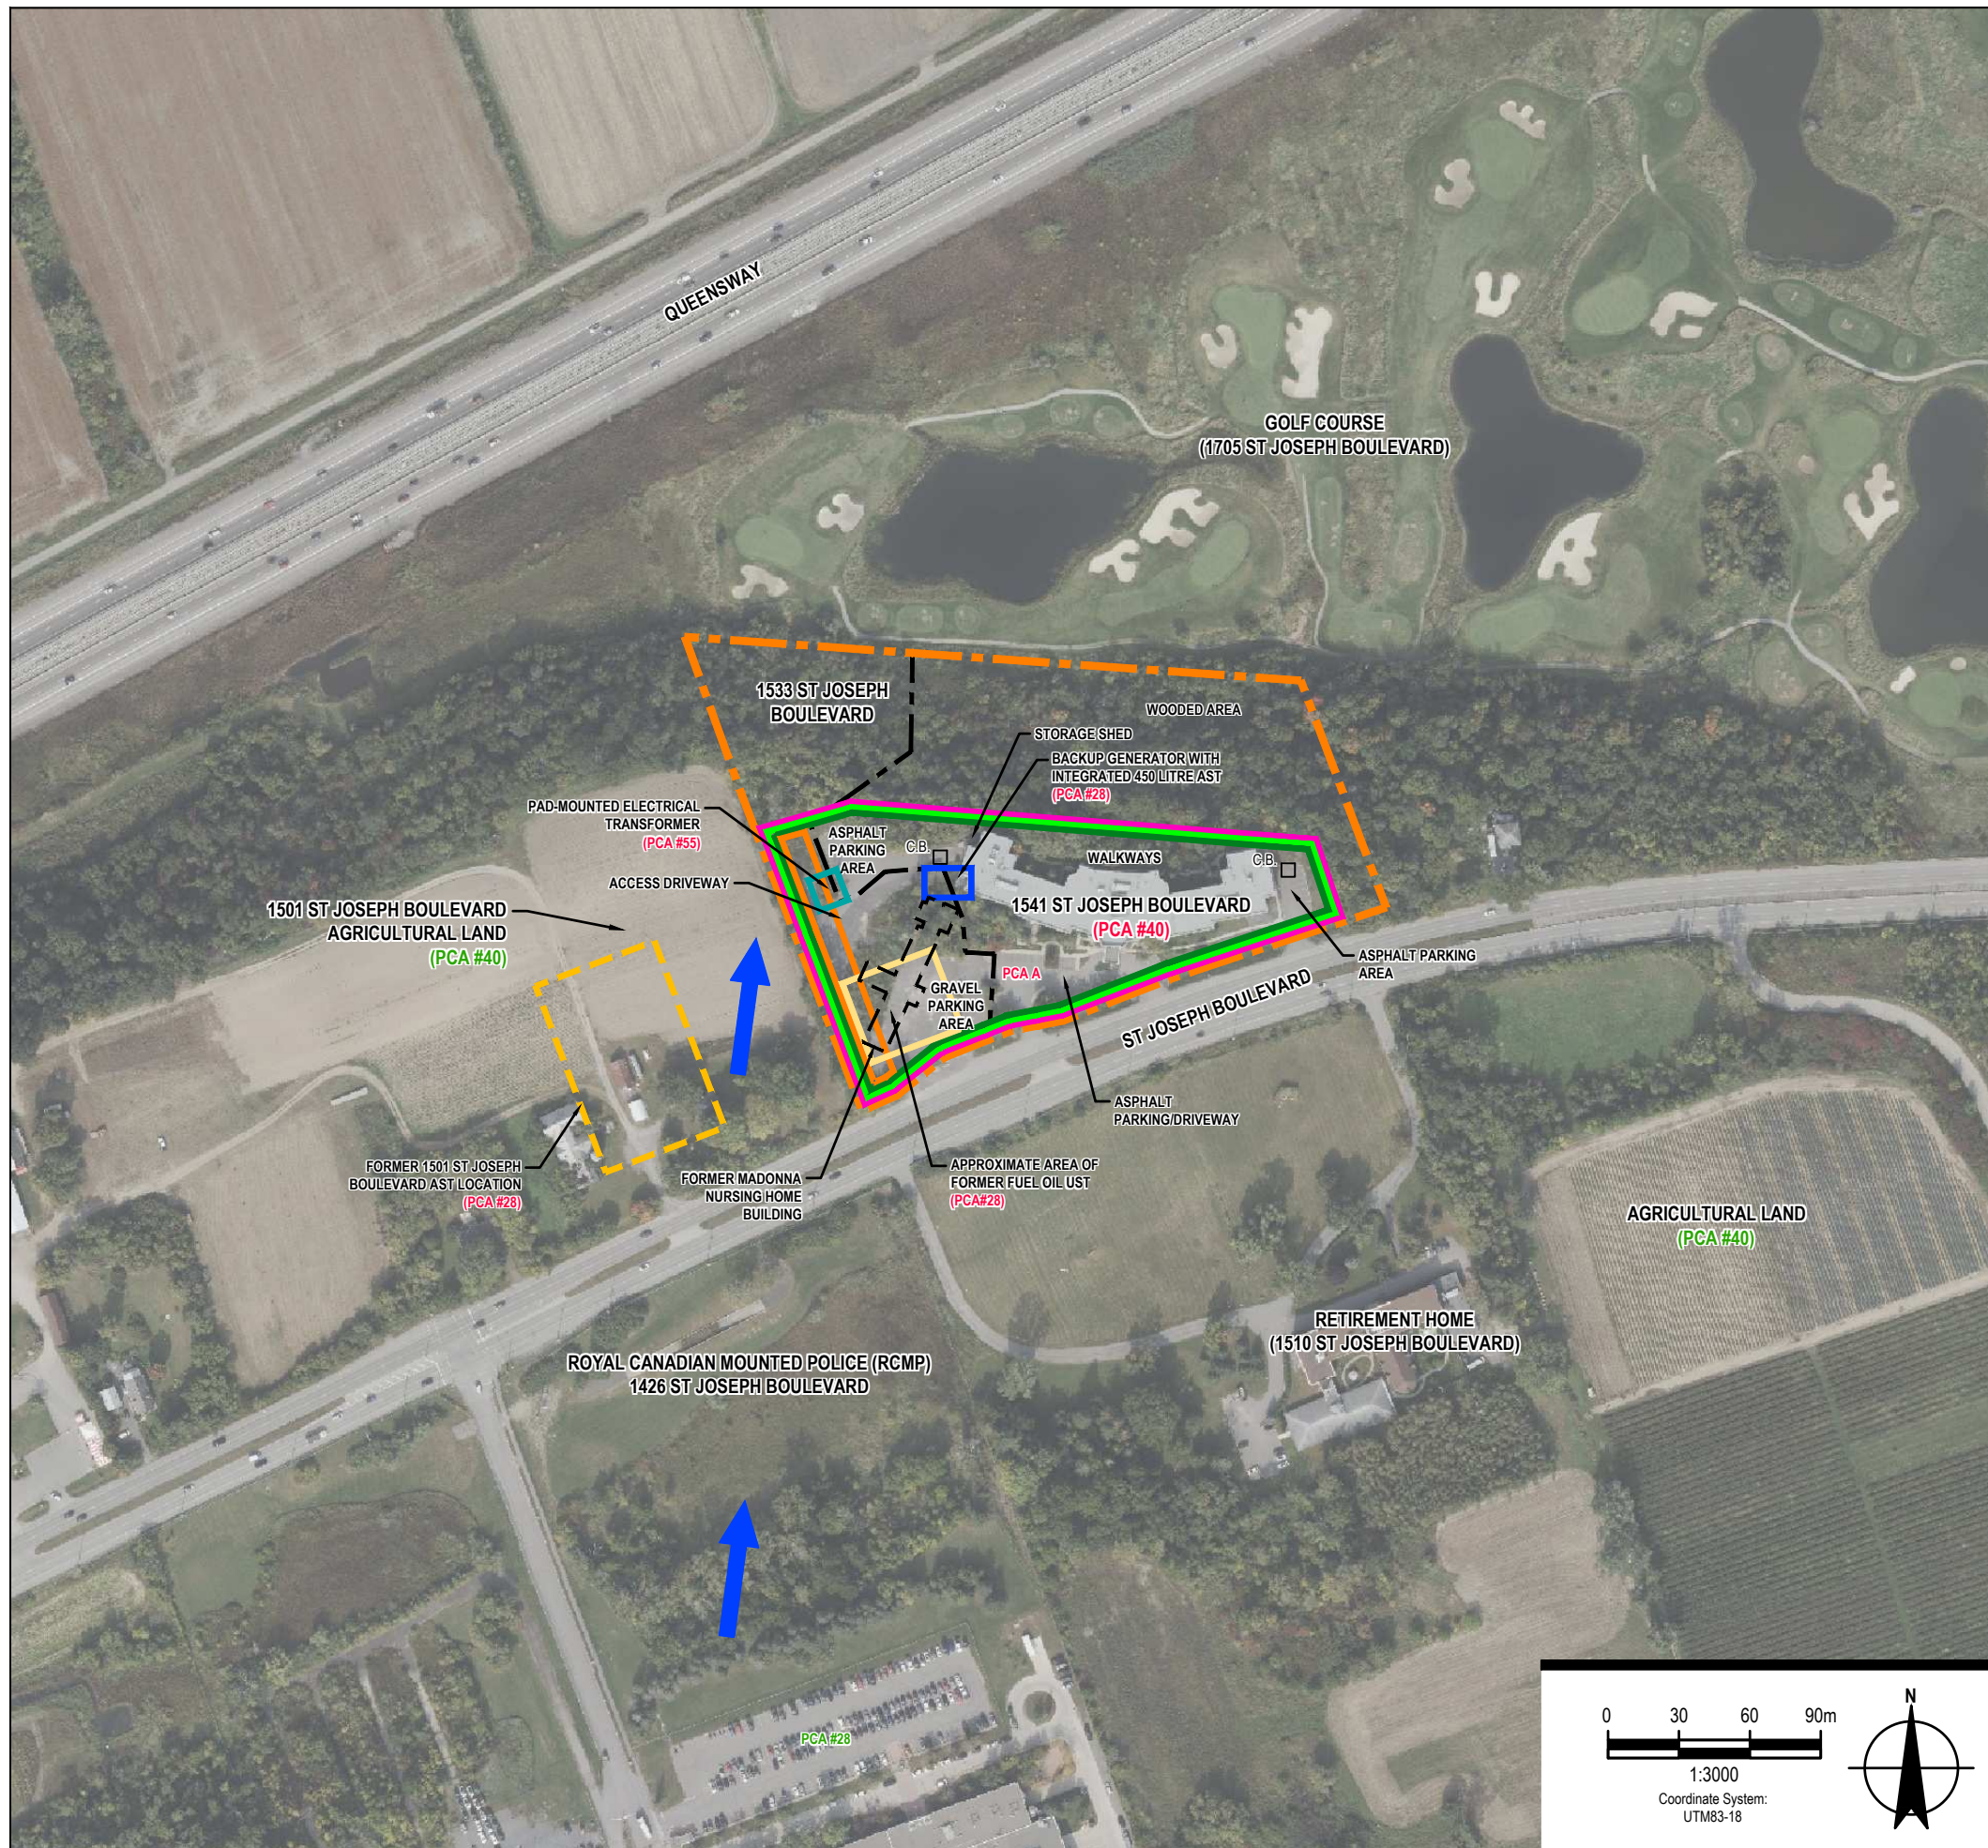
Several off-Site PCAs were identified to be associated with properties located within the Phase One ESA study area (as noted on **Figure 4**) that were not interpreted to have the potential to contribute to an APEC at the Site. A summary of the off-Site PCAs is provided below:

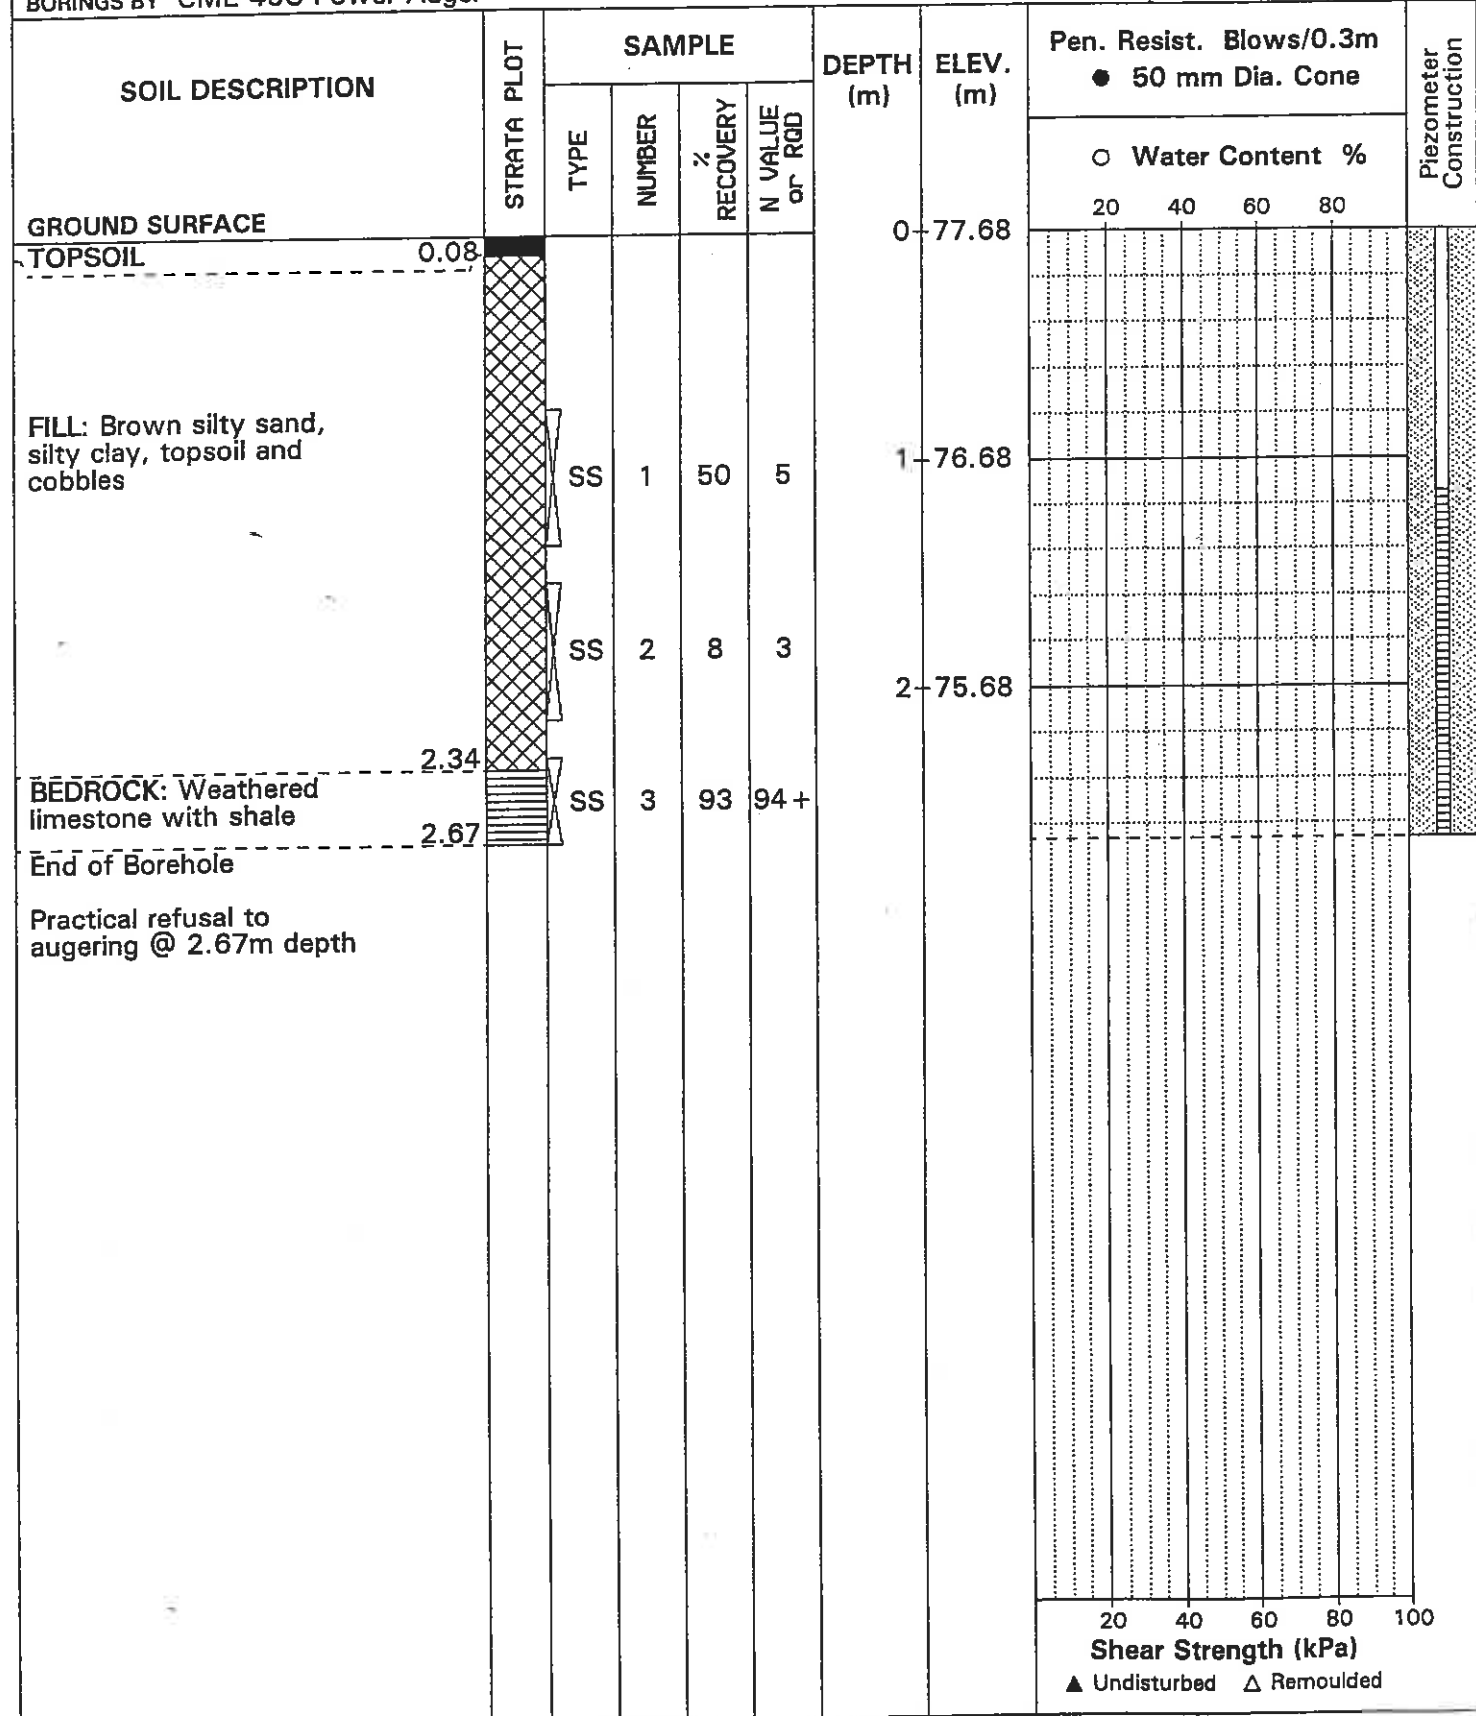
SOIL PROFILE & TEST DATA

Geotechnical Investigation
Proposed Addition, 1533 St. Joseph Boulevard
Ottawa, Ontario

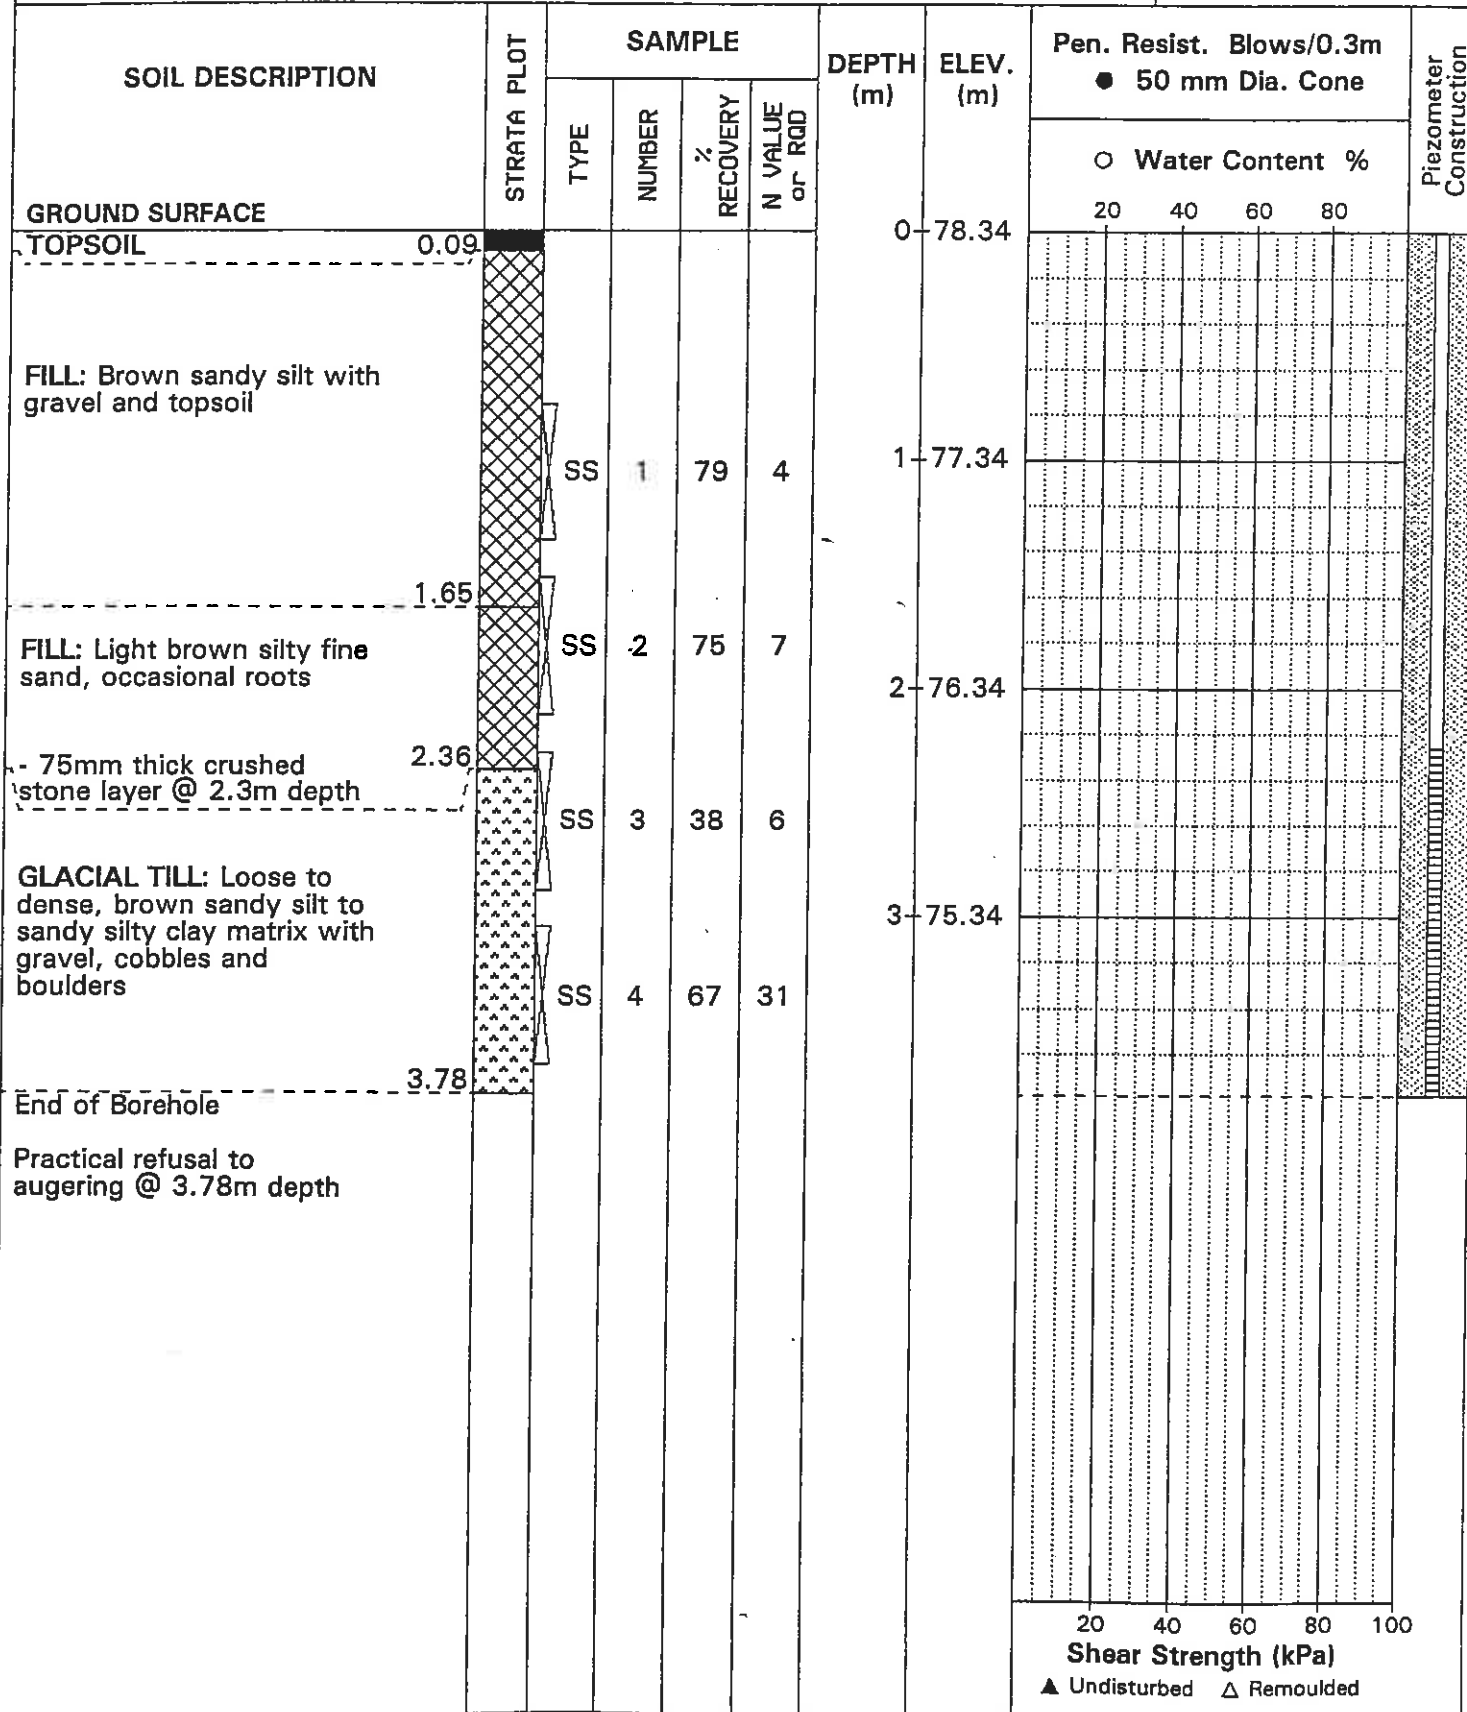
SOIL PROFILE & TEST DATA

Geotechnical Investigation
Proposed Addition, 1533 St. Joseph Boulevard
Ottawa, Ontario

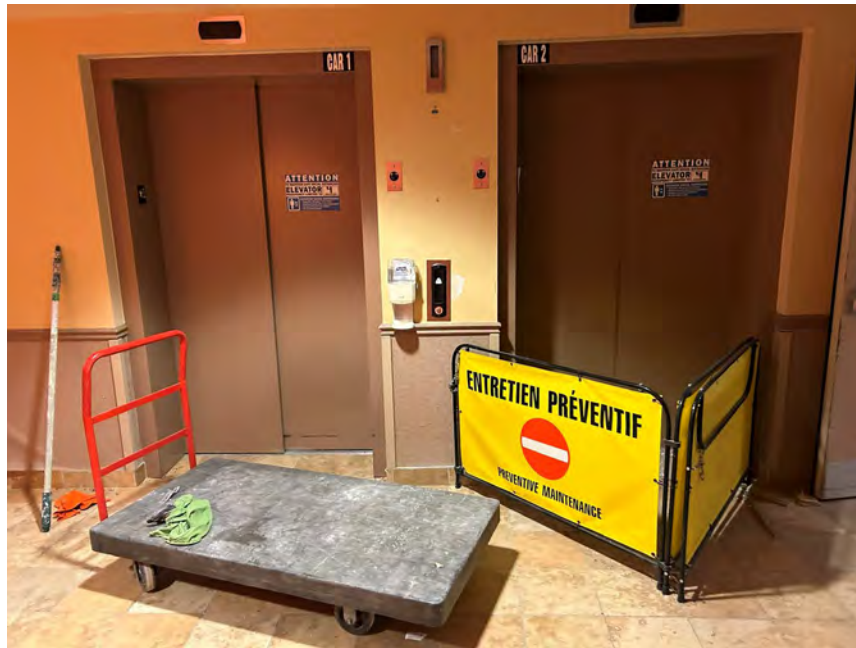
Photo 3 Photo showing two of the three hydraulic elevators in the Site building.

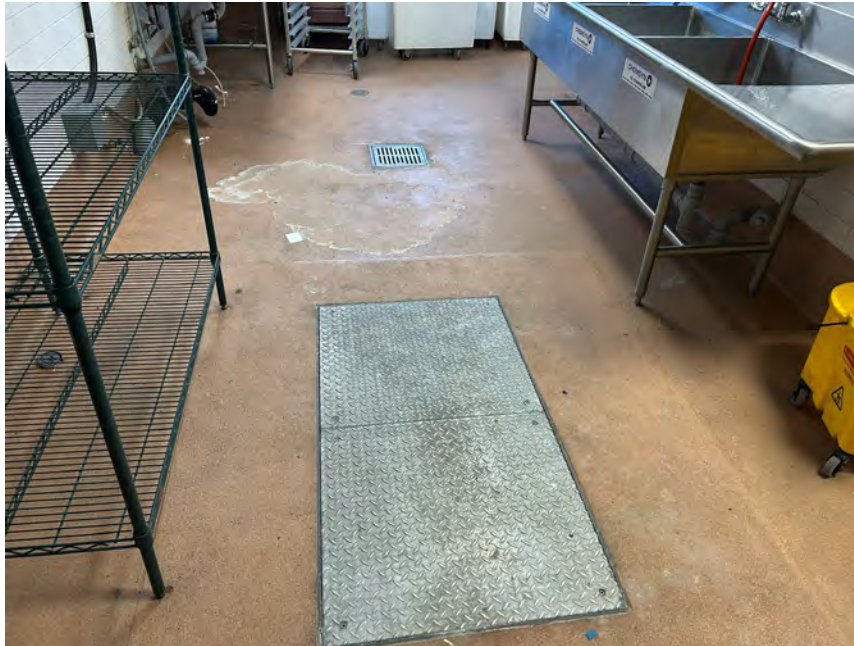
Photo 9 Photo showing the grease trap located in the kitchen of the Site building.

The Site representatives indicated that all water from the commercial kitchen within the site building at 1541 Property parcel passed through a grease trap and the trap was cleaned out quarterly. Based on discussions with the Site representatives and GHD observations, wastewater generated at the Site was limited to domestic wastewater from facility sinks and washrooms within the 1541 Property parcel. According to the Site representatives, domestic wastewater is discharged to the municipal sanitary sewer. No evidence of wastewater generation was observed on the 1533 Property parcel.

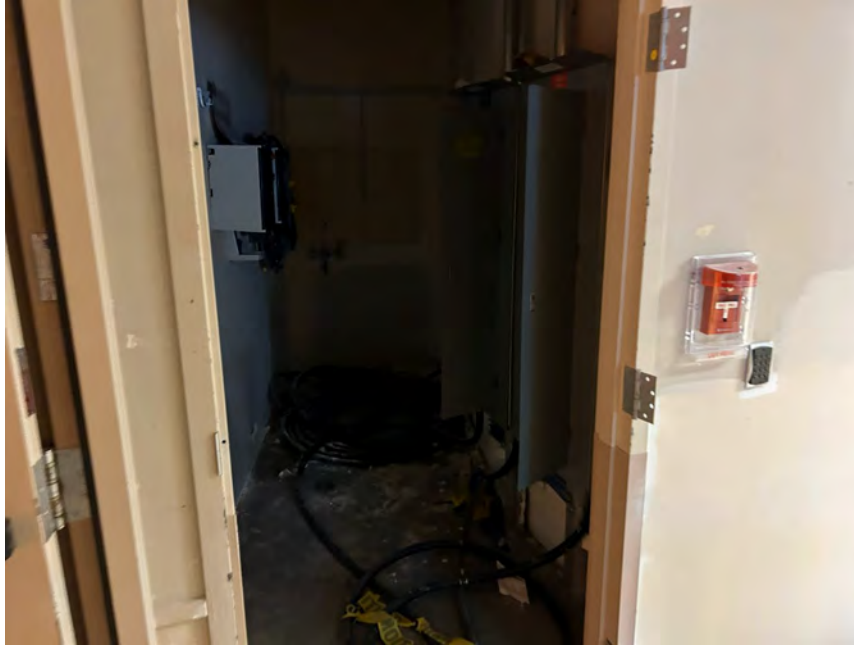
Photo 11 View of the elevator mechanical room and sump on the first level of the Site building, lighting was non-operational.

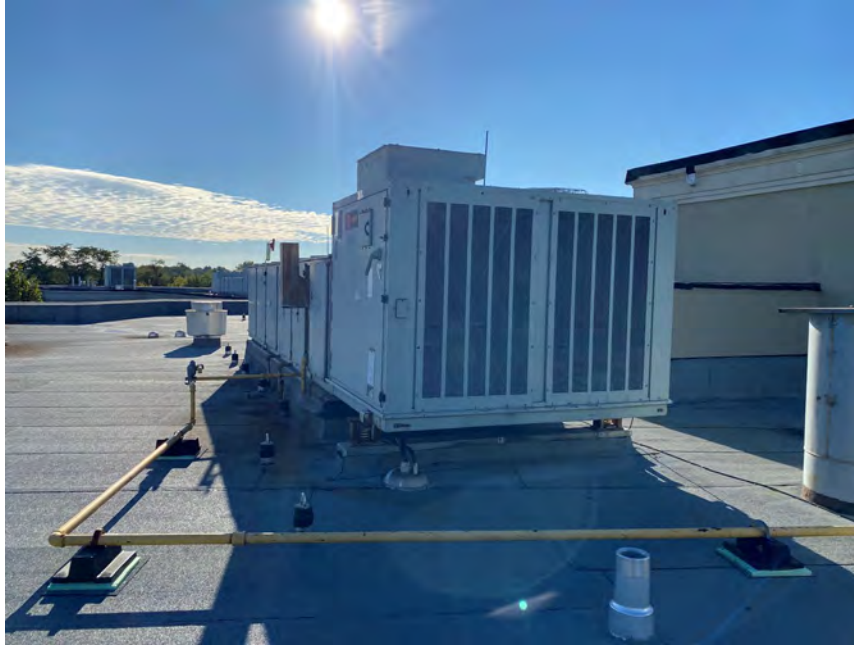
Photo 13 View of a natural gas-fired roof-mounted HVAC unit in the Site building (2024).

Based on GHD observations, air emission sources currently operated at the Site are limited to natural gas-fired comfort heating equipment, and minor emissions from the backup generator. At the time of the Site reconnaissance, no visual evidence of impact to the Site from the above-noted air emission sources was observed by GHD. No evidence of odours or particulate accumulation associated with any potential historical air emission sources was observed by GHD.

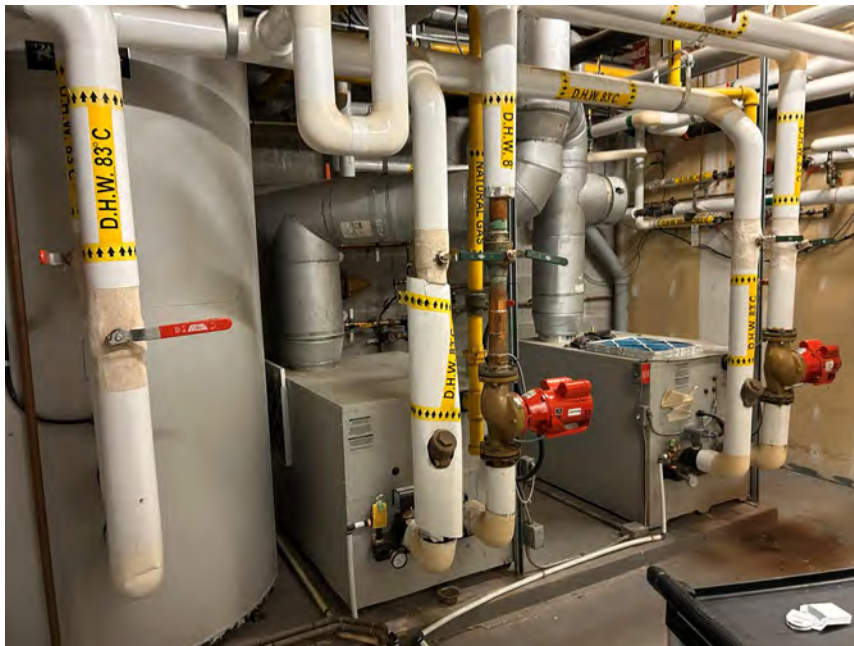
Photo 14 View of the natural gas-fired hot water heaters in the mechanical room on the first level of the Site building.

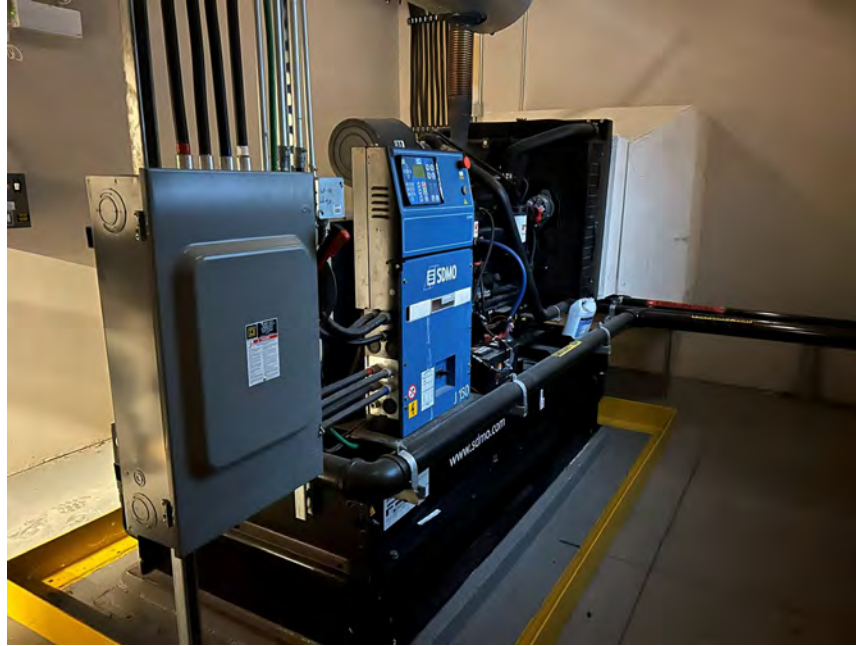
Photo 15 View of diesel-powered back-up generator with integrated 450-litre diesel AST in the generator room in the western portion of the Site building.

Based on discussions with the Site representatives and the Site reconnaissance, a diesel-powered backup generator is located in the generator room in the western portion of the site building (first level) located on the 1541 Property parcel. Diesel for the backup generator is stored in the lower portion of the generator in an integrated 450-L steel-walled AST. The generator with integrated AST was installed in 2007 on a concrete pad. Steel kick plates (secondary containment) were observed around the backup generator at the time of the Site visit. No evidence of any spills, releases, or staining was observed in the vicinity of the generator and AST at the time of the Site reconnaissance. The concrete floors appeared to be in good condition.

The Site representatives were not aware of any spills having occurred at the Site. No staining was observed on the concrete floors throughout the building of the 1541 Property parcel or beneath the backup generator. The concrete floors appeared to be in good condition; however, horizontal and vertical joints were noted in the concrete floor of the Generator Room as well as other Mechanical Rooms with exposed concrete flooring which could potentially be a pathway for contaminant migration if a spill occurred. No visual evidence of chemical spills or releases on the exterior surfaces of the Site were observed by GHD at the time of the Site reconnaissance. No evidence of any spills/releases was identified with respect to the 1533 Property parcel.

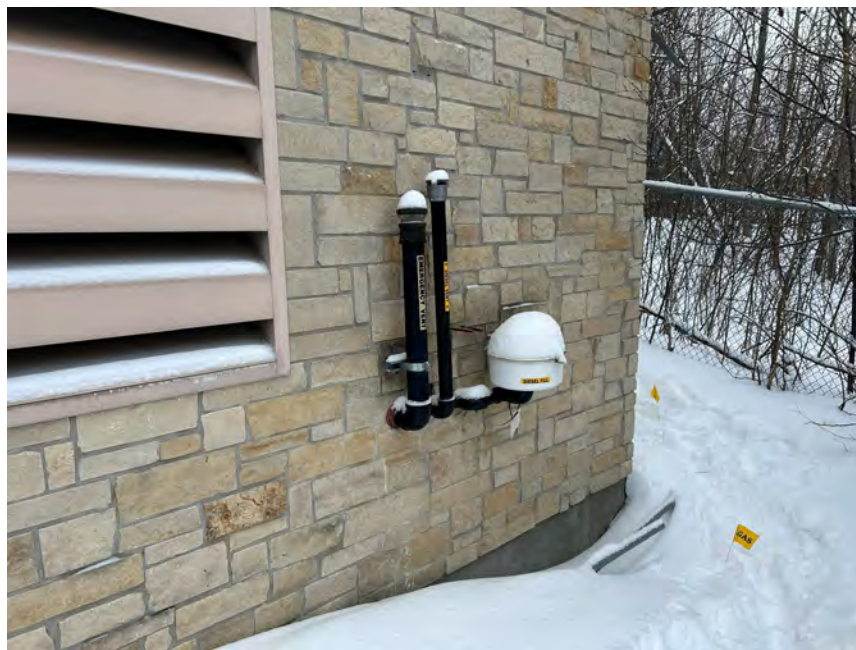
Photo 16 View of the exterior fill pipes for the diesel back-up generator AST, facing southeast.

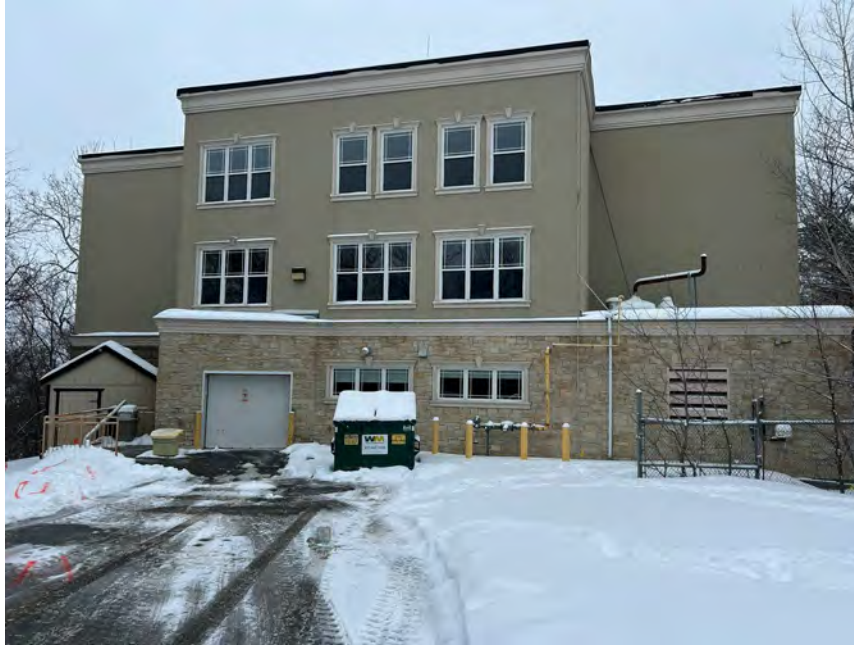
Photo 17 View of the western portion of the Site building, the waste storage area, and the storage shed, facing east.

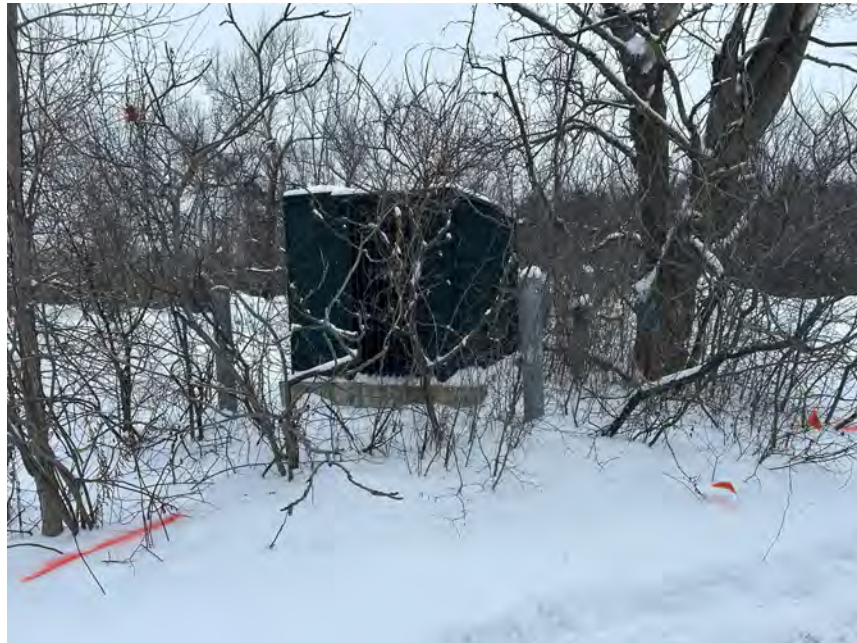
Photo 18 View of the pad-mounted transformer at 1533 Property parcel, facing northwest.

The Site representatives reported that no PCB-containing equipment is currently being used, stored, or handled at the Site. GHD observed one pad-mounted electrical transformer located on the 1533 Property parcel. No evidence of spills or releases was identified to be associated with the transformer, and no staining was observed by GHD on the exterior surfaces surrounding the transformer at the time of the Site reconnaissance. The presence of a transformer on the 1533 Property parcel is a PCA (#55 - Transformer Manufacturing, Processing and Use) in accordance with O. Reg. 153/04. As such, the area surrounding the pad mount transformer on the 1533 Property parcel was identified as **APEC #5**.
