**Hydrogeology Assessment
Metcalf Agricultural Society
2821 8th Line Road, Metcalfe, Ontario**

Final Report
Version 2

Prepared for:
Metcalf Agricultural Society

Prepared by:
Stantec Consulting Ltd.

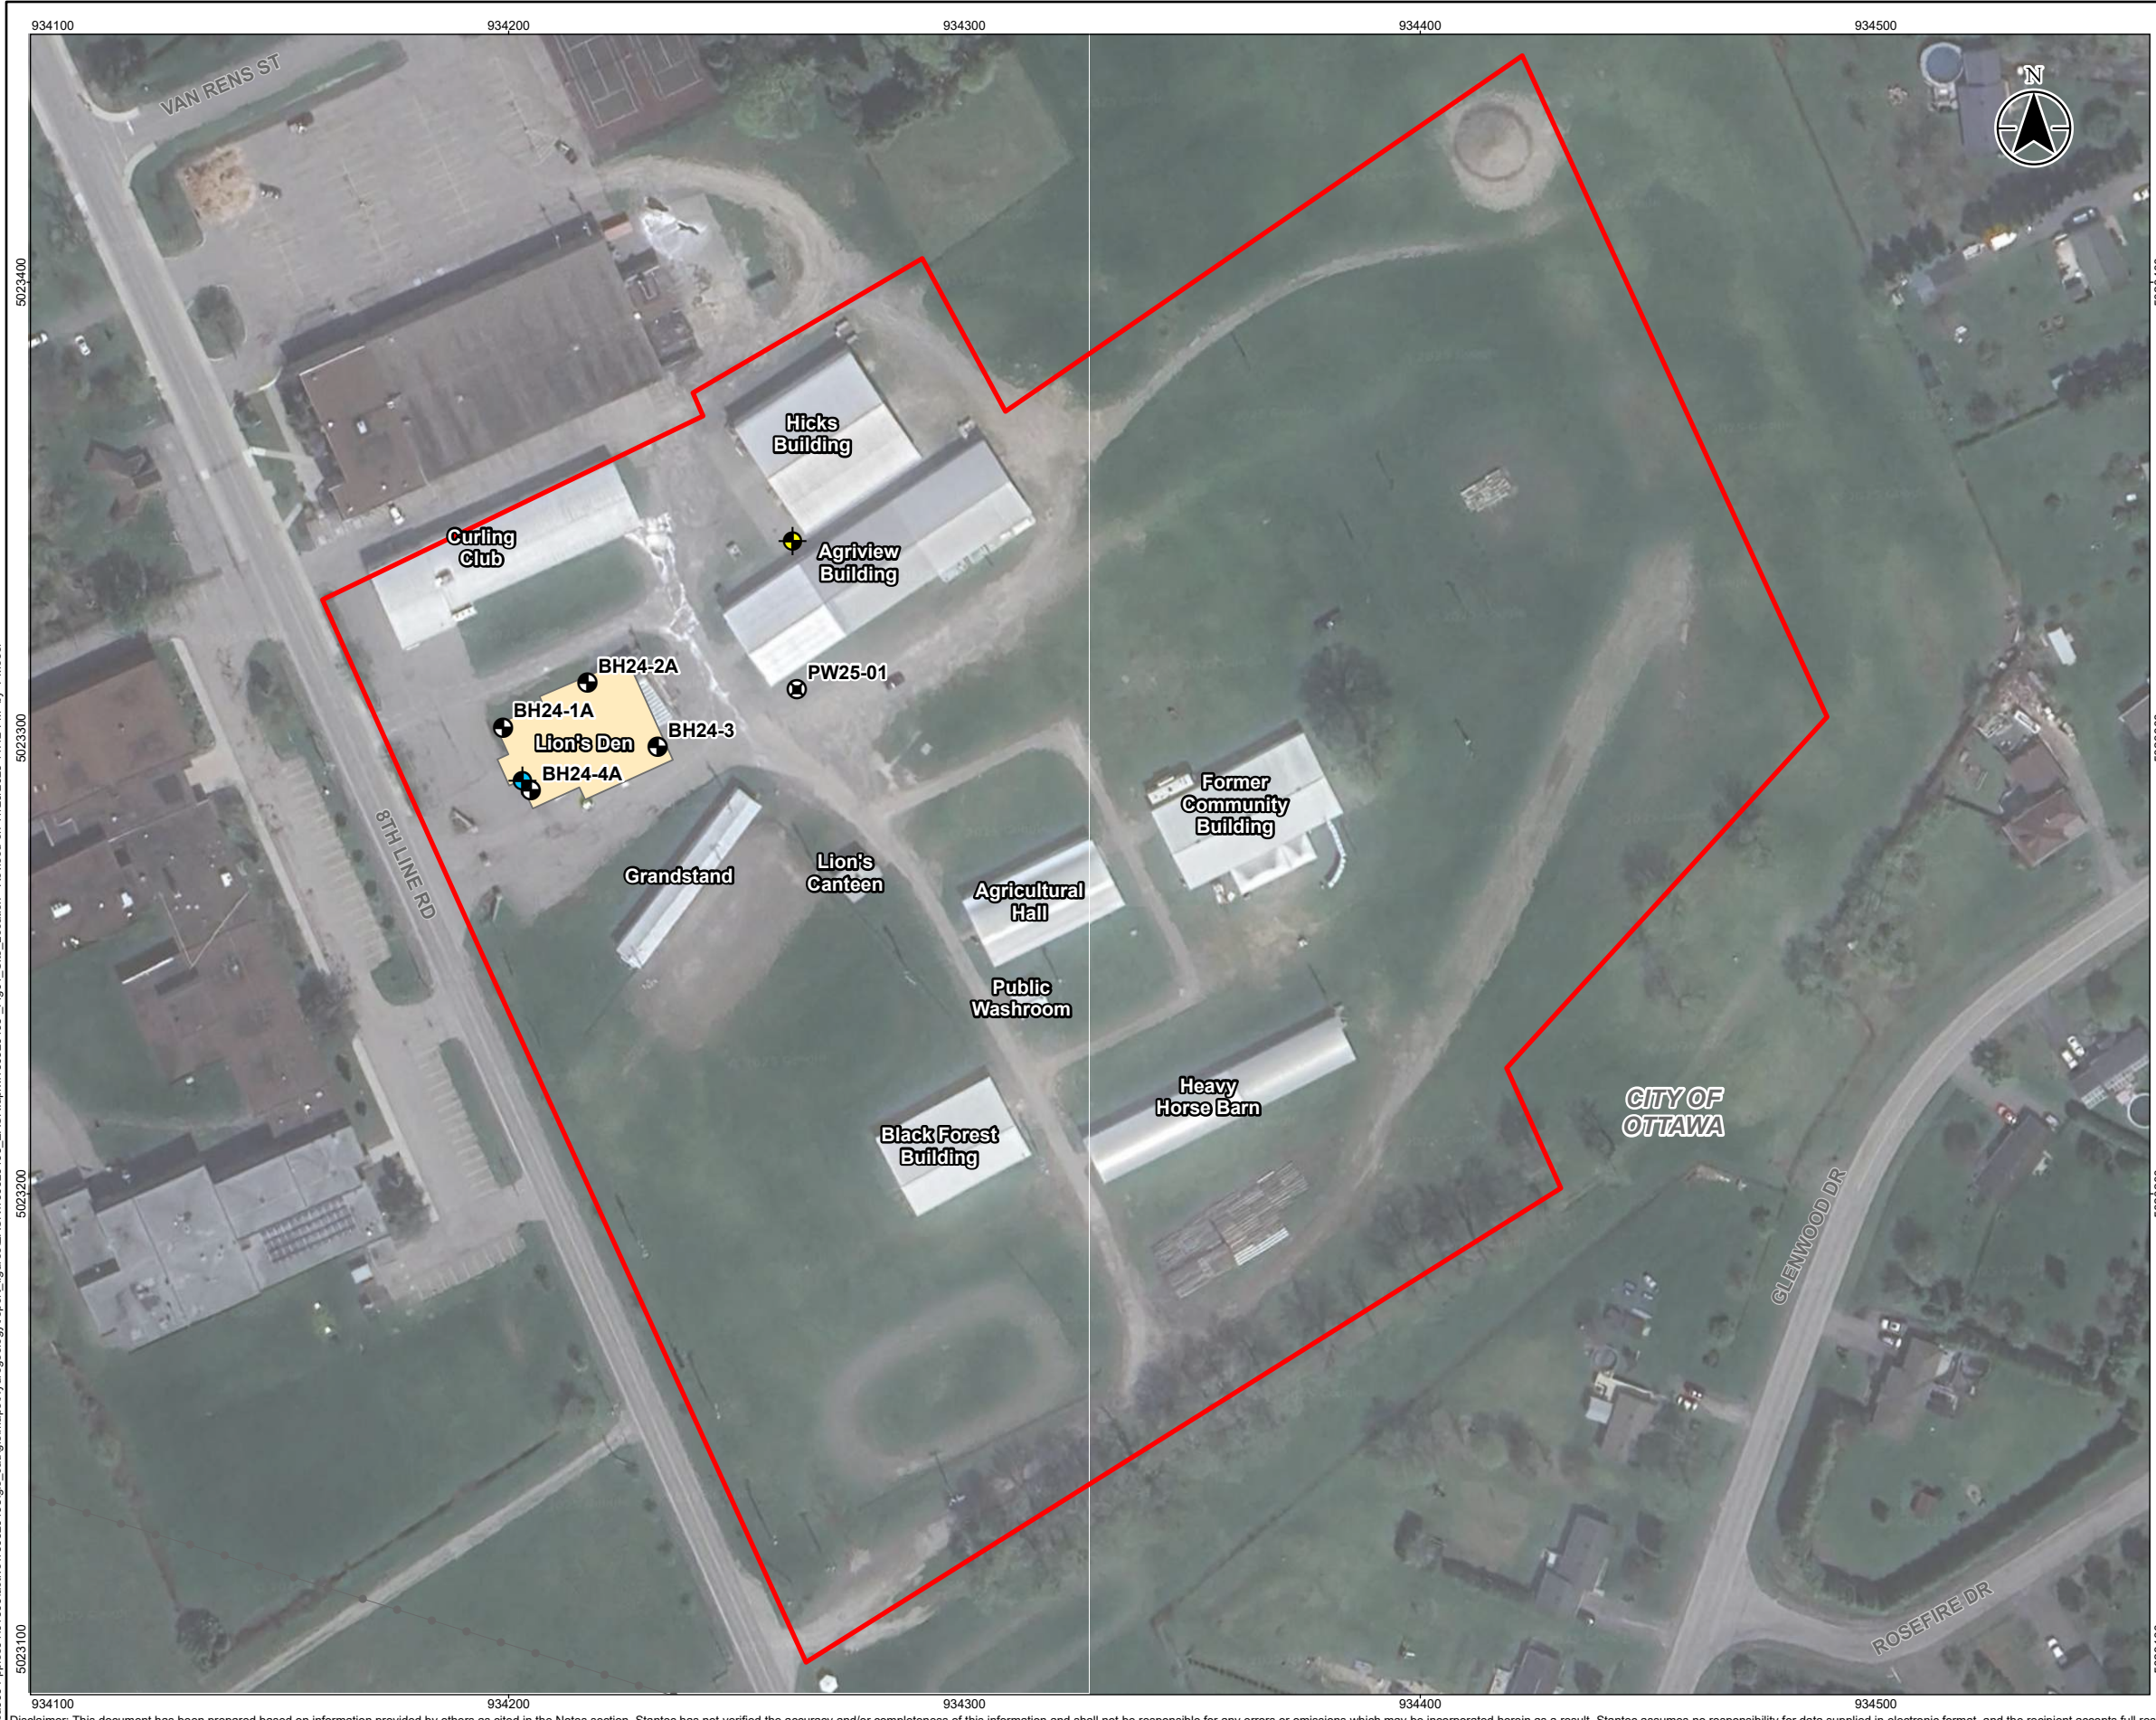
Title: Site Location

On behalf of the Metcalfe Agricultural Society (the Client), Stantec Consulting Ltd. (Stantec) has completed a hydrogeology assessment to support the proposed development of a single-storey building and associated sewage treatment system (the Project), located at 2821 8th Line Road in Metcalfe, Ontario, herein referred to as the Site (Figure 1, Appendix A).

There is a second water supply well on the west side of the Hicks Building ('Existing Well', Figure 1), which supplies water to a livestock wash station.

The Stantec (2025) geotechnical investigation reported similar subsurface conditions to those described above for WWRs. The subsurface conditions encountered consisted of topsoil / fill extending from surface to approximately 1 m BGS followed by limestone bedrock (Stantec 2025). The geotechnical borehole locations are shown on Figure 1.

Lithology at the new water supply well (PW25-01) is described as gravel / broken rock from surface to 1.8 m BGS followed by blue limestone to 11 m BGS. Grey limestone was observed from 11 m BGS to the completion depth. It is noted trace white sandstone was observed between 55 m and 73 m BGS, suggesting potential transition zone from the Oxford / March to the Nepean Formation. The location of PW25-01 is shown on Figure 1 and a copy of the MECP well record is provided in Appendix C.

At the Site, the private well that provides potable drinking water to the Lion's Den and Curling Club ('Existing Water Supply Well' on Figure 1) is interpreted to be associated with MECP WWR ID 1517002 (Figure 4). The water supply well on the west side of the Hicks Building ('Existing Well' on Figure 1) which supplies water to a livestock wash station is interpreted to be associated with WWR ID 1507651 (Figure 4).

The location of PW25-01 is shown on Figure 1 and a copy of the MECP well record is provided in Appendix C. As described in Section 2.2.1, the main formation encountered during drilling was limestone bedrock. Overburden was not observed.

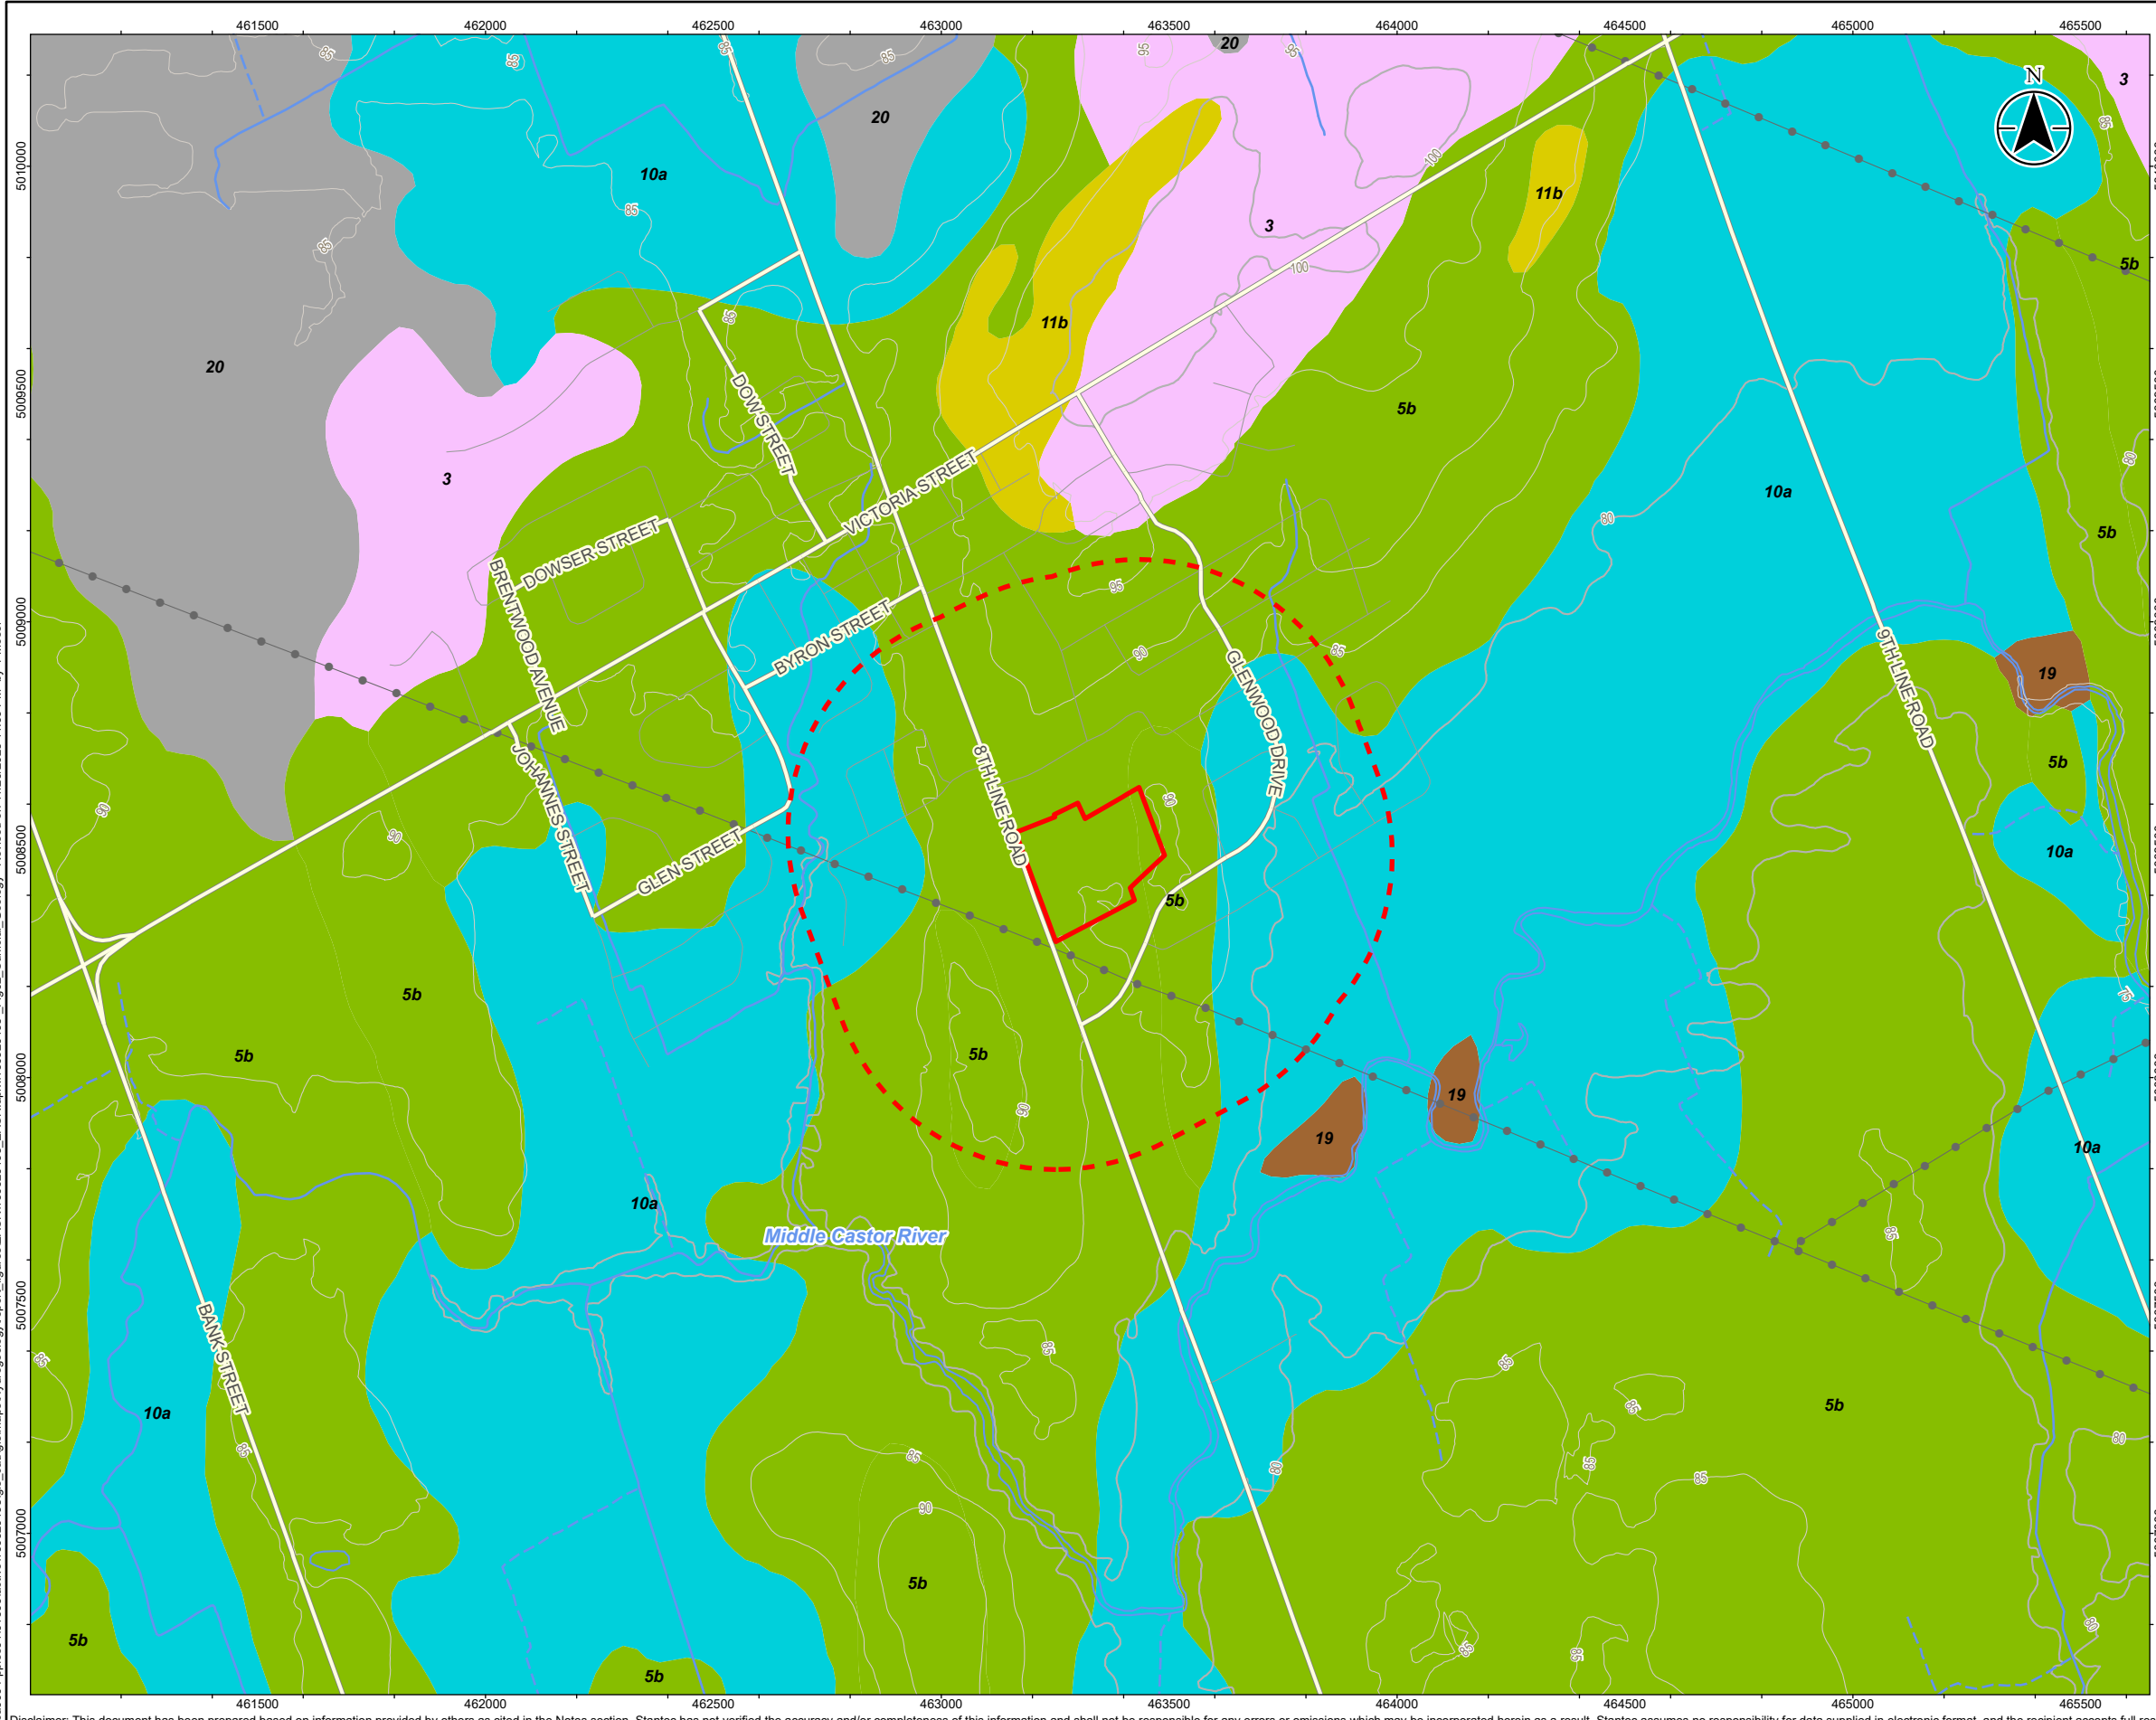
Title
Surficial Geology

Surficial geology and bedrock mapping by the Ontario Geological Survey (OGS 2010) are presented on Figure 2 and Figure 3, respectively. As shown on Figure 2, the Site is mapped in an area characterized by silty to sandy till deposits. Areas surrounding the Site are mapped as fine textured glaciomarine deposits. Bedrock near the Site is described by Armstrong and Dodge (2007) as dolostone and sandstone of the Oxford Formation, part of the Beekmantown Group ((Figure 3). Bedrock beneath the Site consists of limestone and was confirmed during coring completed as part of Stantec's geotechnical investigation (2025) at depths between 0.9 m and 0.8 m below ground surface (BGS).

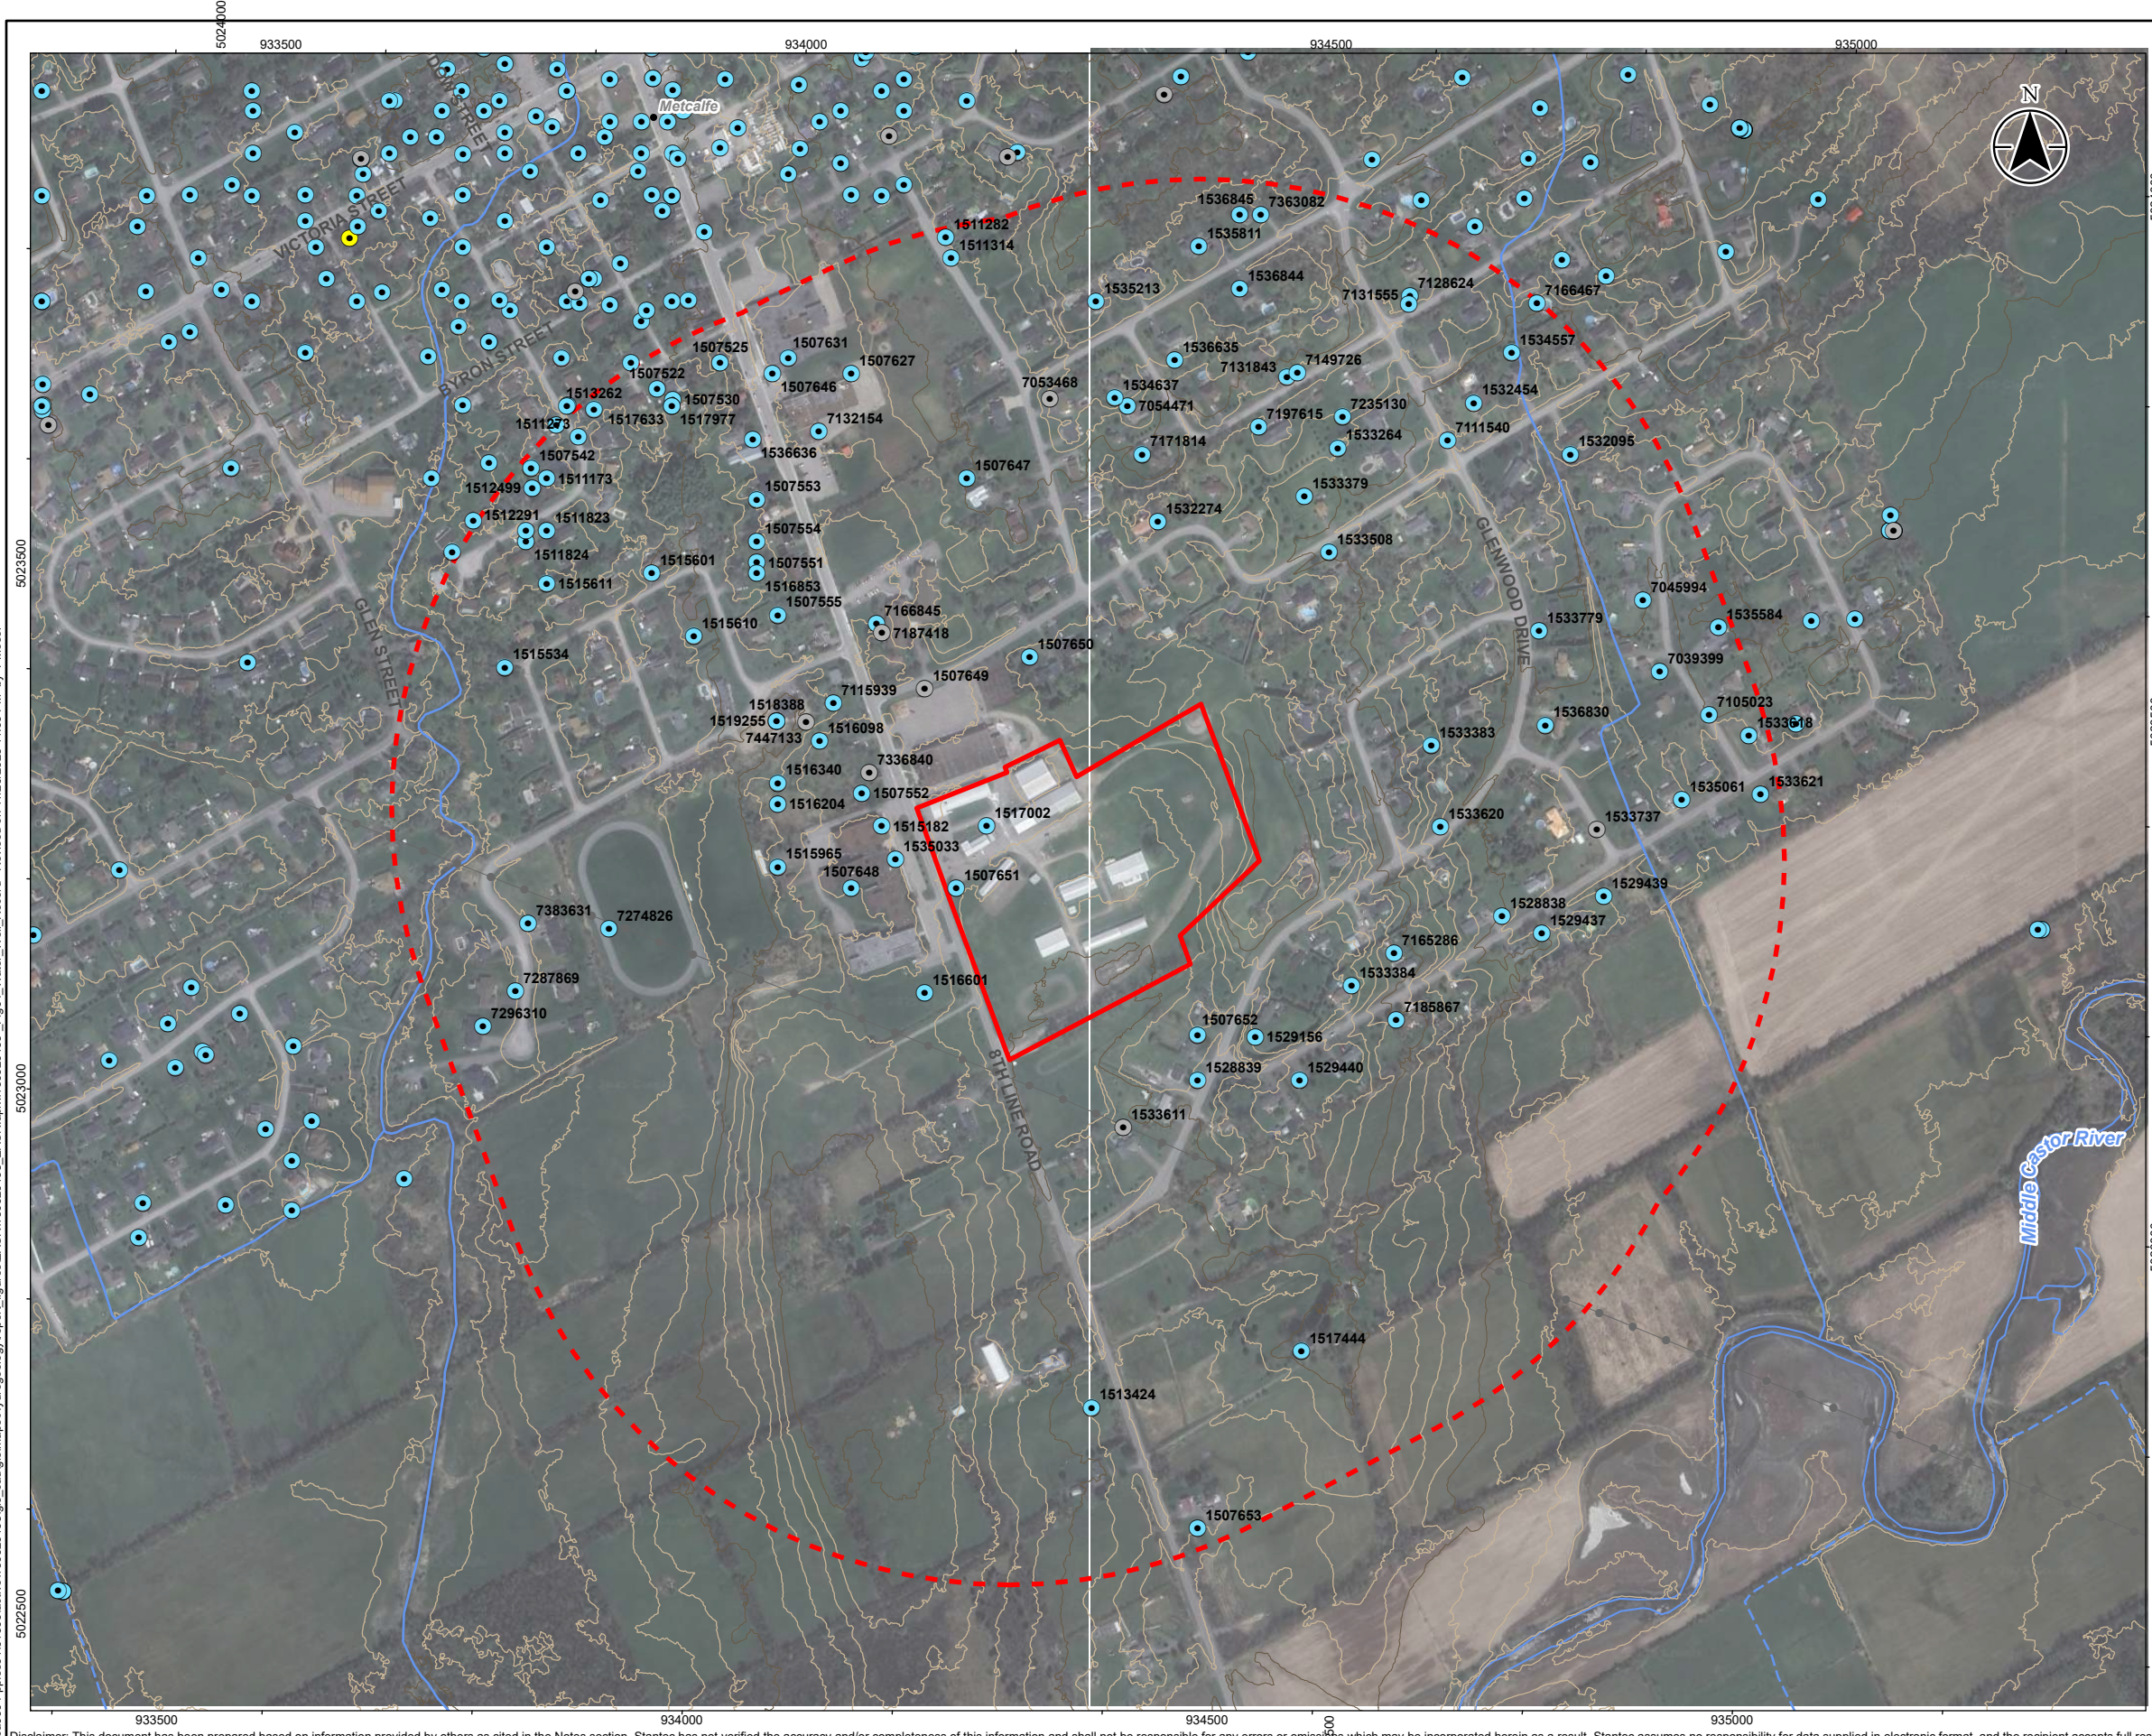
There are two water supply wells near the western end of the Site (Figure 4). The MECP WWR for the commercial well (Well ID 1517002) indicates a layer of clay with sand from ground surface to 1 m BGS followed by limestone bedrock to 40 m BGS. The domestic well (Well ID 1507651) describes the subsurface as hardpan (cemented soil) from surface to 4 m BGS, underlain by limestone bedrock to its completion depth of 10 m BGS.

The potential for private wells within 500 m of the Site was reviewed. Results of the MECP WWRs review identified 103 records, with five reporting wells as abandoned and the remaining reporting wells utilized for water supply (Figure 4). These wells were constructed between 1949 and 2019 and completed to depths ranging from 10 m to 135 m BGS in bedrock. The median well depth within 500 m of the Site is about 30 m BGS.

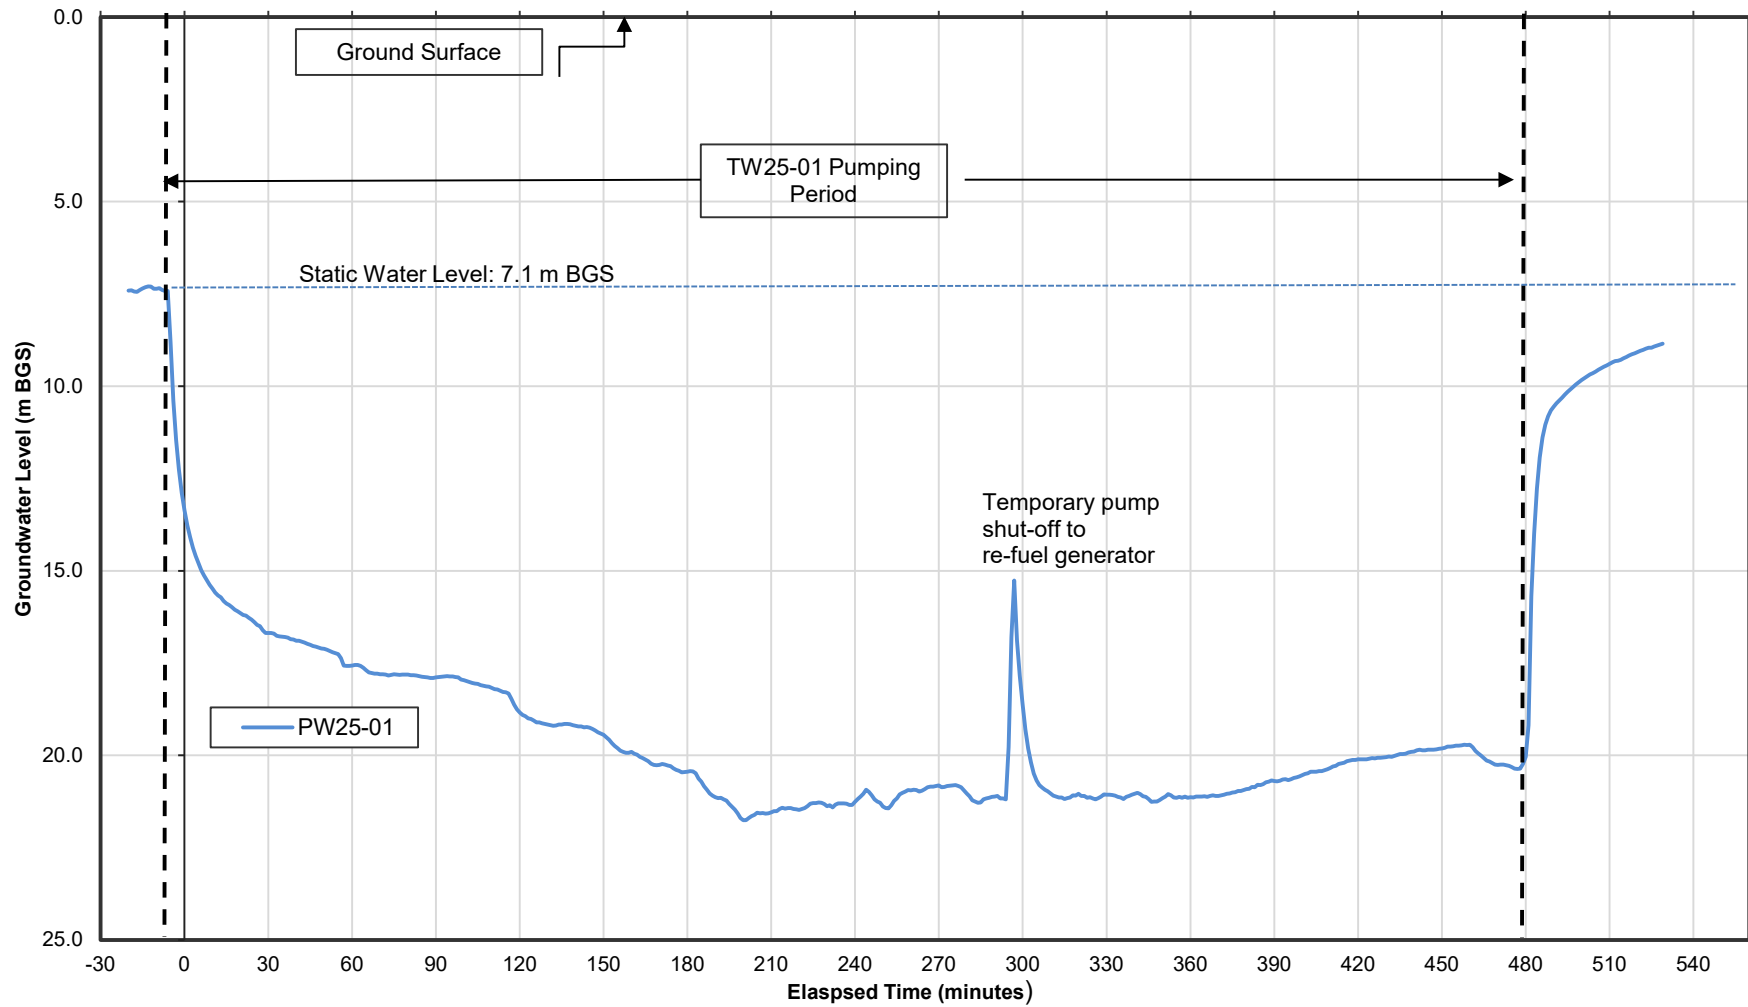
**Pumping Test PW25-01
Water Level versus Time**

After the groundwater supply well installation, the driller completed a one-hour pumping test to estimate the potential yield of the well. The recommended pump rate as noted on the well record is 56.8 L/minute, or 15 Gal/minute (Appendix C). The recommended rate was used to conduct an eight-hour pumping test at the groundwater supply well (PW25-01).

Also as noted in Section 1.2, although it is not expected, the estimated peak demand of 73.6 L/minute would have to be sustained for four hours. The well was pumped at approximately 77% of this rate for eight hours and the water level was stable with approximately 14 m of drawdown and 24 m of remaining available drawdown for the final three hours. As such, it is reasonable to assume that PW25-01 is capable of meeting the estimated peak demand.

To assess the groundwater supply potential at PW25-01, a groundwater pumping test was conducted over an eight-hour period. The test indicated that the well can meet the average and peak demand for the Lion's Den and Curling Club combined. The groundwater quality results met all ODWQS health-related criteria, however, exhibited concentrations of hardness and total dissolved solids above operational guidelines, and sodium above the Medical Officer of Health Reporting Limit. Water softening may be desirable, which may increase sodium concentrations. Prior to occupation, it is recommended that the Client notify the local Medical Officer of Health of the sodium concentration exceeding the 20 mg/L limit. Due to the low field turbidity observed in the fully developed test wells, a UV system may be used as a precaution against bacteriological impacts.
