Muncaster  
Environmental  
Planning Inc.

**RE: 320 Bren-Maur Road West, Barrhaven**  
**Environmental Impact Study - Updated**

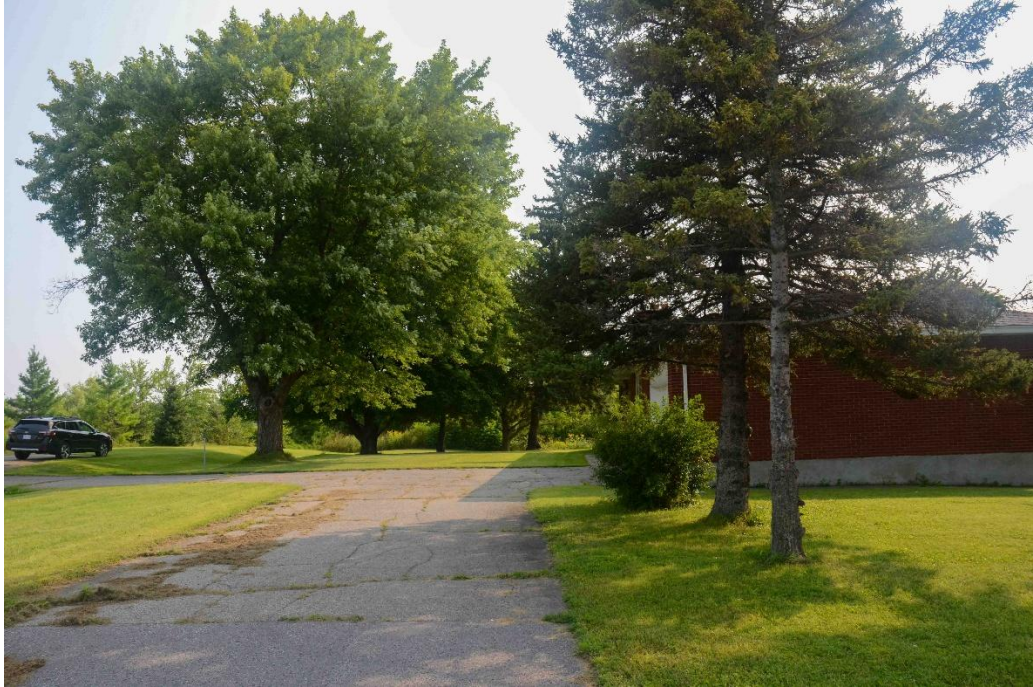
*Photo 1 – Typical conditions of the development portion of the site, with manicured lawn and scattered trees. The mature silver maple is on the left towards the rear, with smaller white spruce on the right. View looking east towards the north residence from Longfields Drive*

The tablelands portion of the site among the two existing residences is dominated by manicured lawns of bluegrass (Photo 3). Other ground vegetation includes June meadow grass, ground ivy, yellow wood sorrel, and common strawberry. There are several scattered deciduous and coniferous trees on the lawns, as described in the Tree Conservation Report by Novatech (2025). These include an 80cm diameter at breast height (dbh) silver maple in the north-central portion of the site to be protected (Photo 1) and a coppice sugar maple to the east of the silver maple. A large stem has been pruned from the silver maple and the sugar maple has many dead smaller stems, with the larger stems in good condition up to 36cm dbh. Two white spruce up to 46cm dbh, and a 40cm dbh bur oak are in the northeast corner of the site. These trees have been pruned and the leaf-out is poor on many branches of the bur oak. Other trees among the lawn and residences are a coppice American mountain ash between the two residences. The individual stems of the mountain ash are up to 20cm dbh. Suckering and pruning are extensive on this tree. A mature (84cm dbh) silver maple is between the north residence and Longfields Drive (Photo 2). This tree appears to be in good condition, with good leaf out. Smaller white spruce (25cm and 36cm dbh) are to the north of the silver maple. These trees have also been extensively pruned and trunk damage is extensive on the smaller spruce.

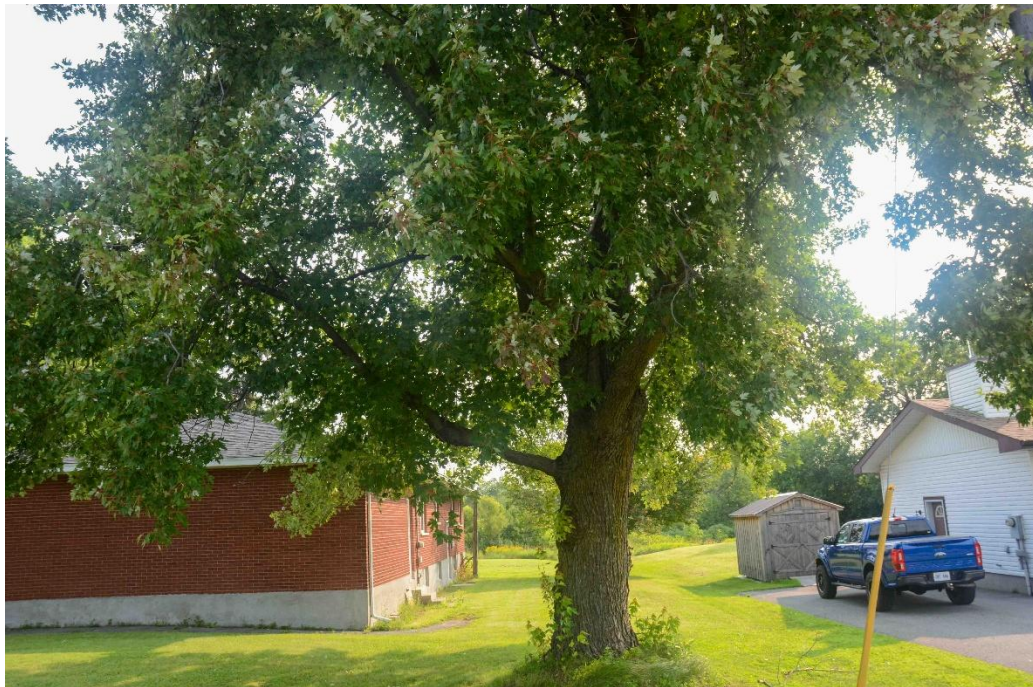
*Photo 2 – The other mature silver maple in the central west portion of the site. View looking east from east of Longfields Drive*

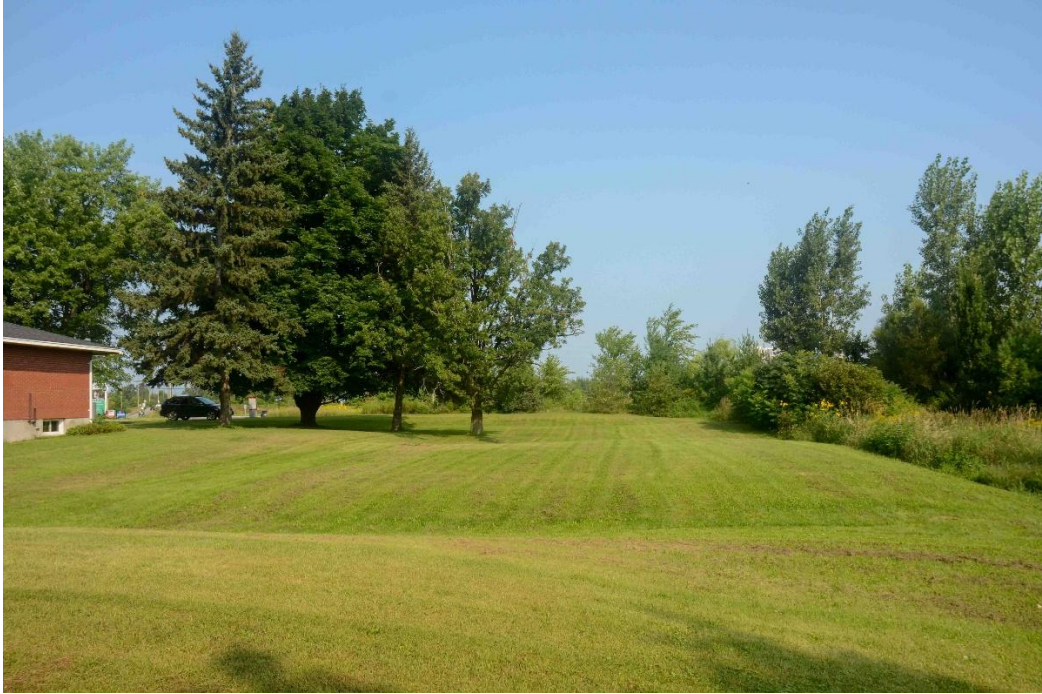
*Photo 3 – East portion of the development portion of the site.  
View looking north from top-of-slope*

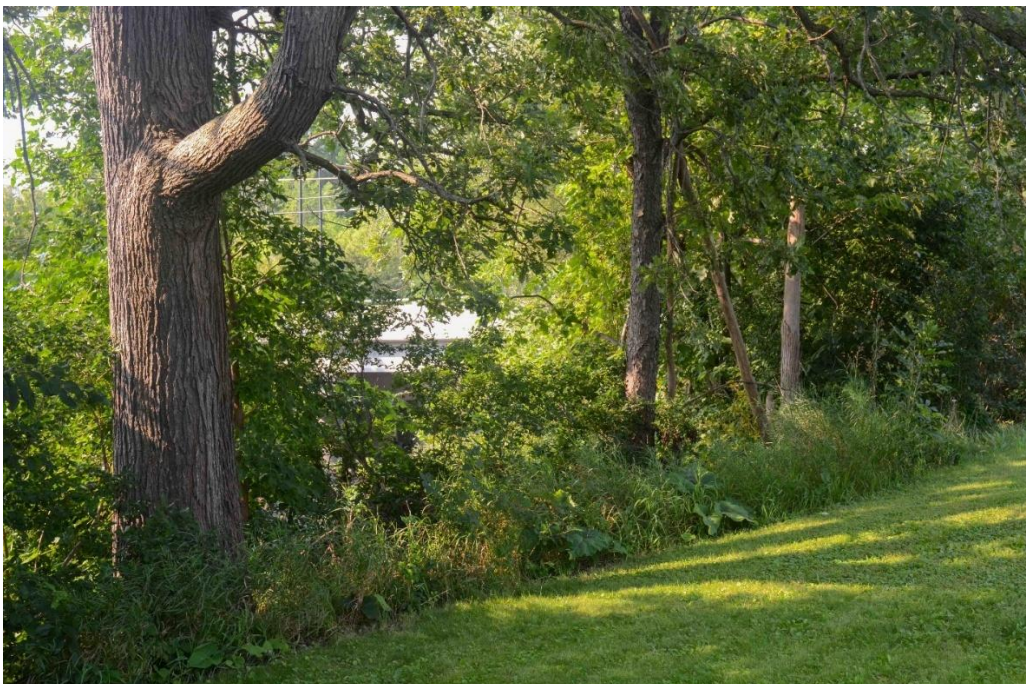
*Photo 4 – The mowed grass extends beyond the top-of-slope towards the Jock River. Larger oaks and other woody vegetation are well established along the slope. View looking southwest*

The vegetation along the bank leading to the Jock River is described as a cultural woodland on Figure 1. Mature bur oak and swamp white oak, in the 60cm dbh range are the largest trees in the river setback, with smaller Manitoba maple, crack willow, black cherry, and basswood (Photos 4 and 5). Except for the leaning coppice Manitoba maples and a couple of dead stems, the trees appeared to be in generally fair to good condition, with reduced leaf-out on some of the larger oaks. Common buckthorn, red raspberry, and tartarian honeysuckle shrubs are among the trees, along with regenerating stems of bur oak, Manitoba maple, basswood, and white ash. Ground flora is well established along the slope including field sow-thistle, common burdock, St. John's wort, wild grape, thicket creeper, Canada goldenrod, New England aster, small white aster, creeping bellflower (a particularly invasive species), orchard grass, reed canary grass, wild carrot, daisy fleabane, hedge bindweed, helleborine, and common ragweed.

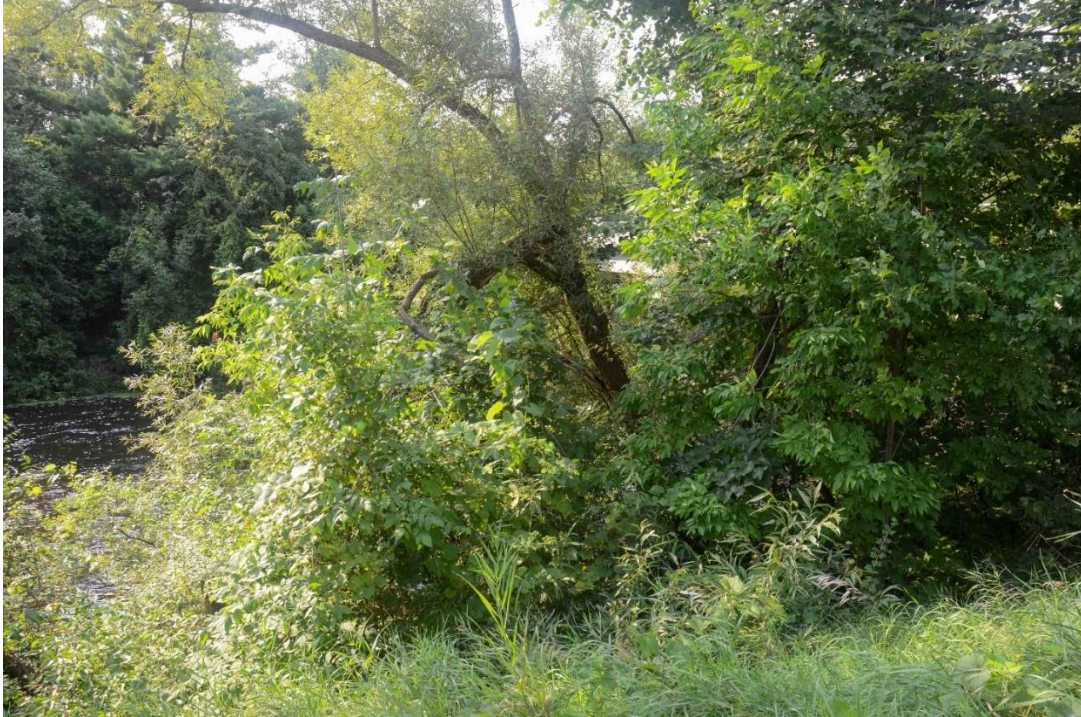
*Photo 5 – Another view of the vegetation down the slope, with the Jock River in the rear left.  
View looking southeast*

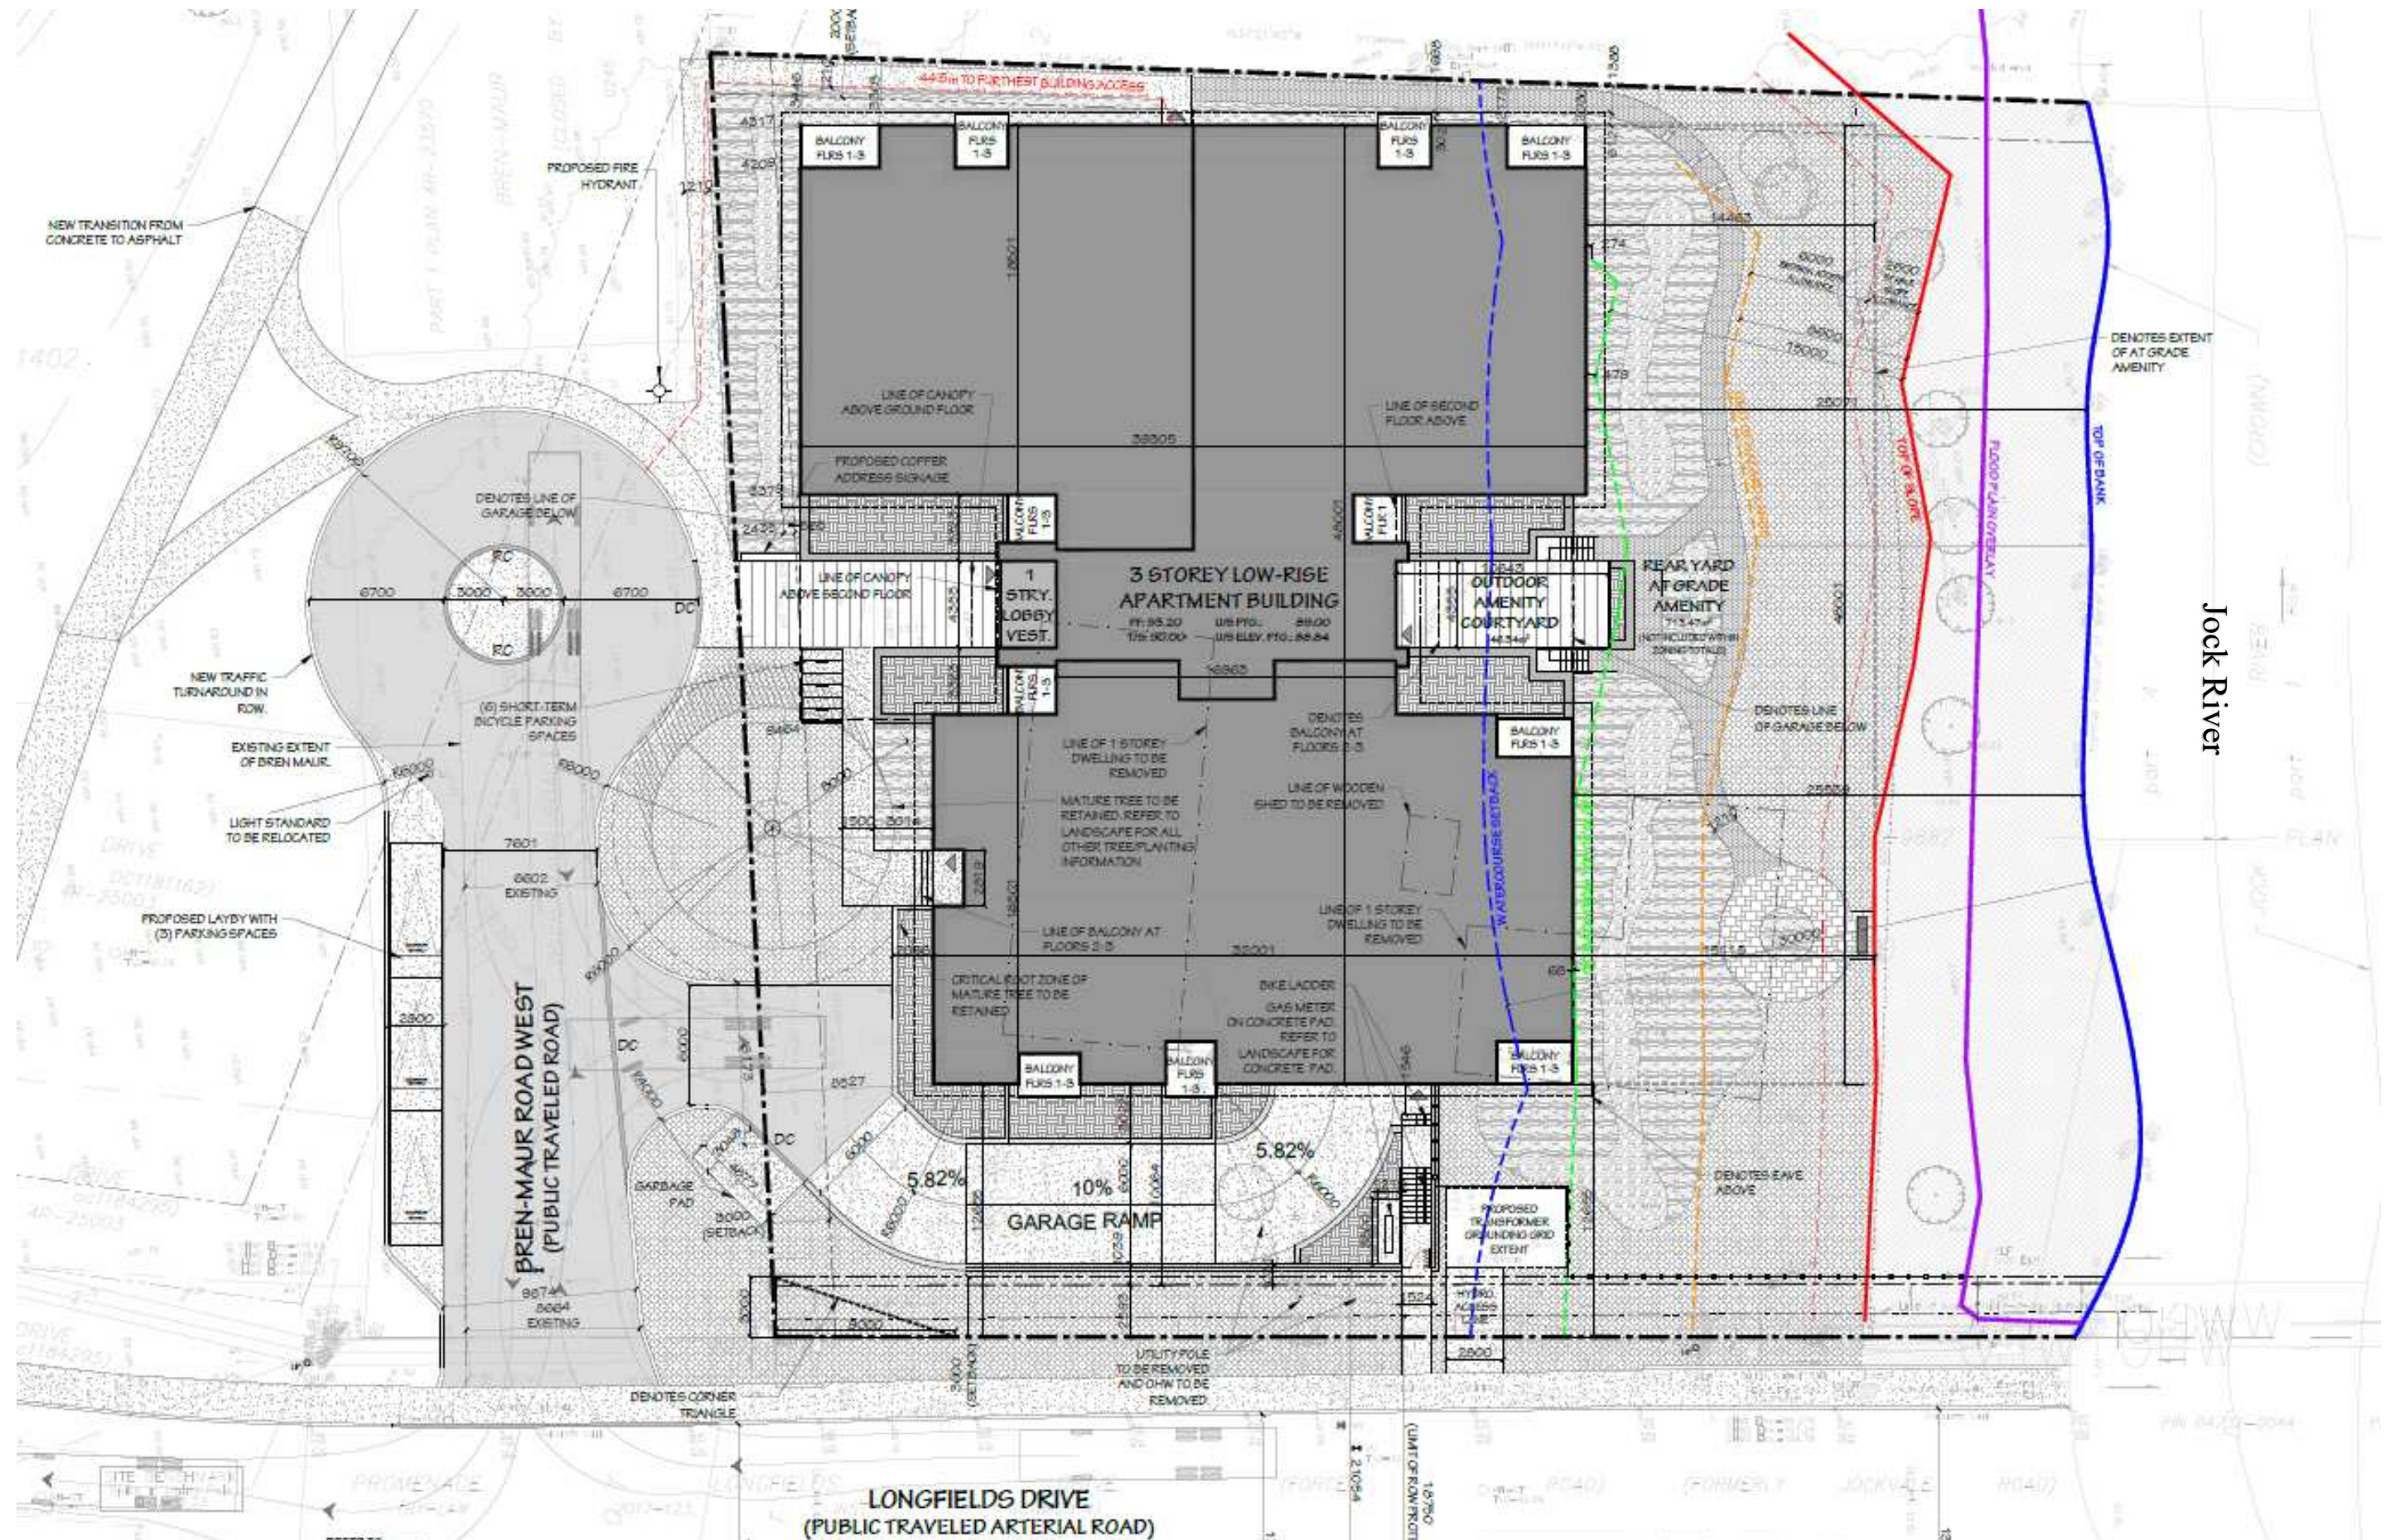
FIGURE 2 – SITE PLAN (Hobin Architecture)

Natural buffers between watercourses and human alterations are important for filtering excess nutrients running into the watercourse, infiltrating rainwater, maintaining bank stability, and providing wildlife habitat. Natural corridors also shade the edges of the river, help to maintain baseflow levels, and keep water temperatures cooler. Section 4.9.3 (7) of the Official Plan and Appendix 10 of the City's EIS Guidelines are used to identify the limits of development from a surface water feature. There are five features that may determine the limits of development: limit of hazard lands, floodplain, meander belt, 15 metres from top of stable slope, and 30 metres from channel top of bank (Figure 2).

(solid blue line – channel top of bank; red – top of slope; dashed orange – limit of hazard lands; dashed green – 15 m top of slope setback; dashed blue – 30 m channel setback; purple – floodplain overlay)

A low-rise three-story wood and brick apartment building with 35 units is proposed for the site, replacing the two existing residences and providing a greater setback from the Jock River. Underground parking will be provided, with access south from Bren-Maur Road West. **Four**

surface parking spots are proposed for the north portion of the Bren-Maur Road West allowance (Figure 2). A new cul-de-sac will be installed at the east end of Bren-Maur Road West and the development will be on full municipal services.
