Phase I – Environmental Site Assessment

4816 Bank Street
Ottawa, Ontario

Prepared for DCR Phoenix Development Corporation Ltd.

Report: PE6552-1
July 25, 2024

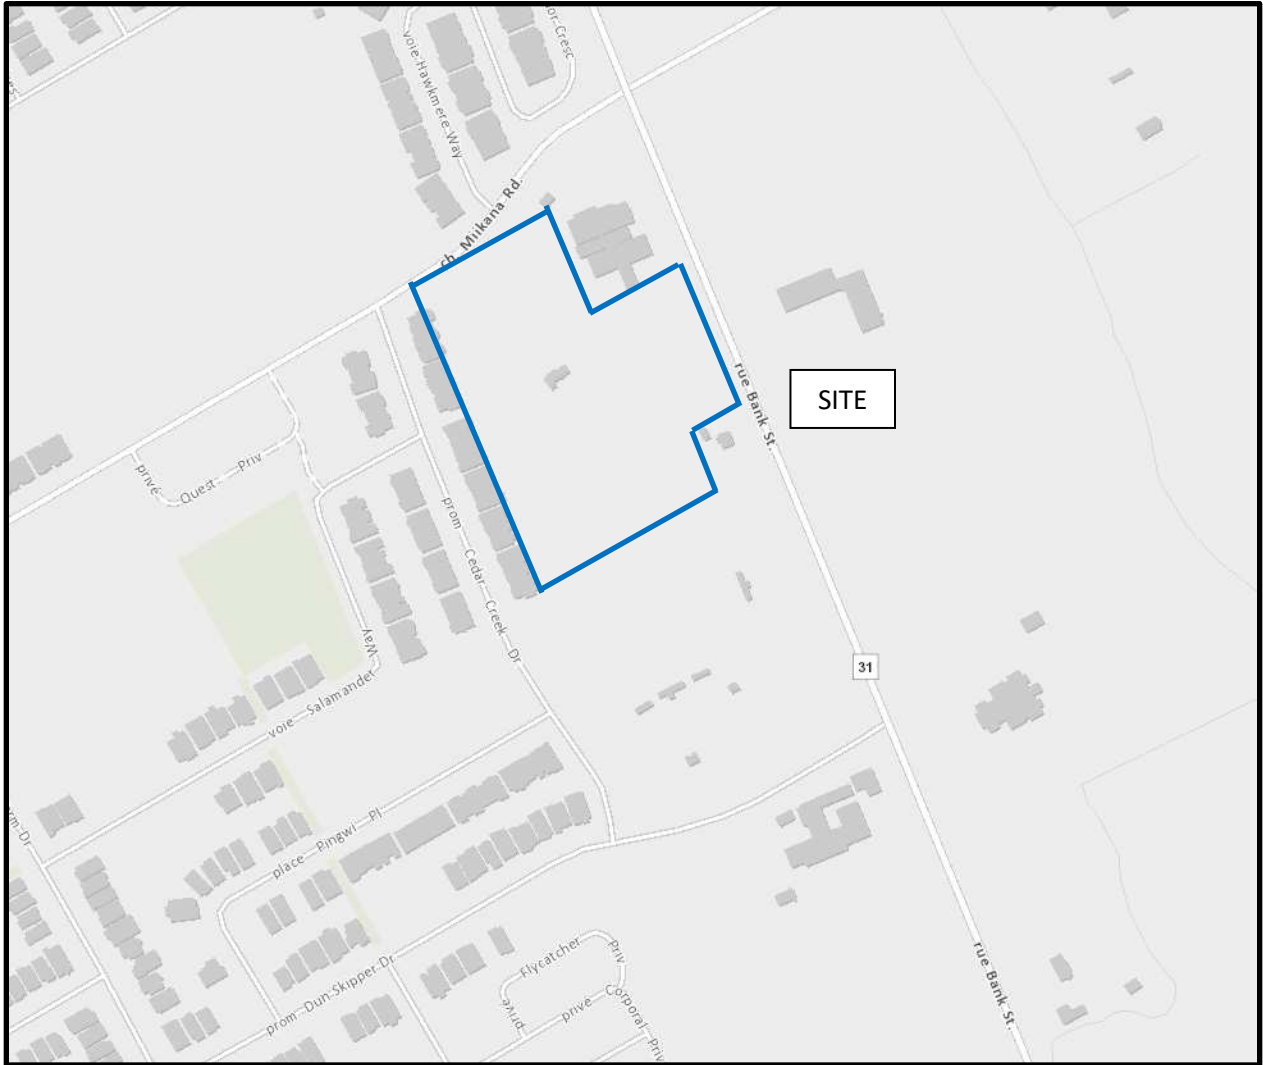
FIGURE 1
KEY PLAN

Address:	4816 Bank Street, Ottawa, Ontario.
Legal Description:	Part of Lot 21, Concession 4, Township of Gloucester, in the City of Ottawa.
Location:	The Phase I Property is situated on the west side of Bank Street, southwest of the intersection of Bank Street and Blais Road, in the City of Ottawa, Ontario. For the purposes of this report, Bank Street runs in a north-south orientation. Refer to Figure 1 – Key Plan, for the site location context.
Latitude and Longitude:	45° 18' 43.5" N, 75° 35' 26.0" W.

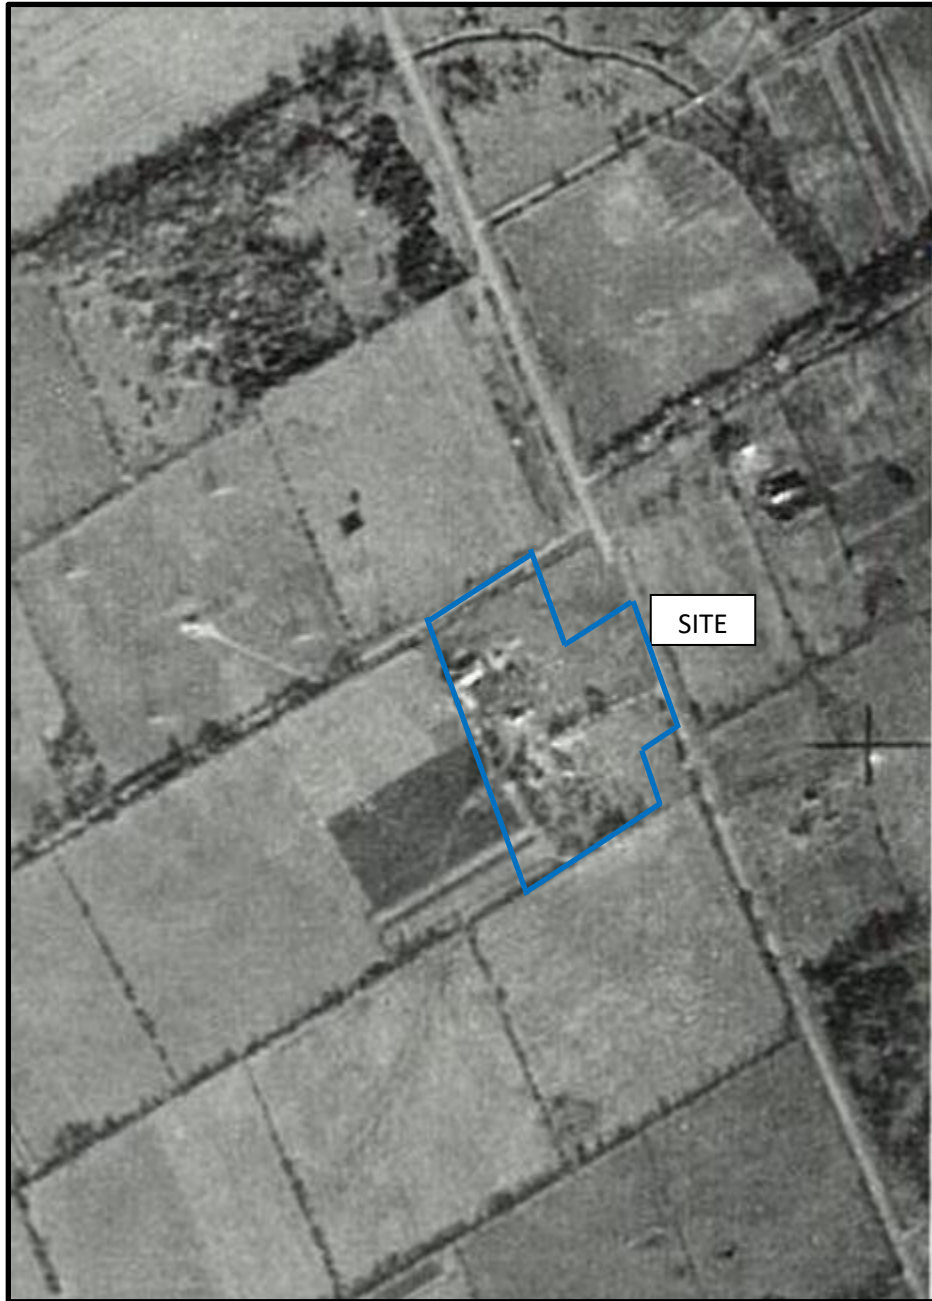
AERIAL PHOTOGRAPH
1945

1945 (Poor Quality, National Air Photo Library) A farmstead consisting of multiple structures is observed on the Phase I Property. The surrounding properties are largely vacant or used for agricultural purposes. Structures can be seen to the northwest and northeast of the Phase I Property. A portion of Bank Street is observed east of the Phase I Property.

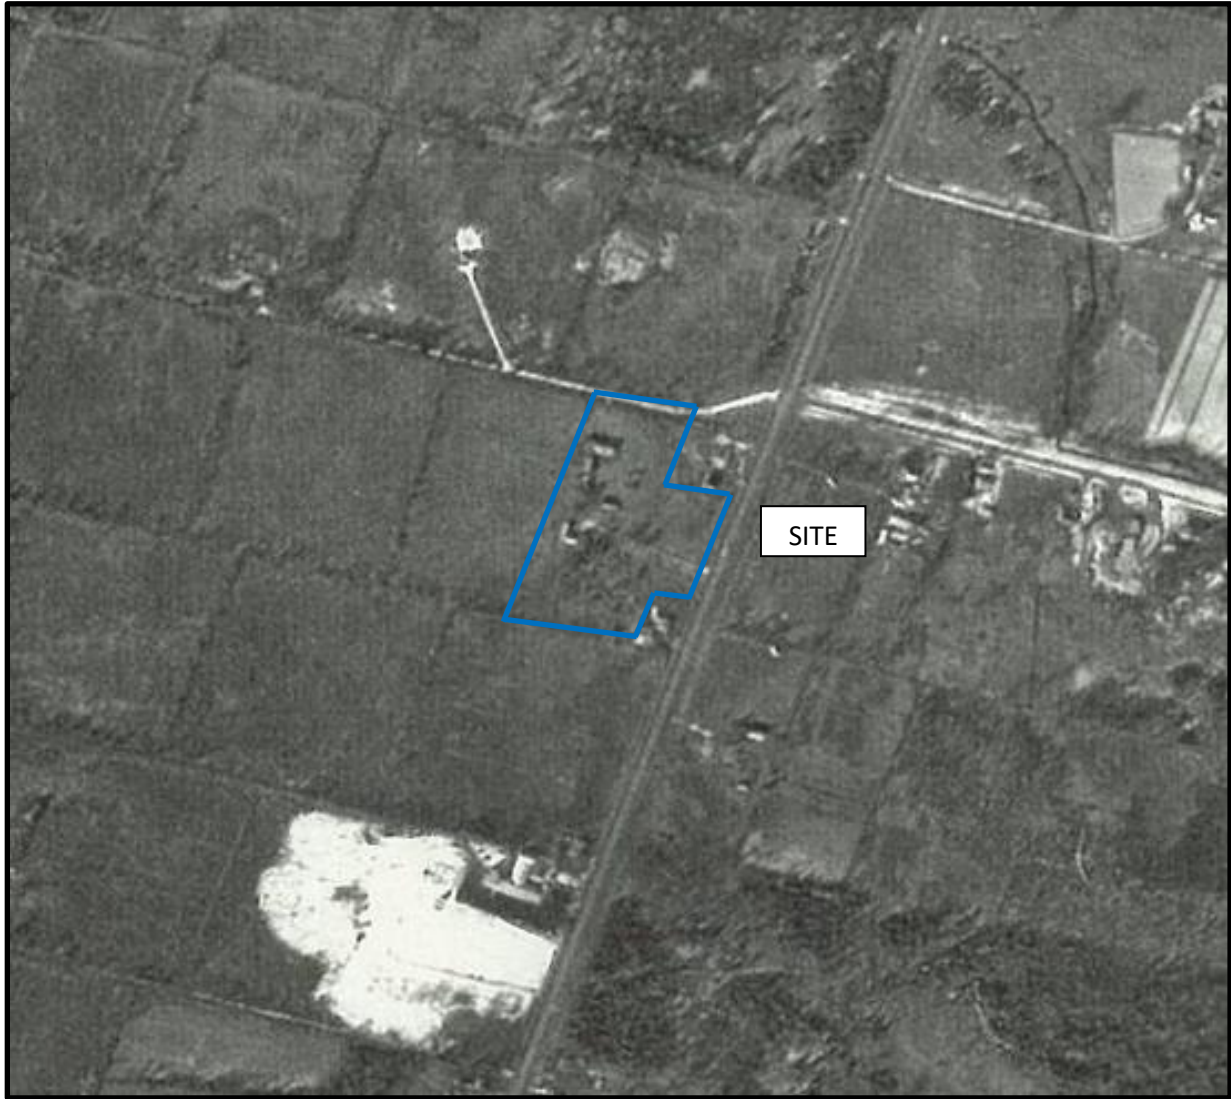
AERIAL PHOTOGRAPH
1967

- 1967 (National Air Photo Library) No significant changes are apparent with respect to the Phase I Property. A residential building can be seen constructed adjacent to the south perimeter of the Phase I Property at 4820 Bank Street. Two structures can also be seen adjacent to the north perimeter of the Phase I Property at 4806 Bank Street. Additional residential construction is observed on the south side of Blais Road. A farm is observed south of the Phase I Property on the west side of Bank Street.

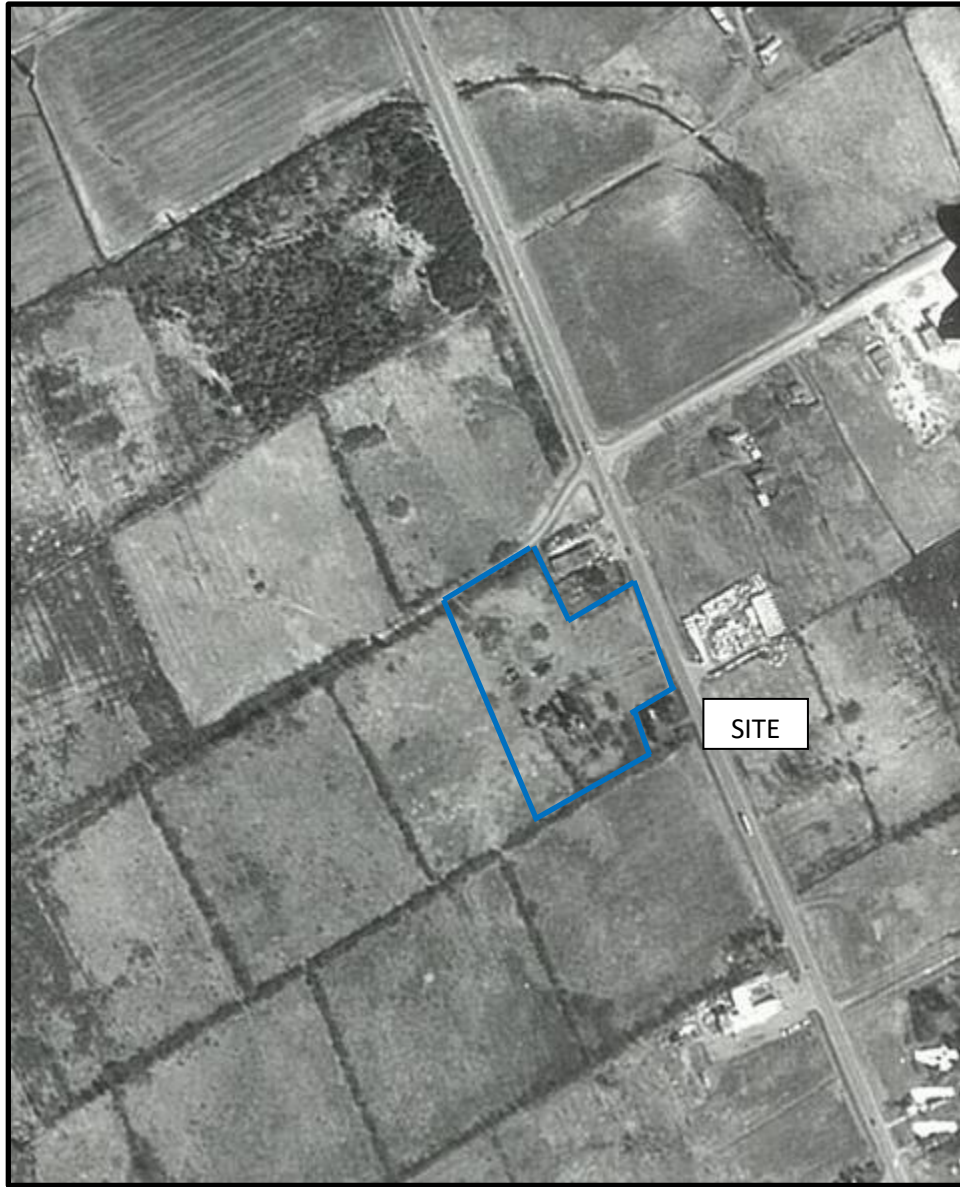
AERIAL PHOTOGRAPH
1985

- 1985 (National Air Photo Library) The northern most building on the Phase I Property has been removed since the previous photo. The structures at 4815 Bank Street have been replaced with permanent structures. No other significant changes are apparent with respect to the surrounding lands.

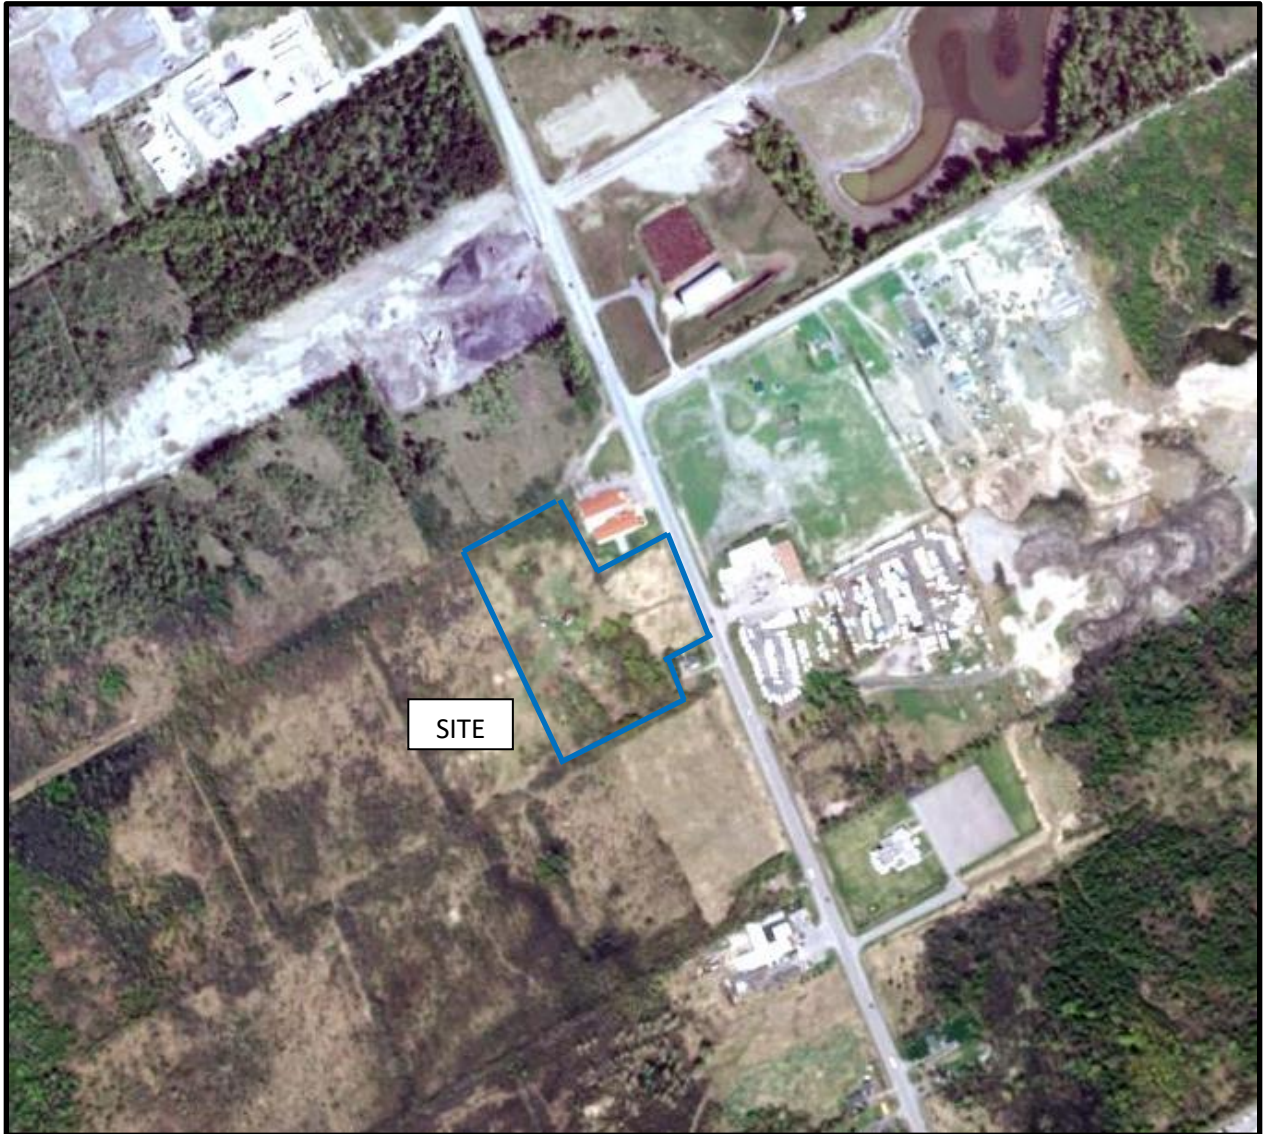
AERIAL PHOTOGRAPH
2008

- 2008 (geoOttawa) A structure on the south side of the Phase I Property was removed and fenced gardens have been erected north and south of its former footprint since the previous photograph. The buildings directly north of the Phase I Property located at 4806 Bank Street have been demolished and replaced with two new commercial buildings. Tree clearing and earthworks are observed further North

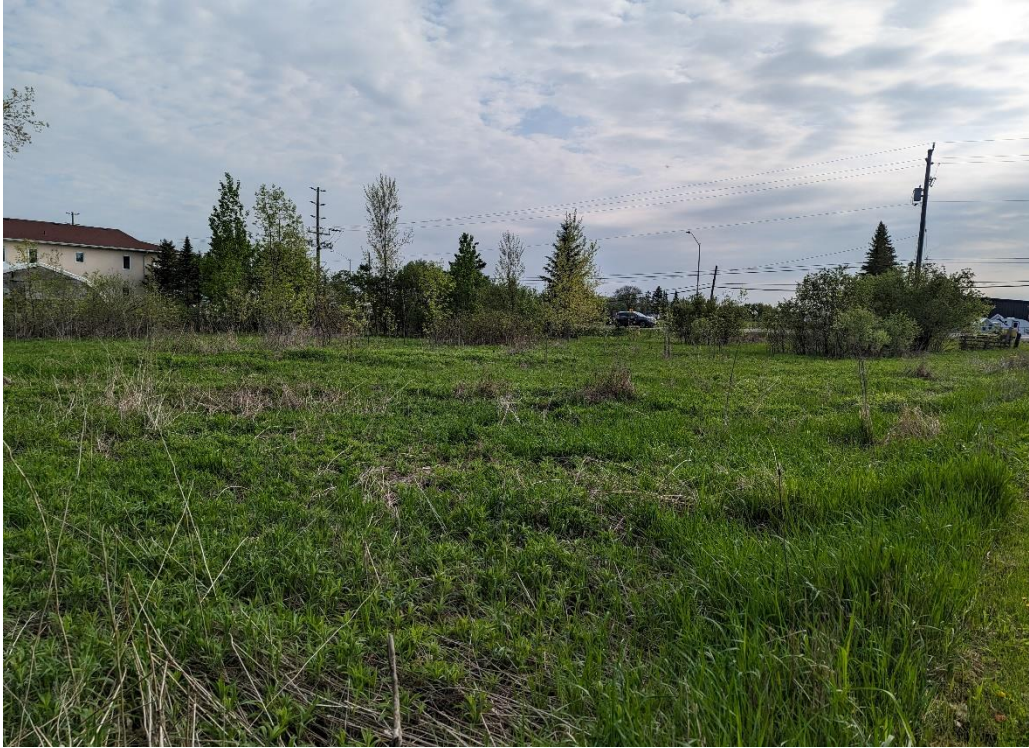
Photograph 1: View looking northeast, from the Phase I Property towards Bank Street.

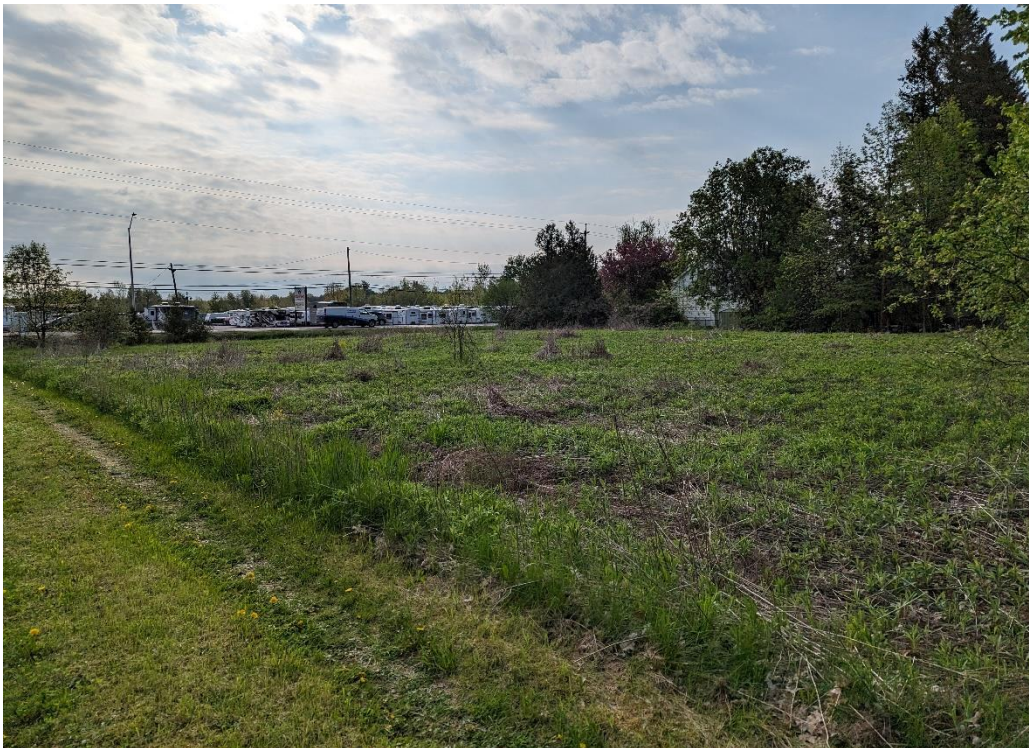
Photograph 2: View looking southeast from the Phase I Property towards Bank Street.

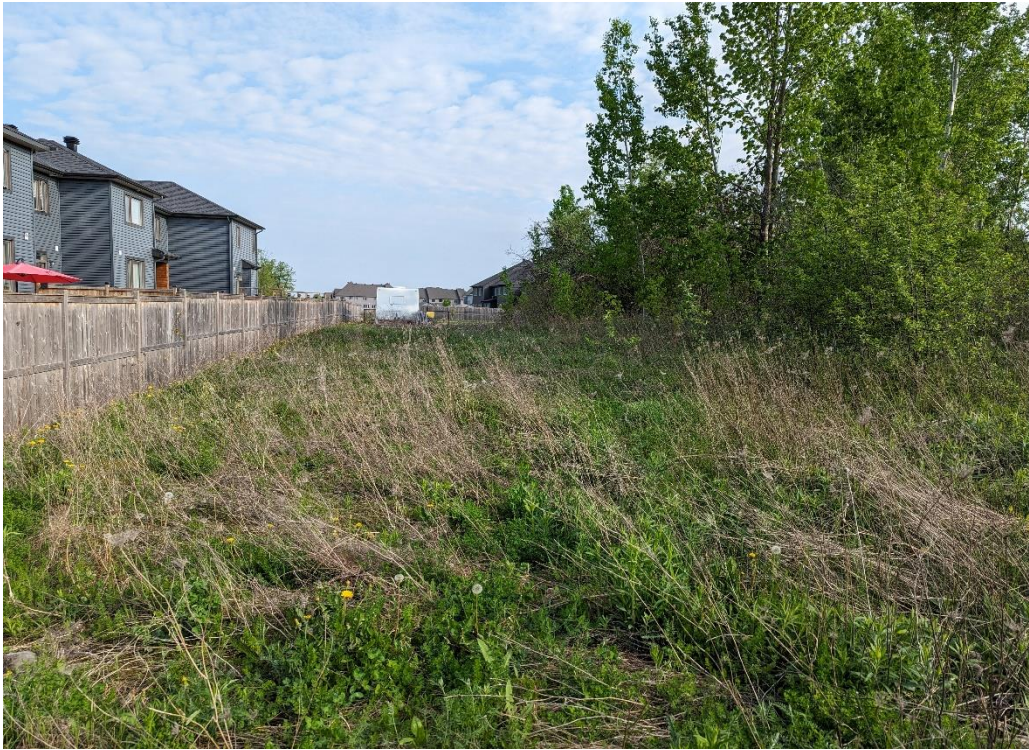
Photograph 3: View looking north from the west side of the Phase I Property towards Miikana Road.

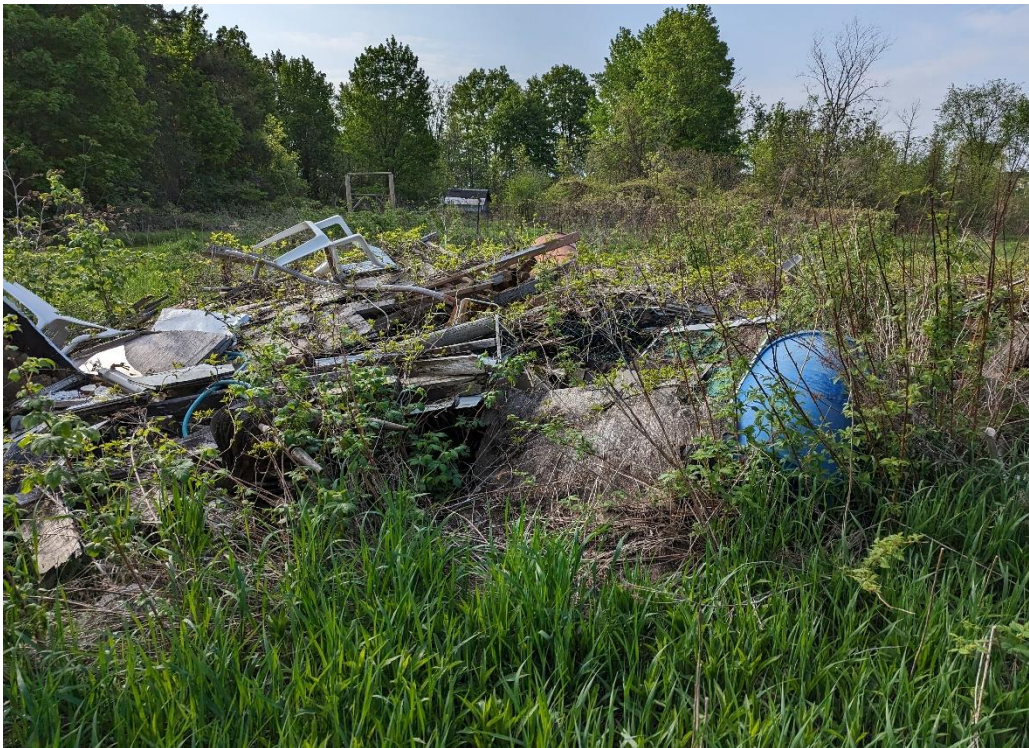
Photograph 4: View looking southeast from the center of the Phase I Property towards 4820 Bank Street.

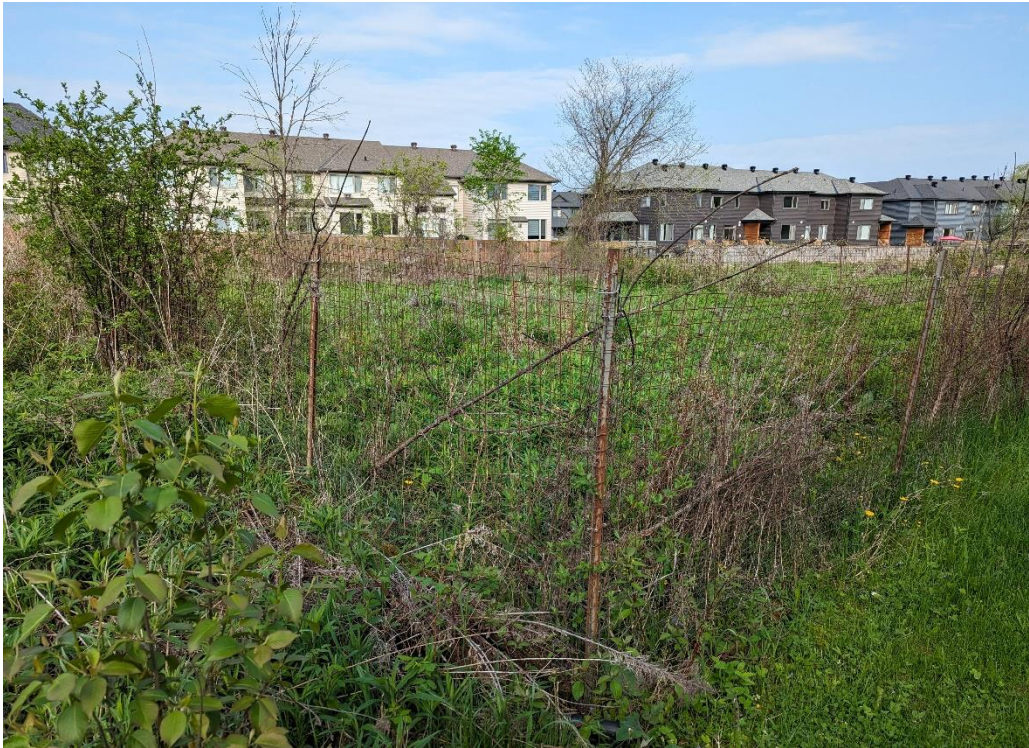
Photograph 5: View looking southwest from the center of the Phase I Property towards Cedar Creek Drive (fenced garden area).

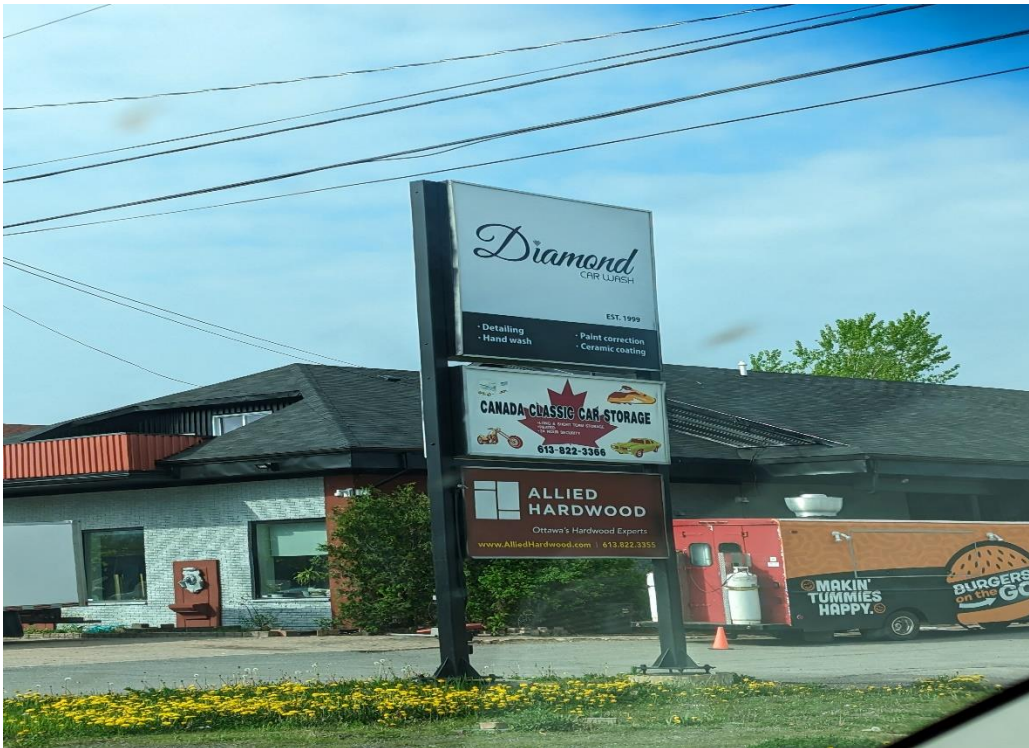
Photograph 6: View looking west from Bank Street, towards 4806 Bank Street – PCA 1 (former autobody garage).

Four records were documented for the property addressed 4806 Bank Street. Two of these records are listed under the facility type 'Motor Vehicle Repair Shops'. The first is N Di Bello which was referenced once for the year 1973. The second, Dom's Autobody, returned records between 1973 and 2017. The activity associated with these records is considered to result in an APEC on the Phase I Property. The remaining two records associated with 4806 Bank Street pertain to commercial flooring stores and are not considered to pose an environmental concern to the Phase I Property.

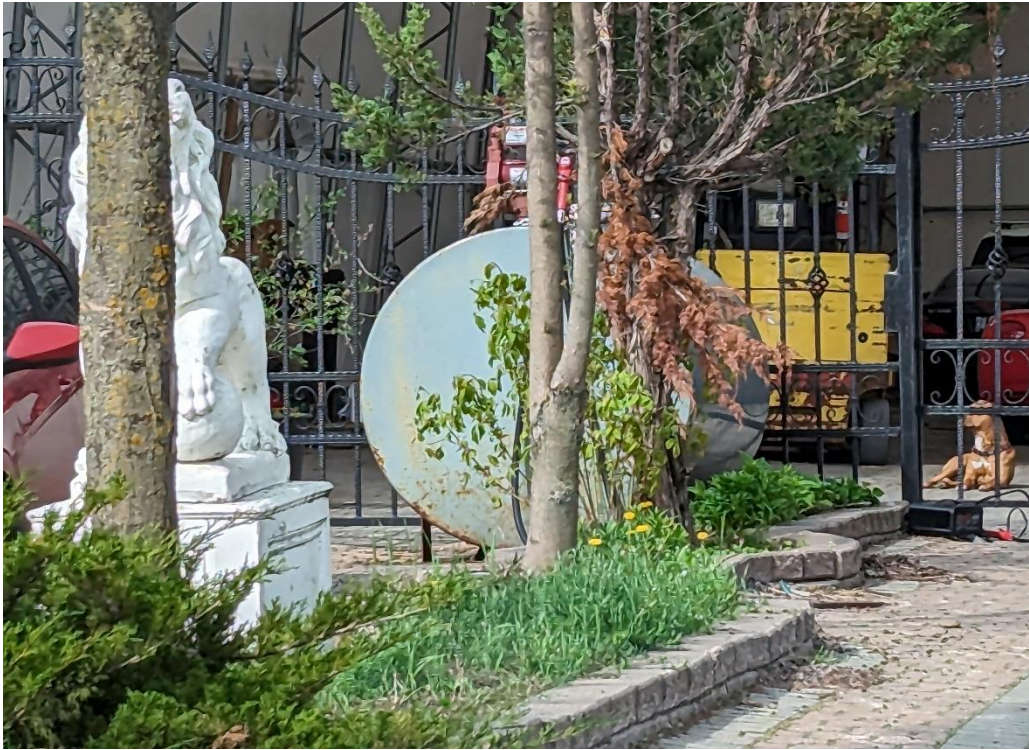
Photograph 7: View looking west from Bank Street toward the 4810 Bank Street – PCA 2 (fuel tank).

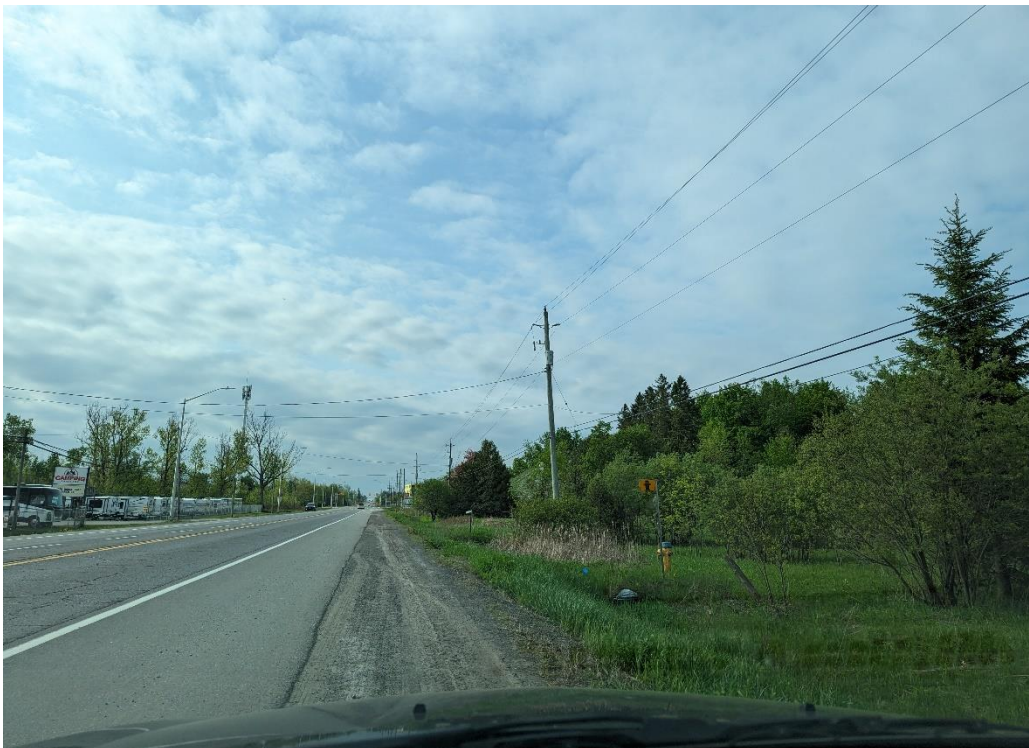
Photograph 8: View looking south, along the west side of Bank Street towards 4820 Bank Street – PCA 3 (pole mounted transformer).
