**RE: 391 Hilversum Lane, Carp  
Environmental Impact Study**

Environmental Impact Study

391 Hilversum Lane  
Carp, City of Ottawa

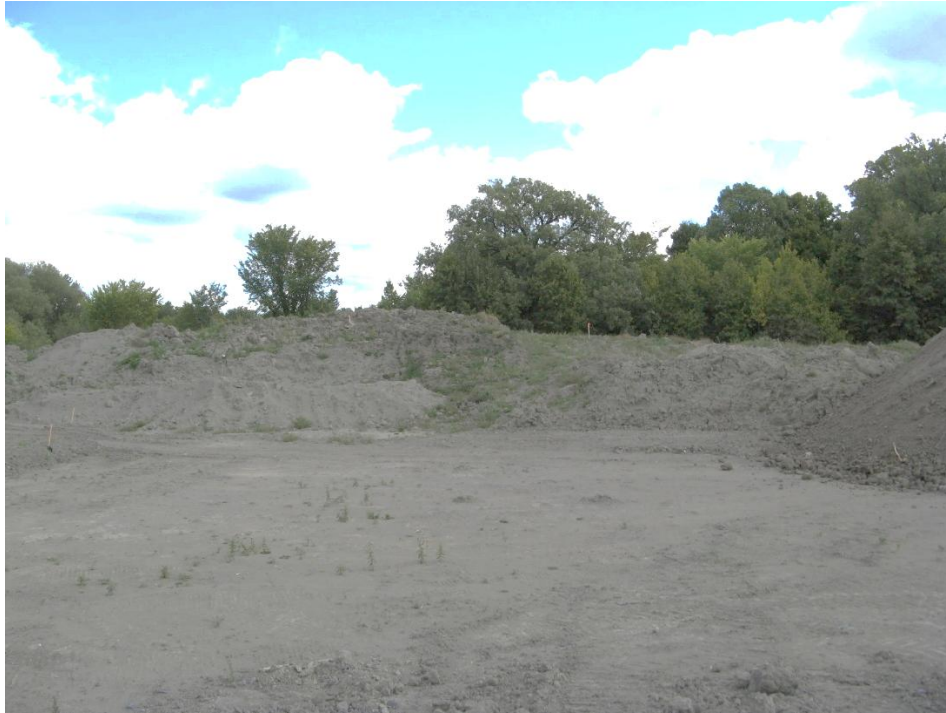
*Photo 1 – Current condition of the site.  
View looking east from Hilversum Lane, with ravine forest edge in the background*

The vegetation and topsoil have been removed from the current site (Photo 1), which was dominated by frequently cut cultural meadow on former agricultural lands. Trees remain in the central ravine containing the Carp River tributary to the east of the current site. Ground flora has begun to regenerate on stockpiles of topsoil along the east edge of the current site (Photo 3). Common ground flora includes Canada thistle, orchard grass, timothy, barnyard grass, common mullein, common milkweed, wild parsnip, red clover, white-sweet clover, common burdock, wormseed mustard, tufted vetch, lamb's quarter, lady's thumb, sheep sorrel, common mugwort, common plantain, and Canada goldenrod.

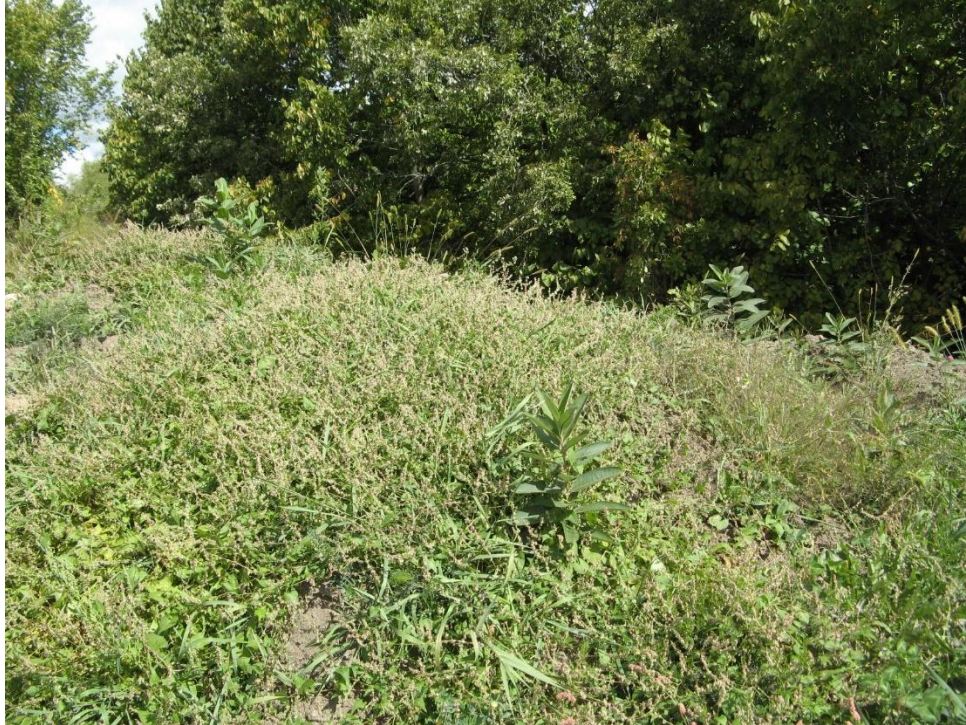
*Photo 3 – Regenerating ground vegetation on portions of the topsoil stockpiles along the east edge of the current site. View looking northeast to outer ravine trees*

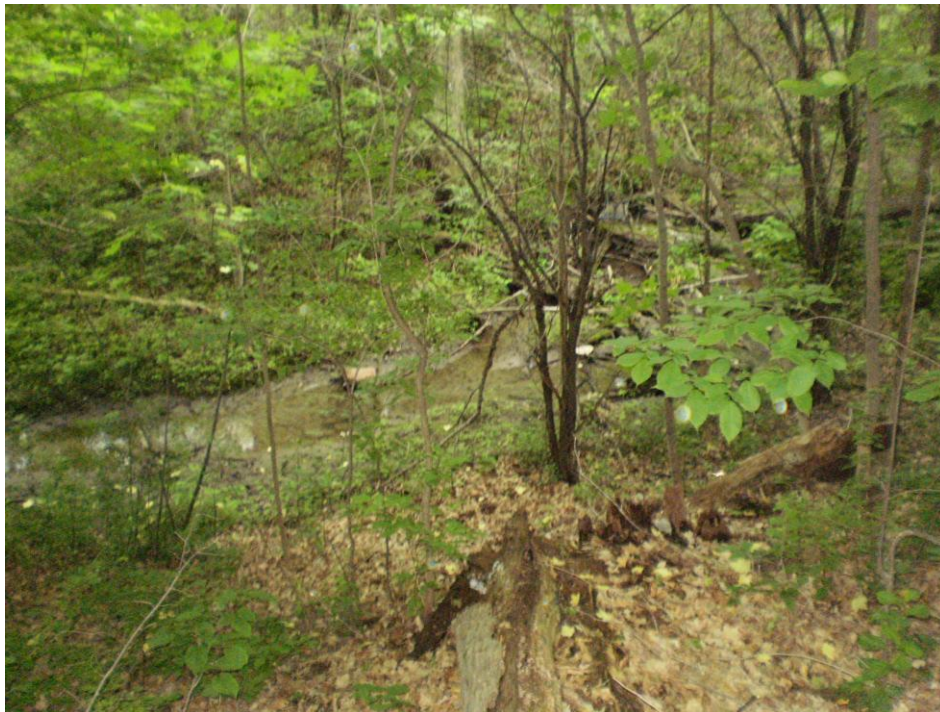
*Photo 4 – Channel with flowing water on June 20<sup>th</sup> in the adjacent ravine. View looking northwest*

Flowing water was observed during the 2019 surveys in the channel at the base of the central ravine (Photo 4), with the channel dry in September, 2025 after a very dry August (Photo 5). The potential fish habitat in the channel is greatly limited by the lack of an open connection with the Carp River to the south, the use of the upper portion of the central ravine as a stormwater management feature, and two long 60cm csp culverts within the central ravine channel. The downstream ends of these culverts are perched, with a 40cm step noted on June 20<sup>th</sup>, 2019. Thus, fish movement through these culverts does not appear possible. The exposed substrate included hard pack clay with some rock protection in association with the culverts providing coarser material. Geo Morphix (2022) noted that the channel banks were composed of clay, silt and sand, and the average bankfull channel width for the channel in the central ravine was estimated at approximately 3.0 metres. Signs of erosion were noted by Paterson (2022) along the lower portion of the slope face that confines the channel in the central ravine. Some minor sloughing failures were also noted by Paterson (2022) in the lower portion of the slope, leaving some exposed tree roots. No evidence of active erosion was noted along the toe of slope.

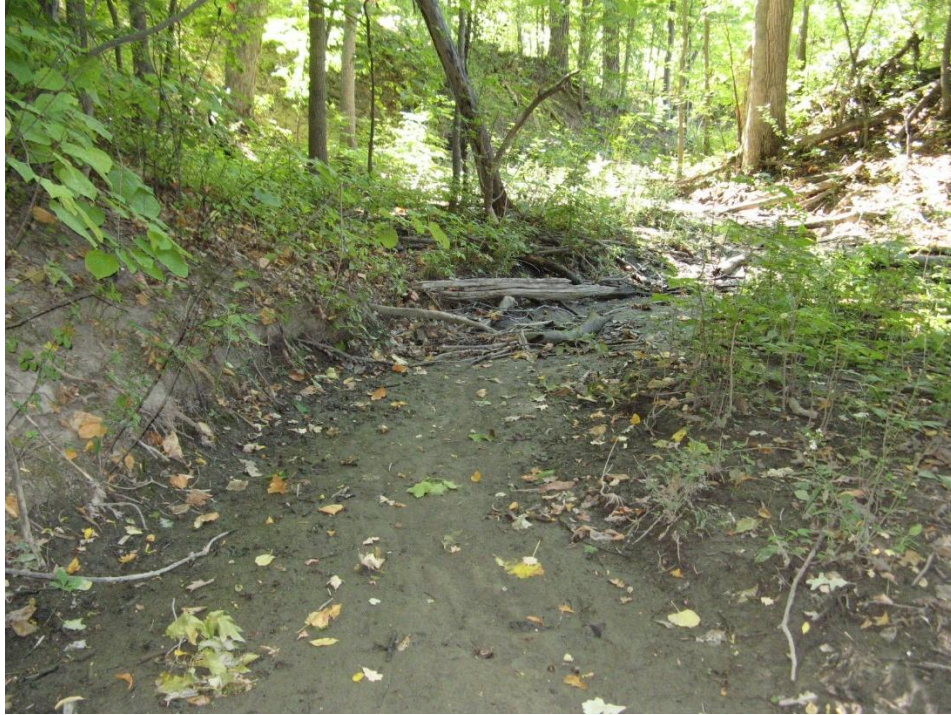
*Photo 5 – Channel was dry on September 9<sup>th</sup>, 2025 after a very dry August.  
View looking north*

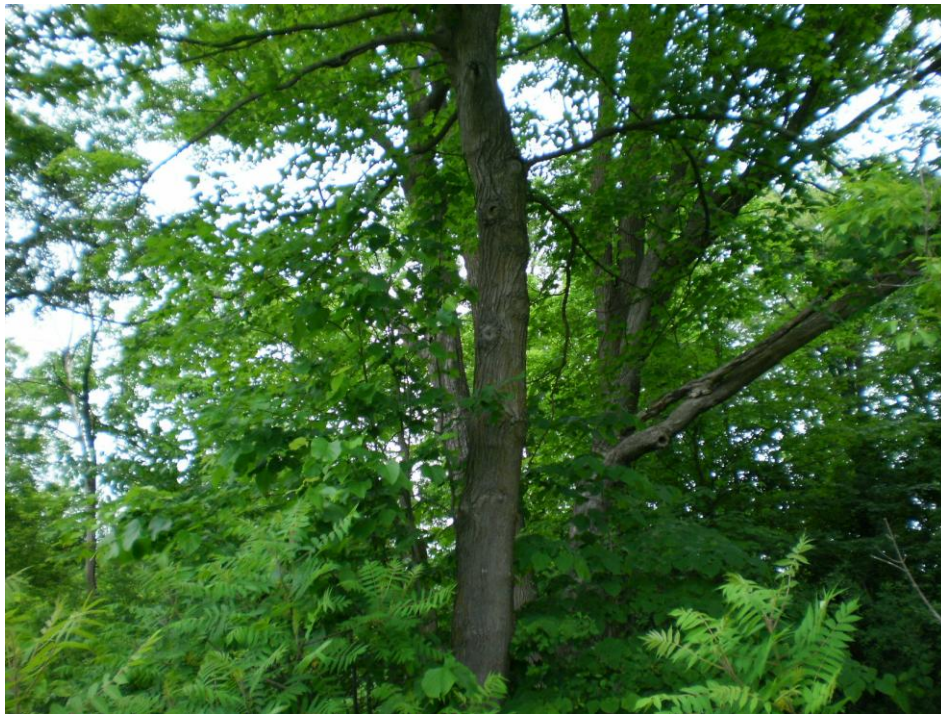
*Photo 6 – Mature sugar maple in the central ravine. View looking west*

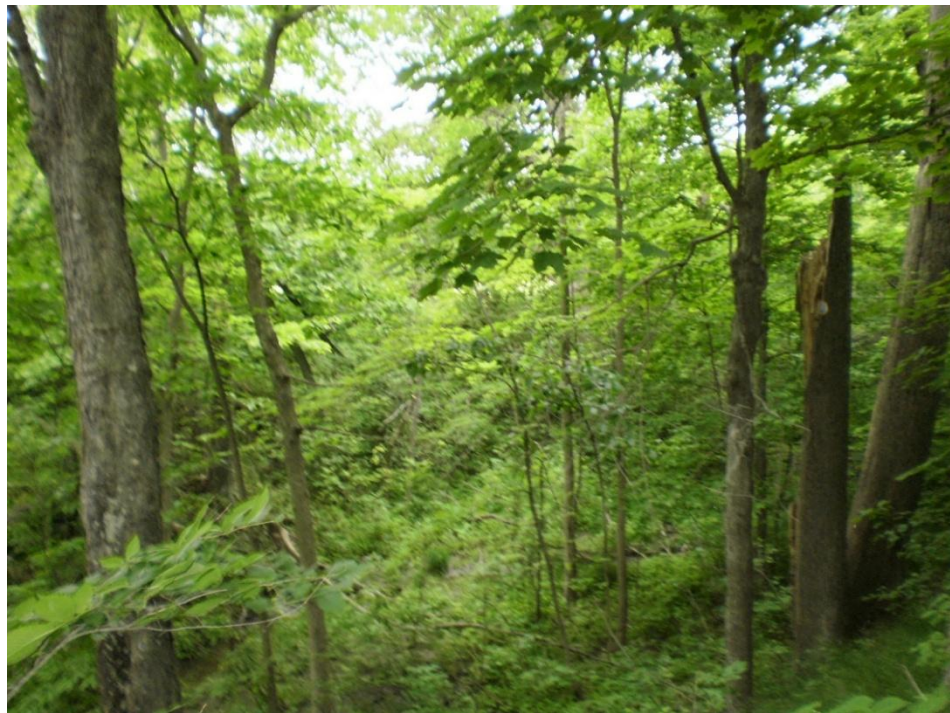
*Photo 7 – Central ravine is generally well covered with deciduous trees. View looking northwest*

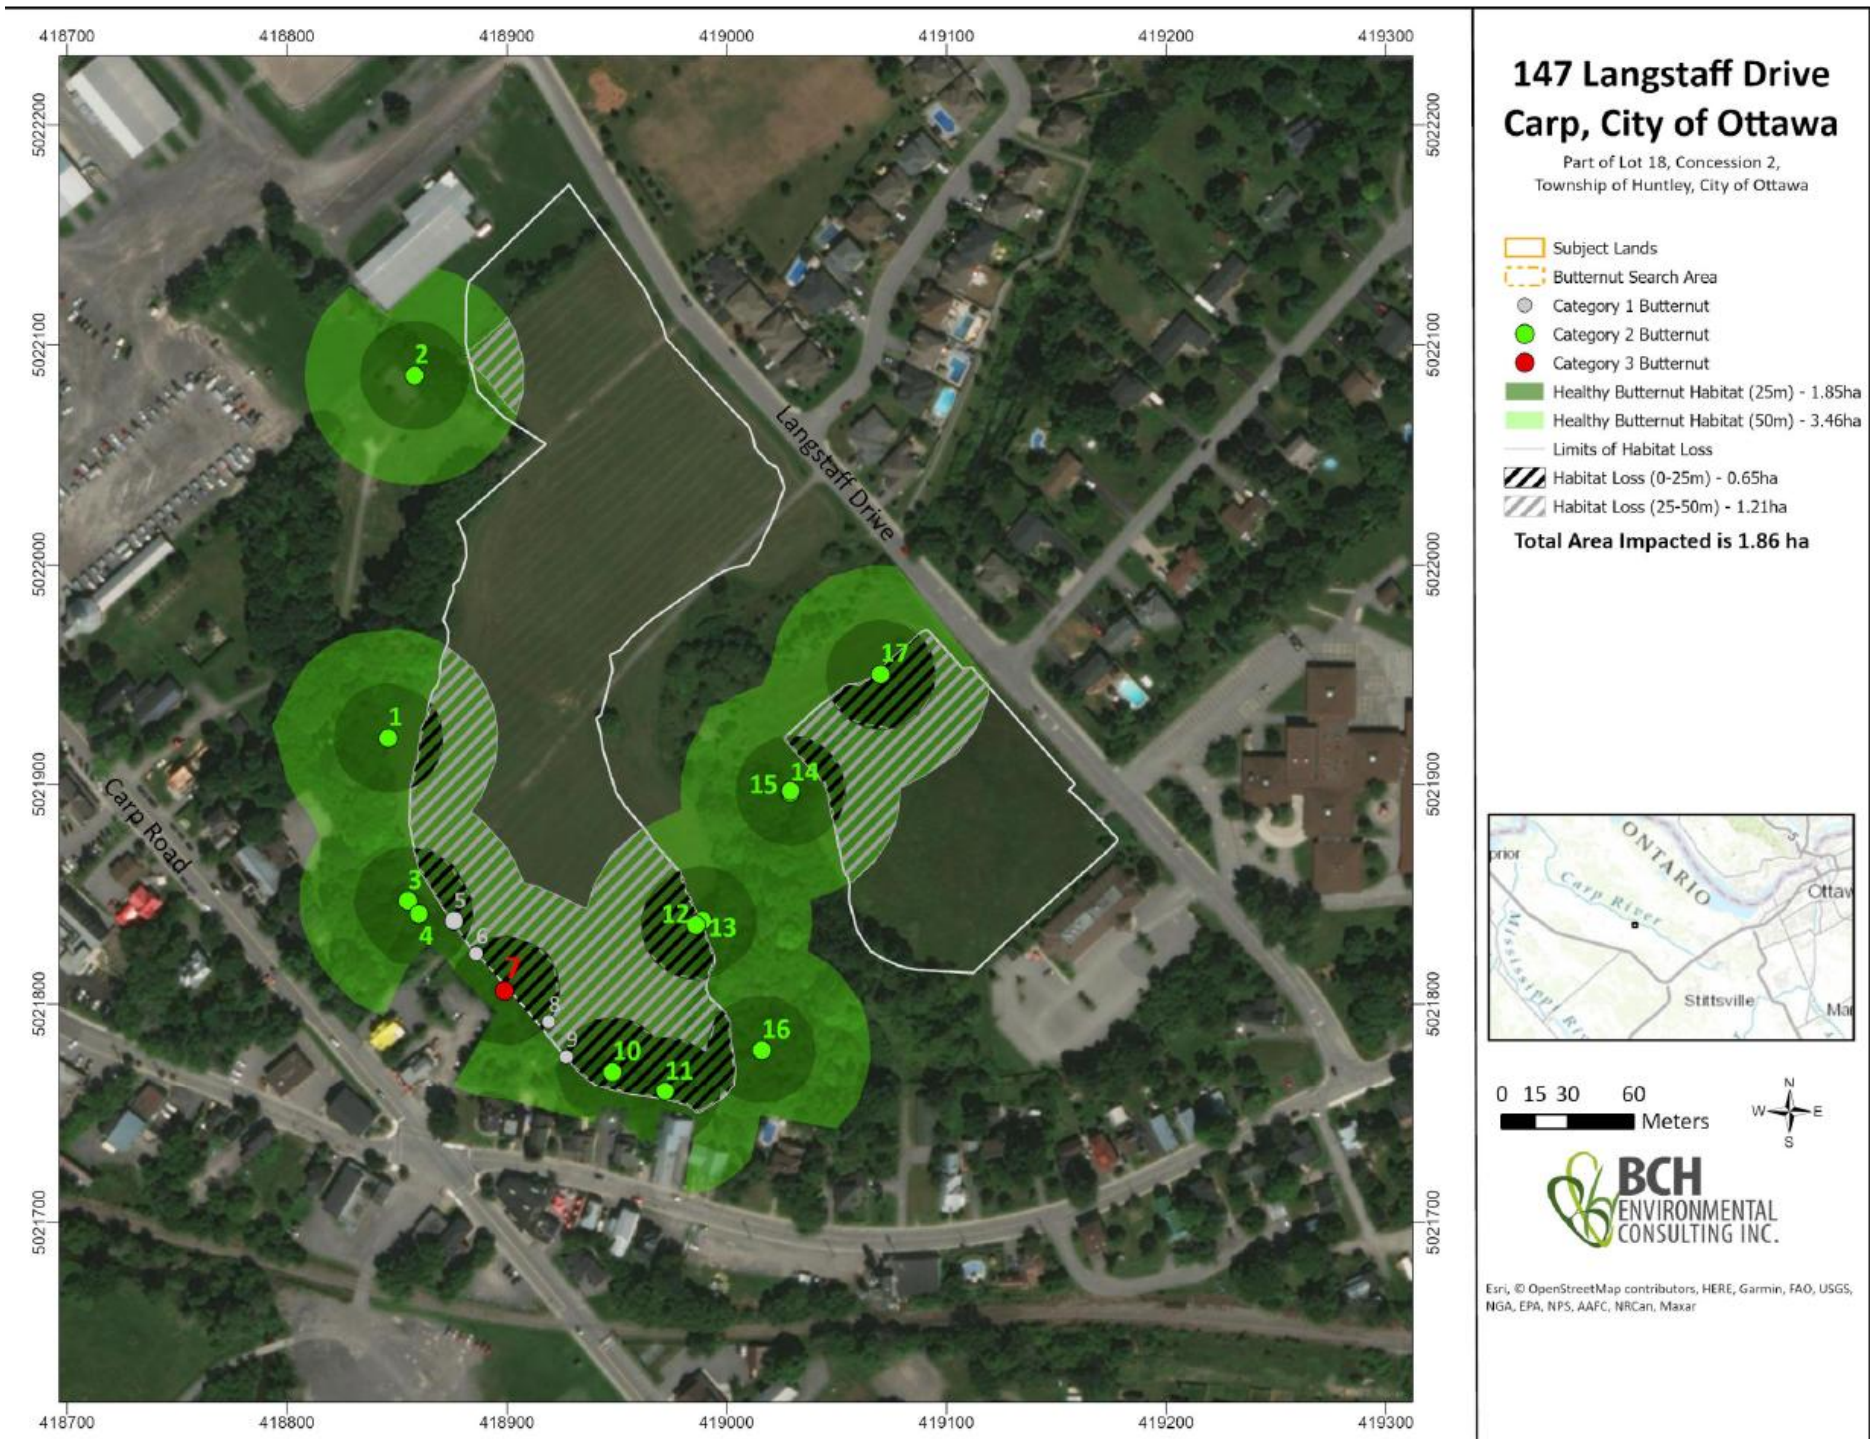
FIGURE 2 – BUTTERNUT LOCATIONS for OVERALL SITE, ASSESSMENT CATEGORIES and HABITAT IMPACTS

In addition to bobolink and eastern meadowlark, butternut has the potential to be on and adjacent to the overall site and seventeen butternuts were assessed on the overall site on June 20<sup>th</sup>, 2019 by Shaun St. Pierre (Figure 2). Fourteen of the 17 butternuts were assessed as healthy but the majority were very young with 10 of the 14 butternuts assessed as Category 2 trees 4cm dbh or less. Two other healthy butternuts (20cm and 31cm dbh) along the west edge of the overall site were originally assessed as Category 3 trees. These trees were reassessed in June, 2021 and the original Category 3 tree to the north (butternut # 5) was assessed as a Category 1 tree, with butternut # 7 remaining a Category 3 tree (see red dot on Figure 2). The other Category 2
