Phase Two Environmental Site Assessment – Northeast Part of 1900 Cyrville Road, Ottawa, Ontario

Final Report

Project No.: 121626297.300

The Phase Two ESA was conducted in support of a Site Plan Control Application for a proposed Costco retail fuel facility at the Site. Stantec understands that a Record of Site Condition is not required by the Ontario Ministry of the Environment, Conservation and Parks (MECP), as the future land use of the Phase Two Property will remain unchanged from its existing commercial use. As such, the Phase Two ESA has been completed in general accordance with Ontario Regulation 153/04 (O. Reg. 153/04), as amended.

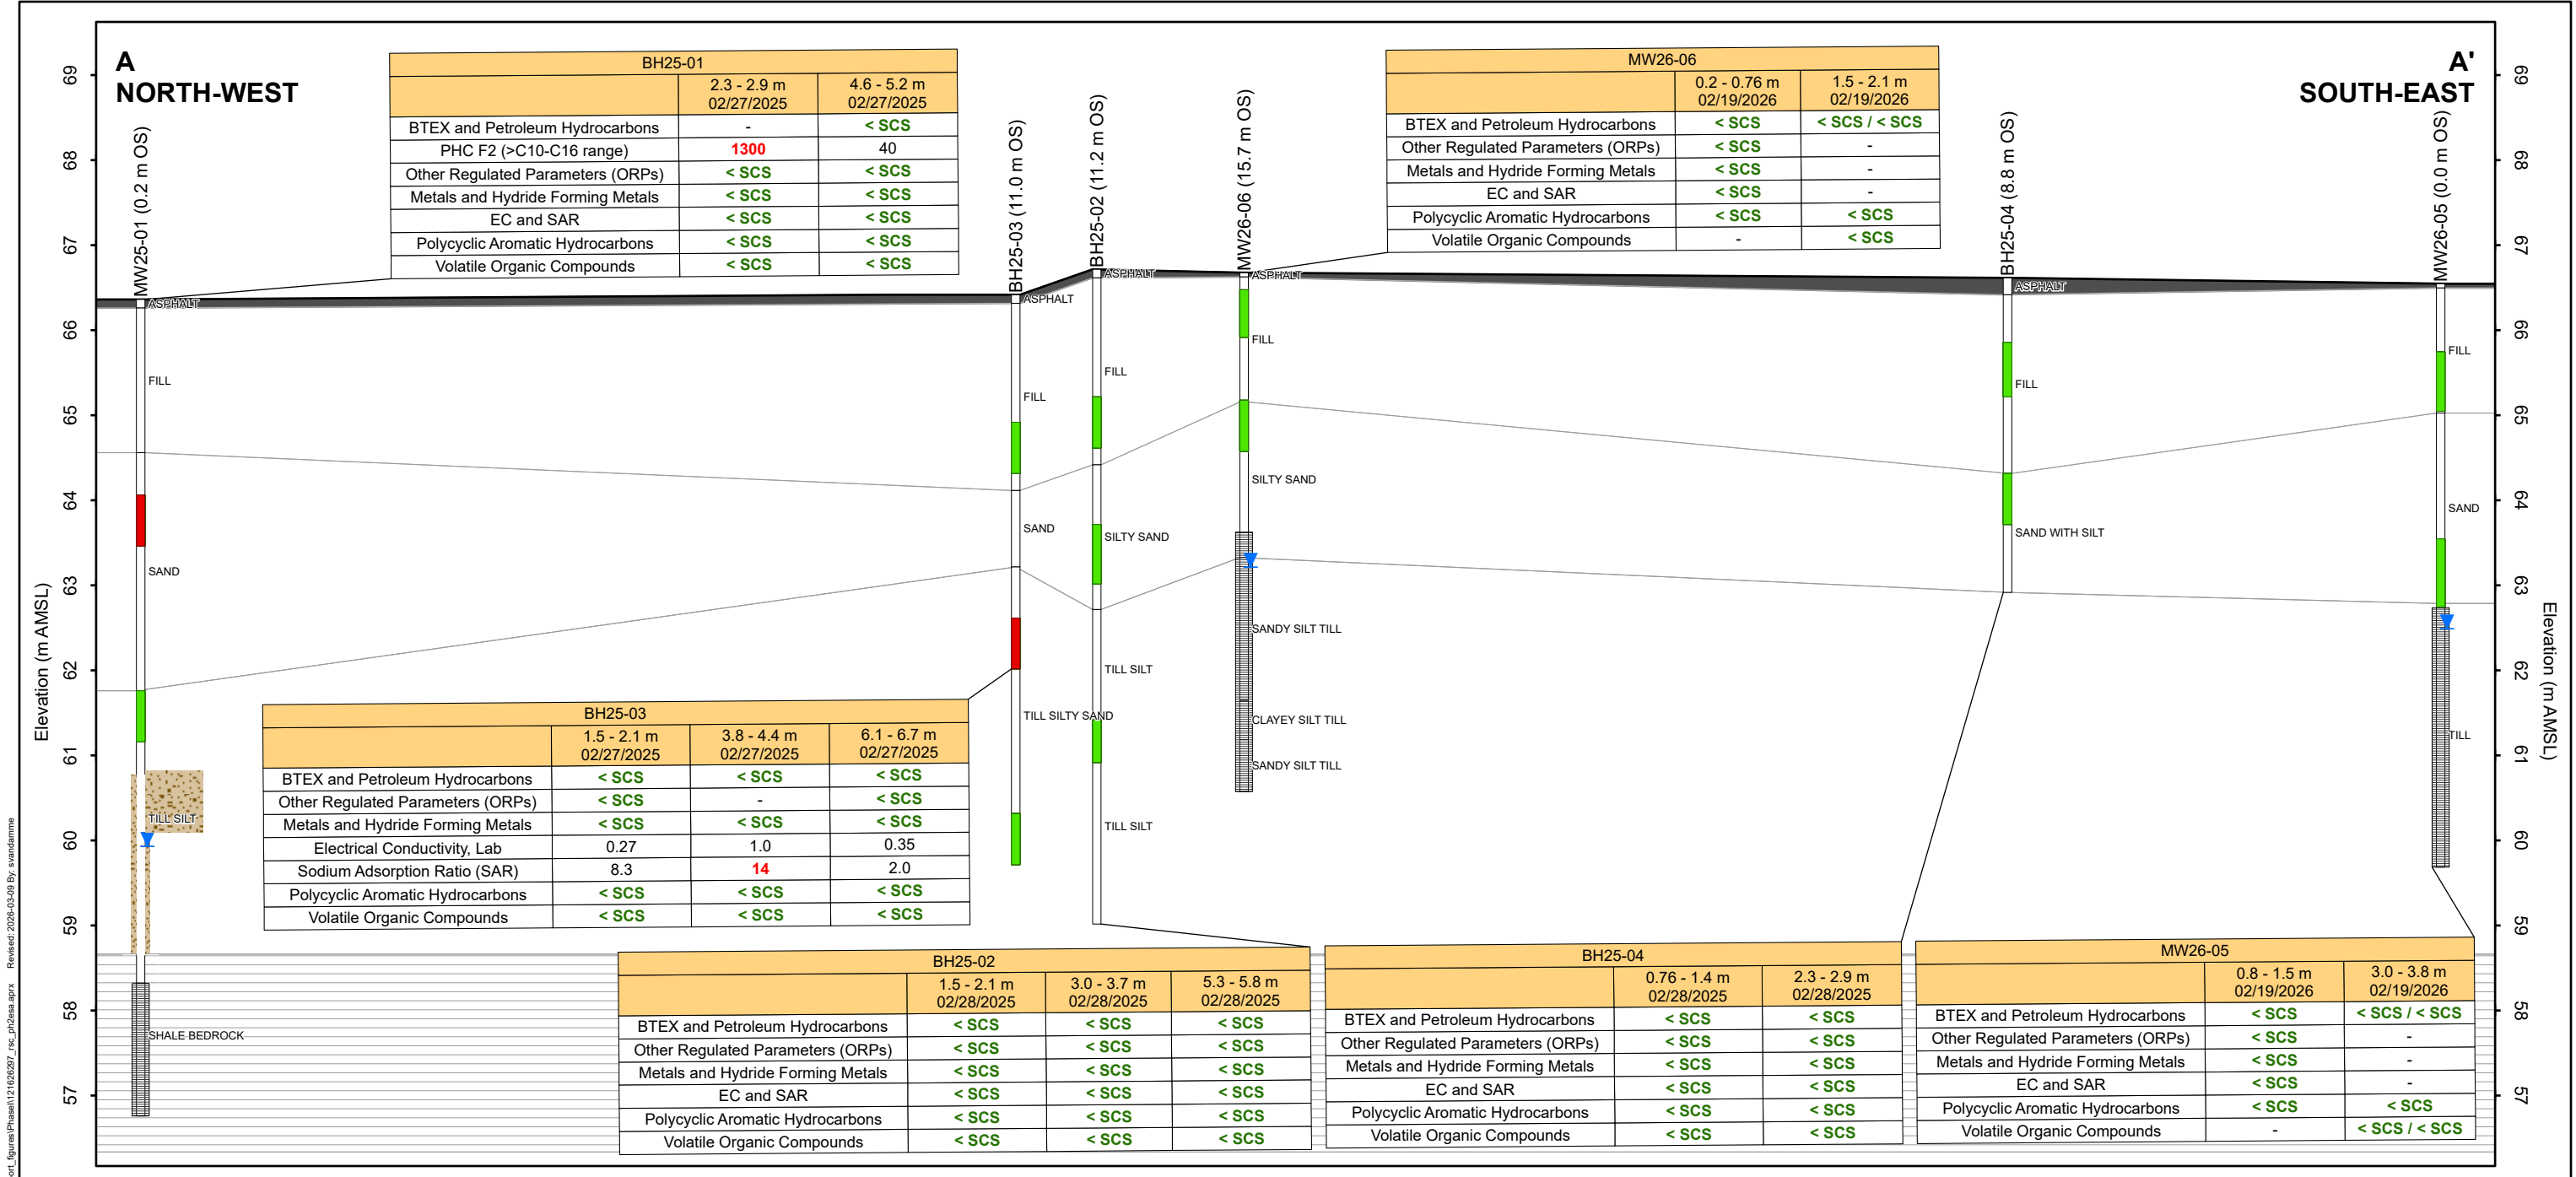
Figure No.
6a
 Title
Summary of Soil Analytical Results

A total of 16 soil samples were submitted for analysis of benzene, toluene, ethylbenzene, xylenes (BTEX), PHC fractions 1 to 4 (F1–F4), volatile organic compounds (VOCs), polycyclic aromatic hydrocarbons (PAHs), metals and/or inorganics. Laboratory results for all soil samples analyzed as part of this investigation reported concentrations below the applicable Table 3 Site Condition Standards (SCS), with the exception of a PHC F2 exceedance in soil at location MW25-01 (1,300 micrograms per gram [$\mu\text{g/g}$]) at a depth of approximately 2.3–2.9 m BGS. The applicable Table 3 SCS for soil PHC F2 is 230 $\mu\text{g/g}$.

Based on the results of the Phase Two ESA, PHC F2-impacted soil, considered localized in the vicinity of MW25-01 at depths of approximately 2.3–2.9 m BGS, requires remediation. As this location corresponds to the future underground storage tank nest, as per Costco, Stantec recommends that the soil impact remediation be undertaken at the time of the Site redevelopment. Impacted soil should be excavated and transported to a Class 1 soil management facility for appropriate off-site disposal, and a qualified environmental consultant should be present to characterize the soil conditions within the final extent of the excavation.
