Phase One Environmental Site Assessment

175 Inlet Private
Ottawa, Ontario

Prepared for:
11034396 Canada Inc.

LOP25-031A

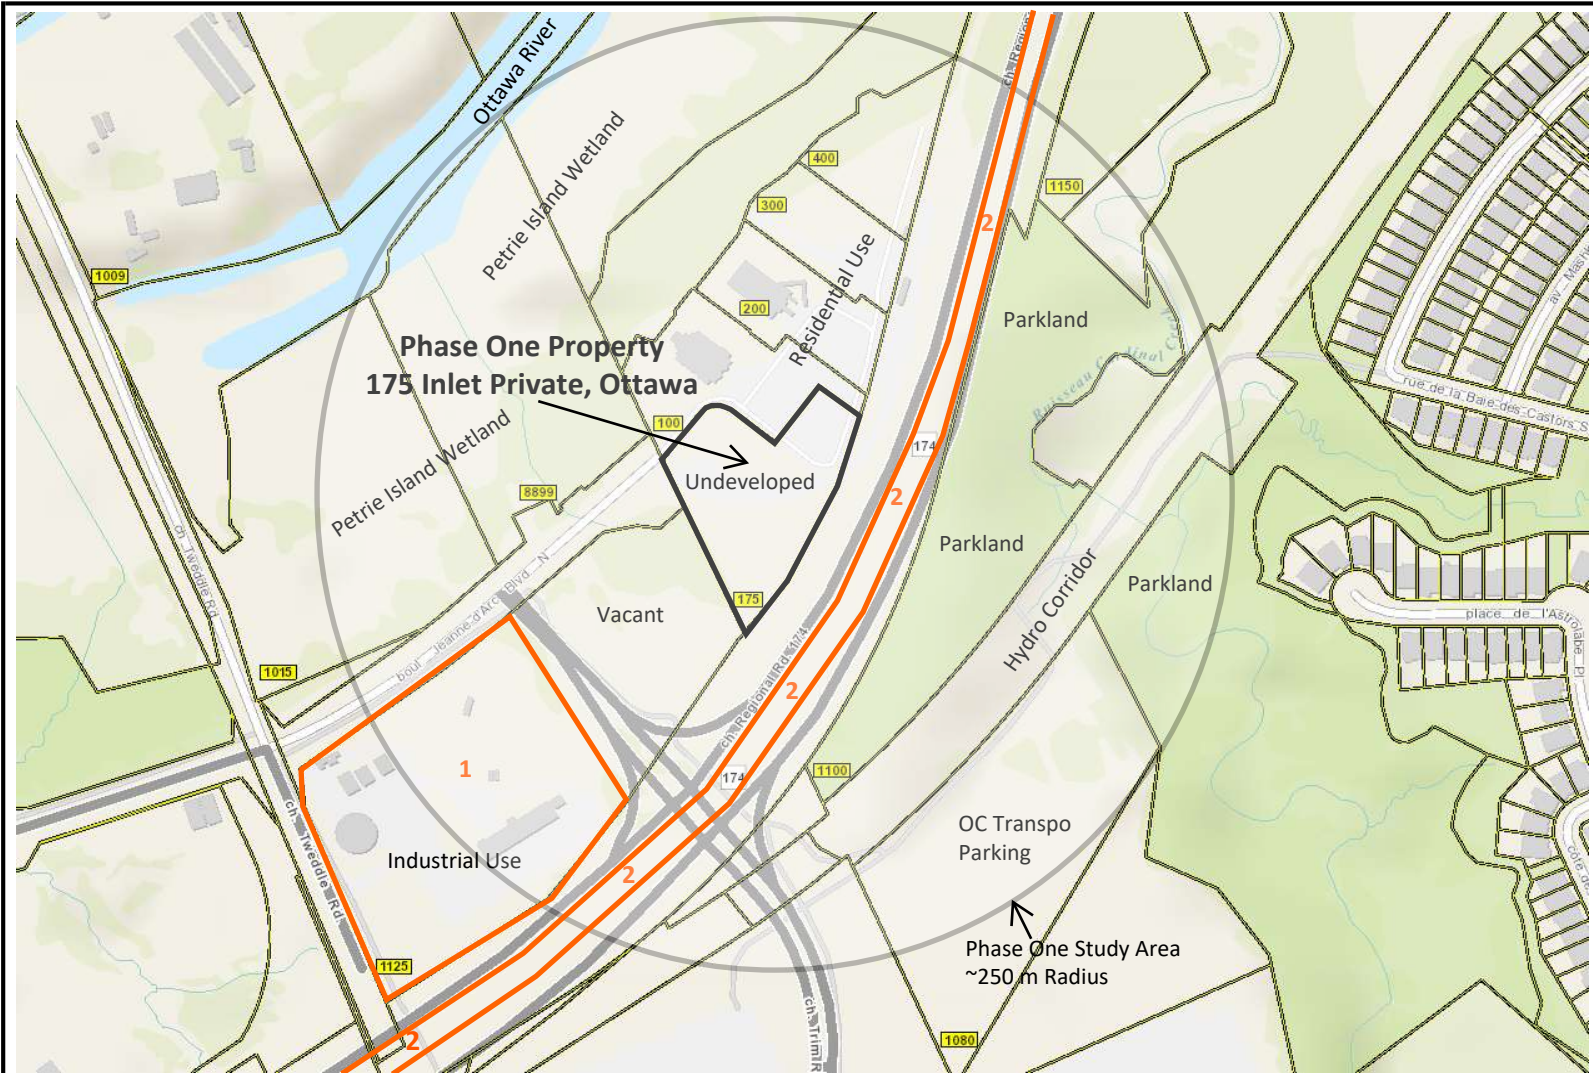
Neighbouring land uses are shown on Figure 3: Surrounding Land Use. One PCA was observed during the review of land use in the Phase One Study Area.

Potentially Contaminating Activity

- 1** Municipal Works Yard, Private Fuel Outlet, Reported Fuel Storage and historical spills
- 2** Former Railway

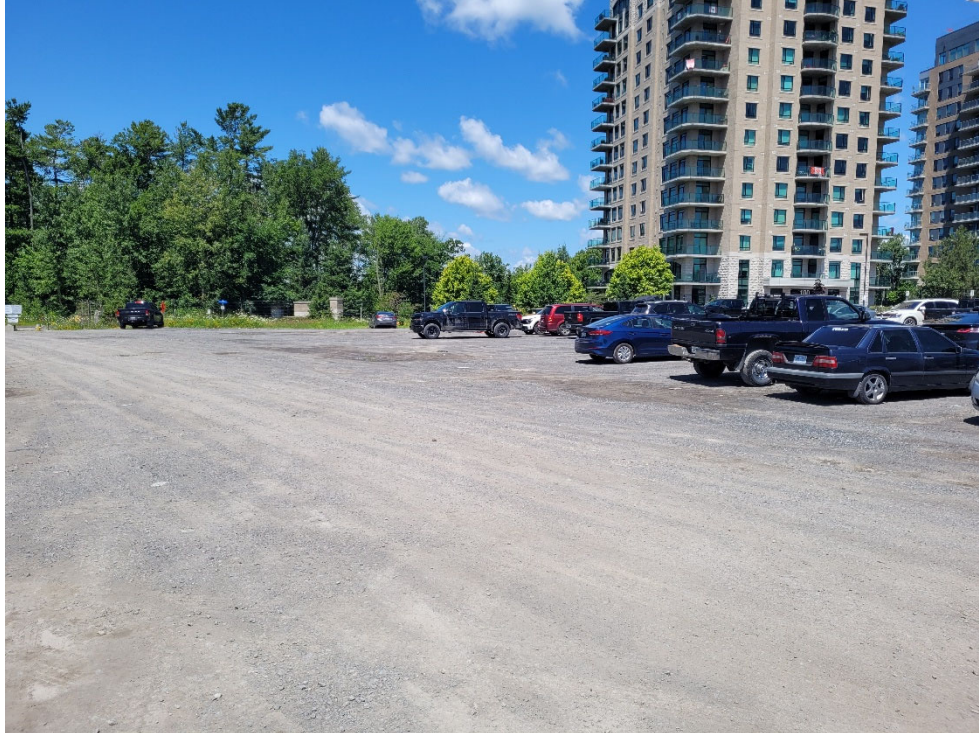
Photograph 1: View of the of the north portion of the Phase One Property looking north. View shows the parking area used by construction employees and access to the Site from Inlet Private to the north.

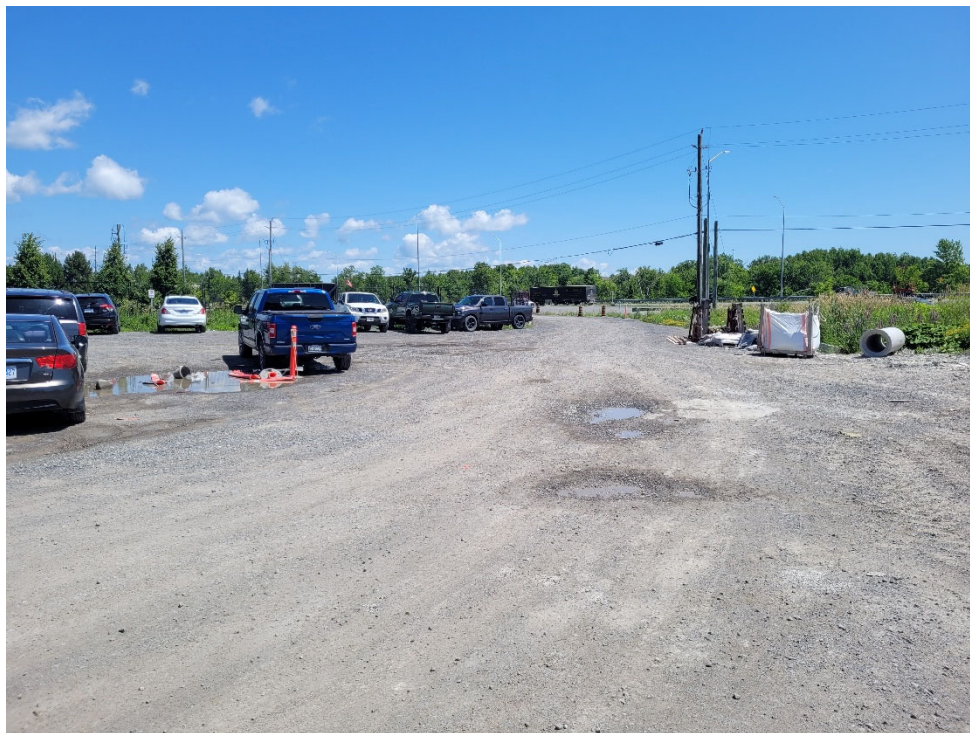
Photograph 2: View of the of the south portion of the Phase One Property looking southeast. View shows the parking area used by construction employees and the access road connecting the adjacent residential construction Site to Inlet Private.

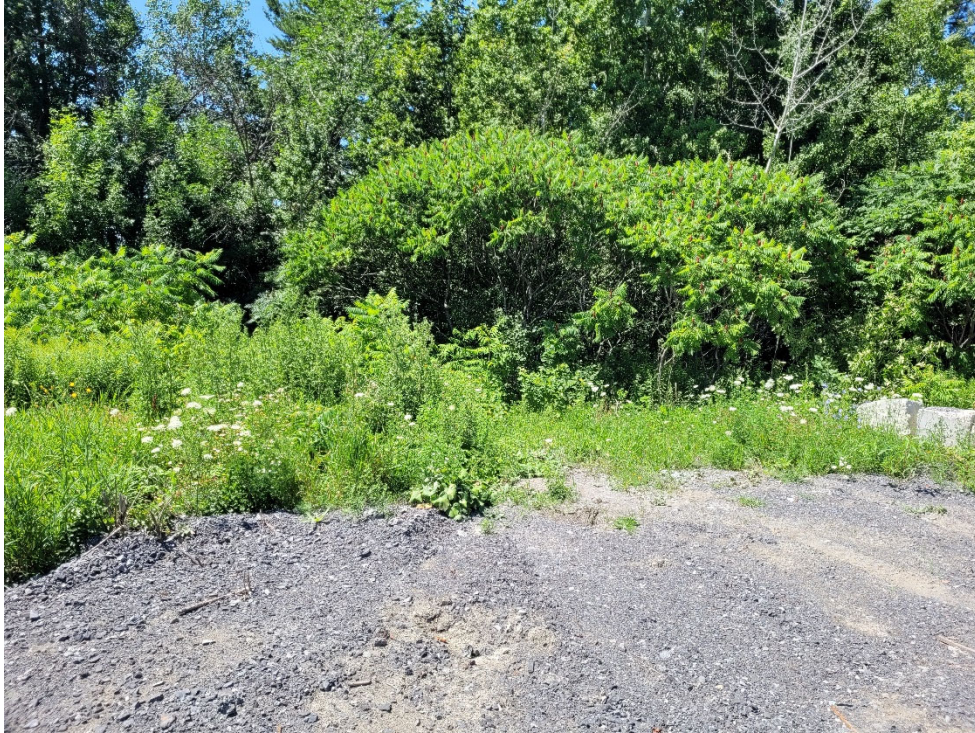
Photograph 3: View of the of the west portion of the Phase One Property looking west. View shows the overgrown vegetation on the west portion of the Property.

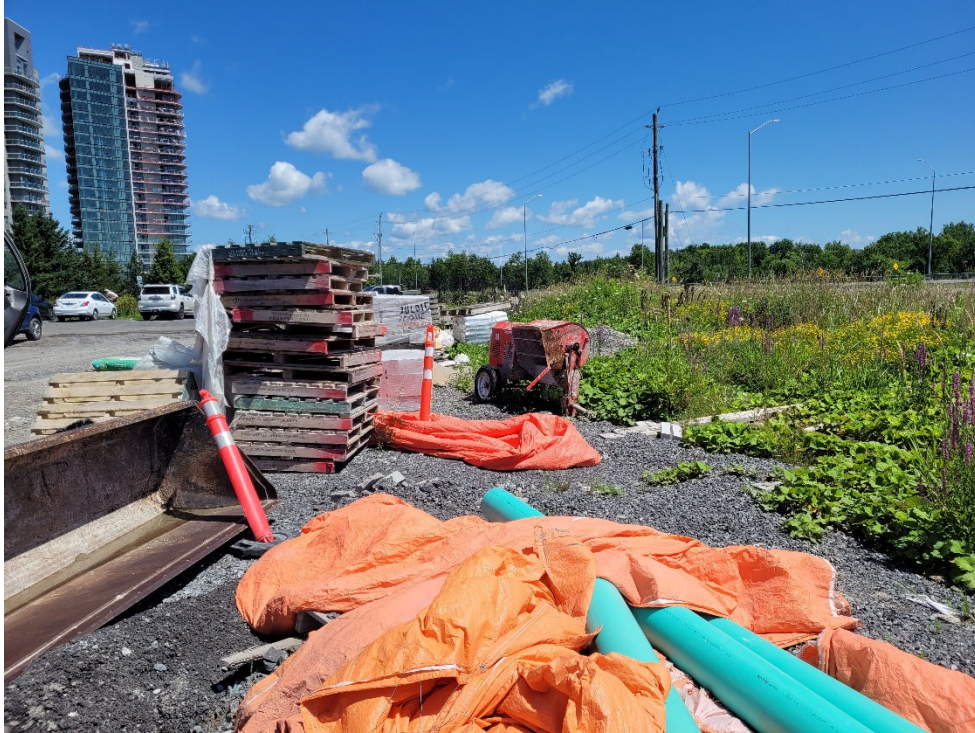
Photograph 5: View of the of the south portion of the Phase One Property looking east. View shows typical material storage for the adjacent construction project.

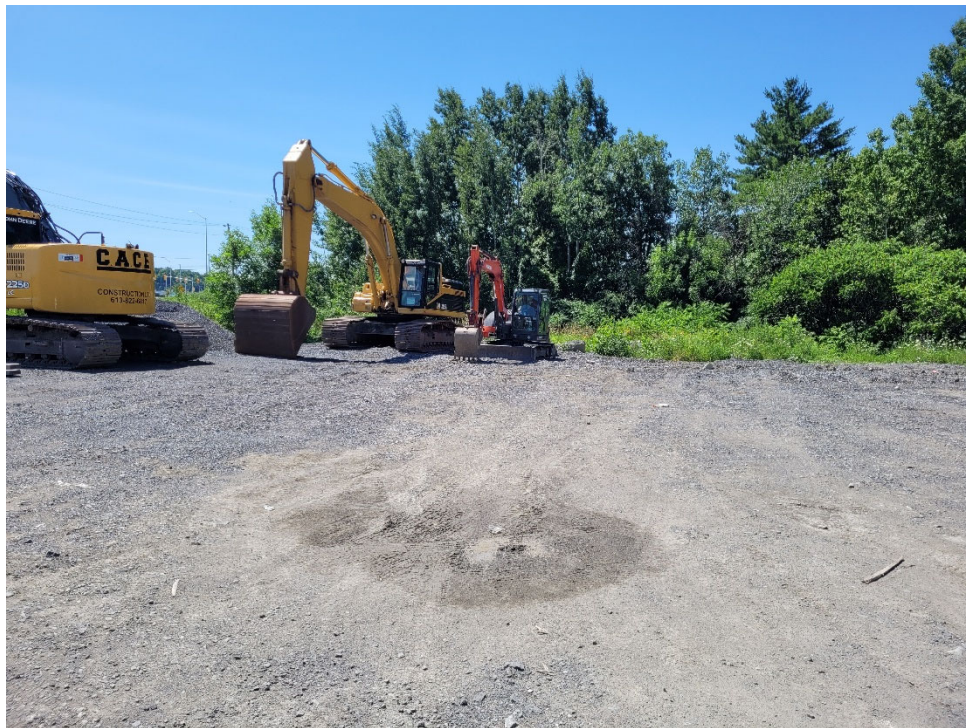
Photograph 6: View of the of the southwest portion of the Phase One Property looking west. View shows construction equipment parking area at the Property.
