Tree Conservation Report

Cisco Ottawa Campus – 2000 & 3000 Innovation Drive

May 5, 2026

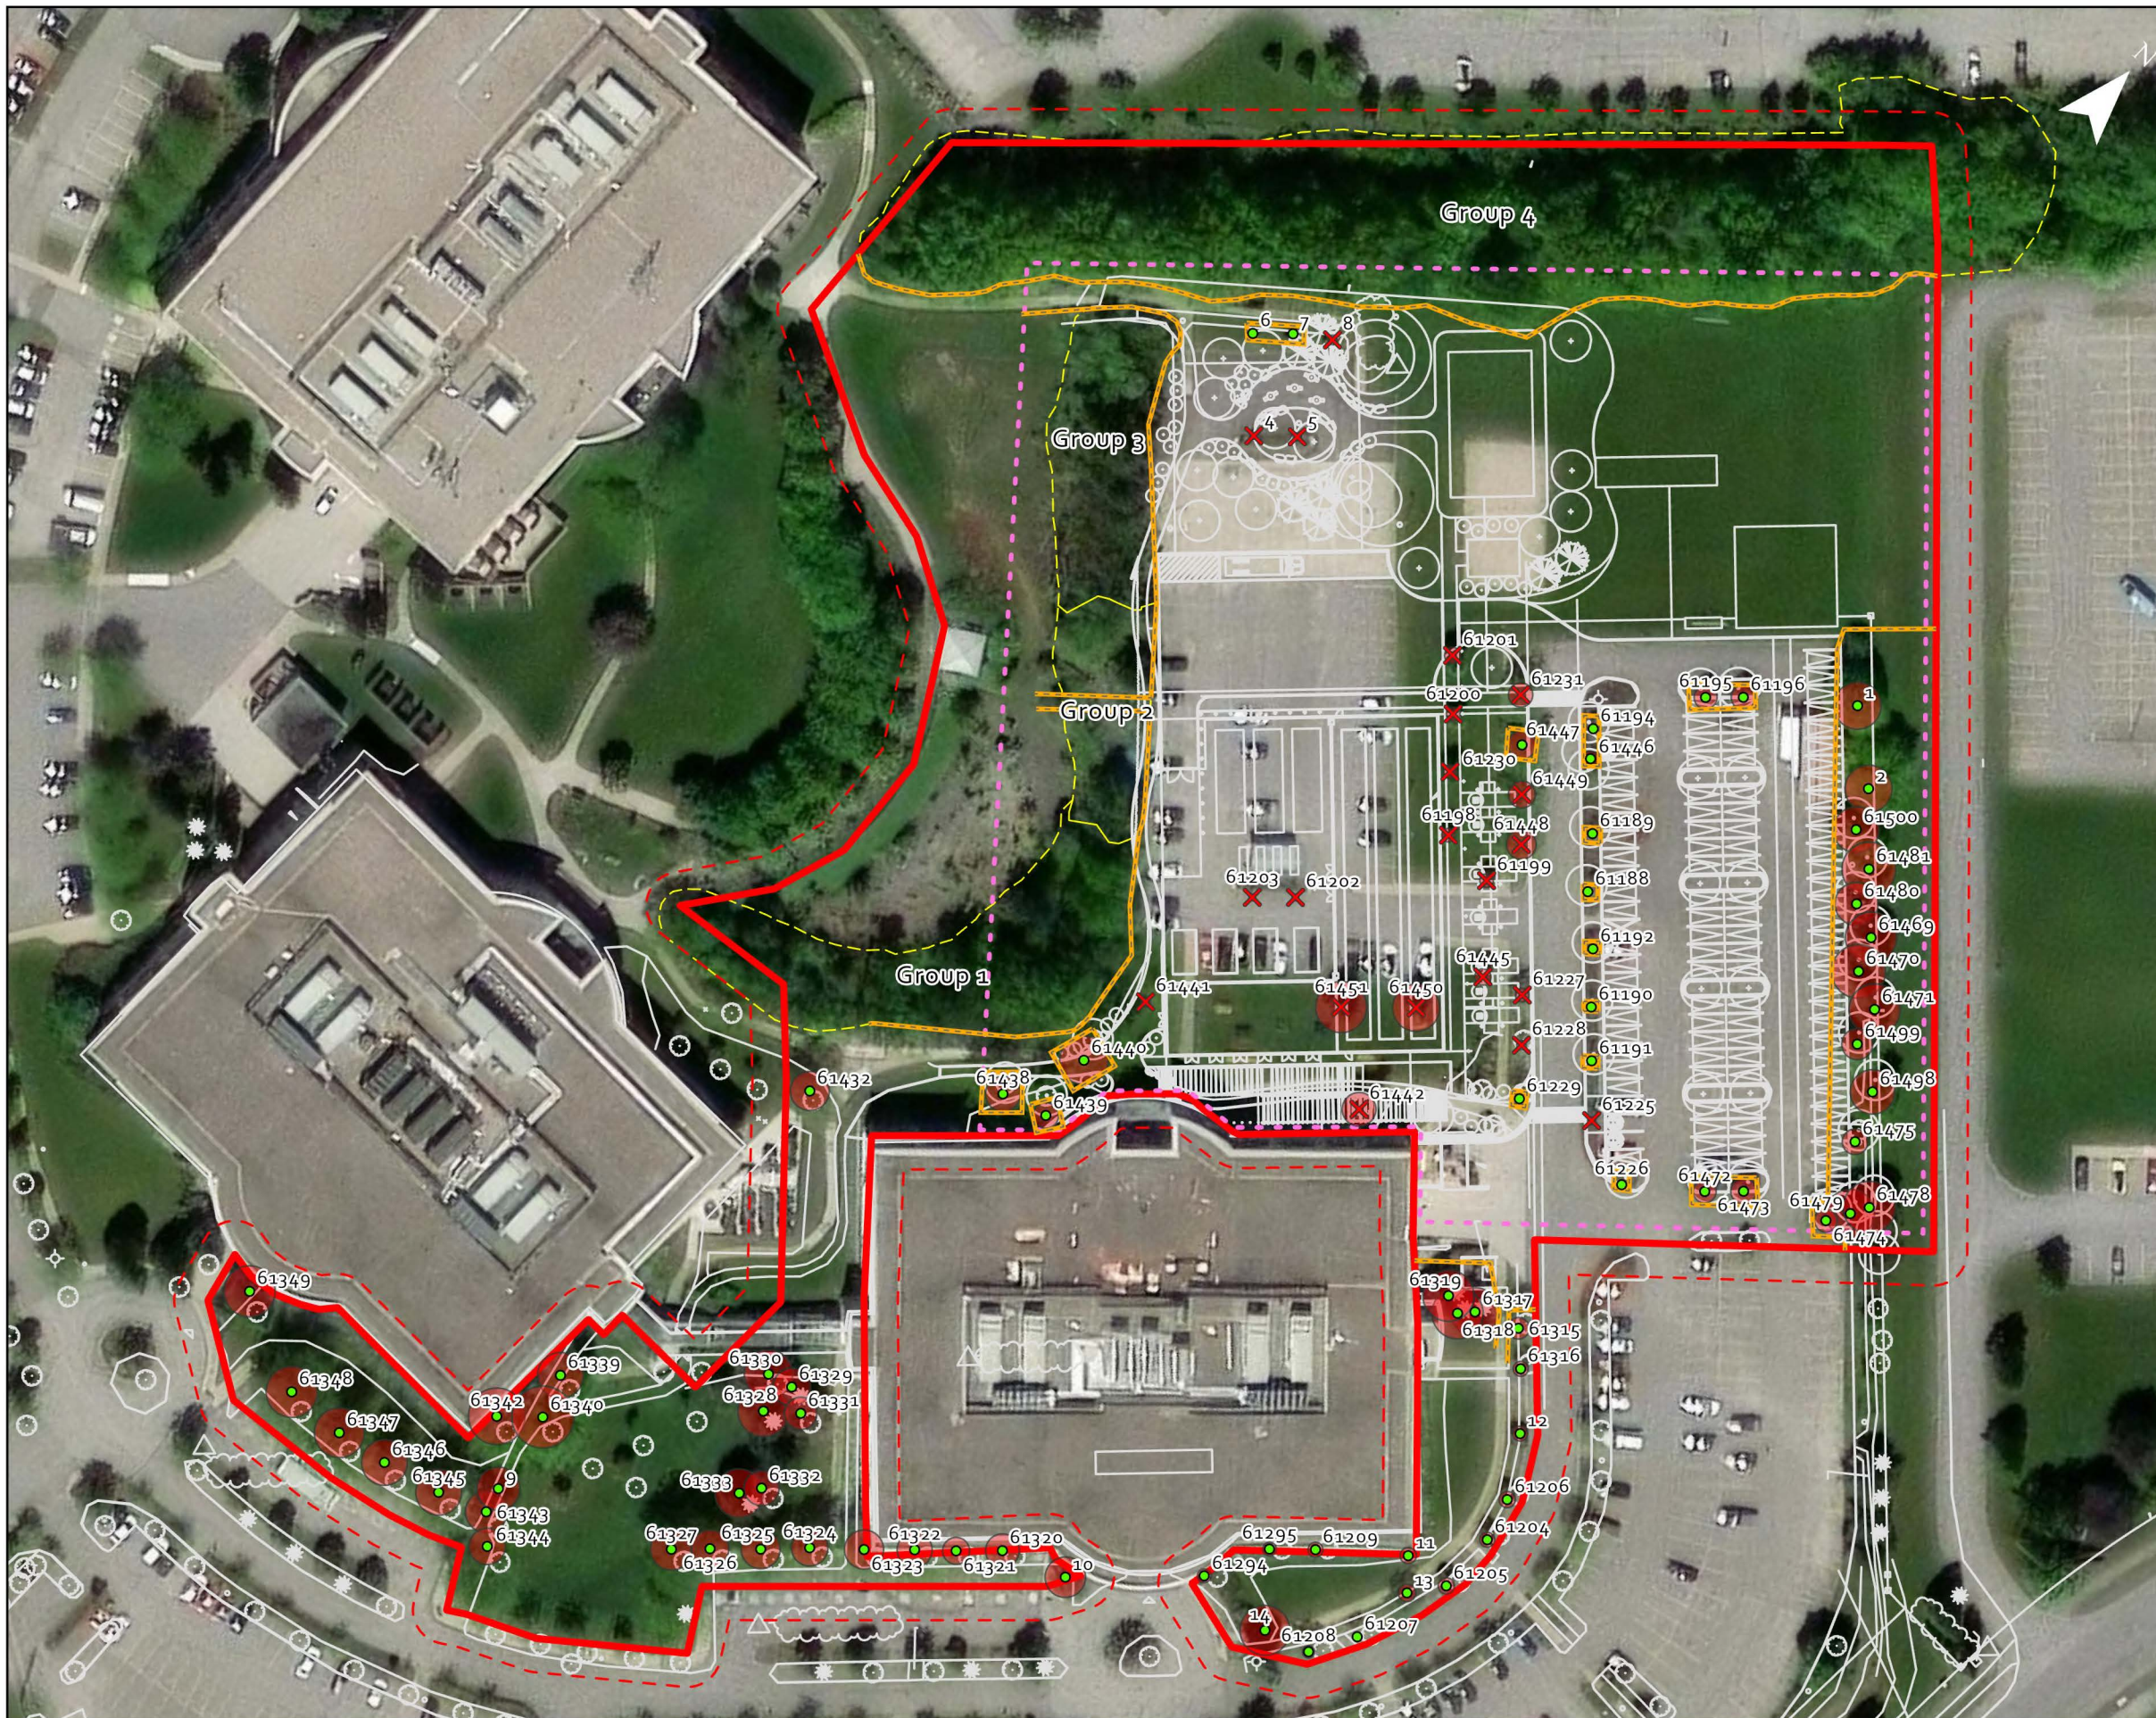
Figure: 4

Based on the conditions of the trees and extent of the proposed construction limits, **Table 2** summarizes the impact and recommended actions of the 101 trees and four (4) tree groups assessed within the Site. It is anticipated that 21 trees will need to be removed within the construction limits. 8 of these are 5 to 9 cm diameter at breast height (DBH) and 13 are >10 cm diameter at breast height (DBH). 80 trees four (4) tree groups on the Site will be retained. These details are depicted on Mandatory Map 2 below (**Figure 3**), as per the City of Ottawa, 2021, and outlined in the Tree Inventory and Assessment Table included in **Appendix A**. Based on the proposed project design no work is anticipated within the critical root zone of any of the retained trees.

Title:
**Tree Impact Assessment
 With Site Plan**
 (Map 2 as per City Guidelines)

Based on the proposed project design and existing conditions of the trees on site, 21 trees have been recommended for removal in order to accommodate the construction. The following recommendations are provided:

- Retain a Certified Arborist during site layout operations to confirm recommended tree removals, pruning, and tree protection fencing in proximity to the construction limits.
