Phase One Environmental Site Assessment 133 Forward Avenue, Ottawa, Ontario

In-Harmony Developments Inc.

Phase One Environmental Site Assessment

OTT-25011403-A0

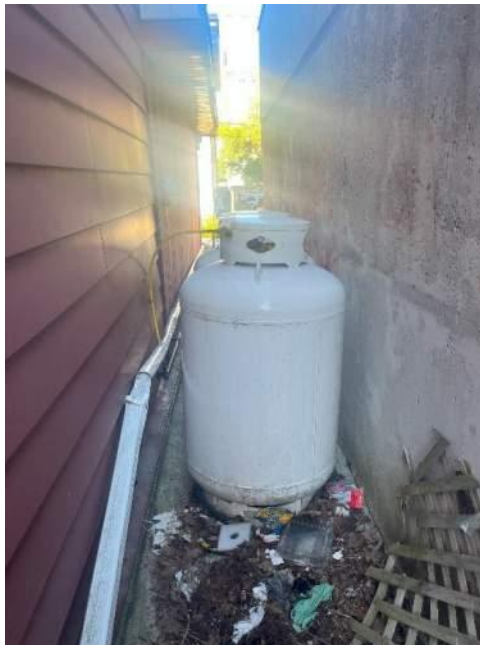
Photograph No. 4

EXP did observe two propane tanks on the north side of the residence. Due to the contents, these ASTs are not considered a concern. Historically, a heating oil AST was present in the southwest corner of the basement. No staining was observed on the concrete floor in this area.

View of the propane tanks on the north side of the residence.

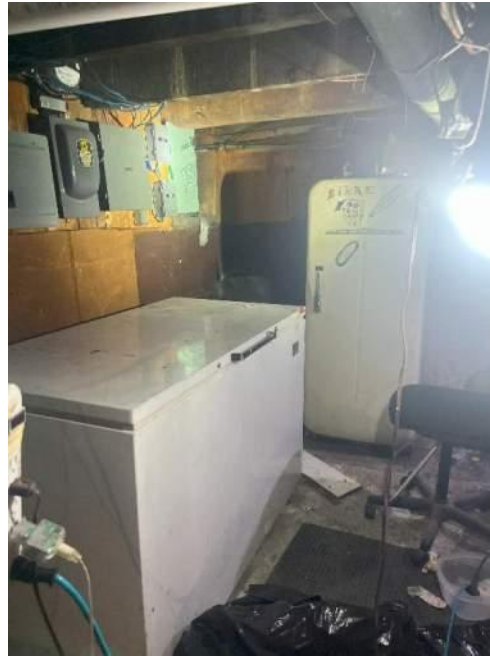
Photograph No. 5

The former on-site furnace oil AST, and the likely presence of fill material on the Phase One property is considered to contribute to APECs. Due to the proximity and inferred up-gradient direction from the Phase One property, the former repair

View of the location of the former furnace oil AST in the basement of the residence.

The Qualified Person who oversaw this work, Leah Wells, P.Eng. recommends that a Phase Two ESA be conducted to address the PCA that may have adversely affected the Phase One property.

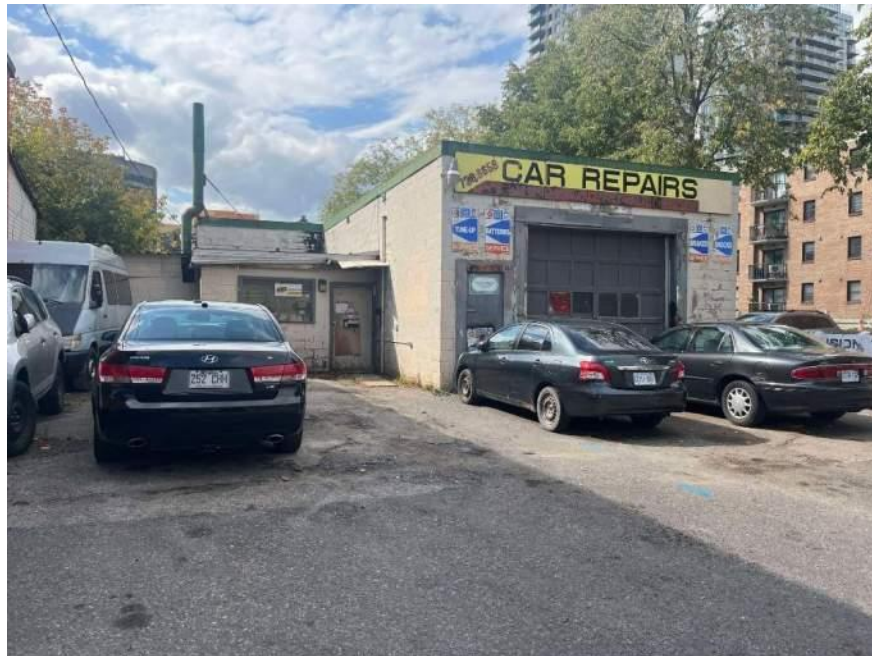
Photograph No. 7

Based on a review of the HLUI database, PCAs identified in the Phase One study included USTs, repair garages, and a former waste disposal site. The garage and USTs at 140 Hinchey Street were considered to contribute to an APEC due to the proximity to and inferred upgradient location from the Phase One property. None of the other off-site PCAs identified in the Phase One study area were considered to contribute to an APEC.

The likely presence of fill material on the Phase One property is considered to contribute to an APEC. Due to the proximity and inferred up-gradient direction from the Phase One property, the former repair garage/gas station at 140 Hinchey Avenue and the furnace oil spill at 154 Hinchey Avenue result in an APEC. None of the other off-site PCAs were determined to contribute to APECs.

View of one of the garage at 140 Hinchey Street.
