TREE CONSERVATION REPORT V2.0

2055 Robertson Road, Ottawa

Tree Conservation Report submitted as Partial
Requirements for a Site Plan Control Application,
November 28, 2025

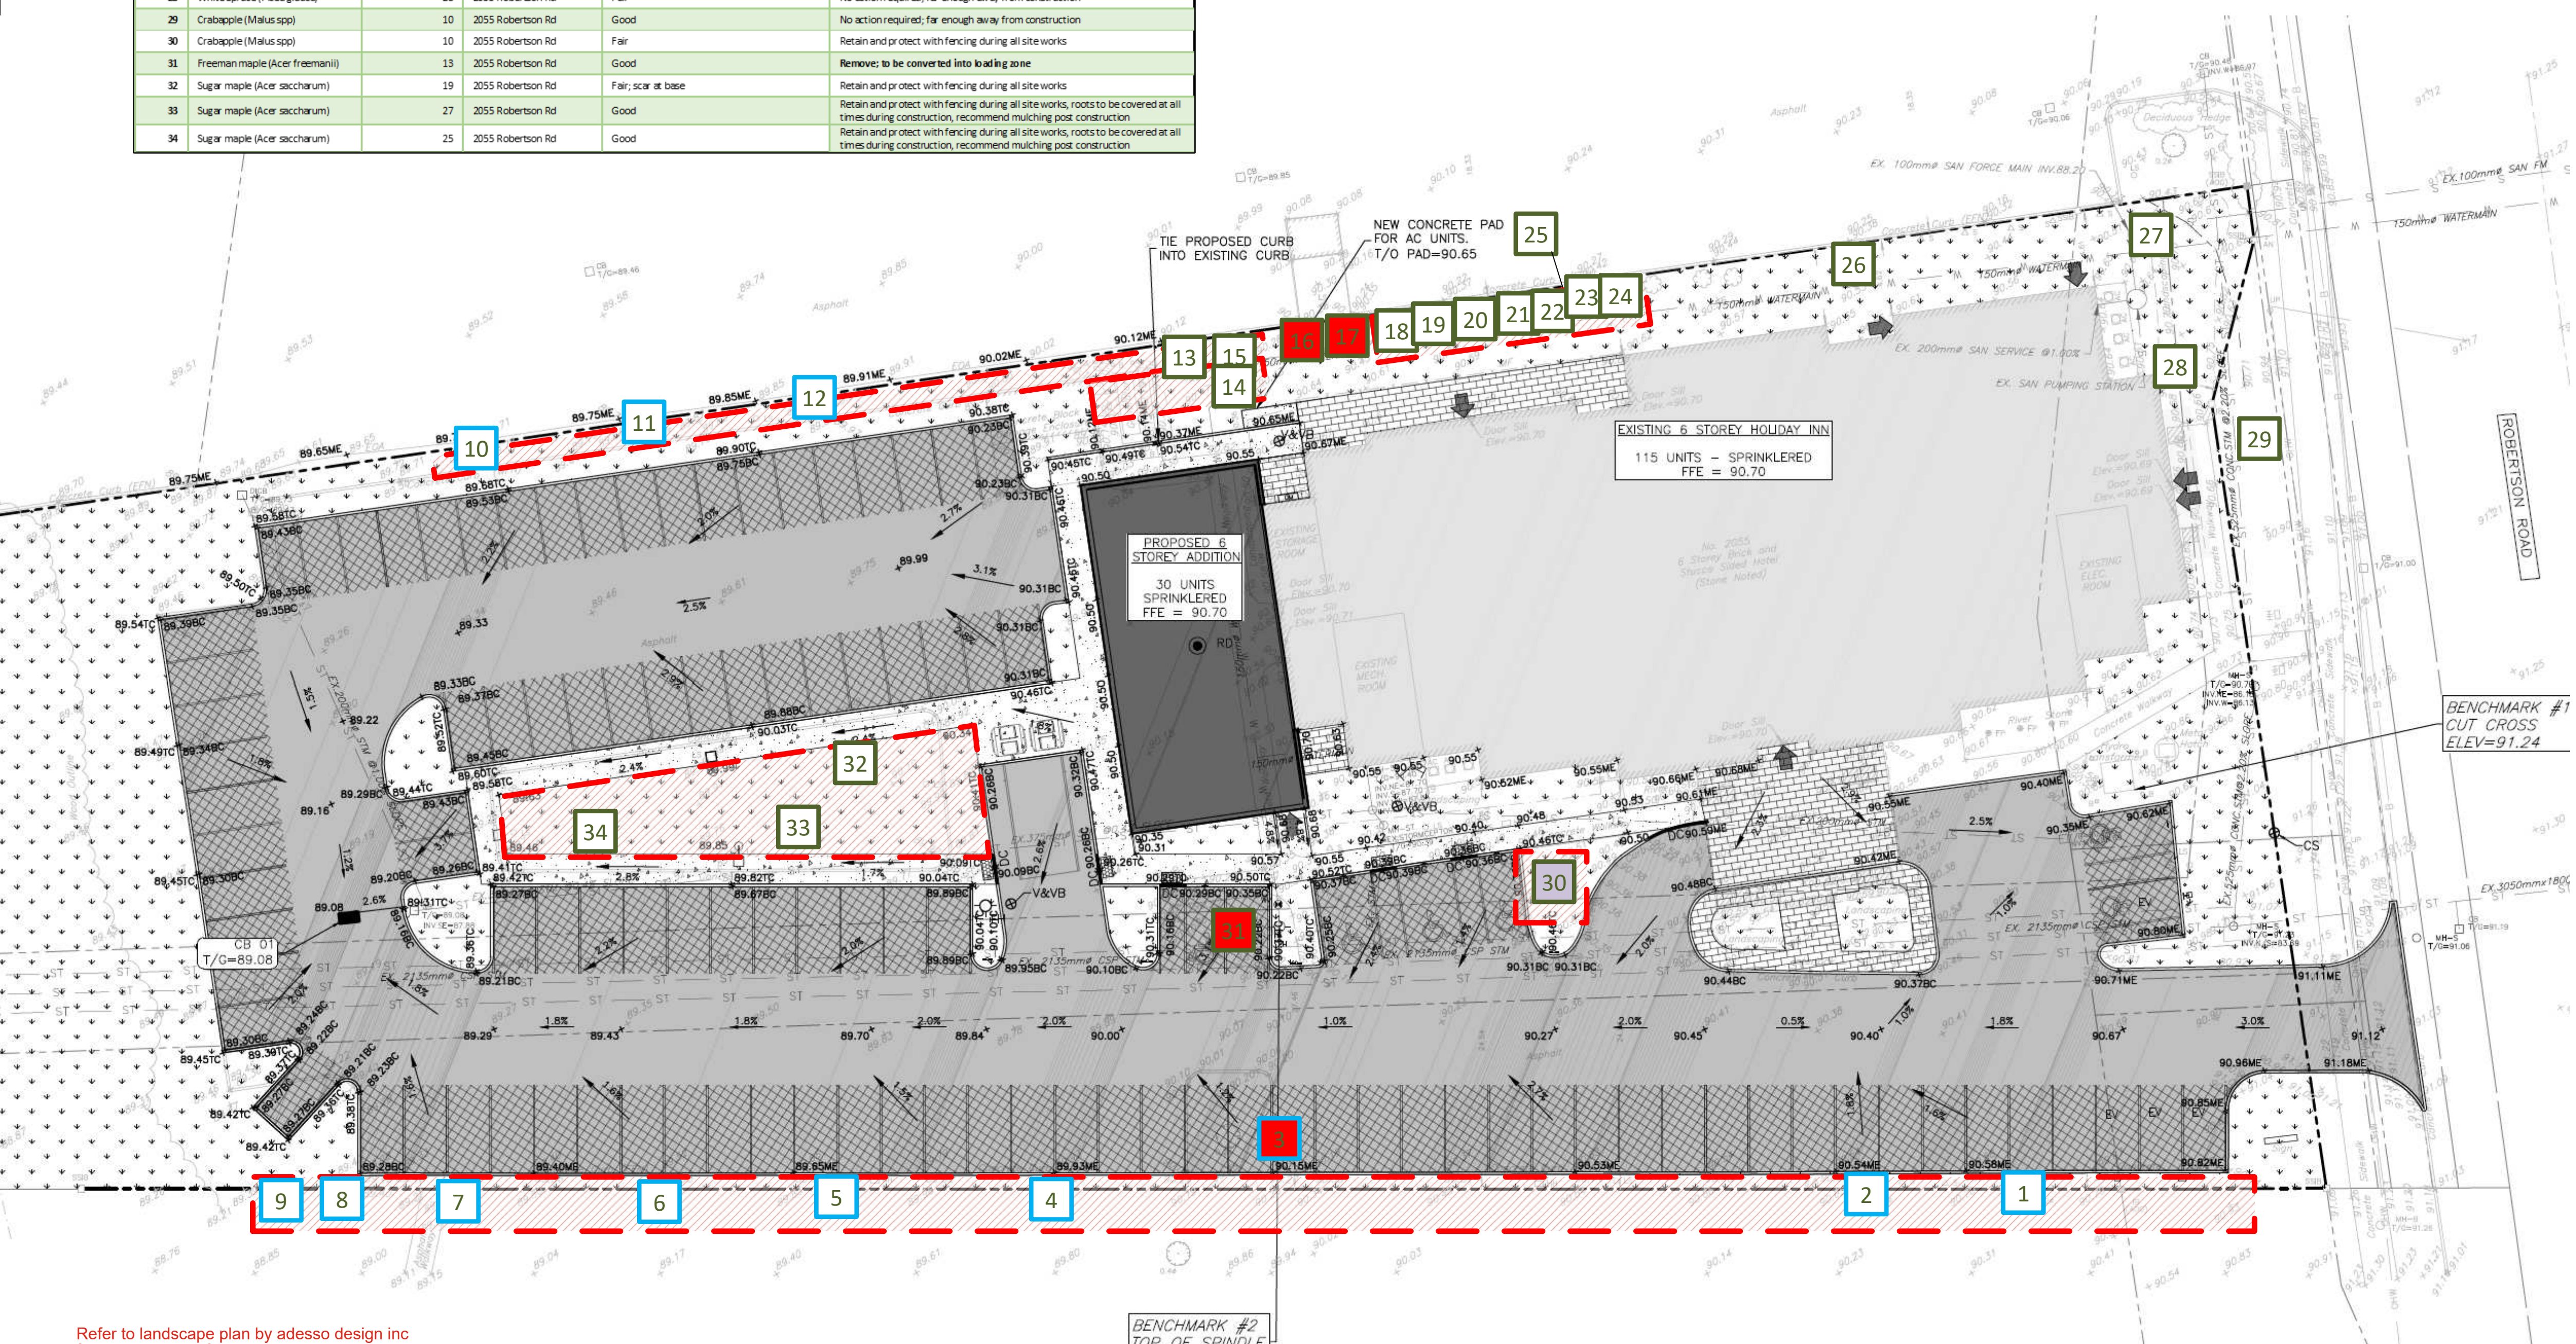
TCR Map#2: Proposed Development and Conserved Vegetation – 2055 Robertson Rd

The location of the parking area will shift slightly along the east property line that will result in an increase in soft surface. This will be of benefit to the trees 10-12 as their rooting area will increase. Along the west property line, there will be no change in the location of the parking lot and there should be no impact on the trees along here except for **tree 3** where the existing bulb out will be replaced with additional parking units. The remaining trees along this edge can be retained effectively if they are protected property and all equipment stays out of the grassy area. Any branches that are in the way of equipment should be pruned ahead of time by an arborist to avoid breakage.

There will be a shift to the loading zone which will result in the removal of **tree 31**. The current amenity area with picnic area will result in a decrease in soft scaping due to a new pathway adjacent to the parking area. This will impede within the critical root zones of **tree 32, 33 and 34**. Since they are still relatively young, they may be resilient enough to withstand the stresses of construction and rooting area loss. Protection of this entire area during the whole project will be key in ensuring their long-term viability. Additional mitigation measures are also recommended such as manual root pruning, watering and mulching.

Trees 16 and 17 are in direct conflict with proposed servicing as a new pipe is required to connect to the old water service (see site servicing plan).

Base Layer: Grading plan prepared by exp dated November 21, 2025

Prior to any site works, protective fencing should be installed around the Tree Protection Area as indicated in *Map#2, Proposed Development and Conserved Vegetation* and maintained until all construction on site has been completed as per the City of Ottawa Tree Protection Specifications (March 2021).
