## **Phase I - Environmental Site Assessment**

3113 Carp Road  
Ottawa, Ontario

June 3, 2022

Report: PE5734-1R

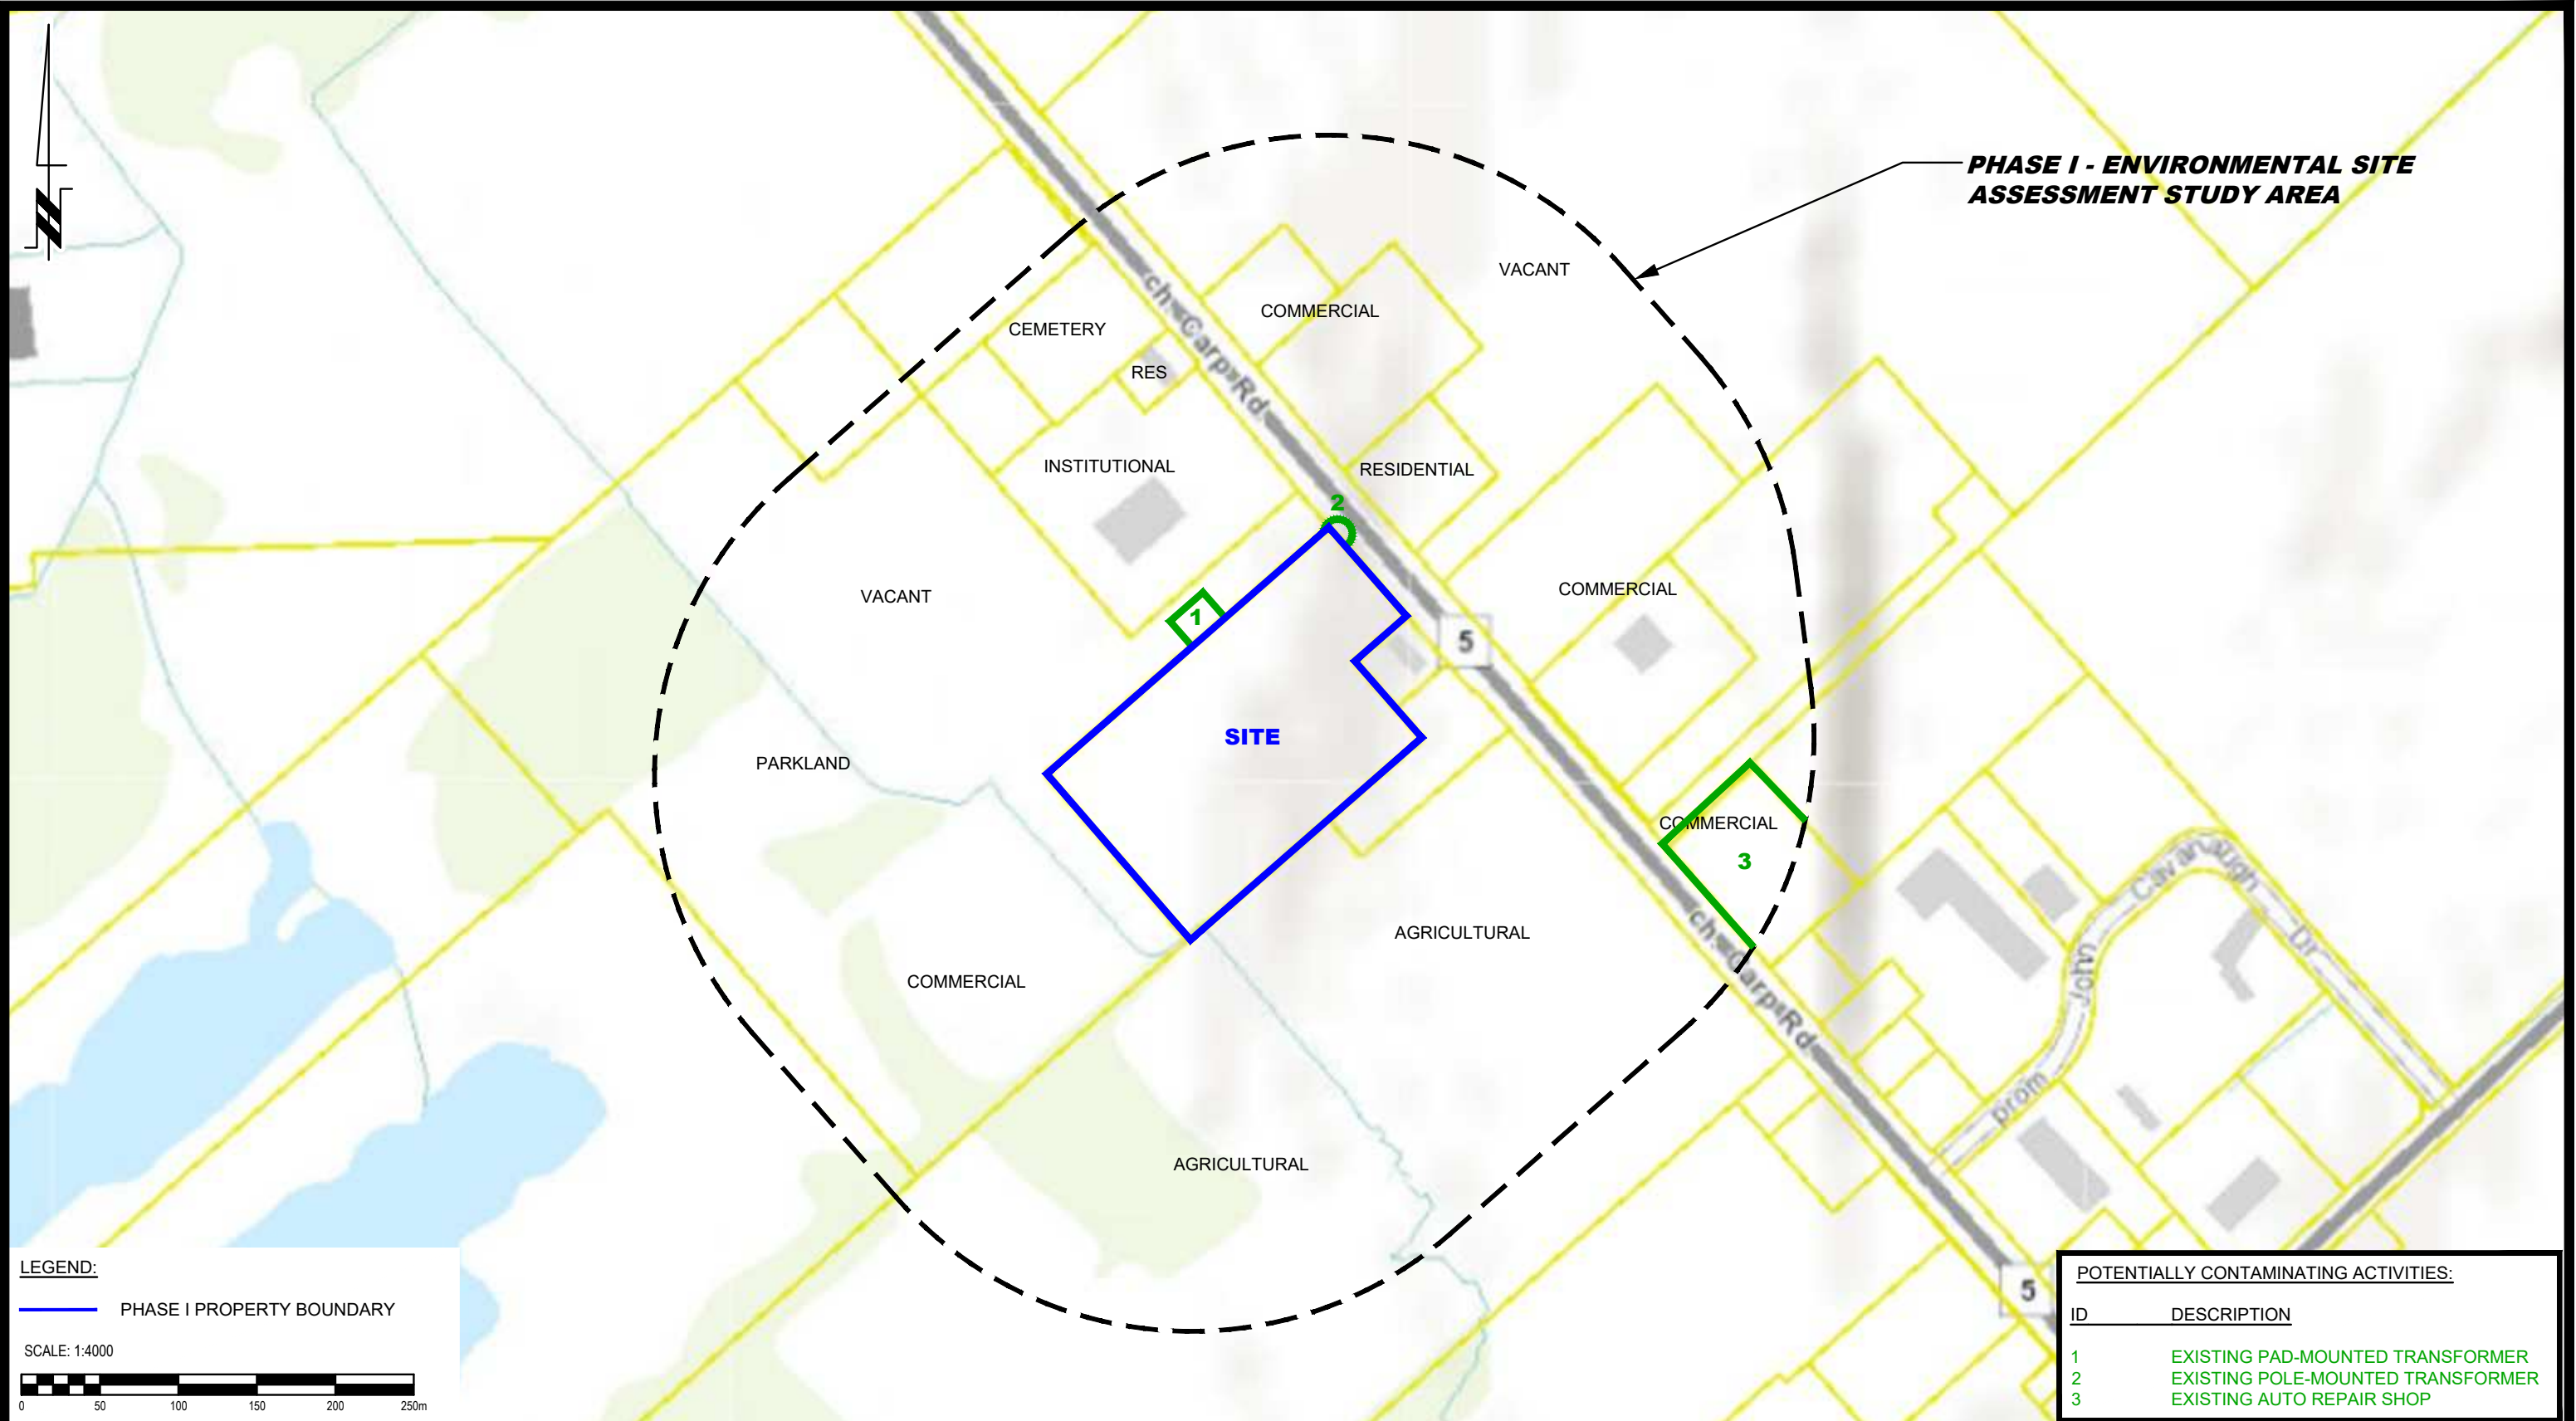
**DRAWING PE5734-2R – SURROUNDING LAND USE PLAN**

An automotive repair shop is present at 3070 Carp Road (approximately 210 m northeast of the subject site). Due to its significant distance away, it does not pose a potential environmental risk to the subject site. Current land use adjacent to the subject site is illustrated on Drawing PE5734-2R – Surrounding Land Use Plan, appended to this report.

Three off-site PCAs were identified within the Phase I study area pertaining to an existing automotive repair shop, one pad mounted transformer and one pole mounted transformer along the western and northern boundaries of the subject site, respectively. They were deemed not to be of any environmental concern to the subject site due to the lack of leakage or staining from those units.

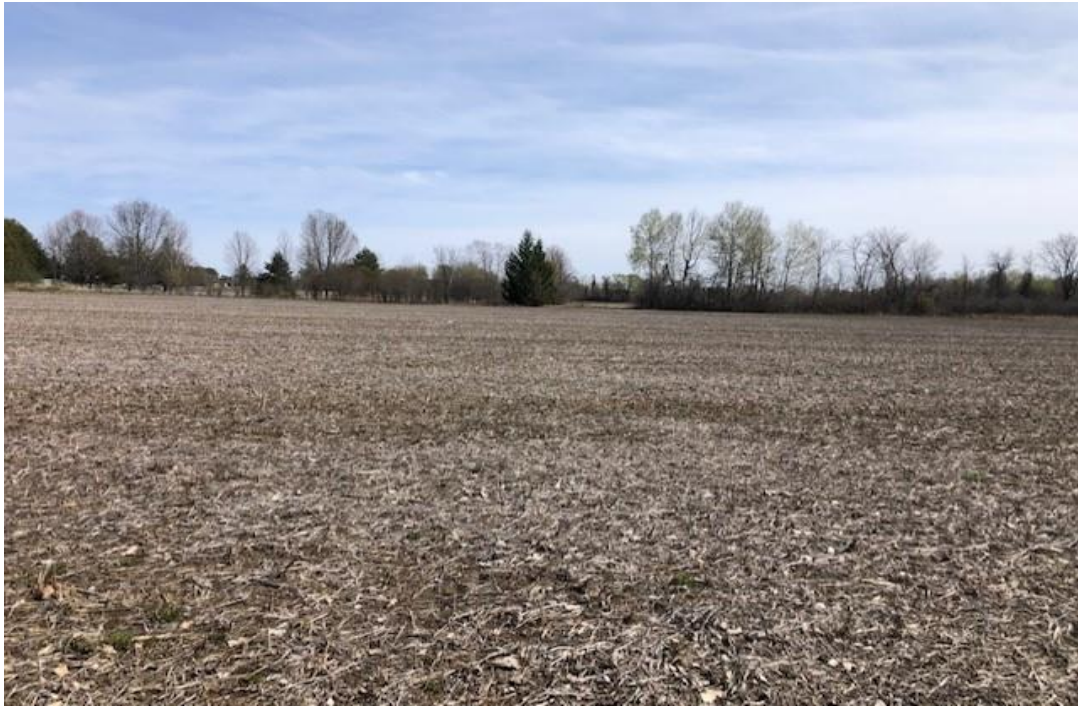
Photograph 1: View of the western portion of the subject site, facing east.

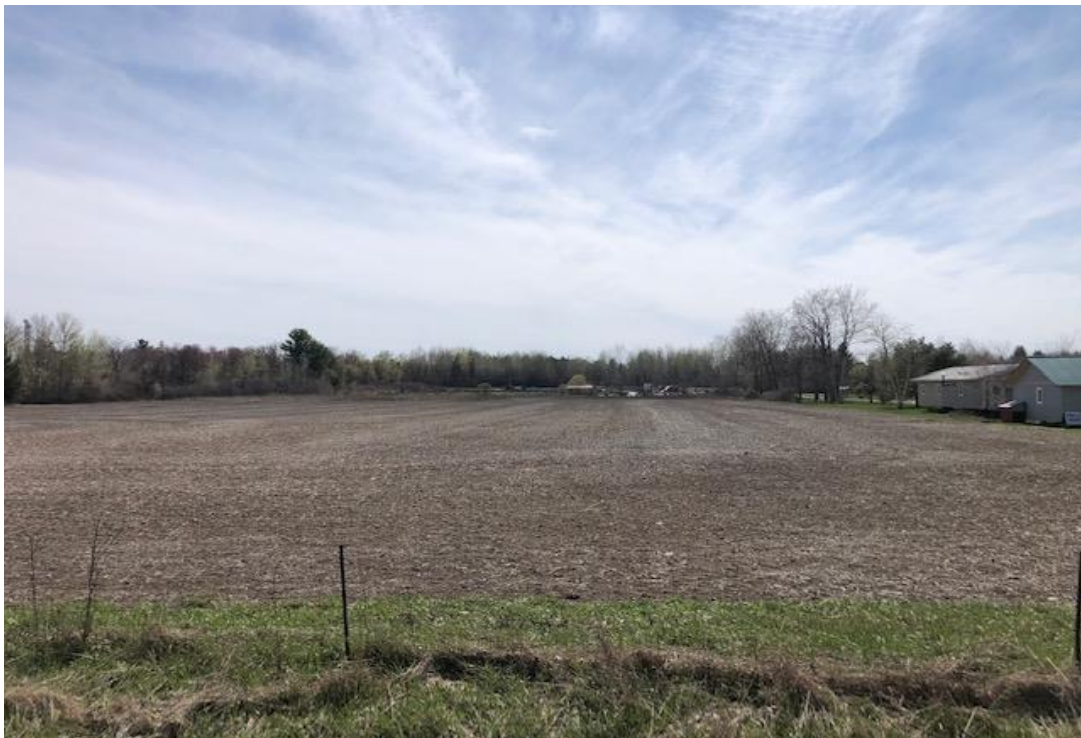
Photograph 2: View of the northern portion of the subject site, facing south.

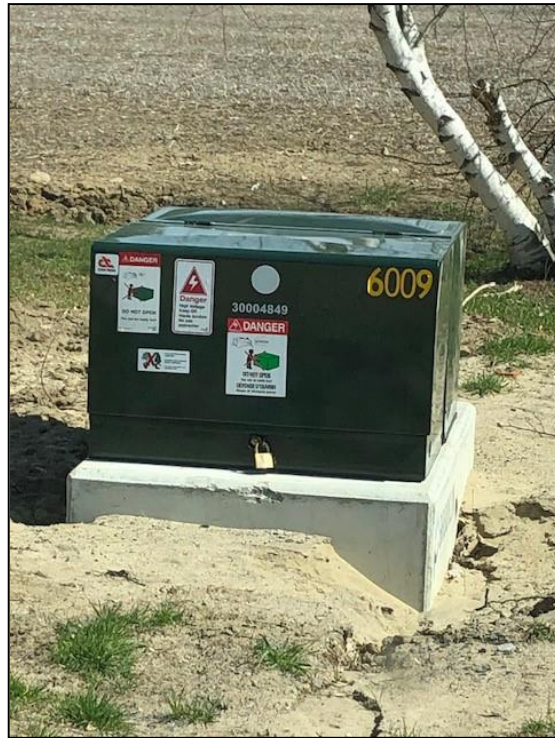
One pad mounted and one pole mounted transformer are present off-site, along the western and northern boundaries of the subject site, respectively. No leakage or staining were observed from these units. The transformers are considered to be potentially contaminating activities (PCAs) that do not result in areas of potential environmental concern (APEC).

Photograph 3: View of the pad mounted transformer along the western boundary of the subject site.
