**PH5068-LET.01.REV.01**

Subject: **Hydrogeological Assessment and Terrain Analysis**  
**3113 Carp Road**  
**Ottawa (Carp), Ontario**

## INTRODUCTION

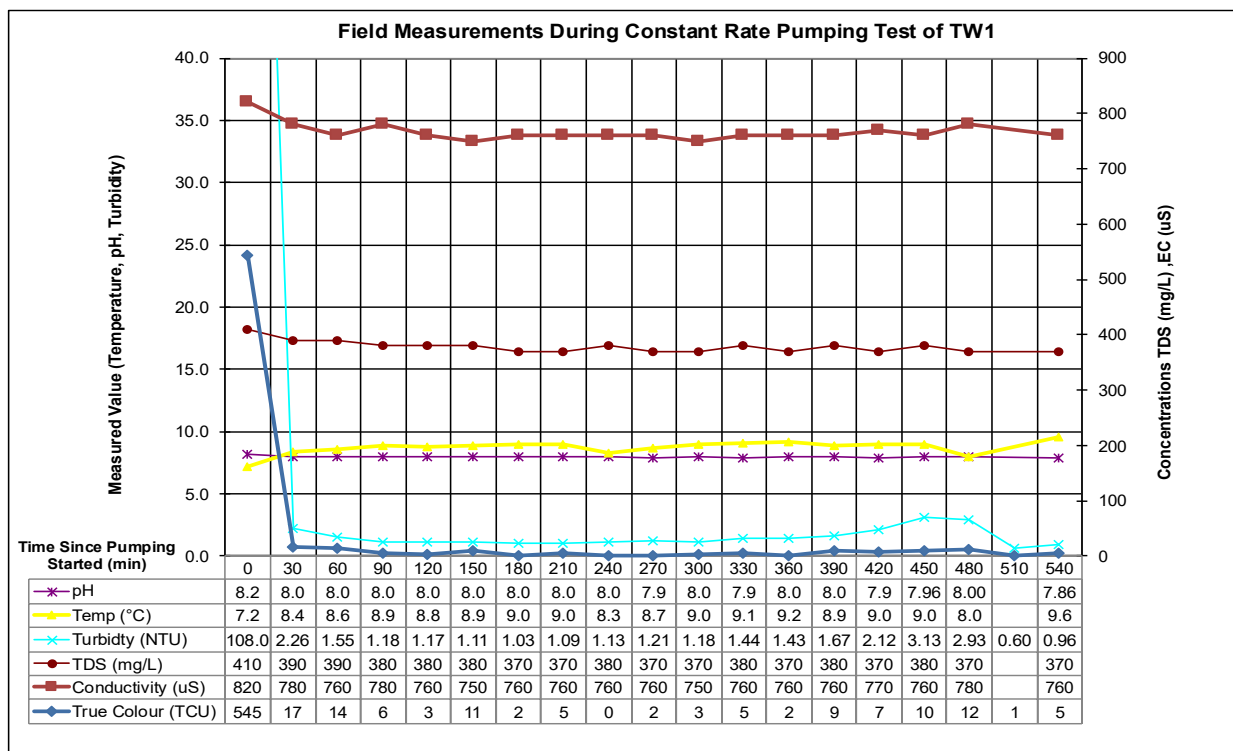
Figure 1: Field Measurements During Constant Rate Pumping Test of TW1

Turbidity, electrical conductivity, total dissolved solids (TDS), pH, true colour and temperature were measured at the wellhead during the pumping test. The measurements and time intervals for each of these parameters are summarized on the graphical representation below. In addition, a HACH Pocket Colorimeter II chlorine reader was used to measure the free chlorine residual level. No chlorine residual was detected in the discharged water prior to the collection of the water samples.

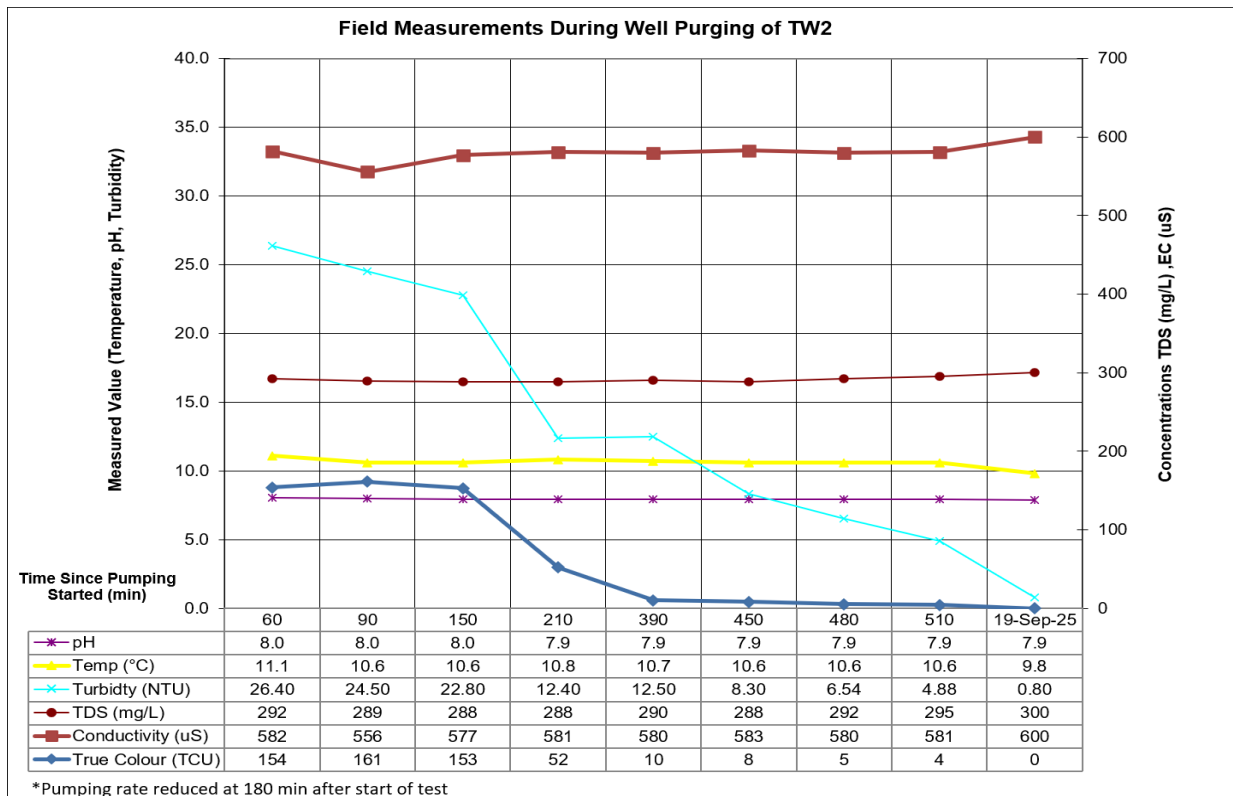
Figure 2: Field Measurements During Well Purging of TW2 on August 28, 2025 and September 19, 2025

According to the WWR for TW2, TW2 was purged at a rate of 74 L/min and experienced a total drawdown of 1.1 m. After 3 hours of discharging at 74 L/min, a total drawdown of 1.1 m was observed by Paterson personnel. After the 3-hour mark, the discharge rate was decreased to 38 L/min for an additional 4 hours. The total quantity discharged during the well purge of TW2 on August 28, 2025 was 22,440 L.

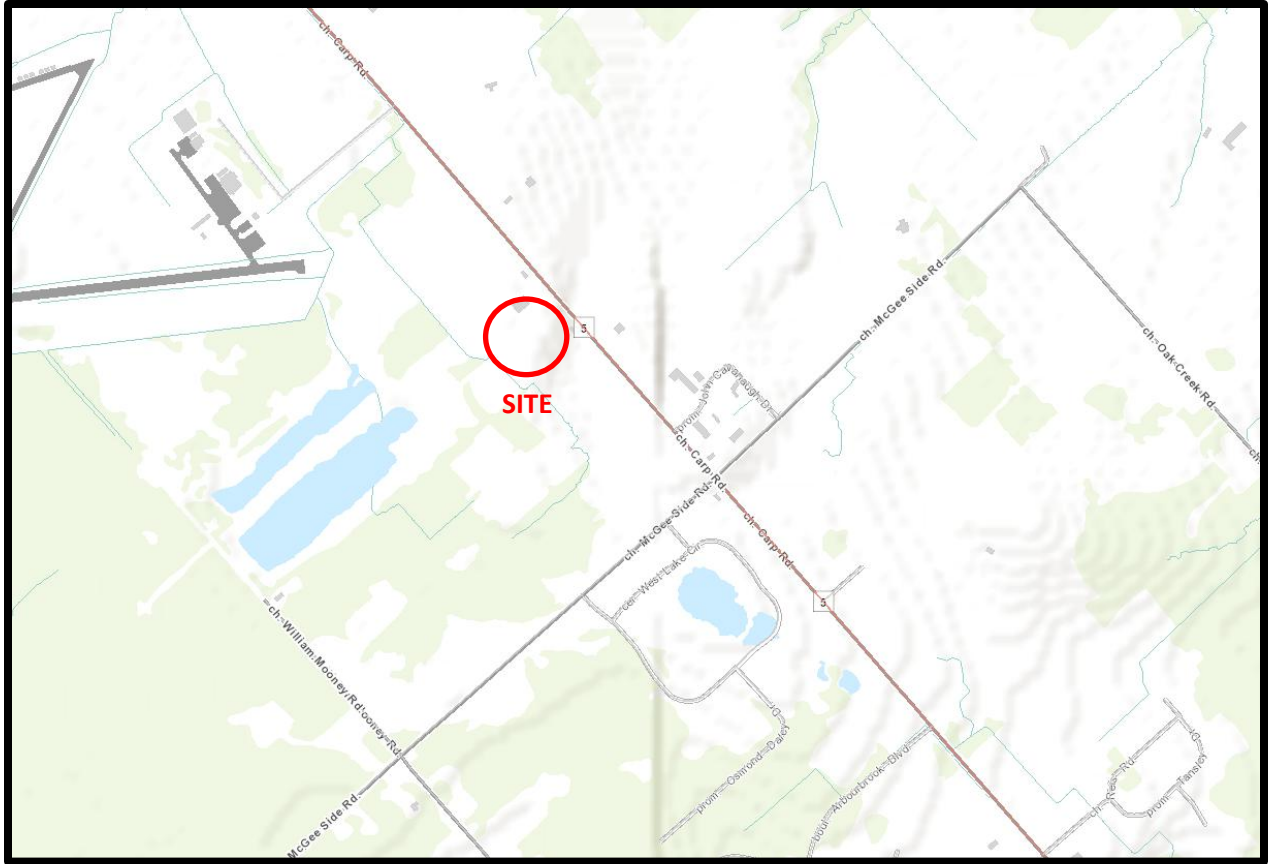
**FIGURE 1**

**KEY PLAN**

The subject site is an approximately 3.06 ha lot and is currently vacant. Historically it has been used for agricultural activities. The Site Plan Application is for a proposed new commercial building and associated infrastructure. Please refer to Figure 1 - Key Plan and Studio G-68 & RP Ancheta Architect Drawing A-012 Rev.0.10 dated July 27, 2026 attached for the proposed site location and site layout.

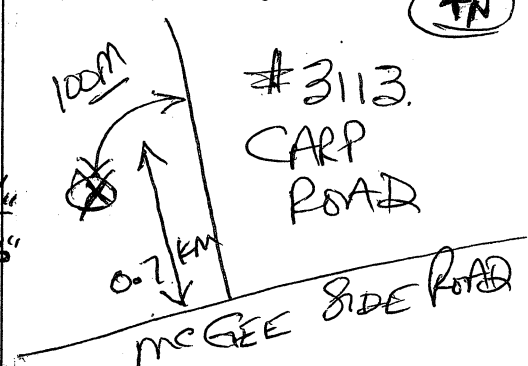
Comments:  
**1HP - 20 GPM Set @ 100 FT**

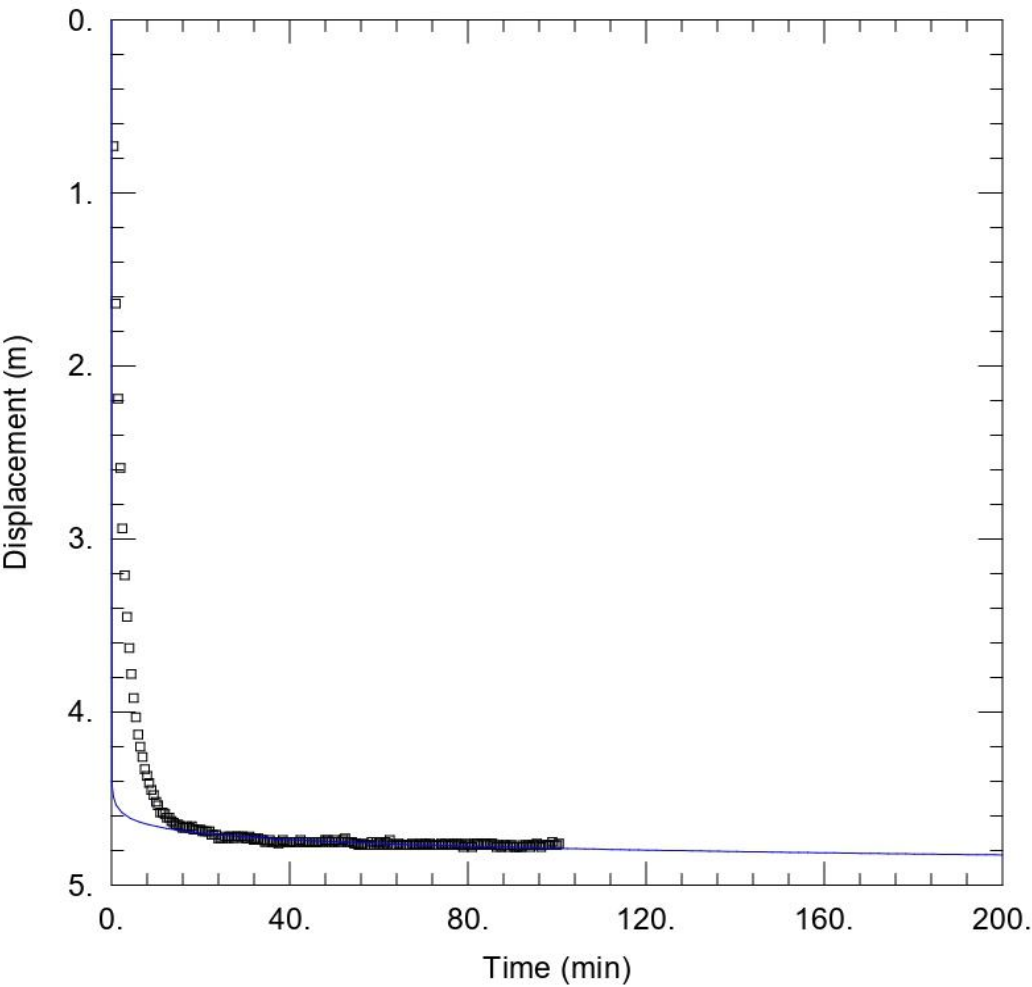
**Pumping Test Analysis Report**

| Site Address: | 3113 Carp Road, Ottawa | Discharge Rate (L/min) | 45.4 |

Recovery data was collected from the well following the completion of the pumping. The well was noted to have achieved 95% recovery approximately 5 minutes after the completion of pumping.

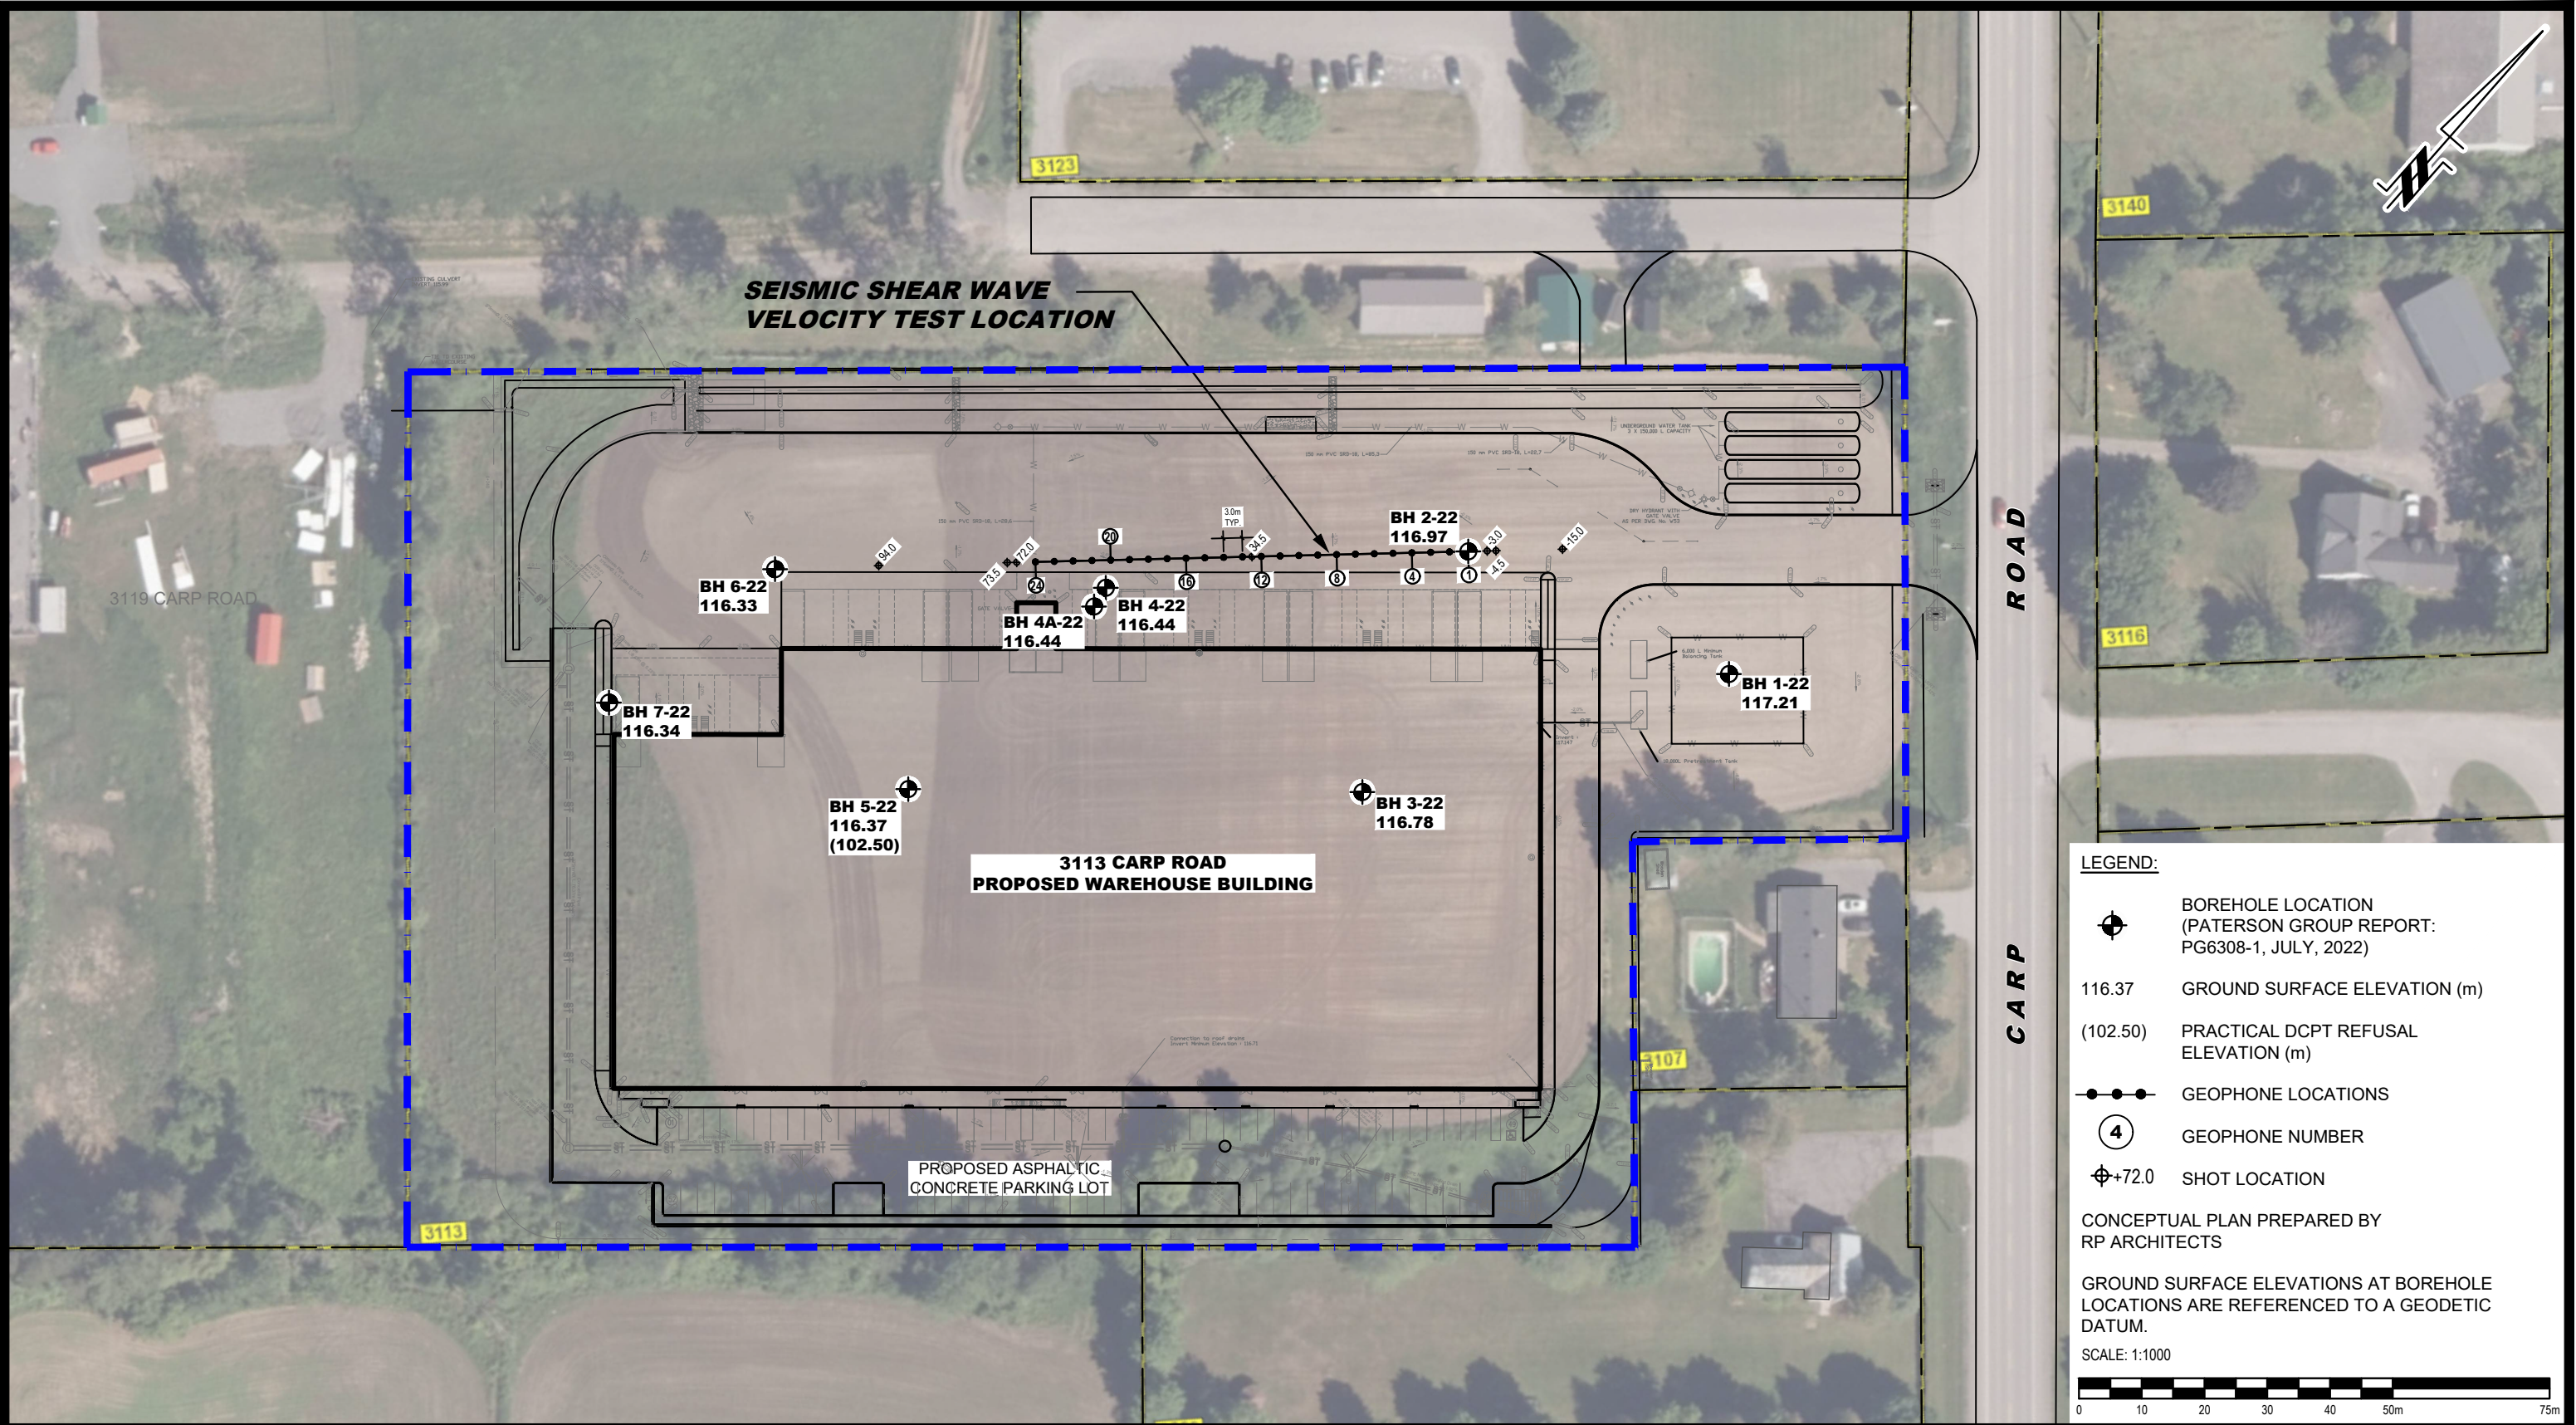
- BOREHOLE LOCATION  
(PATERSON GROUP REPORT: PG6308-1, JULY, 2022)
- 116.37 GROUND SURFACE ELEVATION (m)
- (102.50) PRACTICAL DCPT REFUSAL ELEVATION (m)
- GEOPHONE LOCATIONS
- GEOPHONE NUMBER
- SHOT LOCATION

A series of boreholes were put down on the subject site to delineate the subsurface soil conditions as part of the Geotechnical Investigation (Paterson Report PG7598-REP.01 dated July 31, 2026). Between June 23 and 28, 2022 seven (7) boreholes were completed on the property for the design of the proposed commercial building and its associated infrastructure. The boreholes were advanced to a maximum depth of 7.3 m below ground surface (bgs). One borehole was subjected to a Dynamic Cone Penetration Test (DCPT) which extended to a depth of 13.9 m bgs. Six (6) boreholes were completed within the proposed footprint of the commercial building, and one (1) borehole was completed in the proposed septic bed area. The locations of the boreholes on the property are delineated on the Test Hole Location Plan, drawing PG7598-1, attached.

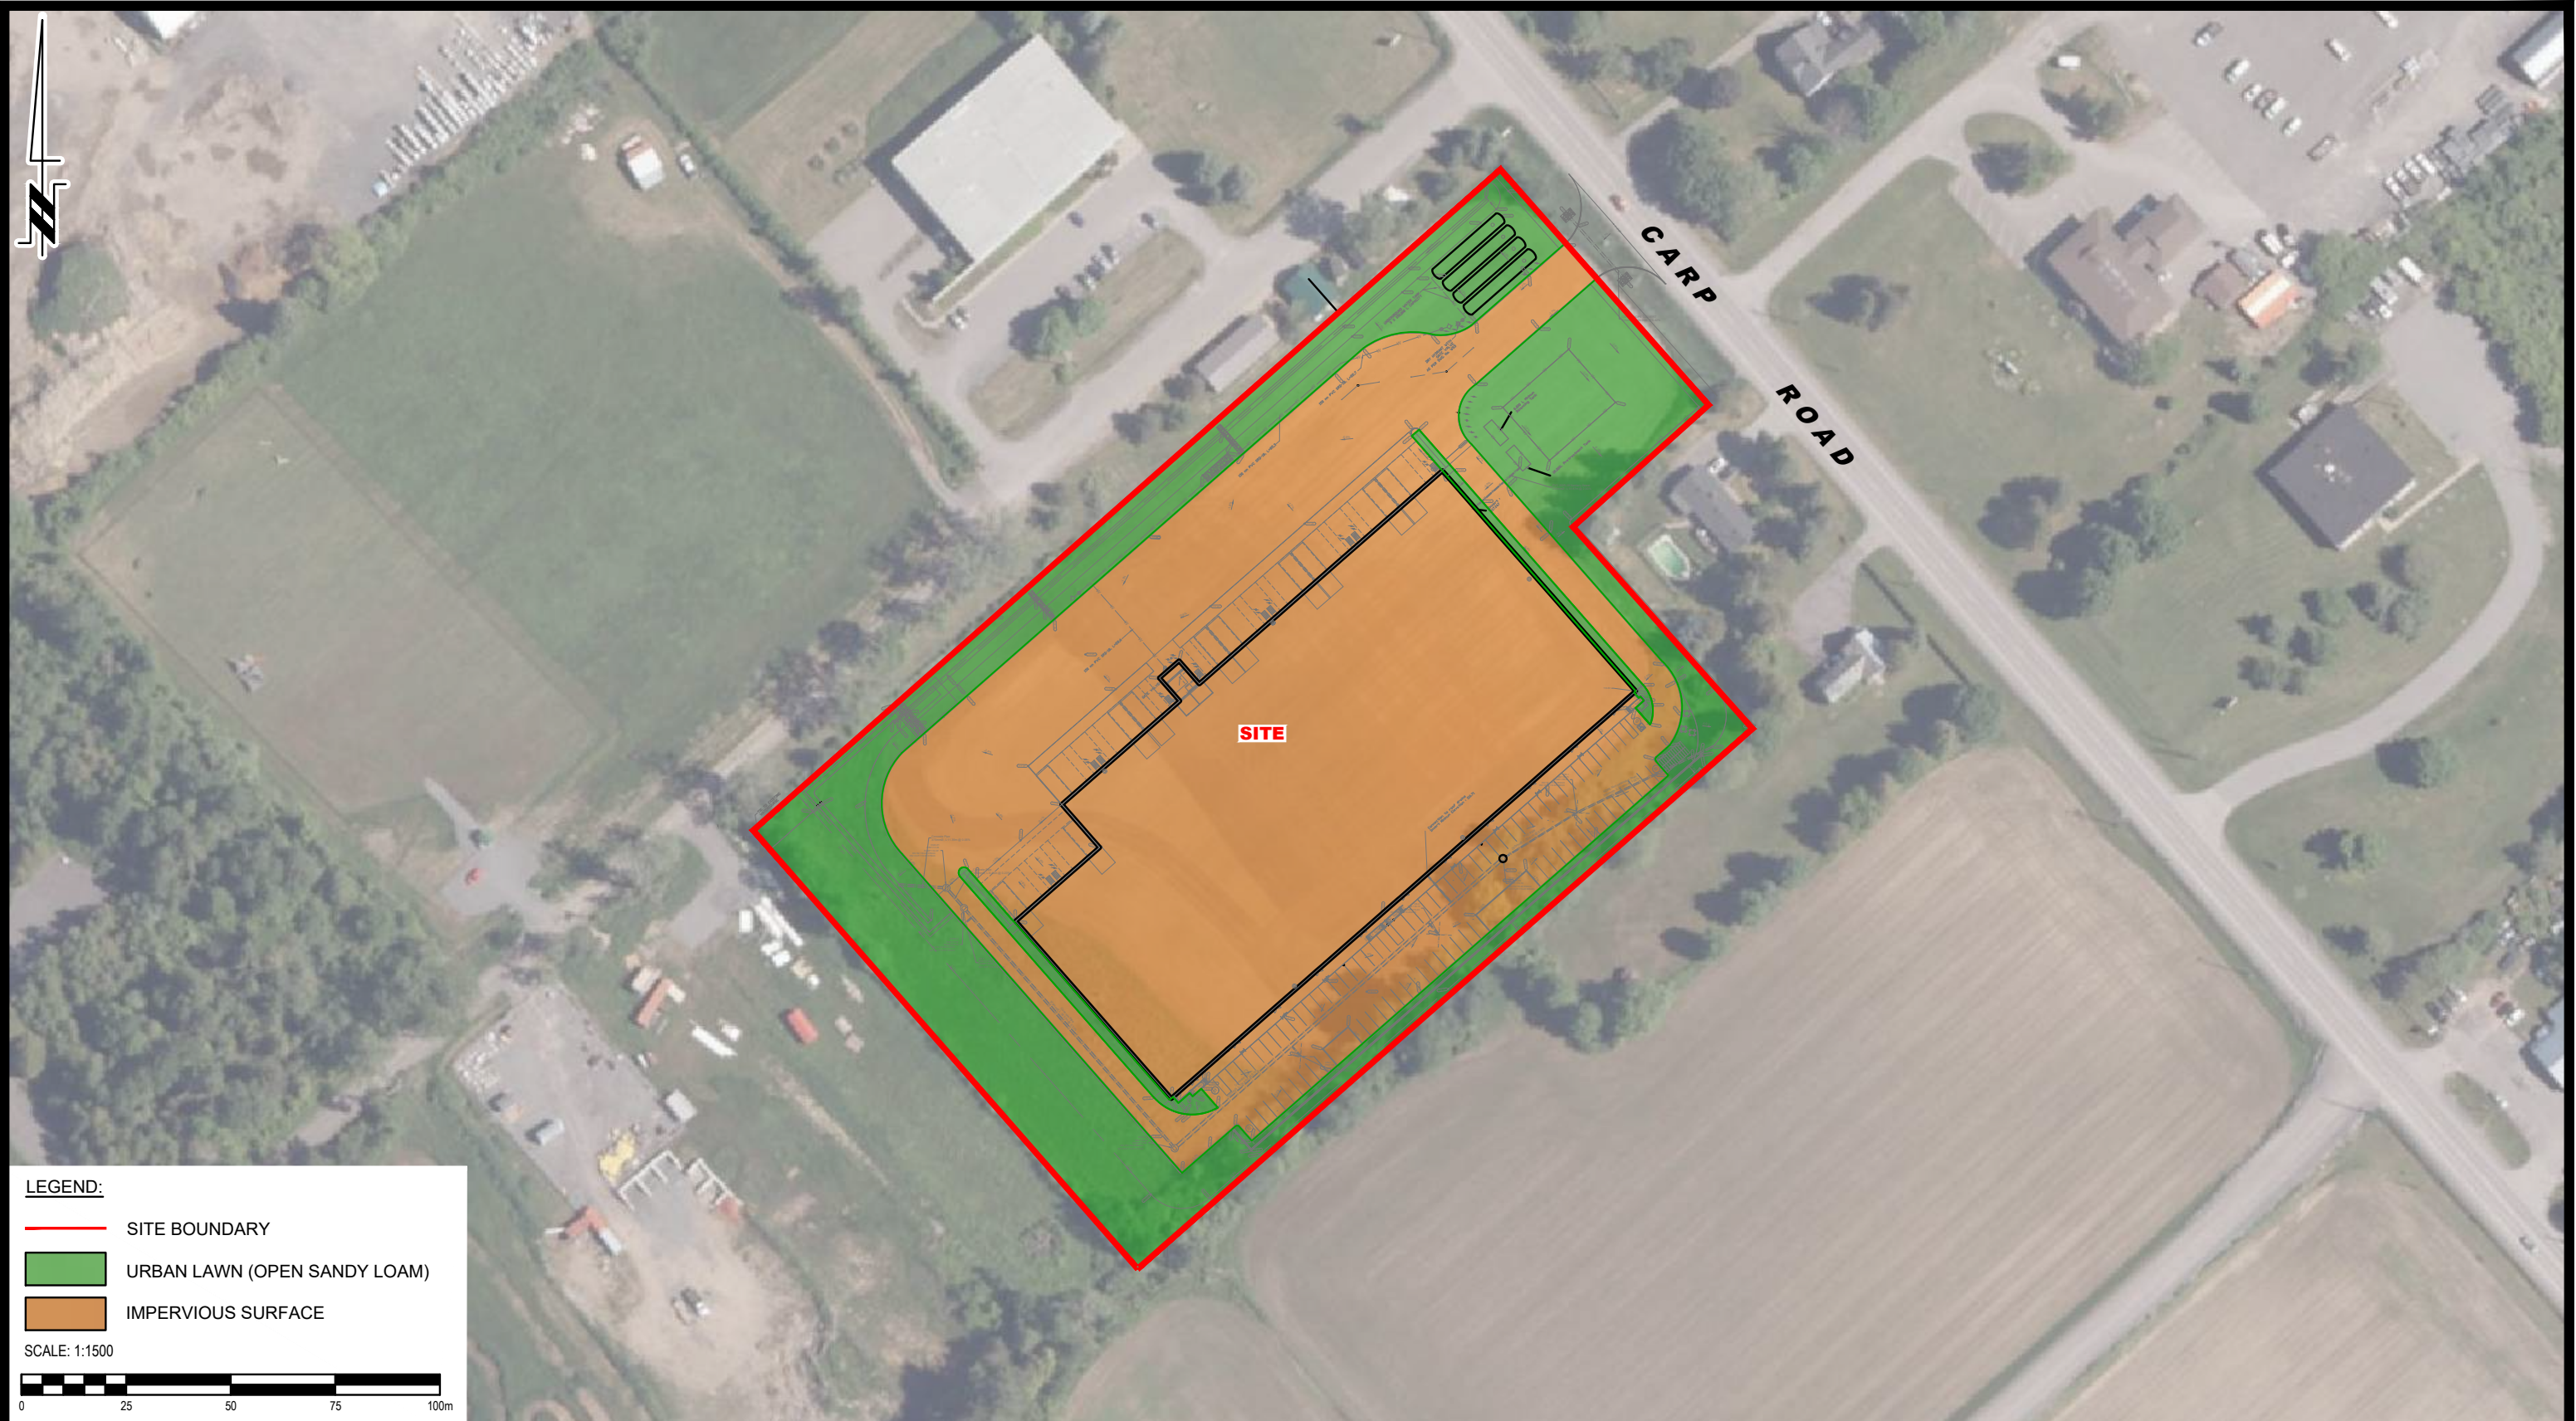
- SITE BOUNDARY
- URBAN LAWN (OPEN SANDY LOAM)
- IMPERVIOUS SURFACE

As previously discussed, soils within the subject site generally consisted of topsoil overlying a sandy loam layer. Therefore, a pre-development soil infiltration factor of 0.4 was given for the materials analyzed on this property. Under post-development conditions, the majority of the site will consist of landscaped areas and impervious surfaces with soil infiltration factors of 0.4 for urban lawn (open sandy loam) and 0 for impervious surfaces.

At the time of the field investigations, the subject site generally consisted of cultivated farmland. A pre-development vegetation infiltration factor of 0.1 was assigned to the subject site. Post-development, areas of cultivated farmland are expected to be removed to accommodate buildings, landscaped areas and roadways. As such, a post-development vegetation infiltration factor of 0.1 was assigned to the developed areas. Impervious surfaces were given a vegetation infiltration factor of 0 due to their negligible potential to benefit from vegetation cover.

The post-development water budget analysis determined that an estimated 2,586,004 L/year of surplus water will infiltrate the surface soils and approximately 10,445,480 L/year will leave the site as runoff. These values equate to an approximate decrease in infiltration of 68.1 % and an increase in runoff of 200.8 %.

The main variable that changed from pre-development conditions to post-development conditions was the addition of approximately 20,796 m<sup>2</sup> of impervious surfaces. This results in reducing the area of pervious materials throughout the subject site, therefore reducing the overall infiltration potential of the subject site. The remaining areas that are not being converted to impervious surfaces will become landscaped surfaces characterized by urban lawn (open sandy loam) material. These landscaped areas have similar infiltration potential to the native silty sand soils (open sandy loam).
