## Phase One Environmental Site Assessment

1144 St. Pierre Street, Ottawa, Ontario

OTT-25016073-A0

December 18, 2025

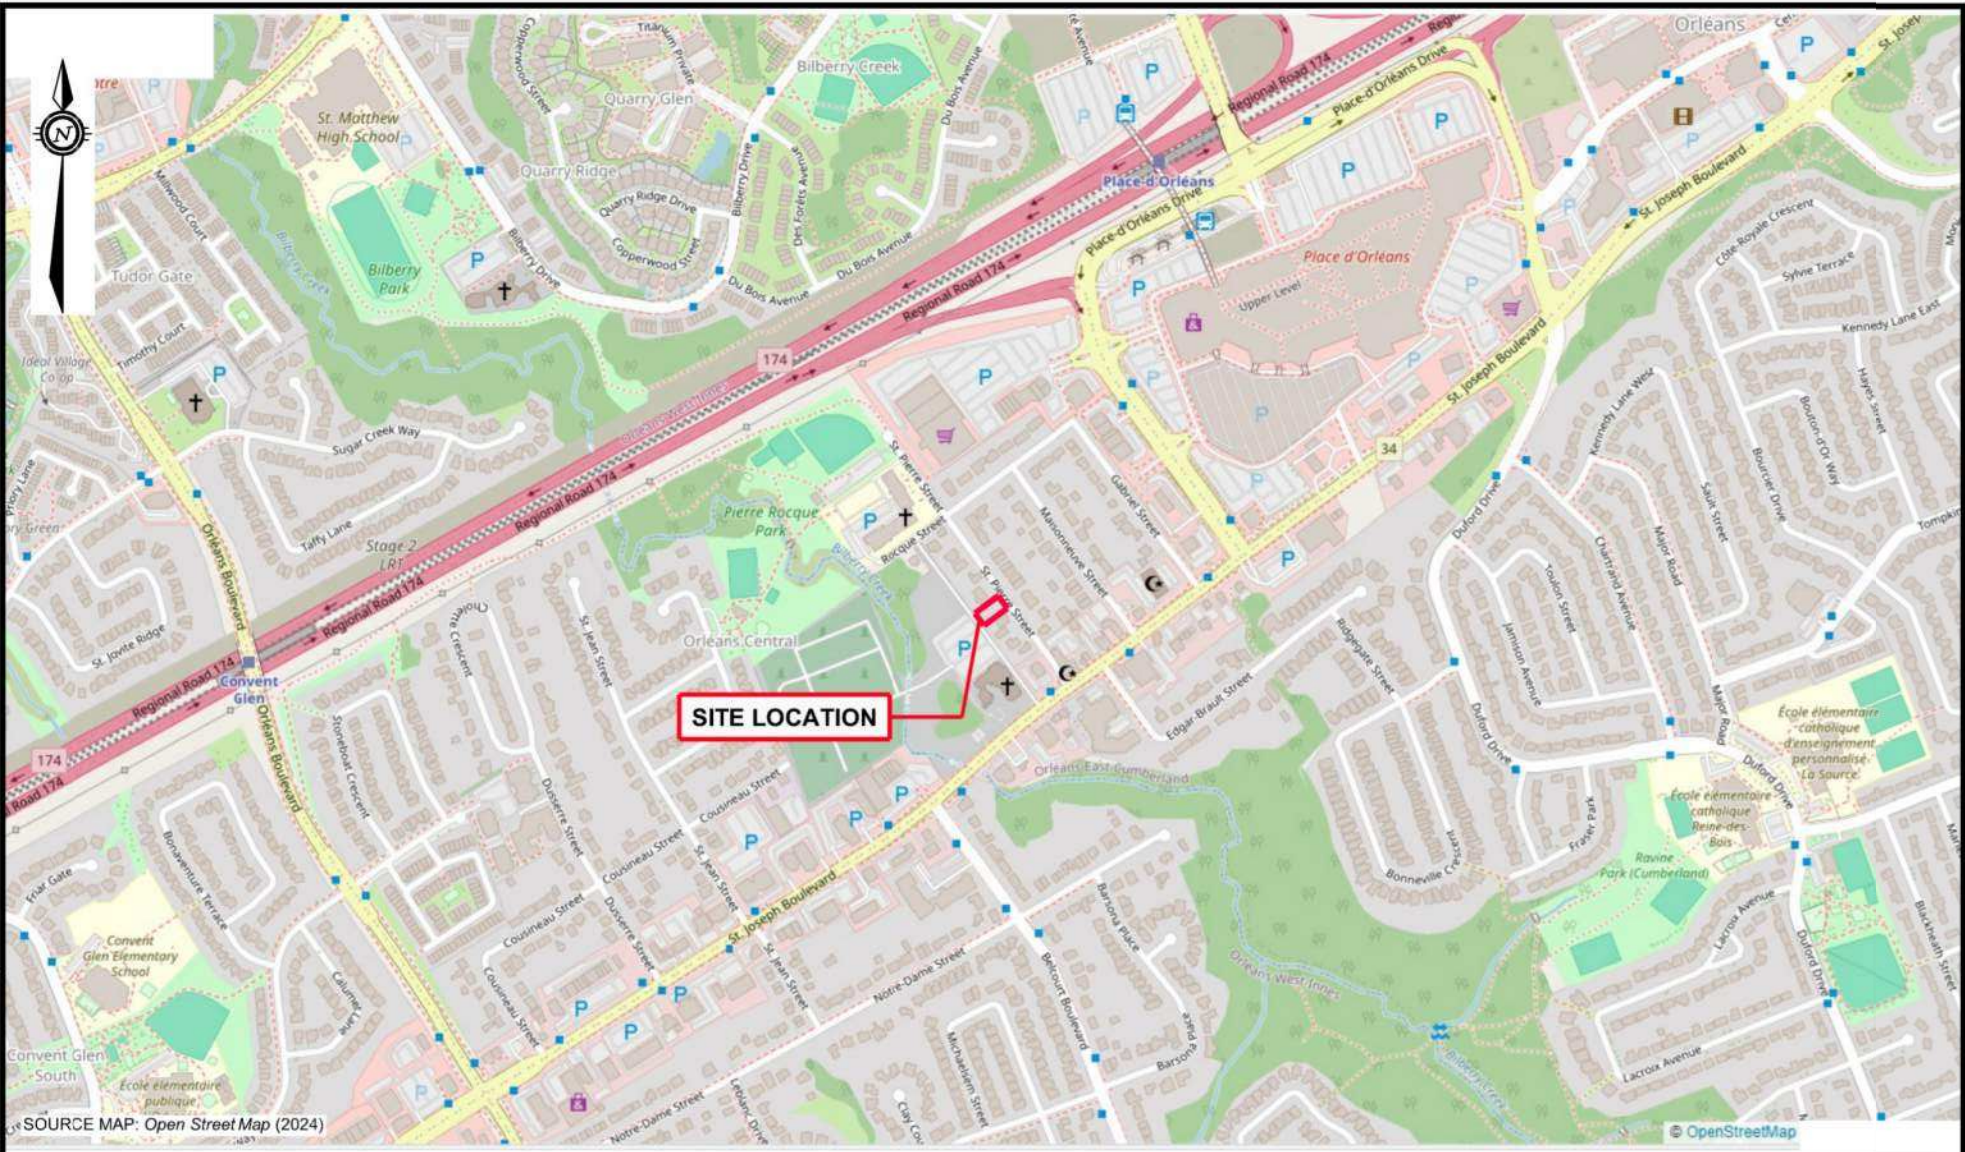
| | | TITLE:<br>SITE LOCATION PLAN | FIG 1 |

The Phase One property is located on the west side of St. Pierre Street, between St. Joseph Boulevard and Rocque Street as shown in Figure 1 in Appendix B. At the time of the investigation, the Site was vacant. The subject site is found in an urban residential neighbourhood which is serviced by municipal water and sanitary systems, as well as connected to overhead electrical supply and buried natural gas networks.

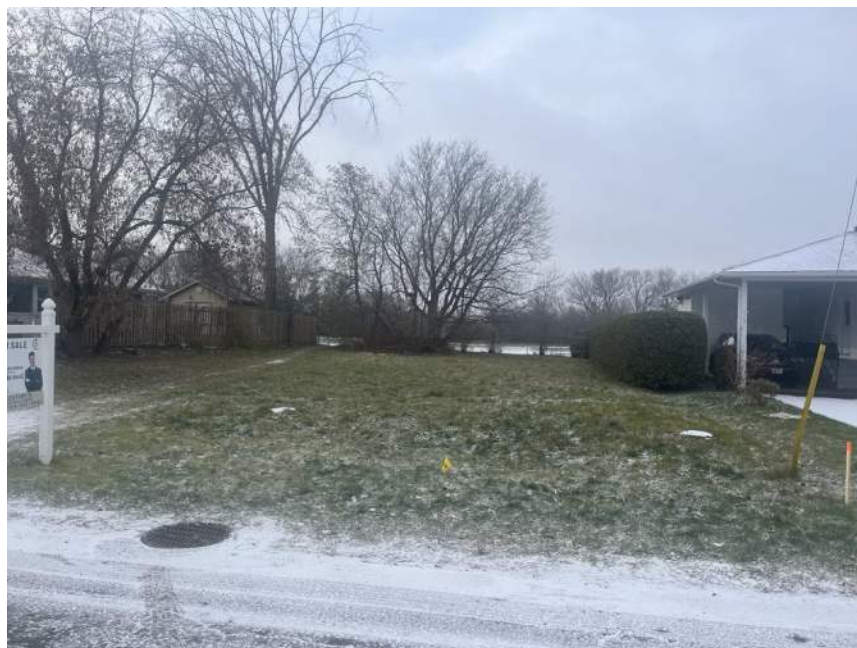
**Photograph No. 1**

No areas of notable staining of soil were observed on the Phase One property at the time of EXP's site visit.

There were no buildings or structures observed on the Phase One property. There were no hazardous building materials or designated substances identified on the Phase One property.

View of the Phase One property looking west
